54 Eglinton Street, Beith: Archaeological Watching Brief

Data Structure Report

issued 30th June 2015

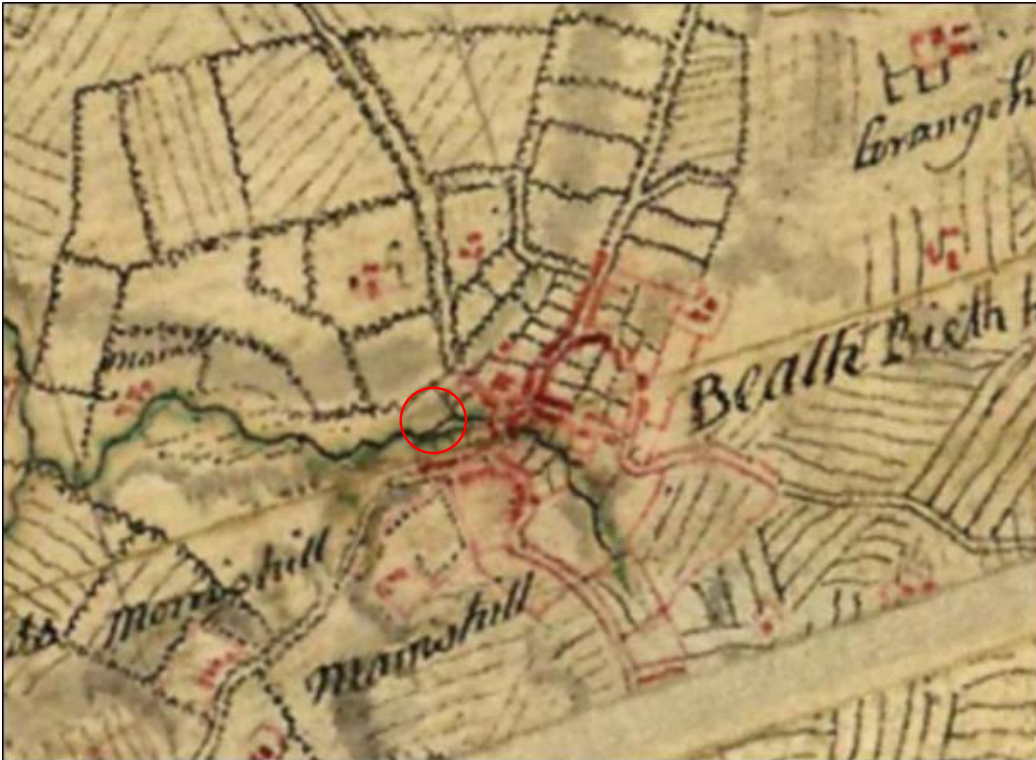
Figure 1a: Roy's Military Survey (Lowlands 1747-55)

5. The West of Scotland Archaeology Service (WoSAS) have recognised an area of archaeological potential based around the likely medieval town of Beith (WoSAS Pin 51561). This is roughly equivalent to the modern town centre of Beith. The parish church of Beith has a medieval foundation and lies approximately 150m to the east of the development area. The area demarked by WoSAS as being the most likely for the survival of significant archaeological material relating to the medieval town of Beith is analogous with the town as it appears on Roy's Military Survey of Scotland (1747-55) (Figure 1a).

22. The remains of a building in the form of a cellar, [004], and an associated boundary wall were identified within the watching brief area and most likely date to the 19th century though an earlier 18th century date cannot be wholly ruled out as Roy's military survey (Figure 1a) shows a significant number of buildings in Beith, some of which may relate to cellar in Eglinton Street. The original ground level to the NNW of Eglinton Street seems to have been steeply sloping and the cellar appears to have been cut into the side of this slope. This would have meant that there was a very distinct difference in level between the rear and front of the building. The extension wall which ran off the cellar to the NNW at the rear of the building seems to correspond to a property boundary marked on both the 1st and 2nd Ordnance Surveys enclosing the garden.

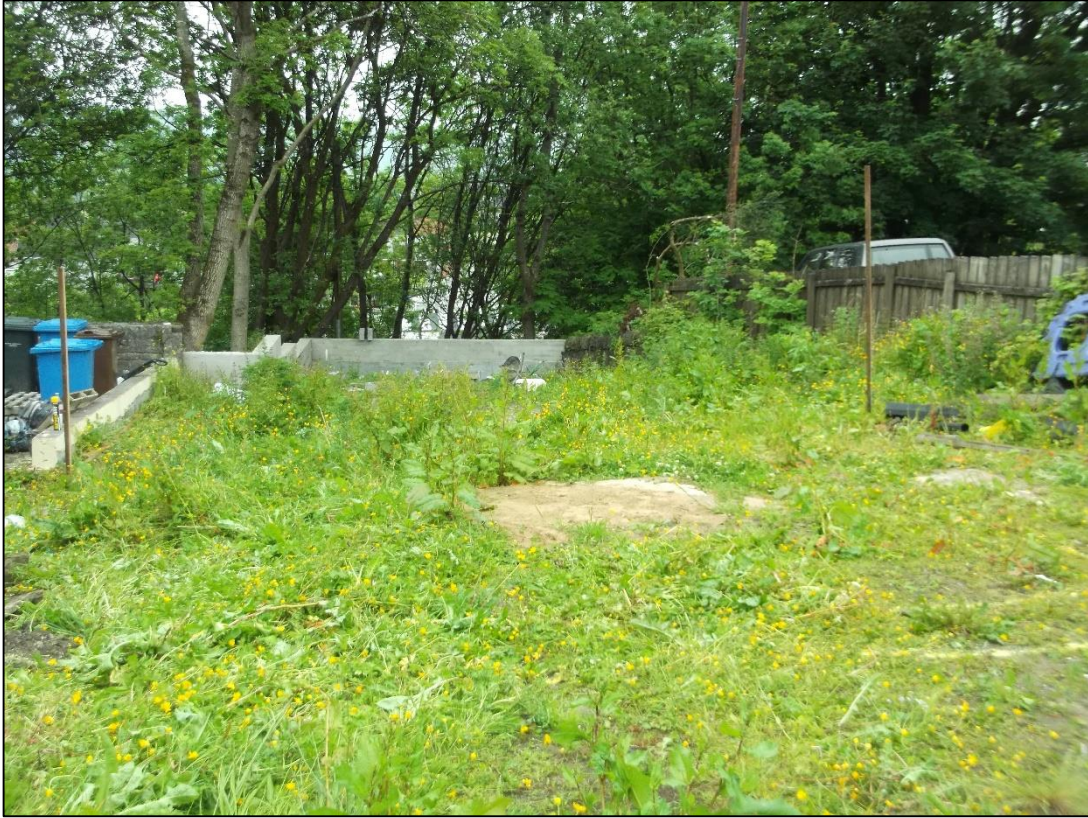
Figure 3a: Pre excavation view of the site. From the S.

12. The excavated area was covered by a very disturbed and overgrown topsoil (001) which consisted of moderately compacted, mixed dark grey/brown, silty sand with frequent inclusions of modern debris (e.g. building stone fragments, brick and domestic refuse). The topsoil layer covered the entirety of the excavated area (Figure 3a), measuring 8.5 m by 7.5m, and also the unexcavated part of the site to the immediate NNW. The topsoil layer had a depth range within the excavated area of 0.1-0.15m thick.

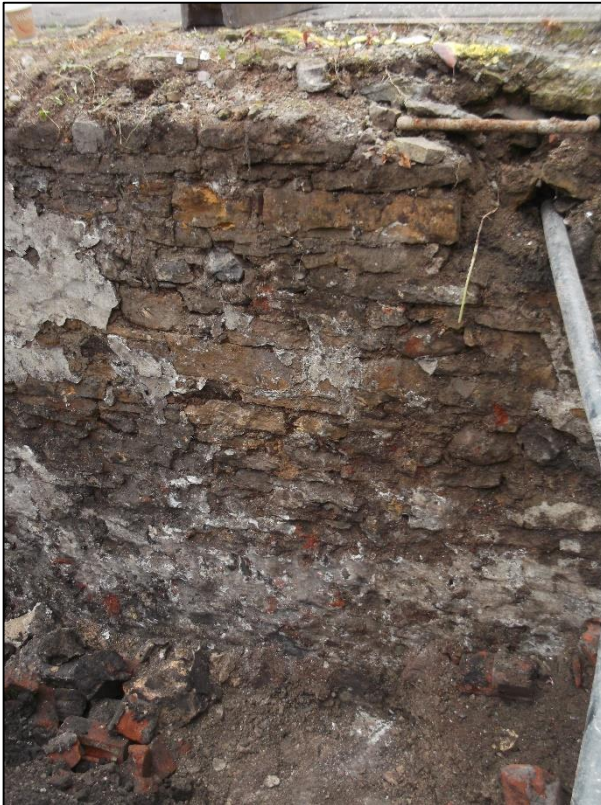
Figure 3b: The SSE wall of the cellar [004] and concrete floor (005). From the NNW.

17. The walls had a consistent width of 0.3m throughout and were built with flat, narrow, slab-like blocks of pale yellow sandstone (measuring 0.5-0.6m long, 0.28-0.3m wide and 0.08-0.12m thick). The bonding for the structure consisted of a pale yellow/grey mortar. The interior faces of the walls were covered, in places, by a pale grey plaster possibly as a form of water proofing. Two beam slots were also observed on the WSW and NNW walls at 0.2m from current ground/street level.

18. These beam slots were roughly square shaped and measured 0.28-0.3m by 0.28-0.3m in size. The walls of the cellar enclosed a concrete floor; (005), which consisted of very compacted mid-grey concrete with what appeared to be aggregate and small and medium sized stones in its make-up. The surface was only uncovered in places (Figure 3b) but it seems probable that it formed the main floor surface within the cellar [004]. The surface covered the entire interior of the cellar measuring 7.2m by 5.7m in extent. The thickness of the surface was unknown.

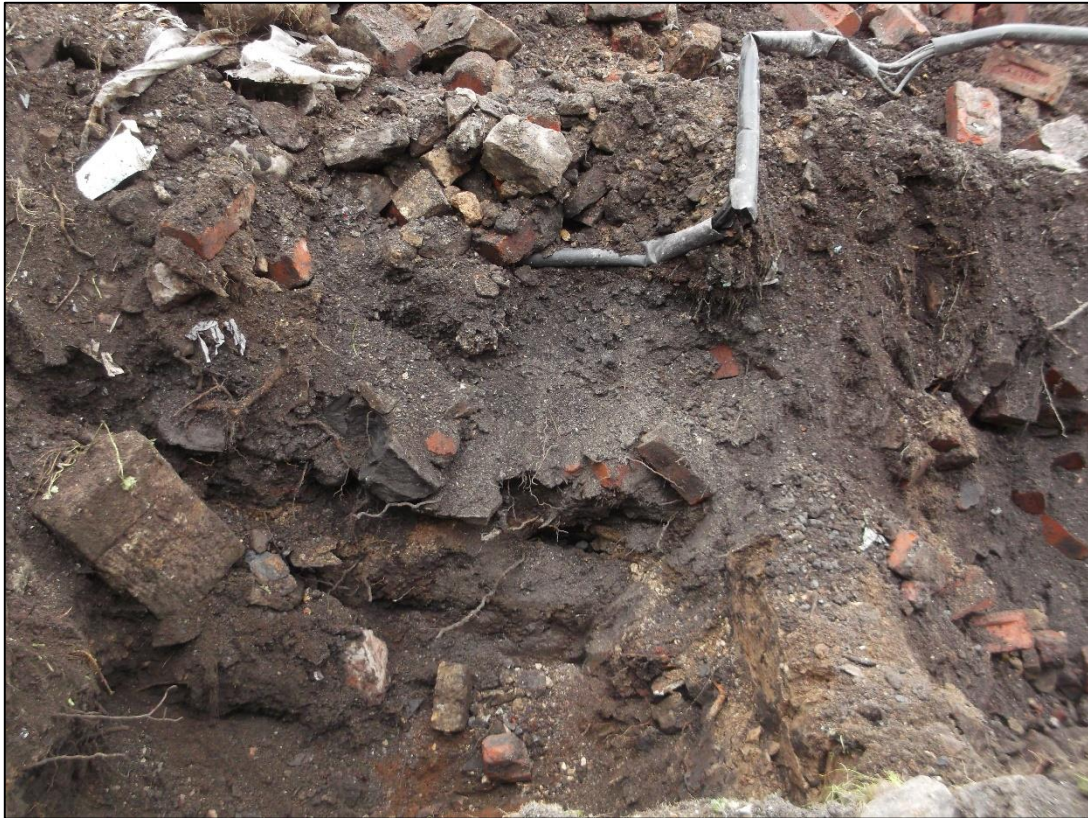
Figure 4a: View of the partially demolished NNE cellar wall [004]. From the W.

15. The cellar (Figure 4b), [004], was rectangular shaped in plan. As well as the SSE and WSW walls revealed after the removal of topsoil (001), a third wall, which formed the NNW limit of the cellar, was revealed underlying modern infill layers (003)/(008). The ENE side of the structure lay outside the excavation area, most likely under the driveway of a nearby pub (The Eglinton Inn). The full extent of the structure measured 7.5m from WSW to ENE (though it continued outside the excavation area) by 6m from SSE to NNW. The structure had a maximum depth from the current level of the street of 2.3m, though the NNE wall had been partially demolished (Figure 4a) to a height of 0.7-1m (at a depth of c.1m from the current ground level).

24. It seems probable that the building was part demolished at some point in the 20th century leaving the frontage and sides as a shell. The back, NNW, wall was probably reduced to allow for the dumping of the first layer of modern rubble, (003). The building material within this layer was predominantly 20th century brick and the domestic refuse within the layer (tin cans and plastic) also appeared to be from the 20th century. The second layer of rubble, (002), contained mostly 19th century sandstone similar to that used in the construction of the cellar though there was also 20th century material mixed in with it. This second layer most likely relates to the final demolition of the building with all the remaining walls being pulled down and used to backfill and level off the area to street level.

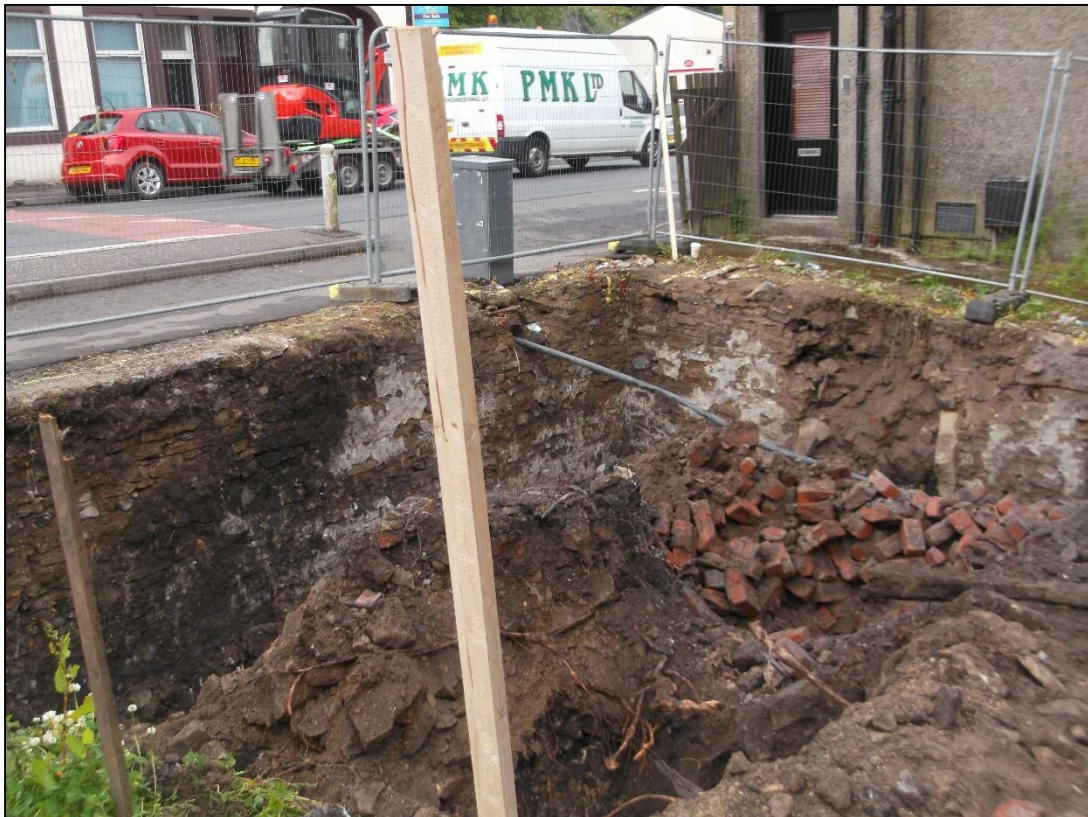
Figure 4b: View of the SSE and WNW walls of the cellar showing the remains of the rubble layers (002) and (003). From the NNE.

13. Beneath the topsoil, the upper parts of a cellar [004] could be discerned, chiefly the SSE and WSW walls (Figure 4b), and two thick layers of modern rubble backfill, (002) and (003),. The uppermost of these two layers, (002), directly underlay the topsoil (001) and consisted of very loose to loosely compacted, mid- grey/grey brown, silty sand with frequent (80%) inclusions of 19th or 20th century building debris (mainly pale yellow sandstone blocks). There was also occasional modern refuse (e.g. drinks cans and plastic) mixed in across the layer. The layer was located mainly within the ENE side of the cellar [004] and measured 5.7m by 1.2-3.9m, narrower in the middle and curving round to be wider at either end, with a thickness of 1.5m.

14. The lower layer, (003), underlay (002) and topsoil (001) where (002) was not present. It consisted of very loose to loosely compacted, dark grey/black (with mid grey patches), silty sand/gravel with frequent (70-80%) inclusions of modern brick. There was also occasional to moderate inclusions of 19th or 20th century building debris and modern refuse (drinks cans and plastic) mixed in with the layer. The layer was located within the cellar [004] across the full extent of its interior. The layer measured 5.7m by 7.2m and had a thickness range of 0.7-2.3m, shallower at the ENE end where it ran under (002).
