Silverbank, Whiting Bay, Arran: Archaeological Monitoring

Data Structure Report

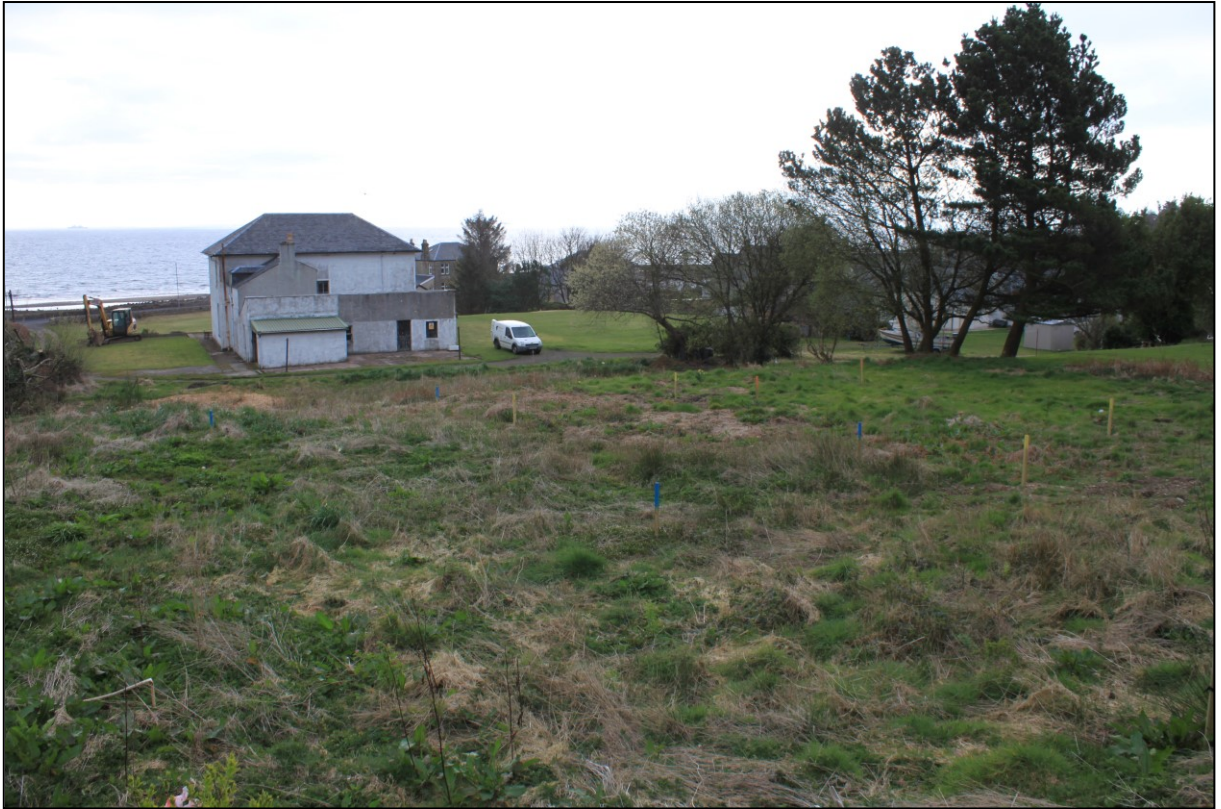
8. The programme of works comprised archaeological monitoring (Figure 2) of ground-breaking works undertaken as the initial stages of construction on a raised terrace behind, to the west of, the existing Silverbank house (Figure 3a). The initial stage of ground-breaking works included vegetation and topsoil strip of the area required for construction of three dwelling places. The area of the vegetation strip was slightly larger than the area of the topsoil strip to provide an area for bunding of the up cast material. An additional area was vegetation and topsoil stripped down the slope in the eastern part of the development area to allow the construction of an access road and join the existing access road past Silverbank house.

Figure 3a: The development area prior to the vegetation strip

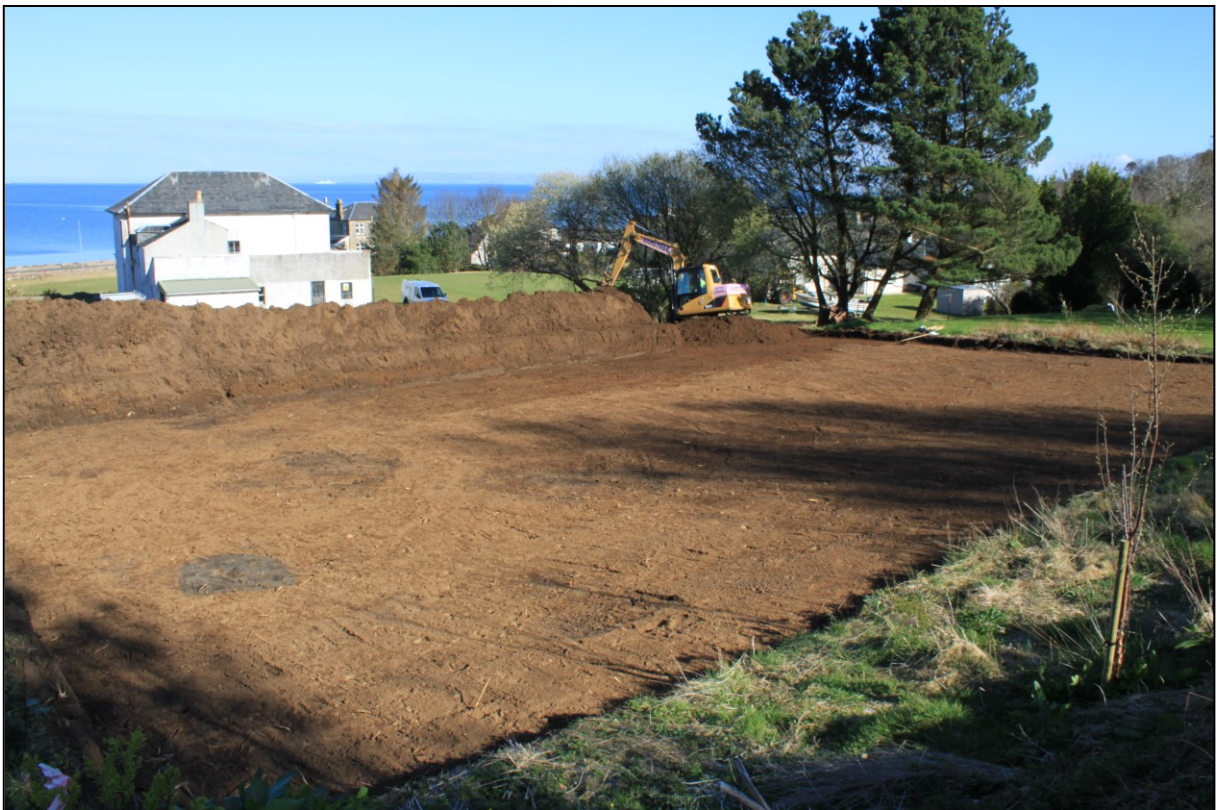
12. Almost the entire area of the terrace was stripped of vegetation (Figure 3b), approximately 30.6m north-south by 21m east-west, during the initial stages of the work. Examination of the topsoil revealed only modern (late 19th to 21st century) material such as white glazed ceramic and pieces of plastic and modern glass. No sign of negative or structural features was apparent in the topsoil (001). The typical depth of topsoil uncovered was between 150 and 250mm, however, in the northwest corner the depth reached a maximum of 410mm.

13. A slightly smaller area, only 18m east-west, was stripped of topsoil down to subsoil (002). The purpose of the smaller area was to permit bunding of the up cast topsoil at the edges of the plot for the construction work. In the flat area of the terrace the subsoil (002) was uniformly orange/brown sandy silt with frequent small sub-rounded stones. Roots and rootlets were common in the subsoil and four large tree bowls, from now removed mature trees, were evident in the area. There was no anthropic material observed in the subsoil.

Figure 3b: The development area stripped to subsoil

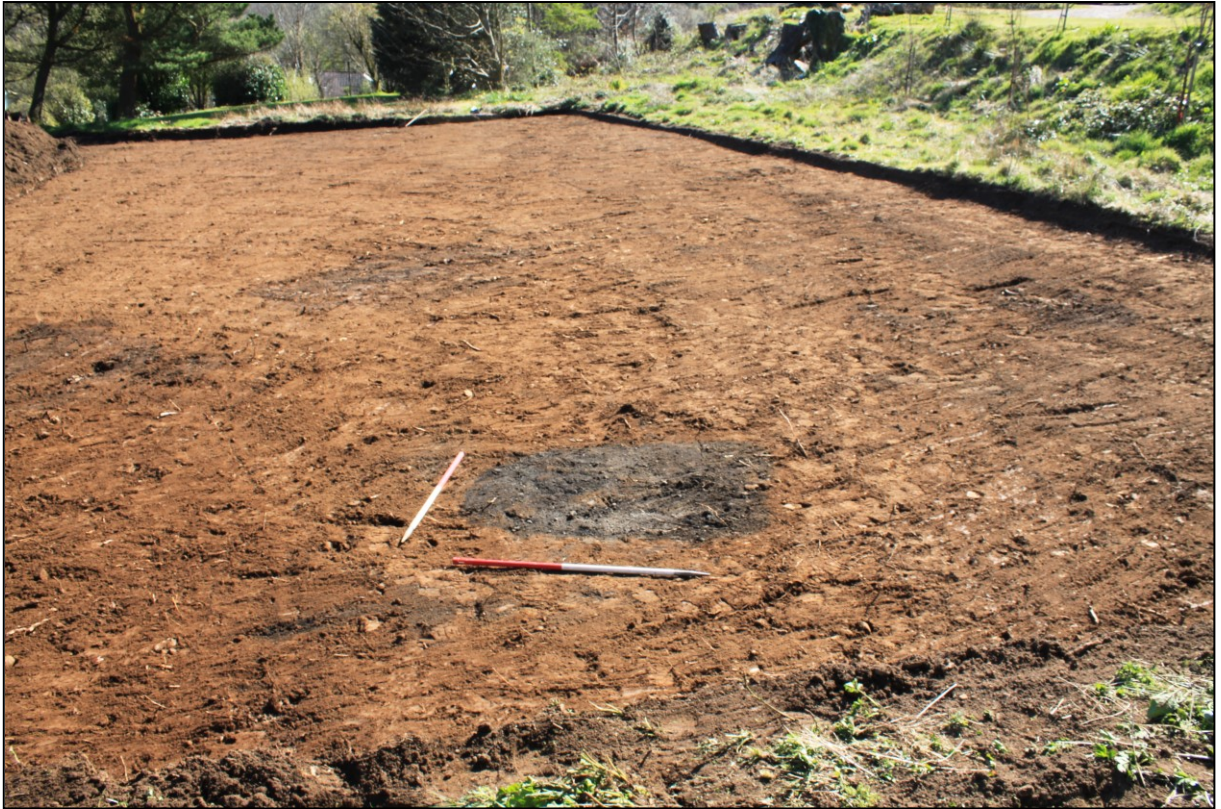
14. A single sub-rectangular feature (003) (Figure 4a) was observed close to the northern boundary of the stripped area, approximately 7m from the northwest corner. This feature was a pit 1.65m by 1.3m in plan. The upper sediments of this pit were investigated and found to contain modern (late 19th to 21st century) ceramic material. The fill of the pit was mainly ash and clinker with some small rounded stones. By its regular form, fill and the anthropic material recovered this feature was confidently identified as of modern origin.

Figure 4a: Location of Feature (003)

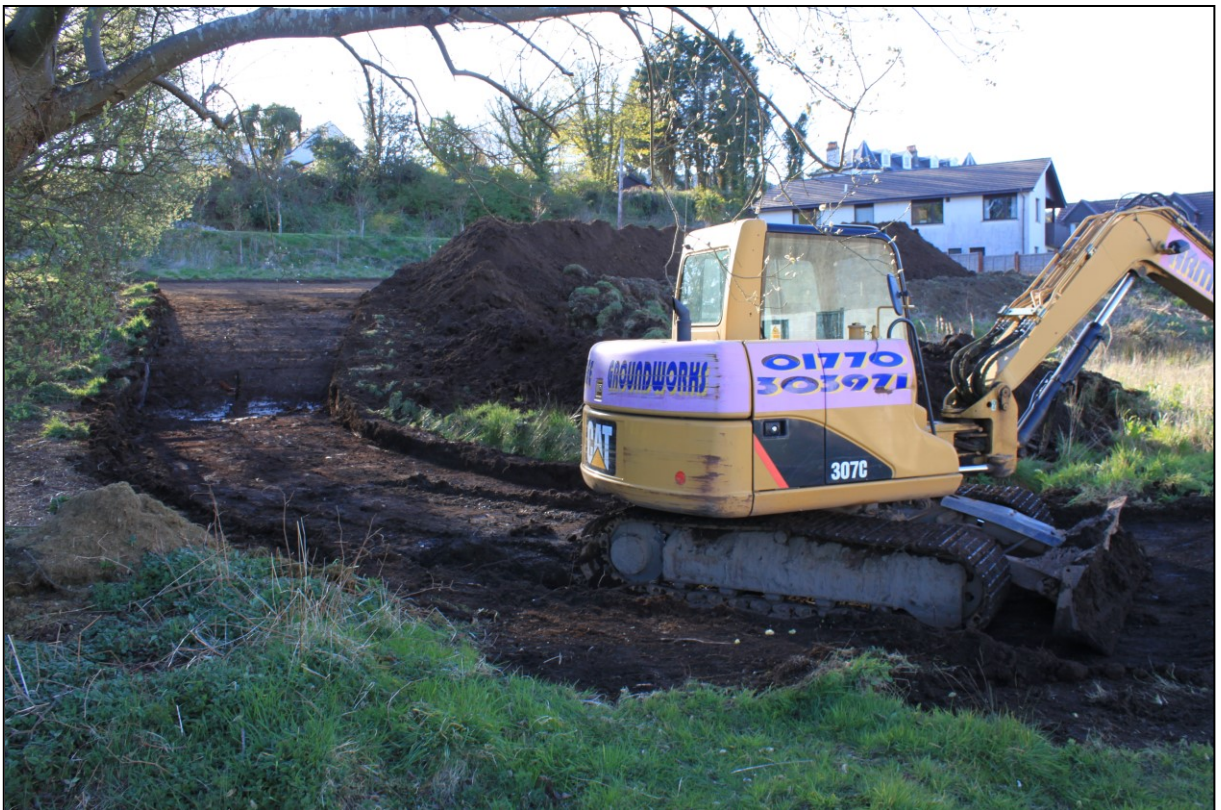
15. Extending east from the southeast corner of the stripped area and down the slope of the terrace another area was stripped in preparation for the placement of an access road (Figure 4b). To this end an area of approximately 4m wide (north-south) by 25m long (east-west) was stripped of vegetation and topsoil. The topsoil in this area was the same as the terrace area and of similar depth. The subsoil along the access road was uniform grey clay (004) without inclusions.

16. A concentration of large stones was observed near the break of the slope in (002) at the beginning of the area stripped for the access road. This concentration of stones was interpreted as a natural feature. This interpretation is supported by the almost immediate transition to subsoil (004) to the east of the stones.

17. The base of the slope was heavily waterlogged. There was some evidence of attempted drainage in the form of a tile and rubble drain. With the exception of the drains no anthropic material was observed in the stripping of this area and no significant archaeological features were observed.

Figure 4b: Access road stripped to topsoil

21. Rathmell Archaeology Ltd was informed that there is the possibility that the 4m wide access road may be expanded if safety considerations or ground conditions require it. Any expansion of the monitored works would take place on the steep clay slope and therefore the chances of archaeological material being uncovered is minimal. In the event that additional stripping did take place more than 90% of the development area would have been stripped to subsoil under archaeological supervision and this would include the entire development area on the flat portion of the terrace.

22. On balance, given the lack of significant archaeological material recovered in the course of the monitoring works, we consider that the development works will not compromise any significant archaeological strata. Rathmell Archaeology Ltd recommends that no further archaeological monitoring work be undertaken with regards to this development and the planning condition be purged. In the event that the stripping for the access road is expanded, given the complete lack of significant archaeological material observed thus far, Rathmell Archaeology Ltd recommends that there is little practical value in archaeologically monitoring this additional work.
