# **Ardrossan Castle Kitchen Vault Consolidation: Archaeological Mitigation**

Data Structure Report

on behalf of North Ayrshire Council

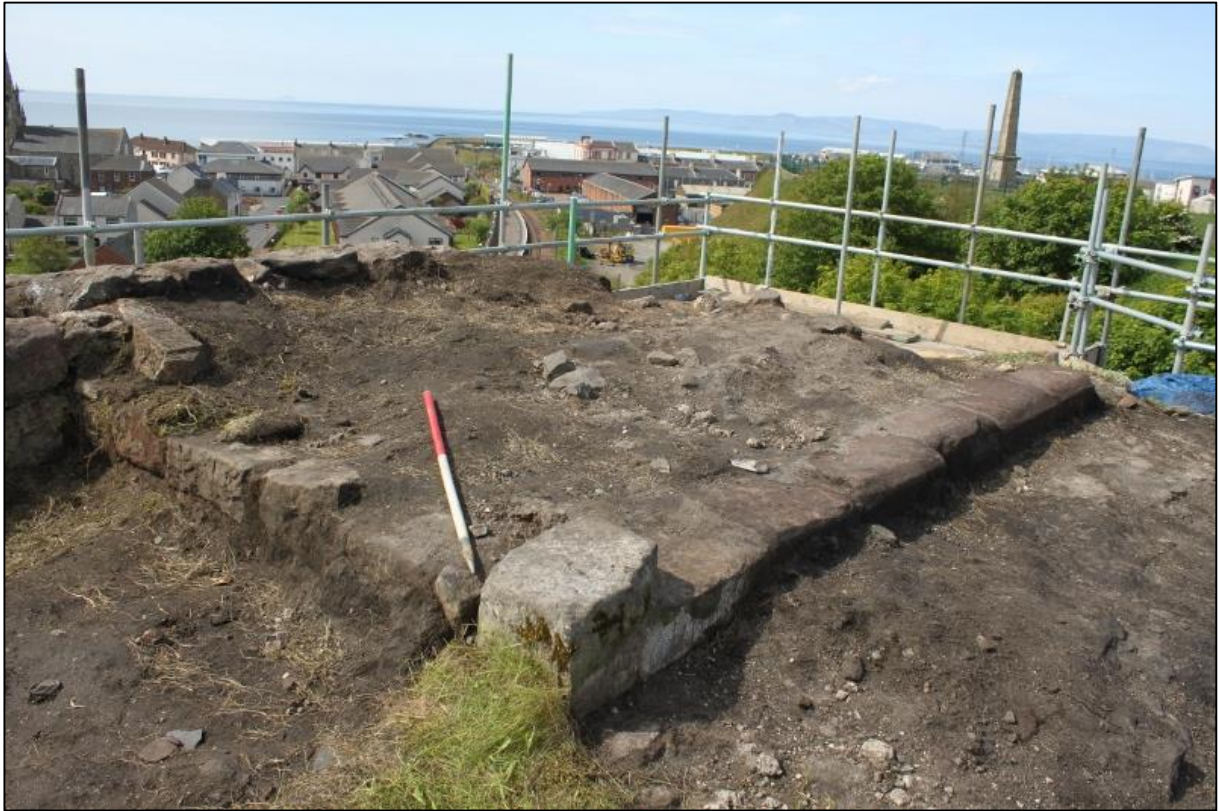
Figure 2a: Vegetation stripped, revealing walls [002] to right and [003]/[007] to left, containing overburden (005)

12. Following the removal of obscuring vegetation, the line of an 'L'-shaped structure was visible on the vault (Figure 1 and 2a). Its relationship to the castle fabric was unclear at this time, as it was largely concealed by a deposit of topsoil/overburden (005), which had built up over the entire surface of the vault but which – having been contained by the presence of the 'L'-shaped structure - was particularly deep in this location. Here it varied between 0.2m and 0.5m thick (Figure 2b), as opposed to the 0.1m - 0.2m depth noted elsewhere. Overburden (005) was humic in character, comprising a mottled dark-brown/black silty clay with numerous inclusions of coal and ash as well as coal-rich and ashy lenses which suggested *in situ* burning.

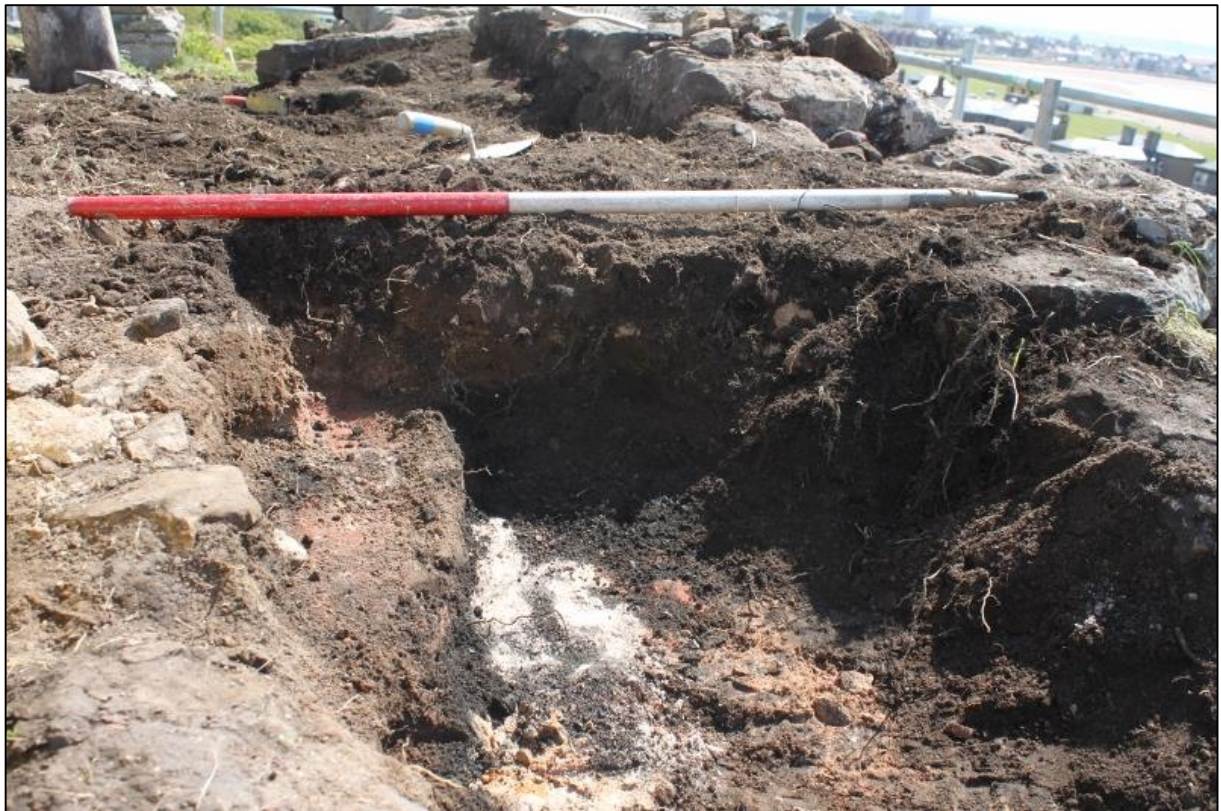
Figure 2b: Section through overburden (005), W side of kitchen vault

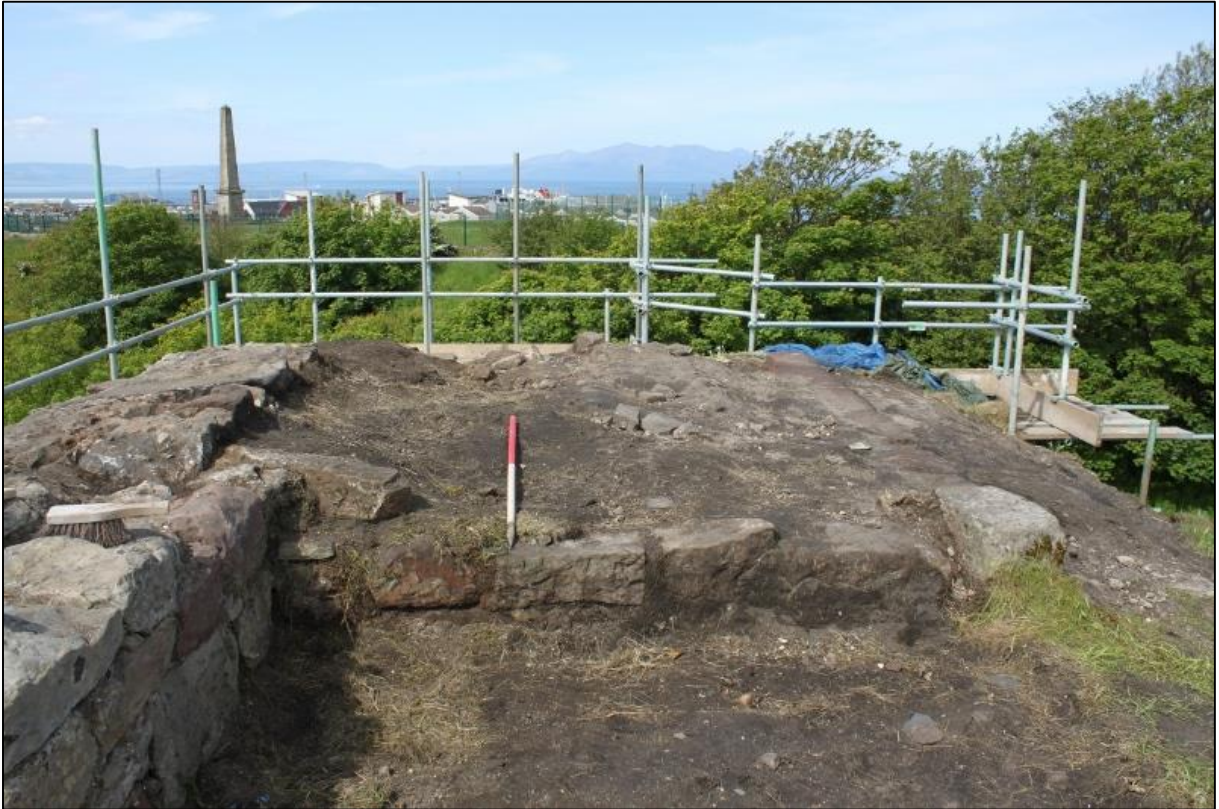
Figure 3a: Looking west towards Wall [002] (above) and Wall [007] (below)

13. As the reduction of (005) progressed, a clearer understanding of the component parts which made up the 'L'-shaped 'structure' soon became apparent. The eastern side of this feature comprised ephemeral traces of a wall [003], running roughly north to south across the width of the vault. Surviving to the height of a single course, this wall was very ephemeral in character, measuring only one block in width; from the little that remained, it appeared to have been built from red sandstone blocks, roughly squared. However, it appeared to have been built upon another wall [007] of more substantial build, with the eastern face of this wall forming a low revetment against which (005) had built up to the west (Figure 3a).

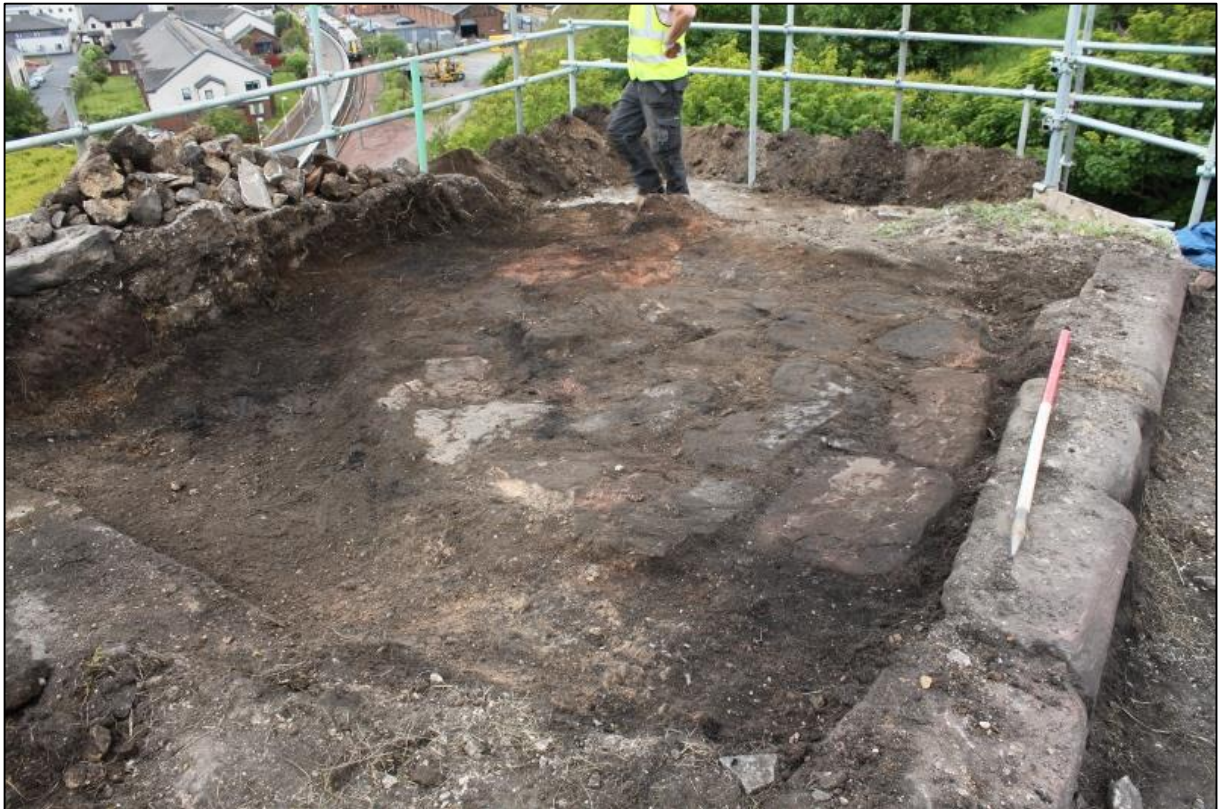
Figure 3b: Paved surface [006], with wall/coping [002] to right

16. Sediment reduction at this level also revealed traces of a level surface [006], made up of roughly worked sandstone slabs (Figure 3b). Further reduction of overburden (005) exposed the full extent of this surface, which measured a maximum of 2.4m from E-W by 1.4m transversely.

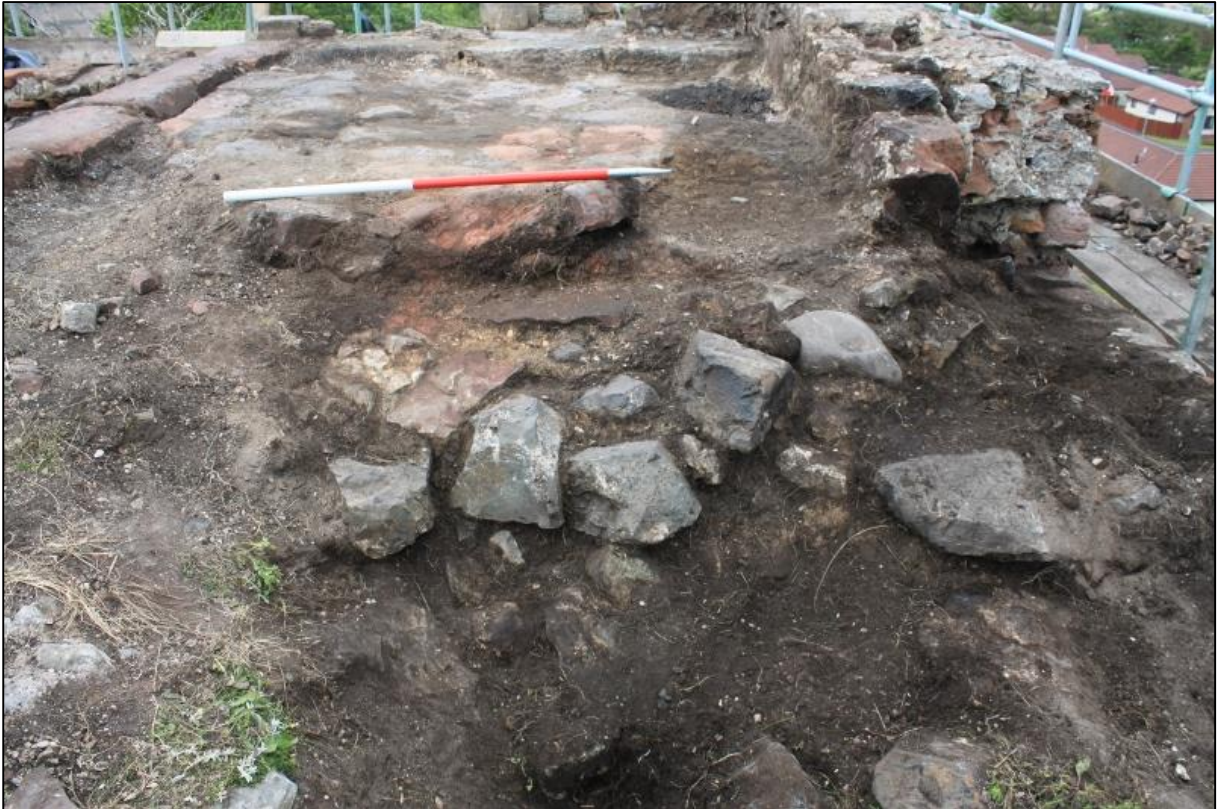
Figure 4a: Surface [006] overlying topsoil/overburden (005) with mortared masonry (009) below

20. It was initially assumed that surface [006] might represent a floor level contemporary with occupation of the kitchen tower, though it seemed rather rough in character to be an internal feature. More detailed investigation followed, revealing that this feature was not directly bonded to the vault below, but rather sat above, with soft sediments surviving between and below the stones (Figure 4a).

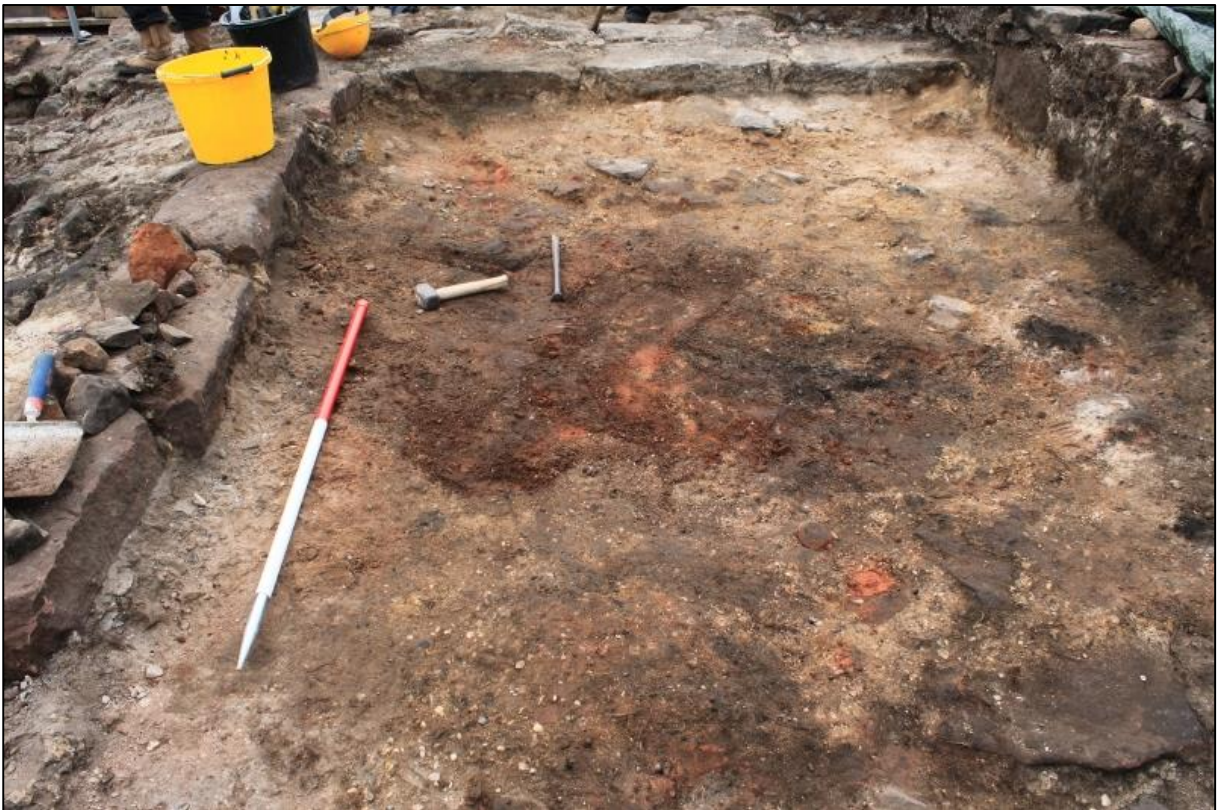
Figure 4b: Surface [006] removed, revealing mortared masonry (009) below with signs of heating and burning evident

24. While the bedding layer (010) itself didn't show any marked indications of burning or heating, some of the stones that made up [006] itself and also some areas of the vault below (composed of the mortared stony layer (009)) had clearly been subject to intense heat which had in some cases left the stones weak and friable (Figure 4b and 5a).

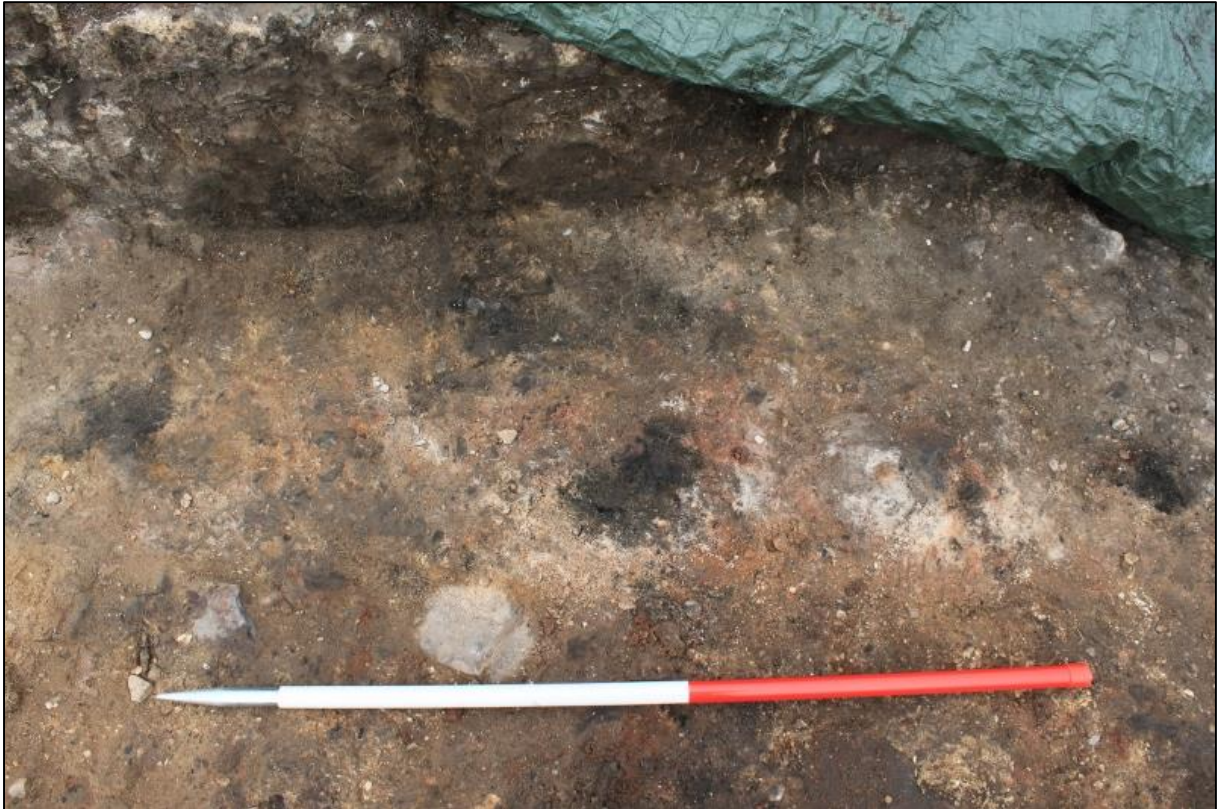
Figure 5a: Detail showing localised heating/burning of mortared masonry (009)

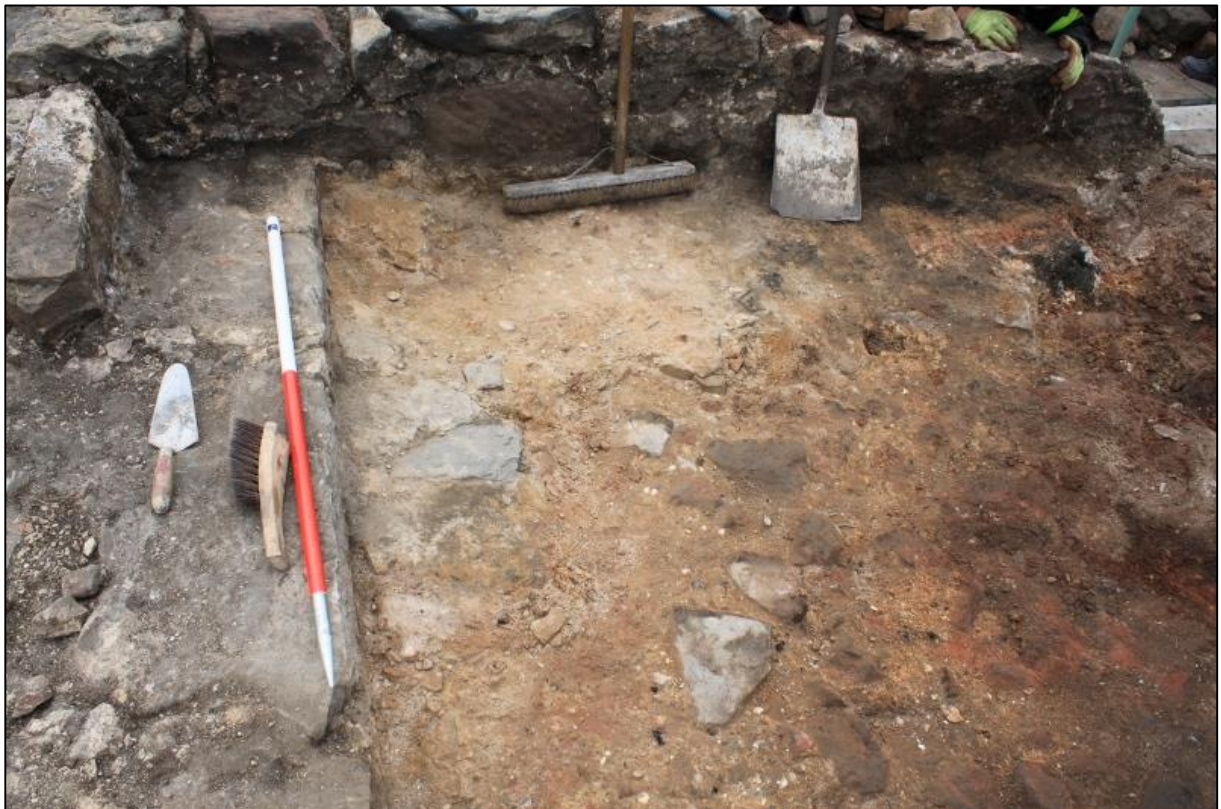
Figure 5b: Fragmentary surface [015] overlying mortared masonry (009), with wall [007] to left

26. Like cross wall [007], surface [015] was bedded onto the mortared masonry [009] (Figure 5b). From this it may be inferred that both features formed an integral part of the structure and may have been part of the original fabric.

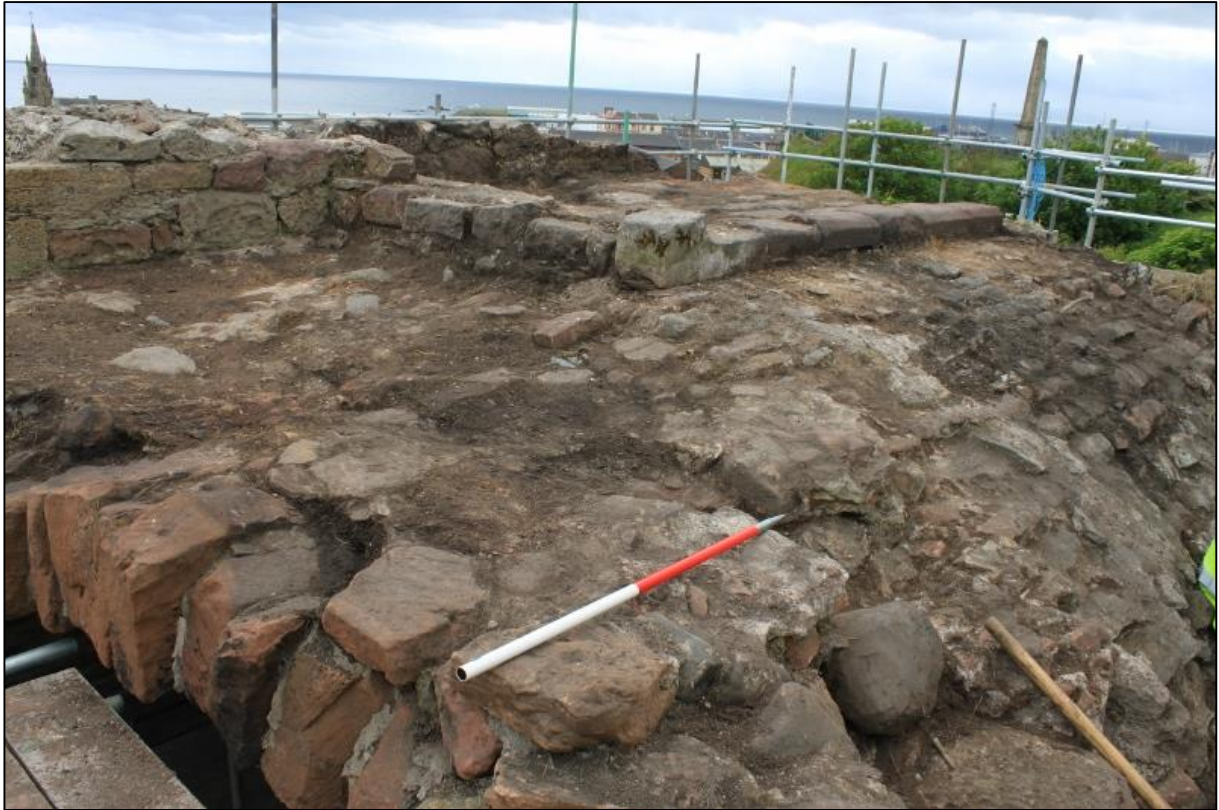
Figure 6a: View across vault towards walls [007] and [002], with projecting 'threshold' stone visible in centre of image

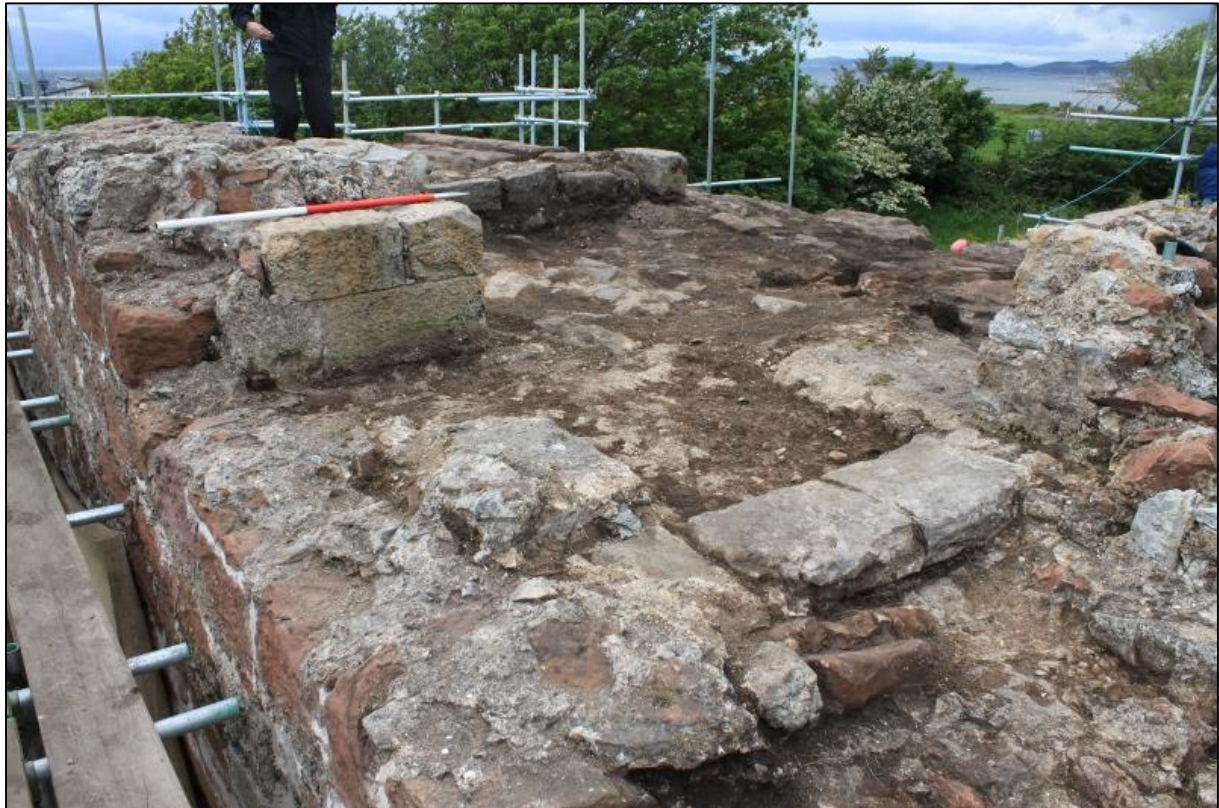
Figure 6b: View across 'eastern chamber' with threshold [008] to fore (right hand side), into to left, and cross wall [007] towards rear of image

32. Located further to the east was a threshold stone [008], indicating an opening which allowed access on an E-W axis into a smaller chamber (of which very little remained) located at the eastern side of the building. Judging by the presence of an intact corbel projecting outwards from wall [001] at the S end of this possible chamber, and the presence of a second, fragmentary corbel similarly projecting from [001] slightly further to the E – this small chamber would have functioned as a garderobe closet (Figure 6b).
