# **Newton Mearns Faith Schools' Joint Campus: Archaeological Evaluation**

## **Data Structure Report**

issued 15<sup>th</sup> May 2015

on behalf of Gardiner & Theobald LLP

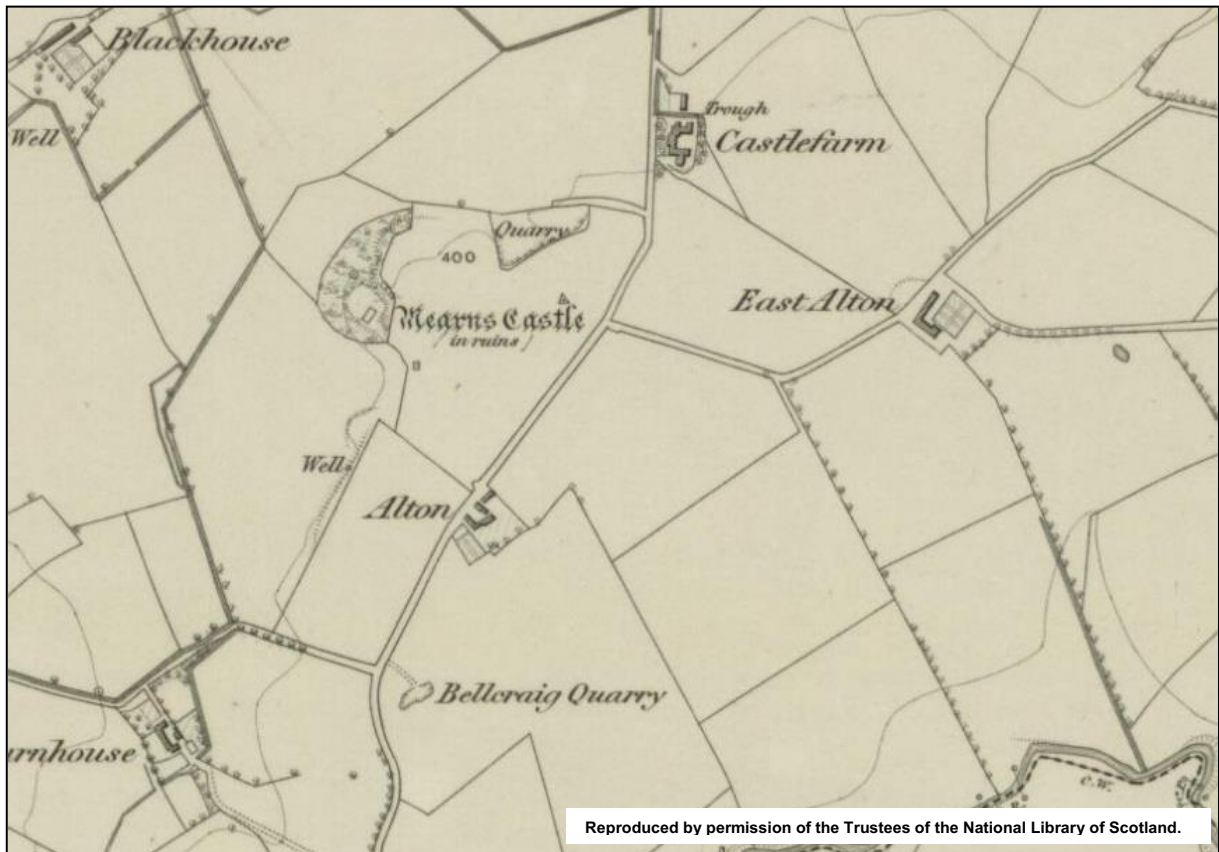
Figure 2a: Ordnance Survey, 1864, 1<sup>st</sup> edition map

8. The 1st edition Ordnance Survey shows a farmstead 'Alton' on Waterfoot Road (Figures 2a and 2b) within the proposed development area (King Henry's Know is also shown and renamed East Alton). Traces of the surviving footings of the structures are visible on modern aerial imagery and members of Association of Certificated Field Archaeologists (ACFA), local amateur archaeologists, have surveyed these and have linked this farm of Alton with the medieval vil. According to the West of Scotland Archaeology Service the *remains of several of the structures visible on the 1st Edition O.S. map are still discernible, although there are signs of modern disturbance, particularly from machine movements*, probably resulting from the widening of Waterfoot Road.

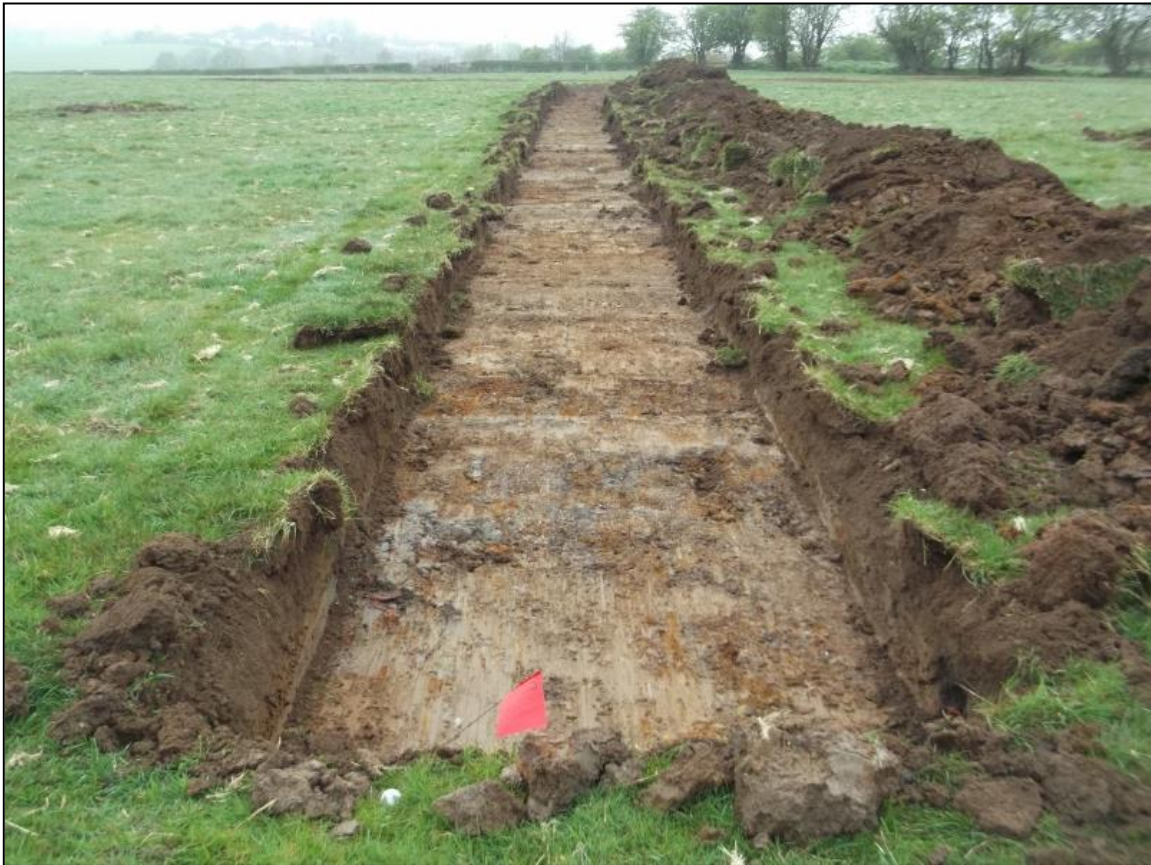
20. Underlying the topsoil across the area, the natural subsoil predominantly consisted of clays (002), (006), (009) and (010). (002) was the most common, and consisted of a very compacted, mottled mid orange/yellow/blue clay with occasional small stones (Figure 4a). (006) was only found in a few trenches to the east and north, and consisted of a very compacted pale grey/blue clay with no visible inclusions. (009) consisted of a compacted, mid- orange/brown sandy clay, with large sections of exposed pale grey sandstone bedrock or boulder clay, which was only present within the terraced area of the farmsteading in Trench 26. (010) consisted of a firm, mid orange/brown sandy clay, with moderate small stones and occasional medium sized stones, present within some of the trenches to the west and north.

Figure 4a: Trench 17 from the ESE showing subsoil (002)

53. On first impressions, one of the most striking aspects about the remains of the farmsteading was its location, occupying the northwest edge of a raised terrace (Figure 4a). This was defined along the southwest and southeast edges by a drystone revetment wall which had been planted with a low hedge of hawthorn trees and which was accessed by an entrance ramp revetted on the northeast side. This terrace clearly formed a discrete planned feature which may even have been an integral part of the build: test-pitting within this terrace revealed a loose, deep and very humic topsoil (Turner 2015), which contrasted with the thin topsoils overlying bedrock which were consistently encountered throughout much of the test-pitting carried out over the northern portion of the site. This was suggestive of an area subject to frequent manuring and intensive cultivation which implies use as a vegetable plot, kitchen garden or kailyard within which livestock were not routinely permitted to wander.

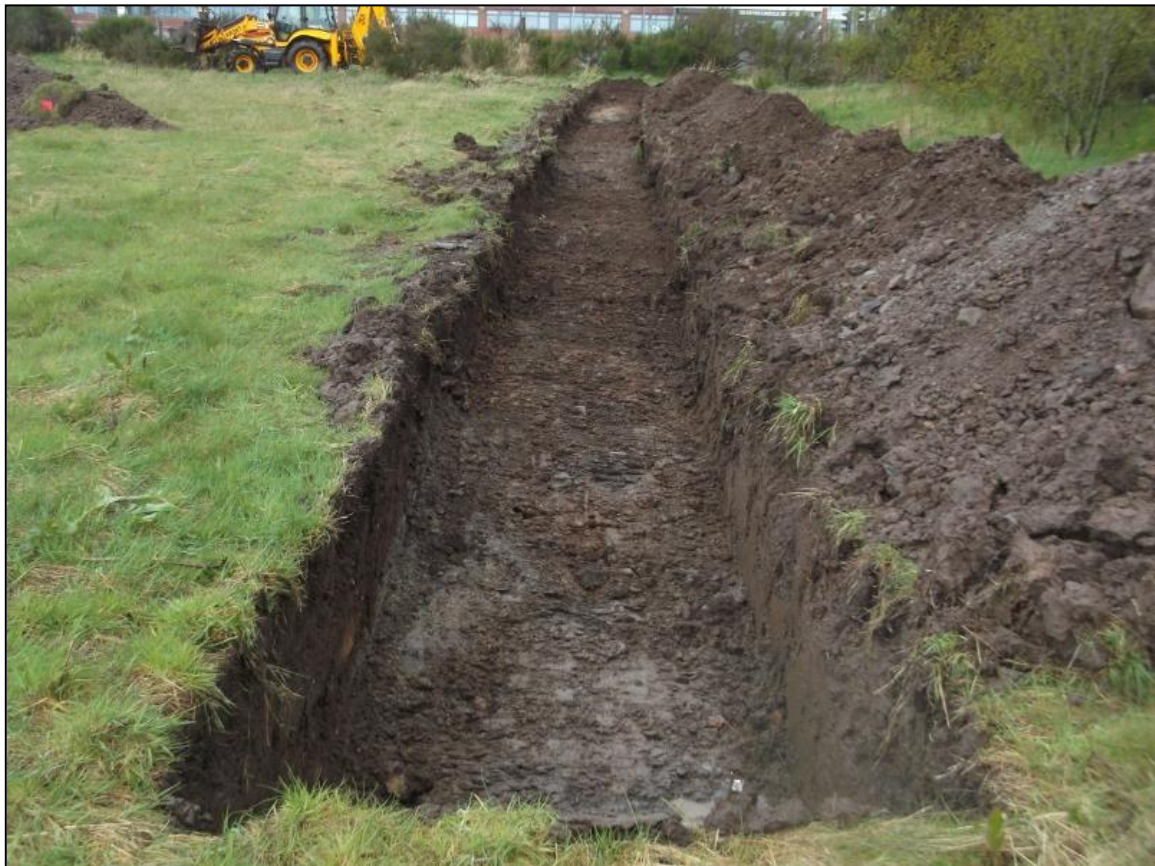
19. (021) was present in the northern field where Trenches 25, 27, 28 and 29 were located. It consisted of a friable, light to mid brown slightly clayey silt, with occasional rootlets, rare stones and frequent inclusions of modern debris (plastics, cloth rags, tins etc.) which measured between 150 to 650mm in thickness. (001) covered the remainder of the area and consisted of a compacted, mid brown silty clay with frequent rootlets and occasional small stone inclusions which ranged in thickness from 200 to 560mm.

Figure 4b: Trench 25 in the northern field from the SE

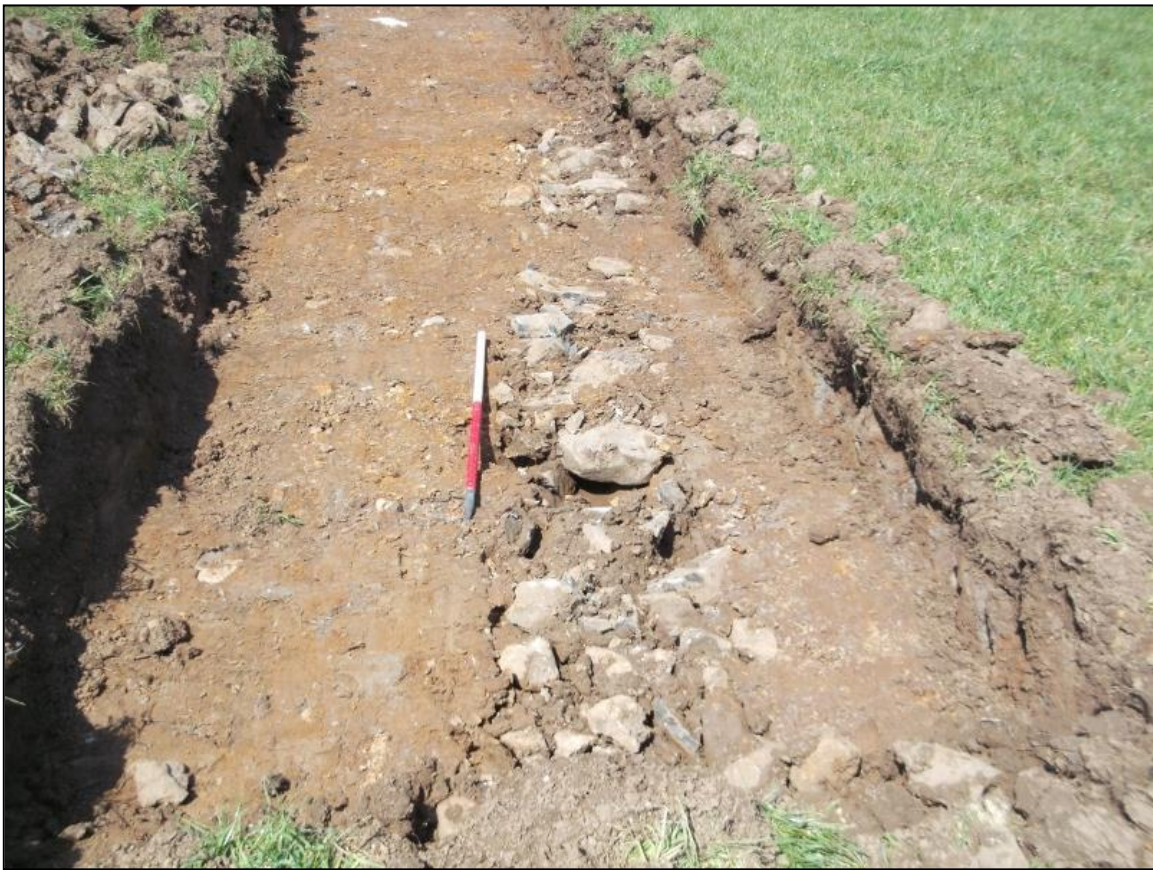
23. The majority of the trenches revealed modern disturbance in the form of field drains. The most frequent type was (003), a rubble drain which measured 0.45m wide (Figure 5a), with examples of this type present across the majority of the area. It contained sub-angular and angular stones measuring up to 0.5m by 0.2m by 0.1m in size. A smaller type of rubble drain (004) was also present in the eastern field in Trenches 21 to 24. (004) measured 0.25m wide and was filled by blue/grey gravel, measuring up to 0.1m by 0.1m by 0.05m in size.

Figure 5a: Rubble drain (003) in Trench 21 from the SSE

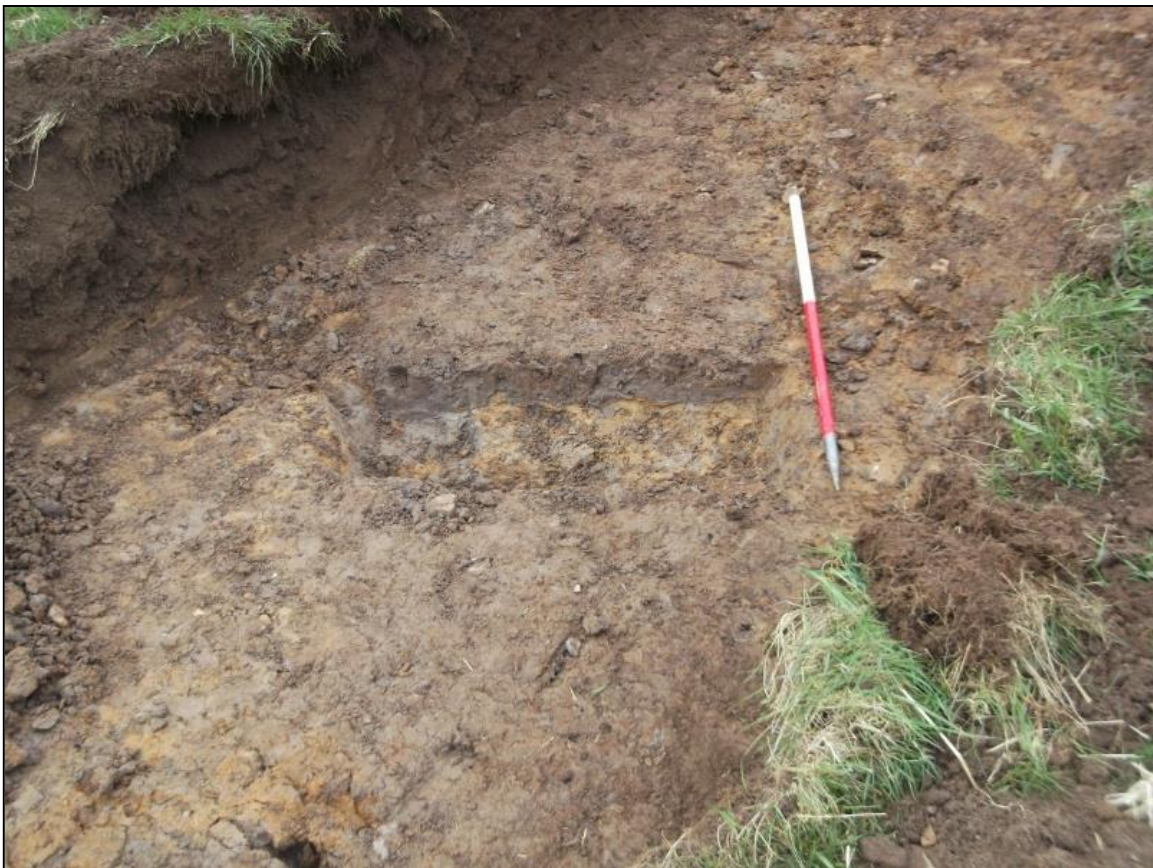
Figure 5b: Linear feature [018] in Trench 17 from the NE

26. The only feature which had the potential to be significant was linear feature [018] in Trench 17 (Figure 5b). This was orientated northeast to southwest and measured 0.95m wide with a maximum depth of 180mm. It had steeply sloping sides and a fairly flat base and was filled by very compact light to mid-brown silty clay with occasional small stones and occasional flecks of coke (019). The shallow and regular nature of the feature suggests that it likely represents agricultural activity.
27. No other archaeological features were uncovered on site and the only artefacts observed were occasional fragments of modern white glazed pottery and burnt flint within the topsoil.

67. On excavation, the linear feature [018] failed to produce any artefacts which would give a definitive date for its origin. However, the feature had a very shallow depth suggesting that it is not substantial enough to represent an earlier feature such as an enclosure or defensive ditch. Instead, with its regular form, it appears more likely to relate to modern agricultural use of the area, possibly a drainage ditch.

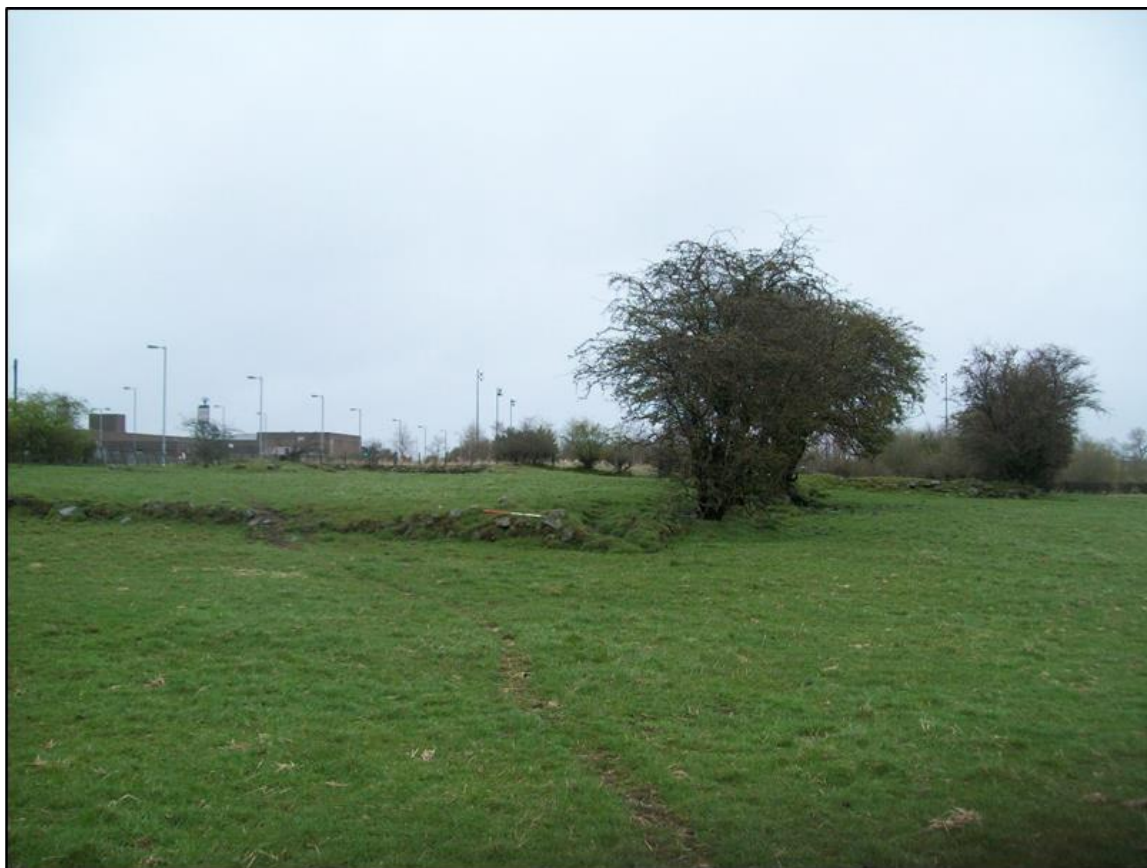
31. The terrace which lay to the southeast side of the farm buildings was defined along its southwest and southeast limits by a drystone revetment, upstanding to a height of 0.5m (Figure 7a). A number of mature hawthorn trees were present along its edge: these represented the remains of an overgrown and now much denuded hedge. Access to the interior of the terrace was via an earthen ramp, located just southwest of centre on the southeast side. The contemporaneity of this entrance feature was demonstrated by the fact that it was reveted along its northeast edge with a similar drystone revetment to that which survived elsewhere along the terrace.

Figure 7a: View from S across raised terrace towards site of farmsteading

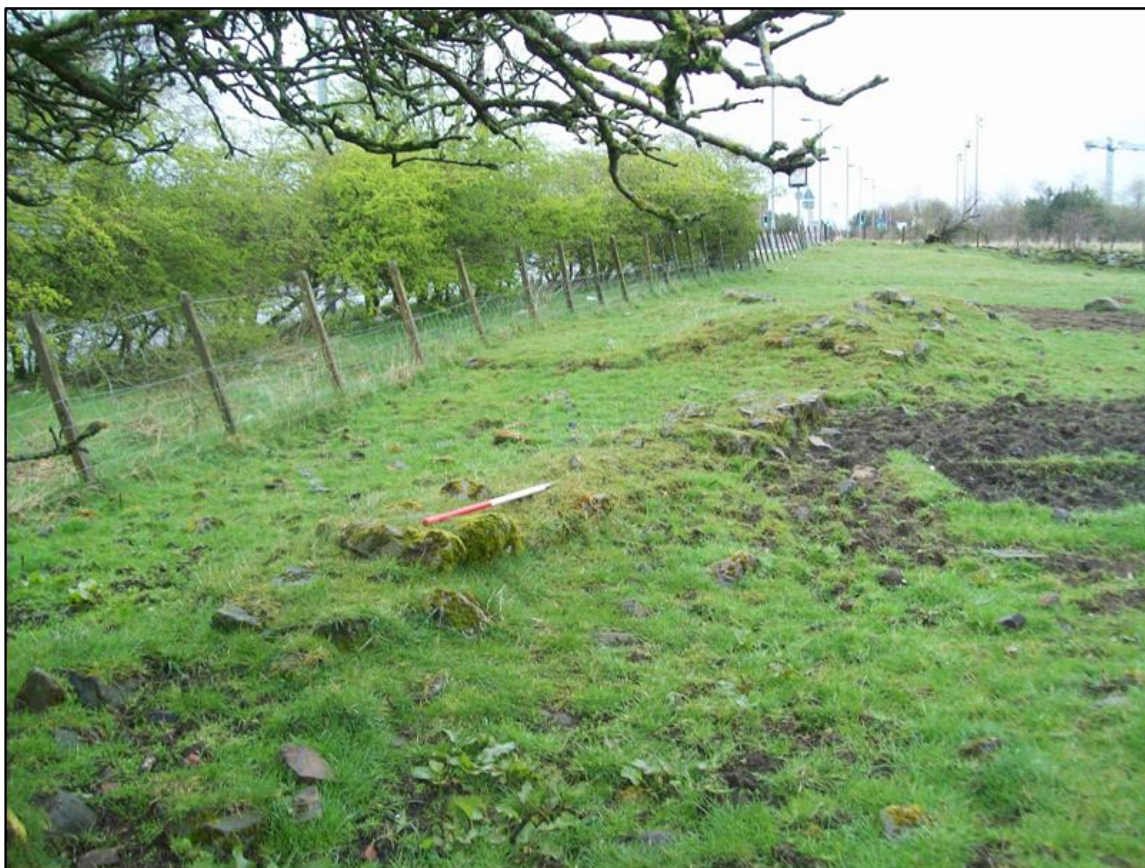
33. The first of these, Structure a, corresponded to the unroofed structure which formed the southwest outlier of the group. It can first be identified with confidence on the 1<sup>st</sup> edition Ordnance Survey map of 1864 where it is shown as an unroofed structure to the southwest of the 'c'-plan range which forms the main focus of the farmsteading.

Figure 7b: Looking across Structure a from S

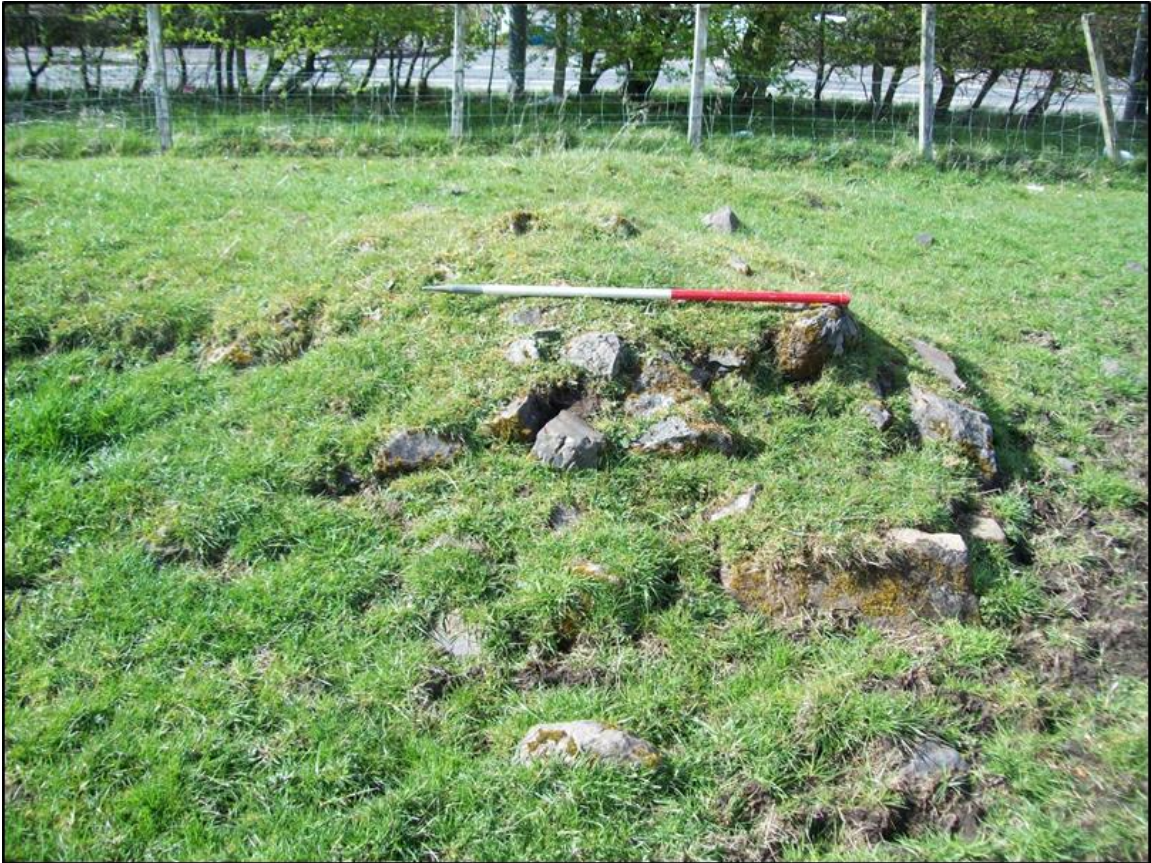
34. The northwest portion of this structure lay beyond the modern field boundary and had been removed by landscaping works, but the southeast portion could be traced along its length (Figure 7b). The walls were of unworked whinstone rubble throughout, except for two quoins forming the basal course at the southeast corner. These were of squared freestone (i.e. sandstone) which had apparently been re-used. This was the only instance where recycled masonry was evident upon the site (Figure 8a).

Figure 8a: Structure a, SE elevation, NE end, showing *in situ* squared sandstone quoin

59. Two squared sandstone blocks had been re-used as quoins at the south corner of Structure a, but apart from these particular items, the style of building was indistinguishable from Structure b. Both structures had surviving wall-widths of 0.6m, and were mainly composed of random rubble (no mortar surviving) with roughly squared

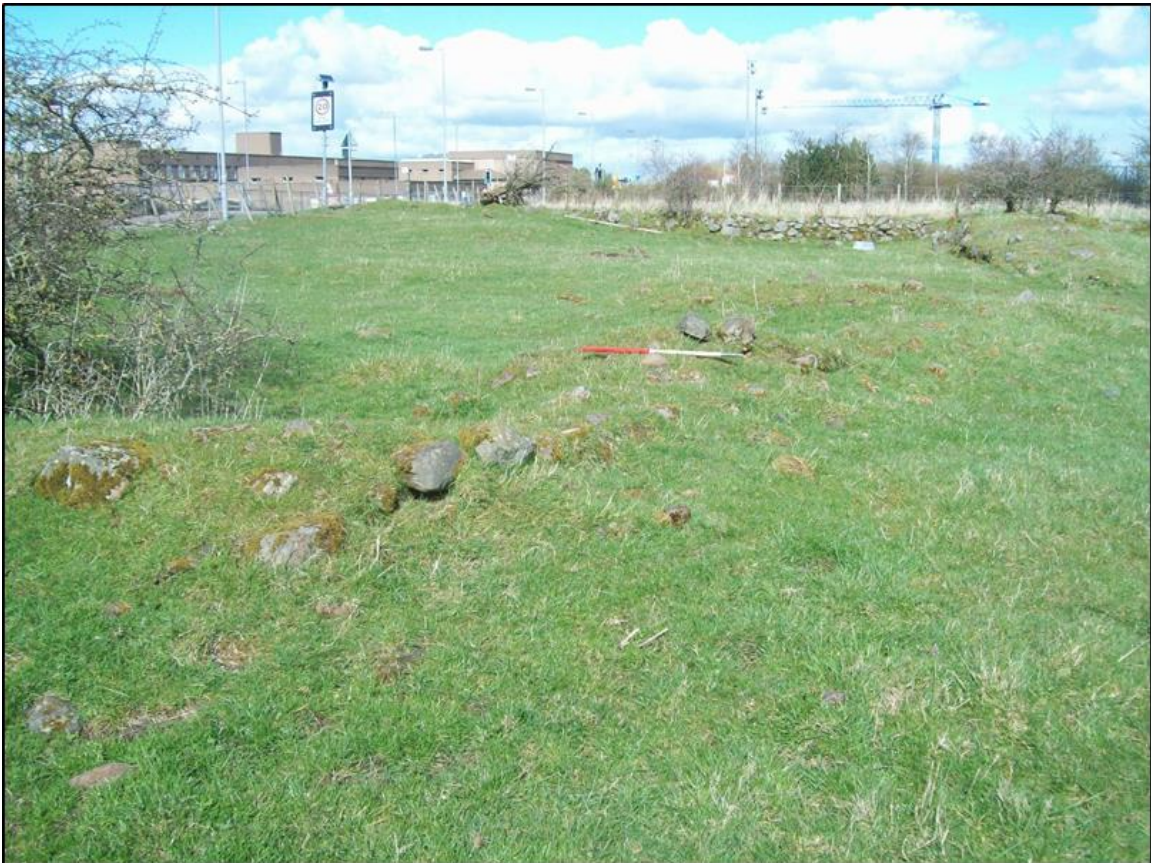
35. The other well-preserved structure was Structure b, again aligned southwest-northeast and upstanding to a height of 0.5m (Figure 8b). Internal and external wall faces were extant in places. Structure b clearly corresponded to the large central structure which formed the rear, southeast side of the 'c'-plan steading. Ainslie's 1796 map suggests that this was one of the earliest elements to appear upon the site, and the historic mapping sequence also suggests that it was abandoned last. No marked differences in construction techniques are evident between Structures a and b: wall widths are a consistent 0.6m, with the rubble built walls composed of blocks of basalt with similar material used in the quoins. These similarities would certainly support a degree of contemporaneity.

Figure 8b: Structure b, viewed from S (ranging pole marks internal crosswall)

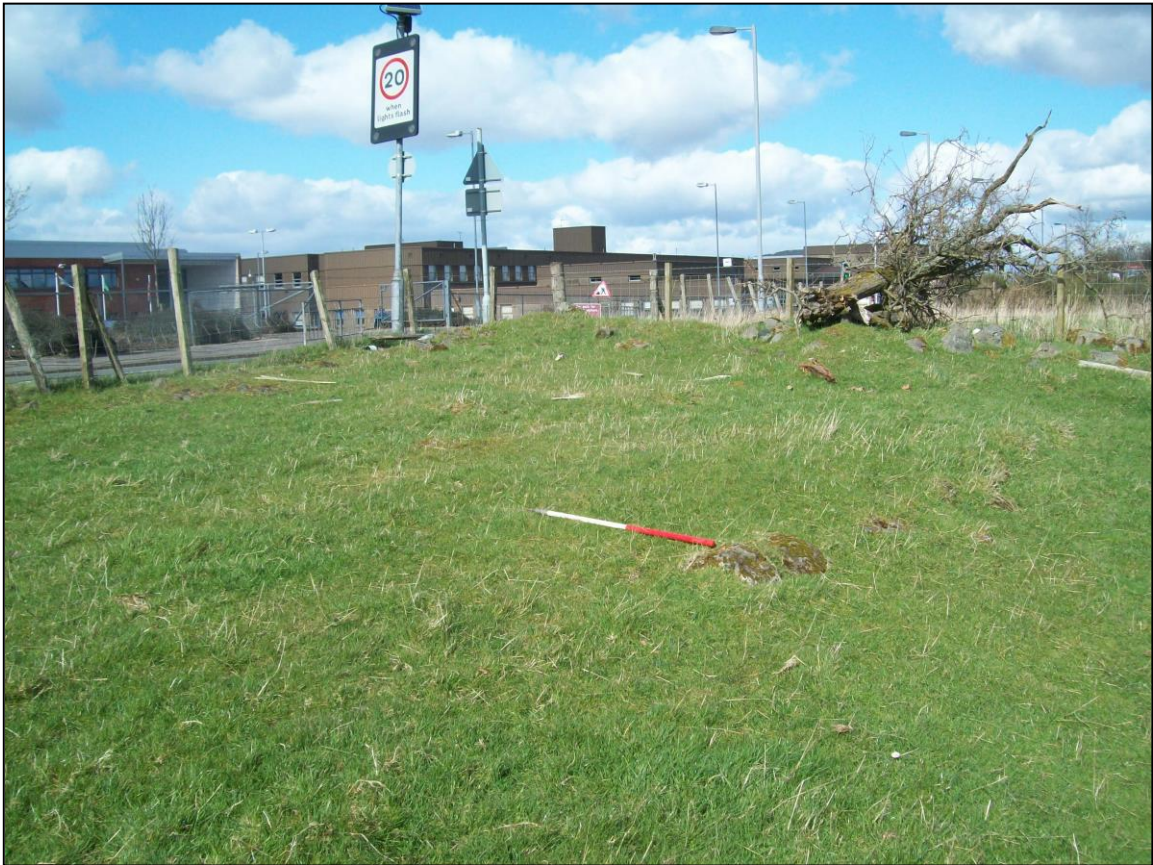
36. Less well-preserved were the remains of the northeastern element within the group, the northeast-southwest aligned outlier which lay to the northeast of the 'c'-plan steading. This structure - Structure e - was visible as a low, grass-covered mound with some traces of walling evident (Figure 9a): there was a wall return surviving in the north corner, and the outline of the southeastern elevation could also be traced as a line of stones protruding from the grass towards the northeast side of the structure.

Figure 9a: Structure e, viewed from S

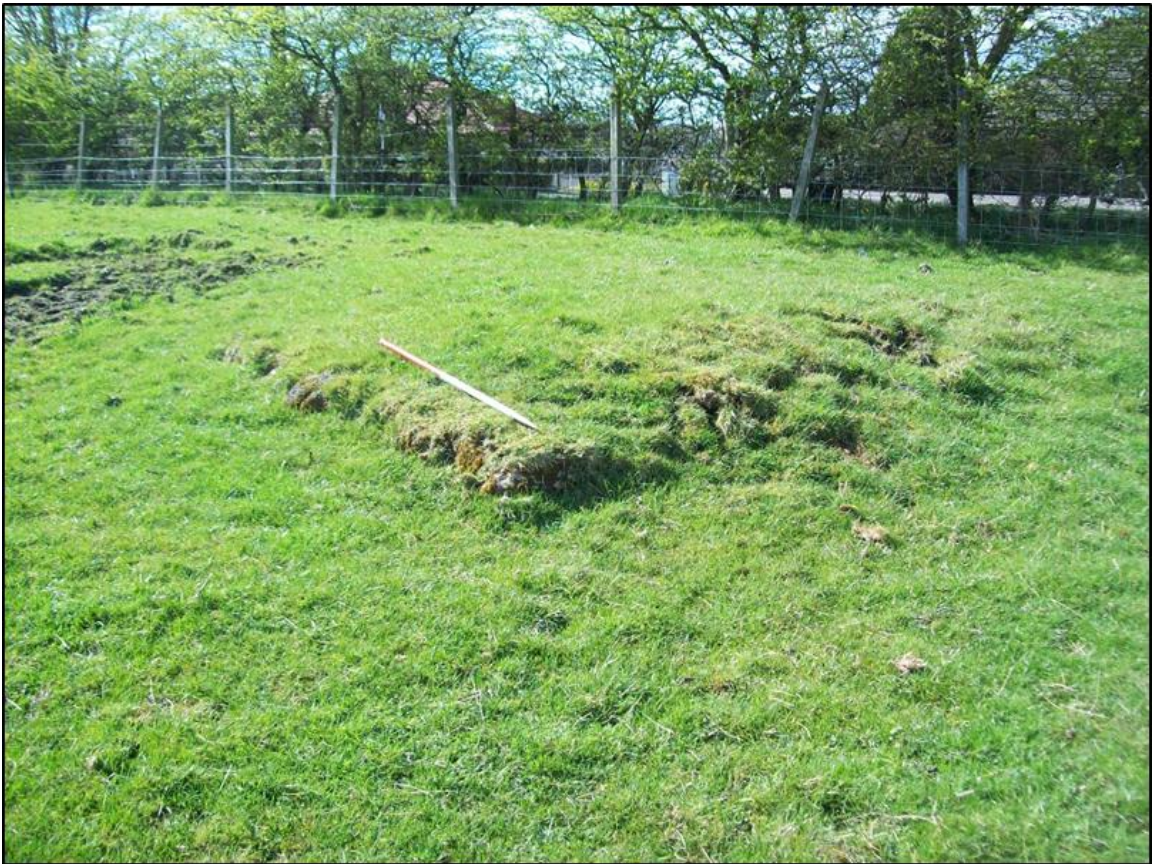
37. Of the two flanking wings of the 'c'-plan steading, only ephemeral traces remained. The southwest wing survived as a mound of grass-covered stone with no discrete structural elements visible, while the northeast wing survived as a raised platform (Structure c) with a single course of walling present defining the southeast edge (Figure 9b). To the immediate northeast lay what appeared to be a small rectangular enclosure defined by a low grass-covered earthen bank on the northwest and northeast sides around a central hollow.

Figure 9b: Structure c, viewed from E

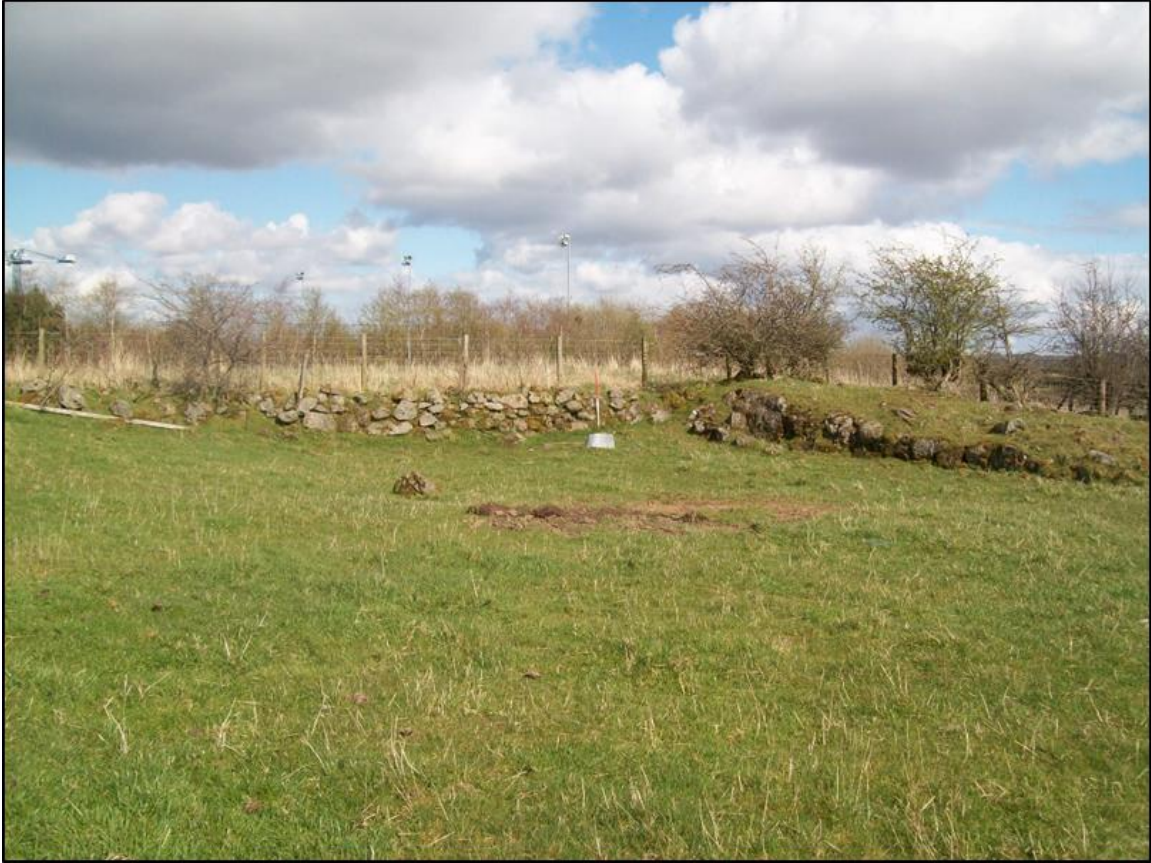
38. Although the buildings themselves could no longer be identified as anything more than low footings, some of their associated elements survived in much better order. The rear terrace/platform has already been described: in addition to this, traces of an enclosed yard or enclosure survived to the rear of the northeasternmost outlier, Structure e. The enclosure had originally been defined on the northwest edge by the external wall of Structure e, on the northeast edge by a revetment wall surmounted by an adjacent earth and stone bank planted with a hawthorn hedge which functioned as a field boundary (Figure 10a), and on the southeast edge by a protruding finger of rock outcrop (aligned northeast-southwest). This latter feature had been further emphasised through the addition of a drystone rubble wall (Structure d) which in places incorporated individual blocks of massive proportions (Figure 10b).

Figure 10a: Sunken yard to rear of Structure e, Structure d (revetted outcrop to right)

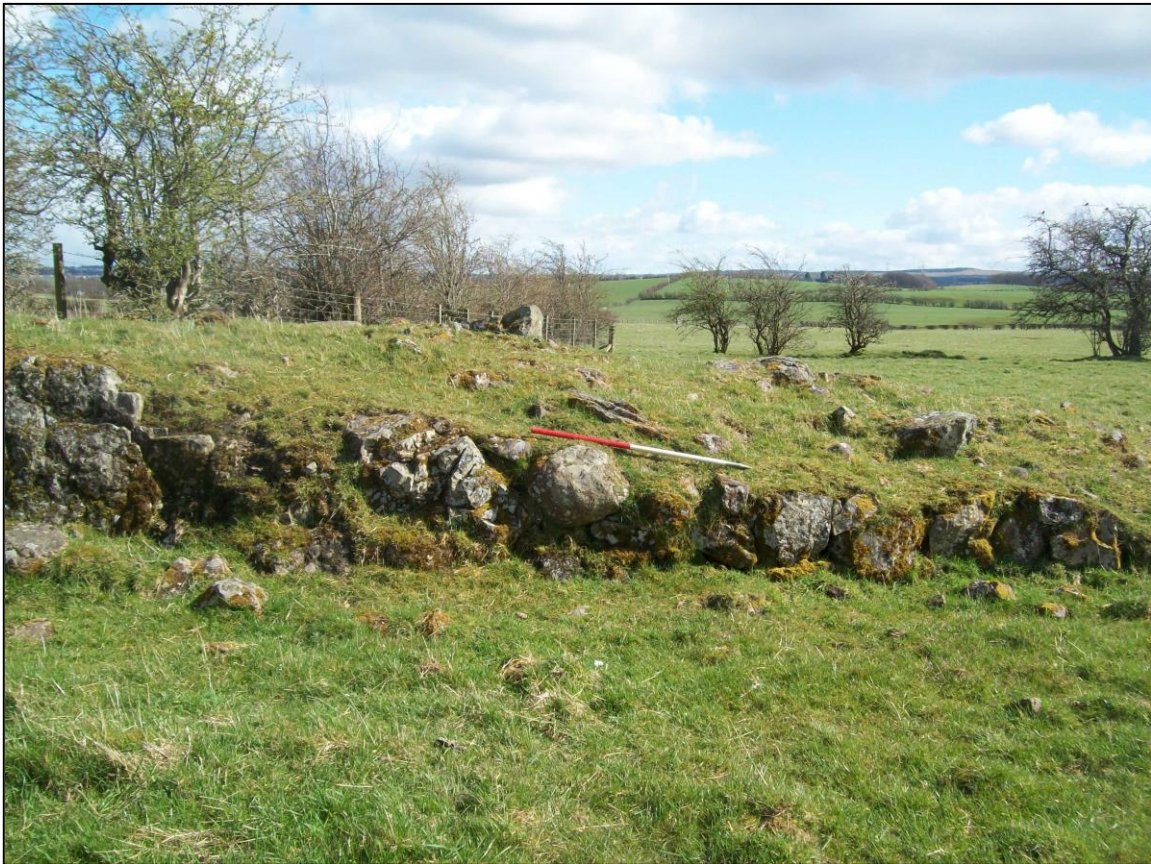
Figure 10b: Rock outcrop with masonry keyed in to form revetment ('Structure d')

57. One final structural element which survived (and which indeed survived in remarkably good condition) was a northeast-southwest aligned stretch of walling ('Structure d') keyed into a protruding finger of outcrop. Together, outcrop and masonry had been used to define the southeast edge of a yard or enclosure lying to the southeast of Structure e.

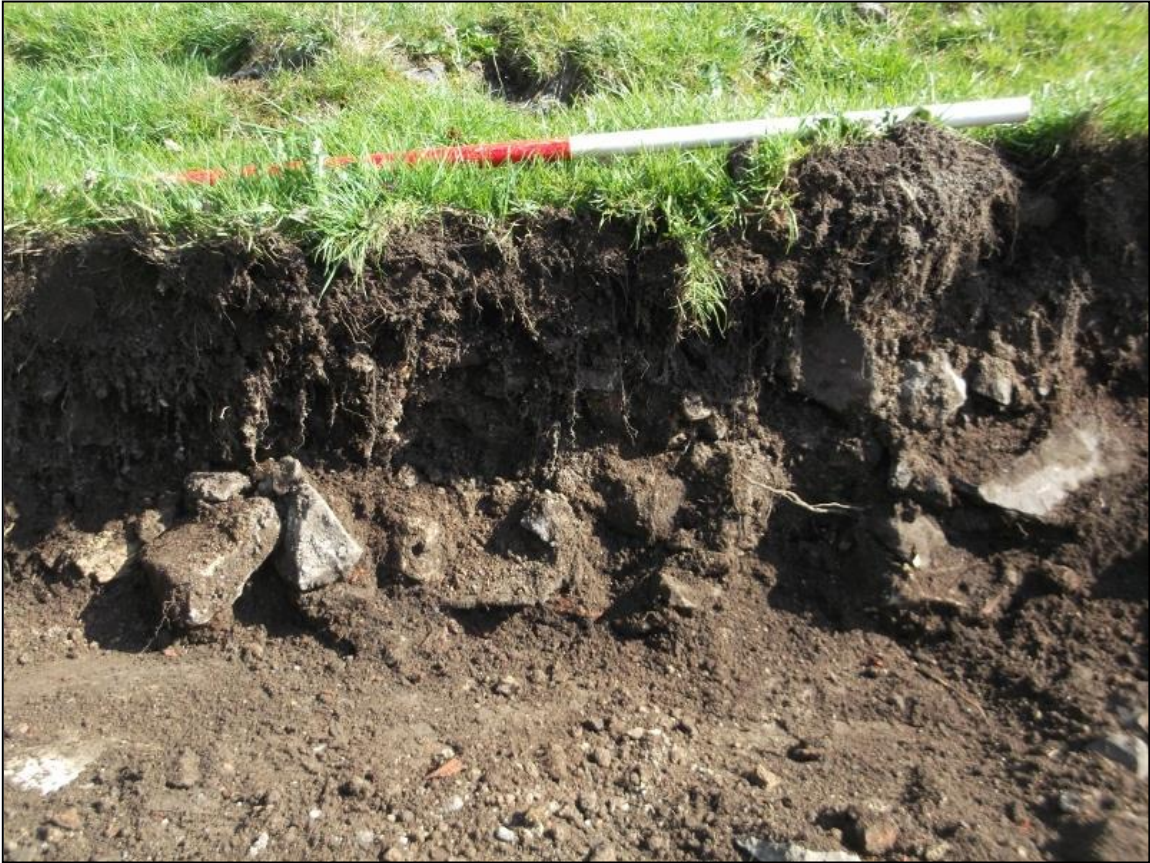
41. The first of these trenches, Trench 32, was located within the interior of Structure a, where it was placed with the intention of identifying any surviving floor deposits. Beneath a thin layer of topsoil (001) measuring 100mm deep, a deposit of angular whinstone blocks up to 0.1m by 0.06m in extent was identified across the extent of the trench (Figure 11a). This layer (011), which was 350mm deep, produced finds of glazed white earthenware and red clay tile, including one fragment of tile with a profile reminiscent of a pantile. The removal of (011) revealed a flat, very compact surface which was initially interpreted as a cement or concrete floor but which was later reinterpreted through comparison with neighbouring trenches as weathered bedrock (012).

Figure 11a: Trench 32, Topsoil (011) overlying stony layer (011)

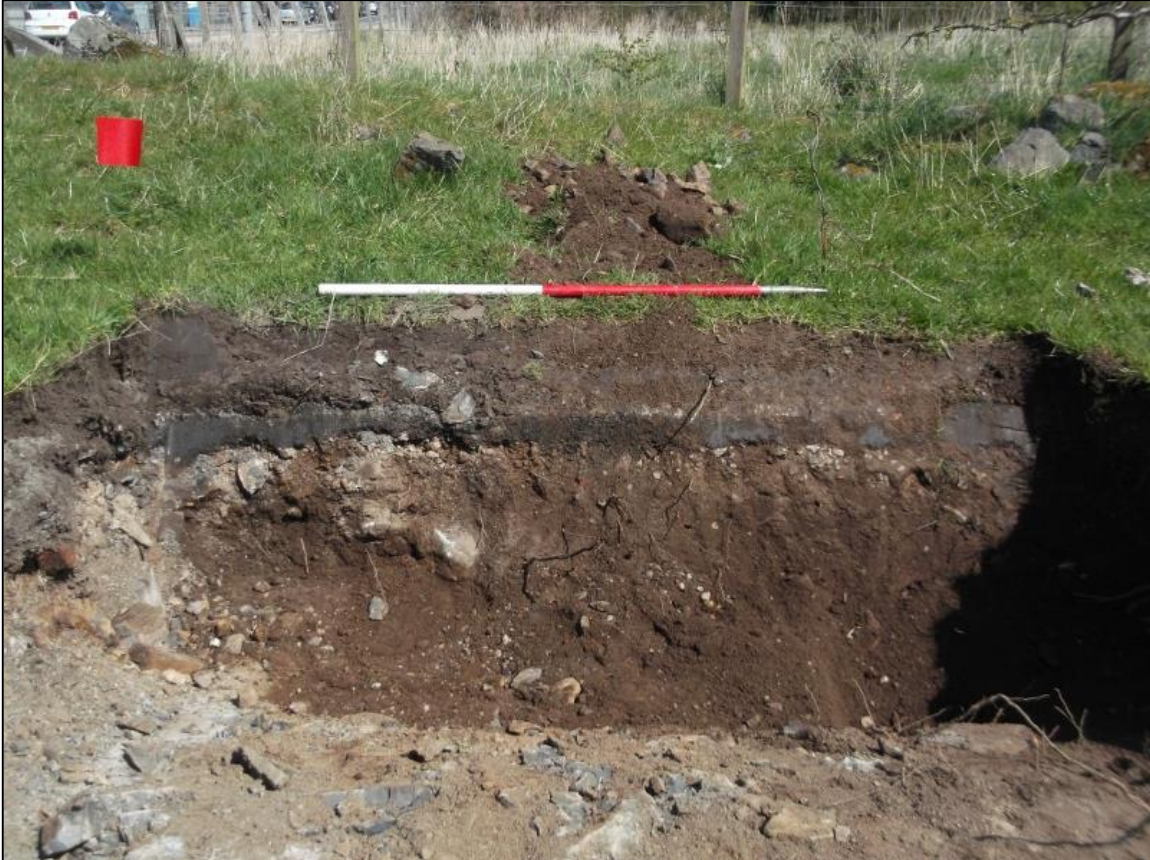
45. Placed to explore the interior of Structure e, the northeasternmost outlier of the steading complex, Trench 36 bore similarities to the trenches described previously, with bedrock (012) overlain by 200mm of stony layer (011) and 180mm topsoil (001). However, at the southeastern side of the trench, (011) and (012) had been cut by a steep-sided pit [014], which had a visible extent of 1.2m by 0.7m but which extended beyond the limits of the trench on the northeast and southeast sides (Figure 11b). It was excavated to a depth of 550mm, at which point bedrock was reached. The fill of this feature was similar in character to the topsoil, comprising a dark-brown, humic sandy silt producing occasional finds of glazed white earthenware and modern glass. A deposit of tarmac or bitumen (023) overlay both (011) and [014], and it is likely that the laying down of the bitumen layer (023) and the cutting of [014] were associated actions which took place in the recent period.

Figure 11b: Trench 36, SW-facing Section showing bitumen layer (023) overlying Cut Feature [114] and stony layer (011)

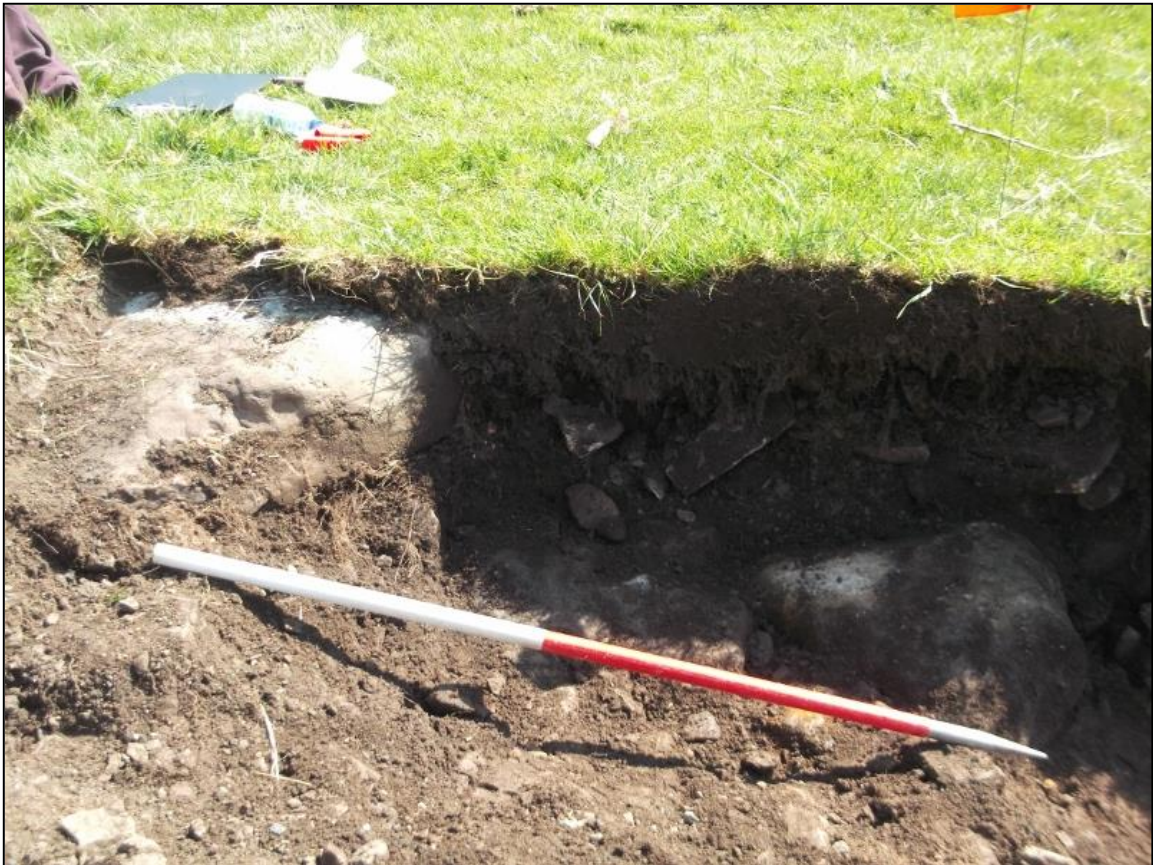
Figure 12a: Trench 38, NW-Facing Section with boulder alignment (015) overlain by stony layer (011)

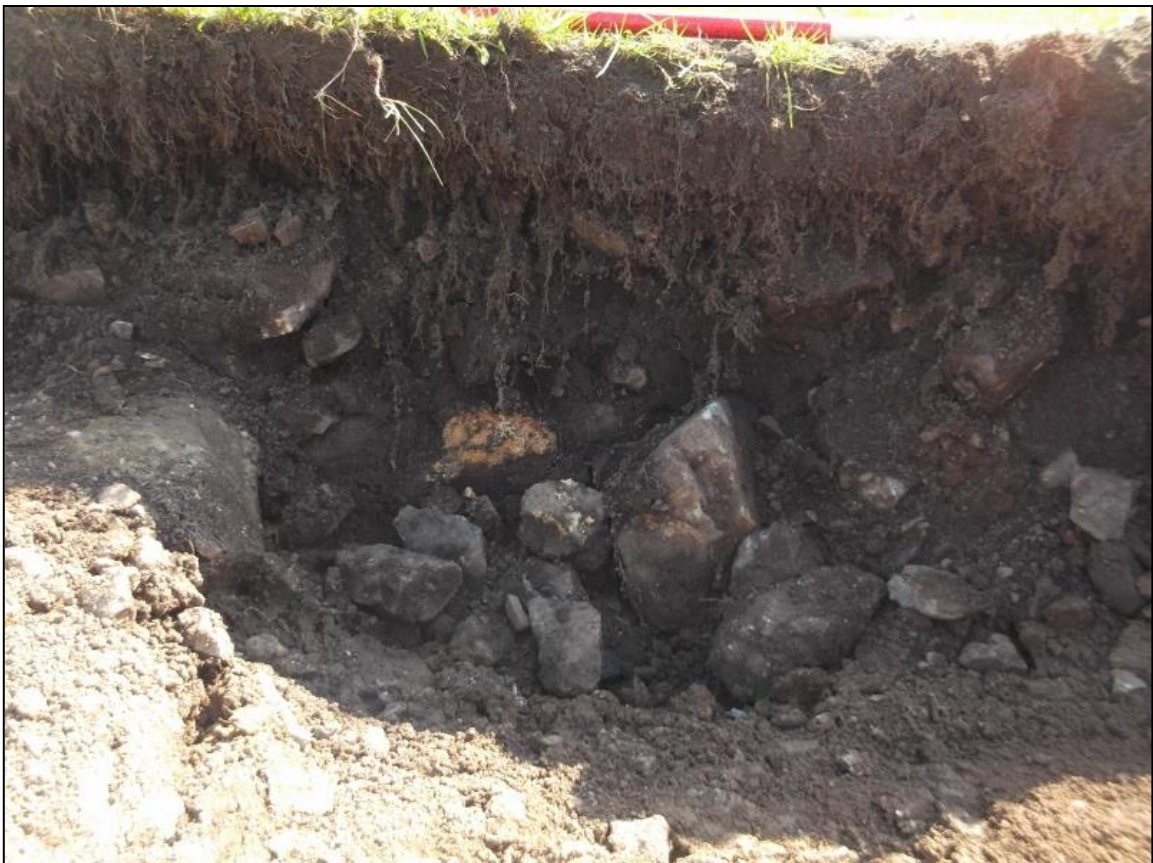
Figure 12b: Trench 38, NW-Facing Section showing drain/soakaway (016)

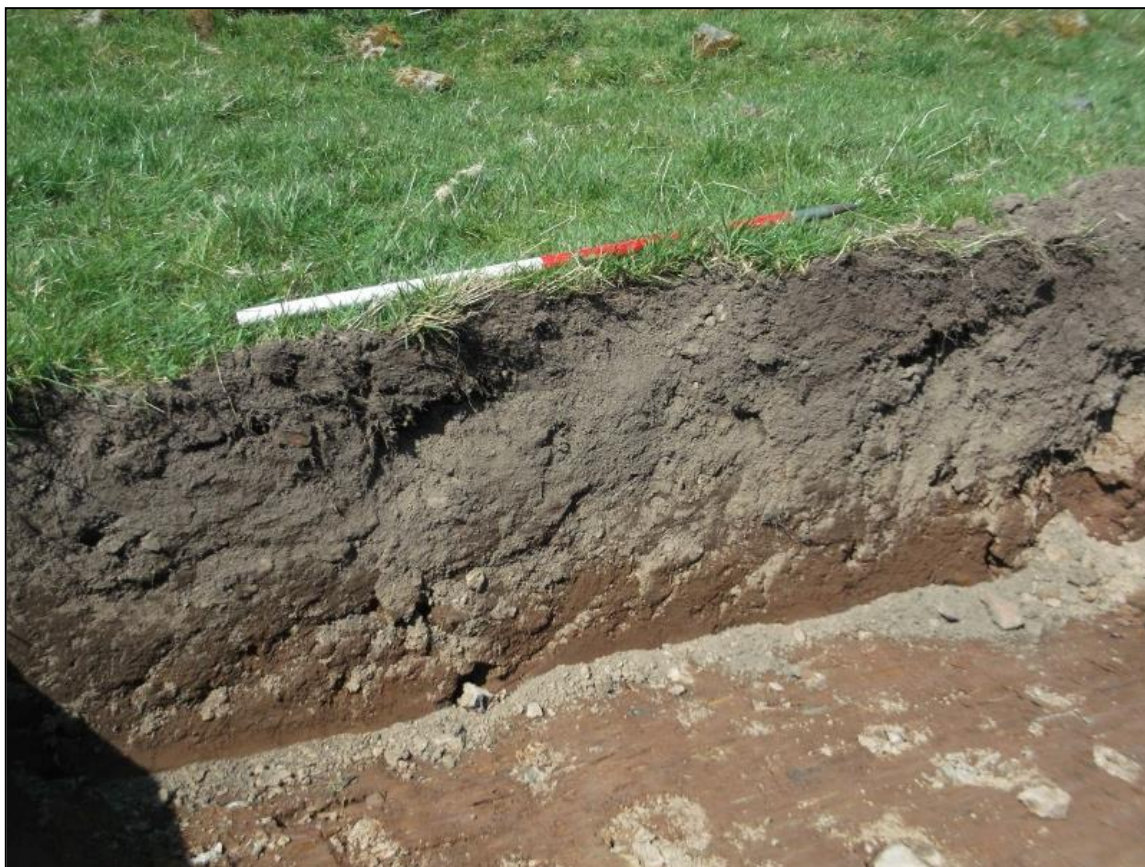
Figure 13a: Trench 40, SE-Facing Section showing depth of topsoil

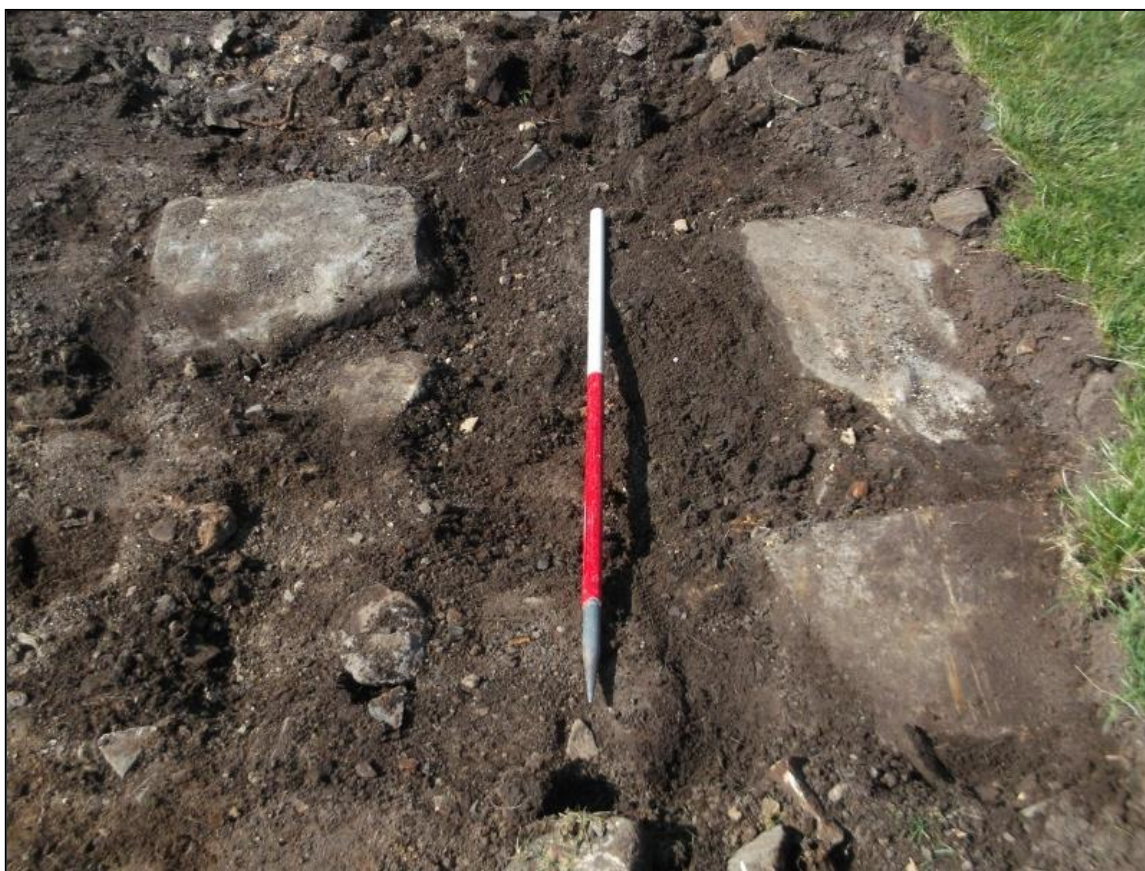
52. The final trench to be opened within this portion of the works was Trench 41, which lay within the northeast end of Structure b. In this instance, a deposit of topsoil (001) 200mm thick overlay a thin deposit of stony layer (011). Beneath (011), several large flat stones or slabs were noted (017). Two of these projected southwest from the northeast baulk, with a further two evident in the centre of the trench (Figure 13b).

Figure 13b: Trench 41, Looking NW across possible floor slabs in base of trench
