Almond Valley Heritage Centre, Livingston: Archaeological Mitigation

Data Structure Report

issued 30th June 2015

RATHMELL  
ARCHAEOLOGY LTD

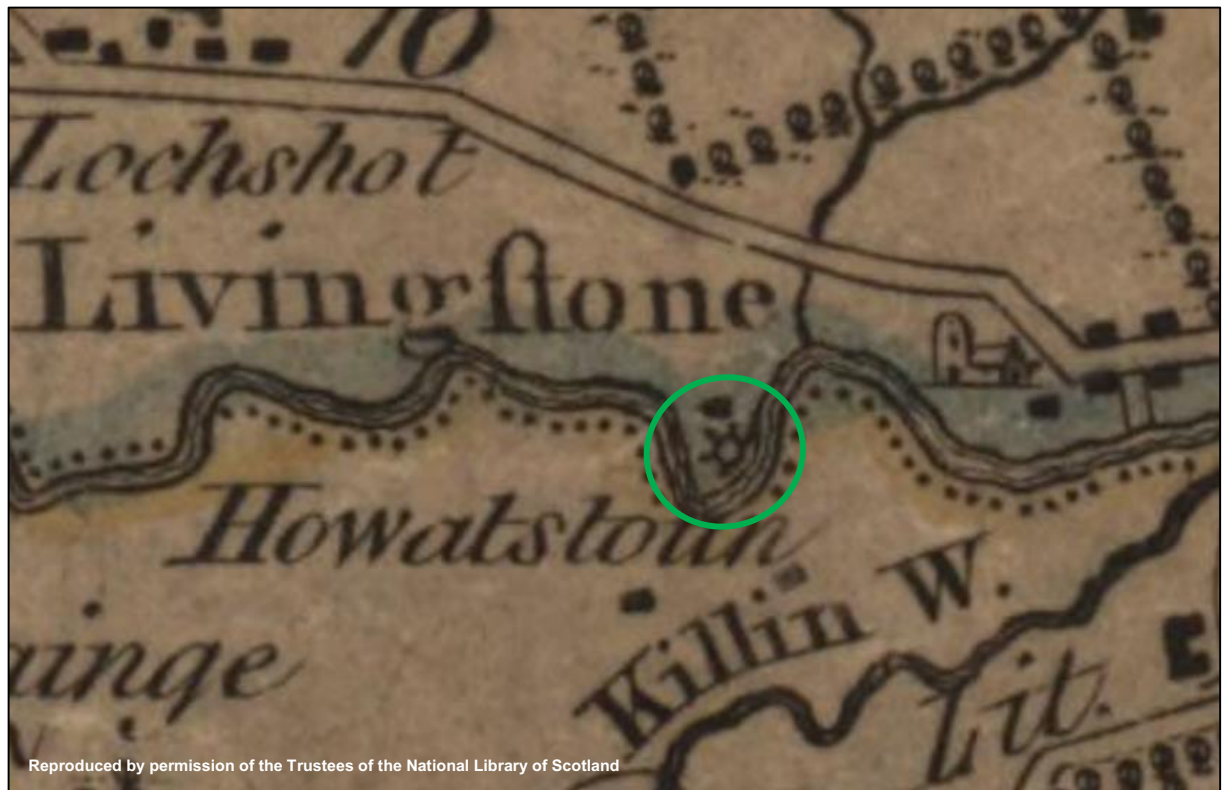
Figure 1a: Armstrong's Map of the three Lothians (1773)

5. The origins of the mill can be identified in the late 18th century. The mill is not depicted on mid 18th century mapping that depicts Livingston village such as Roy's *Military Survey of Scotland* (1752-55) and Adair's *A new and correct map of the Lothians* (1744). However, the mill is depicted by an icon on Armstrong's *Map of the three Lothians* (1773) and Forrest's *Linlithgowshire* (1818) – see Figures 1a and 1b respectively.

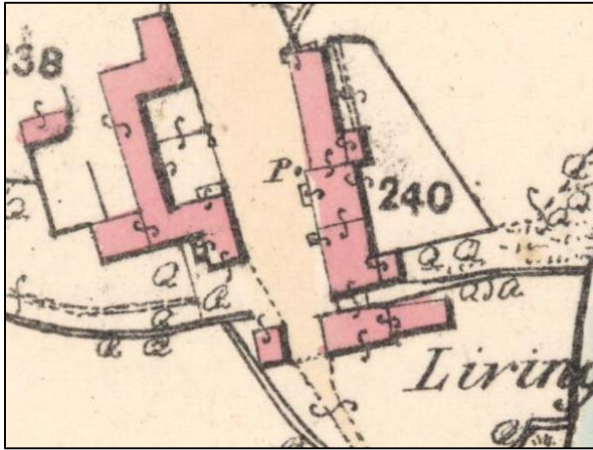
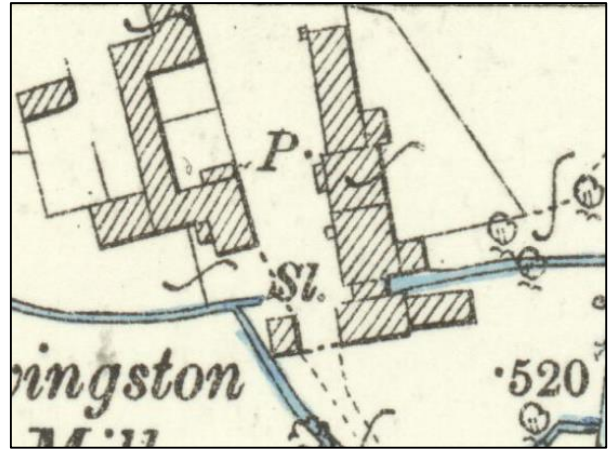
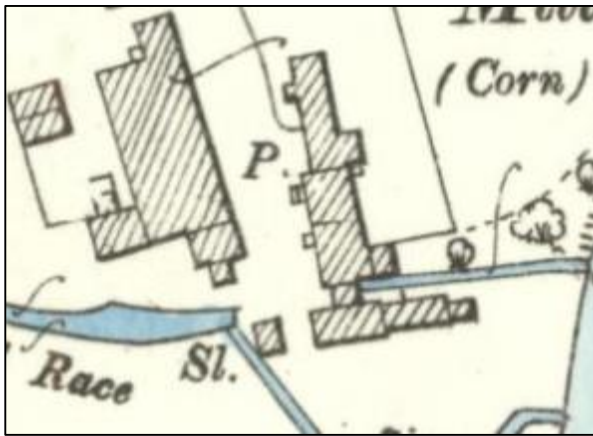
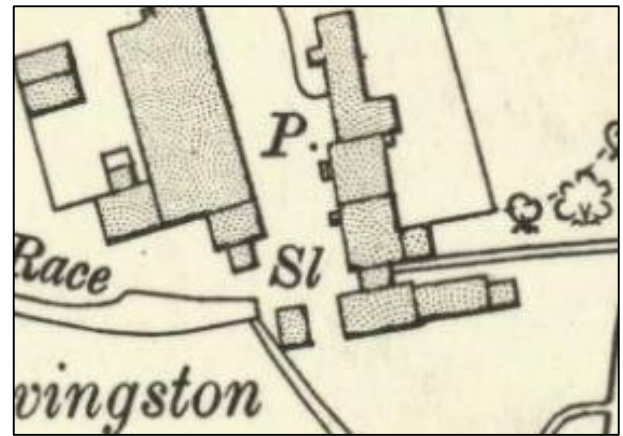
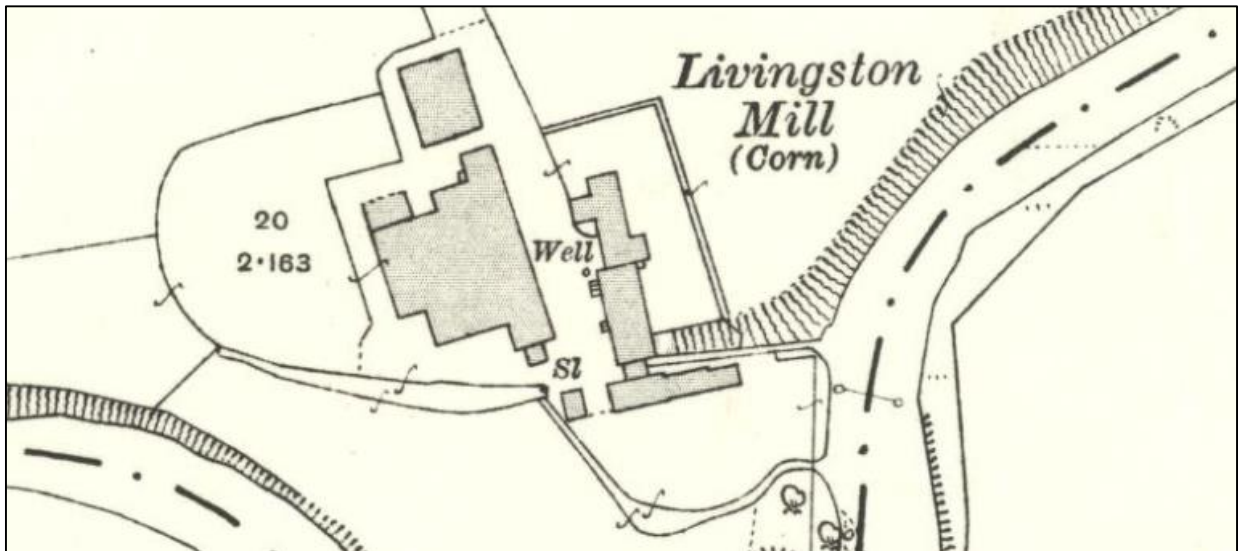
Figure 2: Ordnance Survey 25inch sequence from 1856 to 1916

6. The Ordnance Survey provide sound mapping of the evolution of the mill complex from 1856 onwards (complemented by the Name Book information detailed above). The Ordnance Survey 25 inch sequence from 1856 to 1916 covering both Linlithgowshire and Edinburghshire (see Figure 2) allows good temporal control for the progressive expansion and amalgamation of structures.

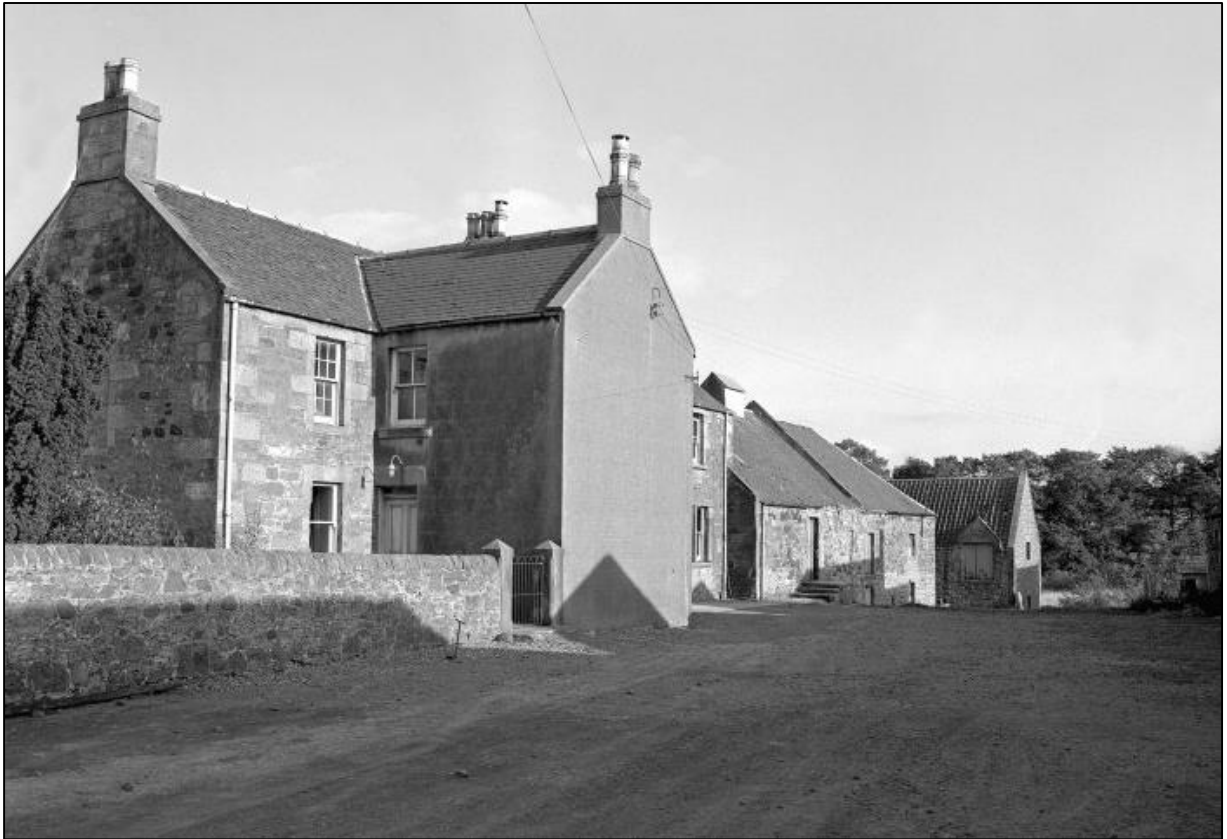
Figure 4: 1975 Hume photograph from NW of Farmhouse, Corn Mill and Threshing Mill
©RCAHMS

9. The listing report that classifies the structures as Category B listed buildings, goes on to make clear that the main interest lies in the Corn Mill which was built c.1770 and had, at that time, been disused since c.1950 but was in a good state of preservation. An image of the character of the mill complex is available from this period from the Hume archives (Figure 4a).

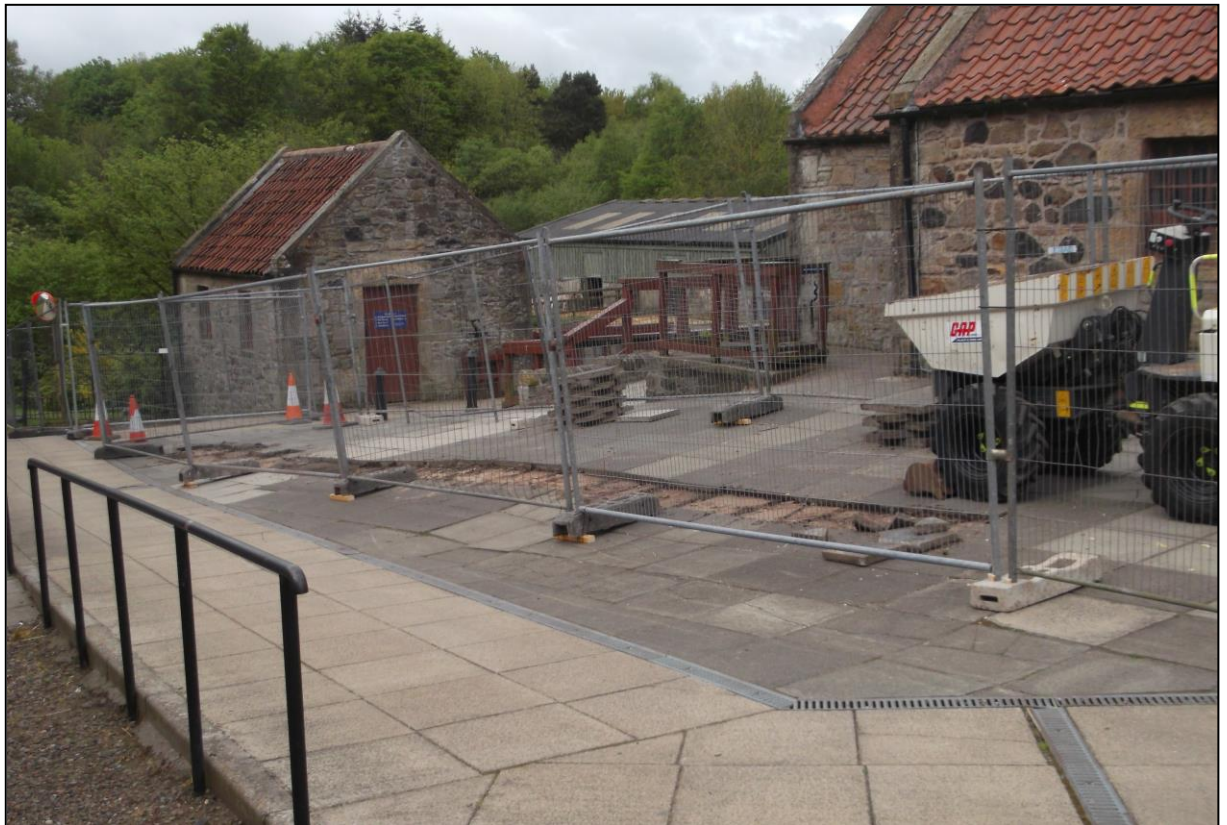
Figure 5: Looking south at service track before excavation

20. Upon arrival on the 26th of May 2015 paving, slabs and cobbles (001), had already been removed along the line of the proposed service track (Figure 5). This was the modern ground surface. The upper layers of sediment consisted of a hard core and concrete sub-base for the paving (002). This modern ground surface ran the entire length of the excavated service track to a depth of approximately 300mm. No significant archaeological material was observed during the excavation of this material.

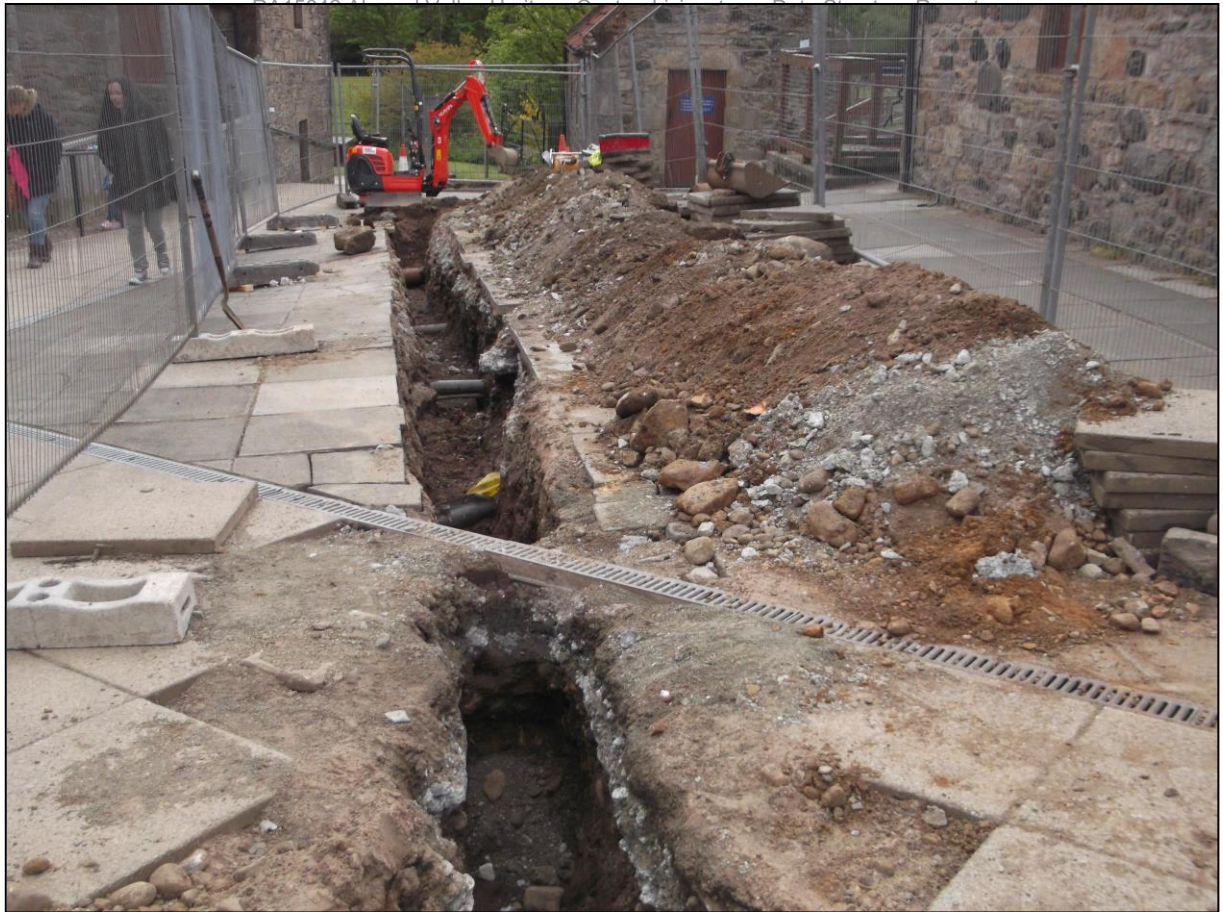
Figure 6: Service track excavated showing multiple existing services

22. Several existing services were uncovered during the excavation of the new service track (Figure 6). Running from north to south, these consisted of a surface drain, an electricity service, a second electricity service and a duct for cabling. Tracks for these services cut through (004) and in some cases cut into (003). All were modern (20th or 21st century) services and of no archaeological significance other than to show disturbance of the ground. At the southern end of the excavated track, adjacent to the culverted lade, a large area of poured concrete (006) based on the subsoil was exposed .

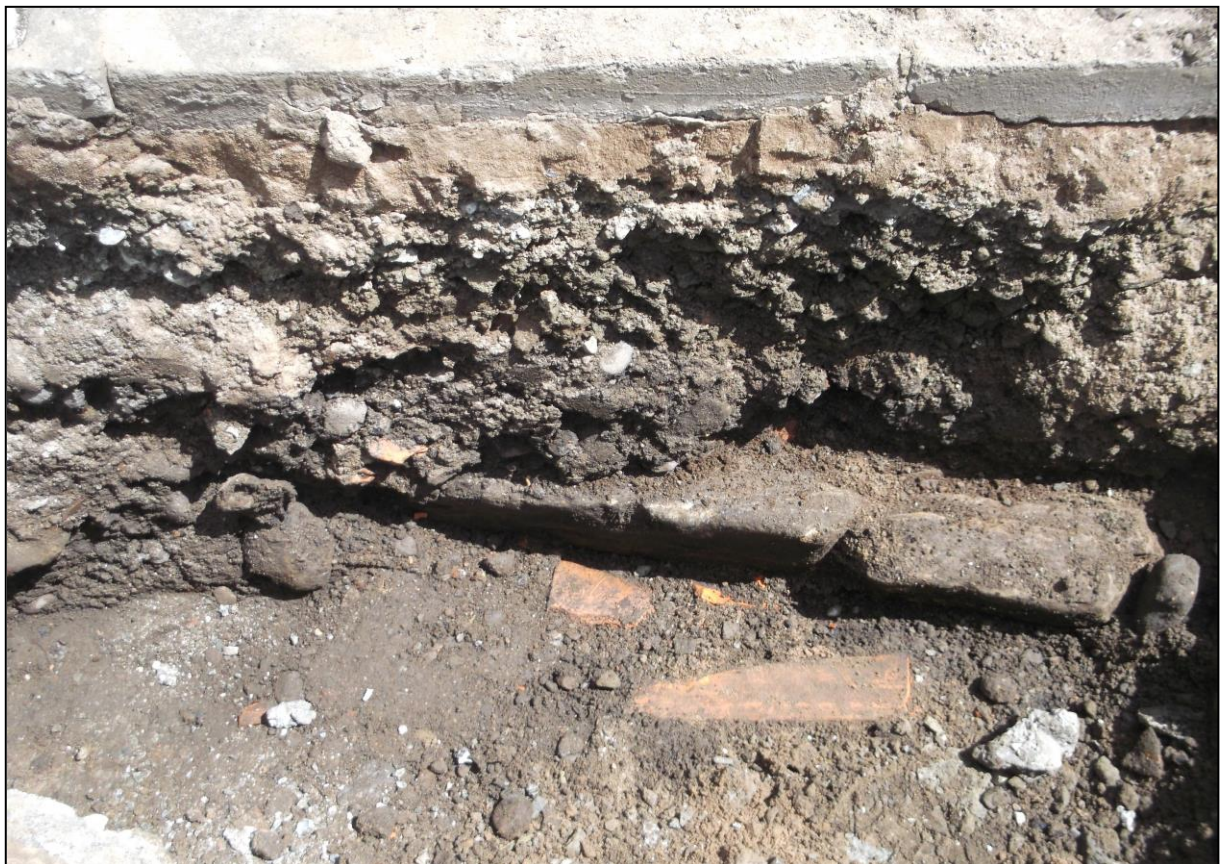
Figure 7: The eastern face of culvert (005) with tile drain within, note made ground over

23. A fifth service in the form of a drain ran roughly north north-east to south south-west through the southern third of the excavated track (005). This drain was first exposed as two opposing lines of stones set approximately 300mm apart (Figure 7). The western line of stones only partially survived, suggesting that this feature had been physically disrupted at some point. This appeared to be the fragmentary remains of a culvert, possibly running from the farmhouse to the mill lade. No capstones were *in situ* and none were present in the surrounding deposits. In addition, tile drains had been placed between the stones. Replacement or renewal of the tile drains was evidenced by broken fragments of old drainpipe between the stones.

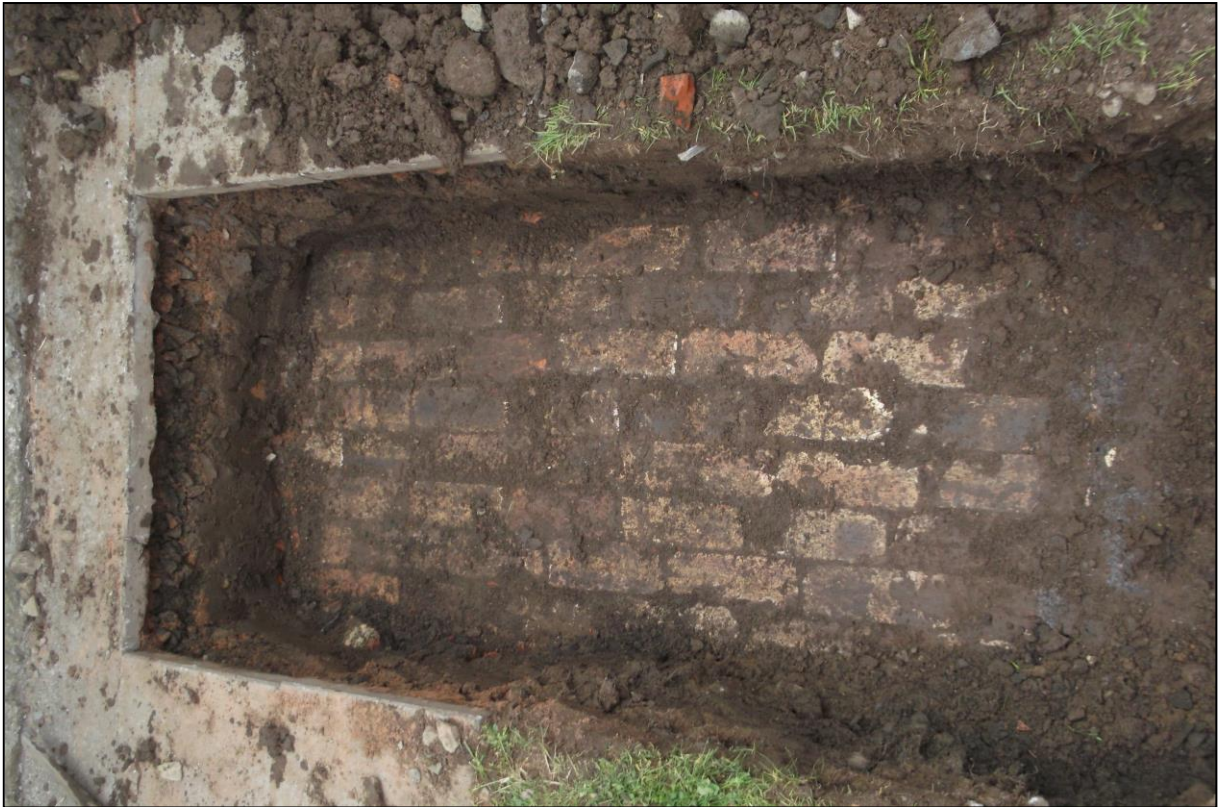
Figure 8: Brick surface within Area B

25. The surface was shallow, one layer thick, un-mortared and with no bedding material present (Figure 8). This appeared to be a modern attempt to hastily create a brick surface, perhaps to dispose of excess building material. This was underlain by topsoil-like material rich in demolition and modern detritus.

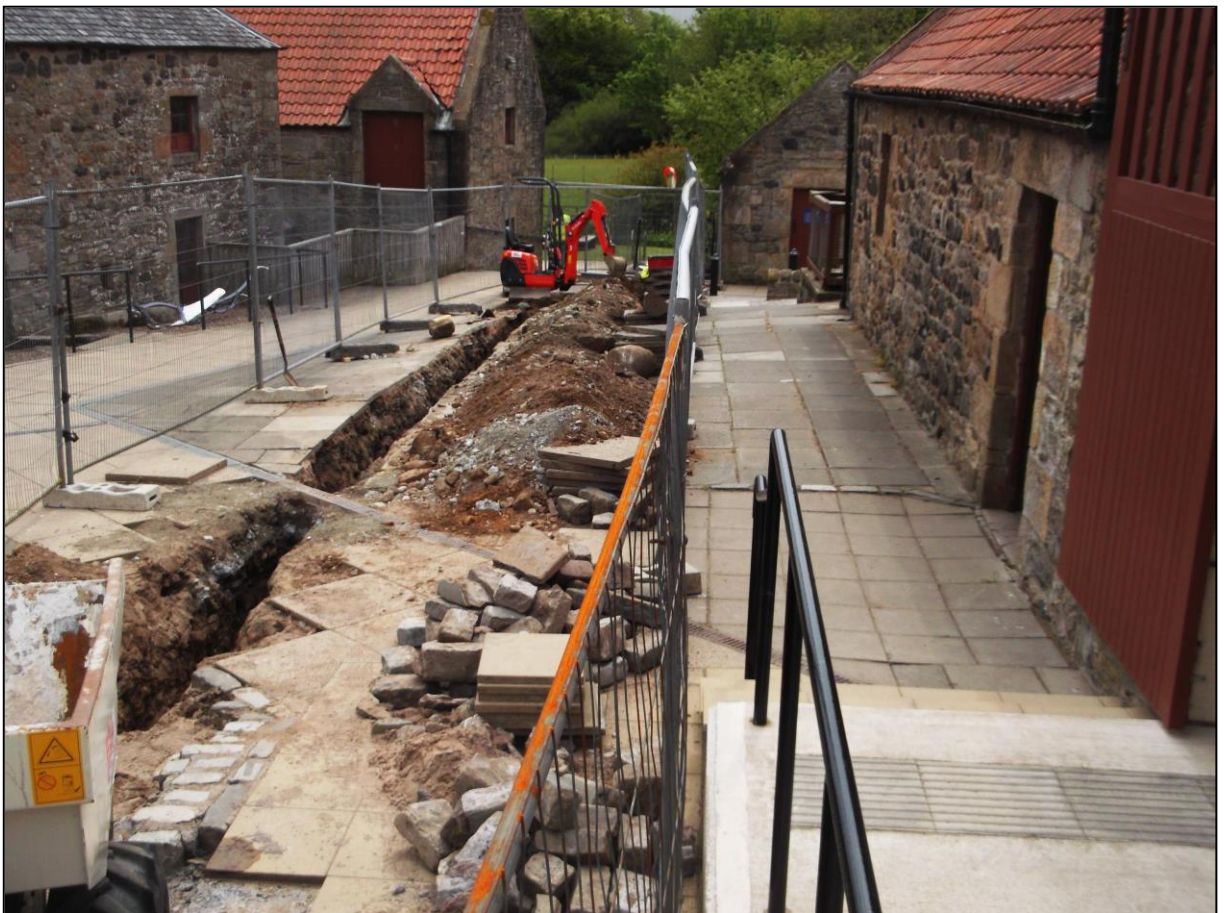
Figure 9: Area A post-excitation

29. The majority of the sediments uncovered formed the sub-base (002) for the placement of a modern ground surface in the form of slabs and cobbles (001) (Figure 9). The layer of black made-ground (004) contained a variety of material including pottery and coal. It was clear that this layer consisted entirely of re-deposited material and had been disturbed multiple times, probably for the placement of modern services. It is likely that the deposition of layer (004) is an attempt at levelling related to the placement of the modern ground surface
30. The brick surface uncovered to the south of the proposed toilet block appeared to be of modern origin. It was a very roughly made surface with no bedding material and no mortar. There were no associated features of archaeological significance.
