Girvan Mains AD Plant, South Ayrshire: Archaeological Evaluation

by Liam McKinstry

issued 10th August 2015

RATHMELL  
ARCHAEOLOGY LTD

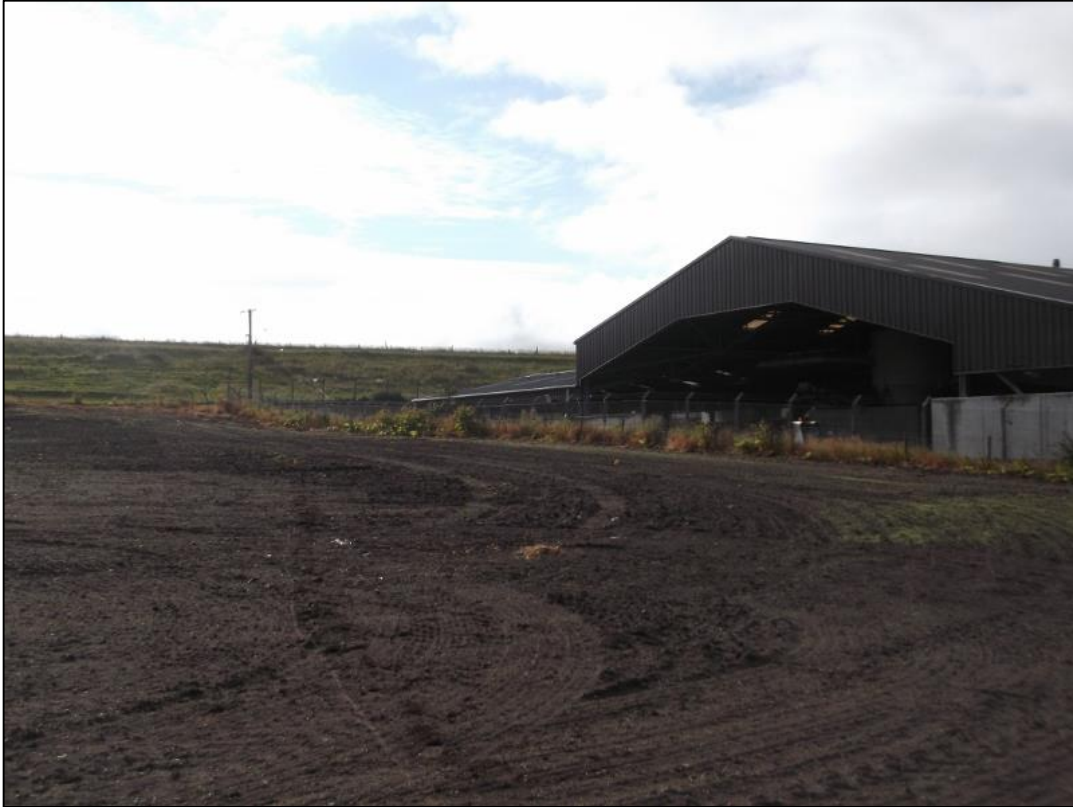
13. The trenches were excavated through a thick layer of plough soil (001) (Figure 3a) which comprised of a moderate to very loosely compacted, mid to dark yellow-brown silty sand with frequent small stone and pebble inclusions. There was also the presence of the last potato crop grown found throughout this layer. The natural subsoil was encountered at depths of between 310 to 520mm below the top of the current ground surface.

Figure 3a: General shot of development area from the NW

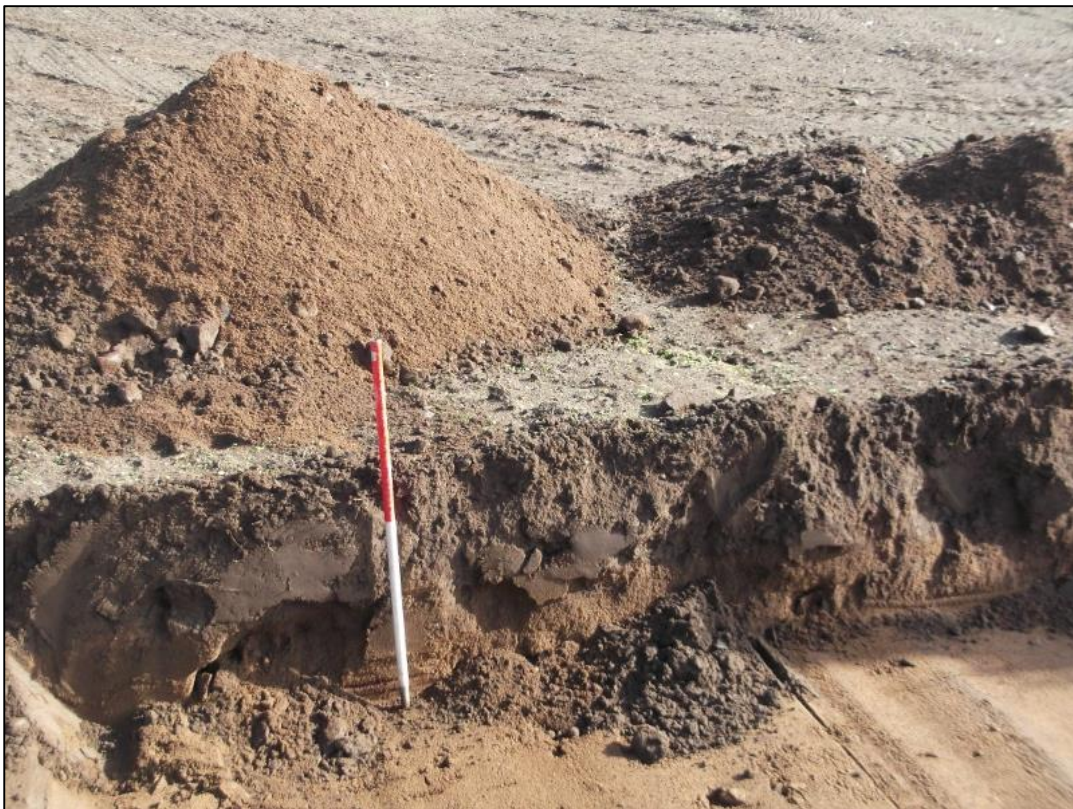
Figure 3b: SW facing section of Trench 2 showing the depth of the plough soil (001)

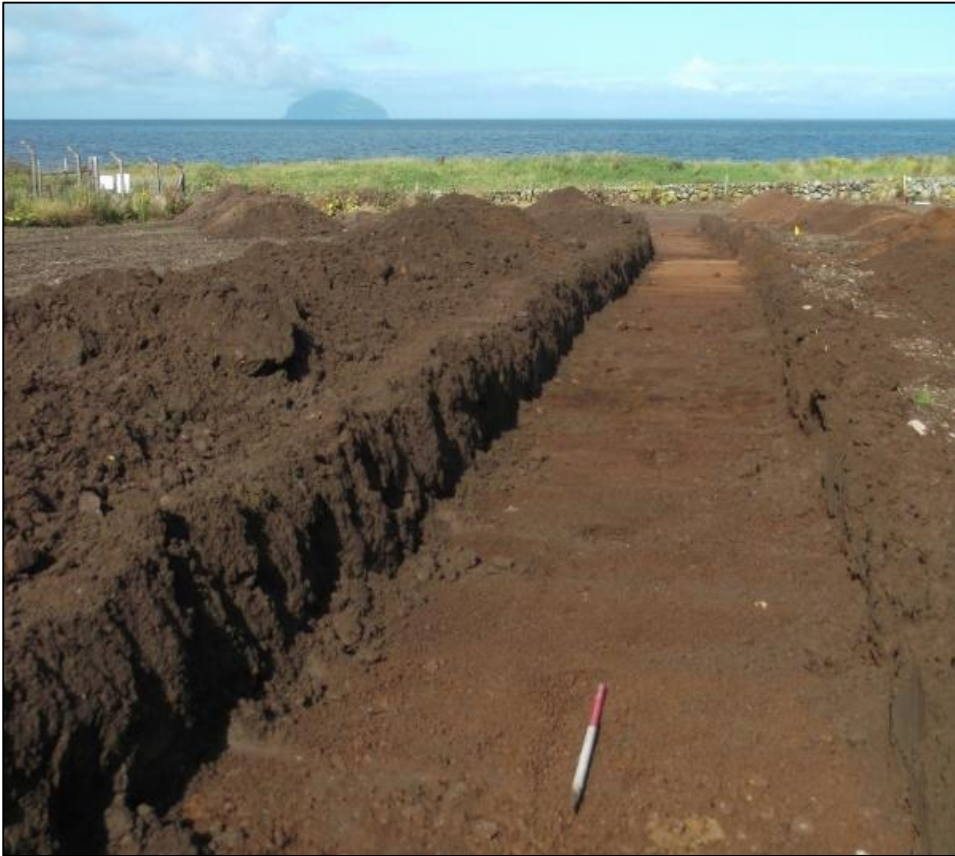
Figure 4a: Post excavation shot of Trench 2 from the E

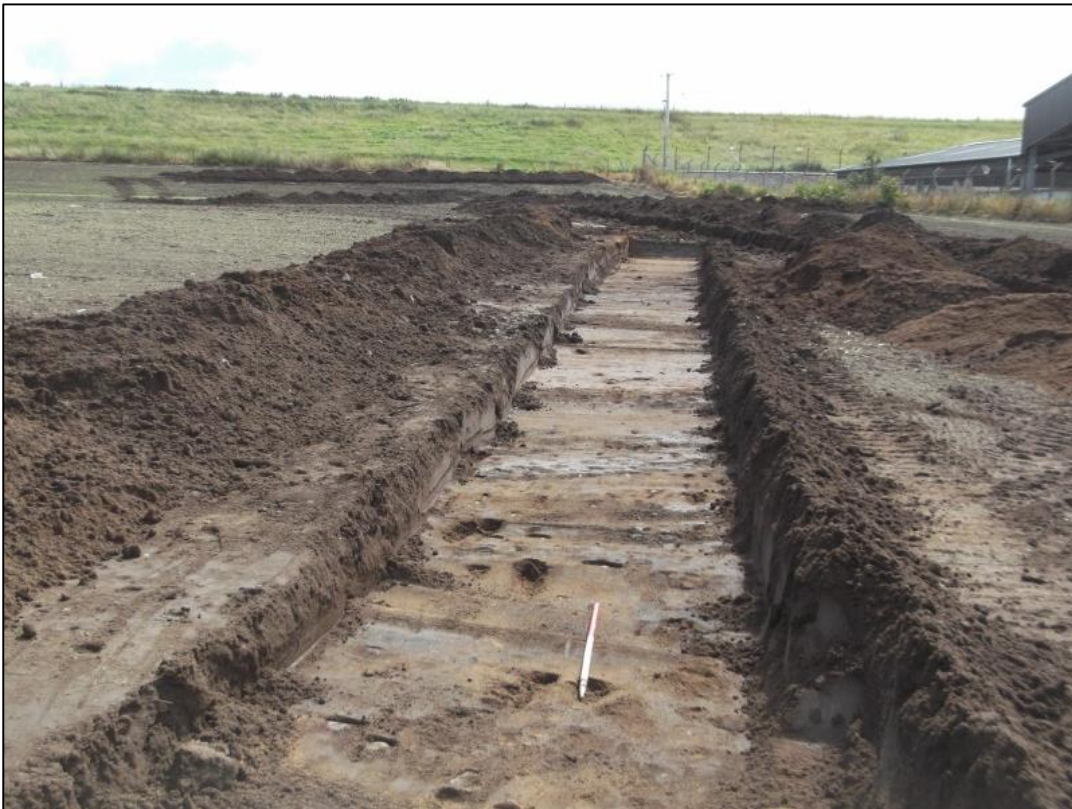
Figure 4b: Post excavation shot of Trench 6 from the NW

6	NW-SE	1.6m by 29.8m 47.68m ²	480 to 510mm	(002) Moderate to loosely compacted, light to mid orange-brown sand with occasional small (rounded) stone and pebble inclusions. (003) Moderately compacted, mid orange-brown sand with occasional to moderate small (rounded) stone and moderate pebble inclusions.	None	None	None
