Former Tobacco Barn, Montrose: Archaeological Mitigation

Data Structure Report

issued 19th August 2015

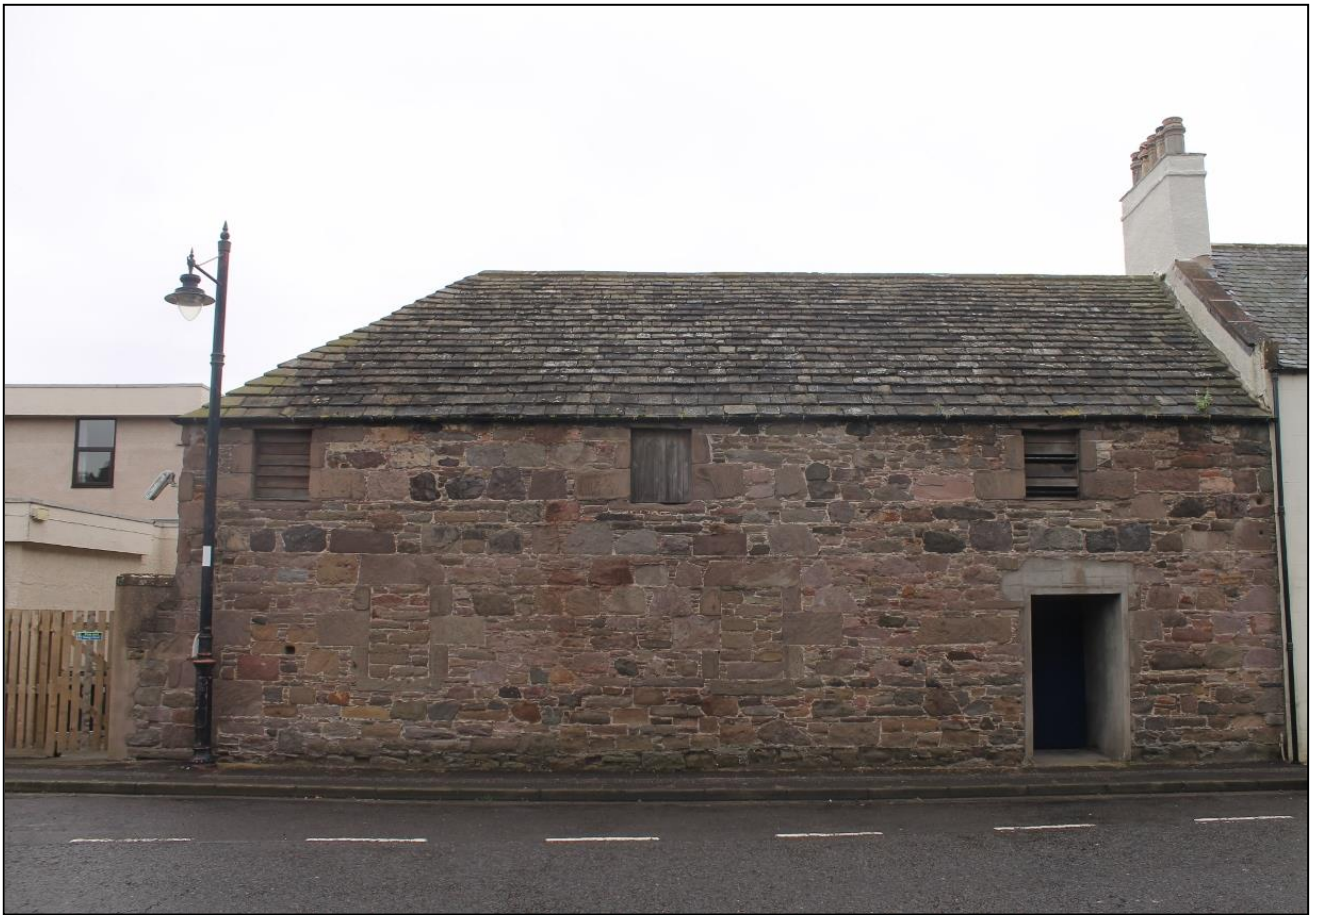
Figure 5a: West elevation

20. The West elevation (Figure 5a) has two windows (i & ii) which have been blocked with masonry, again comprising snecked sandstone rubble, the weathered appearance of which suggests that this blocking may have occurred some time ago, possibly during the 19th or early 20th century. The cill, lintel and rybats comprise squared and rectangular sandstone blocks which have been subject to weathering (Figure 5b), with the rybats ranging in size from 750mm by 400mm to 350mm by 200mm.

21. There are three rectangular vents (iv, v, vi) located one per bay at 1st floor level on the East Elevation. These openings are defined by similar squared sandstone blocks to those used in the ground floor windows, and all lie to the north of centre of each bay. Two of these vents - (iv) and (vi) - still have wooden slats in place, while (v) is blocked by a wooden panel (Figure 5a).

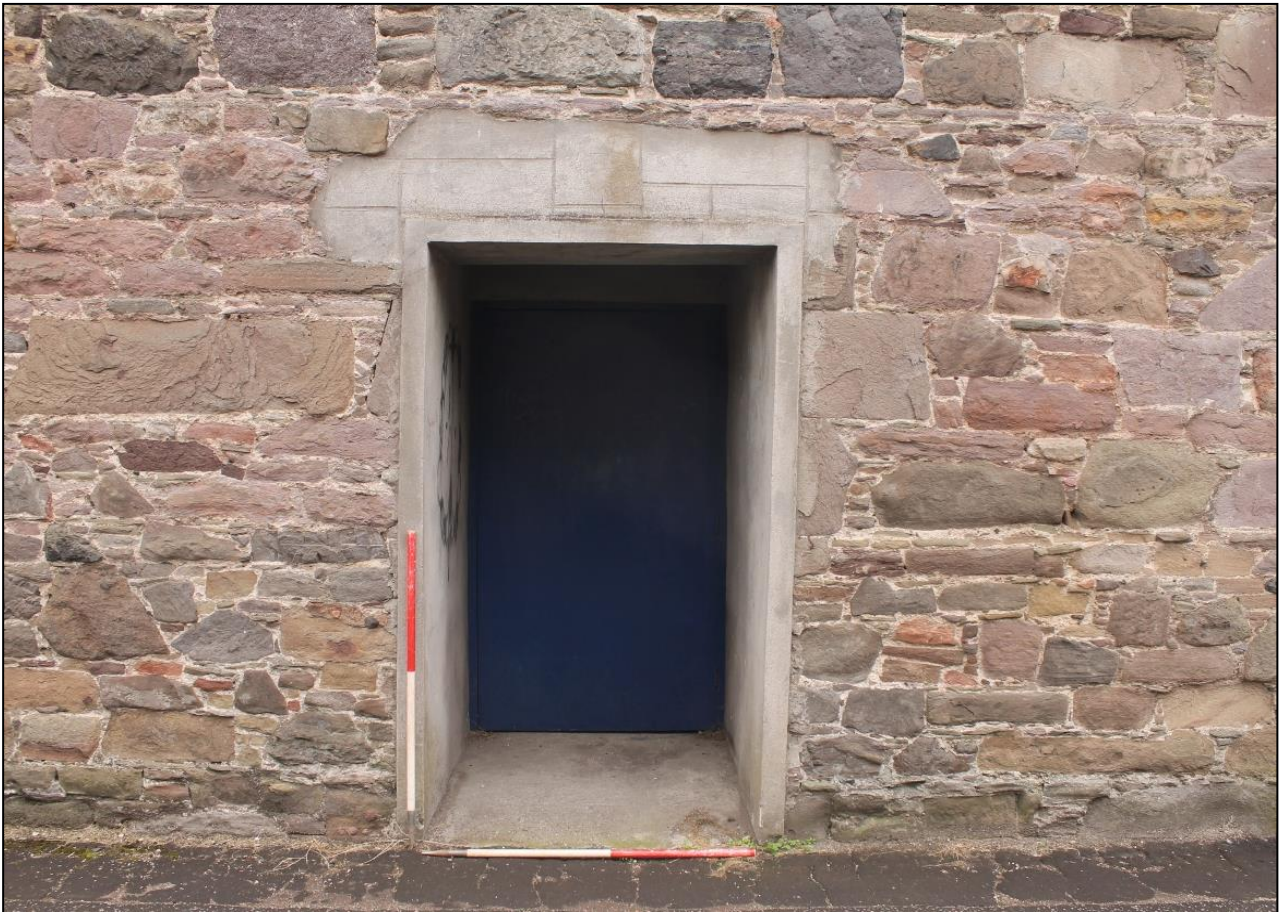
Figure 6a: Doorway (iii) West elevation

22. The doorway (iii) located at the southern end may well be an original feature, however this has been substantially modified, with the replacement of the original stone lintel with a modern equivalent, presumably steel, now concealed beneath a cement margin. The door has also been replaced with modern fire door set back from the pavement, creating a small recessed space to the fore (Figure 6a). The quoins comprise contrasting sandstone block ranging in size from 500mm by 250mm and 400mm by 250mm: they are markedly larger on the south side of the doorway, which suggests that the original doorway was narrower, and that the opening was extended northwards during the insertion of the fire door.

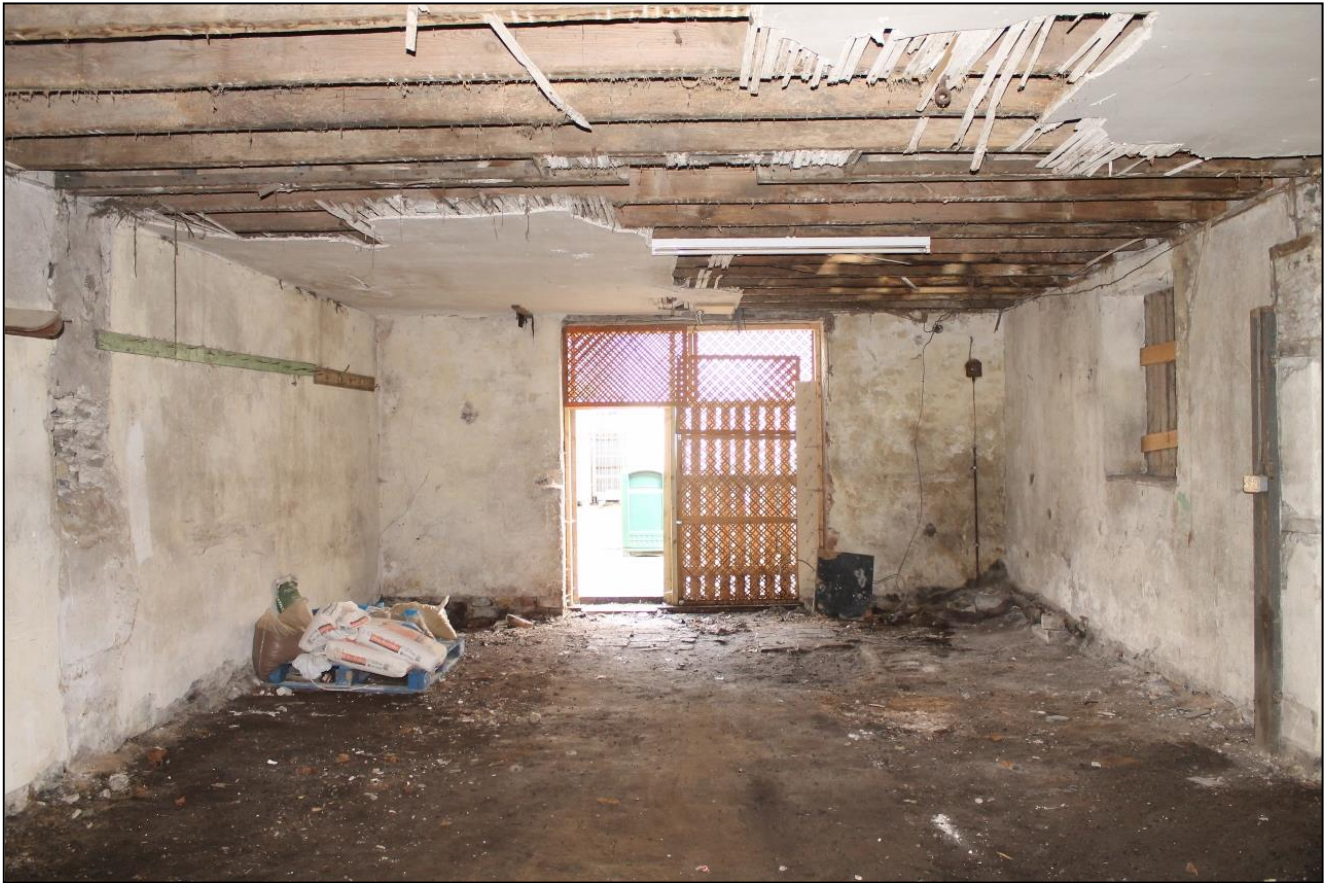
Figure 8a: Main room

26. The larger of the two rooms (Figures 4 & 8a) measures 10m by 5.47m with a lath-and-plaster ceiling, painted white. In general the ceiling is in poor condition throughout. The majority of the flooring is formed by a very compacted clay and topsoil mix. In the centre of the large doorway in the North elevation, there is an area of brick floor measuring 1.50m by 1.40m (Figure 8b). At the southern end of the room there are areas of cobbles and concrete paving with lozenge patterns and measuring 2.40m by 1.70 and 3m by 1.70 respectively (Figures 9a & 9b).

27. All the walls have been plastered directly against the stonework and painted white with patches of the plastering now coming away due to damp and neglect. On the north wall it was possible to record that the masonry comprised an outer sandstone section 300mm wide with an internal brick lining 150mm thick. Where the plaster and sandstone had come away on the east and west walls it was possible to see that the walls were composed entirely of sandstone. The dividing south wall was a much later insertion, formed out of breeze blocks.

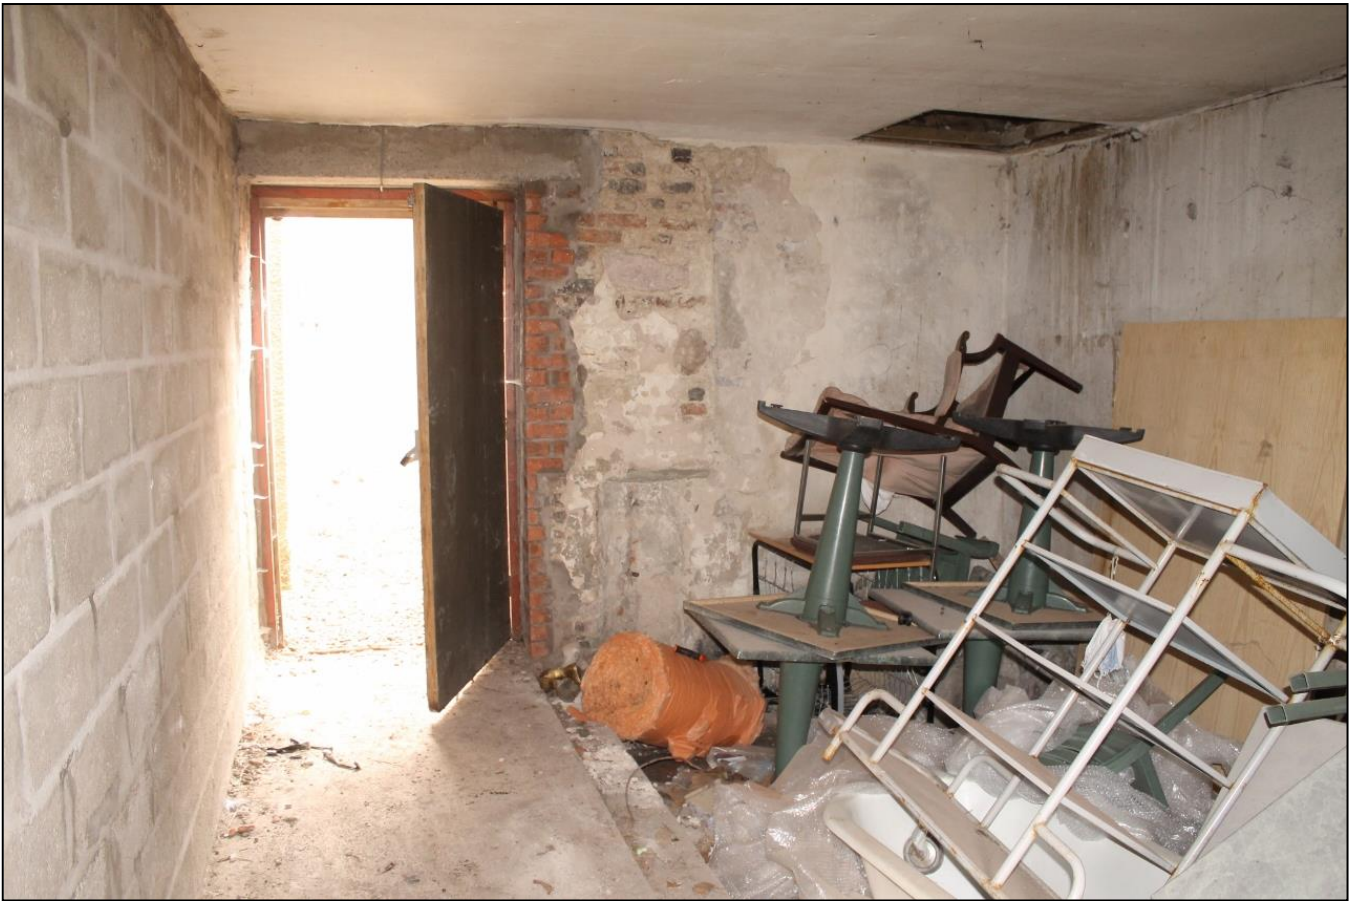
Figure 10a: Store room

28. The store room (Figures 4 & 10a) would once have been part of the main building. It measures 5.48m by 3.46m. In the upper southeast corner is a hatch that allows access to the upper floor. The ceiling is white painted plaster board and the walls are plastered and painted white. The North wall is formed by breeze blocks and separates it from the main larger room.

29. There were a number of chairs, tables and general furniture in the southern side of the room, obscuring the interior and making it difficult to see any details. The cobbled flooring is visible and is most likely part of the same feature recorded in the main room. In the east wall there is a semi-circular recess measuring 1m by 400mm (Figure 10b) with a drain at the base. The presence of the drain at the base indicates the existence of a sink or handbasin at one time.
