**Hunterston Converter and Substation,
West Kilbride, North Ayrshire:
Archaeological Monitoring
Data Structure Report**

by Diane Gorman
issued 17th July 2014
on behalf of RSK Environment Ltd

RATHMELL  
ARCHAEOLOGY LTD

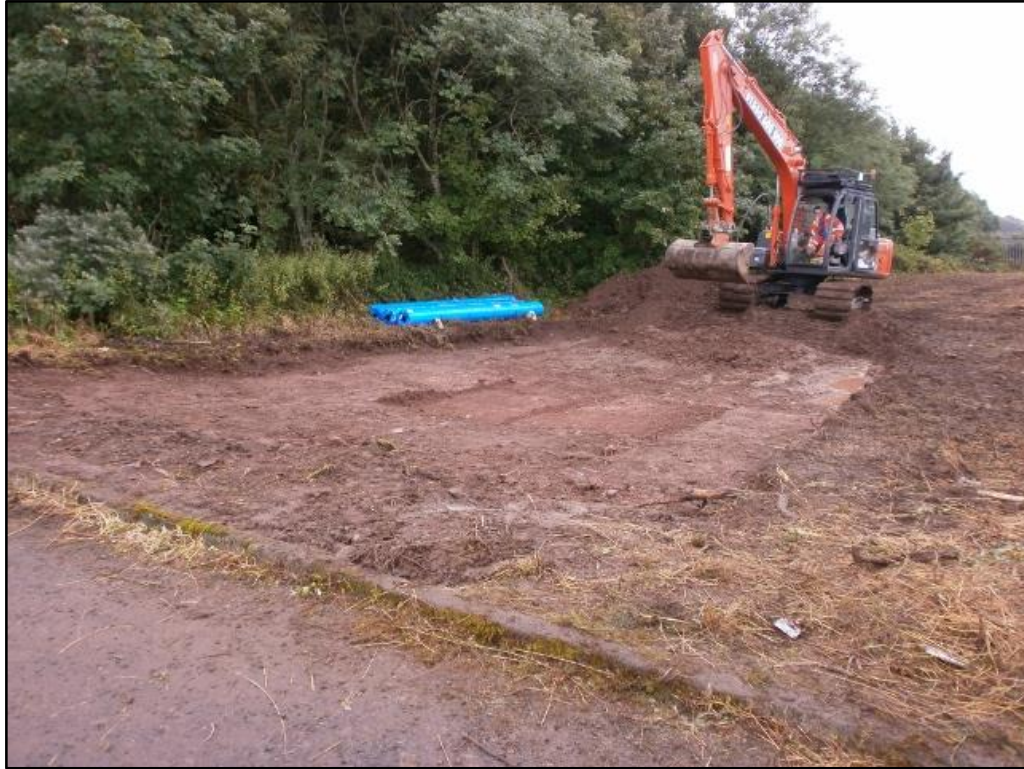
Figure 2a: Eastern stripped area of Siemens Compound Strip

20. A portion of the east side of the compound was the first to be stripped, measuring 82.5m² in total (Figure 2a). This was reduced through the removal of topsoil (001), exposing either (002) or (003) below. The majority of the strip exposed deposit (002) immediately below the topsoil. This was a mixture of red, orange and pink modern debris in a sandy matrix. The debris consisted of red ceramic drain fragments, modern red bricks and red brick fragments, chipped concrete aggregate, modern glass and metal pieces. As excavated, this was 0.1m to 0.2m thick, covering an area of 77.5m².

21. Deposit (003) was limited to the south-west corner of this rectangular stripped area, covering an area of 5m² in extent. This deposit was soft, light pink sand with occasional small to medium red sandstone inclusions, rare worked red sandstone blocks, and occasional concrete aggregate fragments. As excavated, this deposit was 0.2m thickness.

61. The rectangular area stripped at the east side of the compound mainly exposed deposit (002). The material which made up this deposit indicated a layer of demolition material of fairly recent origin. Deposit (003), which was found in the south-west corner of the rectangular area, also seemed to indicate demolition debris. The worked red sandstone blocks would seem to have represented a dump of material from a sandstone building, though not necessarily from the immediate area. The concrete aggregate inclusions within this deposit indicate a fairly recent date. Both deposits (002) and (003) seem likely to have been 20th century in date.

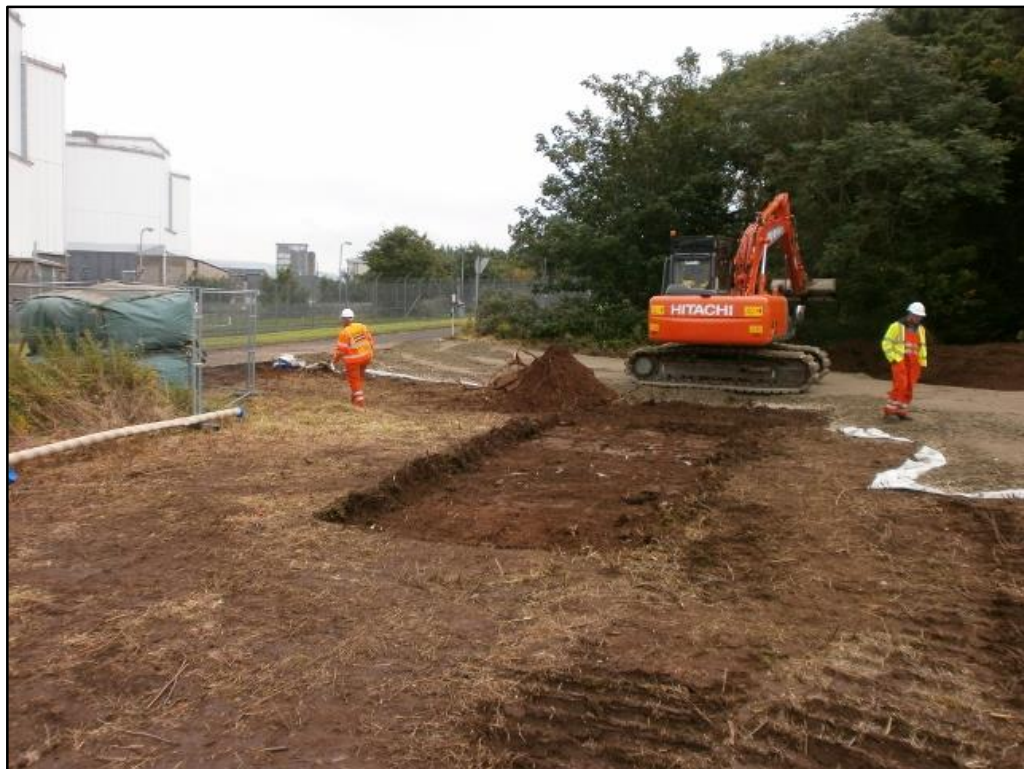
Figure 2b: Showing two smaller areas stripped to the west (Siemens Compound)

22. To the west of the initial Area two smaller areas were stripped (Figure 2b). The first measured 24m², and was reduced through removal of the topsoil (001) to expose (004) immediately below. Deposit (004) was a soft, light to mid brown sandy clay, with frequent roots and rootlets, small to medium stones, occasional modern red bricks and red brick fragments and occasional modern glazed white earthenware sherds. As excavated this deposit was 0.1m thick. The other area measured 12.5m² in extent, with the final level after stripping remaining within topsoil (001).

62. The smaller rectangular area to the west of this exposed only deposit (004) below the topsoil. The nature of this material, being soft and loose, and the artefacts present within the deposit make it likely that this is a landscaping deposit, brought in to level the area. The modern artefacts indicate it is fairly recent in date, having either a late 19th or early 20th century origin.

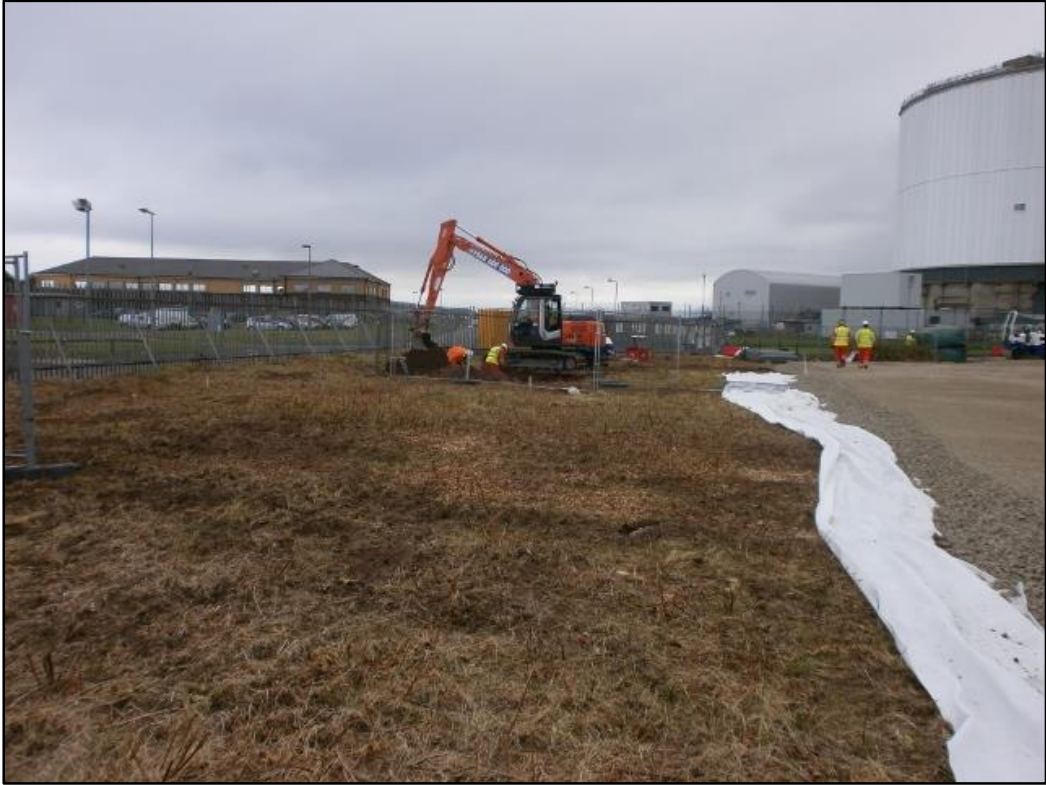
Figure 3a: General shot of compound area & location of investigative trench

23. Other works carried out in the compound area included investigative trenching, in a location at the west side. An area covering 15m² was opened to establish previous service installations, and generally the trench exposed only disturbed ground. However, at the west side of the trench an area 0.5m wide was excavated through previously undisturbed ground.

24. The trench was excavated through topsoil (001) to expose 0.3m thickness of deposit (004) below. Below (004) was deposit (005) which was a soft, black, sandy clay with rare quartz fragments and occasional rootlets, measuring 0.2m in thickness. Immediately below this was (006), a firm, mid grey/light blue clay containing occasional quartz fragments, and measuring 0.4m in thickness. Context (007) was exposed below (006): measuring 0.2m thick, this context consisted of a mixture of soft slate, bedrock and gravel, the usual deposit found immediately above bedrock proper. Bedrock (008) was below this, at a depth of 1.4m. Bedrock in this area is red sandstone.

63. The investigative trench excavated at the west side of the site generally exposed very recent disturbance from recent service installations. However, the 0.5m width of less disturbed ground adjacent was worthy of note. The possible landscaping deposit (004) was also found in this area, at a depth of 0.5m. The nature of the deposit which was found below (004) - deposit (005) - possibly relates to industrial activity in the area. The black sandy nature of the deposit with its quartz inclusions could relate to a burnt deposit of sand.

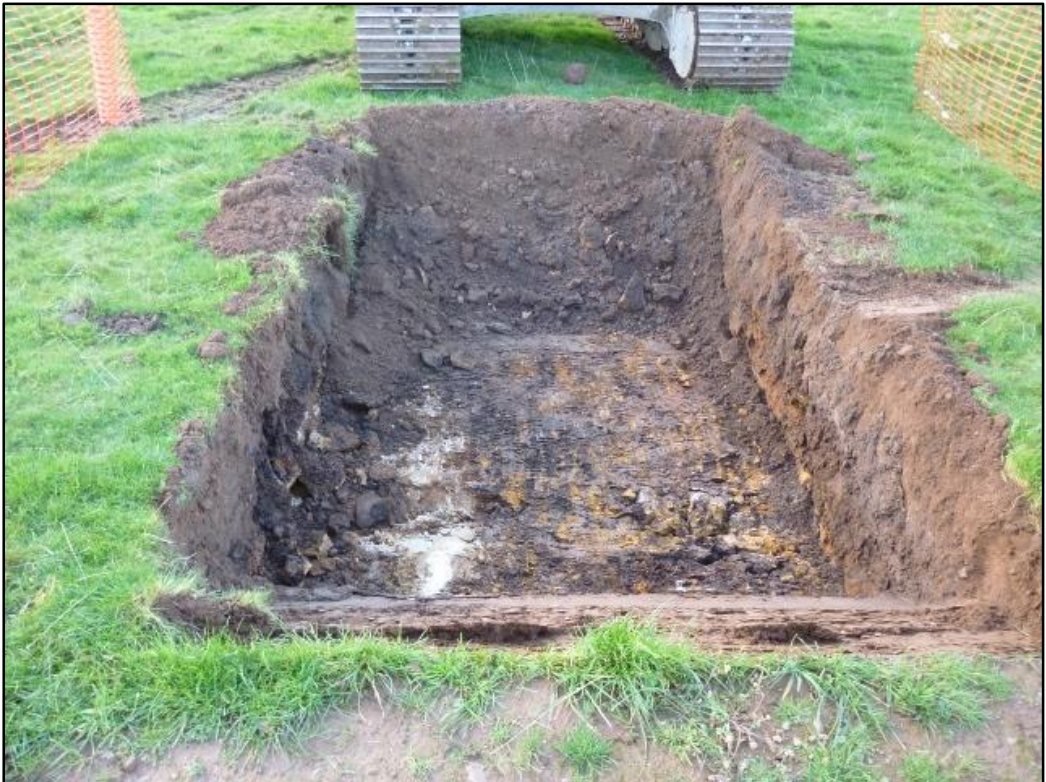
Figure 3b: Deposit (3020) within Test Pit One, Area 3

39. Excavation reduced the test pits through the uppermost deposit of topsoil (3001) which varied between 0.2m to 0.3m in thickness and which covered the entire area. Also exposed was deposit (3021), which was composed of softer, fractured yellow sandstone, a deposit often found above natural bedrock. Test Pit One also exposed a layer of (3020), a soft, finely grained black deposit (Figure 3b).

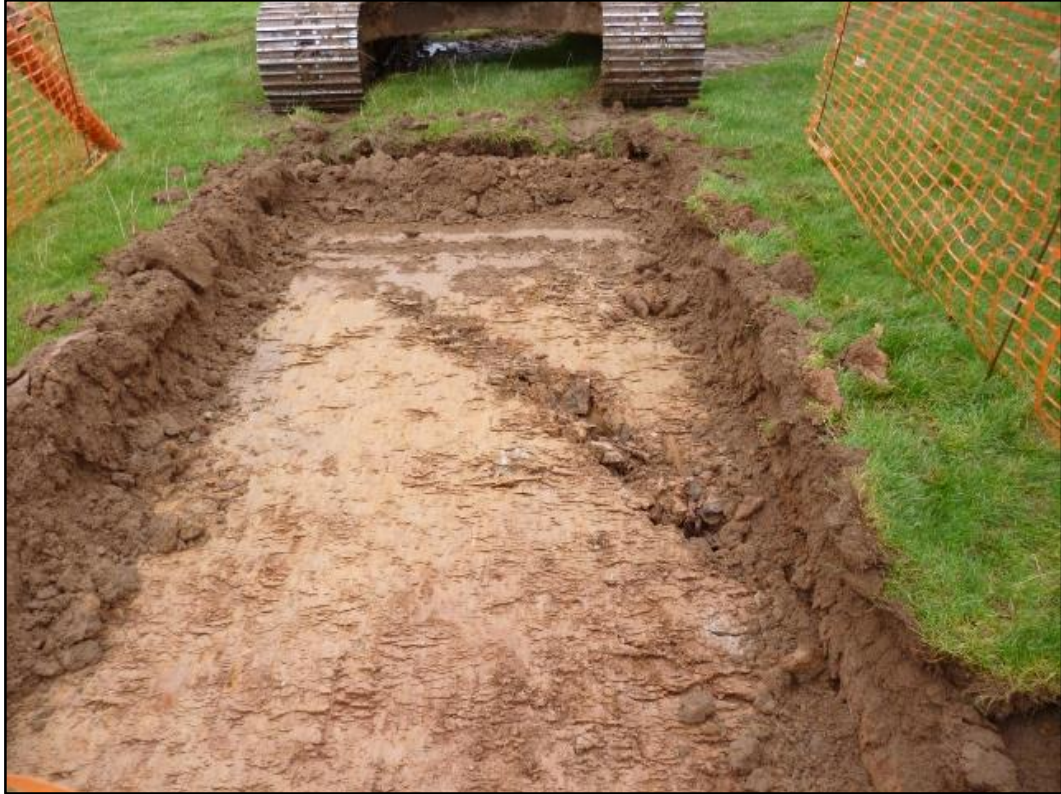
Figure 4a: Field drain [3006], Test Pit 10, Area 3

37. Rubble drains are represented by [3006]. Drains assigned this number were 0.4m wide, filled by deposit (3007). This deposit was loose, dark brown silty clay, with large unworked stones. Natural bedrock in the area was (3019), which comprised a yellow sandstone.

72. The majority of features exposed during the haul road strip pertain to agricultural improvements of the land, with little other indication of human activity in the area. Approximately ten rubble field drains [3006] were exposed during the course of the monitoring, orientated west to east across the field. No further red tile field drains [3004] were noted.

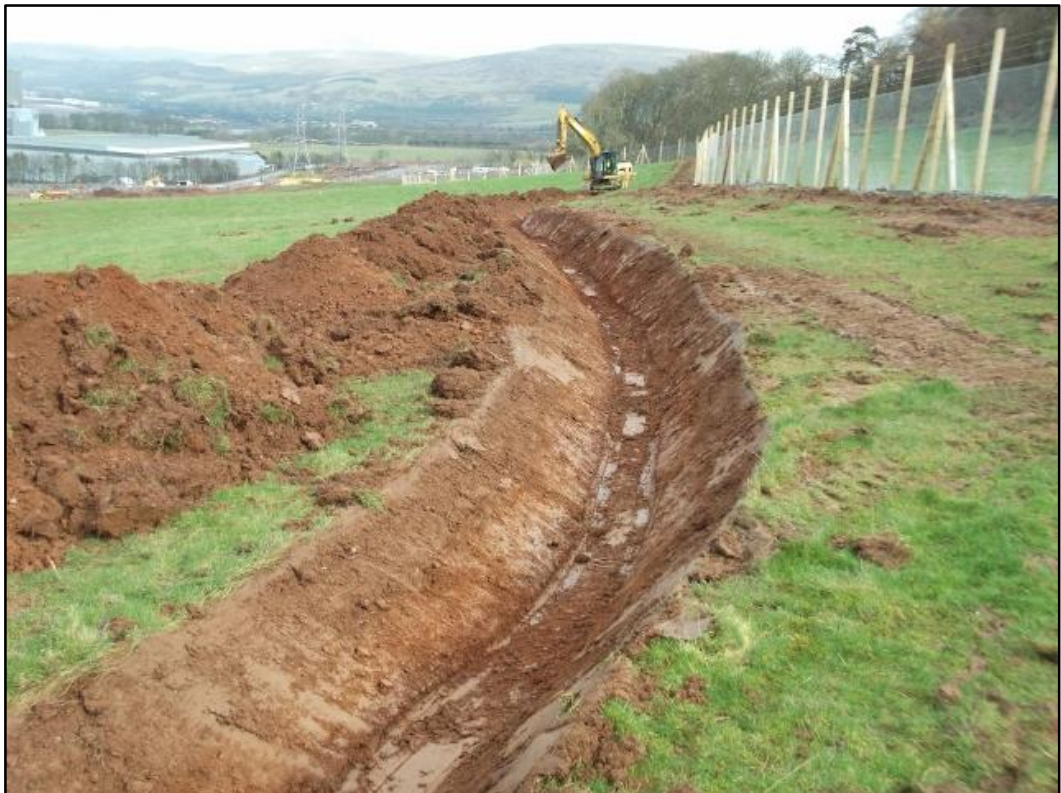
Figure 4b: General shot of drainage ditch, Area 3

41. One 14 ton tracked 360° mechanical excavator was used to excavate 484m² of drainage ditch, using a V ditch digging bucket. The drainage ditch was located at the west and south boundaries of the Converter Station Field. It was 1m wide, varying in depth between 0.5m and 0.8m. Excavation of the ditch began at the south-west corner of the field, heading north-west along the western edge of the CDM boundary for 280m. They then returned to the south-west corner of the field before excavating north-east along the southern edge of the CDM boundary for 150m (Figure 4b).

42. The excavation along the western edge of the CDM fence reduced the drainage ditch through the uppermost strata of 0.3m to 0.5m thickness of topsoil (3001), which covered the entire area. The first 106m of the ditch from the south-west corner heading in a north-west direction, did not reach subsoil, exposing instead 0.2m to 0.25m thickness of hillwash deposit (3008) below. This deposit was compacted light brown/orange clayey silt with occasional small stones and rootlets.

43. Beyond this point, excavation through topsoil exposed subsoil (3002) below. As excavated, this deposit was 0.2m to 0.25m thick within the drainage ditch. From 106m from the south-west corner to 170m from the south-west corner (continuing in a north-west direction) bedrock (3019) was exposed below subsoil (3002) at a depth varying between 0.4m and 0.6m.

71. The possible feature [3011] which was found in the section of the drainage ditch seems most likely to result from natural geological movement in the area rather than human activity. Materials similar to the fill of [3011] lay adjacent to it on the south side, deposits (3012) and (3013). This suggests a natural flow and deposition of material downslope, rather than purposeful infill. The feature itself is likely to result from geological displacement, perhaps the result of flooding. The layer above, (3014), seems to be a mixture of deposits (3012) and (3013), which again seems likely to indicate natural origins, with animal burrowing seeming the most likely explanation.
