# **Hunterston Converter and Substation, West Kilbride, North Ayrshire: Archaeological Evaluation**

Data Structure Report: 2<sup>nd</sup> Addendum

issued 30<sup>th</sup> June 2014

on behalf of RSK Environment Ltd

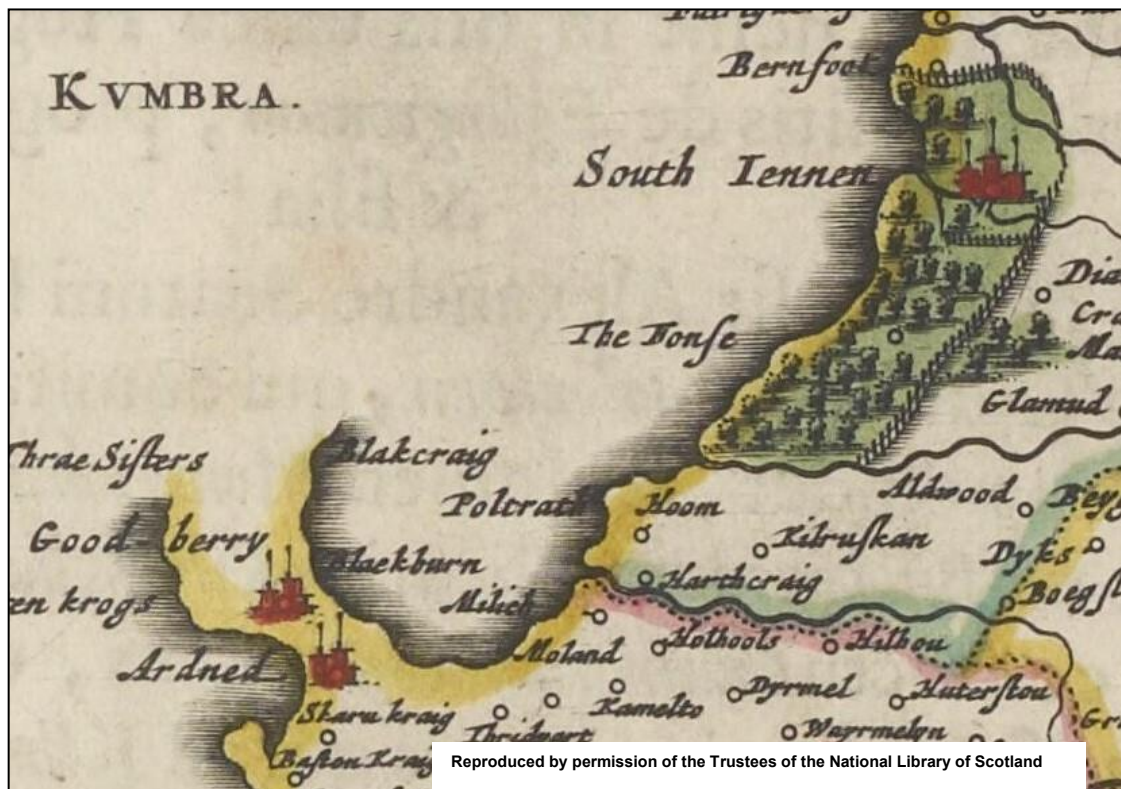
Figure 2a: Blaeu's 1654 Map of Cuninghame, showing the Place-name 'Good-berry' in use, and featuring major defensive buildings at Portencross, ?Hunterston and Southannan

28. The use of the place name 'Goldenberry' in some form dates back to at least the mid-17<sup>th</sup> century, where it is depicted as 'Good-berry' on Blaeu's 1654 map of Cunninghame (Figure 2a). There does not, however, appear to be an association with any building at this time, though substantial dwellings are shown nearby at Ardeil, Portencross and South Iennan (i.e. Southannan). It is assumed that the major dwelling house assumed to be linked with the placename 'Ardneil' is actually Hunterston, for archival records held by the National Archives of Scotland first mention the Hunters of Hunterston in 1527 and it is likely that the family papers go back much further.

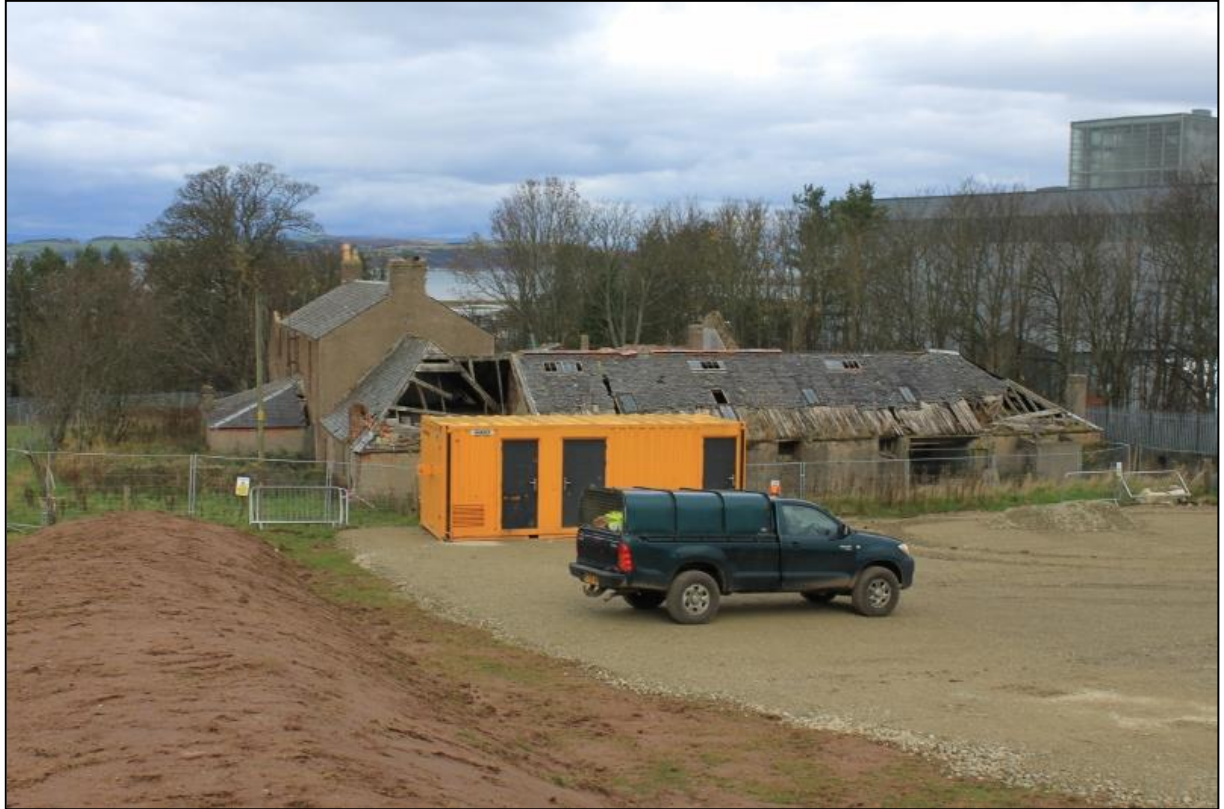
Figure 4a: View of Goldenberry Farm from north, with cowshed/?dairy 'd' to right and House 'a' to left.

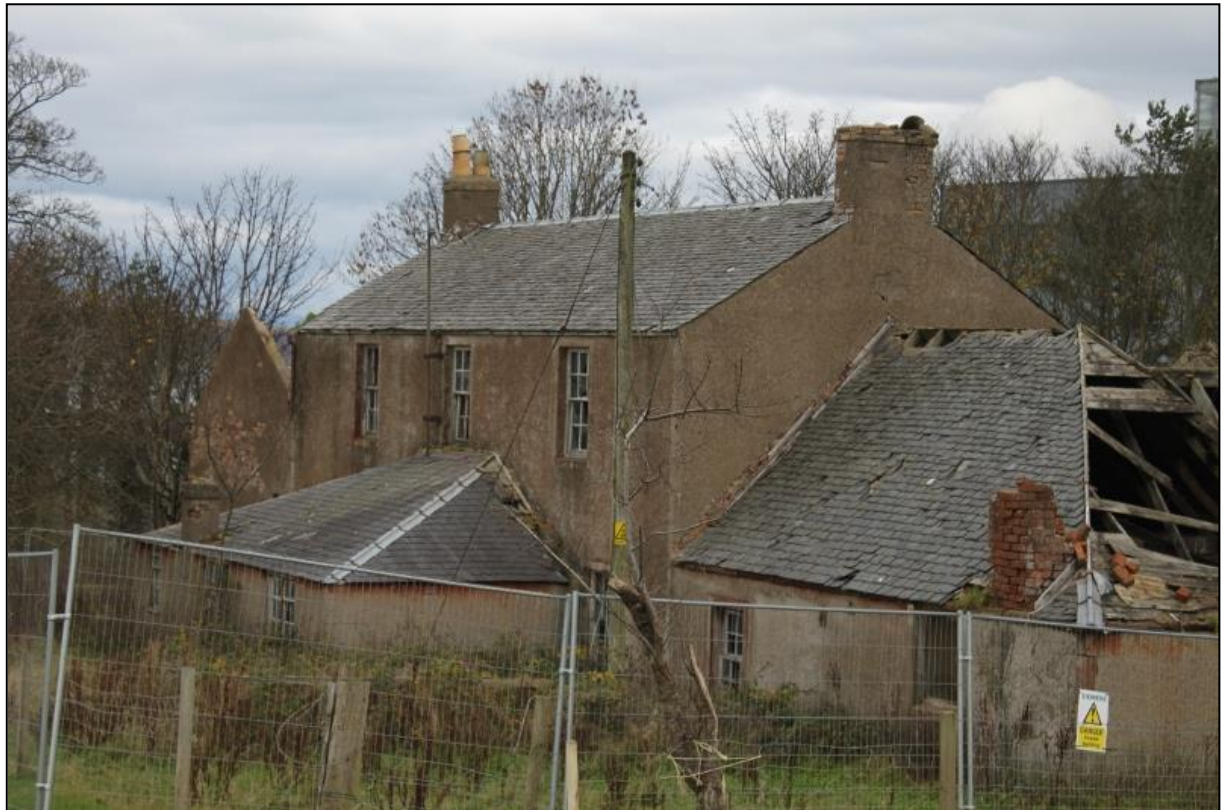
33. Forming the core of the farm buildings is the farmhouse itself (Figure 4b). Rectangular in plan, farmhouse 'a' measures 3 x 2 bays in extent, and is two storeys high, with a pitched slated roof. A central door with a 2-pane transom light above opens out into the courtyard on the north-east elevation. Windows flank the doorway, with one window per bay in the upper storey on both long elevations. The windows are of original sash-and-case design.

34. On the rear (external) north-west elevation of 'a', the flanking ground floor windows have been displaced slightly to accommodate a one storey outshot or extension ('b'). Outshot 'b' is not shown on the Ordnance Survey 1<sup>st</sup> Edition map, which suggests it may be a recent addition. A later date is further strengthened by the presence of a vent in the south west wall which suggests either construction (or potentially, insertion) at a later date when either gas lighting or gas heating was introduced. The windows are also of different design: they are larger windows, not of traditional sash-and-case construction, indicating a 20<sup>th</sup> century construction date. However, this must be balanced against the presence of the displaced ground floor windows of 'a:' while these represent typical sash-and-case windows contemporary with the original build of the farmhouse, it is possible that the windows were themselves moved at the time 'b' was constructed. Unfortunately, with the whole of the exterior surfaces of both 'a' and 'b' concealed beneath a coat of roughcast, any further information which remains inherent in the masonry could not be identified.

Figure 4b: Rear, NW, elevation of Farmhouse 'a' with outshot 'b' and structure 'c' (?scullery or wash-house) to fore

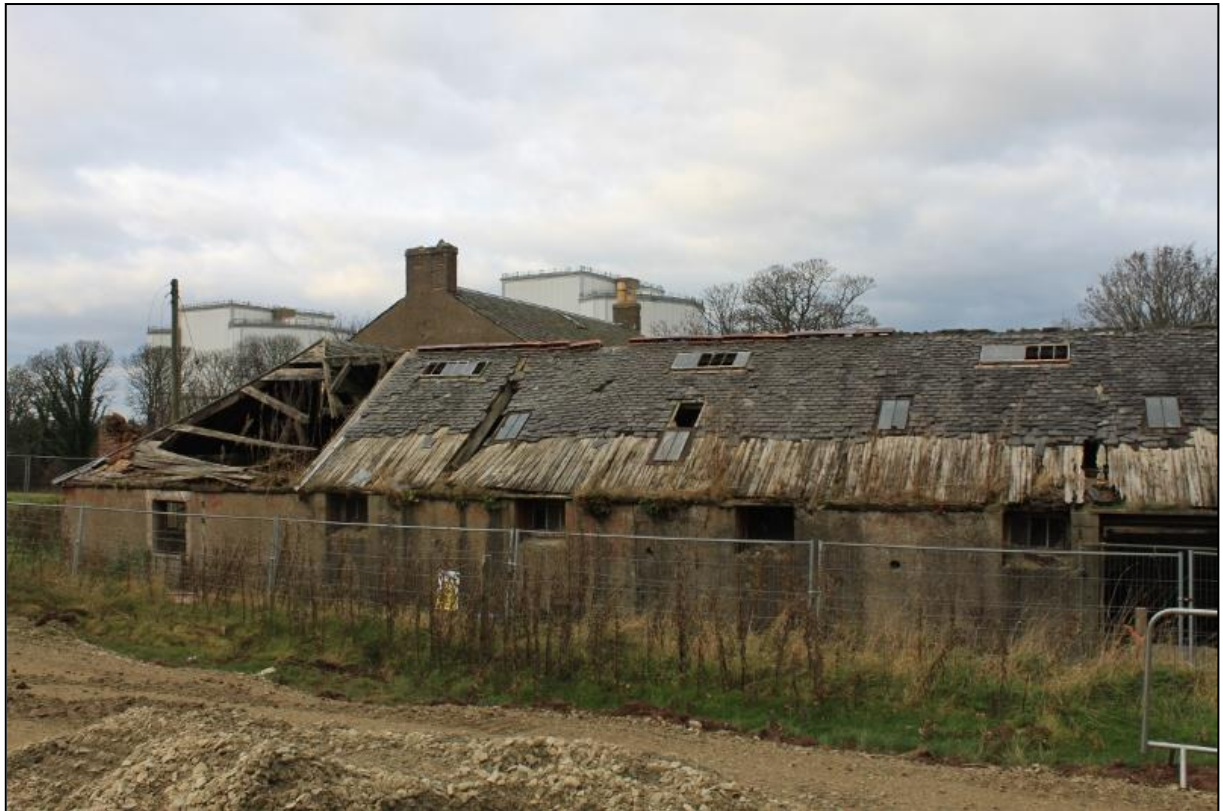
38. Structure 'd,' which formed the south-east edge of the courtyard farm layout, was rectangular in plan and measured 4 bays in length (Figure 5a). It had recessed small three-pane windows sitting over a sloping sill. These were located at wallhead height, with salt-glazed ceramic pipes built into the thickness of the wall at the midpoint between the two windows. The roof was slated, merging into the roof of structure 'c' at the south-west end and incorporating the timbers of structure 'l' at the north-east end. Two rows of rooflights were evident, an upper rank of five-pane lights set at irregular distances, and a row of smaller two-pane lights set one per bay above the wall-mounted ceramic pipes. Ventilated ceramic ridge tiles had been laid along the apex of the roof.

39. With the emphasis clearly placed on the provision of copious ventilation and with lighting restricted to glazed panes at high level in the walling and also in the roof, it was clear that the structure must have served some function associated with handling or stalling of livestock. No definitive interpretations were possible from an external inspection alone, but it seems from the level of lighting available that structure 'd' probably functioned as a dairy, as opposed to a byre or cowshed.

Figure 5a: Cowshed/?dairy 'd' with structure 'c' to left and farmhouse 'a' to rear

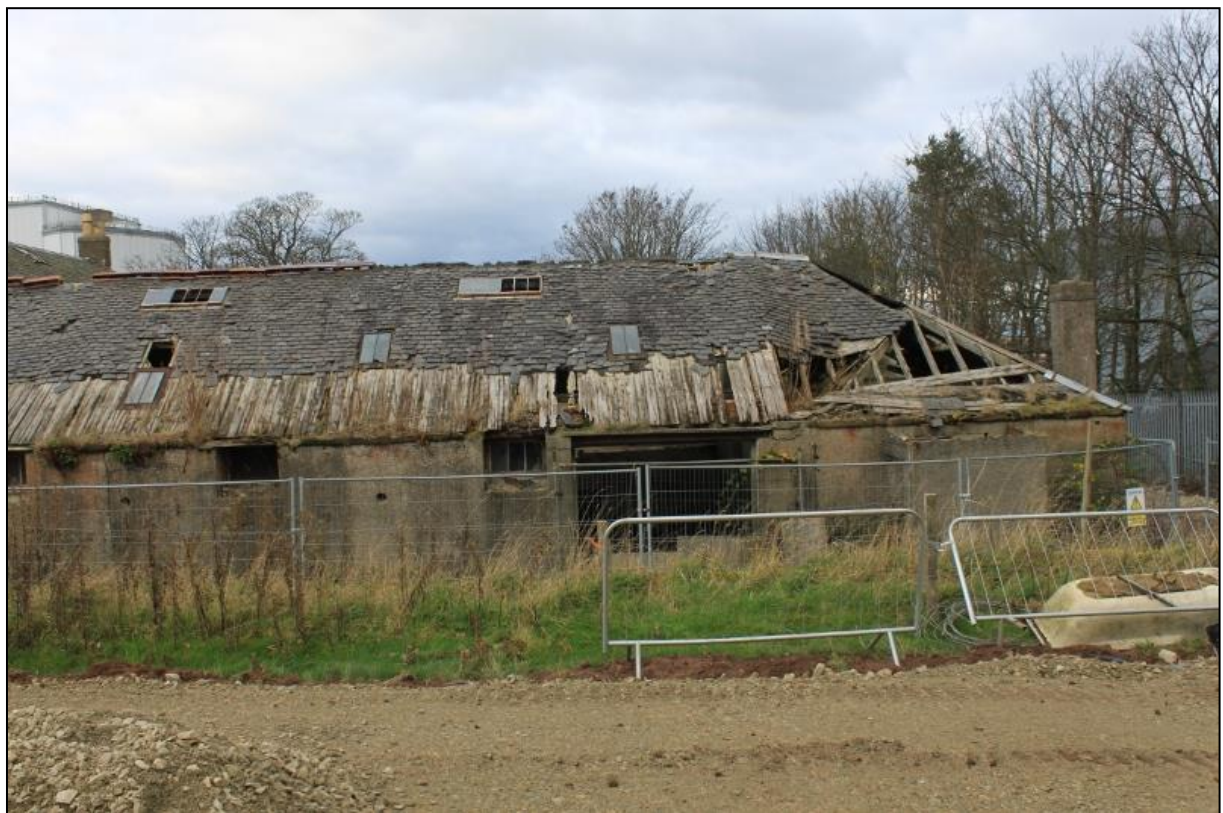
40. A broad doorway at the north-east end, once covered by a sliding door, appears to have been a later insertion. Beyond this doorway, a small extension 'k' with a central single door in the south-west elevation also appears to be a later addition (Figure 5b). This abuts the junction between structures 'd' and 'l': the exposed timbers suggest that both would originally have been one storey high, the original timbers of the roof now incorporated into the raised roof structure in a manner similar to that observed previously in structure 'c.'

Figure 5b: NE end of cowshed/?dairy 'd'

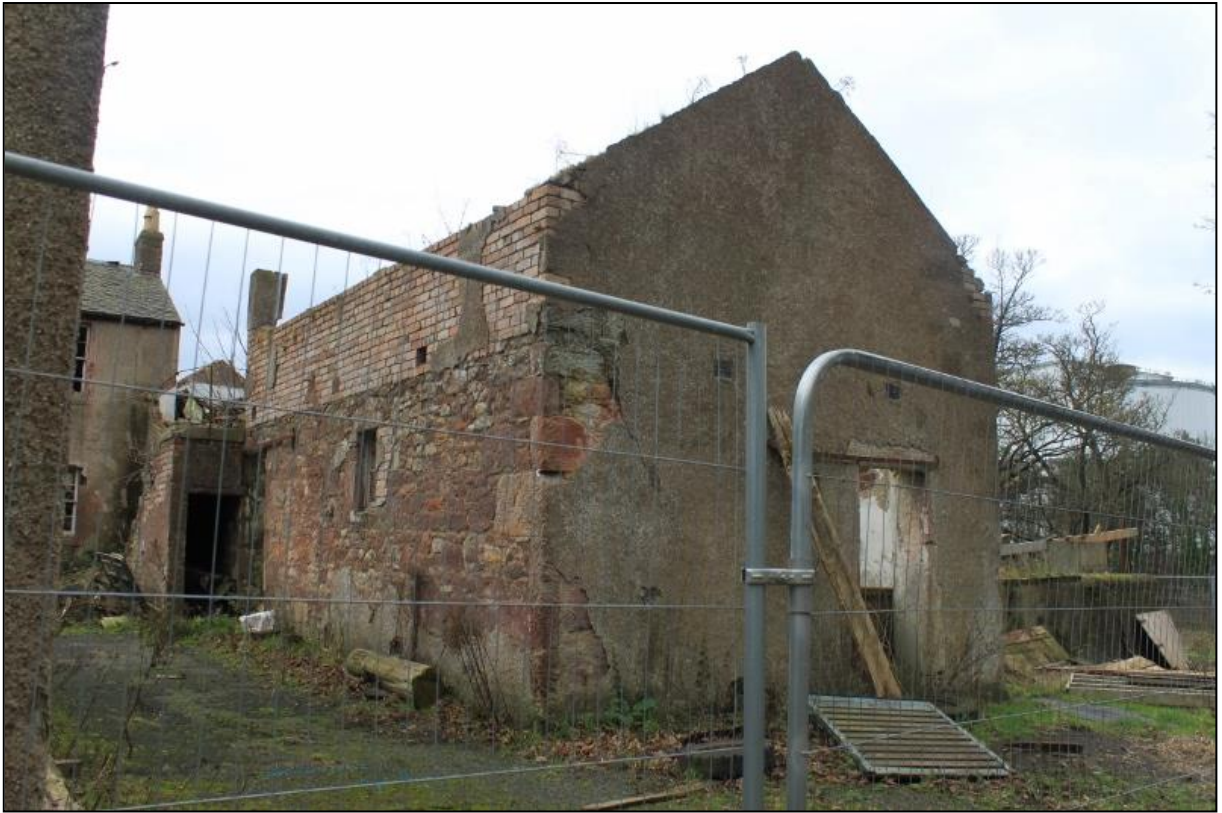
41. Structure 'e' was arguably the most interesting of the structural elements, mainly because much of the external render which originally covered its south-east elevation had fallen away, revealing the fabric (Figure 6a). Rectangular on plan, the structure had begun its life as a single storey building, composed of snecked rubble walls with roughly squared quoins. The fabric appeared to be dominated by sandstone. It is unclear whether the roof was originally hipped or pitched, but at some point it was built up using yellow bricks to create an attic level. The presence of small iron grilles within the walling at regular intervals suggested that this work had taken place in a period when gas lighting or heating was in use, perhaps in the early 1900s. Access to the upper level was via an external stair composed of brick, i.e. contemporary with the raising of the wall height.

Figure 6a: Structure 'e:' Detail of quoins on E elevation taken from the W

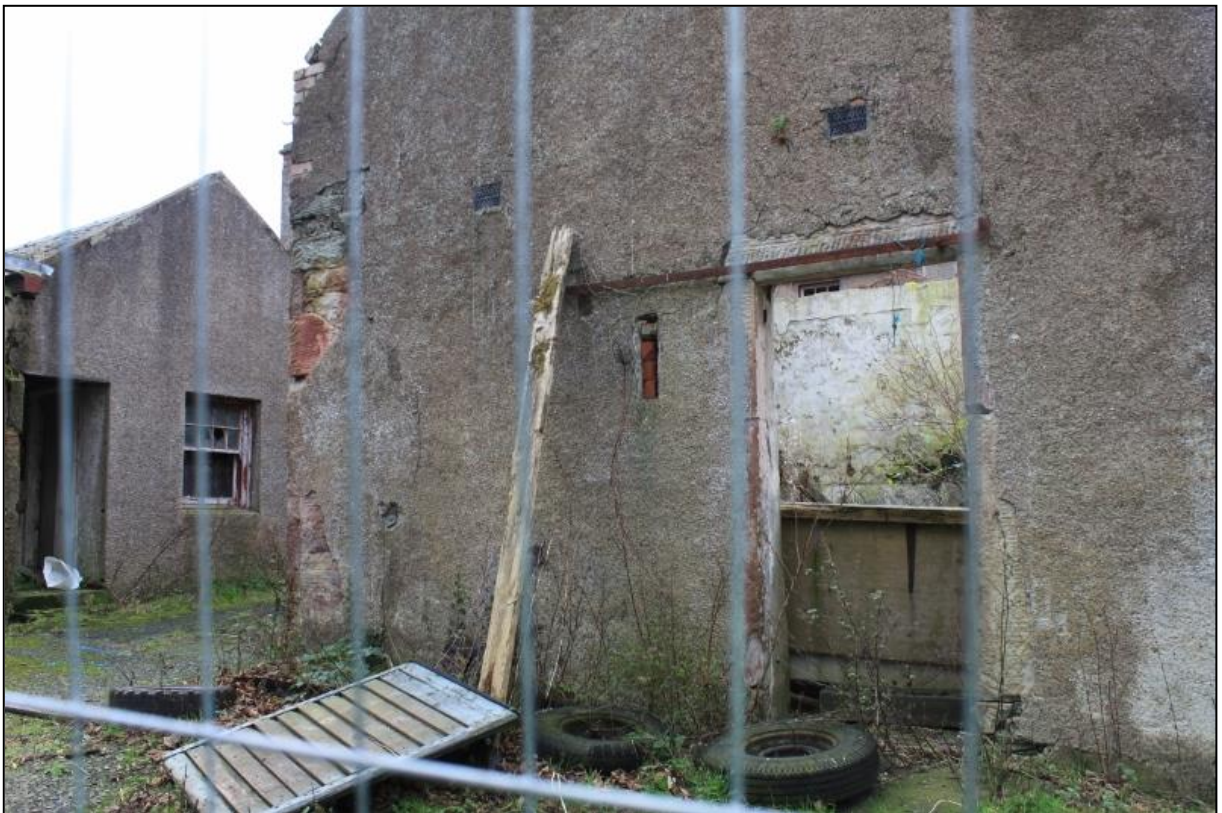
42. Access to the interior was via a narrow doorway in the south-west elevation (Figure 6b). Set slightly off-centre, this opening had once been associated with a sliding door, the rail of which survived above. It seems to have been a later insertion: the location of the original doorway is unclear, with no evidence for openings apparent on the south-east elevation. There is an additional narrow doorway at the south-west end of the south-east elevation, located just to the north-east of the brick forestair. The presence of a slot-type window in the north-east elevation might suggest a barn, while the presence of a 'window' in the south-east elevation is more difficult to interpret. Set unusually high, this may be a hatch as opposed to a window, allowing access at attic level for the loading/unloading of hay or straw for animals housed below.

Figure 6b: Structure 'e:' detail of NE elevation, showing original slot-type window, later ventilator grilles and sliding door.

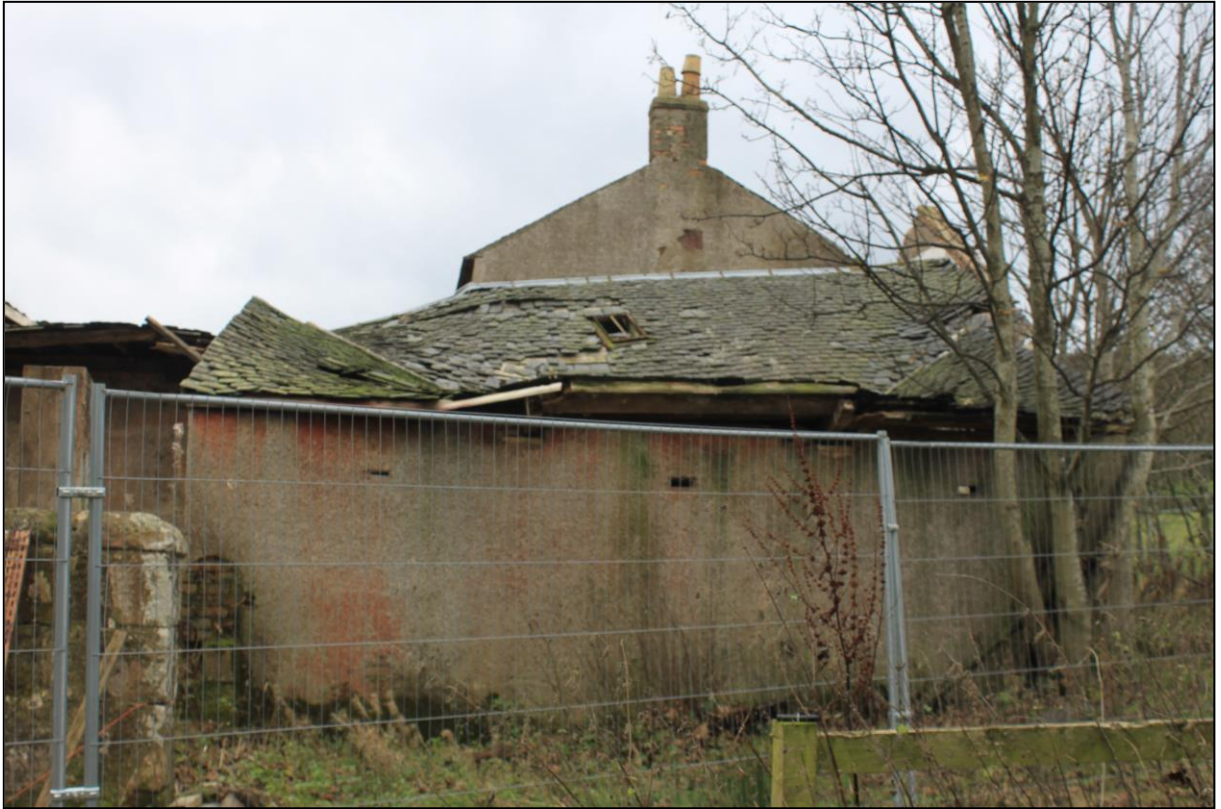
44. Structure 'f' was a modern brick structure, constructed adjacent to (and abutting) the external wall of structure 'e.' It had horizontal slot type windows which had once held metal grilles, features consistent with the use of gas heating or lighting (Figure 7a). Its purpose could not be ascertained, but it clearly functioned as some kind of ancillary structure.

Figure 7a: Structure 'f', with return of unnamed wall to left.

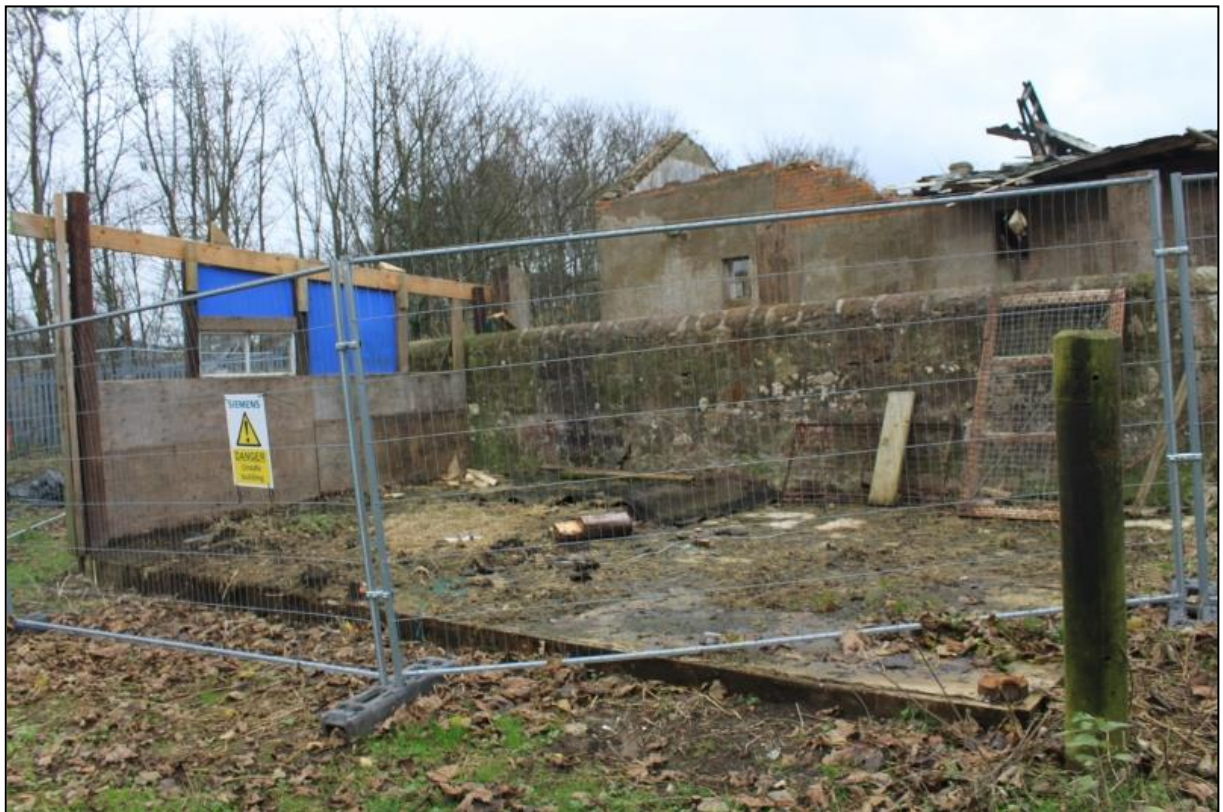
45. Structure 'h' was very modern in build (late 20<sup>th</sup> century), surviving only as an area of hard-standing associated with the upstanding remains of timber stud walls. It abutted the exterior of structure 'g', which comprised a low mortared wall which appeared to form a small yard or paddock adjoining the main courtyard farm structure (Figure 7b).

Figure 7b: Remains of structure 'h', comprising concrete apron and one upstanding stud wall (unnamed wall forming external courtyard to rear)

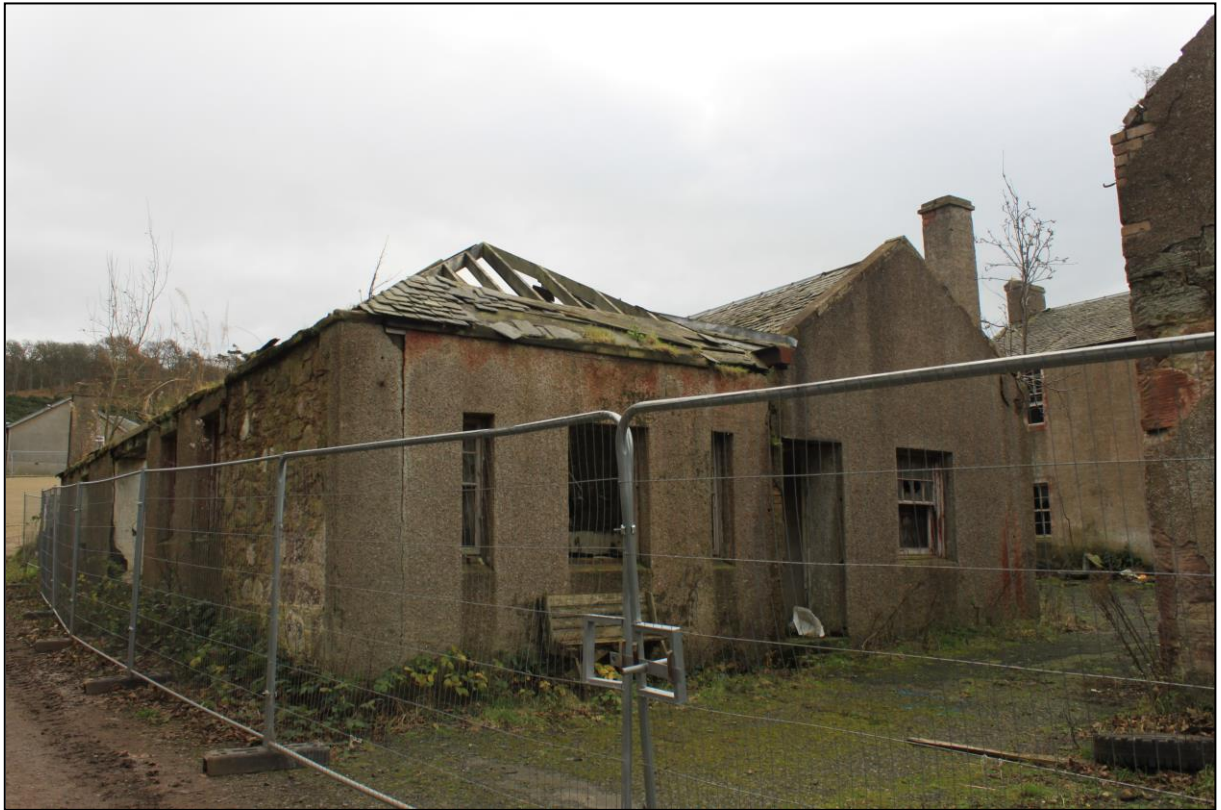
48. It can be surmised that the external structure 'j' was the earlier of the two. A portion of masonry has been exposed on the south-west elevation, revealing coursed rubble with squared broached sandstone quoins (Figures 8a & b). The roof is hipped and slated (c.f. structures 'b,' 'c,' and 'd') which is consistent with the original elements of the courtyard farm structure. Its slot type windows are unusual features, suggestive of ventilation slots but unusually long in comparison to most examples (c.f. the example on the north-east elevation of structure 'e' – Figure 6b). By contrast, structure 'l' had a pitched roof with a gable wall at the north-west end, which (judging by the patterns identified elsewhere throughout the structure) may indicate that it is a later addition of late 19<sup>th</sup> century date. Structure 'l' was also equipped with a single sash-and-case window located adjacent to the doorway in the north-west elevation, which may suggest a workspace as opposed to livestock accommodation.

Figure 8a: NW Elevation, structures 'j' and 'l'

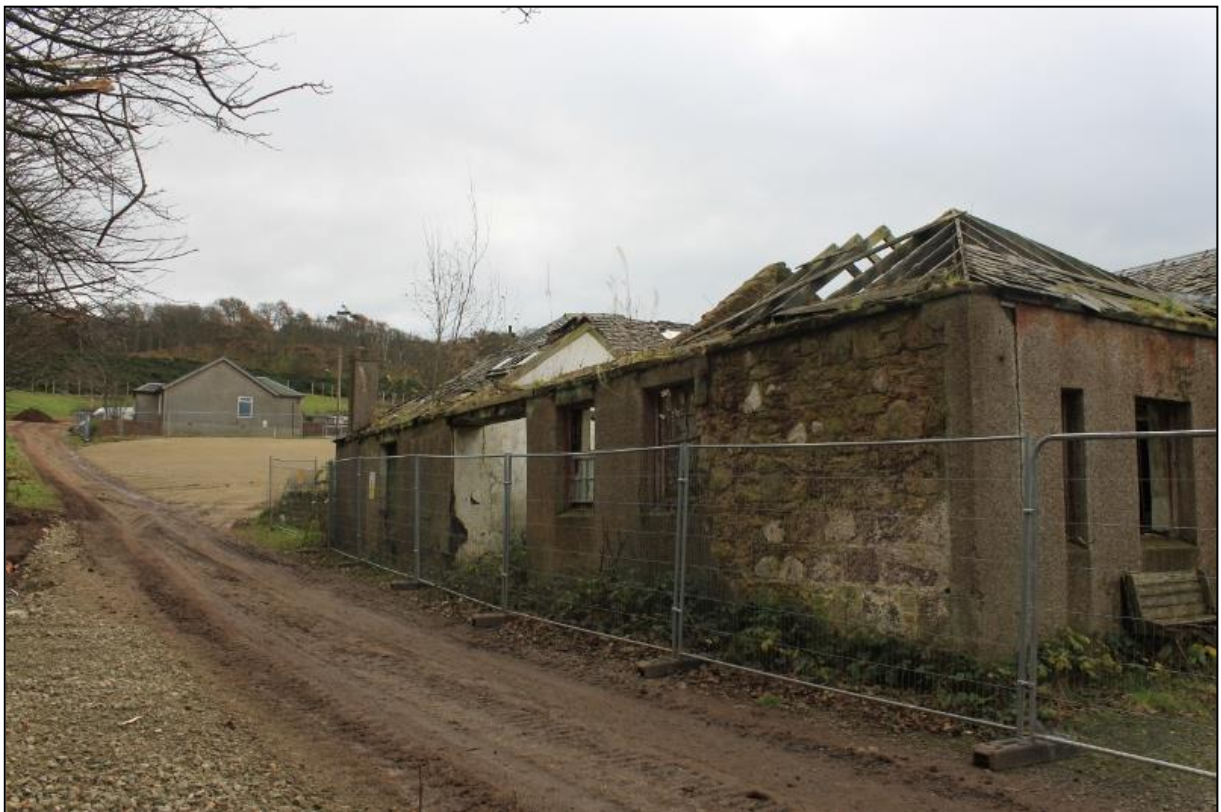
Figure 8b: NE Elevation, structure 'j'
