Dean Castle Country Park: Archaeology Project

Interim Report

by Alan Matthews

issued 2nd June 2015

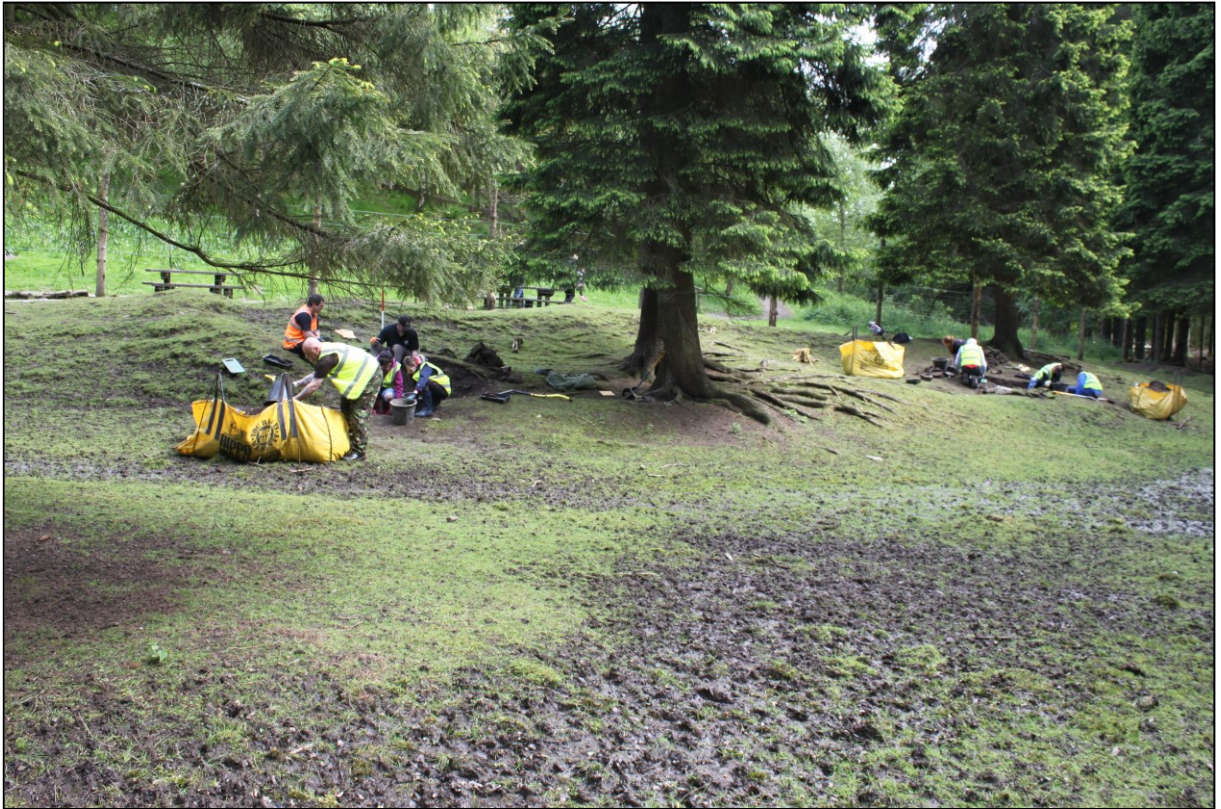
Figure 1: Trench 2 (on the left) and Trench 1 (on the right)

8. Undulating ground alongside the eastern fence of the deer paddock indicated the presence of buried structures. The findings from excavations carried out in the early 70s suggested that these were stone built structures related to mine workings lying to the south and also located within the deer paddock. Two trenches were excavated over the course of the weekend. These were placed in the south-west and north-west corners of what has been interpreted as a large central structure located adjacent to the modern fence. These trenches measured roughly 3m by 1m in extent and ran diagonally across the corners.

9. Both trenches revealed similar sediment although Trench 1 (the southernmost) was excavated to a greater depth. The topsoil, (101) and (201), in both cases consisted of dark brown sandy silt with frequent small stones. The depth of the topsoil varied but was generally about 200mm deep. Beneath this was a compact layer of medium to small stones with frequent inclusions of mortar, (102) and (202). This layer was suggestive of building rubble and contained several small finds. Beneath this, in both trenches was a further layer of possible building rubble, (103) and (203), consisting of medium sized, water-worn stones and inclusions of mortar. This layer was much more compact and level than the layers above.

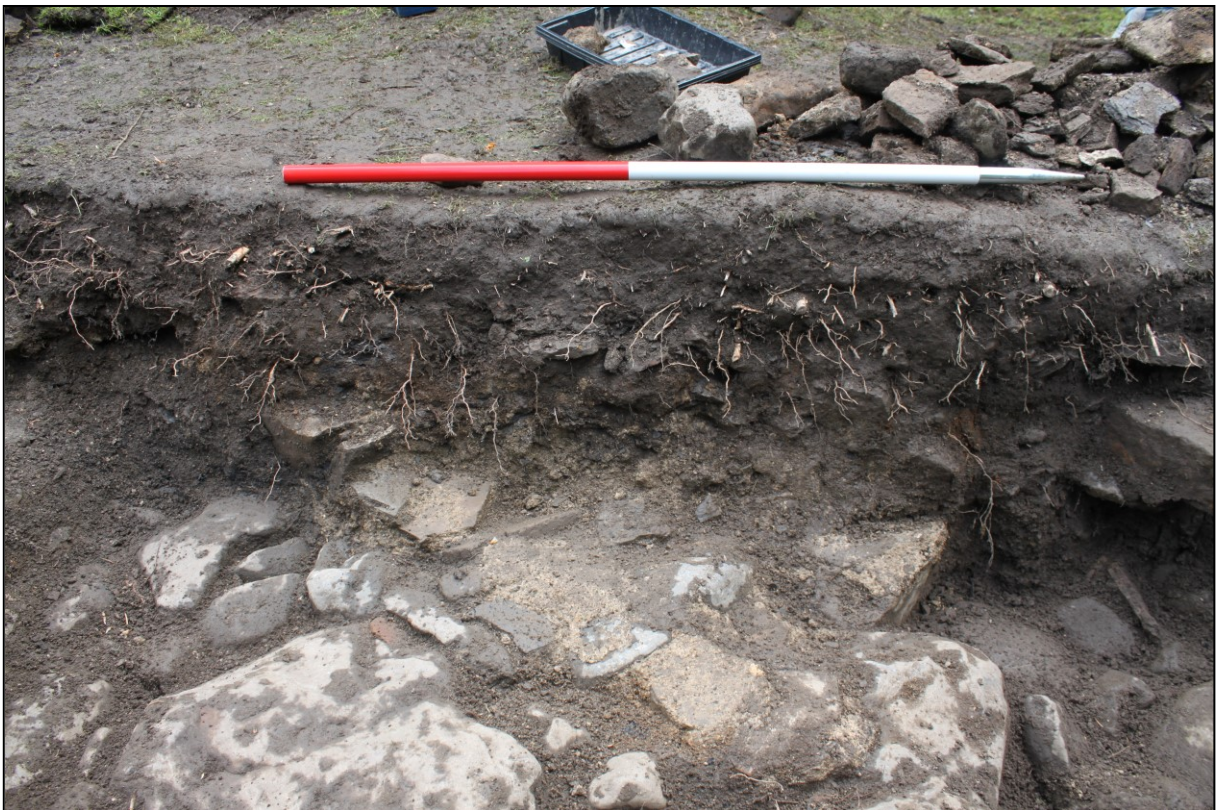
Figure 2: Possible wall foundation in Trench 1

10. Only in Trench 1 was there time to excavate through layer (103). Beneath this was a layer of large water-worn boulders and medium-sized angular stones with some seemingly *in situ* mortar. From the small area which was exposed, it was possible to surmise that this may have represented the foundation course of an *in situ* building material, the remains in question suggesting the corner of a stone wall approximately 500mm thick. No artefacts were recovered from this depth and it was not possible to confirm the line of this wall in Trench 2.

12. The archaeological works were able to confirm the potential for survival of structural remains in the location identified as the site of buildings possibly associated with 17th or 18th century coal mining activities. Traces of mortar and possible demolition material were recovered from both trenches along with some anthropic material. None of the material recovered was earlier than the 19th century in date. The additional excavation carried out in Trench 1 was able to reach a possible foundation course which may have represented the remains of a wall defining the corner of a structure. This wall was not located in Trench 2.
