**Premier Inn, Ellon Road,
Aberdeen:
Archaeological Mitigation**

Data Structure Report

issued 30th May 2015

on behalf of Whitbread Ltd.

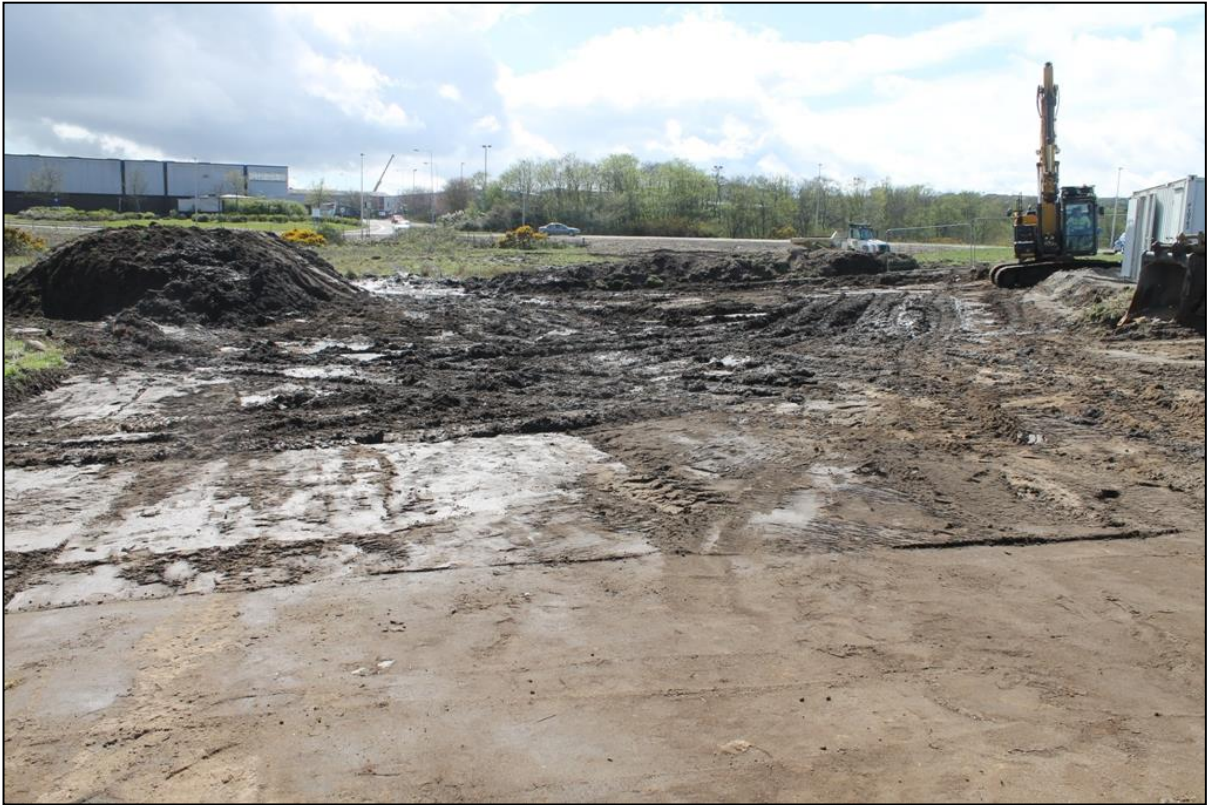
Figure 4a: Working shot of completed area stripping at S end (phase 1)

14. The first stage of archaeological monitoring works covered the machine stripping an area to lay a surface for the future compound required during the construction of the building extension (phase 1). The area of the compound measured approximately 66m in length and 25m wide (Figure 4a & 4b). The stripping in this area revealed the depth of the topsoil (001) as 320mm, and showed that it was formed of a mid-brown moderately compacted sand and soil mixture with frequent bioturbation. Beneath this topsoil (001) were a loose to moderately compacted, light brown sand with infrequent medium (150-200mm) sub-angular stones (002) and a deposit similar to (001) with very infrequent small (10-70mm) sub-angular stones and both rubble and ceramic field drains (003).

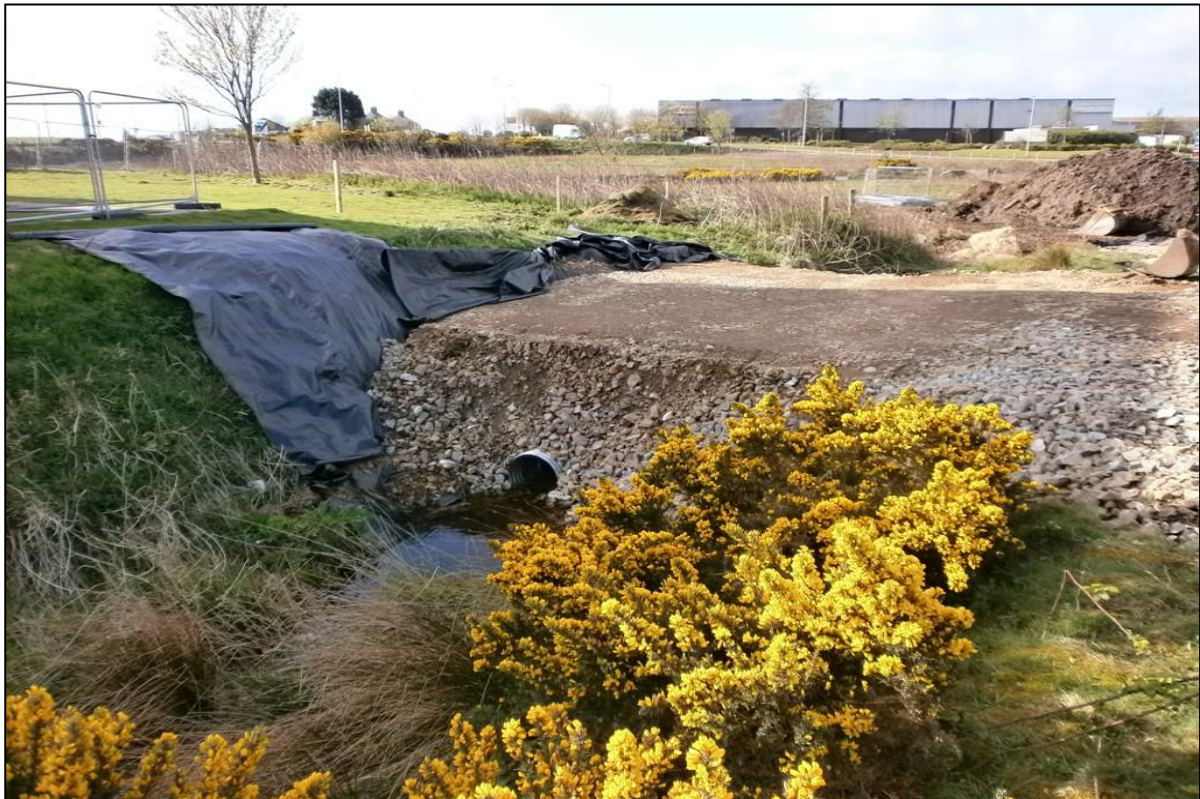
Figure 5a: Working shot of culvert construction (phase 1)

15. Between the two stages of groundbreaking works, a large culvert had to be constructed to bridge the burn and allow access to the building development site from the compound for the machine excavator (Figure 5a).

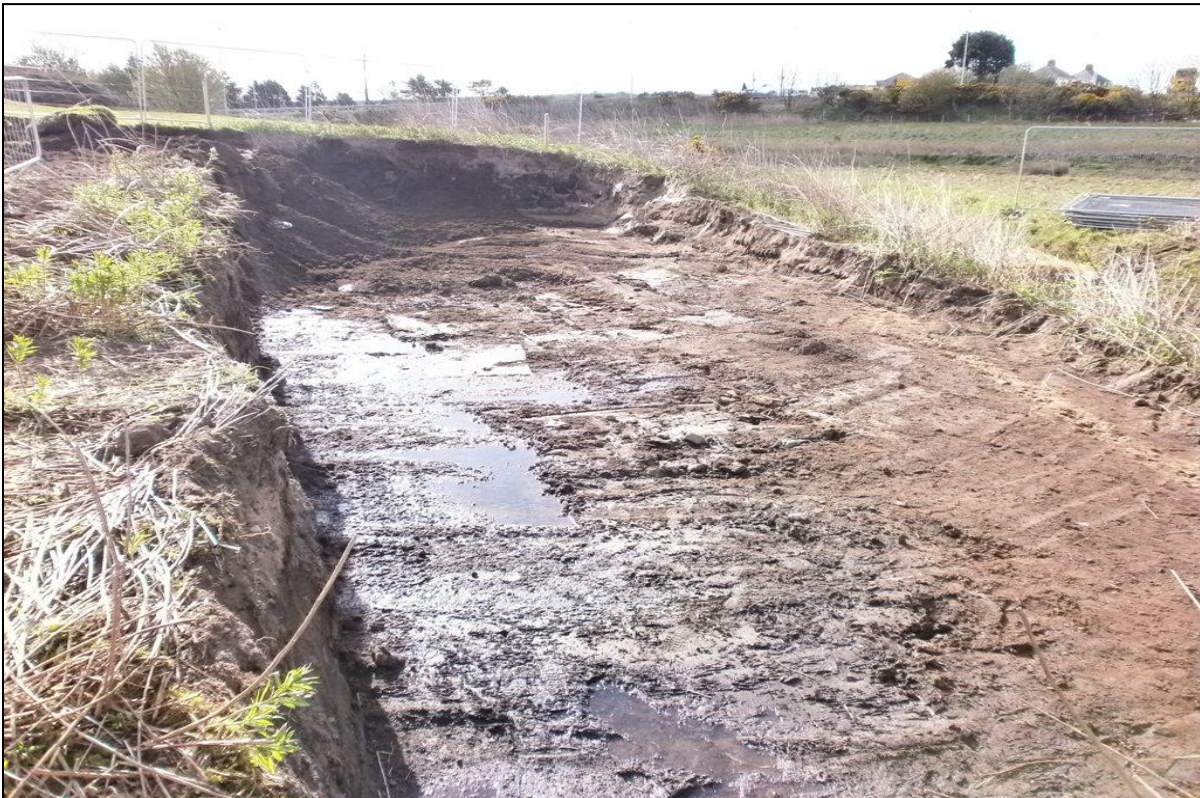
Figure 5b: Working shot of excavation in strip 1 (phase 2)

17. Strip 1 (Figure 5b) revealed the depth of the topsoil (004) as 800mm, and showed that it was formed of loosely compacted, mid-brown sandy silt with frequent bioturbation, infrequent medium (100-300mm) sub-rounded and sub-angular stones and very frequent modern construction detritus (Figure 6a). Beneath this topsoil (004) were a very wet and compacted dark grey sandy clay with no inclusions (005) and a wet and very compacted dark brown sandy clay with small (10-70mm) sub-rounded and sub-angular stones (006) (Figure 6b).

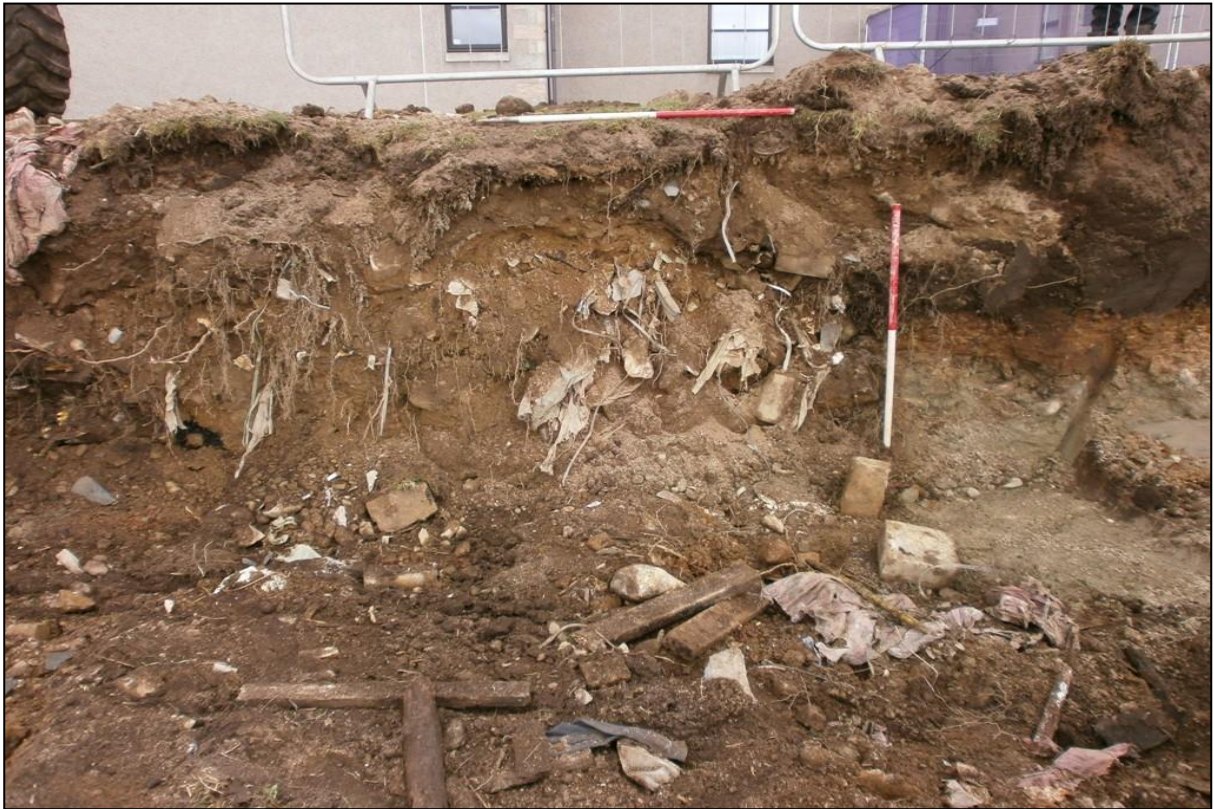
Figure 7a: South facing section of strip 2 (phase 2)

18. Strip 2 (Figure 7a) revealed the depth of the topsoil (004) as 800mm with a large modern pit cut into it and filled with modern construction detritus (Figure 7b). Beneath this topsoil (004) was a moderately compacted, yellow/grey sand with small (10-70mm) sub-angular stone inclusions.

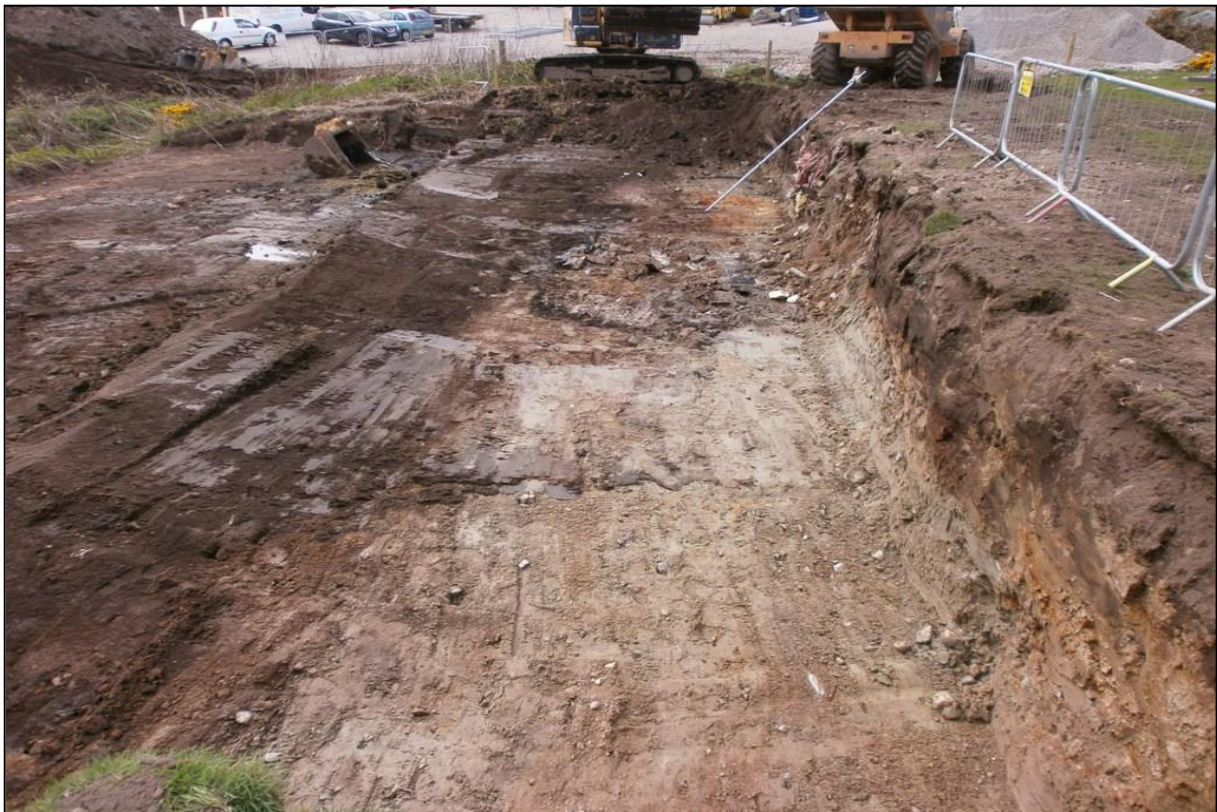
Figure 7b: Working shot of excavation in strip 2 (phase 2)

19. In the immediate and wider landscape there are a number of sites that have been recorded representing archaeological activity from the Prehistoric up to the Post Medieval periods. However during each stage of monitoring works no significant archaeological features were uncovered.
20. The only anthropic features recorded were in the form of rubble-filled and ceramic drains, present in both phase 1 & 2, and a pit filled with modern construction detritus in phase 2. The field drains are considered to represent late 18th to 19th century agricultural activity and would have been inserted during a period when the landscape across much of Scotland was under a regime of 'improvement'. The modern pit was most likely dug during the initial construction of the hotel.
