Lawfield Steading, Dalkeith: Archaeological Mitigation

Data Structure Report

Author(s)	Peter Klemen		
Date of Issue	6 th November 2015	Version	1.0
Commissioning Body	WS Dunsire & Sons		
Event Name	Lawfield Steading, Dalkeith		
Event Type	Historic Building Recording; Appraisal Level		
Event Date(s)	October 2015		
Rathmell Archaeology Code	RA15095	OASIS Ref:	Rathmell1-228860
Location	United Kingdom: Scotland: Mid Lothian		
NGR	NT 3560 6550	Parish	Dalkeith
Designation(s)	None

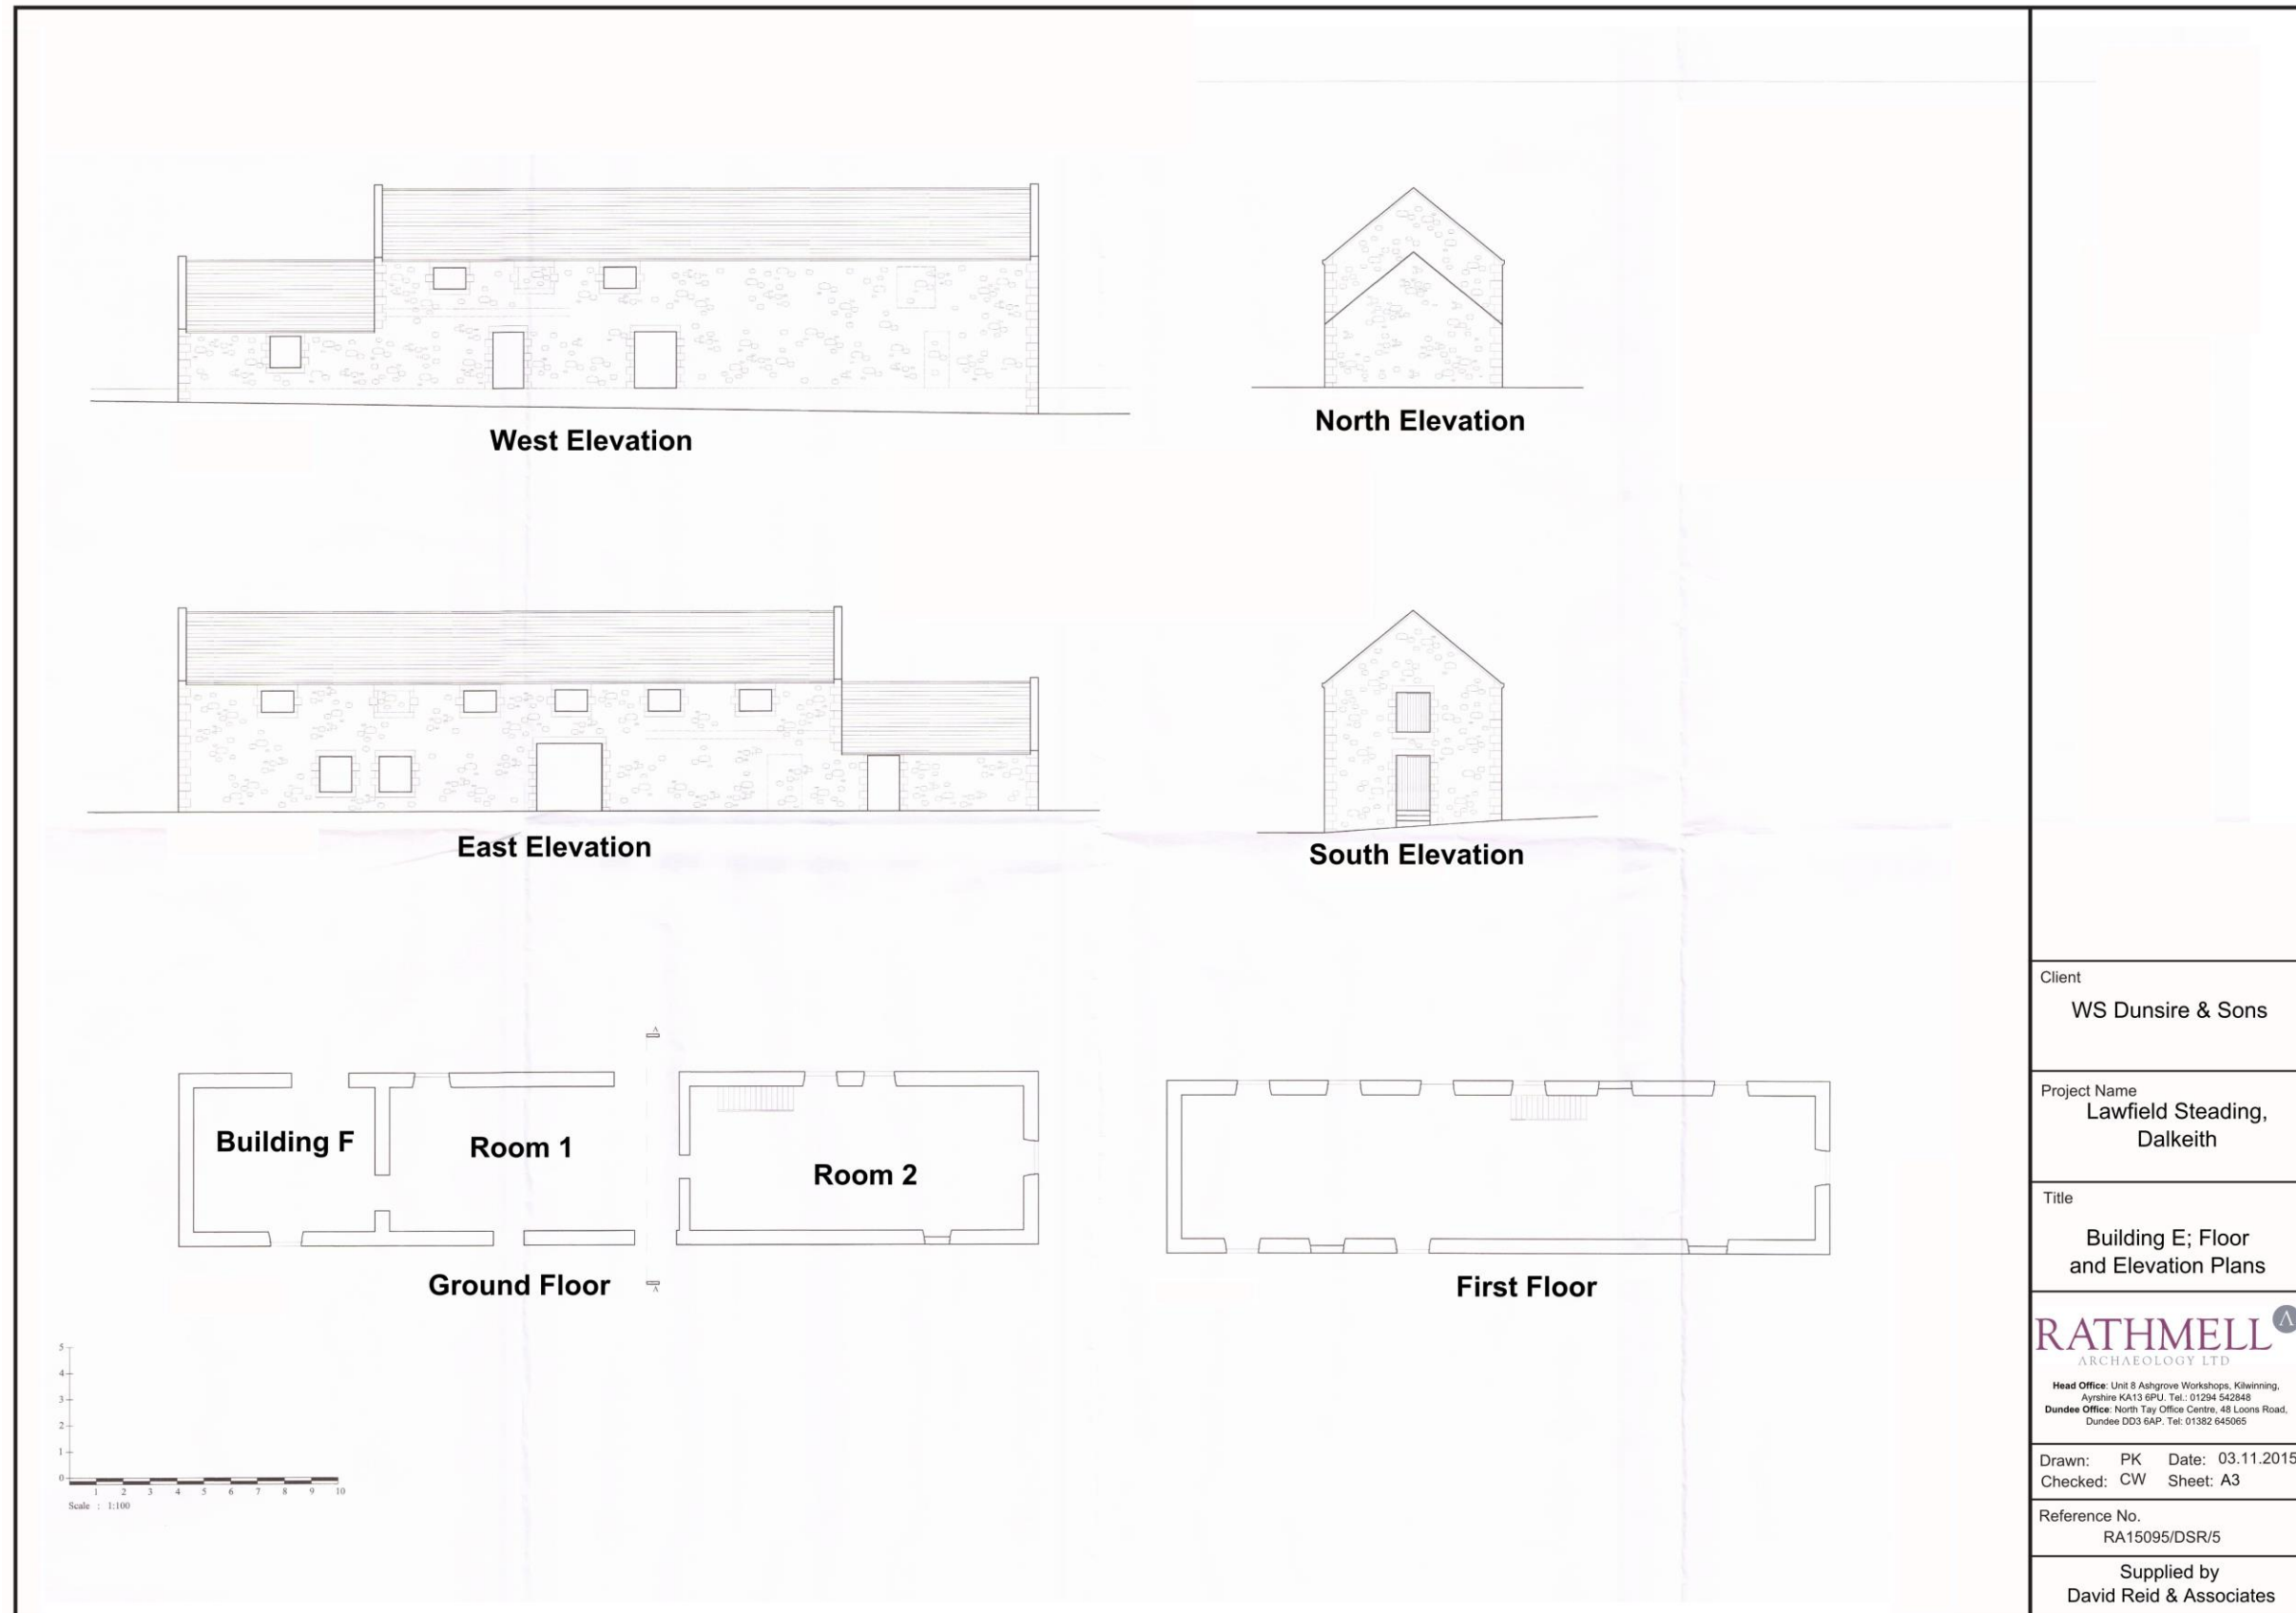
Figure 5: Existing Floor and elevation plans for Building E

10. The intended layout for the new development retains the original steading configuration although the proposed development requires a large number of the present structures to be demolished. This particularly applies to the more recent elements of the steading, many of which are fabricated from modern brick, concrete blocks or steel. By contrast, some of the stone buildings are to be retained and refurbished, for example buildings E & F (Figure 5).

19. On the east elevation there are six openings (one per bay) at first floor level, with less evident on the west elevation. Here, three openings are present at first floor level. These are unlikely to have been glazed windows; instead, they were probably infilled with slatted timber louvre-type fittings to help keep the first floor area well-ventilated. The west elevation has three doorways on the ground floor (Figure 5): a broad vehicular entrance in Bays 1-2; possibly a later insertion, a narrow pedestrian entrance in Bays 3-4, and a second pedestrian entrance in Bays 7-8. (Figure 5).

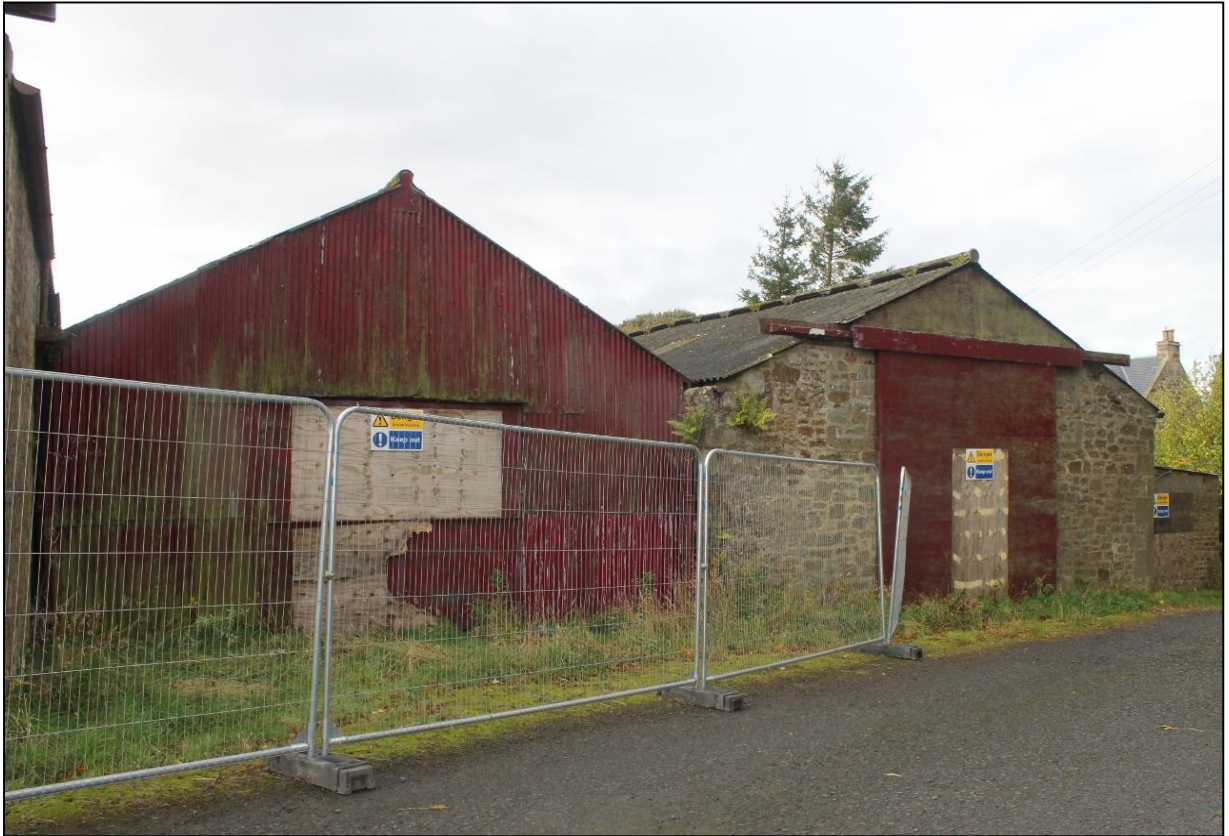
Figure 6a: Buildings J & I (Left-Right); east elevation

15. All guttering and downpipes were of cast iron construction with doors, structural ironwork and some of the modern exterior surfaces painted dark red (figure 6a). The quoins and margins on the early elements were worked sandstone.

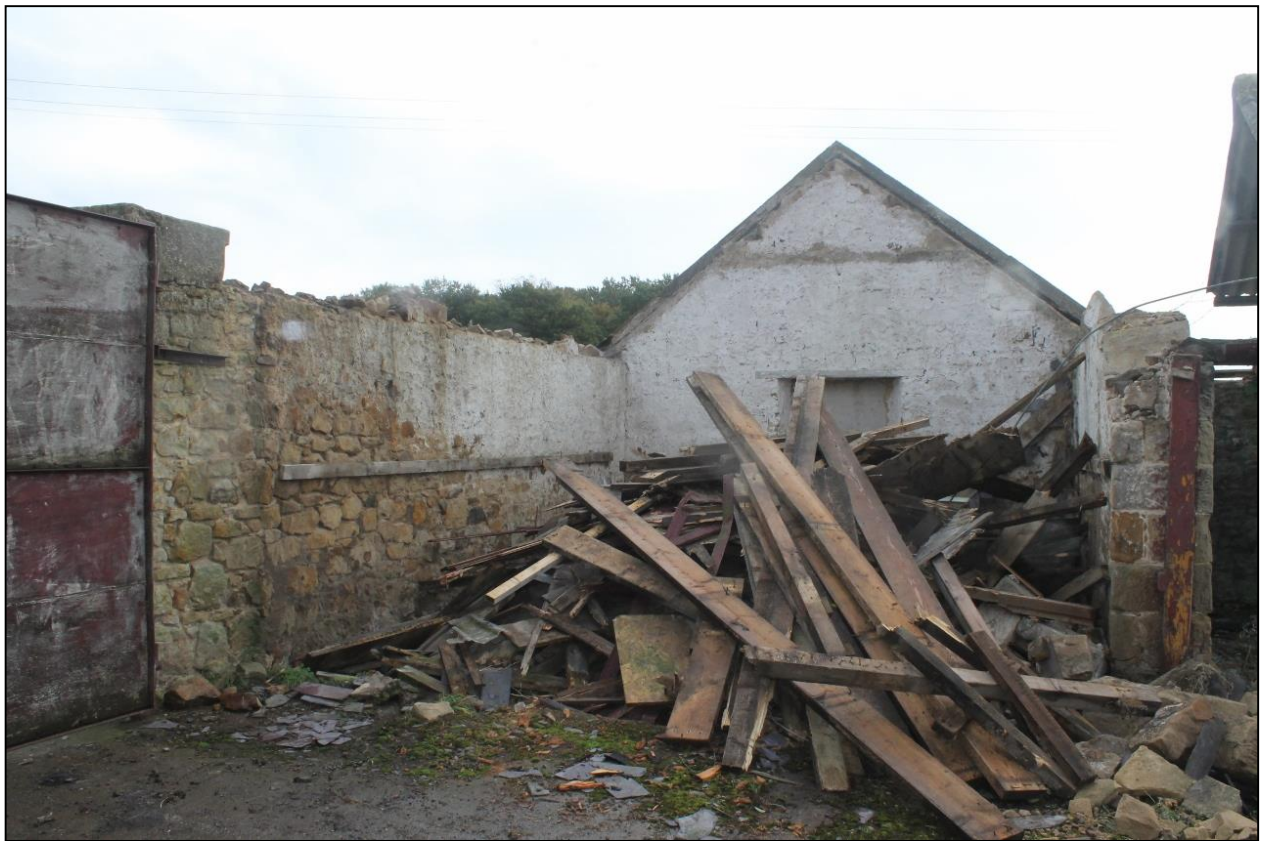
Figure 6b: Building A; interior

16. Building A is a square, single storey 1 x 1 bay structure. The S, W and E elevations are of snecked sandstone rubble. The timber roof had been removed for safety concerns prior to the survey. Previous pictures from the structural survey demonstrated a pitched slated roof adjoining to building B. There is evidence that the interior had been plastered and painted white (Figure 6b). Its original function is unclear.

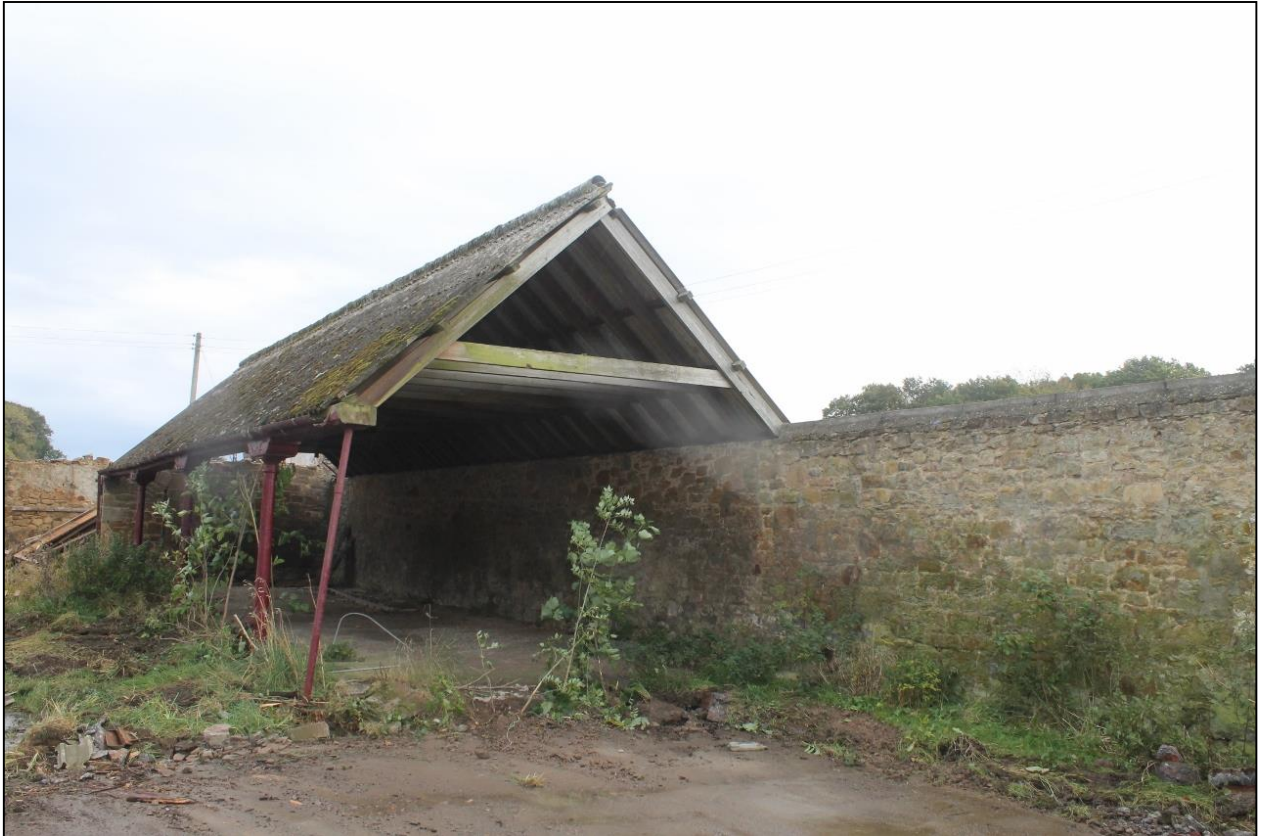
Figure 7a: Building B

17. Building B comprised a single storey open-fronted structure measuring 4 x 1 bays, with timber roof trusses clad in corrugated fibre-cement roof supported on a steel frame with the wall extension depicted in the 2nd edition Ordnance Survey (1894) forming the building's southern side (Figure 7a). It is possible that the structure was erected during this phase of additions in the late 19th century.

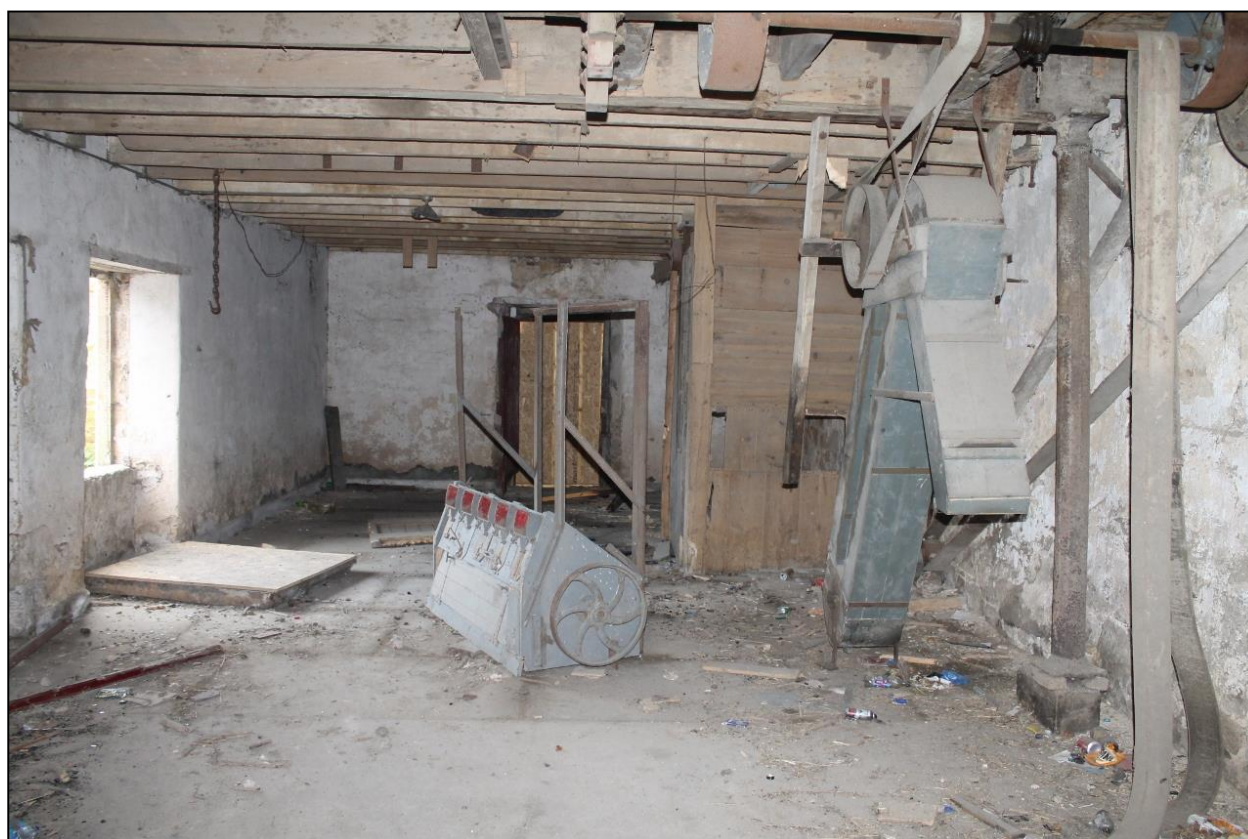
Figure 8b: Room 1, Building E; view to the southern end

18. Building E was a two storey structure which was to be retained and refurbished; the presence of processing equipment (Figure 8b) still in place suggests that it may have functioned as a threshing barn on the ground floor with the granary and drying floor located on the 1st floor. It is rectangular on plan, and measures 6 x 1 bays in extent. The whole building is constructed of snecked sandstone rubble (Figure 7b & 8a) with broached sandstone quoins. The ground floor is divided into two rooms; 1 and 2 (Figure 5, 8b & 9a), the roof pitched and slated. Some of the roof trusses and purlins appear to have been replaced (Figure 9b).

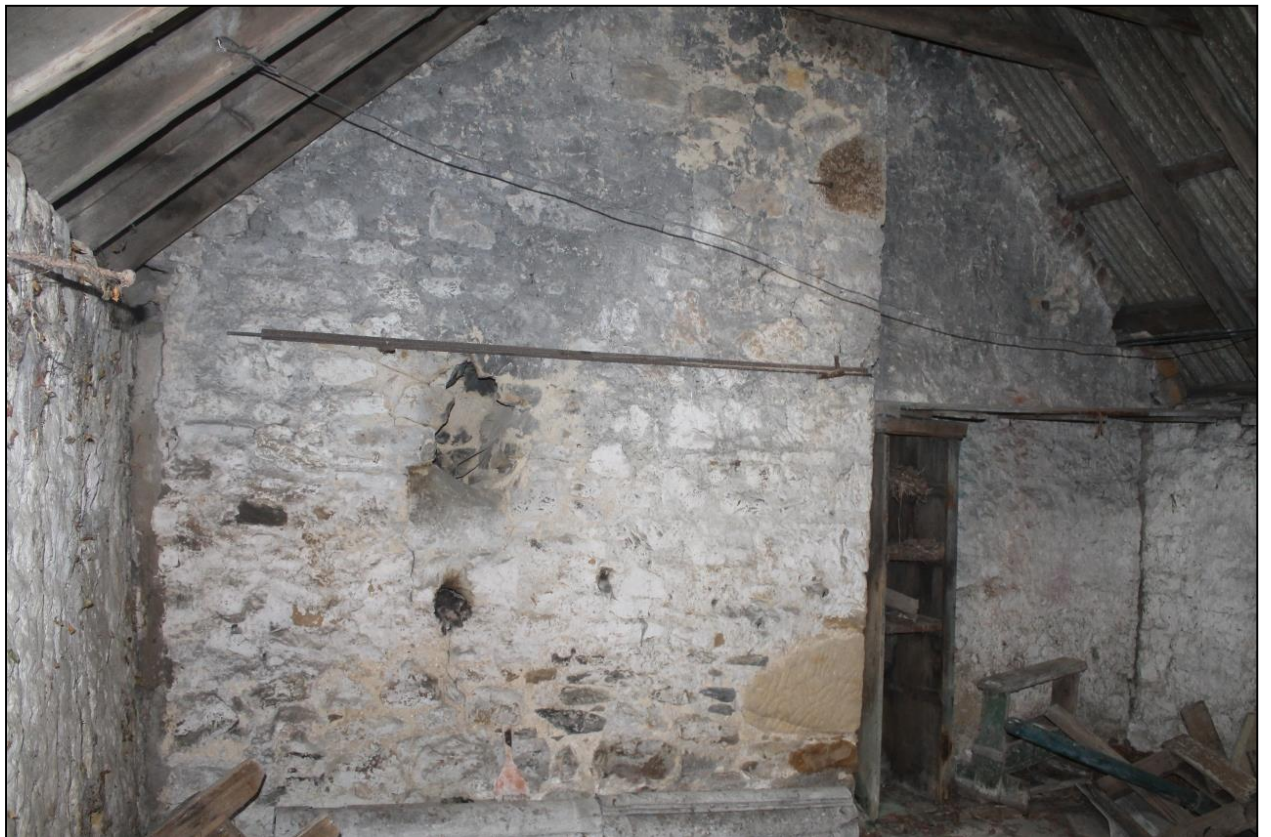
Figure 10b: Building G; chimney breast in south room

21. Building G is rectangular in plan, comprising a single storey 4 x 1 bay structure, subdivided internally into two chambers. The masonry is snecked rubble, and it has a pitched slated roof. The S room is rectangular in plan with one doorway on the east elevation and a single window on the west elevation. The north elevation has a chimney breast present, but the flue has been capped (Figure 10b). Whitewash has been directly applied to the stonework.

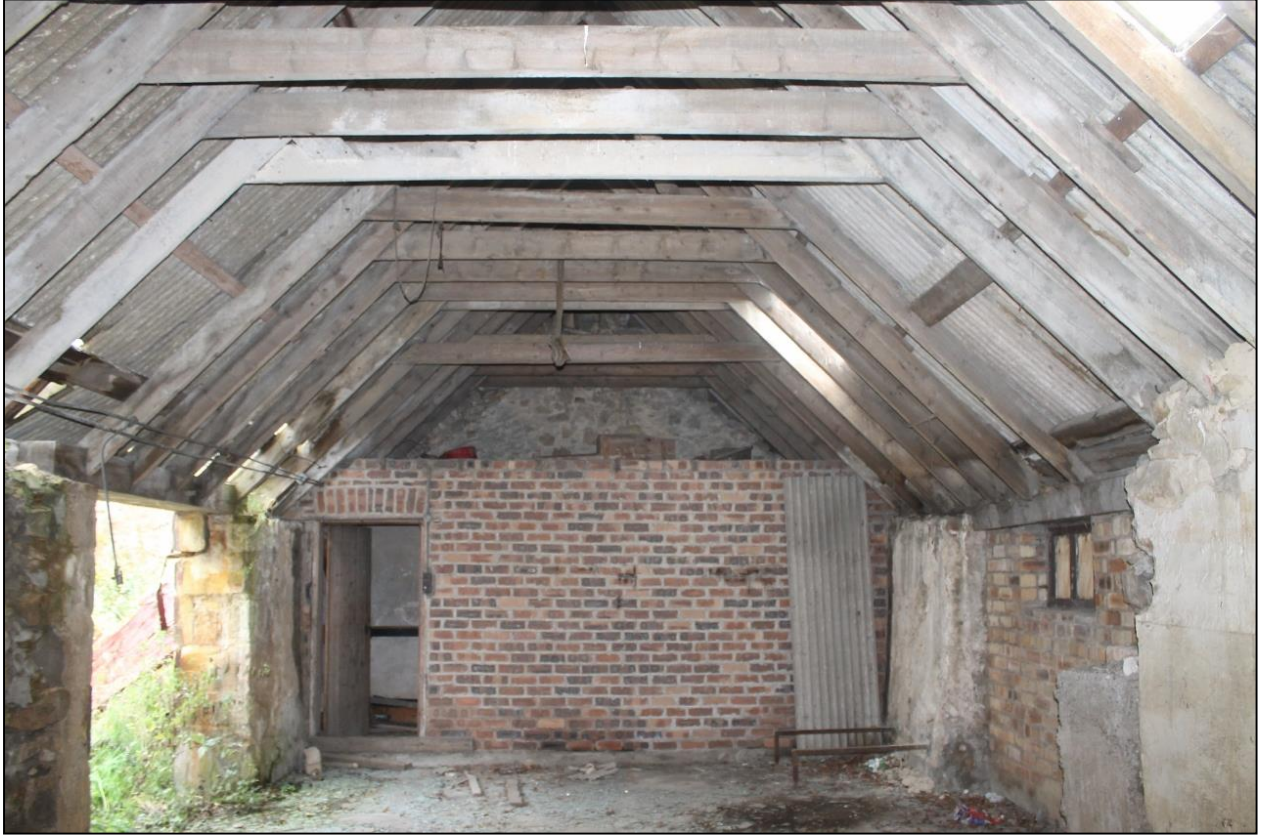
Figure 11a: Building G; north room showing modern brick dividing wall

22. The north room, which is rectangular in plan, has been subdivided into two smaller chambers by the insertion of a modern brick wall (Figure 11a). There is one window on the N elevation, one window and two doorways on the E elevation with one blocked doorway and one window on the W elevation. All the walls are plastered and painted white. Room 1 may have functioned as accommodation, or it could, alternatively, have been in use as a milkhouse or dairy. The quoins and margins are broached sandstone.

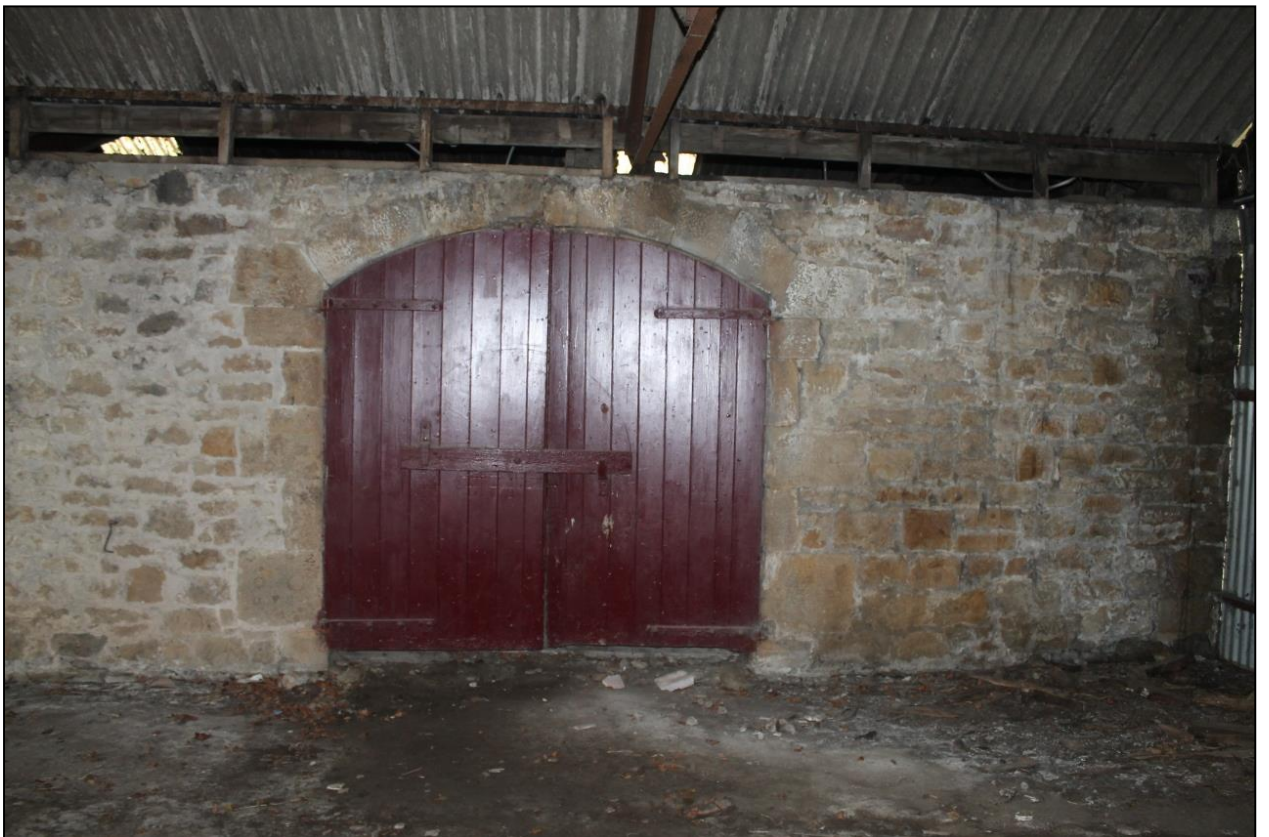
Figure 11b: Arched doorway; building J

23. Buildings I and J are rectangular in plan, single storey and 9 x 1 bays structures and constructed of uncoursed snecked sandstone and modern brick with steel framed and asbestos roofing. Along the central dividing wall there are three doorways: two have arched openings defined by broached sandstone jambs and voussoirs (Figure 11b), which may suggest that they represent the entrances of an earlier cartshed that was later converted into cattle accommodation. Both buildings have quoins and margins of broached sandstone. The W end of building I & J is an open area that has been used to house and feed cattle (Figure 12a) with a large doorway in the W elevation. There are a further two doorways in building I on the E and W elevation and two doorways on the same elevation in building J. The E end of building J is formed of corrugated metal sheeting.

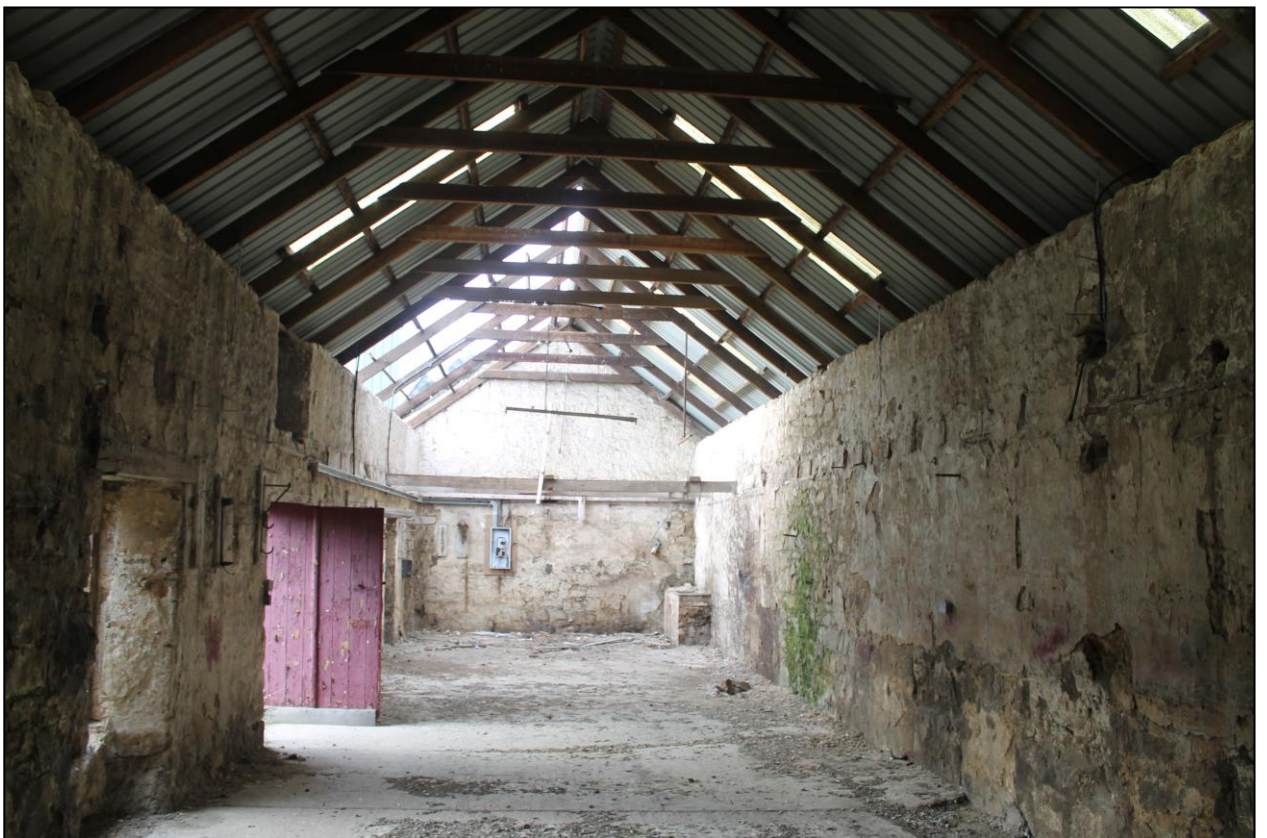
Figure 12b: Building K; view to the west end of the building

24. Building K is a rectangular 3 x 1 bay, single storey-and-attic, snecked rubble structure with a pitched slated roof (Figure 12b). Joist-holes define the line of the former loft. On the E elevation there is a single doorway with three window and doors on the ground floor of the S elevation and one centrally located access hatch for the 1st storey. All the quoins and margins are broached sandstone. The presence of pegs/hooks in the walls at the W end indicate that the harness for draught horses was kept here. A sink also provided fresh water for cleaning and feeding. This suggests that this building housed the stables.

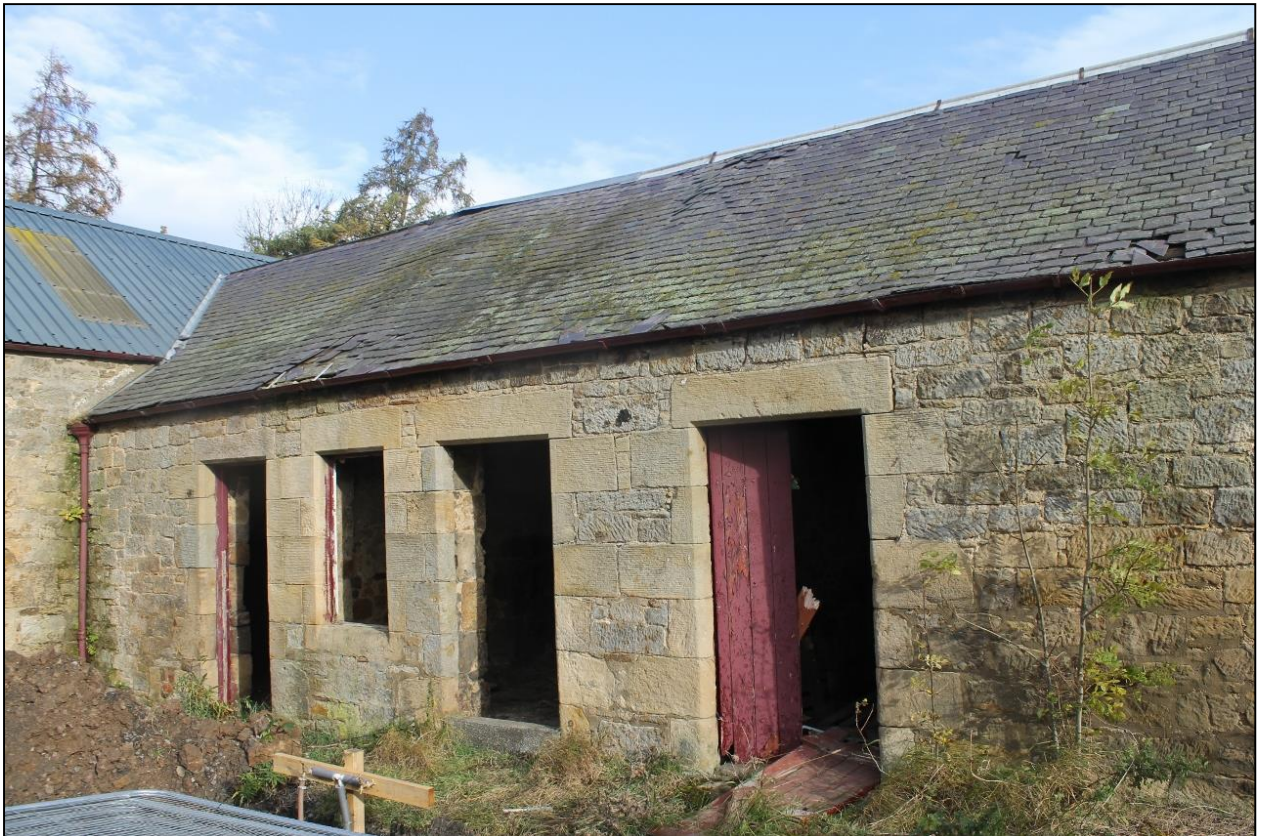
Figure 13a: Building L; west elevation

25. Building L is rectangular on plan and comprises a single storey 3 x 1 bay snecked rubble structure subdivided into three separate chambers (Figure 13a). The roof is pitched and slated. All three doorways and the single window are on the W elevation: the middle room has a central chimney on the N elevation (Figure 13b). The base of the chimney is open with the flue visible but no fireplace, suggesting that a stove was once present. All the quoins and margins are broached sandstone.
