Seafield Cottage, Blackwaterfoot: Archaeological Evaluation

Data Structure Report

by Claire Shaw

issued 9th February 2007

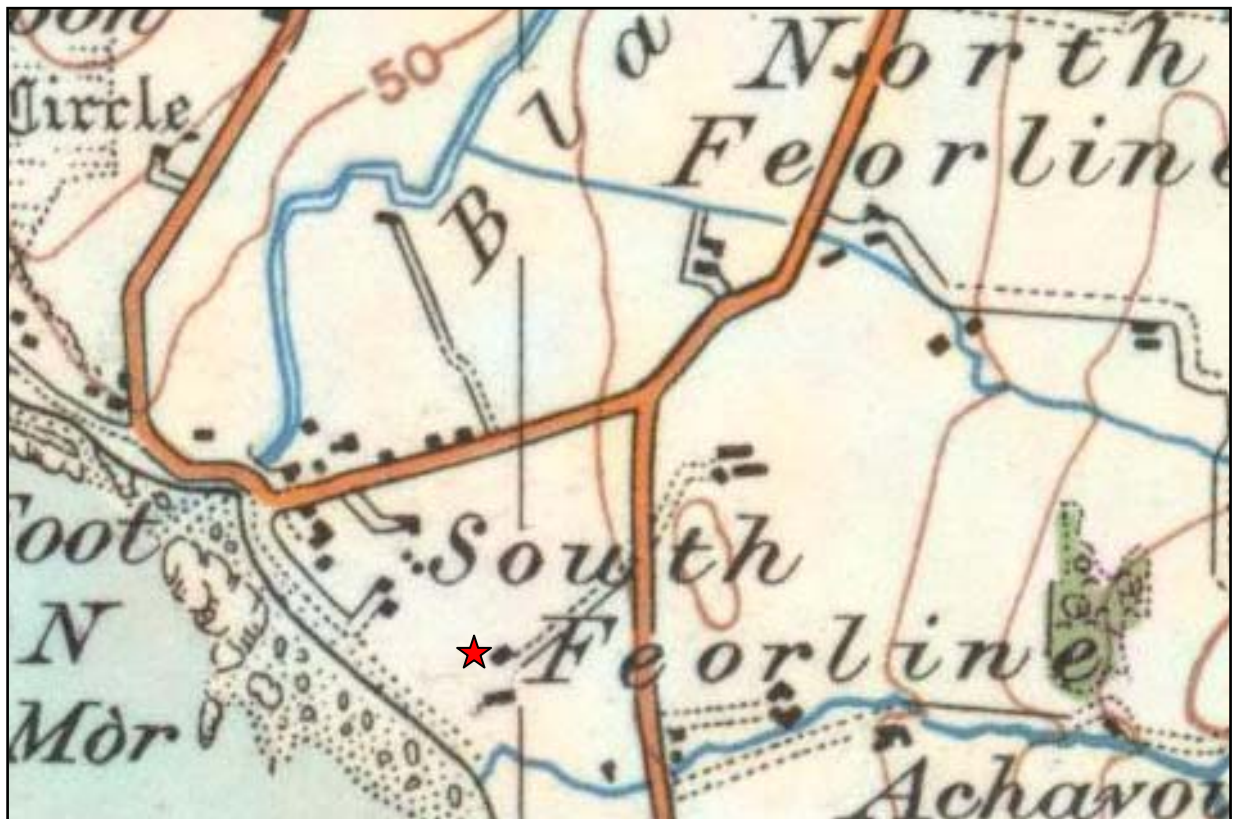
Figure 1b – Ordnance Survey 2nd edition (1899)

- 3.1 General cartographic evidence indicates that the study area has broadly always been open ground with the cottage located at the eastern corner of the field (Figures 1a-1b). However, although there are no archaeological sites or finds within the development area, there are a number with the general locale, which allowed speculation for the potential.

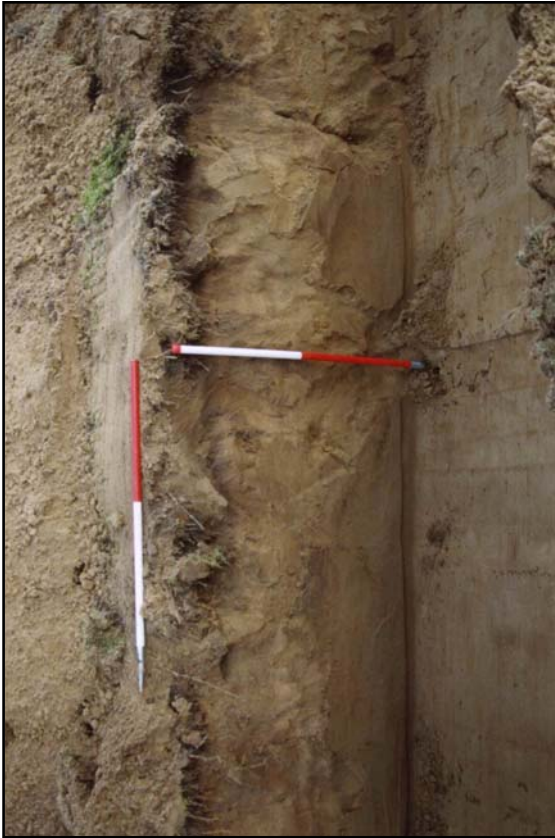
Figure 3a – Trench 2- section through mound

- 4.5 Trenches 2 and 5 were purposely placed to transect the large mound (NR: 8980 2792) that is located at the southern end of the development area. The section through this mound clearly shows that this feature is of no archaeological significance. The accumulation of such a quantity of sand does not appear to be wind blown as there is no visible banding within the deposit, which is characteristic of progressive wind blown sand. These mounds are a common feature along the shoreline of this area and may indicate sand dumps relating to the construction of the houses which form Blackwaterfoot. Furthermore it is noteworthy that there is a significant lack of a soil formation on the mound, indicating its 'recent' creation. Within the eastern face of the mound there are the remains of a small brick built structure. On discussion with a local it was revealed that this structure was a store, presumably cut into the sandy mound to keep the contents cool.

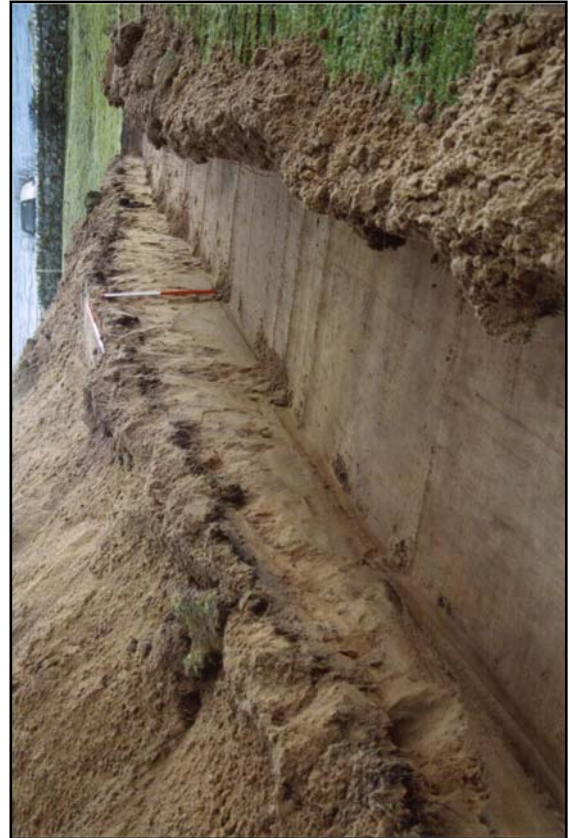
Figure 3b – Trench 2 – through mound

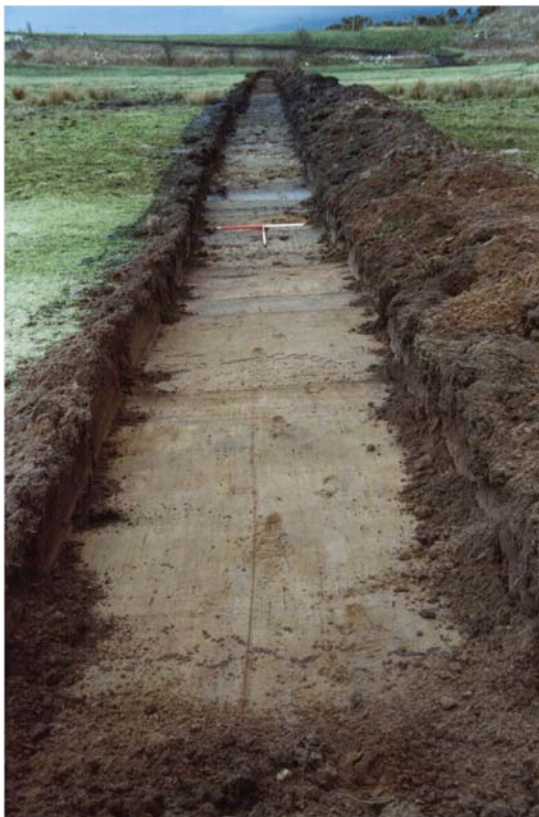
Figure 3c – Trench 3

- 4.2 The three longest trenches, which practically extend the length of the development area, exhibit a common stratigraphic sequence with sandy/silty topsoil with a varying depth of between 60mm and 200mm. This overlay a varying subsoil which denoted the boundary with the raised beach. At the south-western end the trenches were dominated by a homogenous deposit of clean, red/orange coloured sand (Figure 3a & b). At a common point across the field (Figure 2), the underlying sand gave way to a distinct horizon of rounded beach pebbles which denoted the start of the raised beach (Figure 3c). Although the terrain of the field does not show classic indication of this geological feature (stepped landscape), the underlying geology clearly demonstrate the occurrence of this event which formed at the end of the last ice age, some 10,000 years ago. It is possible to see that in this area of the island there appears to have been a minimum a two phases of isostatic lift, the initial phase resulting in a visible stepped topography of the prehistoric shoreline.

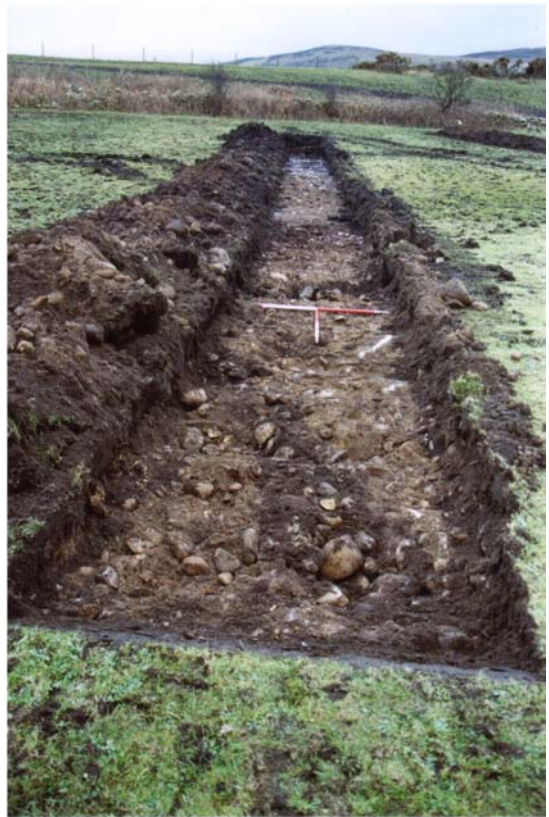
Figure 3d – Trench 6

- 4.3 The remaining three trenches (1, 4 & 6) were placed within the north-western end of the development field and as a result exhibited only the underlying raised beach in an orangey sand matrix (Figure 3d).

- 4.4 An abundant number of modern red ceramic and stone rubble field drains (Figure 3d) were found throughout the site in all but Trench 4. All were cut into the underlying natural (beach pebbles).

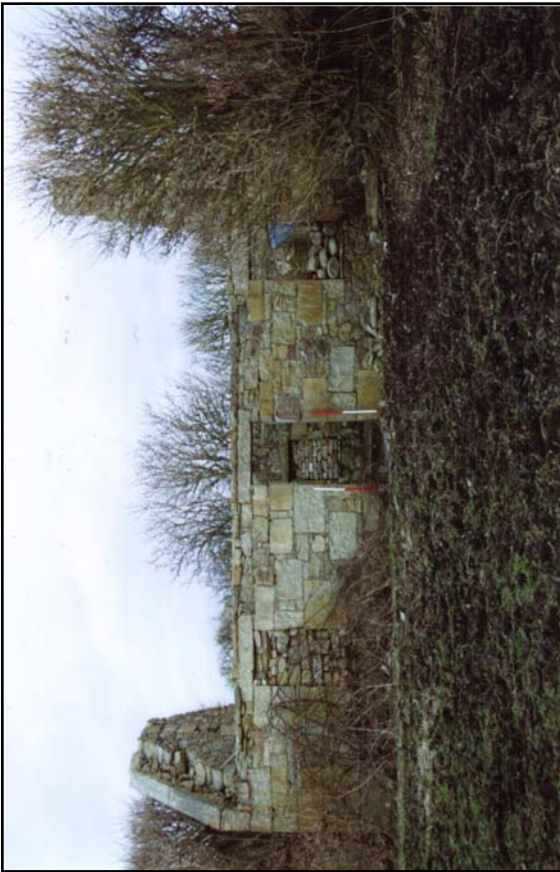
Figure 4a: Seafeld Cottage

- 5.2 The cottage sits in a north-west to south-east orientation, measuring 15m by 8m (including the outbuildings). The structure is constructed from fairly regular ashlar blocks of sandstone varying in size from large to small, with occasional round beach cobble incorporated within the main squared build (001) (Figure 4a). In its current condition, the building is nothing more than a shell (Figure 4a-d), with no roof, aperture fittings (windows, doors) or floor, which would have formed the single storey building

- 5.3 Externally the cottage faces south-west, with a single entrance doorway (002) located in the middle (2m by 0.97m), with two opposing window apertures (003 & 004) (1m by 1.40m). The window on the north-western side has been blocked with small rectangular blocks (Figure 4a). The rear of the property contains two window apertures (102 & 103) within the central section, measuring average 0.90m by 1m. These apertures have been blocked, potentially as a result of the addition of an out-building to the rear of the property.

- 6.4 The 19th century cottage (locally known as Murchie's Cottage) was subject to a level 1 building recording. In its present state the cottage is nothing more than a shell (Figure 4a-d), with no roof, aperture fittings (windows, doors) or floor, which would have formed the single celled building. The structure is currently being used as a shelter for horses which graze the field. Apart from the addition of two small external out-buildings it appears that the cottage has not been subject to any significant phases of development and in effect remains as it was when constructed in the early 19th century.

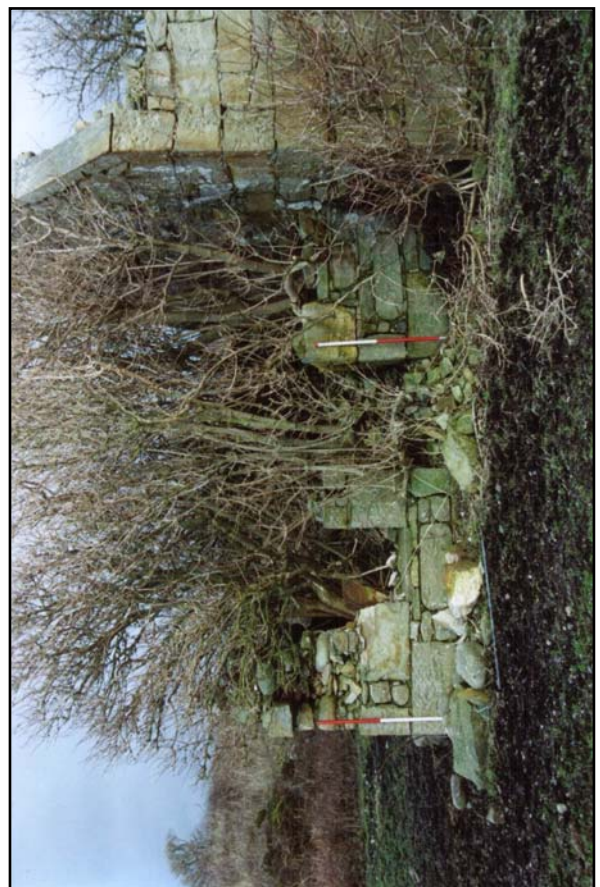
Figure 4d: Outbuilding

- 5.6 There are the remains of two outbuildings attached to the cottage, on the north-western gable end and to the rear of the property (Figure 4d). The small outbuilding on the north-western gable end measures 4m by 4.5m and is in a ruinous state, though a partial doorway and window can be seen. The structure stands to a maximum height of over 2m and is heavily overgrown with vegetation. To the rear of the property there are the remains of another ruined outbuilding, measuring 3m by 7m and standing to a height of 1m. In addition a brick built toilet has been added at the northern corner, measuring 1.37m by 1.6m.
