**Dendoldrum Farm Wind Turbine,  
Inverbervie:  
Archaeological Mitigation**

Data Structure Report

issued 22<sup>nd</sup> June 2016

on behalf of Muirden Energy

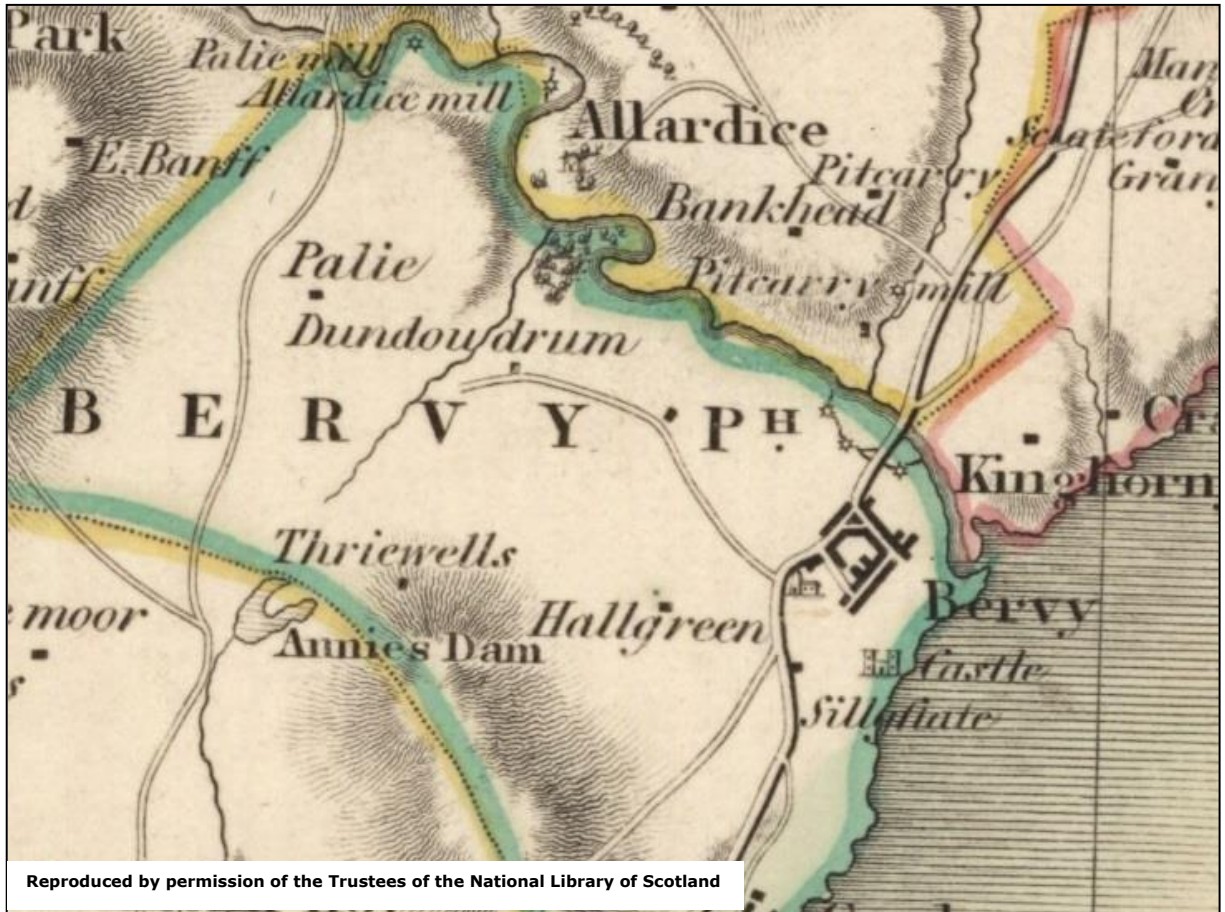
Figure 1a: Extract from Thomson *Kincardine Shire* (1822)

5. The first depiction and labelling of Dendoldrum is on Thomson's (1822) *Atlas of Scotland* (Figure 1a), there is little detail provided, but the farmstead is depicted as a black square and labelled as 'Dundoudrum'. The area to the south in which the development is located is blank.

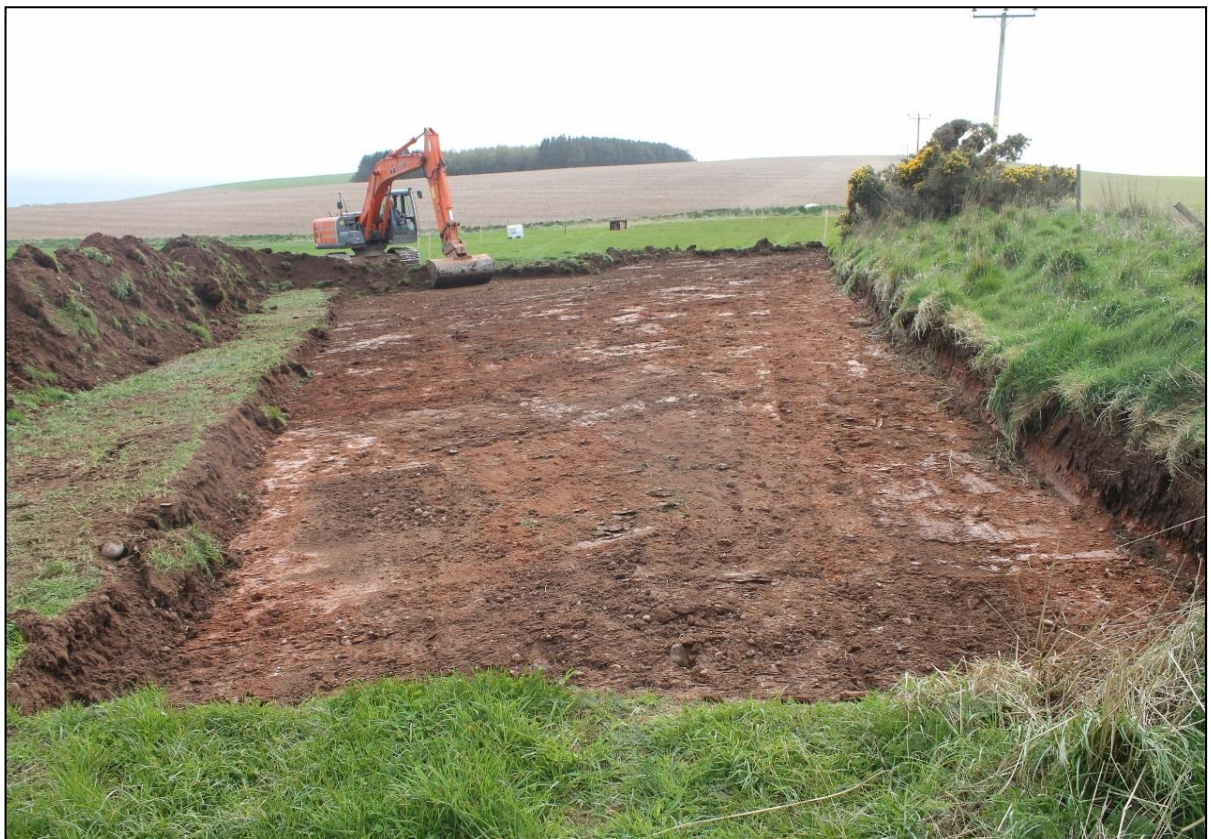
Figure 2b: Northern edge of turbine storage and crane pad area.

18. The first stage of archaeological monitoring works covered the machine digging of the turbine and turbine storage area and the crane pad area. The turbine was to be stored on site before being erected, thus the need for a larger area to store the turbine. The excavation started at the northern edge of this area and moved south with the total area excavated including the turbine area, turbine storage area and crane pad area being 1685m<sup>2</sup> (Figures 2b, 3a & 3b). The length of the haul road was 165m in length and 4m in width (Figures 4a & 4b).

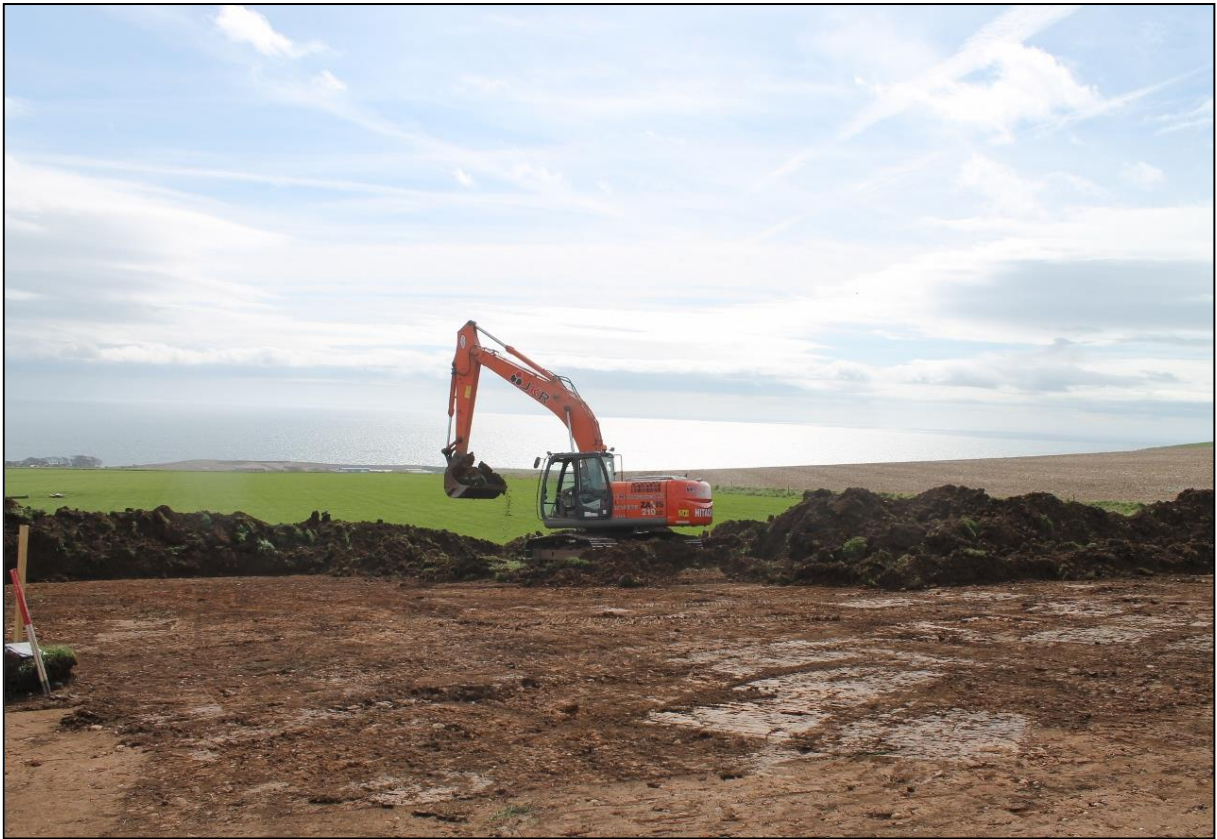
Figure 3a: Excavating turbine storage and crane pad area.

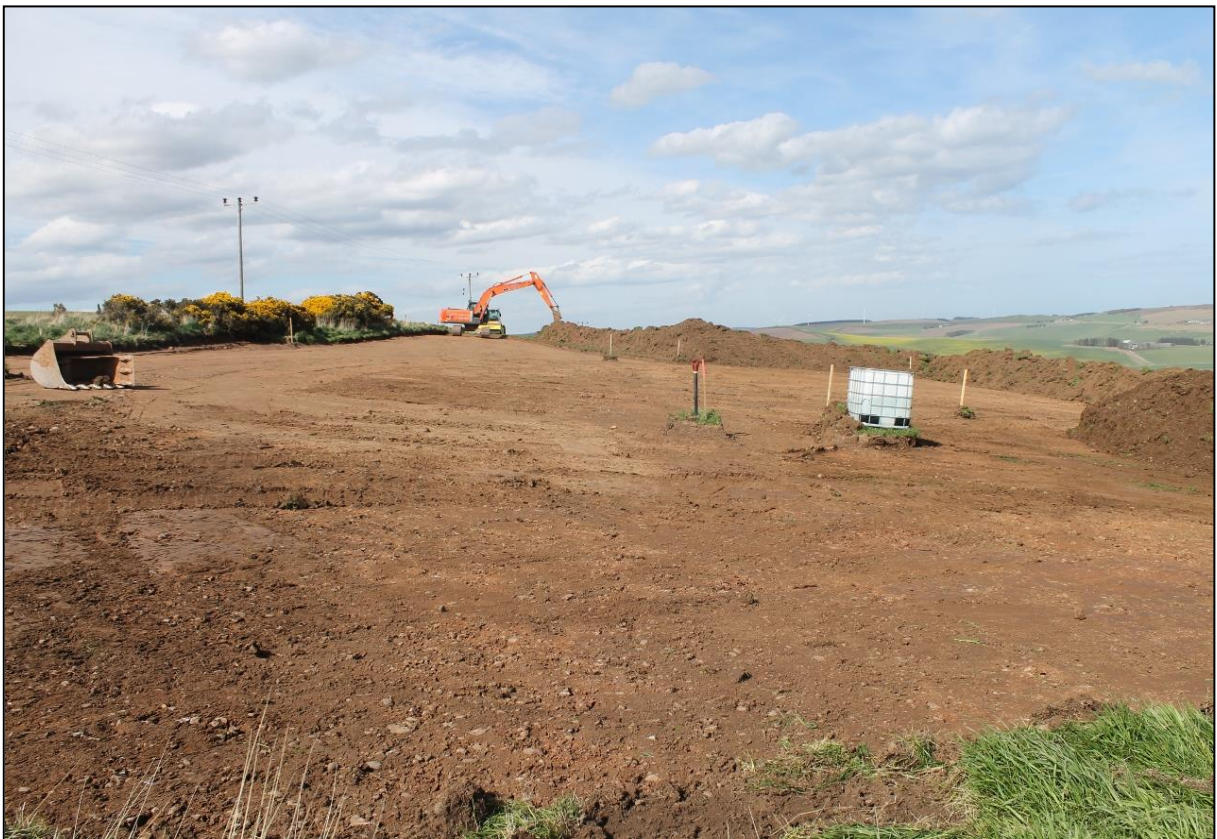
Figure 3b: Turbine storage, crane pad area and turbine area fully excavated. Turbine area located in the foreground of the image. Demonstrating context (002).

19. Across the areas excavated 250mm-300mm of (001) topsoil was removed and exposing (002) the natural subsoil. Context (001) was characterised by a moderately compacted, mid-brown clay and sand mix with very frequent small to medium sized rounded stones (50mm-100mm in size) and very frequent rootlets. Context (002) was formed of a compacted orange brown clay with very frequent small to medium sized rounded stones (50mm-400mm in size). In areas the clay had a higher sand inclusion, approximately 50/50, although the overall majority exposed was clay (Figures 3b, 4a & 4b).

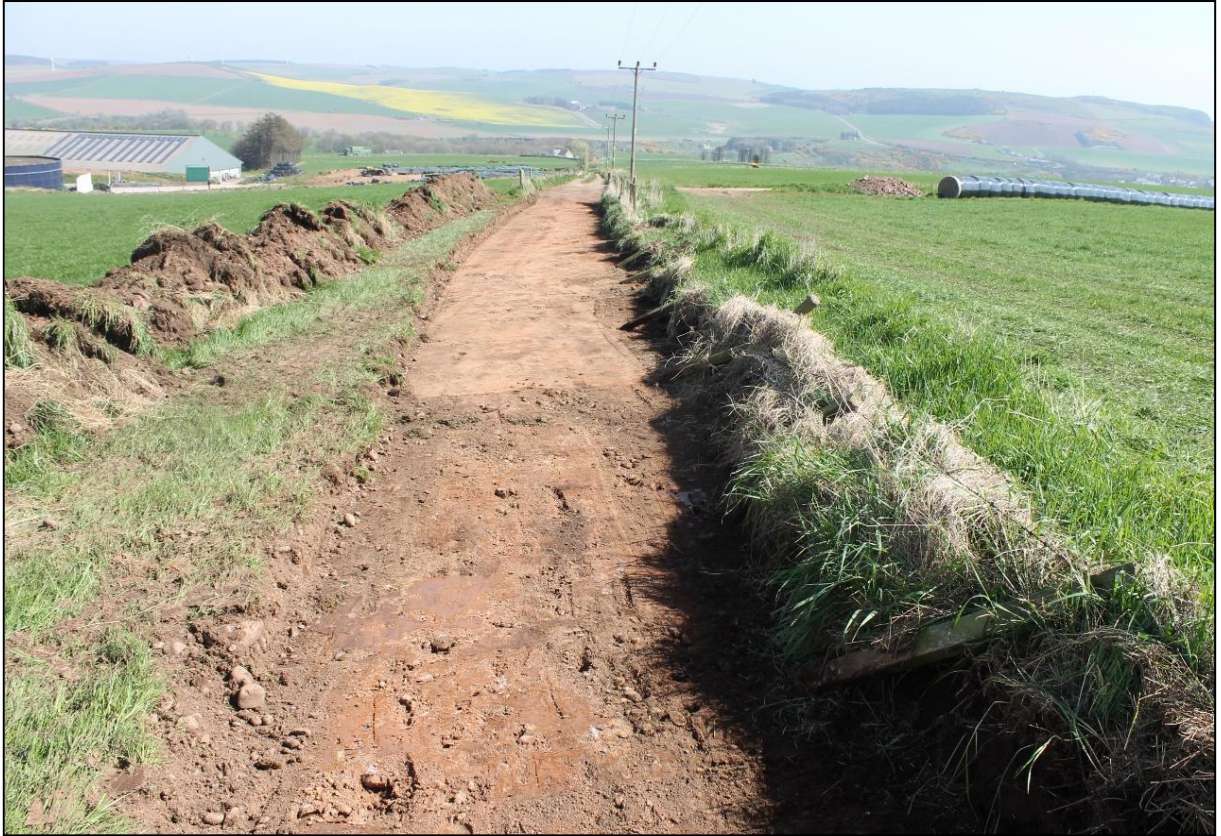
Figure 4a: Lower northern section of haul road and demonstrating context (002) recorded across the excavated areas.

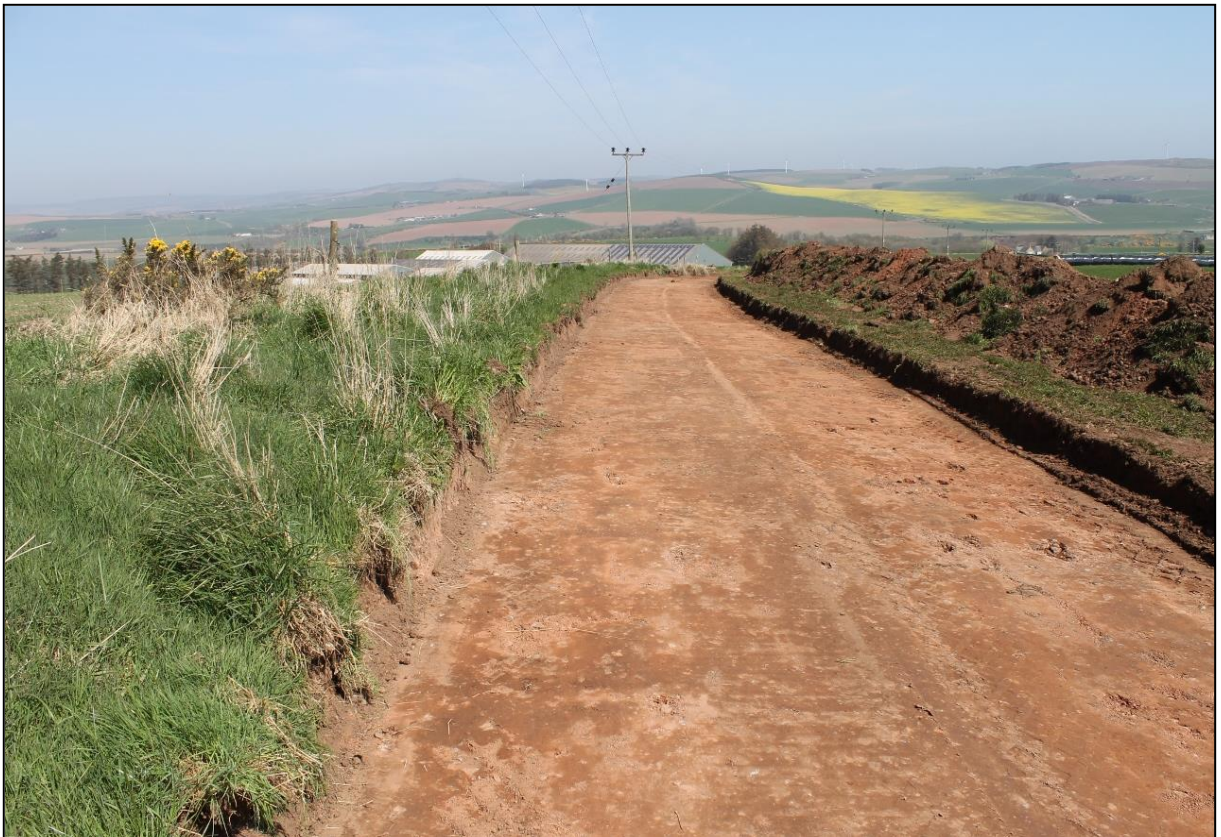
Figure 4b: Upper southern section of haul road and demonstrating context (002) recorded across the excavated areas.

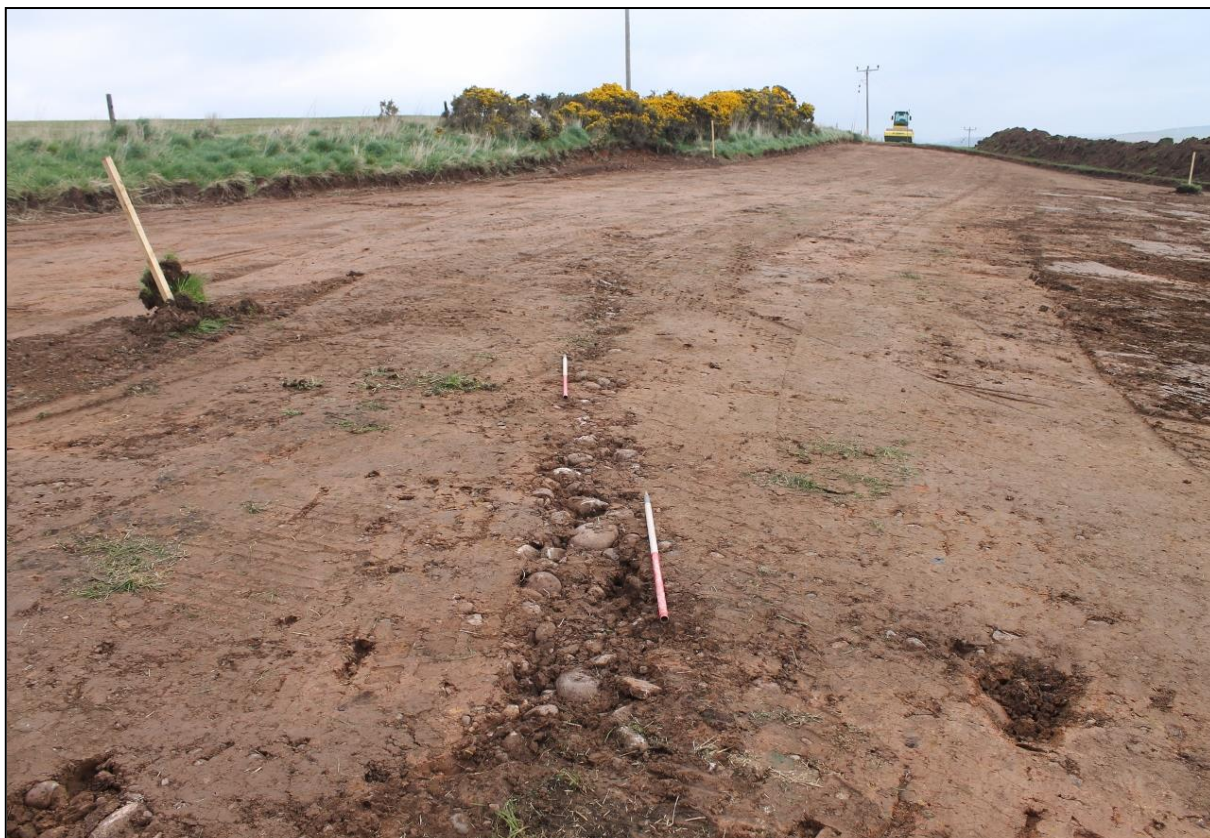
20. Only two features were recorded. Feature (003) was located in the north-western area of the turbine area and consisted of a north-south aligned 25m linear, measuring 400mm wide and filled with medium sized rounded stones (100mm-250mm in size). The last 2-2.5m at the south was in better condition (Figure 5a).

Figure 5a: Feature (003, rubble field drain in located in the north-western area of the turbine area.

28. The only anthropic features recorded were in the form of a rubble-filled drain exposed in the north-western area of the turbine area. This form of field drain is considered to represent 18<sup>th</sup> to early 19<sup>th</sup> century agricultural activity and would have been inserted during a period when the landscape across much of Scotland was under a regime of '*improvement*'.

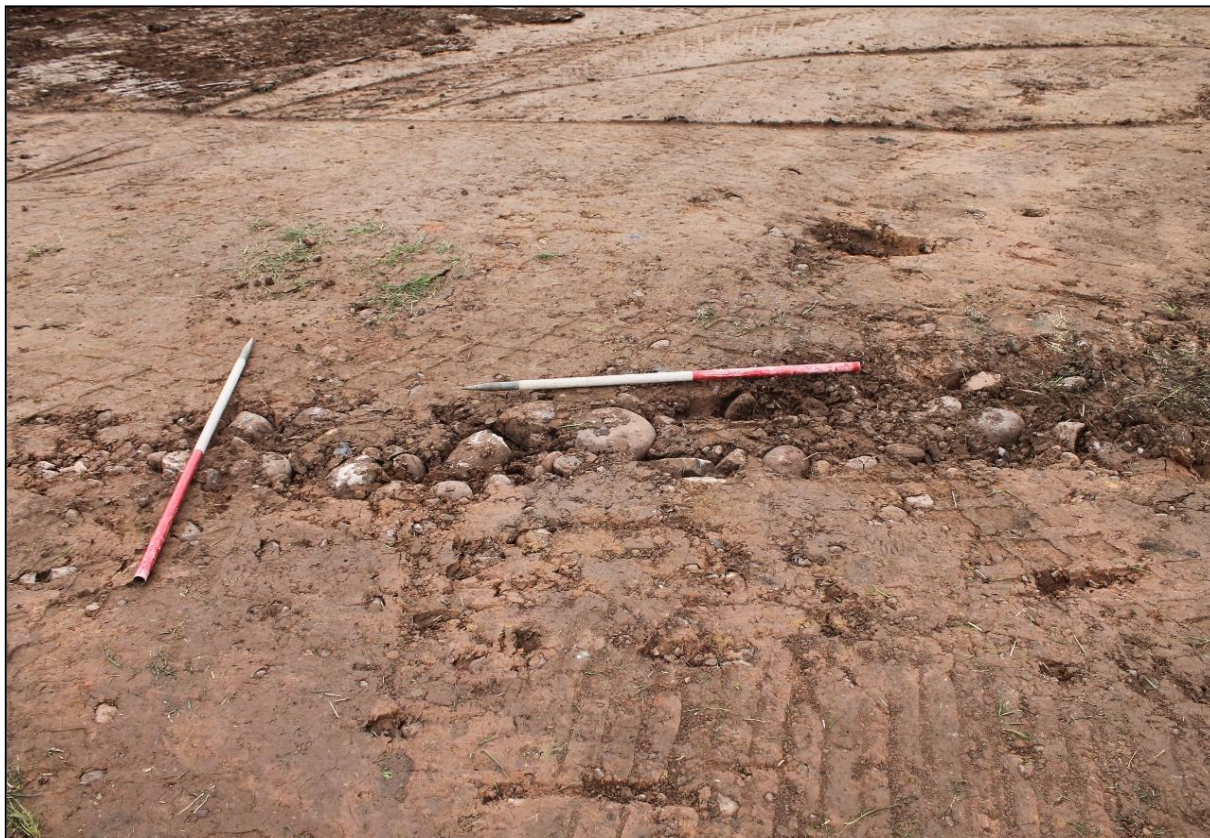
Figure 5b: Feature (003, rubble field drain in located in the north-western area of the turbine area. Showing the last 2-2.5m.

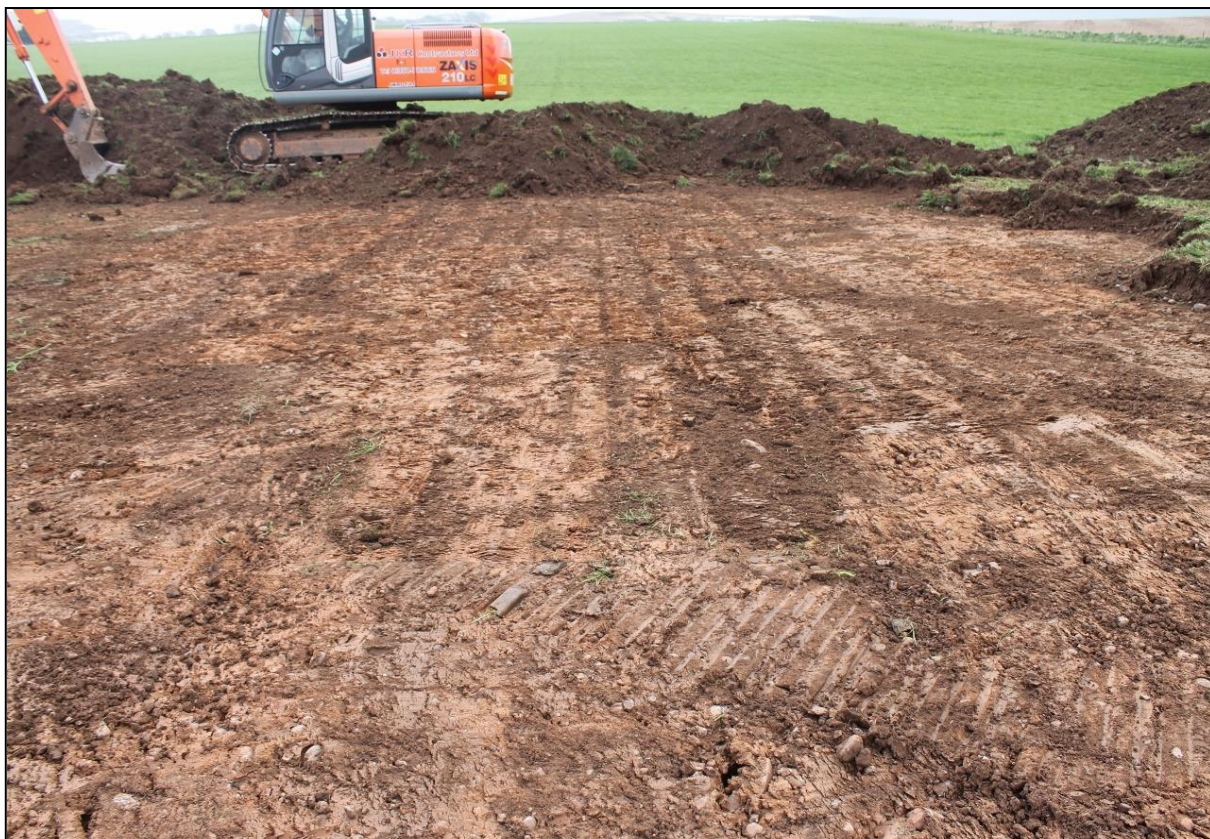
21. The second feature, (004) consisted of a grouping of eight east-west aligned linears approximately 17m in length and running to the east edge of the turbine area (figures 6a & 6b). The linears were 700mm wide by 30-40mm in depth and spaced evenly at 250mm. They all had gently sloping sides and a rounded base forming a 'U-shaped' profile. The fill was formed by (001).

Figure 6a: Feature (004), plough scars located in the eastern side of the turbine storage and crane pad area

29. The second feature, characterised by a grouping of eight evenly separated linears located in the eastern area of the crane pad and turbine storage area represents agricultural activity in the form of plough scars. It is not known when the field was last ploughed, but the evenly spaced nature of the plough scars would suggest that they are modern and possibly 20<sup>th</sup> century in date.

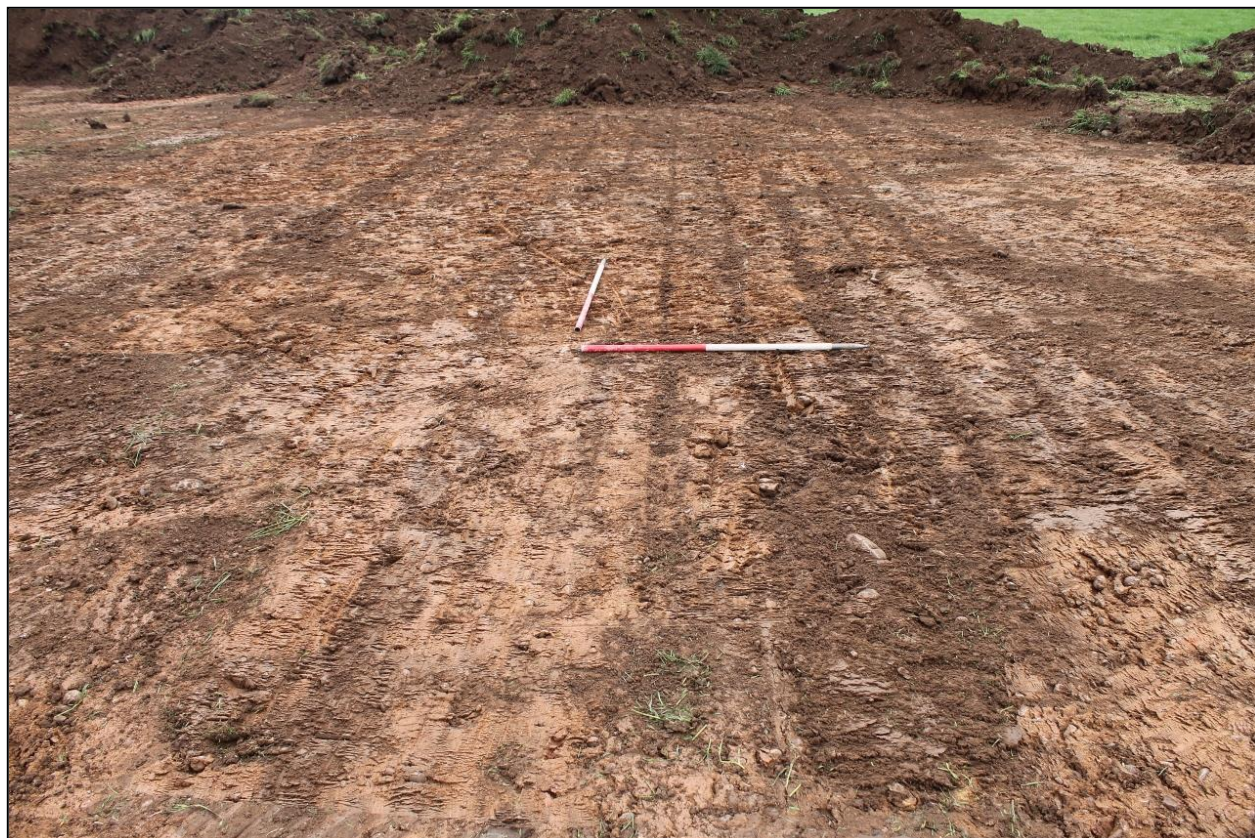
Figure 6b: Feature (004), plough scars located in the eastern side of the turbine storage and crane pad area. With ranging rods.

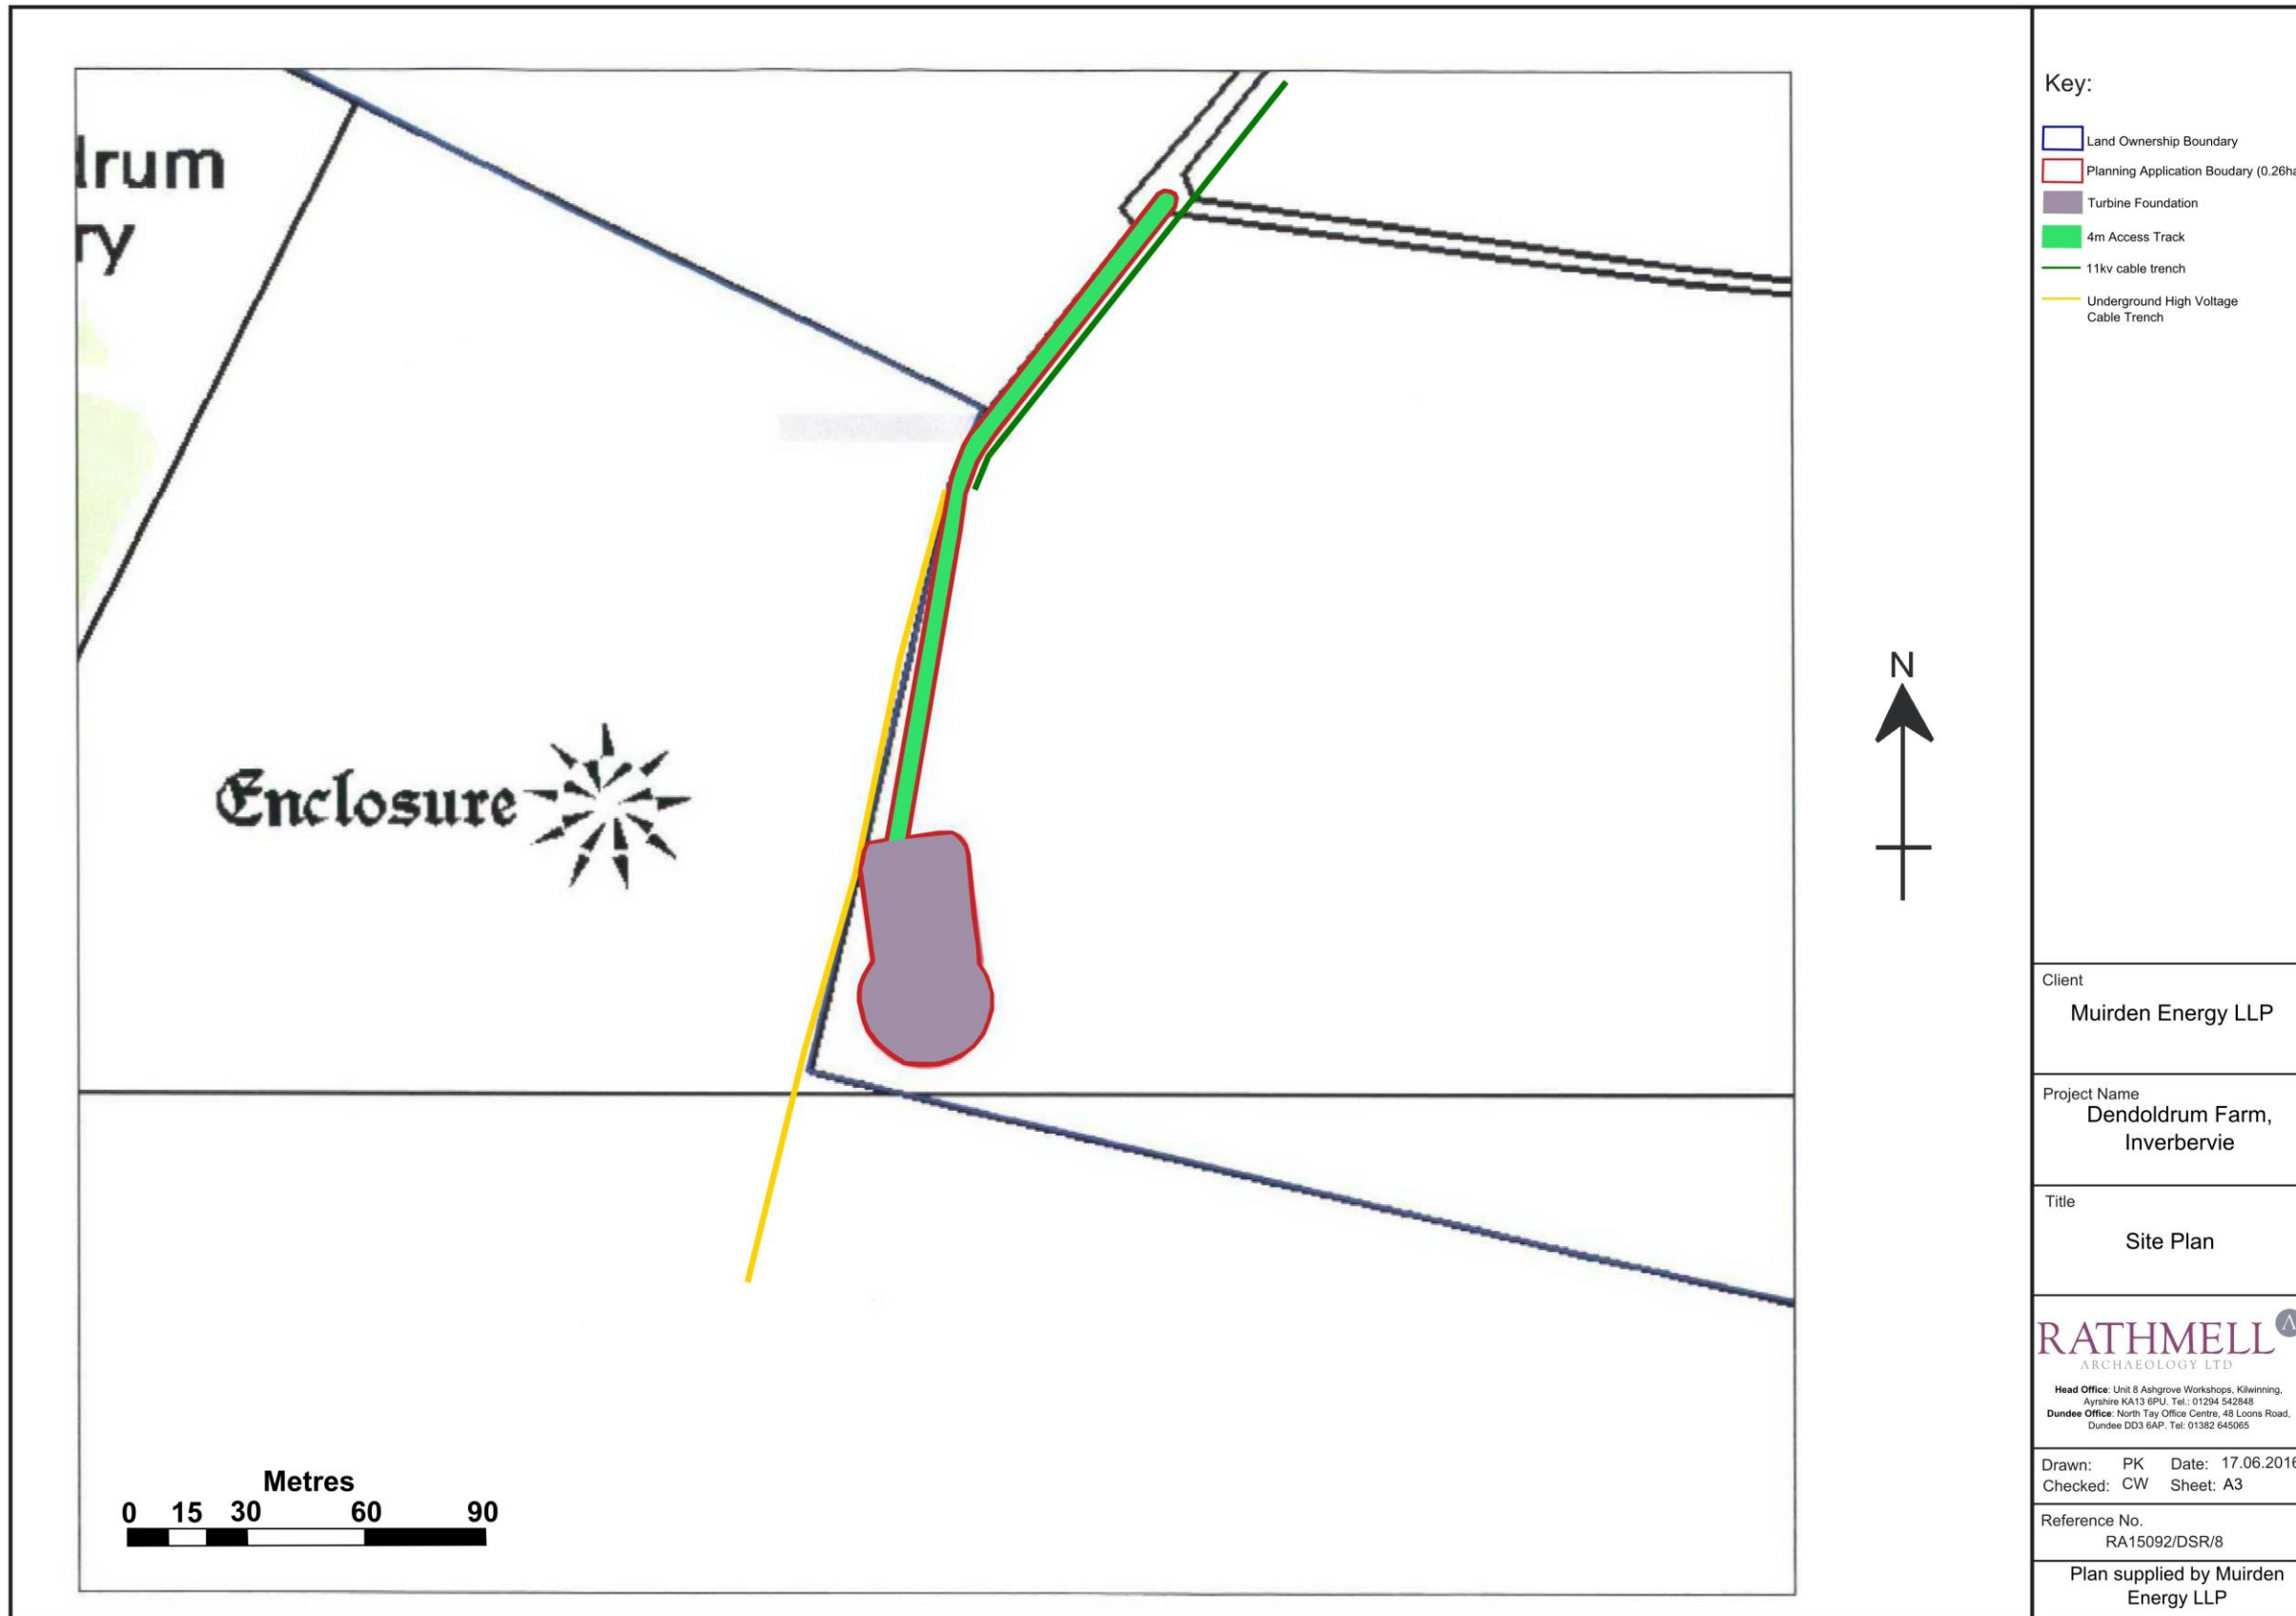
Figure 8: Site Plan of the monitored areas: turbine base, turbine storage and crane pad area, haul road and cable trench

22. The second stage of works comprised the excavation of two cable trenches (Figures 7 & 8). The first cable trench ran parallel to the haul road, turbine area and turbine storage area on its west side (Figures 9a & 9b). This trench was to take the high voltage line underground from present day overground route between electricity poles 24-28.

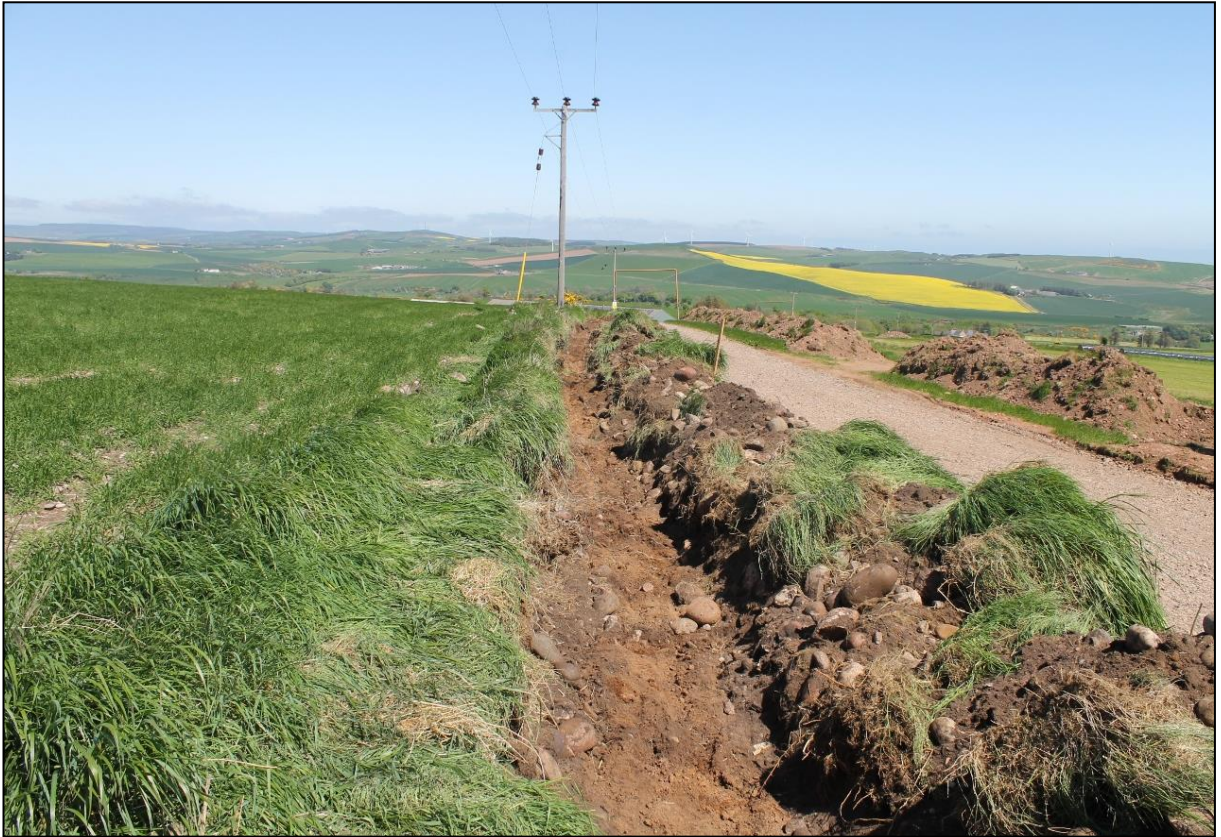
Figure 9a: Cable trench to take the high voltage electricity cable underground looking north.

23. Context (001) comprised the same topsoil/ploughsoil as that recorded for the adjacent areas and at the same thickness. The dimensions for the cable trench were 248m in length and changed in width from 600mm to 2m wide. Context (002) formed the natural subsoil and the same as that recorded along the length of the haul road and across the turbine area, turbine storage area and crane pad area.

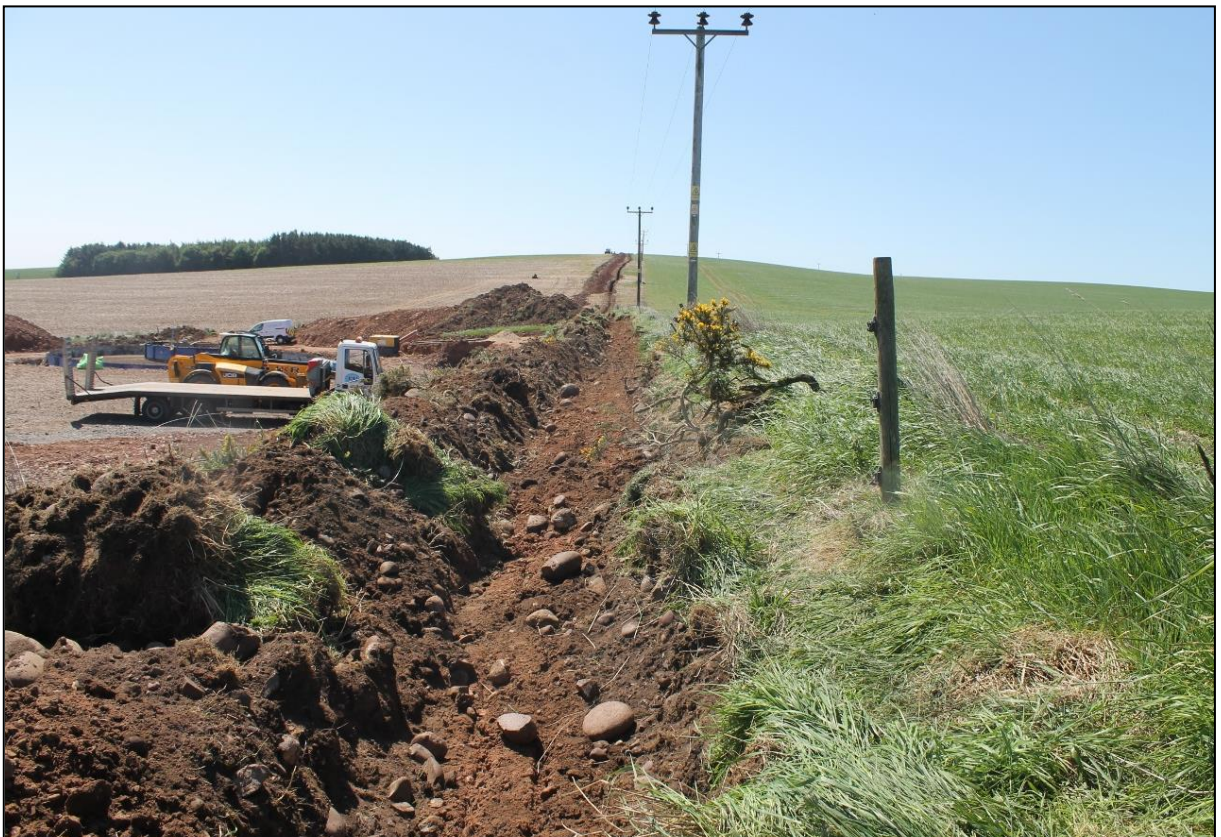
Figure 9b: Cable trench to take the high voltage electricity cable underground looking south.

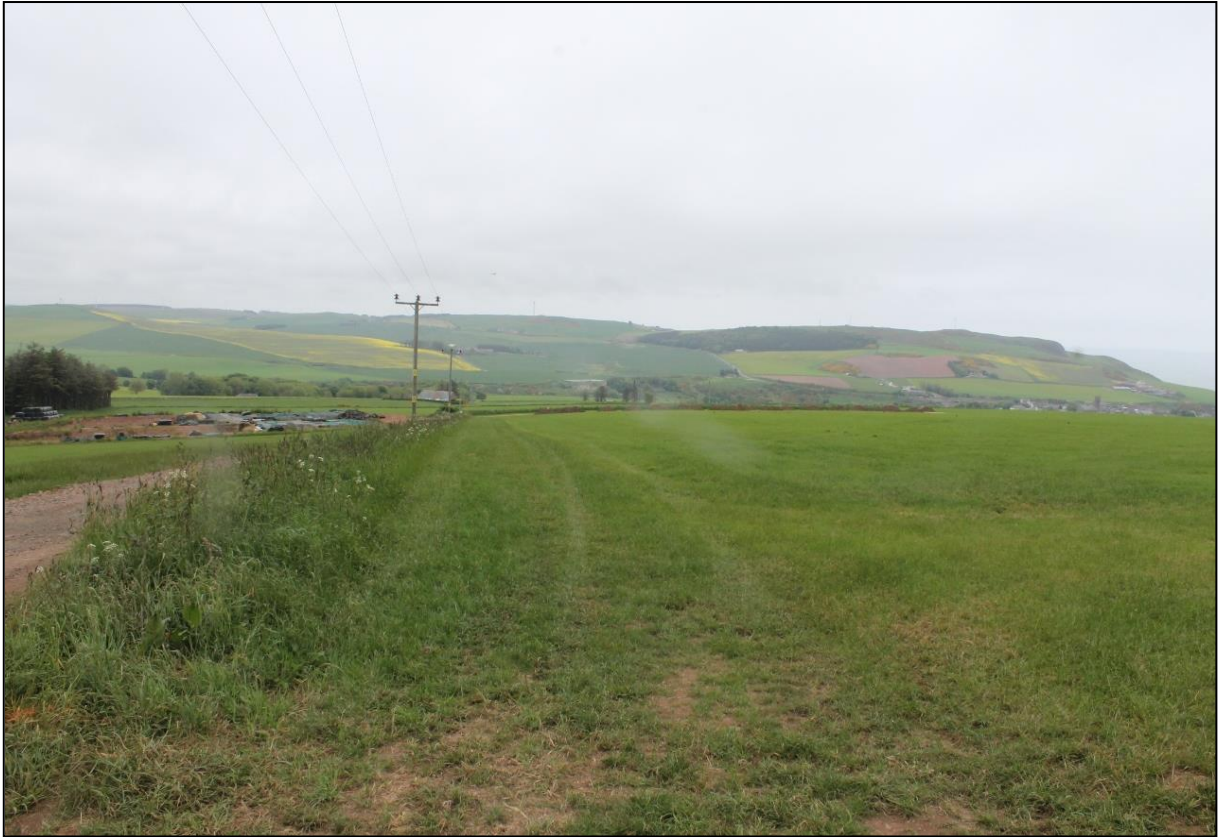
Figure 10a: Post excavation of the upper southern section of the 11kv cable trench.

24. The second cable trench was to take the 11kv cable from the turbine to the existing sub-station. The route of the 11kv cable trench followed the east side of the haul road and along the fence line the adjoining field. In total 645m was monitored with the trench being a width of 600mm.

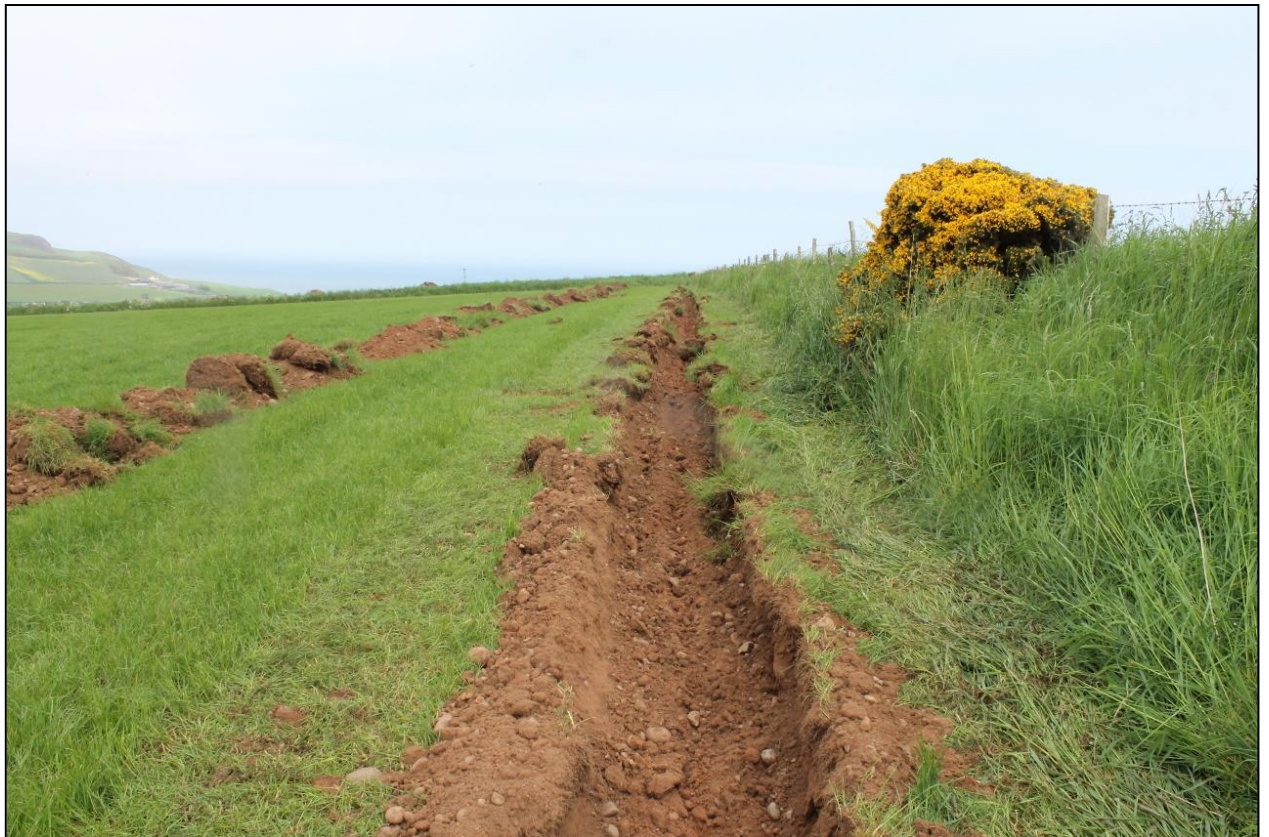
Figure 10b: Topsoil excavated from the lower north-eastern section of the 11kv cable trench.
