Castlehill, New Cumnock: Archaeological Monitoring

Data Structure Report

issued 9th May 2016

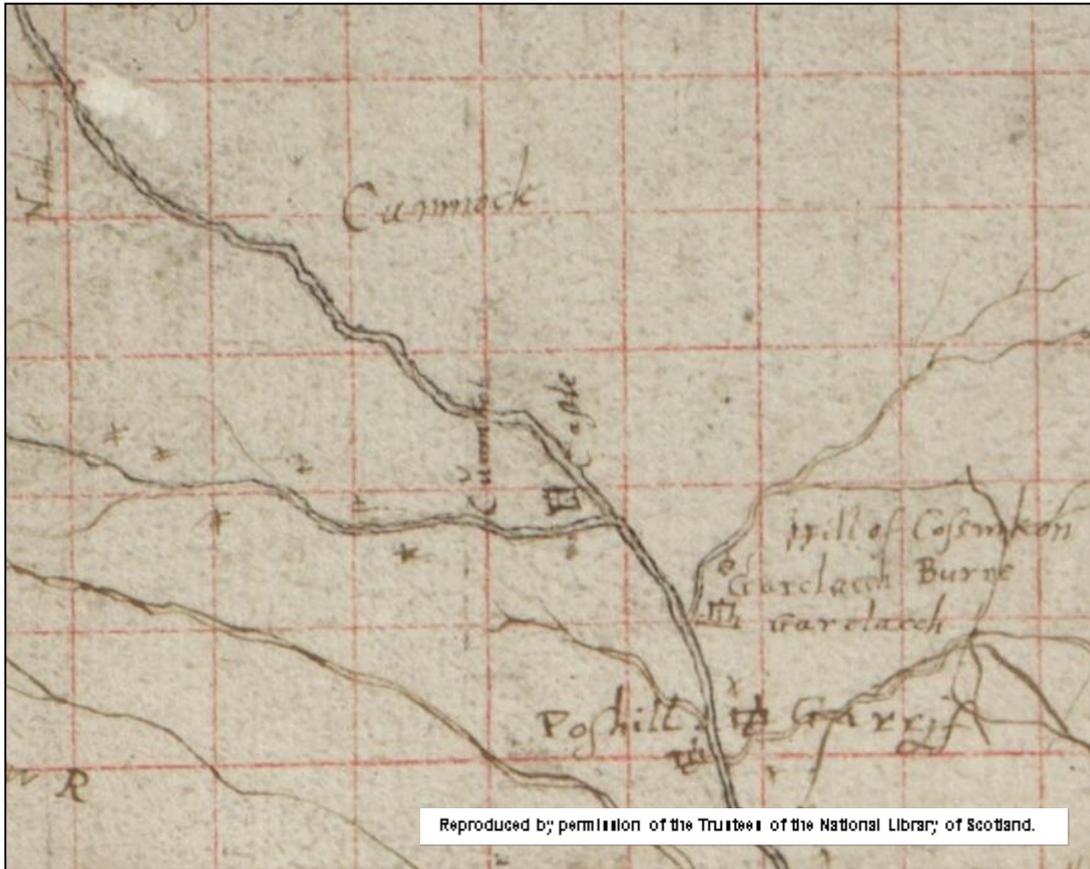
Figure 1a: Extract from Pont's map of 1583-96

8. The cartographic evidence for New Cumnock Castle is strong, with the earliest reference within Pont's map of 1583-96 (Figure 1a). Adair's map of 1685 (Figure 1b) denotes 'Cumnock C' which presumably refers to the castle rather than the town. Moll's map of 1745 (Figure 2a) also shows 'Kumnock Castle' and confirms that there were some above ground remains within the 18th century. Later historic maps, such as Roy's of 1752-55 (Figure 2b), show Cumnock but do not refer to it as a castle possibly suggesting that there were fewer notable above ground remains left within the castle at that point.

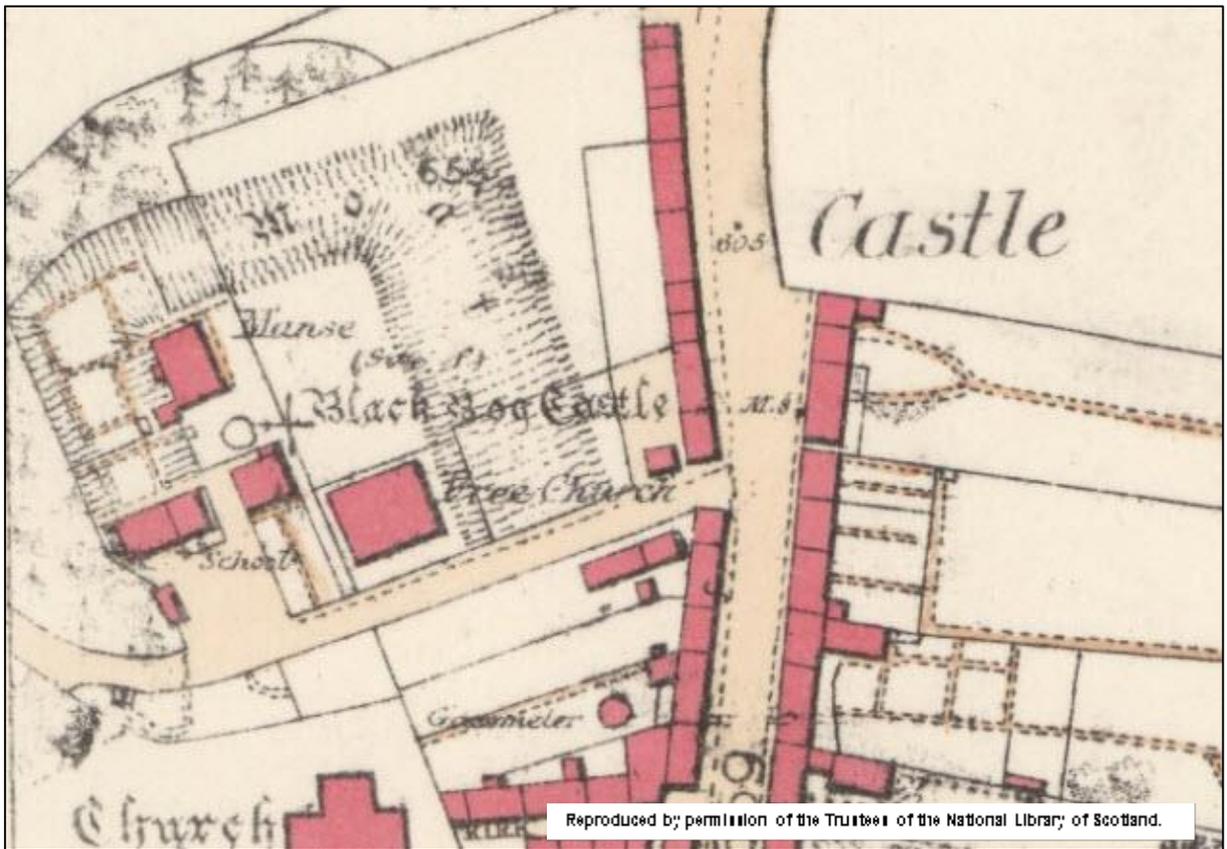
Figure 3a: Extract from 1st edition Ordnance Survey 1860

10. The first edition Ordnance Survey map (Figure 3a) depicts the moat still extant to the south-east side of the Free Church. By the second edition Ordnance Survey map (Figure 3b) the moat to the south-east of the church appears to have been filled in. Excavations carried out to the immediate north of the 17th century church and grave yard uncovered a level linear bank which ran along the edge of Castlehill Road (Matthews, A. and Rees, T. 2003). This bank was 1.5m thick and covered a buried ground surface. The excavation proved that the cemetery wall cut into this linear bank suggesting that the bank material was either upcast or a form of bank/glacis associated from the southern side of the moat. This material could date to the medieval period with the initial excavation of the moat through to the last known activity or occupation in 1650. From this it would be reasonable to infer that the southern side of the moat underlies Castlehill Road.

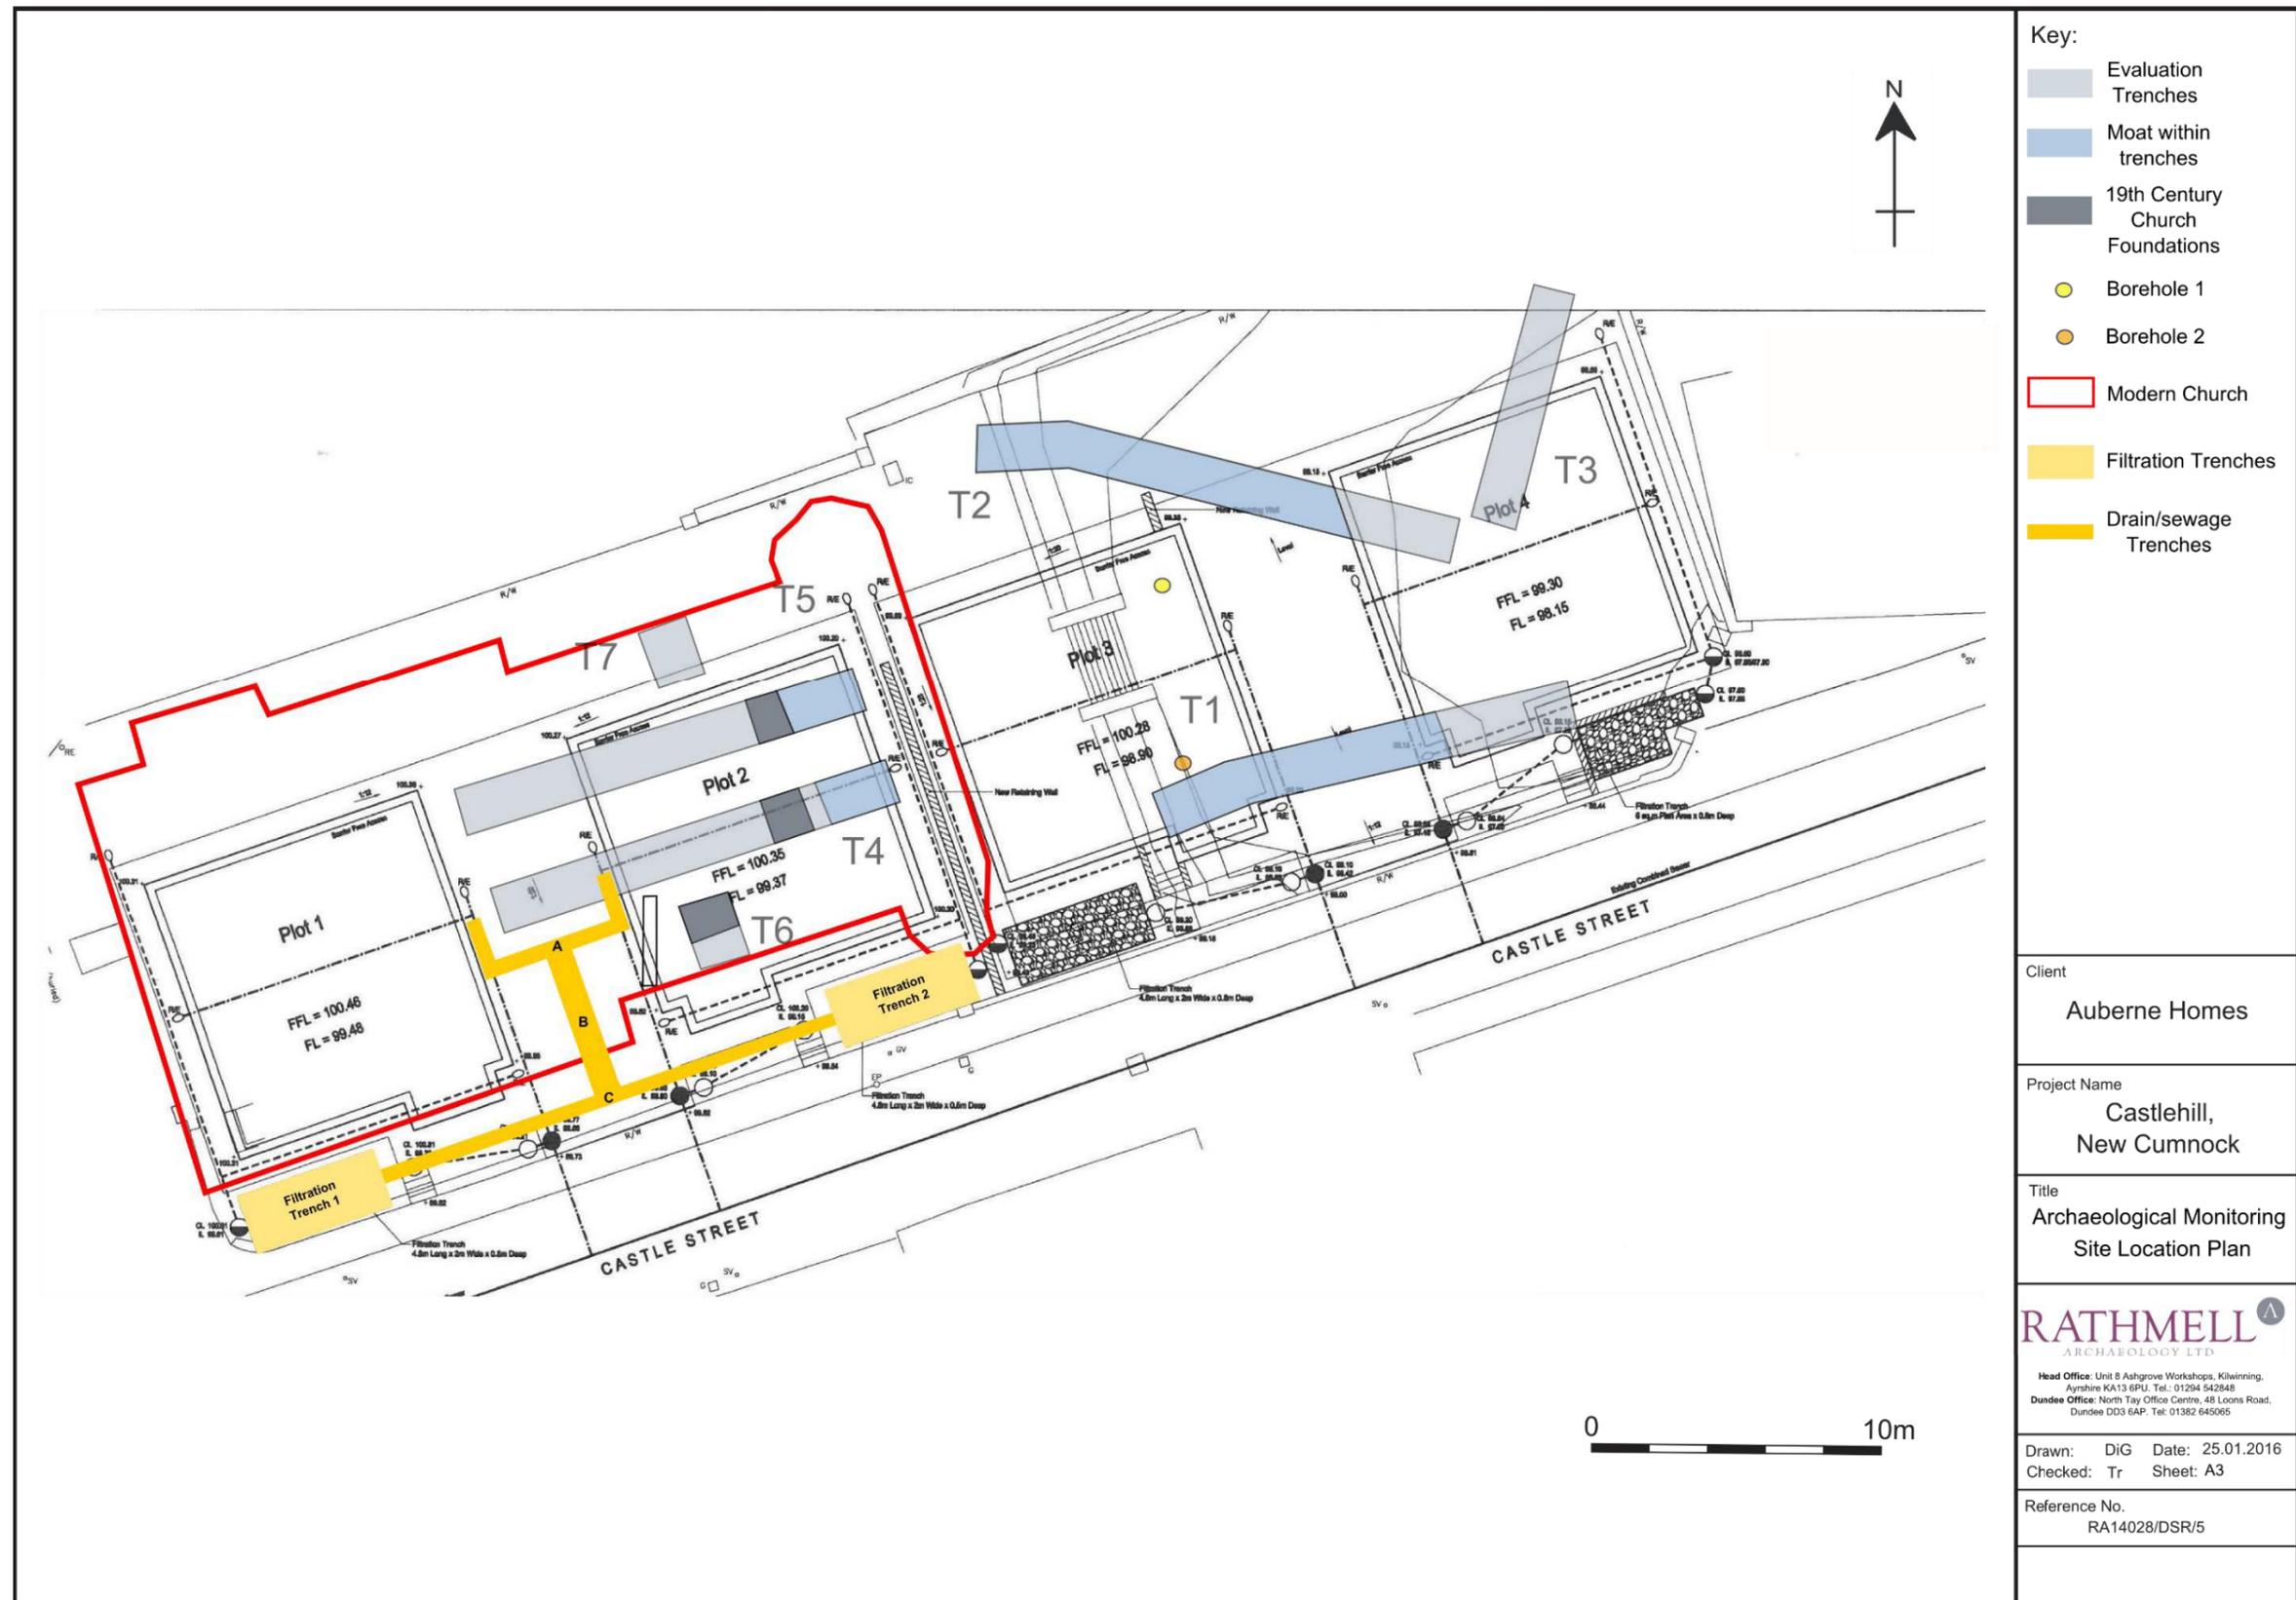
Figure 4: Archaeological Monitoring Site Location Plan

12. The investigation revealed a linear concentration of stone and clay within the footprint of the church, thought to be the possible remains of a foundation wall for the castle. A large ditch was also identified within the grounds of the church which correspond to the historical mapping evidence for the castles moat. The historic mapping indicated that the moat had a width of between 20 to 24m which was consistent with the span of the ditch encountered during the archaeological evaluation works, found to be 22m wide (Figure 4).

and two of the borehole samples were to be retained by Rathmell Archaeology Ltd for further analysis (Figure 4).

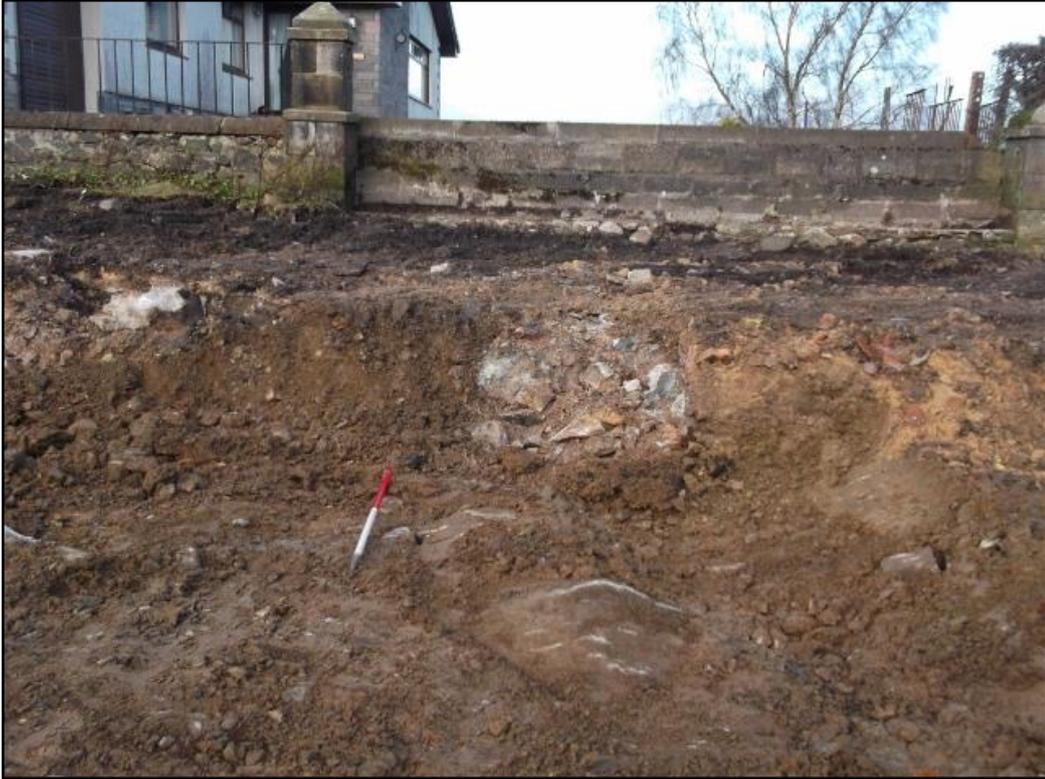
Figure 5a: Foundations [004] in SW facing section plot 2

22. The recently demolished remains of the 20th century church were located within plots 1-3. These remains consisted of the walls/foundations of the building, [004], which were blonde sandstone chunks and blocks and grey worked and unworked stones which were mortared in place. The wall/foundation had a thickness of 0.5m and a width 0.7m. Beneath the wall/foundation was a bedding layer of concrete (003) which also acted as internal flooring and outside surfaces. These remains were abutted by layer (007) and underlay the upper layers (001) and (002).
23. The fragmentary remains of brick structures, (014) and (020), were also identified abutted by Layer (007) close to the NNW edge of plot 2. These structures had an unclear relationship with the 20th century church building and were only observable in section.

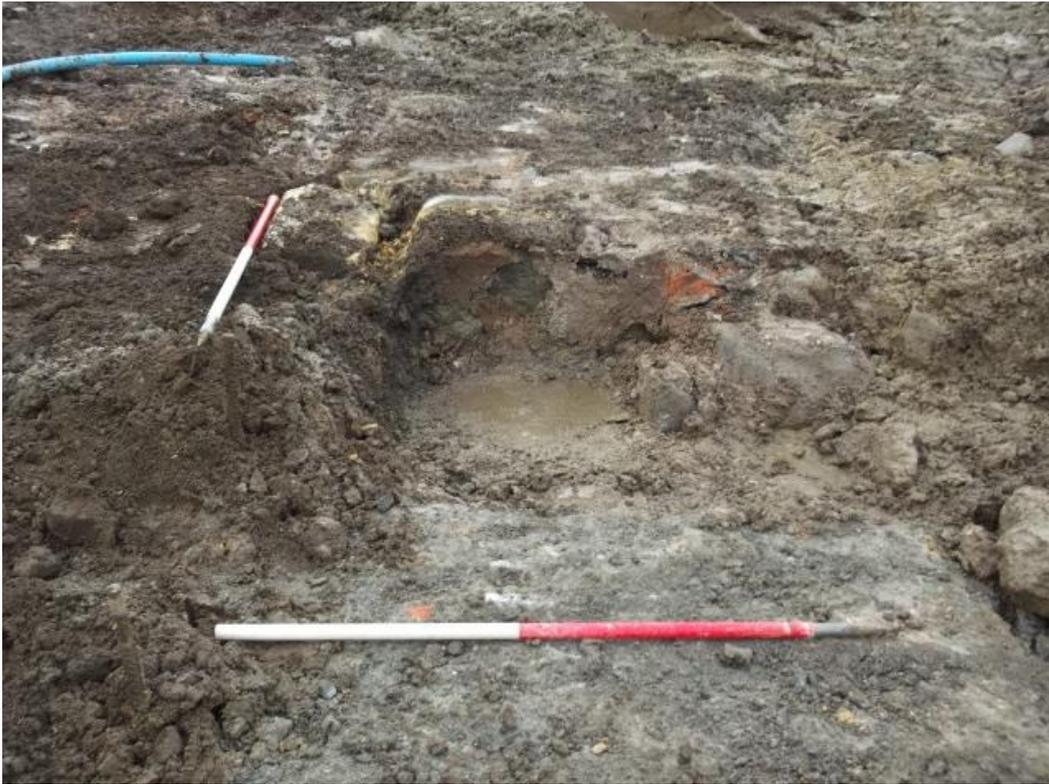
Figure 6a: Structural Remains [010] at south side of plot 2

A stretch of the 19th century wall, [010], was identified within SSE part of plot 2 and was most likely part of the 19th century church identified in the original evaluation trenches (McKinstry 2015). This stretch of wall consisted of five worked, rectangular shaped grey stone blocks and worked blonde sandstone blocks which were mortared into place. The section of wall underlay the 20th century concrete layer (003) and was surrounded by layer (007).

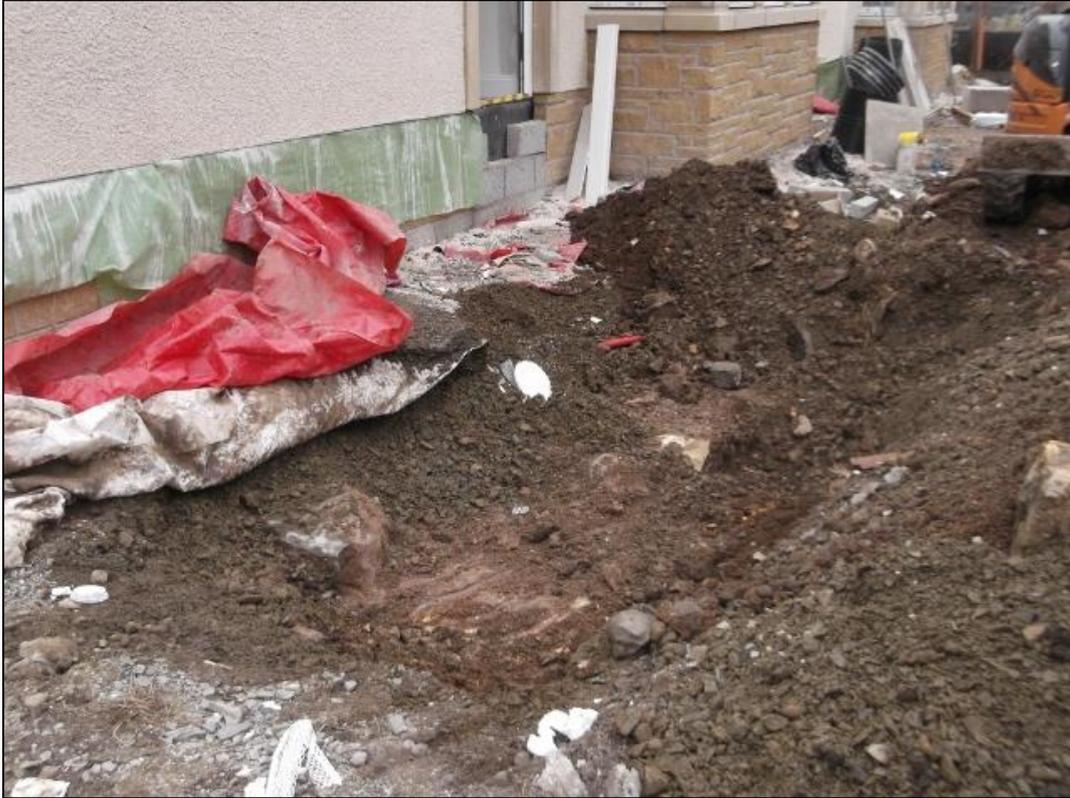
Figure 7a: Retaining wall [026] within filtration trench 1 from the SW.

31. The Foundations of 20th century church were identified within trench B (Figure 7b). The foundations consisted of an upper wall section [024] which was constructed using large roughly worked boulders (0.75m x 0.68m x 0.48m in size) and smaller stones. The wall was bonded with a mixture of orange/buff coloured mortar and mid grey brown clay. The wall measured 1.2m in length (within the main drain trench), 1.6-1.7m wide and had a thickness of 0.35-0.4m. The wall section most likely related to other structural remains [004] which are discussed earlier in the report. Directly beneath wall section [004] was a layer of concrete and rubble (027) which may have been a bedding layer for the foundations. This layer had a thickness of 0.2-0.3m and a width of 1.6-1.7m. To the immediate SSE of the church foundations in trench B was a deposit of mid grey-brown/orange-brown clay with very frequent medium sized stone rubble and occasional larger building stones. The layer had a thickness of 0.6m and an extent of 1.2m long (within the trench) by 0.8-1m wide. The deposit (025) seems to have acted as core material between the church foundations and a retaining wall [026]. The retaining wall (Figure 7b) constructed using large flat stones/blocks (0.7m x 0.35m x 0.08-0.15m in size). The structure was bonded with orange/buff coloured mortar and measured 1.2m in length (within the main drain trench), 1.2-1.3m wide and had a thickness of 0.6m. Both the foundation wall [024] and the retaining wall [026] were both orientated in a WSW to ENE direction. The retaining wall [026] was also identified within filtration trench 1 (Figure 7a).

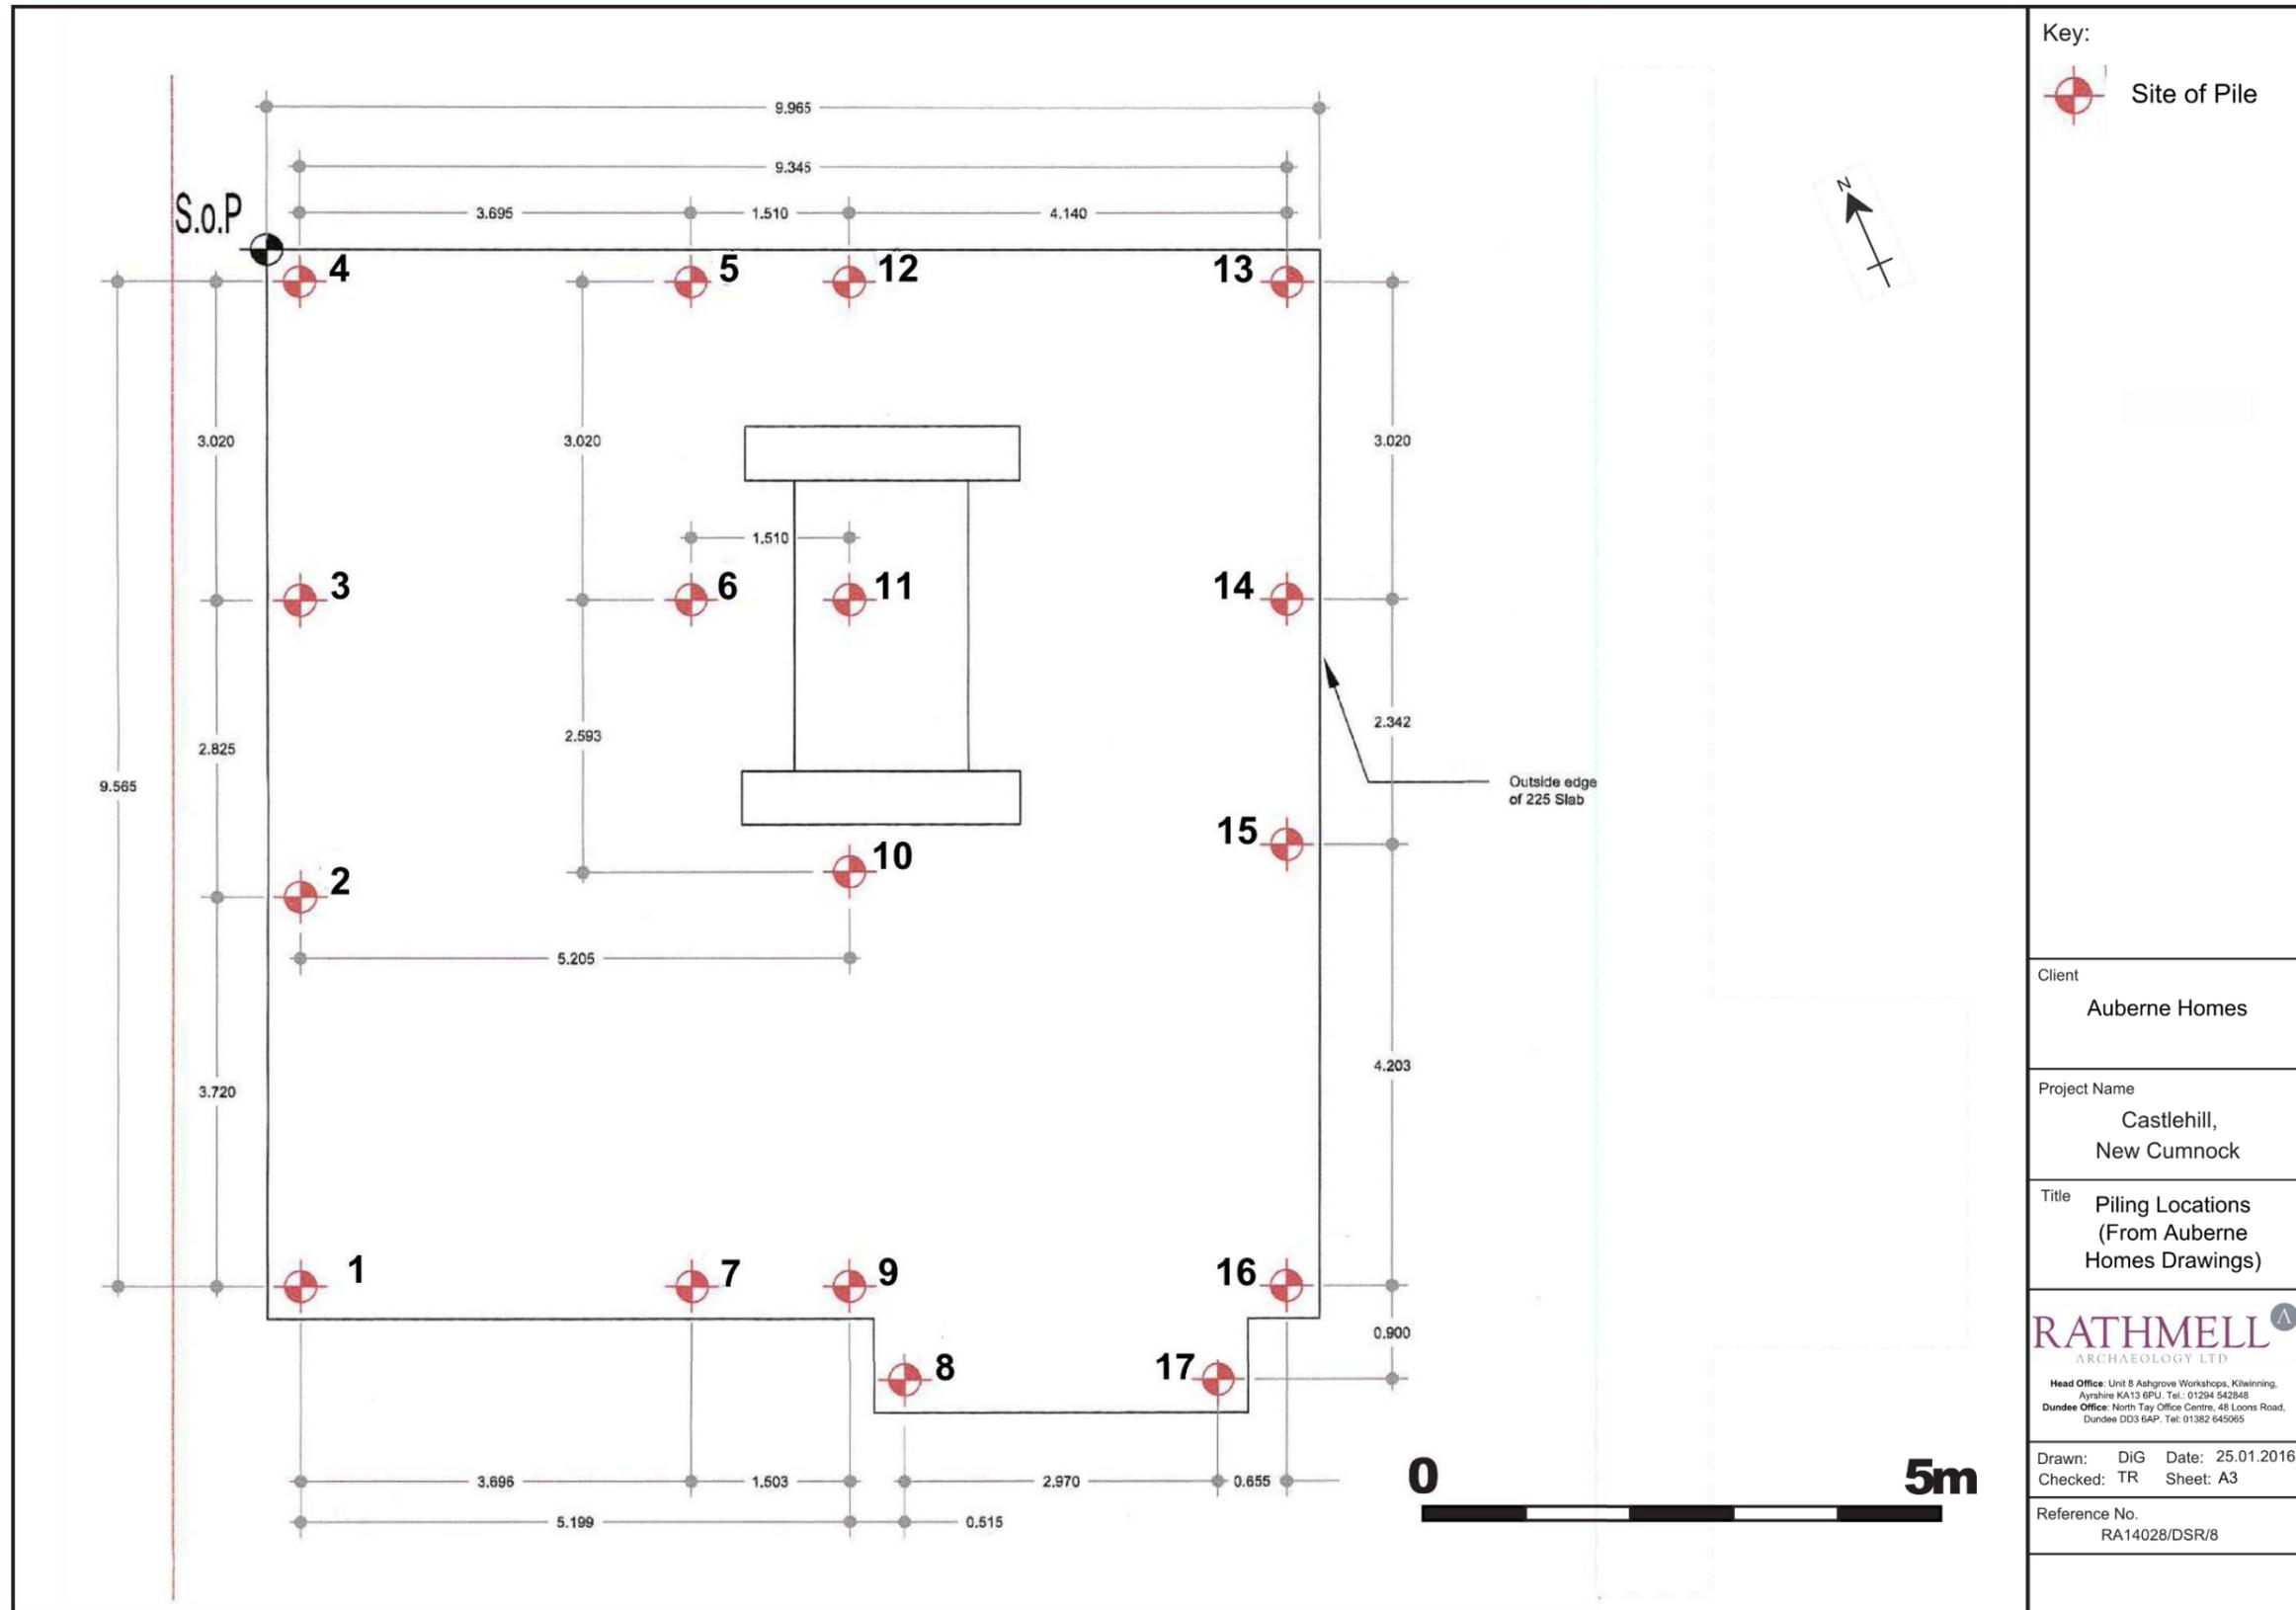
Figure 8: Piling Locations (plot 3)

28. To facilitate the pile and ring beam structure, seventeen piles were drilled into plot 3 (Figure 8), begun at the final ground reduction level in this area. Circumstance allowed the archaeologist a view of the upper 0.2m of piles 3, 4 and 12 which showed grey clay (019), similar to deposits (006) and (016).
