3 Bank Street, Kirriemuir, Angus: Archaeological Mitigation

Data Structure Report

issued 13th January 2016

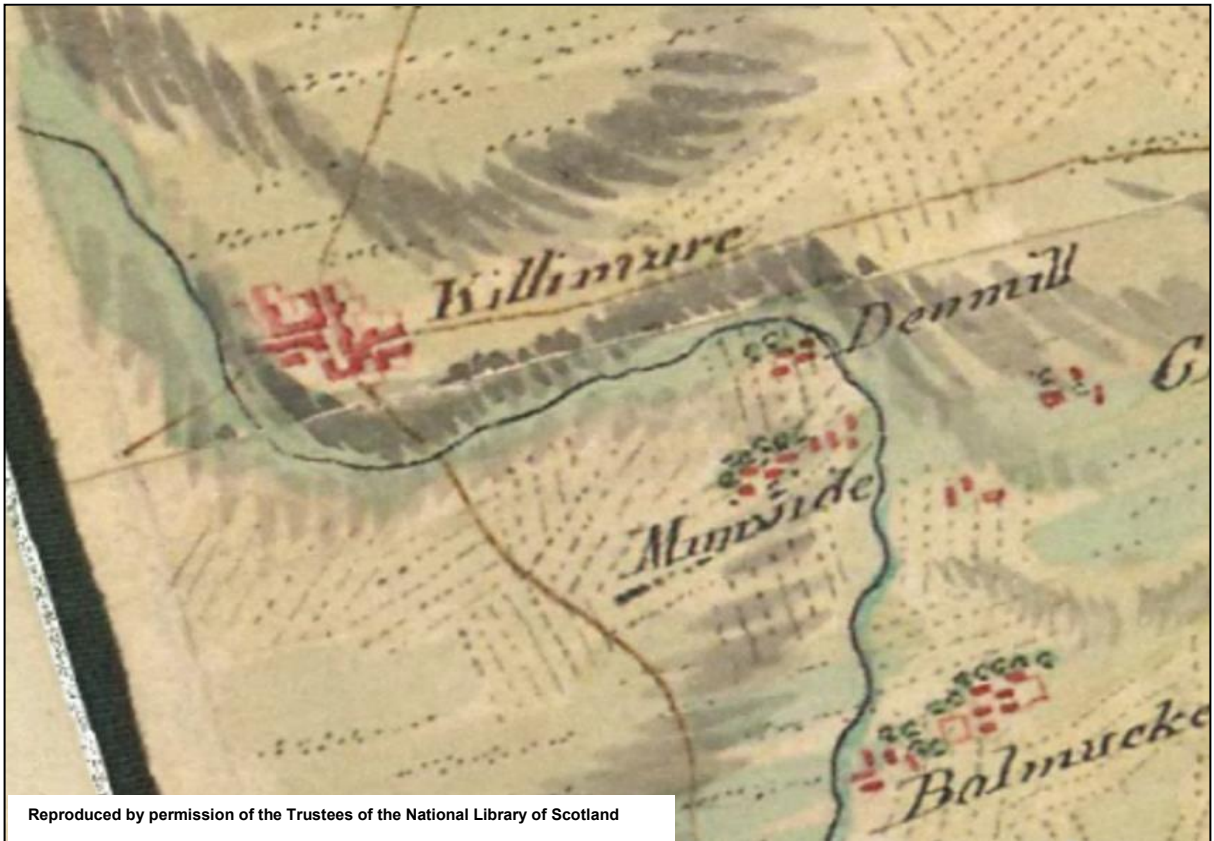
Figure 2a: Extract from Roy's Military Survey of Scotland (Highlands) (1747-52)

6. The earliest known depiction of the town is on Timothy Pont's map (1583-1614) where the town was labelled as 'Kellymur' (Figure 1a). Robert Gordon's slightly later map (1636-1652) shows a similar spelling for the town: 'Kellymuir' (Figure 1b). Neither of these maps indicates the size or layout of the town but merely depicts the place name. The first map to give an indication of the town's layout is William Roy's *Military Survey of Scotland: Highlands* (1746-1752) (Figure 2a) where what appears to be the present day High Street and Bank Street are depicted, indicating that many of the current buildings situated on these streets - including the Hook's Hotel (the focus of the development) and its associated grounds and outbuildings - date back to at least the mid-18th century (Figure 2a). The map also shows another change in the way the town's name was spelt, 'Killimure'.

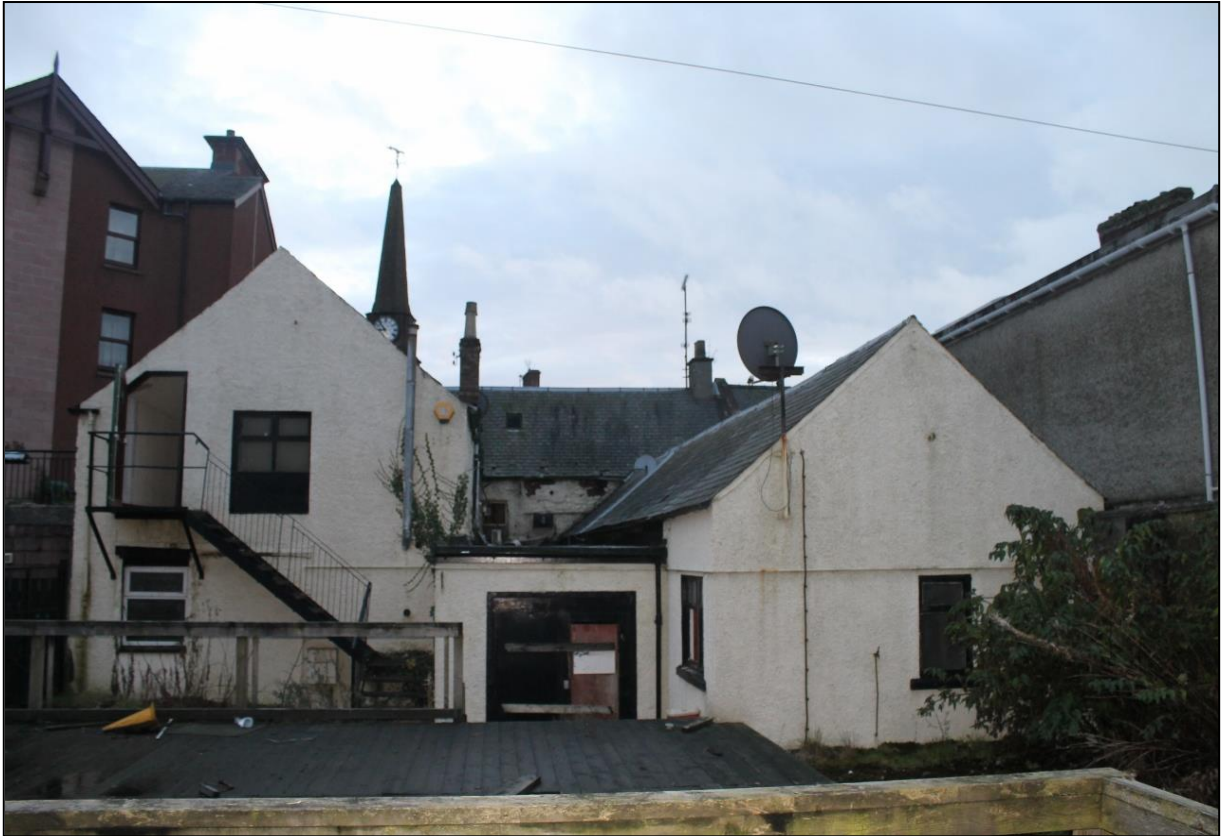
Figure 6a: North/Rear elevation and showing the modern central in-filling

17. From here it can be seen that the structure which fronts onto Bank Street is composed of snecked red sandstone, and that there is a single small skylight in the roof (Figure 7a). Three north-south oriented buildings extend back from the front, southern building: all have an exterior finish of pebble dashed render, painted cream. The east and west structures have pitched slated roofs, while the modern central structure has a flat felted roof (Figure 6a).

18. The building on the east (left) side (Figure 3 & 6a) is an original element: on the upper west facing elevation, snecked sandstone masonry is visible behind the cream paint and on the east elevation the snecked red sandstone has been left fully exposed (Figure 7b). Along the first floor west facing elevation are three modern dormer windows with catslide roofs which project about the original roofline.

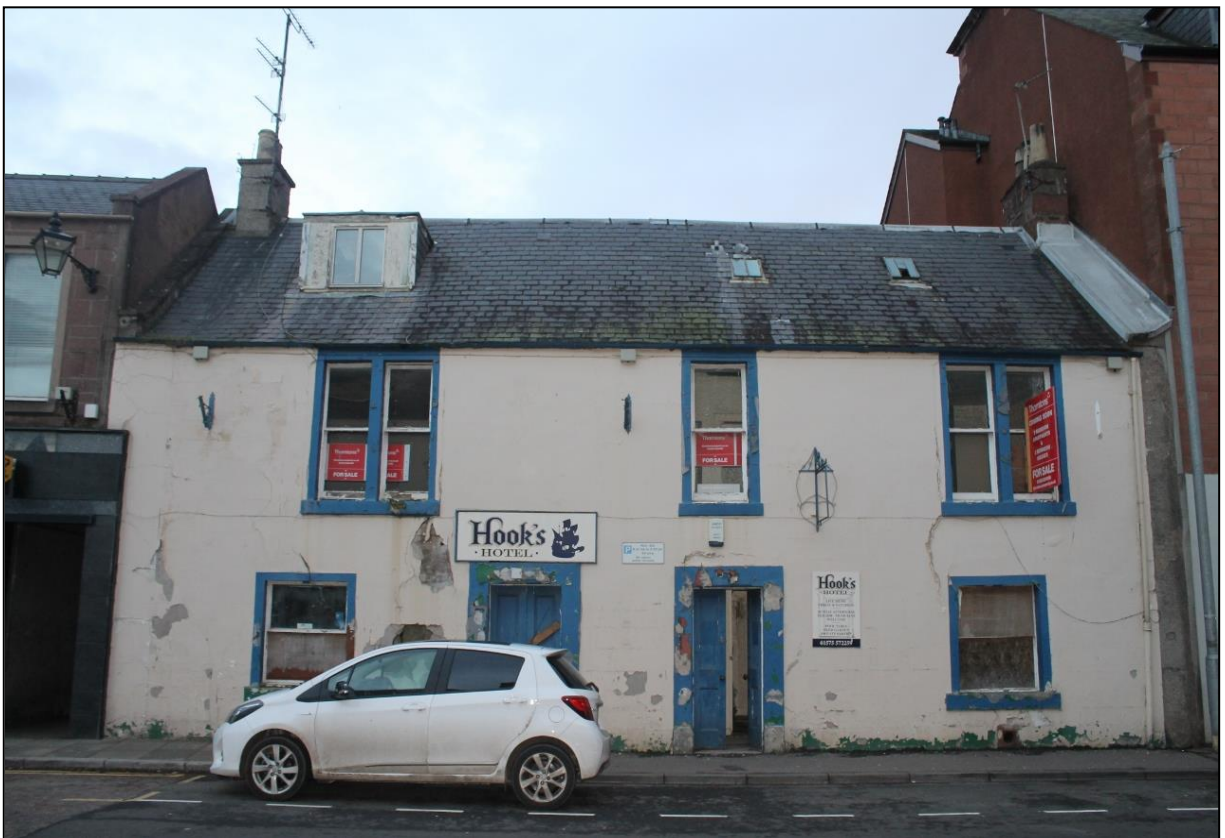
Figure 6b: South/Front elevation

14. The south, front elevation is three bays in length and measures approximately 13m in width. The structure comprises two storeys and an attic, and is treated externally with a cement render, painted cream and incised to give the illusion of ashlar blocks (Figure 6b). The ground floor has two broad sash and case windows, placed on the outer bays of the southern elevation, and two double panel doors, centrally located (Figure 3 & 6b).

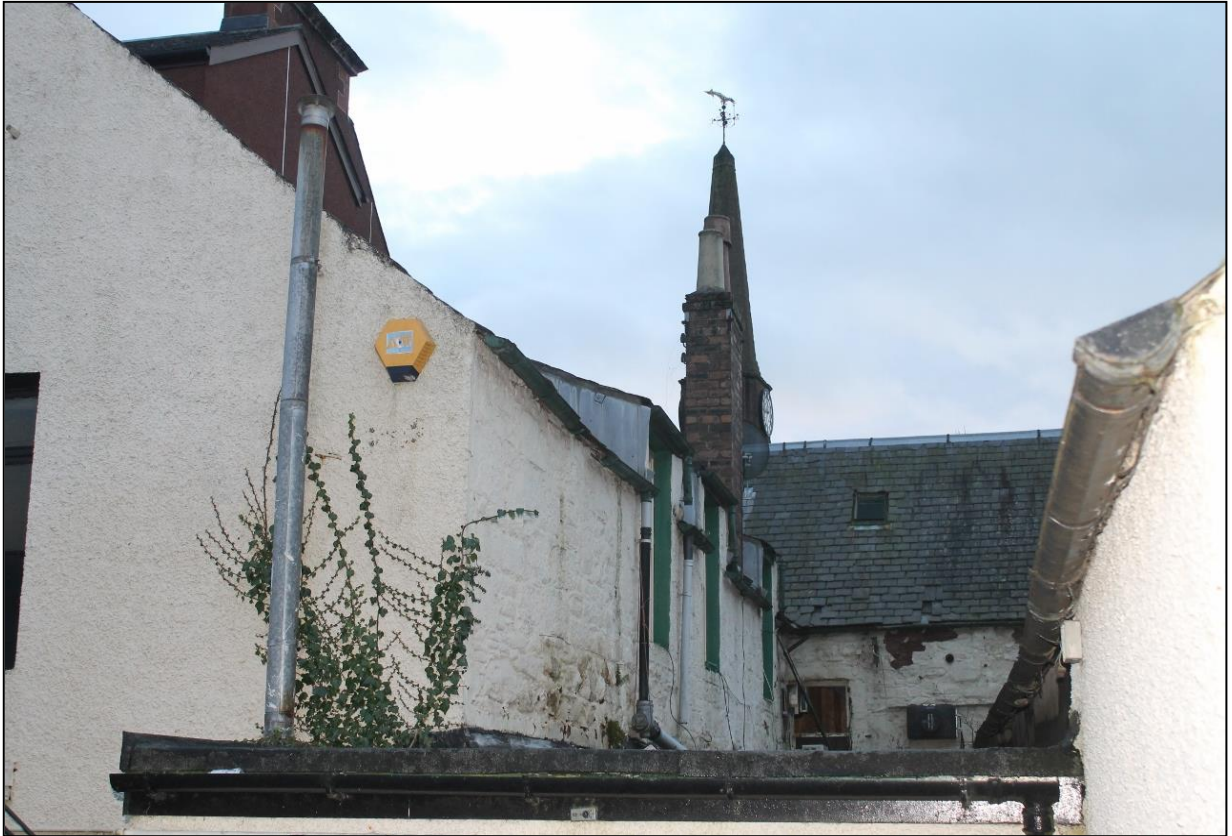
Figure 7a: Demonstrating the snecked red sandstone construction

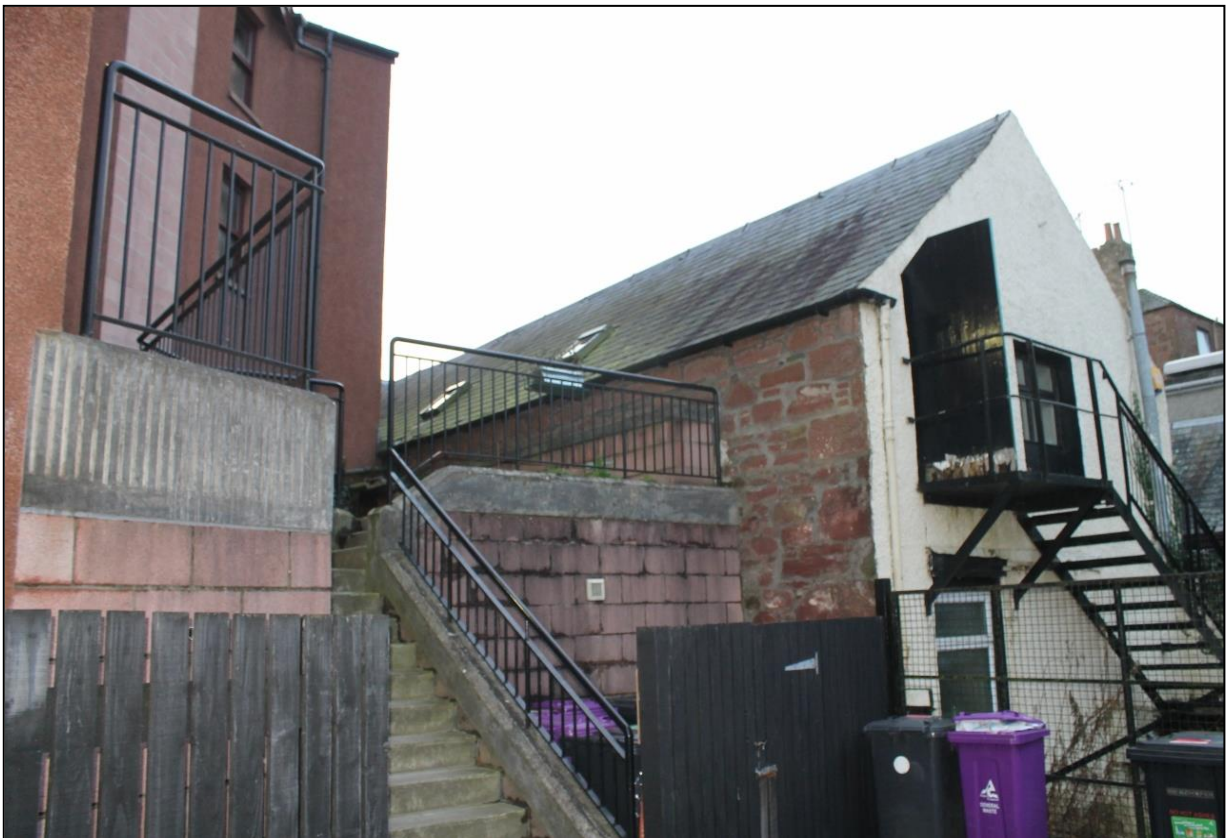
Figure 7b: Demonstrating the snecked red sandstone construction of the east elevation

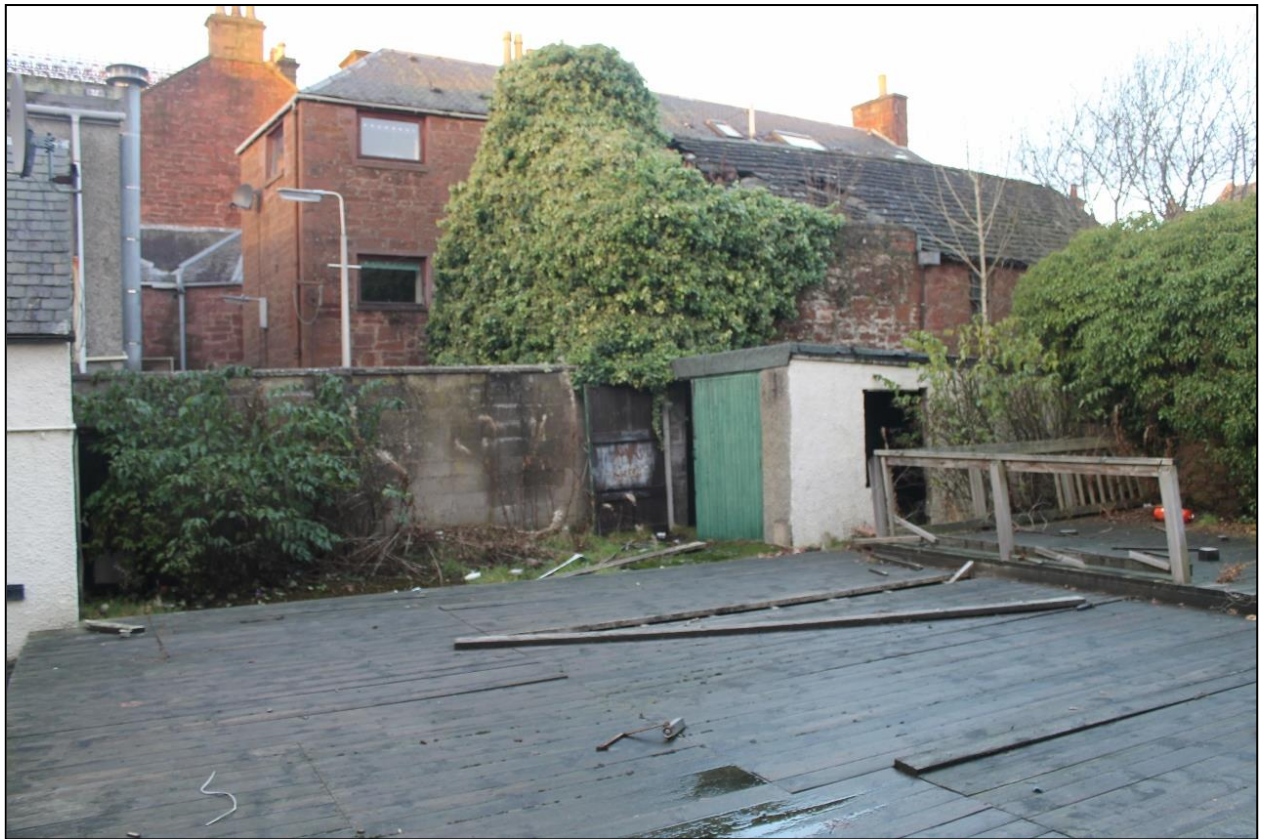
Figure 8a: Demonstrating the 'Beer Garden' area and structural features

21. The 'Beer Garden' measures approximately 17m by 15m and consists of wooden decking on a concrete base/floor. In the northwest corner there is a modern outbuilding measuring 3m by 4m with the south and east sides constructed using breeze blocks and the north and west sides incorporating the original snecked red sandstone walling. It has a flat roof with interior timber sarking and the exterior is felted. There is a section of wall, measuring approximately 7m in length, between the outbuilding and main building where concrete blocks have been used to infill an area where an earlier structural feature has been removed (Figure 8a).

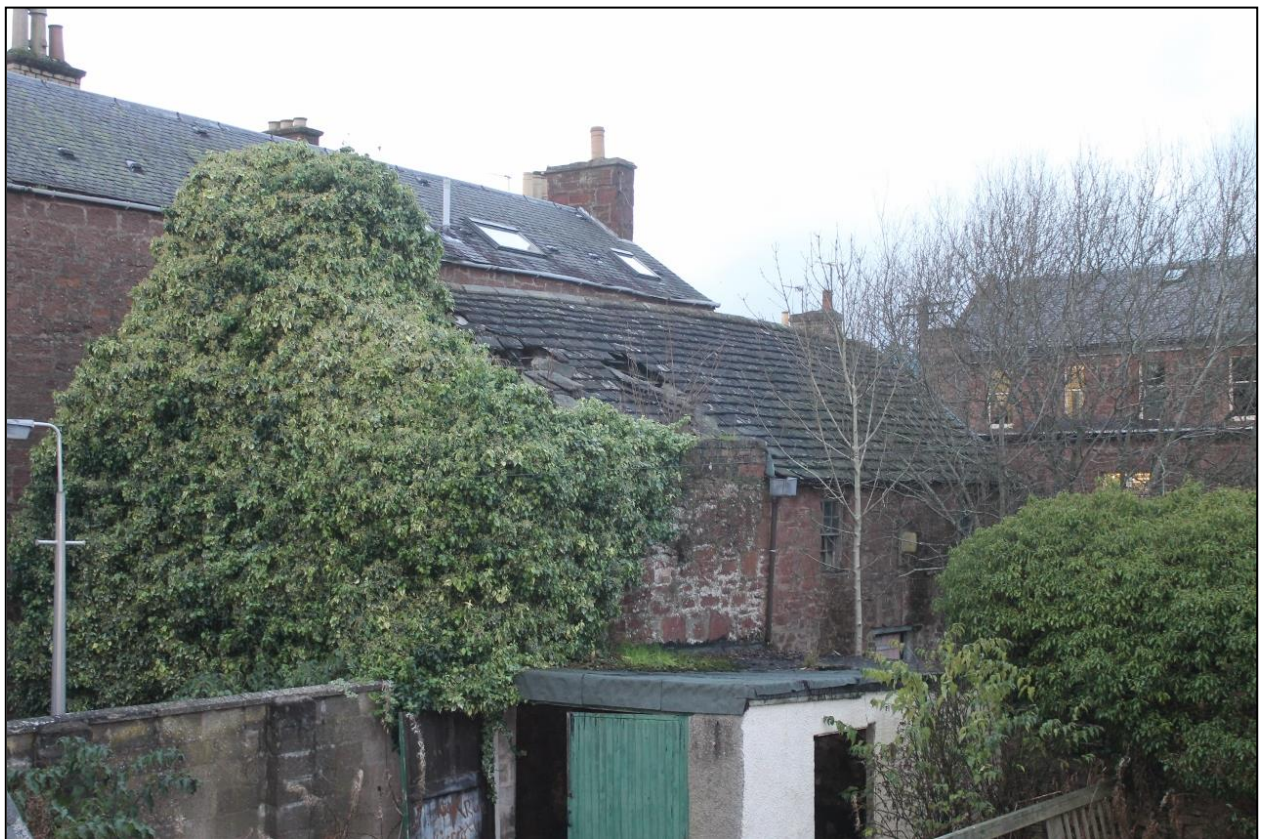
Figure 8b: East and south (ivy covered) elevation of the 'Warehouse' structure to the northwest of the development area

22. The 'warehouse' located in the northwest of the development area was not accessed due to safety concerns regarding the roofing. Therefore, all observations were recorded from the exterior. The structure is rectangular in plan and measures at least 3 by 1 bays in extent with a pitched stone tile roof and of snecked red sandstone construction which has been heavily weathered (Figure 8b). The south elevation could not be observed due to the growth of ivy (Figure 8b) although the survey provided by Peter Inglis Architects depicts the presence of a single window/access (Figure 3).

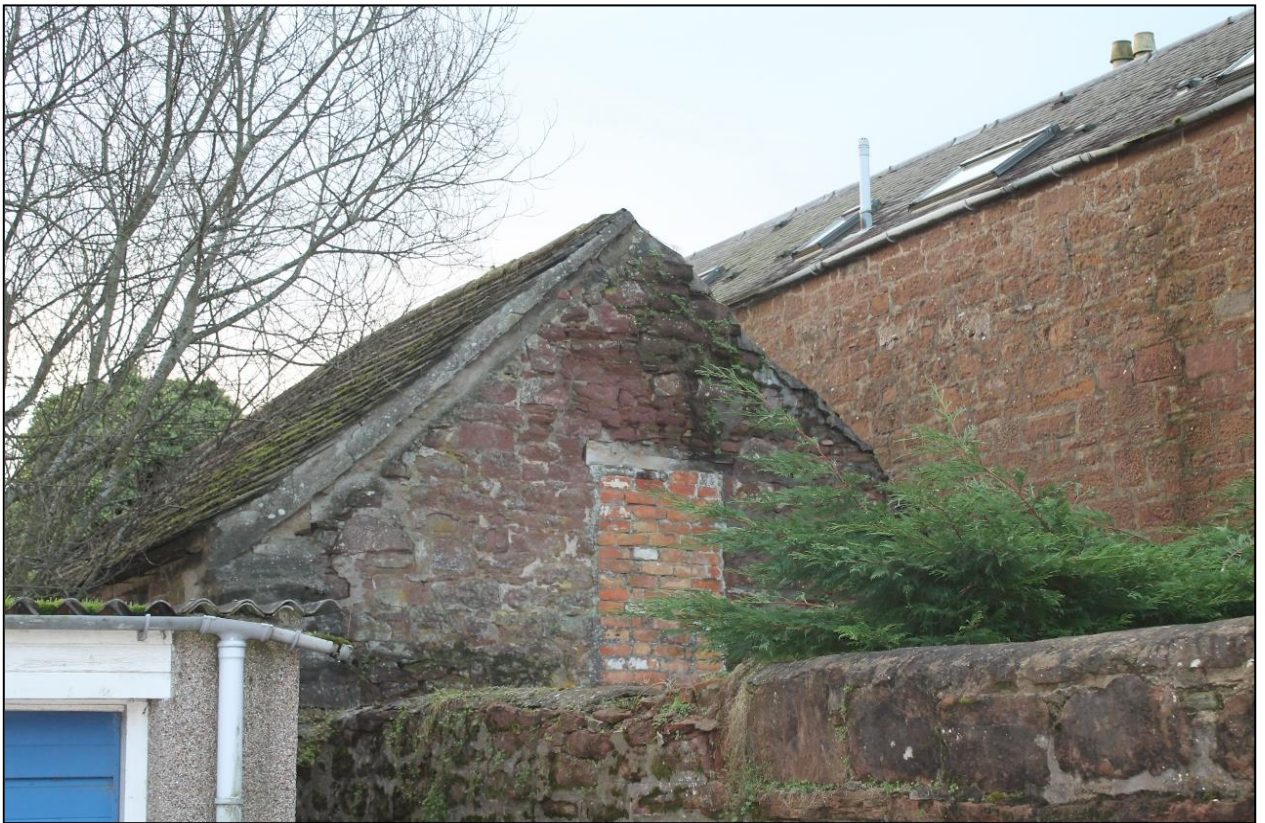
Figure 9a: North elevation of the 'Warehouse' structure to the northwest of the development area

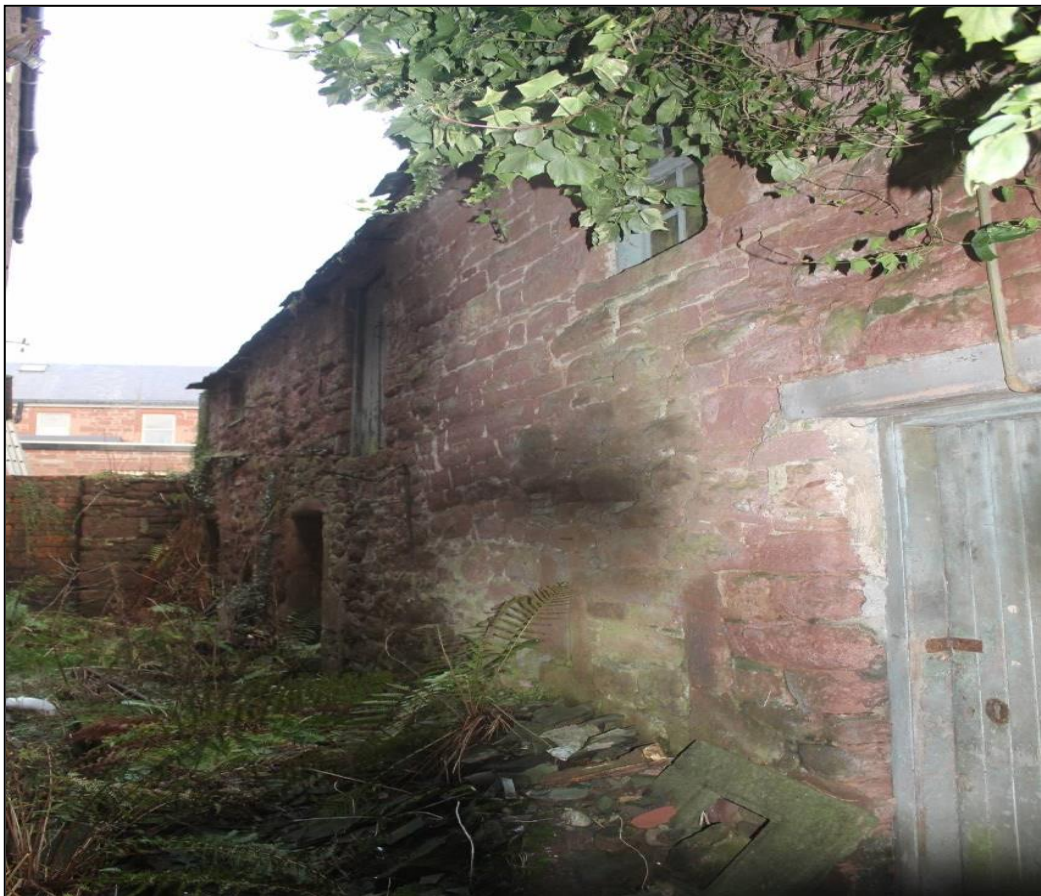
Figure 9b: West elevation of the 'Warehouse' structure to the northwest of the development area

24. At ground floor level on the west elevation (Figure 3 & 9b) there are two doorways, one located centrally and the other at the southern end. The door at the south end has a timber doorframe and lintel with its wooden door still in place while the centrally located door has a sandstone lintel and jambs. It was not, however, possible to observe if a door was present here due to the restricted access. There is one window at the north end and again it was not possible to observe any detail here due to restricted access.

25. On the first floor, there are two widows both of which would appear to comprise a single light subdivided into 6 panes. These are located at the south and north ends of the west elevation with a centrally located doorway or hatchway at first floor level with its wooden door still present (Figure 9b).

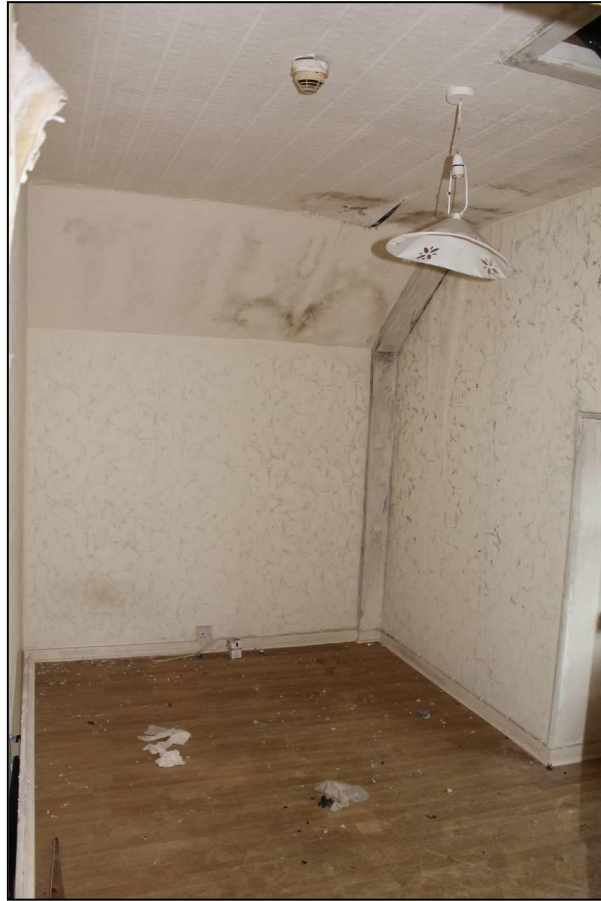
Figure 11a: Bedroom 1

27. The first floor is composed of 6 bedrooms and one bathroom and a small store cupboard (Figure 5). Bedroom 1 measures 3.5m by 2.1m by 2.5m with access to the roof space in the northeast corner: here, timber trusses and sarking visible. There is one two-light sash and case window in the north elevation that is visible from the exterior of the building. The walls are of plaster board with laminate flooring (Figure 11a).

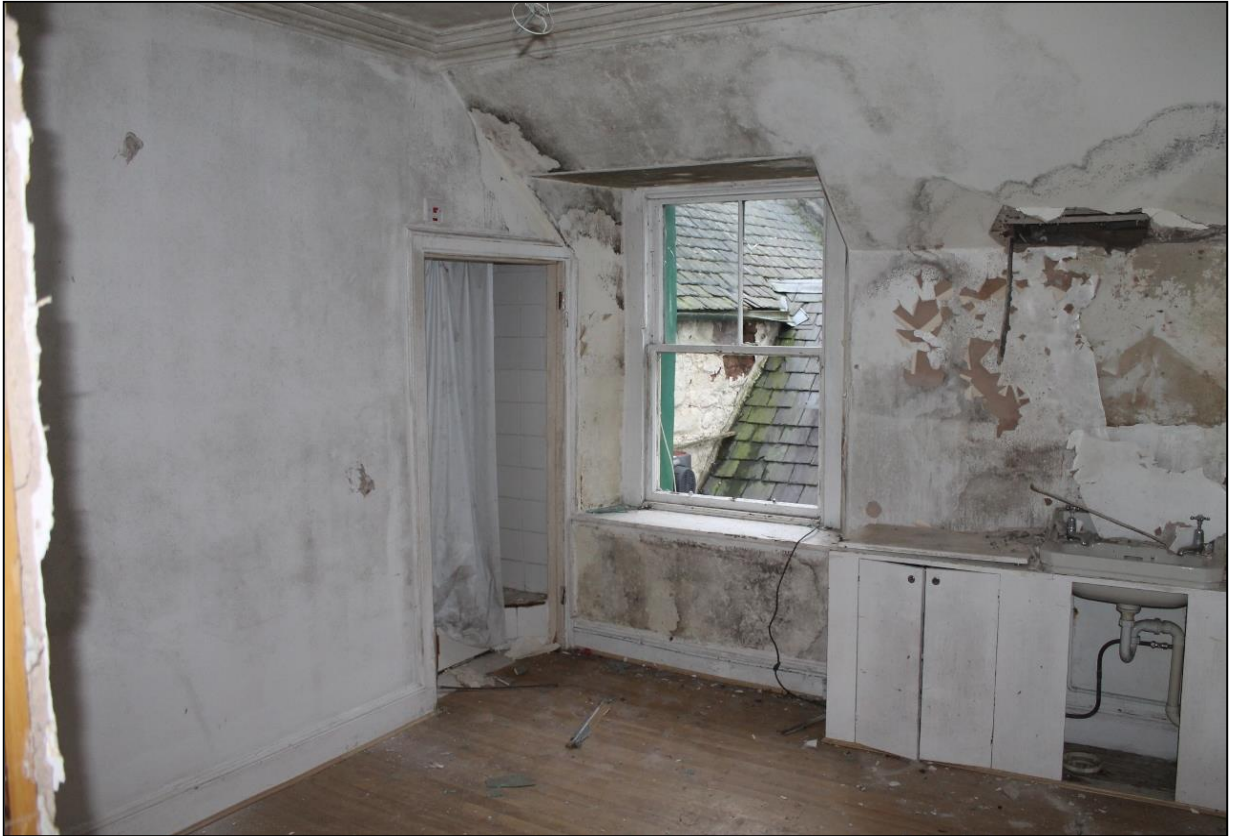
Figure 12a: Bedroom 4

29. Bedroom 4 is 2.9m by 3.4m by 2.5m with a shower in the southwest corner and a modern sink in the northeast corner. There is one two-light sash and case window on the west elevation. As with the previous bedrooms the skirting is timber and there is a cornice present, the floor is laminate with lath-and-plaster exposed on the west wall and the remaining walls formed of plaster board (Figure 12a).

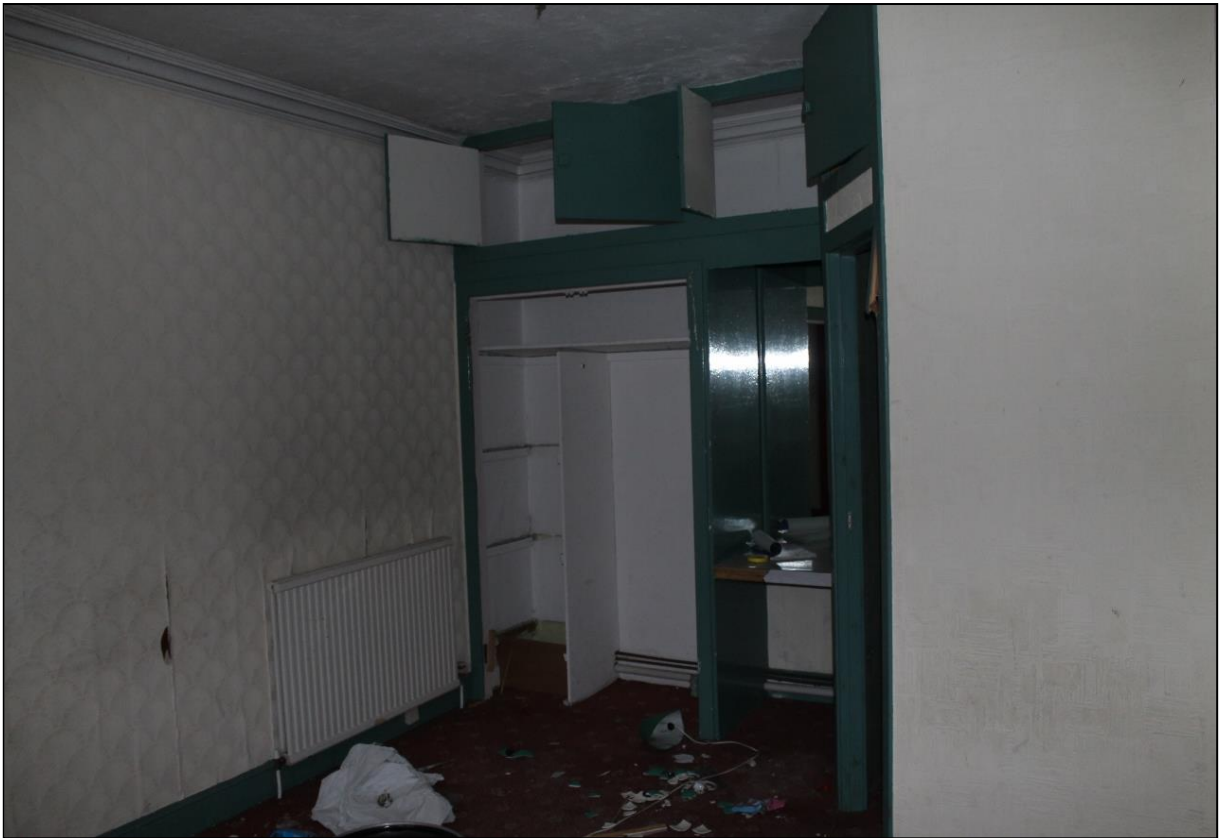
30. Bedroom 5 is 3.4m by 4.9m by 2.7m, wooden skirting and a simple plaster cornice. There is one window on the south elevation, comprising a two-light sash and case window with the original timber frame surviving (Figure 12b). On the north side of the room there has been the insertion of modern storage and a shower room (Figure 13a).

Figure 13a: Bedroom 5 and modern fittings

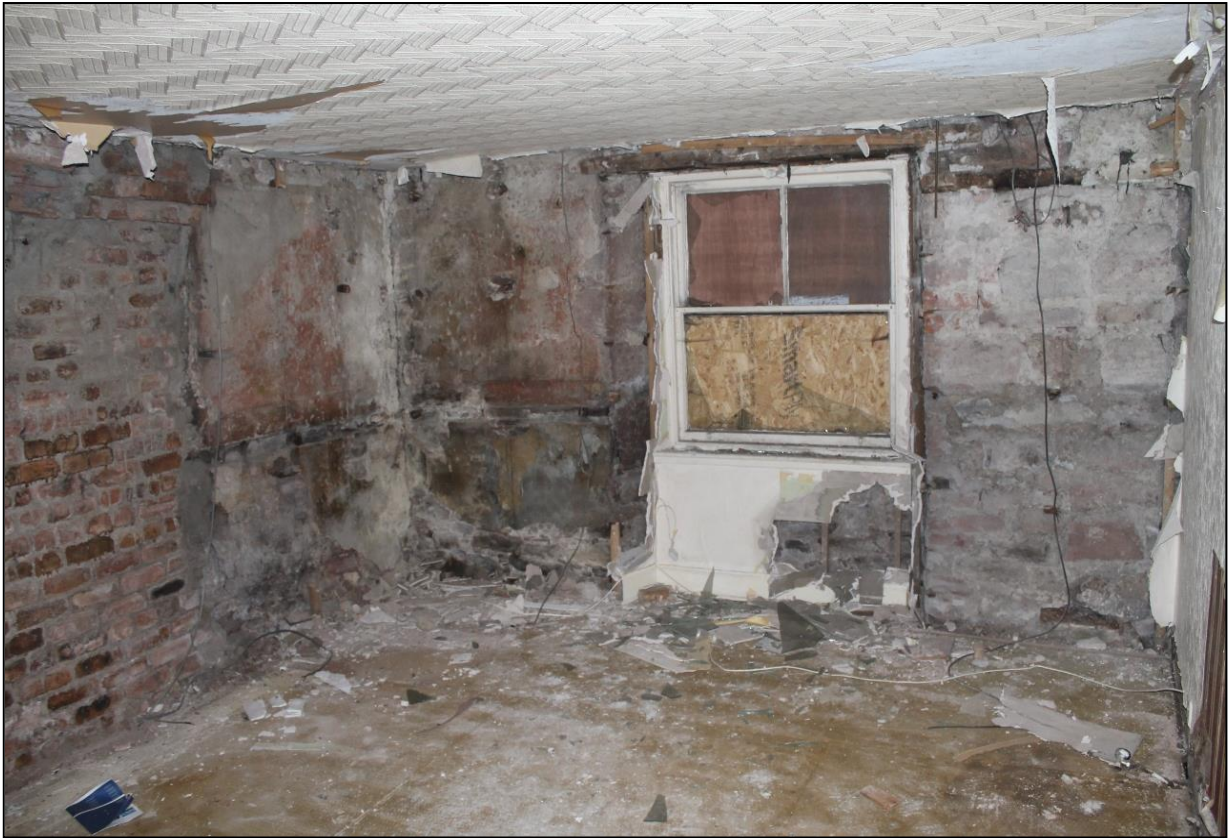
Figure 15a: Dining Area

36. The window on the south elevation of the dining area was blocked and therefore the room was pitch black. All observations were made by torchlight. The room measures 5m by 3.7m by 2.1m with the finishes removed, revealing the original snecked red sandstone masonry on the north, east and south walls (Figure 15a) with the west wall lined with modern plasterboard.

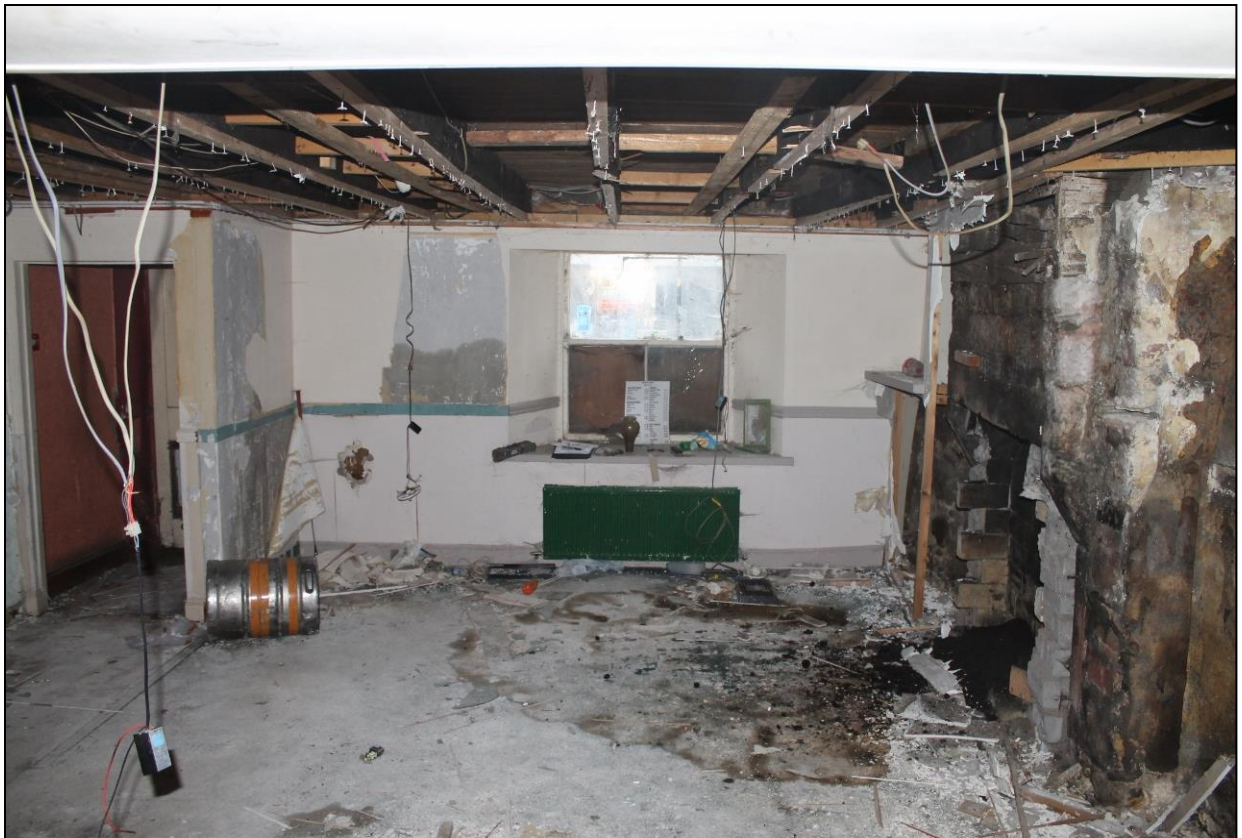
Figure 15b: Public Bar

38. The public bar and bar area were recorded as one area (Figure 4). The total length was 11.5m by 5.2m in the south end ('Public bar') and 3.5m at the north end ('bar area') with a height of 2.5m. Both rooms are in a poor state of condition with all modern finishes removed, revealing snecked red sandstone masonry on the west wall and central dividing wall between the bar and function suite (Figure 15b).

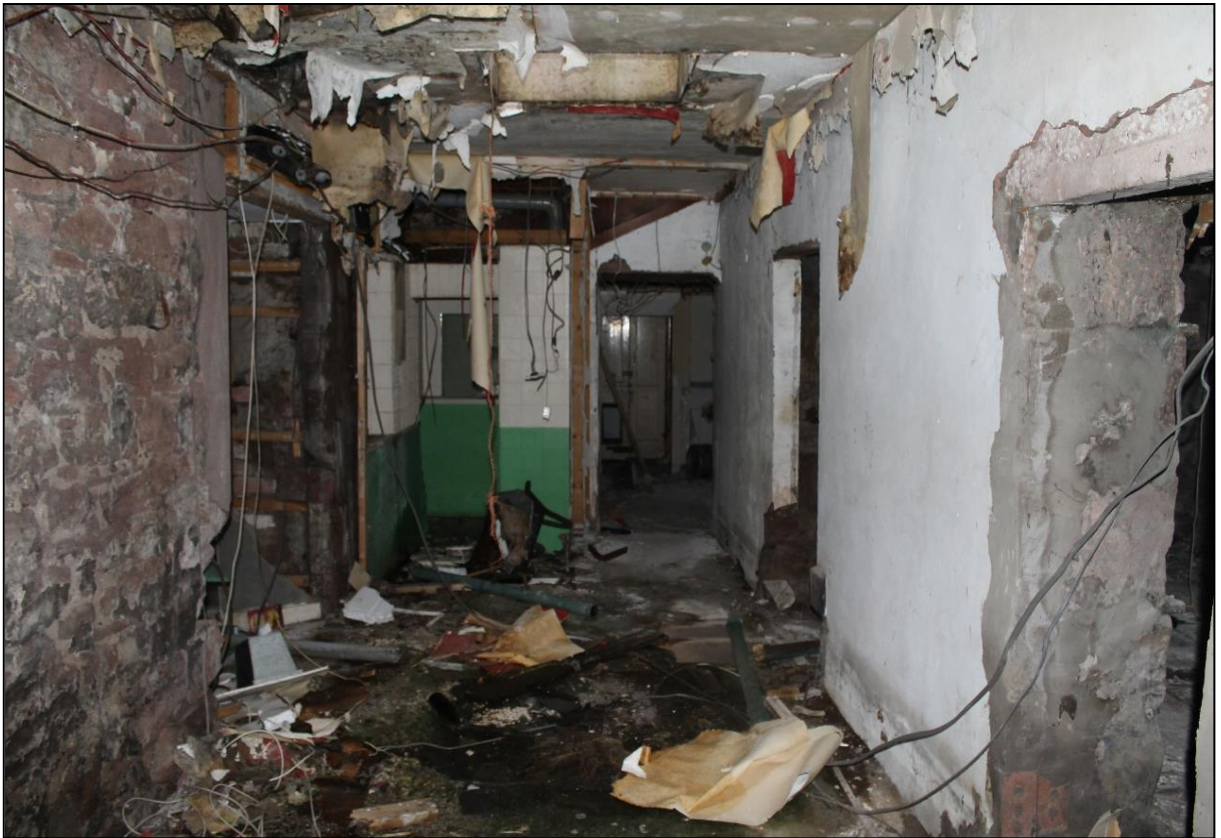
Figure 17a: Function Suite southern end

40. The function suite can be divided into two areas; a southern area forming a rectangle and measuring 2.4m by 7.3m by 2.7m, and a northern area forming a square and measuring 6.6m by 8.1m by 2.7m (Figure 4). As with the rest of the ground floor, the function suite is in a poor condition with all modern finishes removed with the snecked red sandstone masonry visible on the west and east walls and south dividing wall between the bar area (Figure 17a).

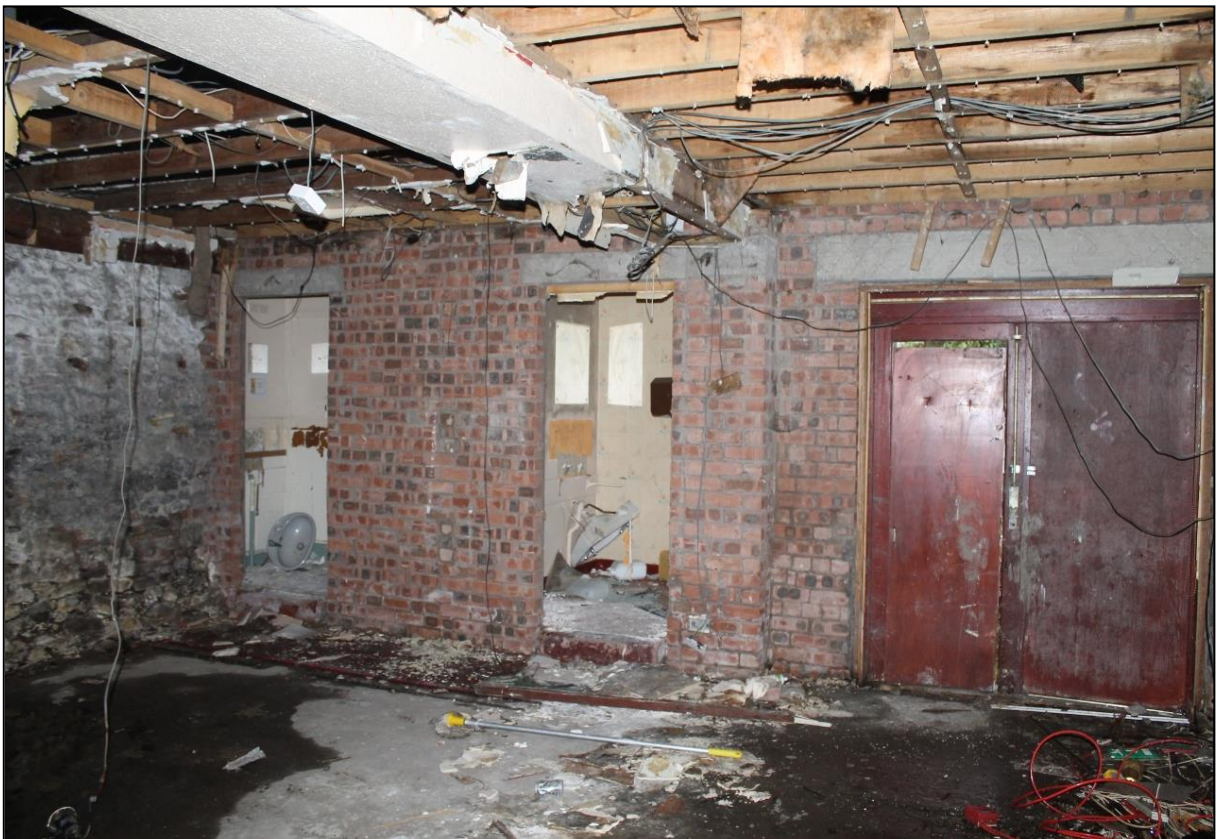
Figure 17b: Function Suite northern end

41. The central section of the ceiling/roof is a modern insertion with modern timber beams and trusses all visible. The north end of the function suite has a concrete floor with the southern area formed of wood which is very rotten and degraded. The far north wall is constructed of brick with a square extension; 4m by 3m and represents a toilet area and part of a modern extension (Figure 17b), the original snecked sandstone is visible on the west and east walls.

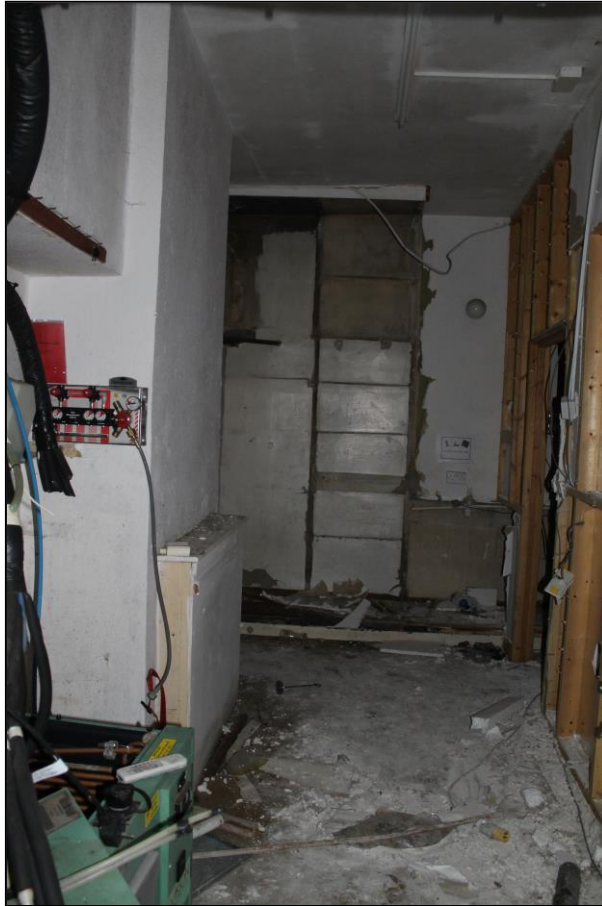
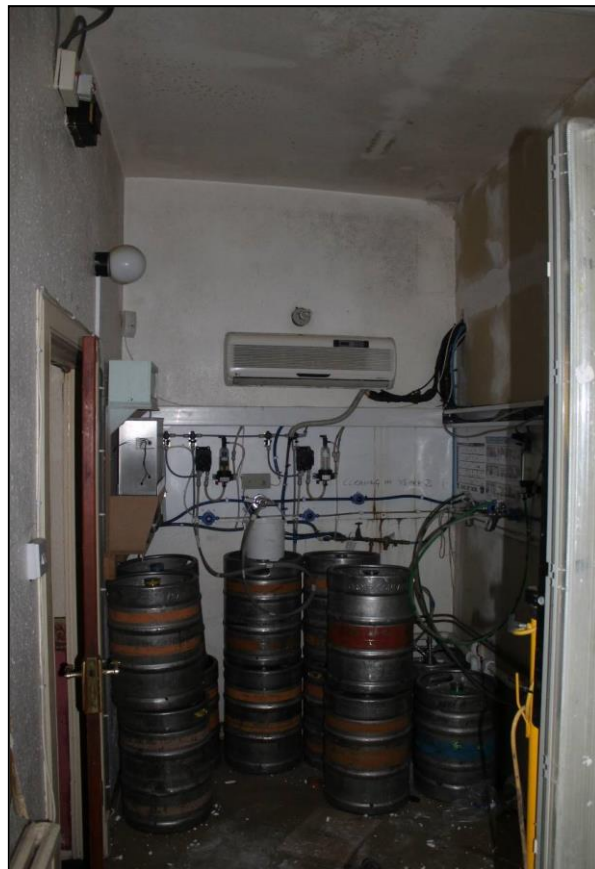
43. To the south of the pool room is the kitchen which is separated by the brick wall. The dimensions are 4.6m by 2.8m by 3m with the floor and walls all tiled. All the fixtures have been removed apart from the hood for the cooker ventilation (Figure 18b). There is a small storage area; 4.6m by 1.8m by 3.0m and a keg store; 4.6m by 1.8m by 3.0m that form the last two rooms. Both are modern additions with no original stonework visible, although there is a blocked fireplace on the north wall of the storage area

(Figures 19a & b).
