Girvan Mains, South Ayrshire: Archaeological Mitigation

Data Structure Report

by Claire Williamson
issued 8th February 2016
on behalf of Mr Andrew Young

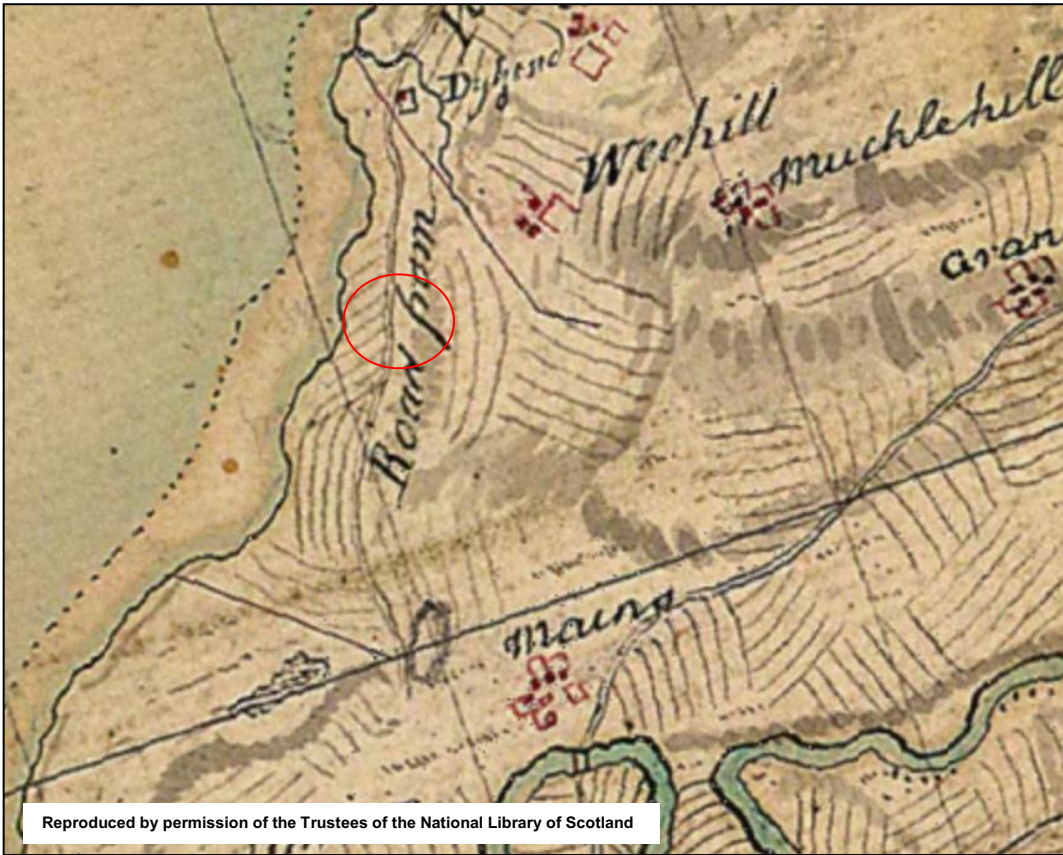
Figure 1: Roy's Military Survey (1752-55)

8. Cartographic evidence for the area suggests that the site was always open farmland during the post-medieval and early modern period. Roy's map of the Lowlands shows Girvan Mains Farm and its associated farmland (Figure 1) and both the 1st and 2nd edition Ordnance Surveys also show the farm and its associated fields. The boundaries of the field in which the site is located appear to be relatively unchanged from the mid-19th century onwards (Figure 2).

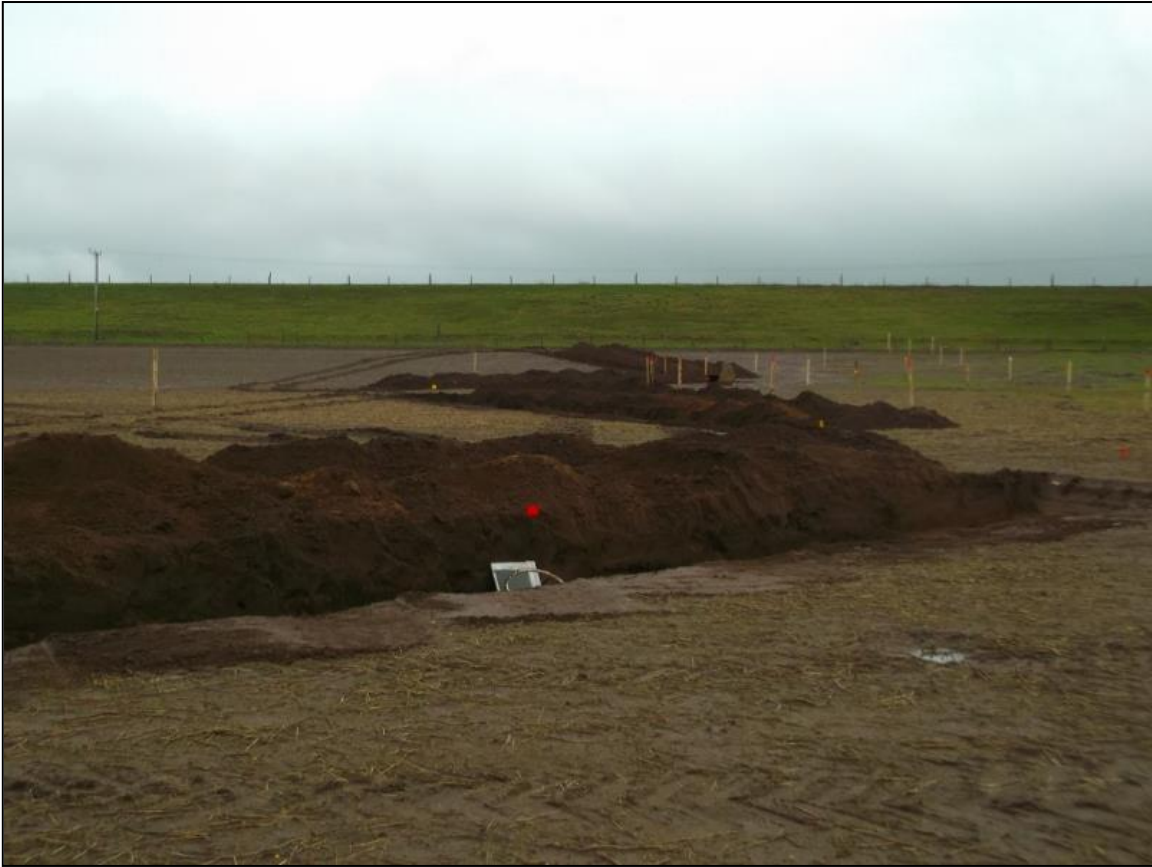
Figure 4: General shot of site from the west, showing the ground sloping up to the east

10. The proposed area was located within agricultural land that had been previously ploughed and used for a potato crop. The ground had a gentle slope downwards from east to west (Figure 4).

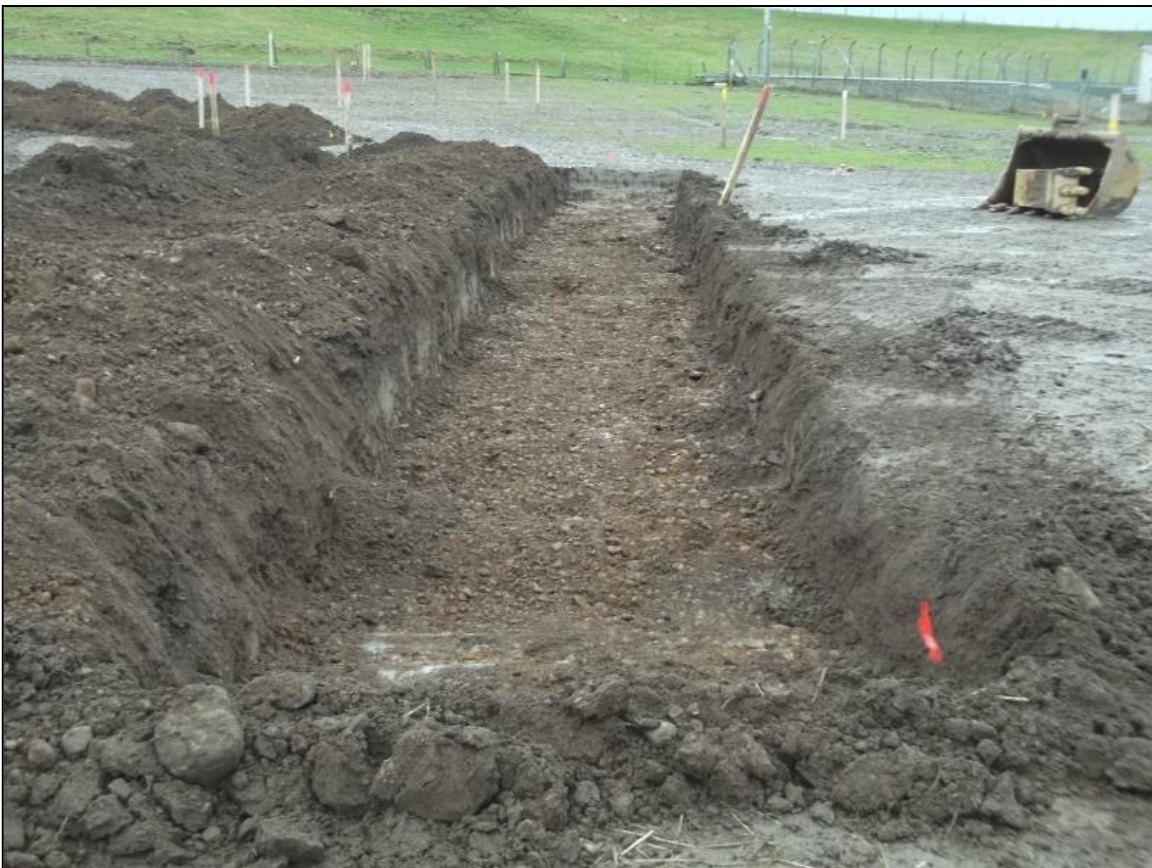
Figure 5: Trench 3 from the north-northwest showing subsoil (002)

17. The subsoil across the eastern half of the site consisted mainly of (002) with a small area of (003) in the northeast corner. (002) comprised a moderately compacted mottled light to mid-orange sandy clay and gravel (Figure 5); while (003) comprised a firmly compacted mid-orange brown sandy clay with frequent small stone inclusions.

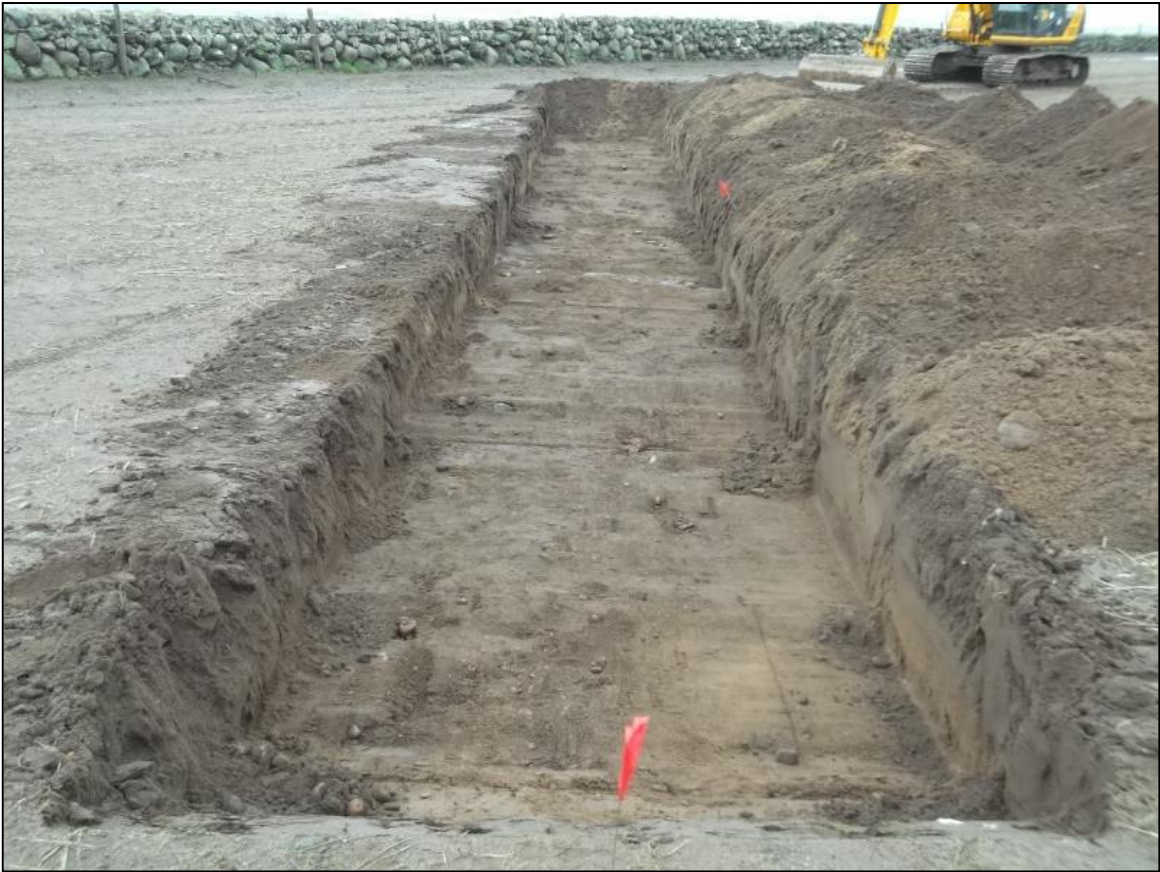
Figure 6: Trench 1 from the south-southeast showing subsoil (004)

18. Across the west, the subsoil was mainly characterised by (004) with some patches of (005). (004) comprised a firmly compacted dark red orange sand with occasional small stone inclusions (Figure 6), and (005), a loosely compacted dark red brown rounded beach gravel.

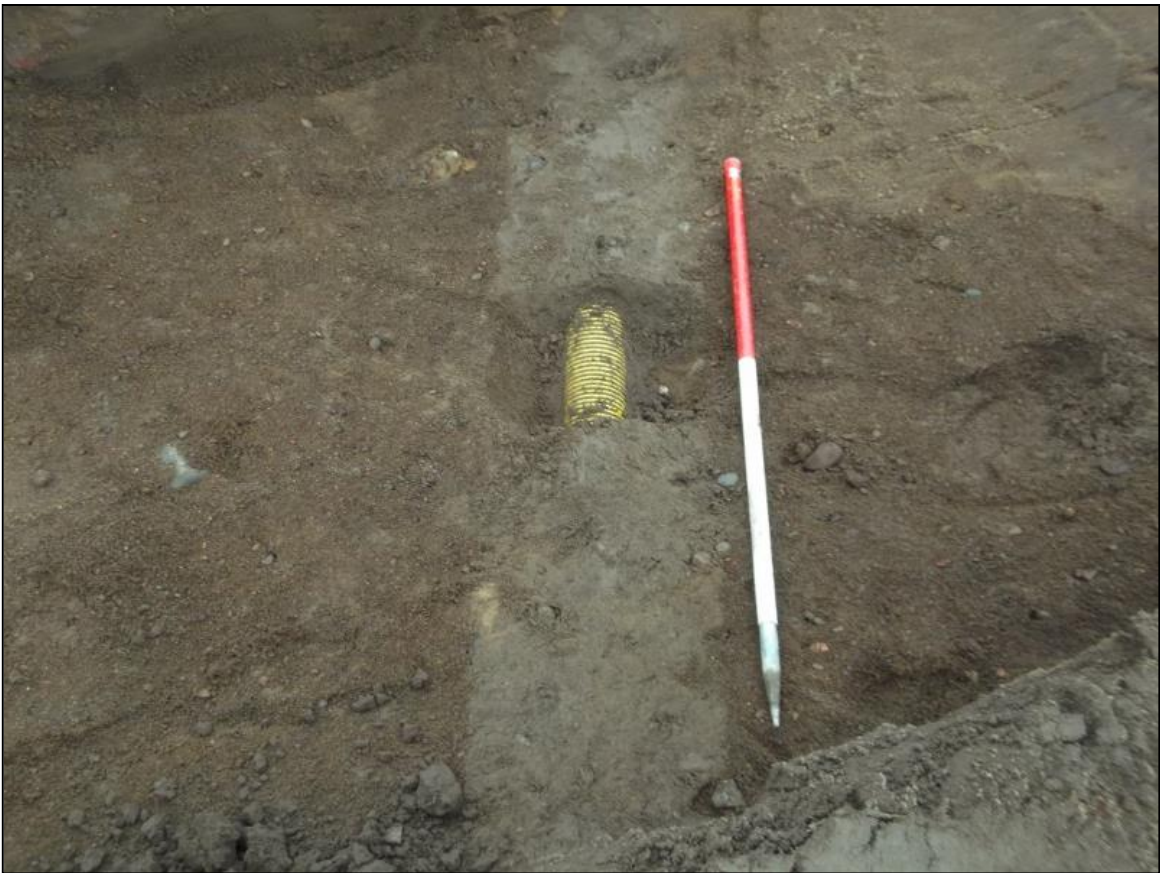
Figure 7: Field drain (006) in Trench 1 from the west

19. The only archaeological feature present in the area was field drain (006), which sat in Trench 1 at the western end of the site (Figure 7). This consisted of a linear shaped feature running east to west measuring 0.35m wide and 130mm deep. The cut had gradual sloping sides and a flat base and was filled by (001). It contained a circular yellow corrugated plastic pipe that was also perforated, and which measured 0.1m in diameter.

21. No significant archaeological features were uncovered during the course of the archaeological works. The only feature present was field drain (006) at the western end of the site. The very modern nature of the drain itself indicates that it was inserted at some point during the late 20th century, or even in the early 21st century, likely during the ground's use for potato crops. The natural slope of the ground places the western end of the site at the lowest-lying point, explaining why water would have been more prone to gather at this location. That the drain did not continue into the next trench along, Trench 2, also indicates that this would have been a localised area of flooding, occurring badly enough in this location to warrant the need to take action.
