**Livingston Retail Park,
West Lothian:
Archaeological Mitigation**

Data Structure Report

issued 7th March 2016

RATHMELL  
ARCHAEOLOGY LTD

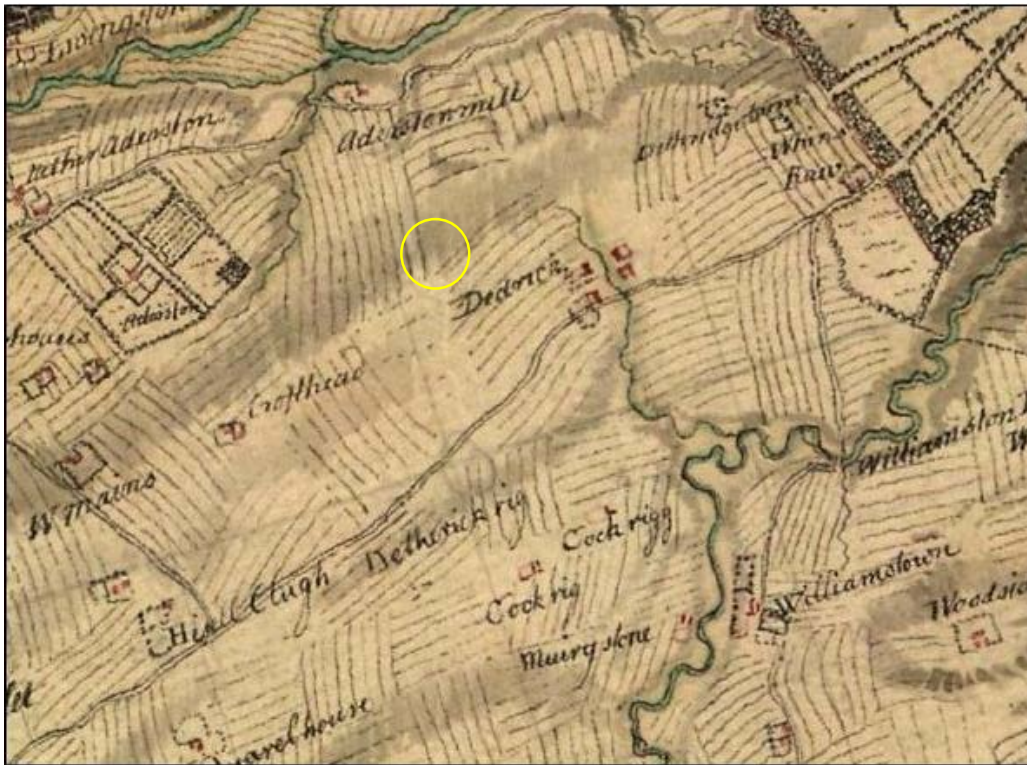
Figure 1a: Roy's Military Survey of Scotland, 1752-1755, Lowlands

6. Examination of historical mapping shows the site first as open, then as enclosed agricultural land. William Roy's Military Survey of Scotland (1752-1755) (Figure 1) shows the area as cultivated fields. Several farms or small dwellings surround the development area. 'Andersonmill' is to the north, 'Dedrick' to the immediate east and several other small dwellings to the south and west. The village of 'Livingston' is also depicted on Roy's survey further to the north on the other side of River Almond.

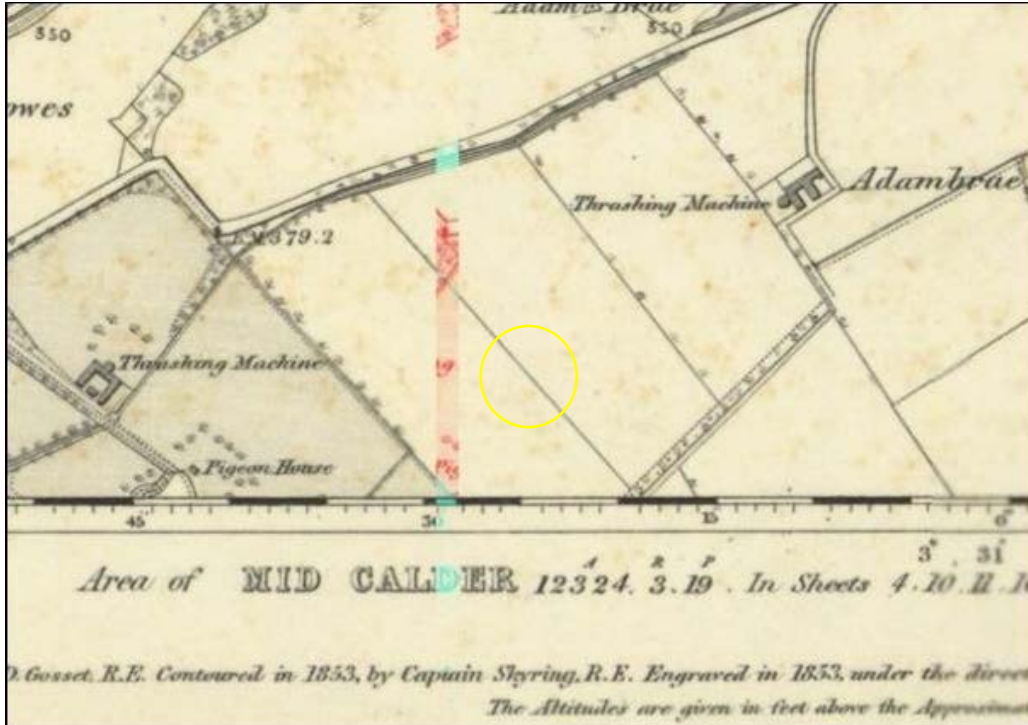
Figure 1b: 1st edition Ordnance Survey, 1853, Edinburghshire, Sheet 4

22. From the mapping evidence the development area would appear to be relatively unchanged from the middle of the 18th century onwards. The hedgerow crossing the site could be observed in the 1st and 2nd edition Ordnance Survey maps but the excavated trenches showed that the fields on either side of the hedgerow had been heavily disturbed.

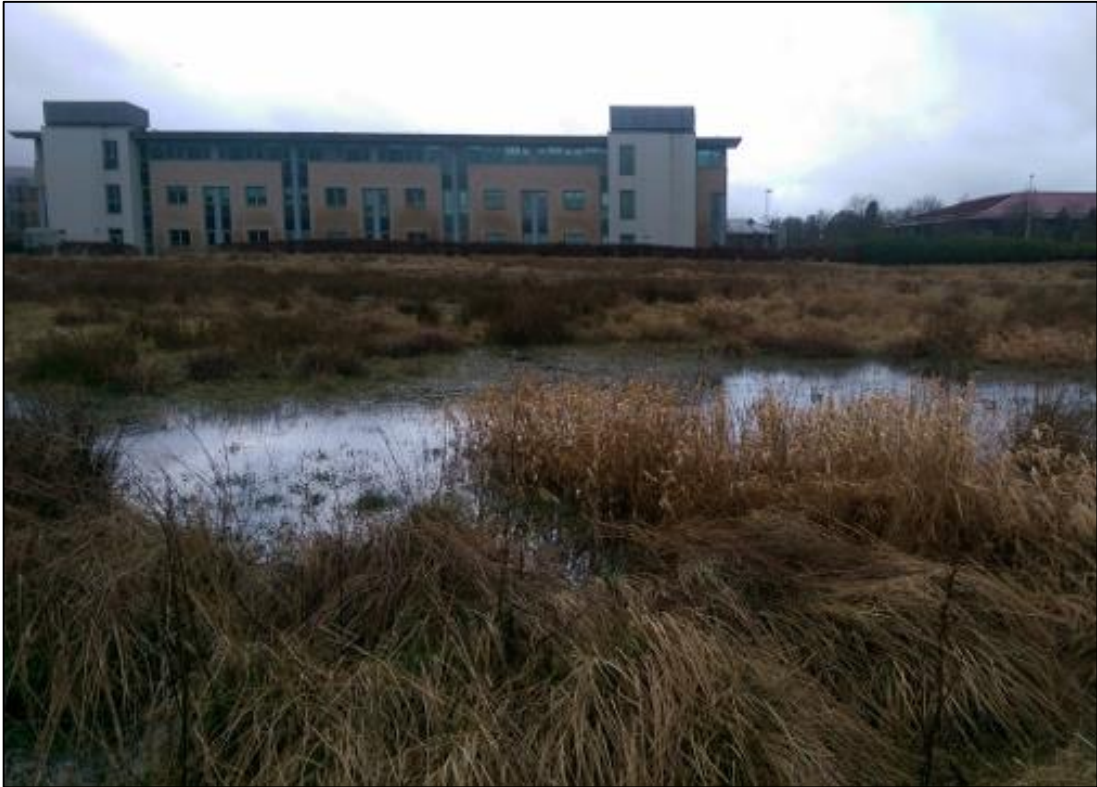
14. The site had been divided by a northwest to southeast running hedgerow and both fields appeared to be heavily waterlogged with areas of standing water in the central and north eastern parts of the site. The trenches revealed that the fields had suffered extensive disturbance in recent years with the topsoil in the north eastern field (001) and in the south western field (003) consisting of moderately compacted mid brown or grey-brown silty clay with occasional inclusions of modern detritus such as building materials or refuse.

Figure 3a: Pre excavation view of the site from the north showing waterlogged area.

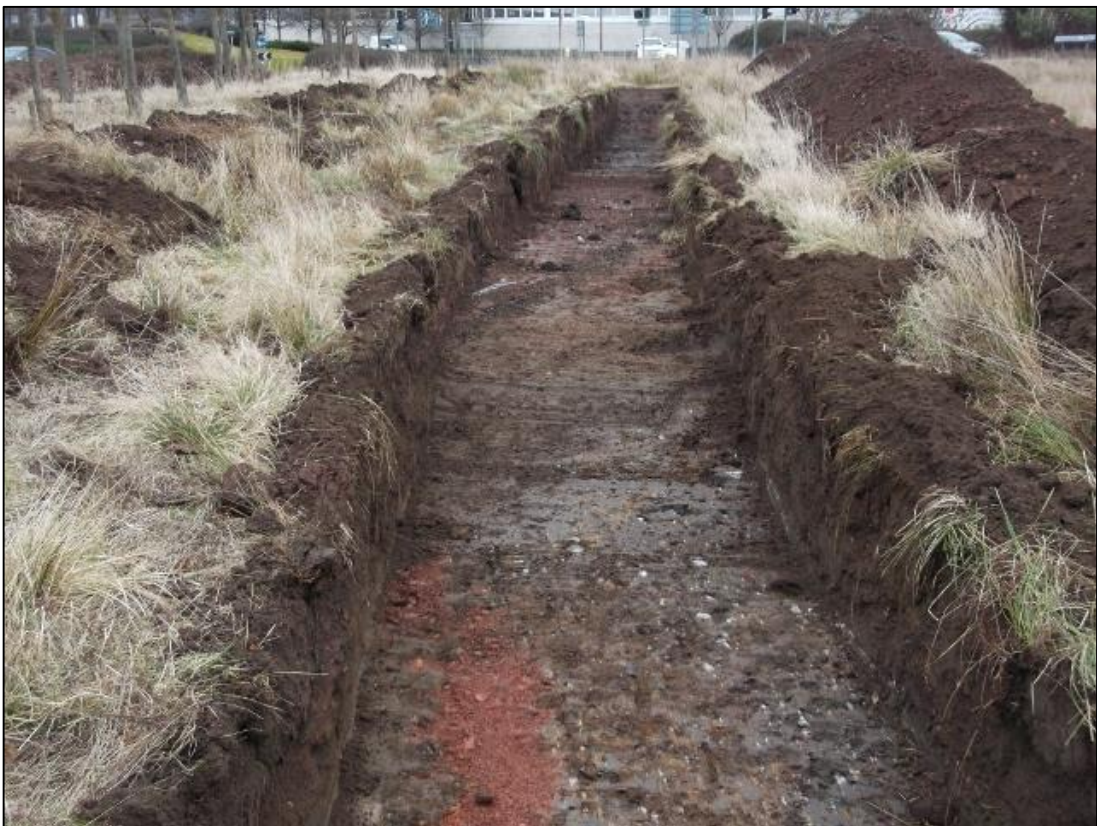
15. These topsoil layers overlay substantial spreads of made ground (002) and (005) which comprised of very firmly compacted mid brown-grey silty and yellow-brown clay with very frequent inclusions of modern detritus, mainly building material though sherds of post medieval and modern pottery were recovered from this layer in Trench 13 These layers were present in a number of the trenches (Figure 3b), particularly near the edge of the site, and had a thickness range of between 0.3-1.2m.

Figure 3b: View of Trench 1 from the southwest showing made ground (002).

24. The site then seems to have been used to store material which was probably a mixture of topsoil and subsoil from the construction of nearby buildings with waste from that construction process. This deposition of this material or made ground, (002) and (005), served the purpose of raising the level of the fields, particularly near the surrounding roads.

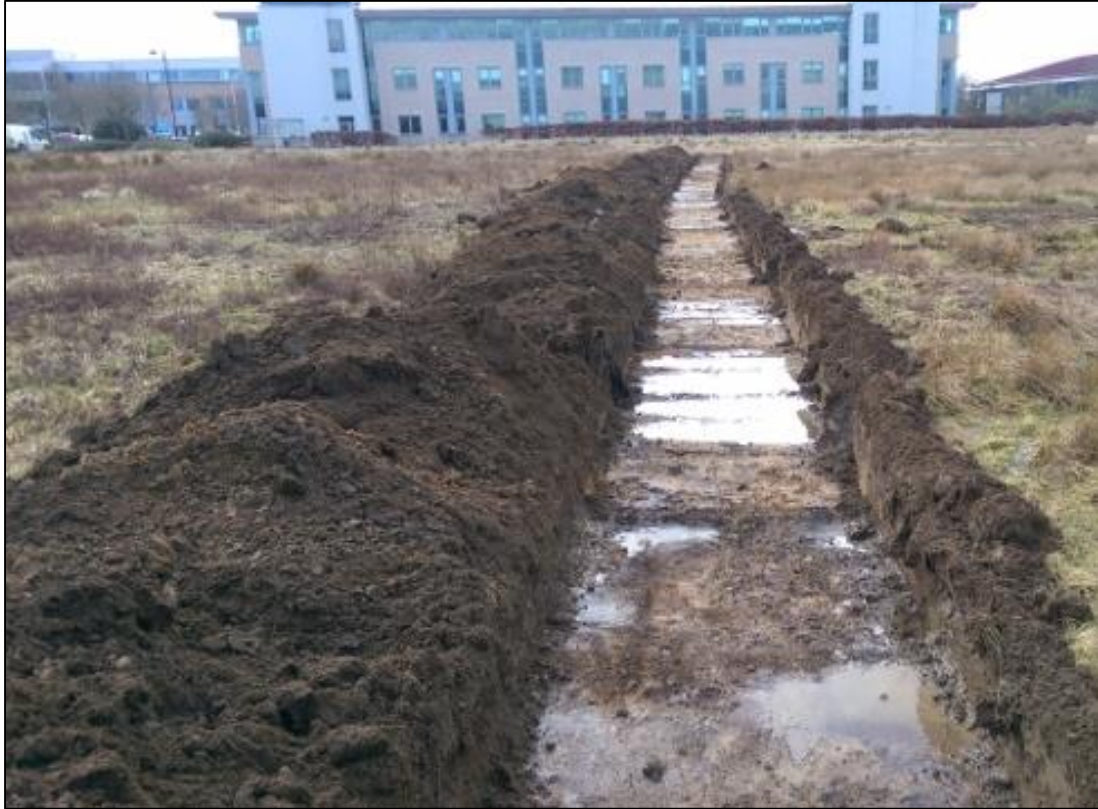
16. Underneath these layers of made grounds was the naturally occurring subsoil (Figure 4a). For most of the site the subsoil (006) consisted of firmly compacted light to mid orange brown clay with moderate to frequent small to medium sized stone inclusions. Within Trench 6 the natural subsoil (004), which had suffered from disturbance, consisted of firmly compacted light brown clay with occasional small sub rounded stone and construction and building material inclusions.

Figure 4a: View of Trench 9 showing the natural subsoil (006) from the east.

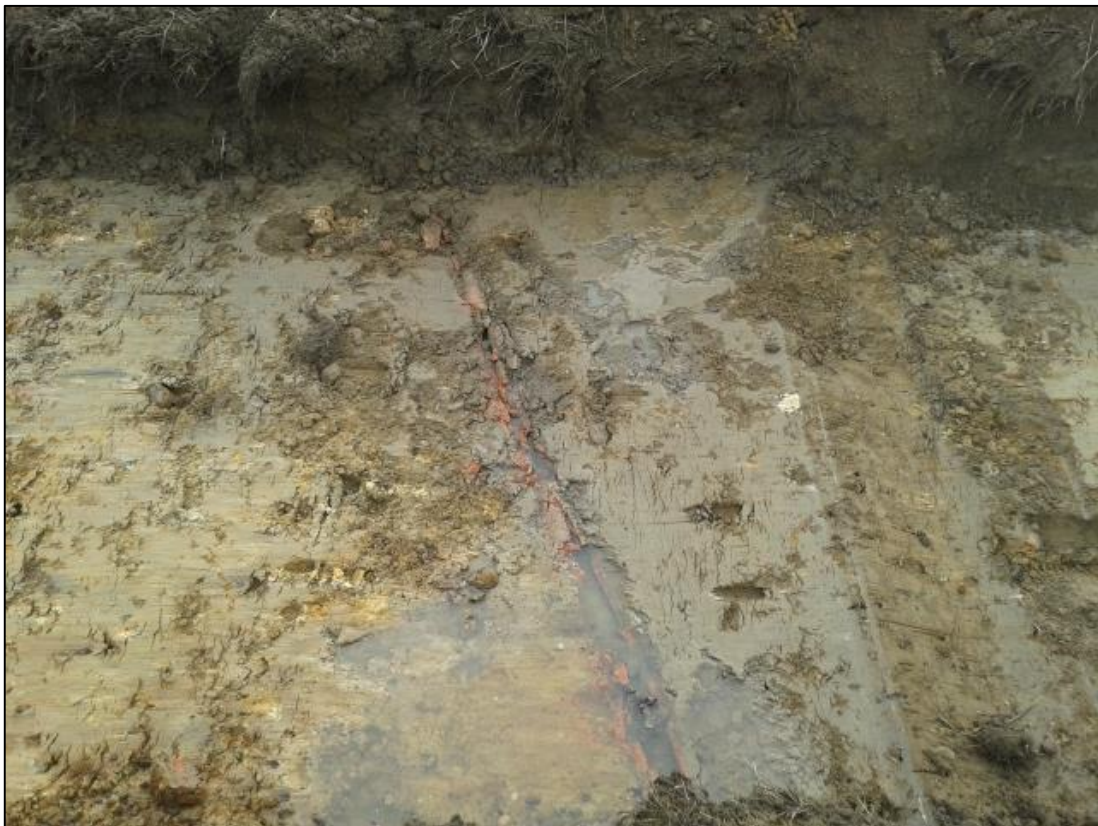
19. A series of ceramic drains (Figure 4b) were identified in trenches 7, 9 and 10 which were spaced 5m apart and were orientated in a northwest to southeast direction. The pipes were orange/buff coloured with a diameter of 0.2m diameter. The pipes were placed within narrowly cut trenches which were filled with mid to dark grey clay with no inclusions. The width of trench was 0.25m but the depth was unknown as the pipes were still in use with water still flowing through them so they could not be fully excavated without flooding the

Figure 4b: View of ceramic drain (007) within Trench 9 from the north.

25. Modern service trenches, (009) and (010), were cut into this made ground and may have been an attempt to use these fields as an outlet for the drainage from the surrounding buildings and roads within the Business Park. The earliest features identified were the series of ceramic field drains cut into the natural subsoil which most likely dated to the 19th or early 20th century. Only a few of these drains seemed to have survived and it seems likely that many were destroyed at the same time the original topsoil was removed.
