Bell's Brae Refurbishment, Edinburgh: Archaeological Mitigation

Data Structure Report

Author(s)	Peter Klemen		
Date of Issue	1 st May 2018	Version	1.0
Commissioning Body	Sundial Properties		
Event Name	Bell's Brae Refurbishment, Edinburgh		
Event Type	Building Inspection and Monitoring		
Event Date(s)	November 2015 – April 2018		
Rathmell Archaeology Code	RA175091	OASIS Ref:	Rathmell1-240711
Location	United Kingdom: Scotland: Edinburgh		
NGR	NT 24161 73970	Parish	Edinburgh
Designation(s)	None

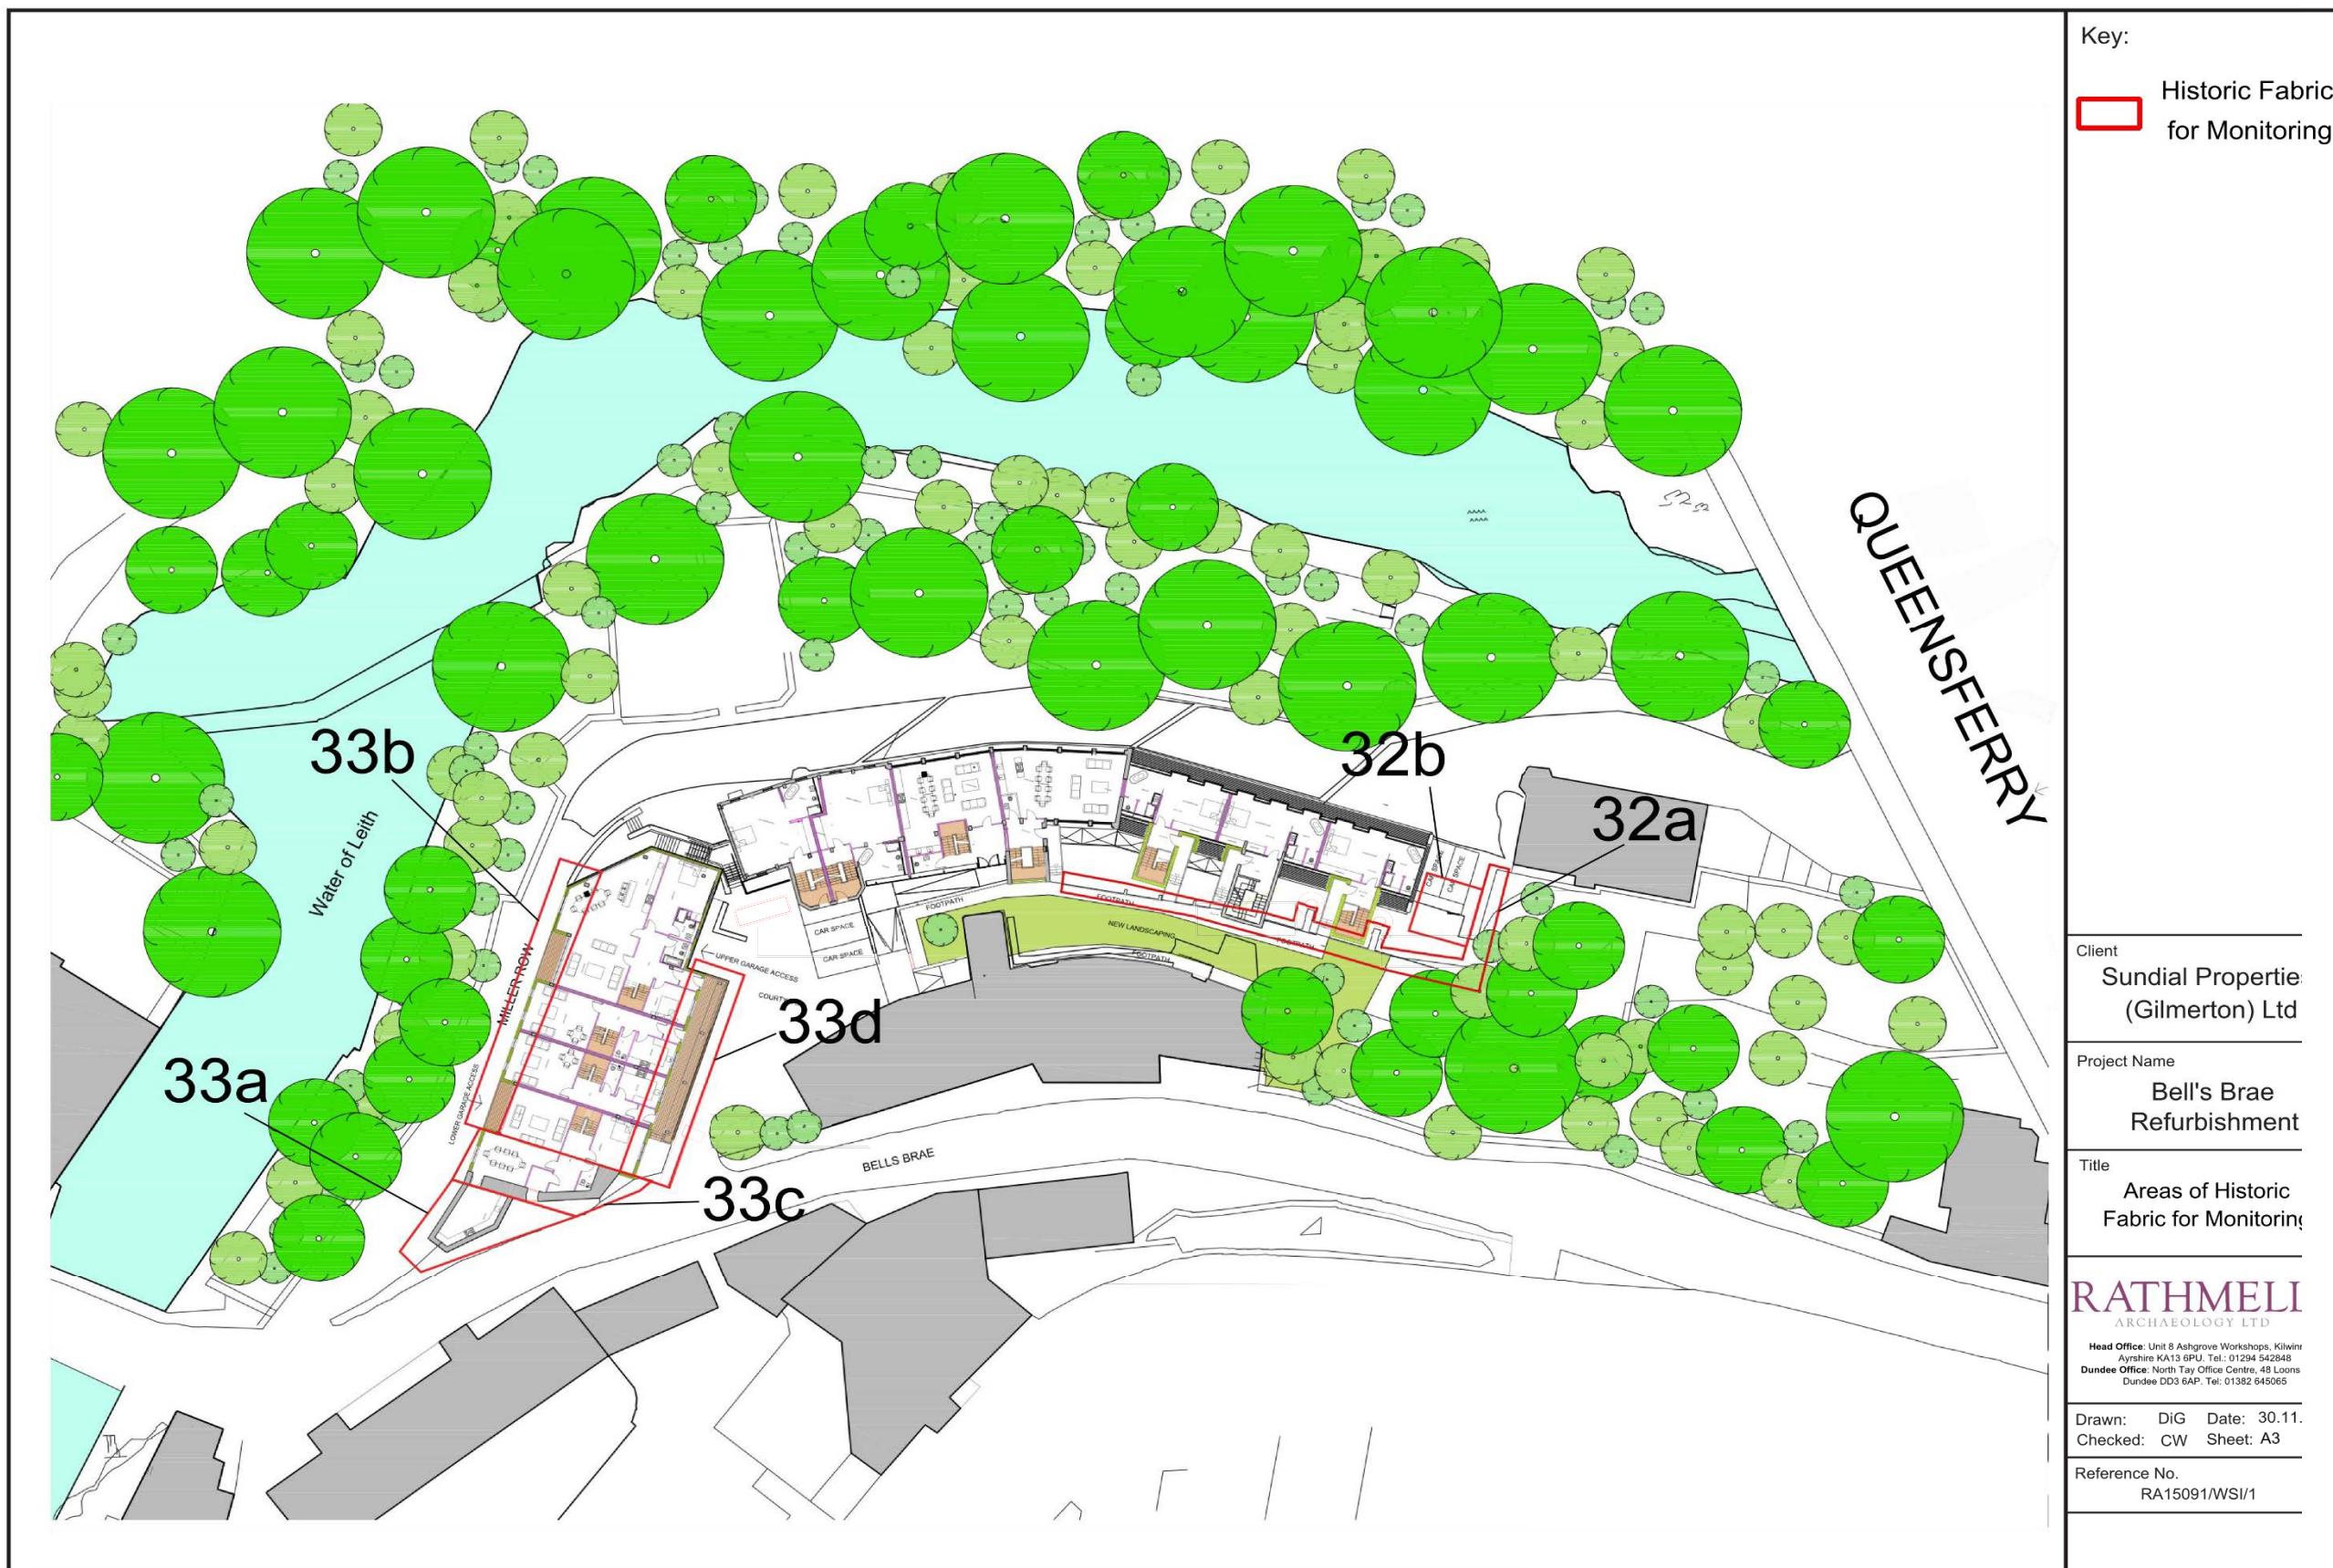
43. No.10 Bell's Brae identified and potential historic elements are (Figure 3):
 - a. Retaining structures to south and east (definite)
 - b. Freestanding external walls to east forming fire exit (probable)

44. For the Garage block/office suite they are (Figure 3):
 - a. Whole of retaining wall and wedge shaped structure at southern end (definite)
 - b. Sections of southern gable, abutted by wedge shaped structure at southern end (definite)

- c. Lower courses of western wall (definite and probable)
 - d. Retaining structures to east below ground level (probable)
45. For both properties there was a need to consider the potential for historic elements to have been obscured by modern finishes. On balance, other than at the specific locations identified at No.10 Bell's Brae this was very unlikely given the character of the build. For the garage block/office suite there was a higher potential given the clear evidence of retained historic fabric on both floors.

Figure 3: Plan of the development showing the areas of original structural fabric and monitored areas.

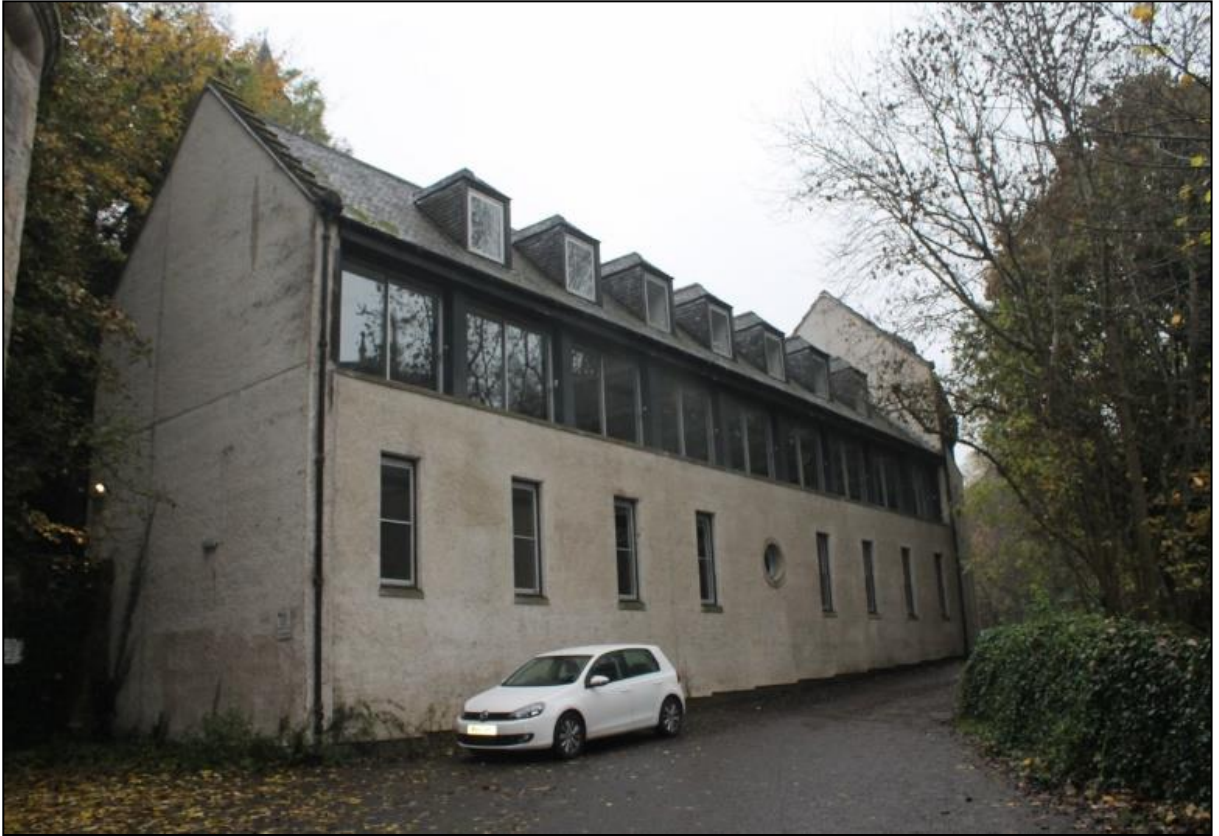
modern double glazed windows and metal surrounds (Figures 4a & 4b) surmounted on a brick basal course. Of note the eastern gable of No.10 Bell's Brae stops short of the historic gable location, which is identifiable through a cobble detail in the adjacent parking bay and in the line of the enclosure wall for the fire exit.

Figure 4a: East end of No.10 Bell's Brae, note brick basal courses under render.

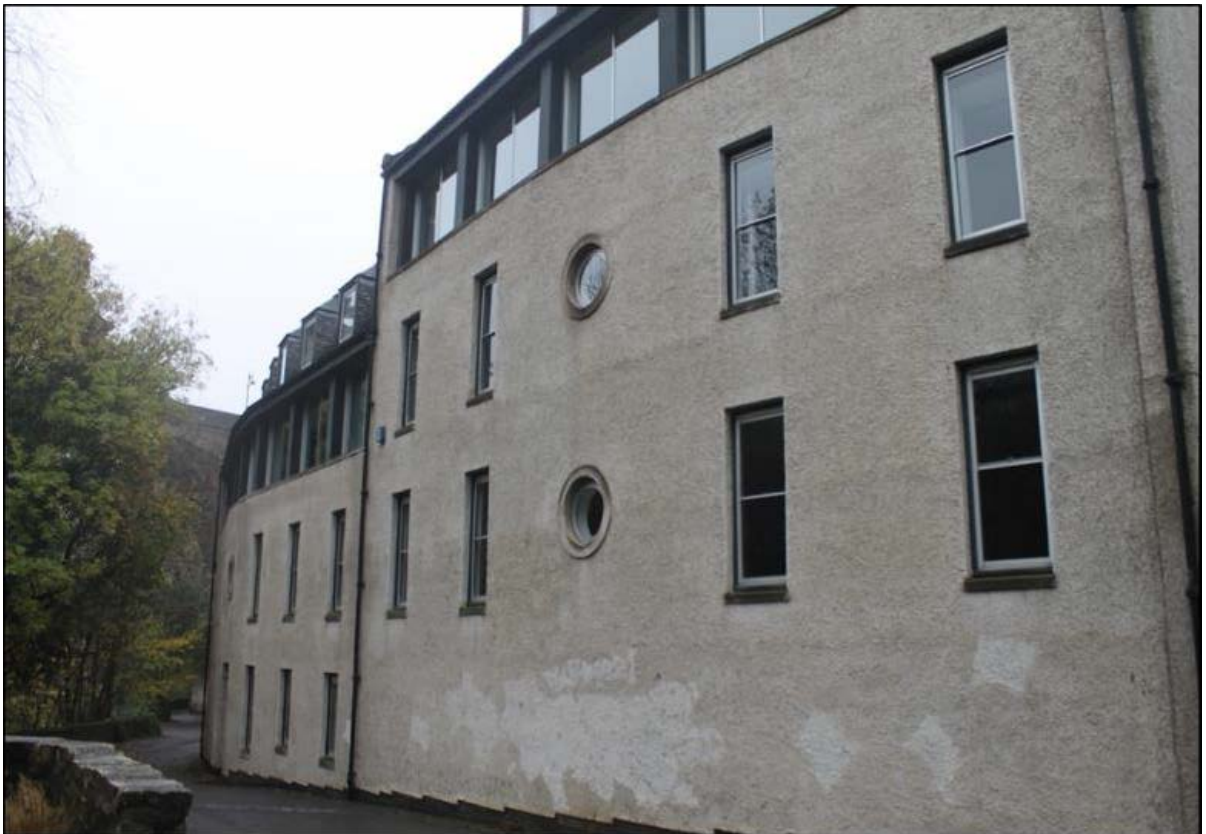
Figure 4b: West end of No.10 Bell's Brae, note brick basal courses under render.

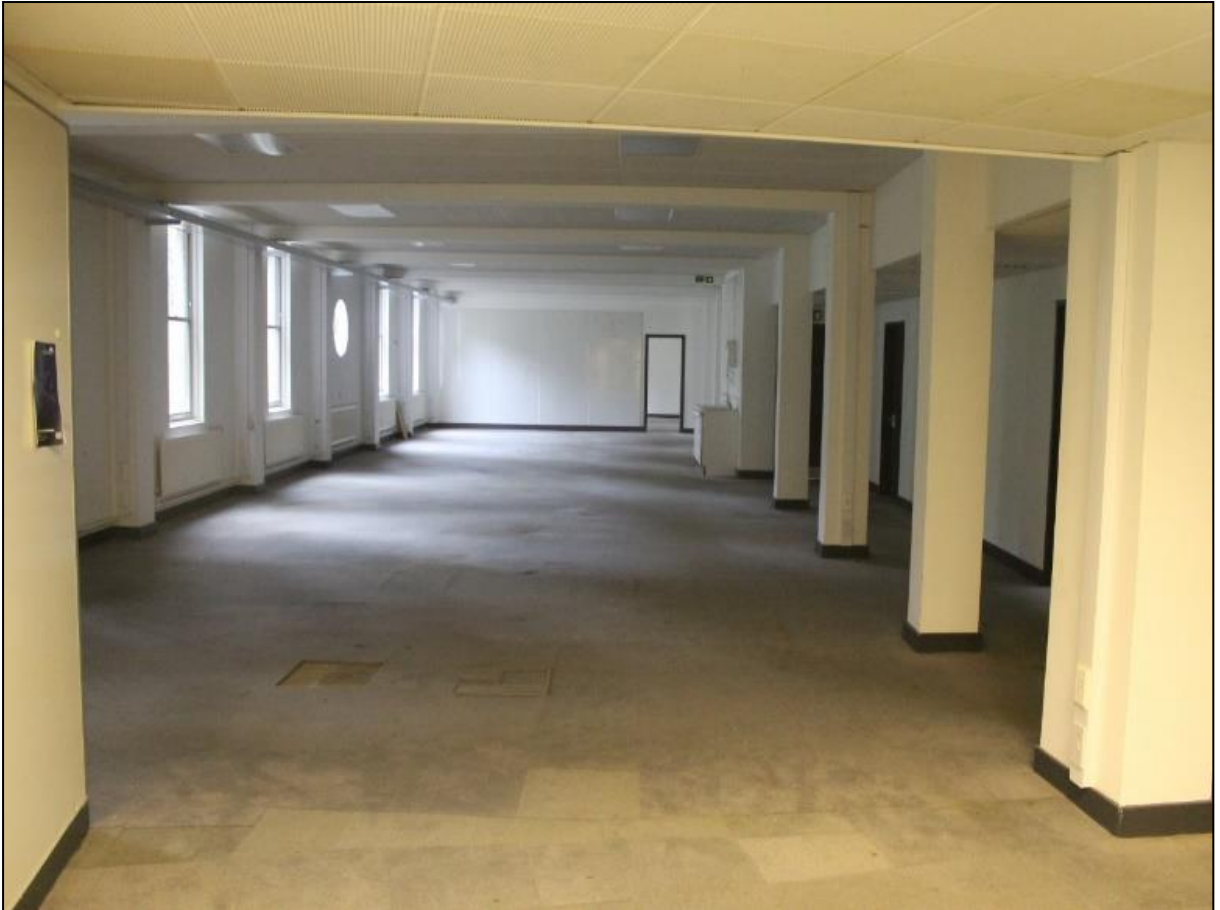
Figure 5a: Basement floor open planned office space.

19. The basement floor was formed by a large central open plan office space (Figure 5a) with 8 small rooms leading off from it; 5 along the south and 3 in the northwest corner (Figure 5b). There are two further medium sized rooms at both the east and west ends (Figure 6a). There is a hallway and stairwell located at the west end of the building providing access to all the above floors and a centrally located stairwell that opens into the central open planned space.

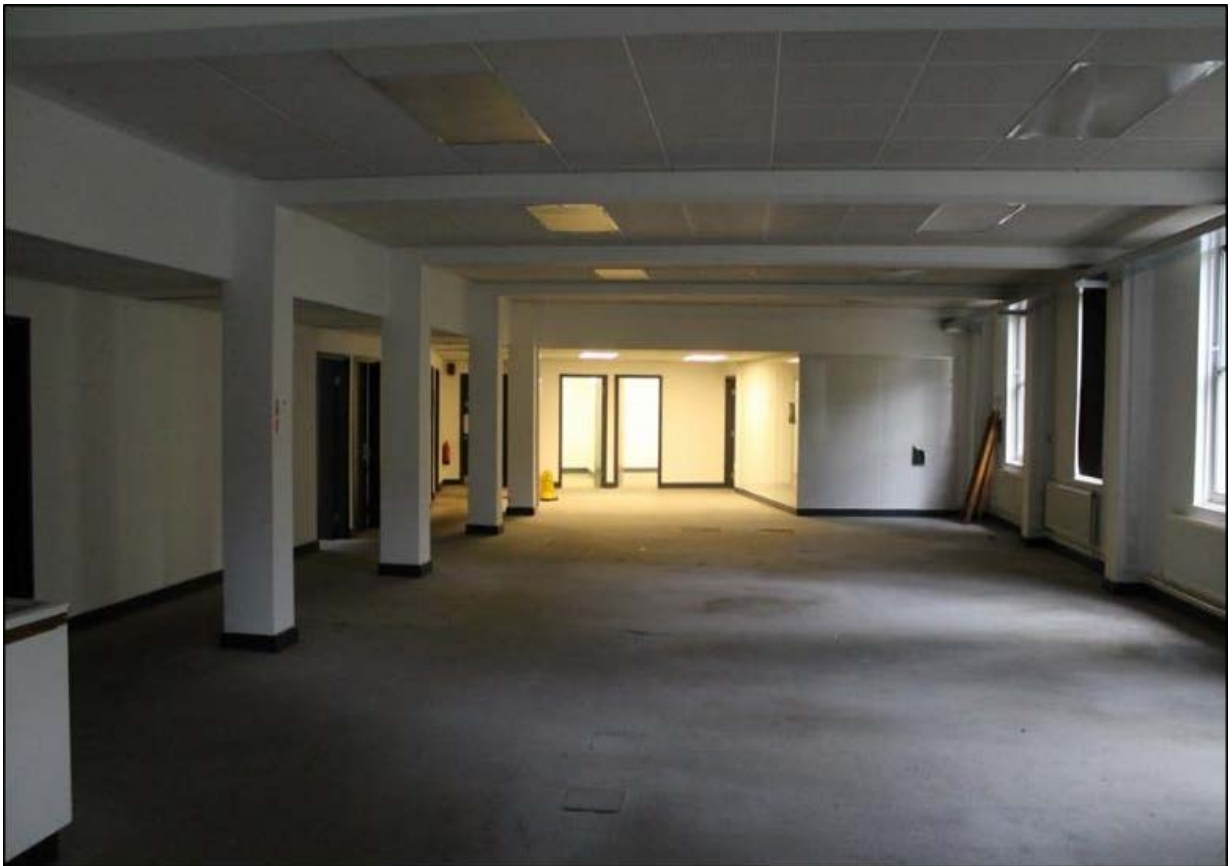
Figure 5b: Basement floor open planned office space and showing the rooms along the south side and at the far northwest side.

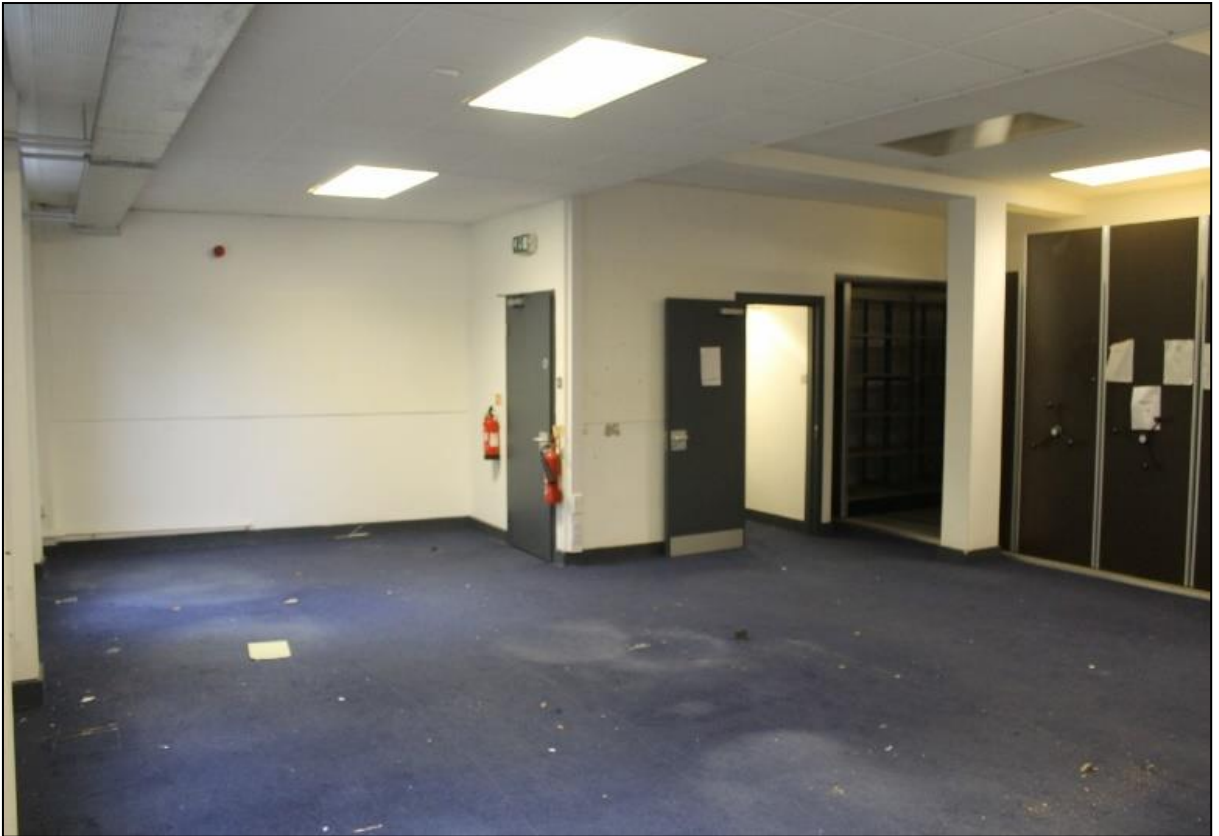
Figure 6a: Basement room at the west end.

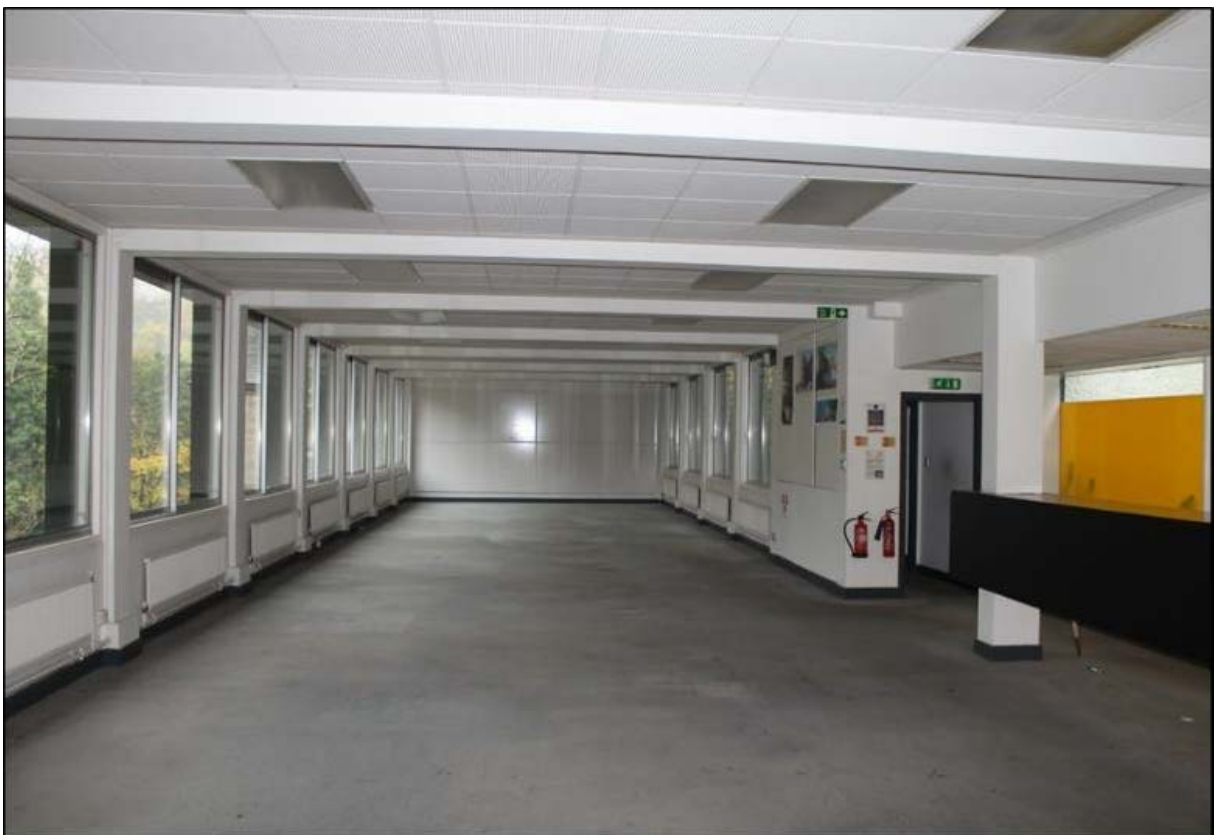
Figure 6b: 1st floor open plan office space, east end.

20. The 1st floor is formed by a large open planned office space (Figure 6b & 7a) with a corridor along the southern side and where the toilets are located. Two small rooms are located at the west end of the 1st floor.

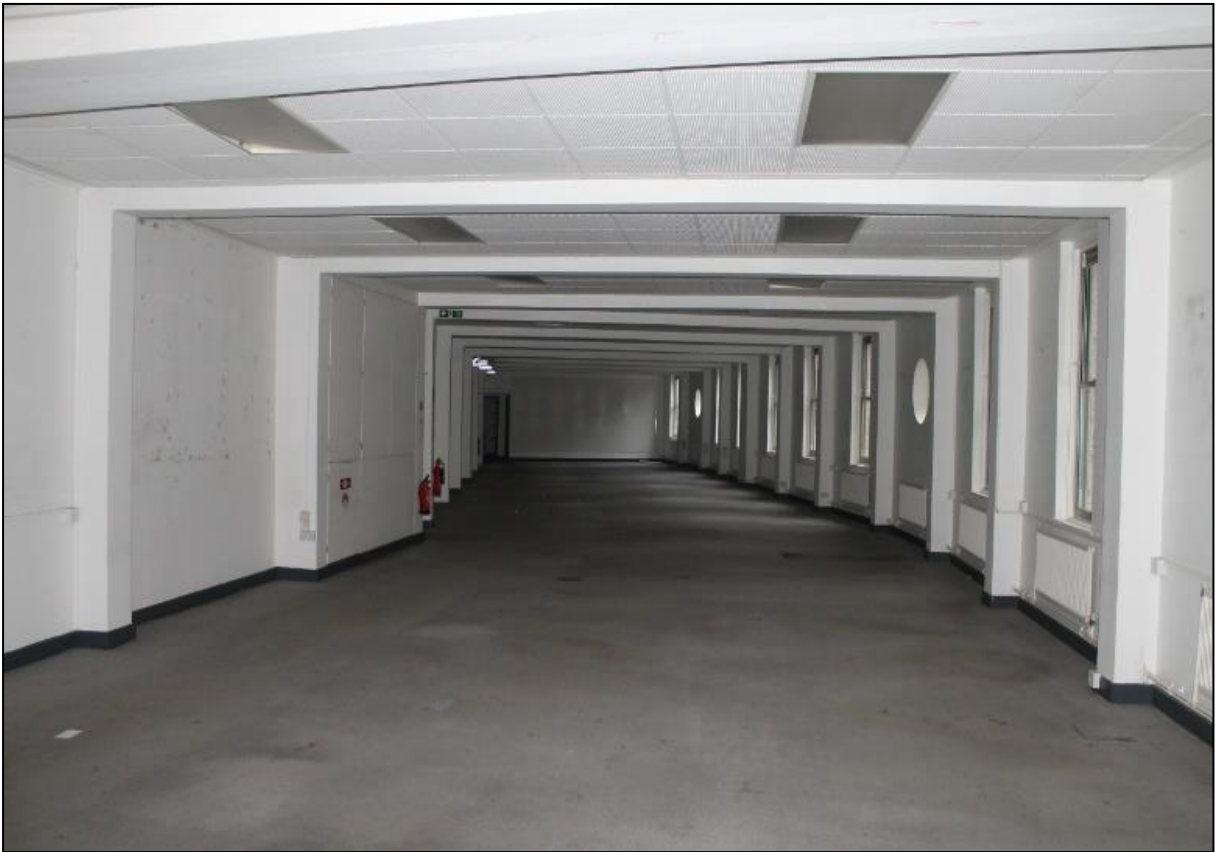
Figure 7a: 1st floor open plan office space west end.

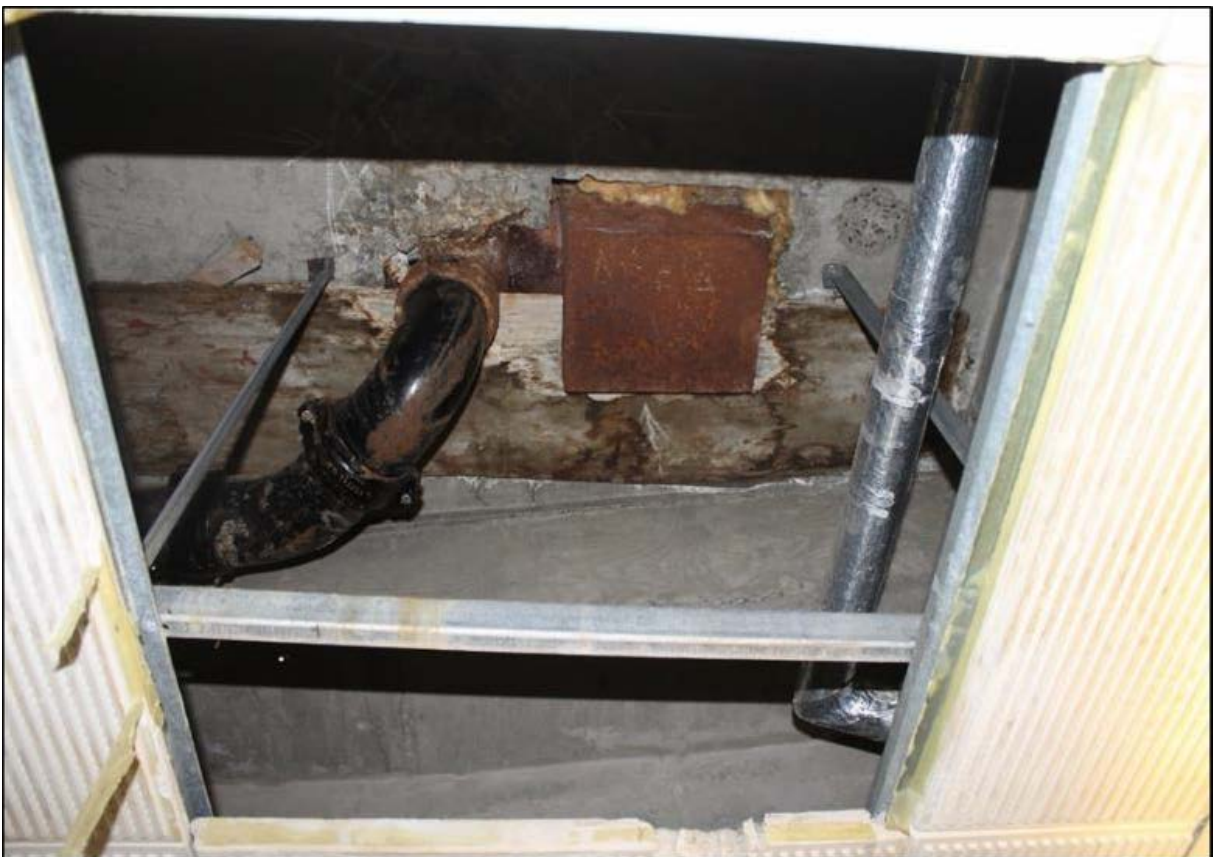
21. There are areas in the suspended ceiling and floor where it is possible to observe the structural/building method employed. This is formed of reinforced concrete (Figures 7b, 8a & 8b) that has been poured into a framework and employing a concrete framed construction method to form the beams, columns, floor/ceilings slabs, stairwells and in areas the dividing walls along with the use of breeze blocks. All walls are plastered and painted white with modern doorways inserted into the framework construction and it would appear no original doorways re-used.

Figure 7b: Showing the modern concrete ceiling.

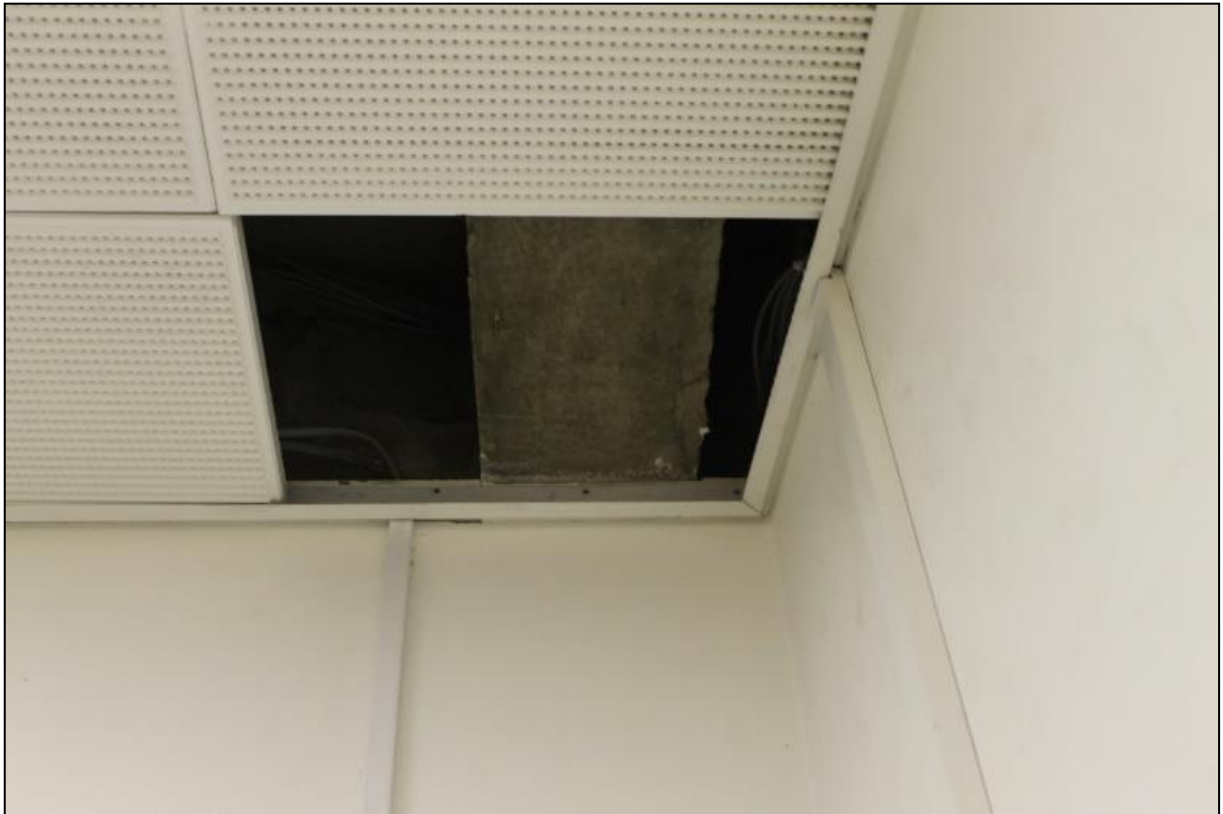
Figure 8a: Showing the modern concrete structural beam.

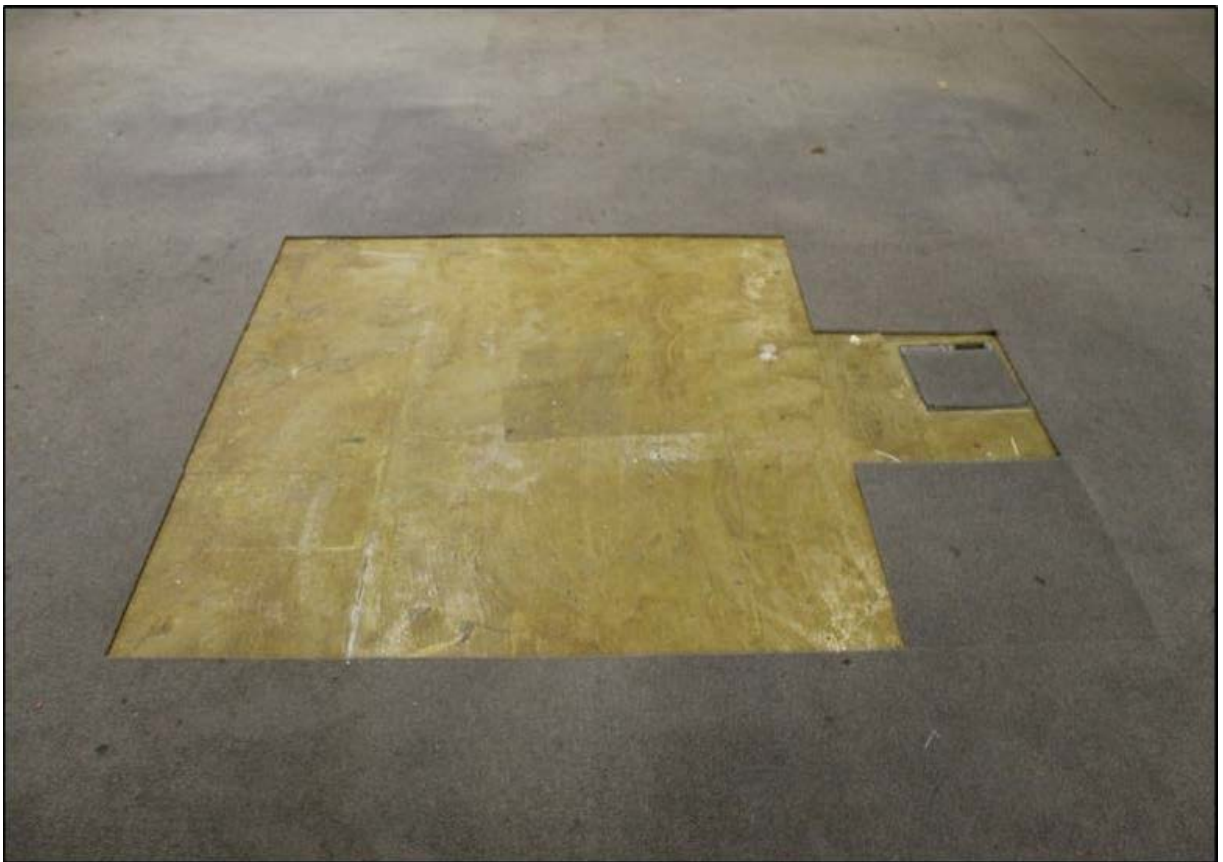
Figure 8b: Showing concrete flooring.

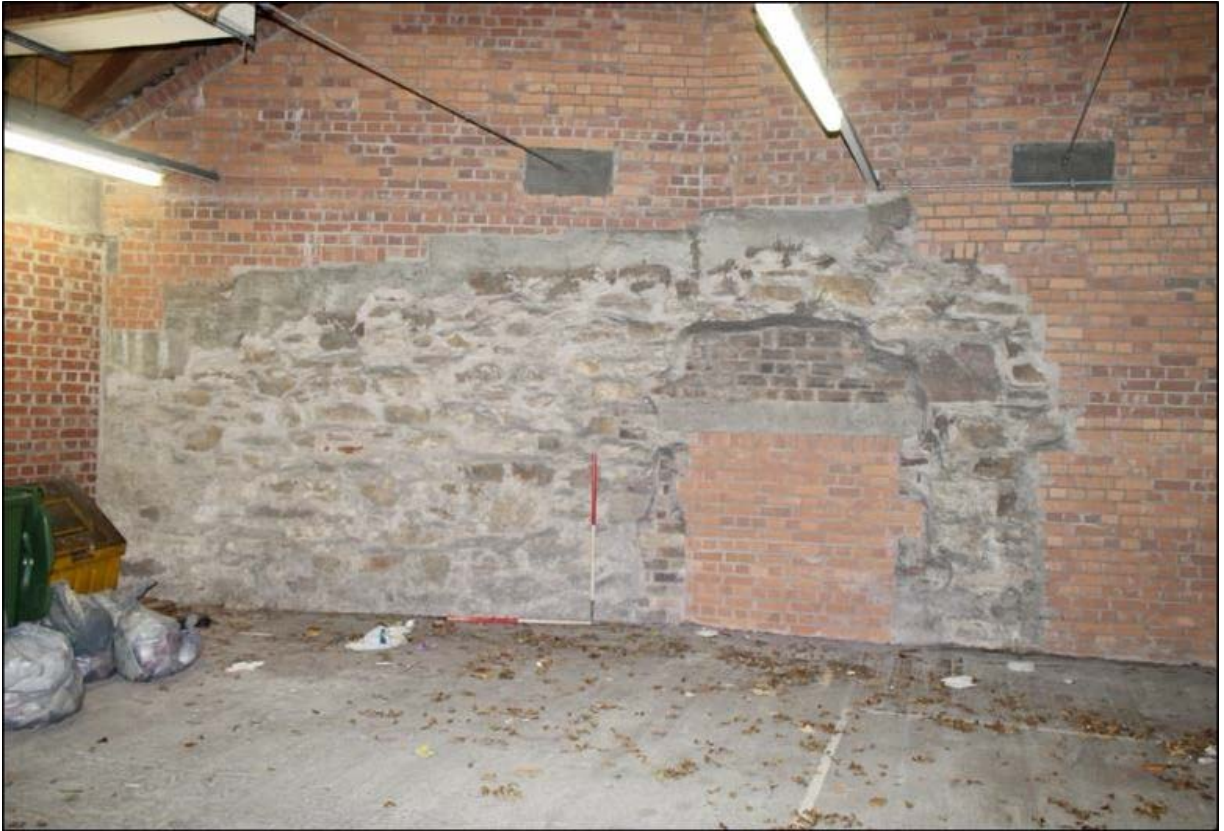
25. The interior garage area is formed by reinforced concrete flooring, modern timber trusses for the roof and brick walls with very little of the original structural elements surviving. However, on the southwest interior wall there is evidence for the original snecked sandstone that has been kept and brick used to infill around and form the primary building material. There is also evidence for a small square doorway with a concrete lintel (Figure 9a).

Figure 9a: Historic structural elements on the southwest wall of the interior of the garage area.

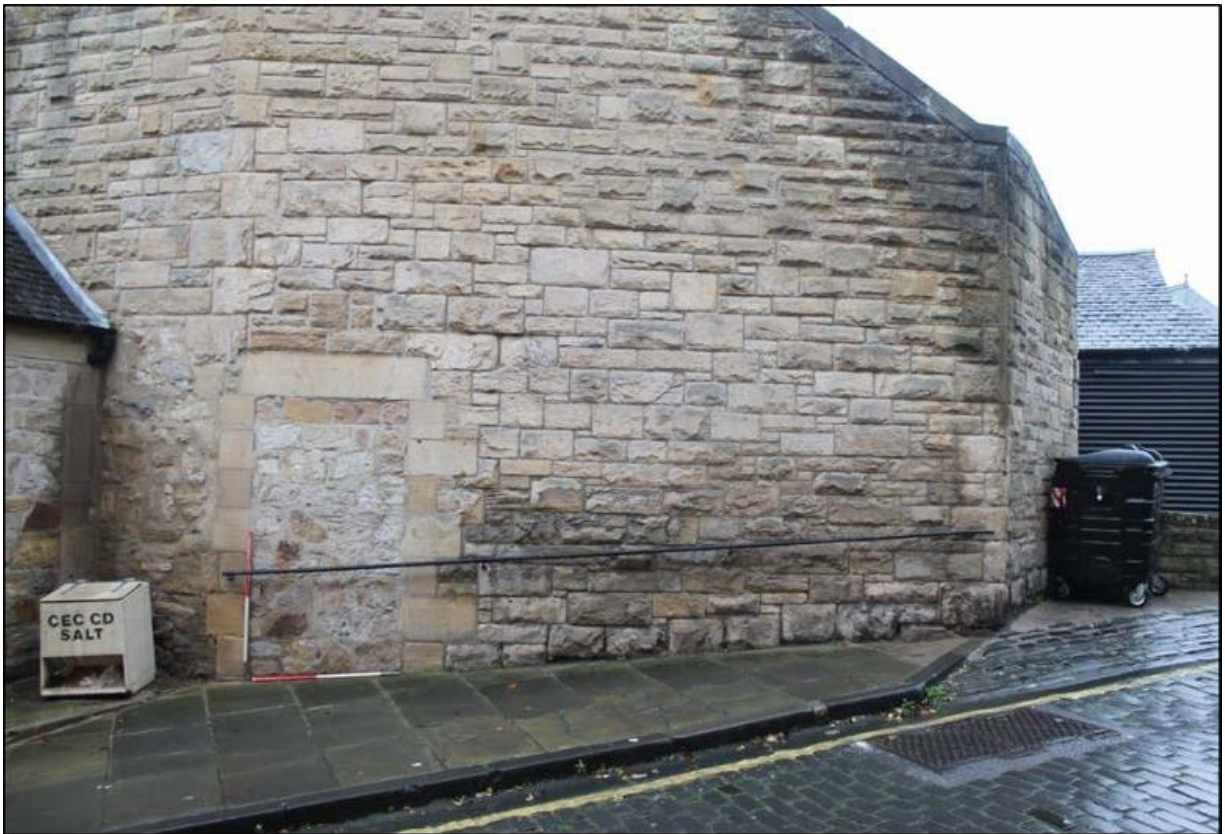
26. On the exterior of the garage block/office suite on the south facing elevation there is evidence for an original doorway that has been filled in with the broached sandstone lintel and surrounds visible. The original snecked sandstone construction is visible and forms approximately the lower half of the south facing elevation (Figure 9b).

Figure 9b: Historic structural elements on the south elevation showing infilled doors.

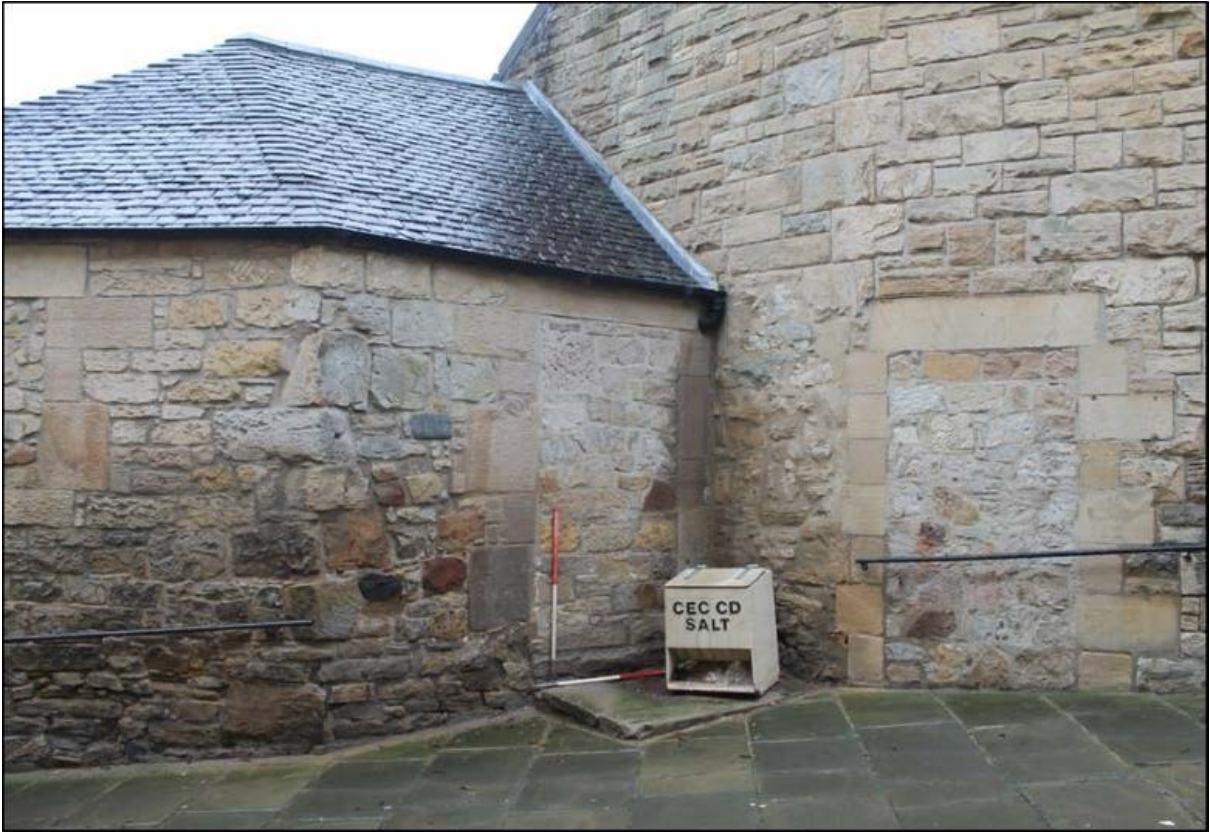
Figure 10a: Historic structural elements on the south elevation showing infilled doors.

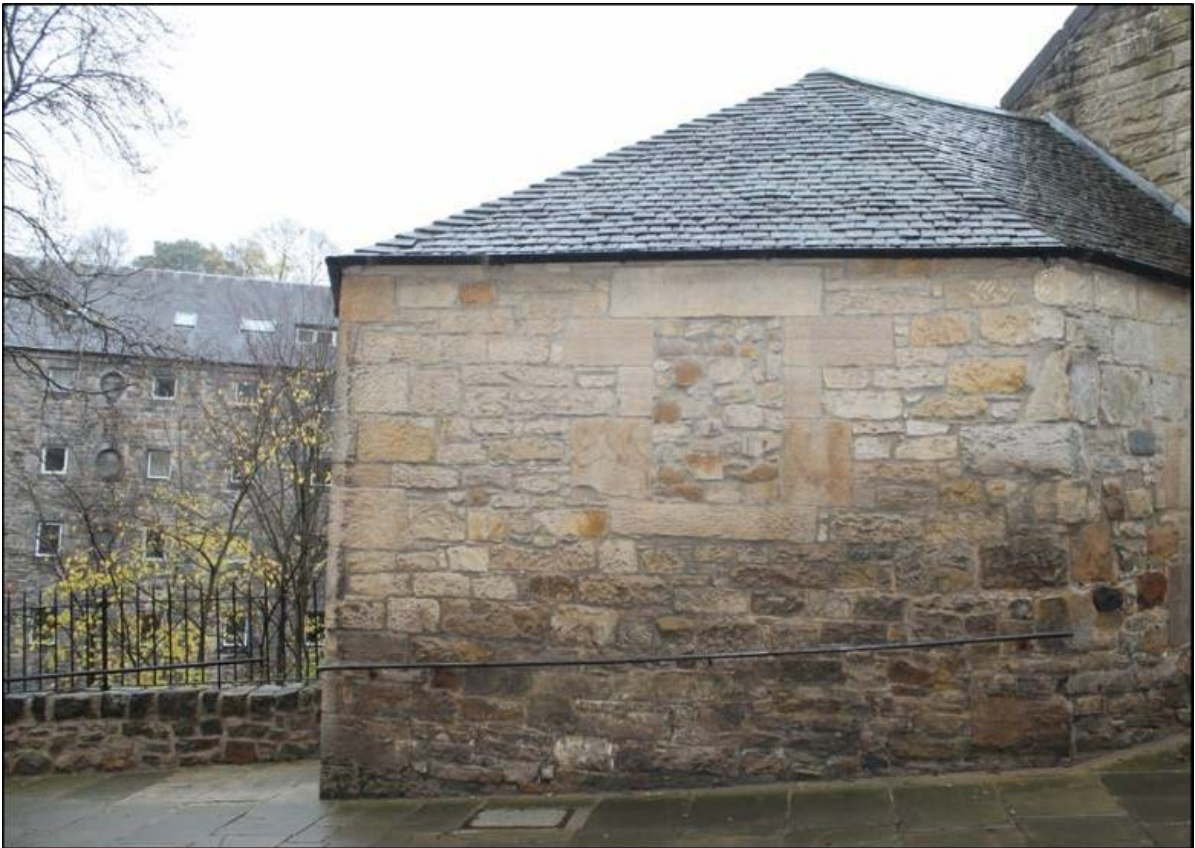
Figure 10b: Historic structural element on the southwest corner showing infilled window.

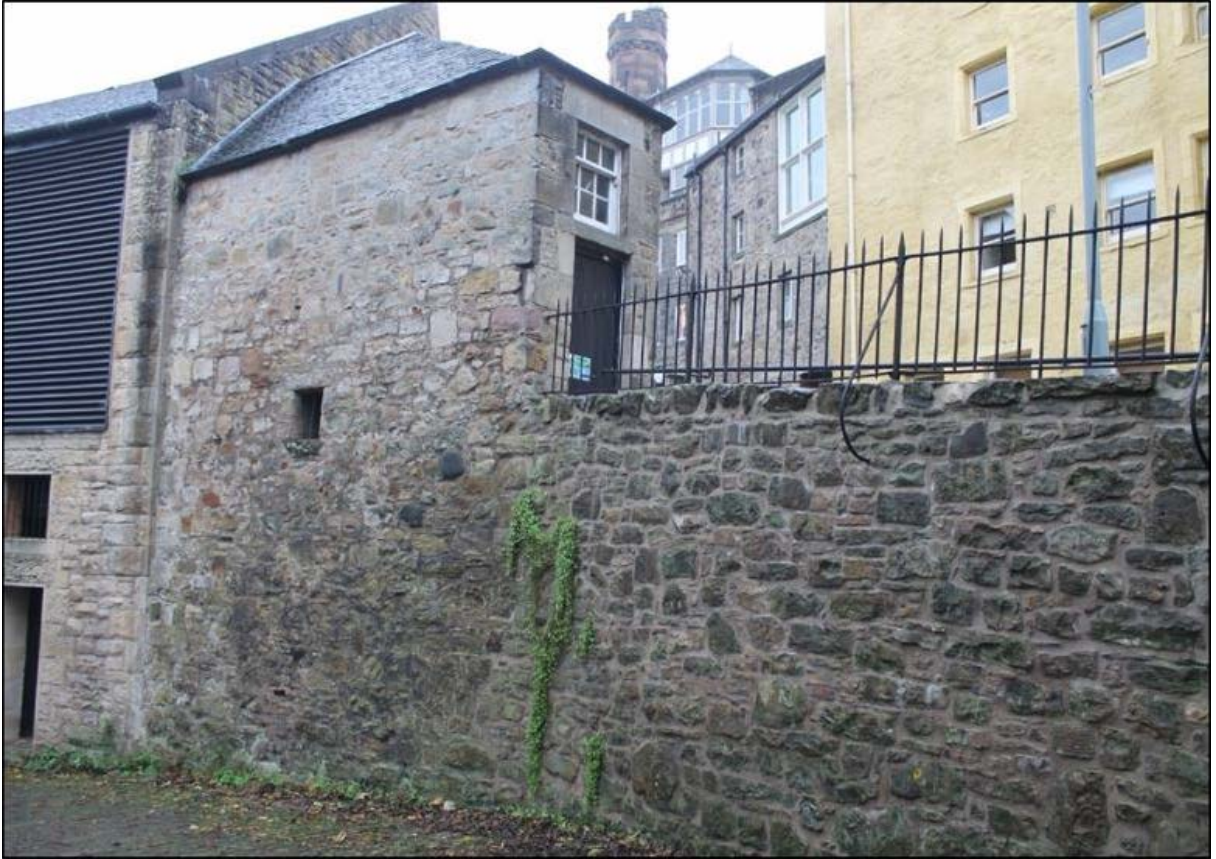
Figure 11a: Historic structural element on the southwest corner of garage/office building.

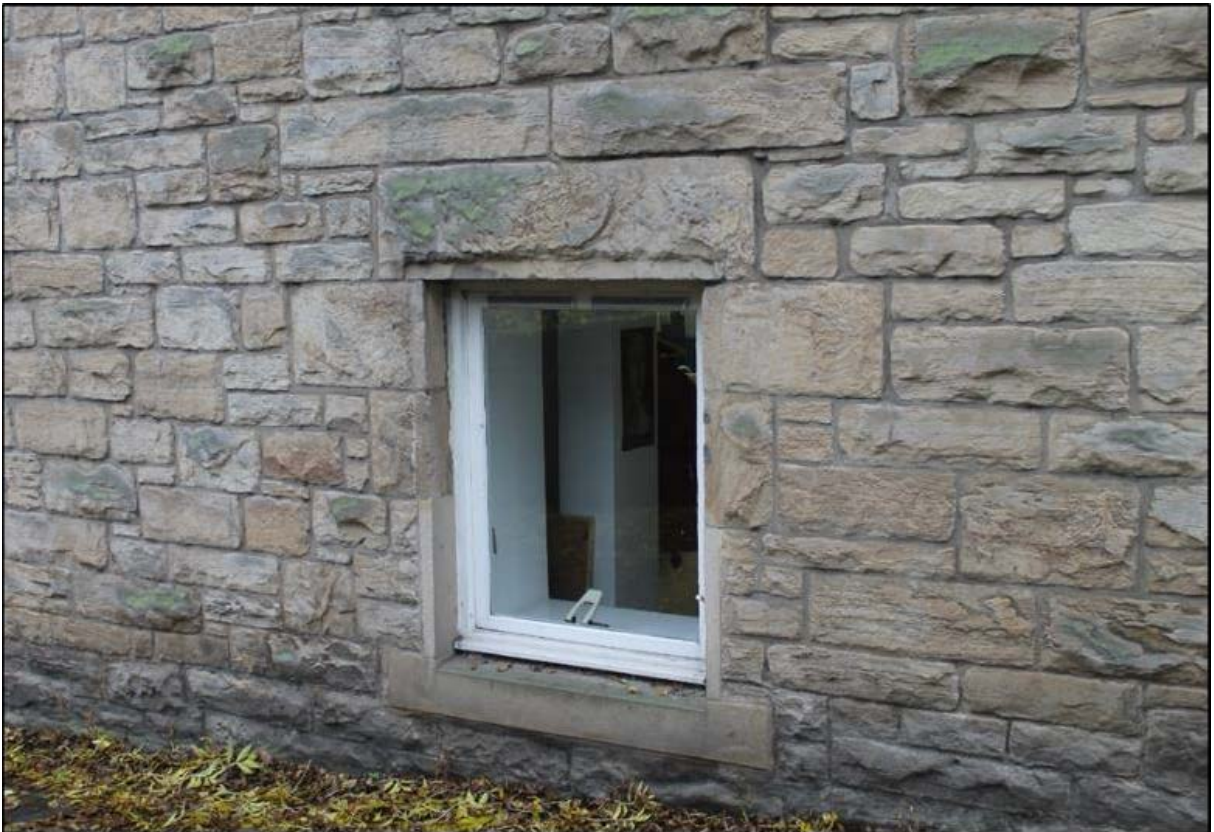
29. On the southwest facing side there is one modern wooden doorway forming a fire escape and a single window. The window has broached sandstone lintel, cill and rybats with the doorway incorporating the cill of the window as the lintel and irregular shaped rybats around the edge of the doorway (Figure 11a). The northwest facing elevation, fronts onto Leith Water and Miller Row and has a small square opening centrally located that may possibly have acted as a vent (Figure 11a). It was not possible to inspect the interior due to access issues.
30. Along the north and northeast facing elevations there is evidence that approximately the lower two-thirds is of historic snecked sandstone construction with three of the four windows containing original structural elements; lintels and rybats though all the cills are modern sandstone replacements (Figure 11b & 12a).

Figure 11b: Window on the north elevation showing historic and modern stonework of garage/office building.

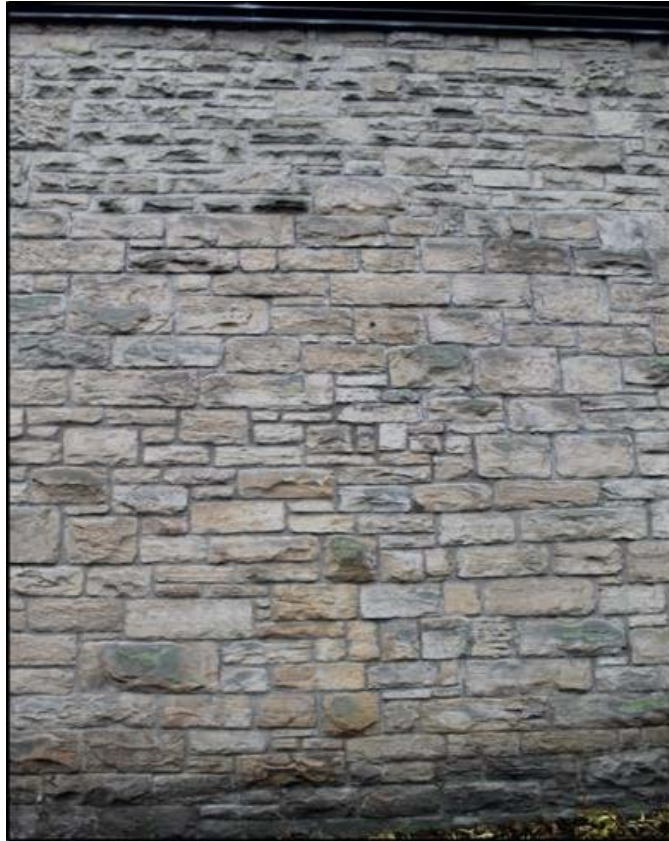
Figure 12a: Showing historic stonework (lower courses) and modern stonework (upper courses) on the north elevation of garage/office building
