Bell's Brae Refurbishment, Edinburgh: Archaeological Mitigation

Data Structure Report

Author(s)	Peter Klemen		
Date of Issue	1 st May 2018	Version	1.0
Commissioning Body	Sundial Properties		
Event Name	Bell's Brae Refurbishment, Edinburgh		
Event Type	Building Inspection and Monitoring		
Event Date(s)	November 2015 – April 2018		
Rathmell Archaeology Code	RA175091	OASIS Ref:	Rathmell1-240711
Location	United Kingdom: Scotland: Edinburgh		
NGR	NT 24161 73970	Parish	Edinburgh
Designation(s)	None

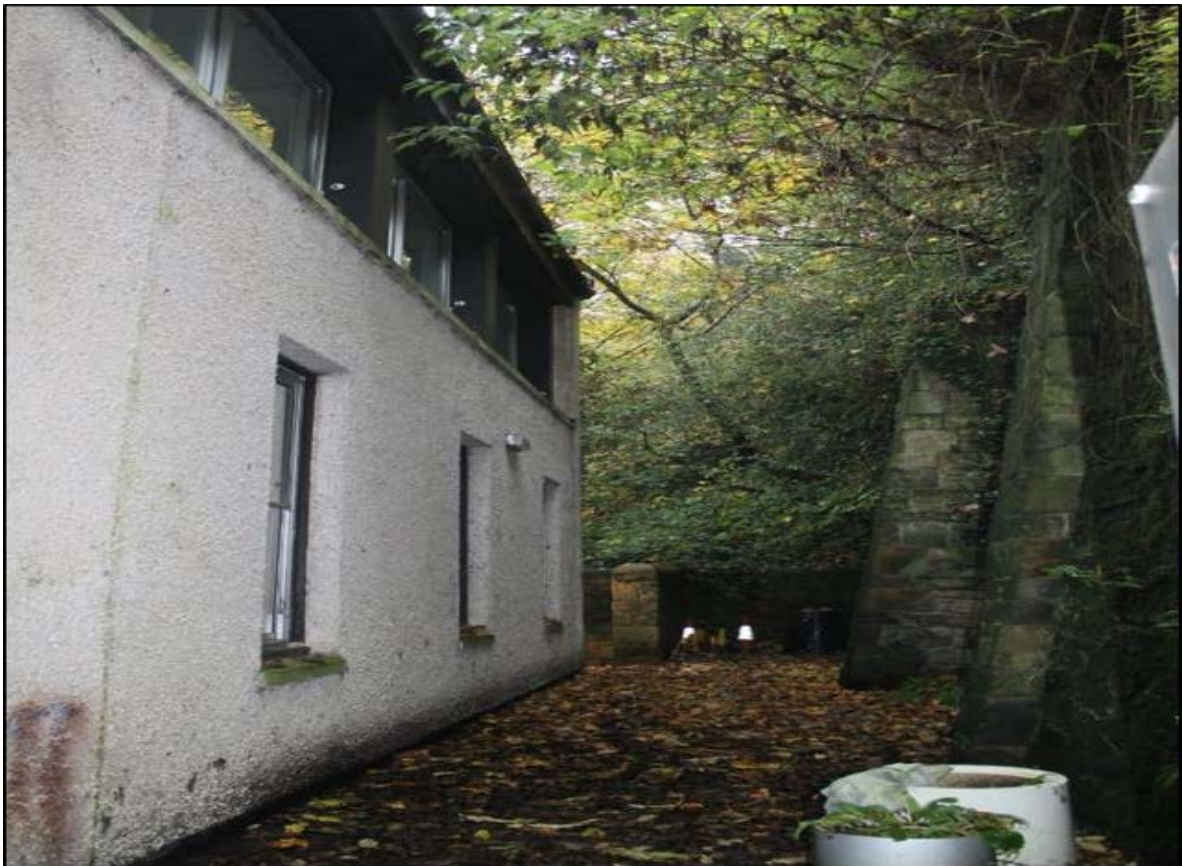
22. The eastern half of No.10 Bell's Brae is freestanding, with historic retaining structures standing slightly to the south of the building (see Figure 12b). Further west the modern building abuts the retaining structures for the slope. The rooms in the basement along this section of the south side are clearly built onto the historic retaining wall (Figure 13a). If there is to be removal or significant alteration to the modern fabric within this area there is the possibility for the potential of original structural elements to have survived.

Figure 12b: Location for new stair, note brick basal course of modern structure

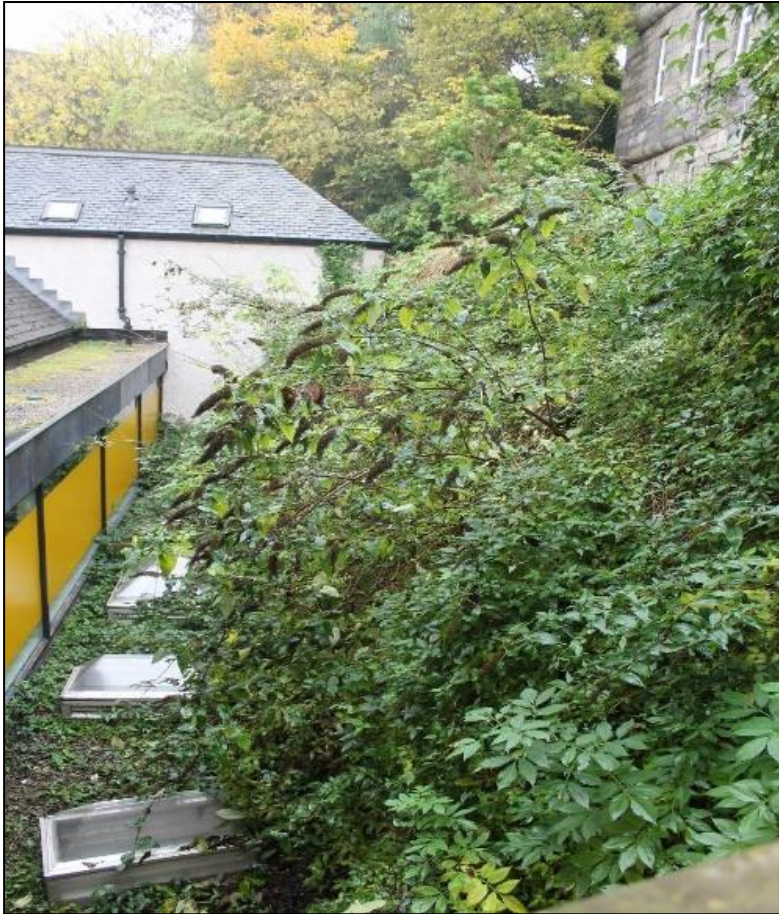
Figure 13a: View over the top of the basement rooms and joining onto the present retaining wall.

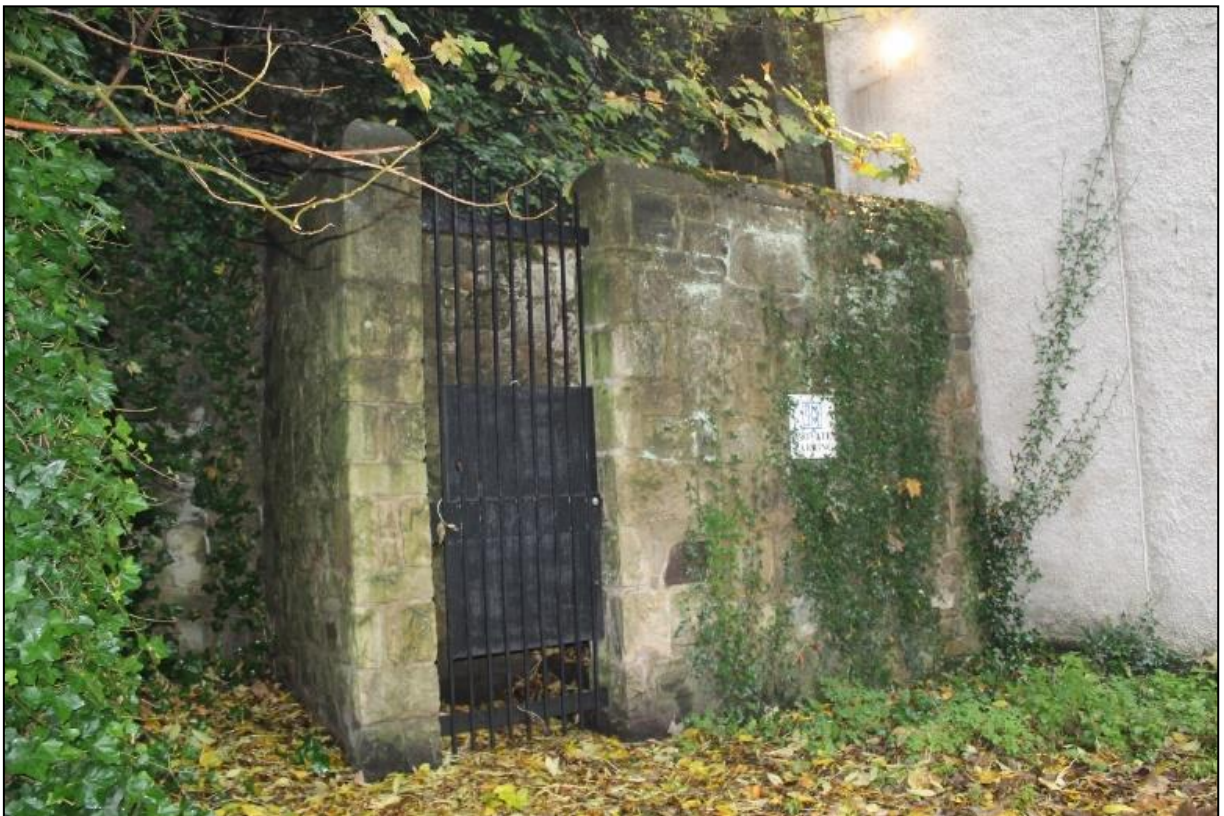
23. To the far eastern end of No.10 Bell's Brae there is an external stone stair that forms a fire escape (Figure 13b). The stonework possibly represents an original element of the 1830s building fabric that has been incorporated into the modern build.

Figure 13b: Fire escape at east end of No.10, historic stonework marking E end of historic structure.

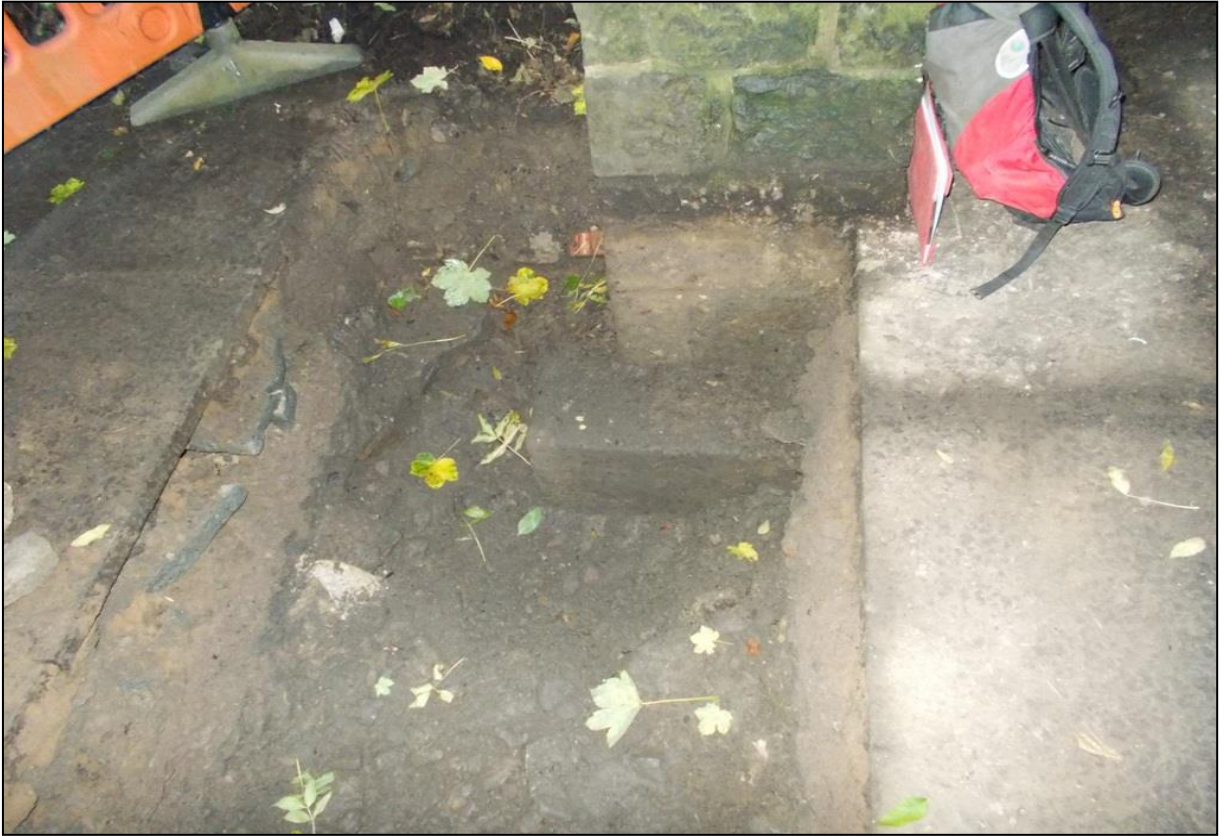
Figure 14a: Test Pit 1

33. The upper surface if Test Pit 1 was formed by flagstones (001) followed by an orange brown bedding and 60mm in depth (002). Context (003) was characterised by Made ground and formed of a mid brown sand matrix with Type 2 hard core, concrete slabs fragments, red brick and 470mm in depth. The final context in Test Pit 1 (004) was a Made ground of dark brown silt and sand with very frequent large sub angular and sub rounded stones ≤300mm by 300mm (Figure 14a).

35. In both test pits and at 500mm below the present ground surface a single shaped stone block was recorded (007). The stone was approximately 300-350mm in depth and extended out from the base of the buttresses from 220mm to 690mm (Figure 14a).

47. Test Pits 1 and 2 demonstrated the lower structural elements in the form a shaped stone (007) representing the top of the foundation for the buttresses associated with the existing rear retaining wall; most likely 19th or early 20th century in date.

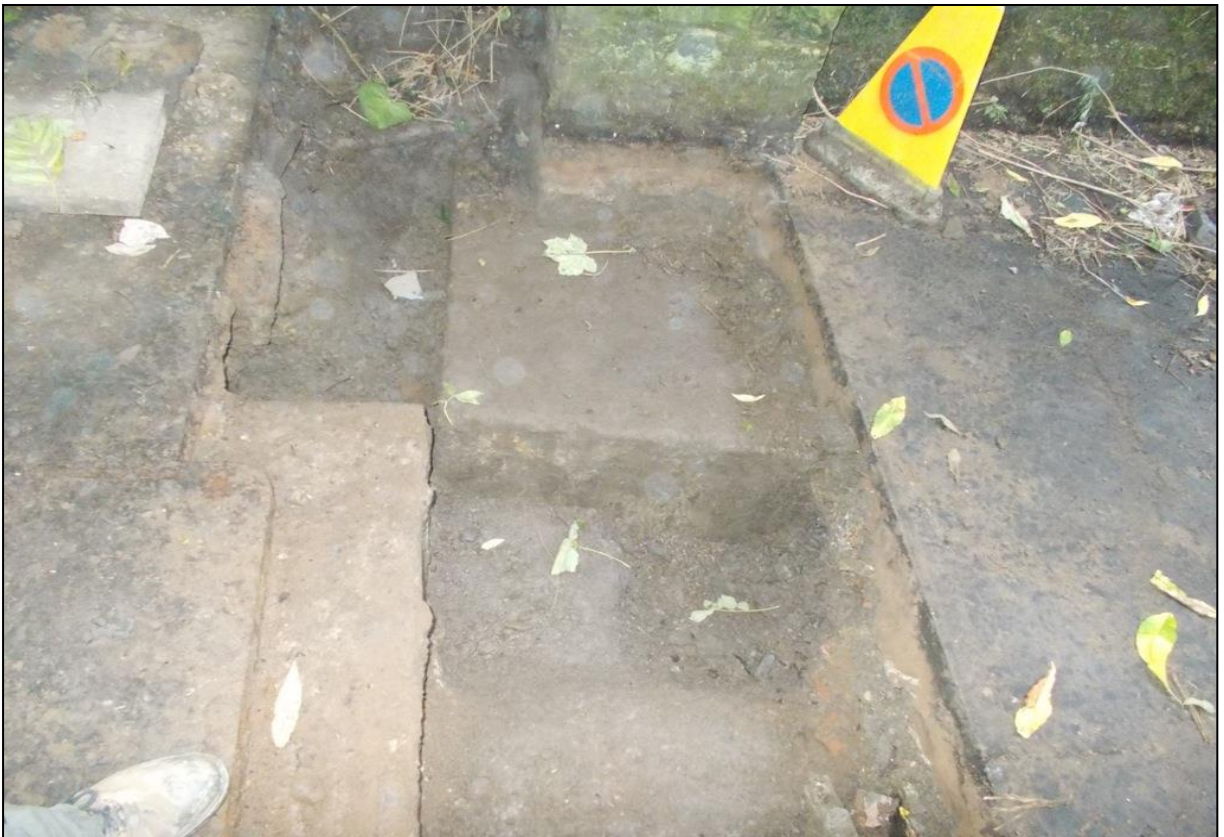
Figure 14b: Test Pit 2

34. As with Test Pit 1 the upper surface of Test Pit 2 was formed by Flagstones (001) with contexts (002) and (003) forming the next contexts. The final two contexts of (005) and (006) were formed by concrete (005) and Pea Gravel (006) respectively (Figure 14b).

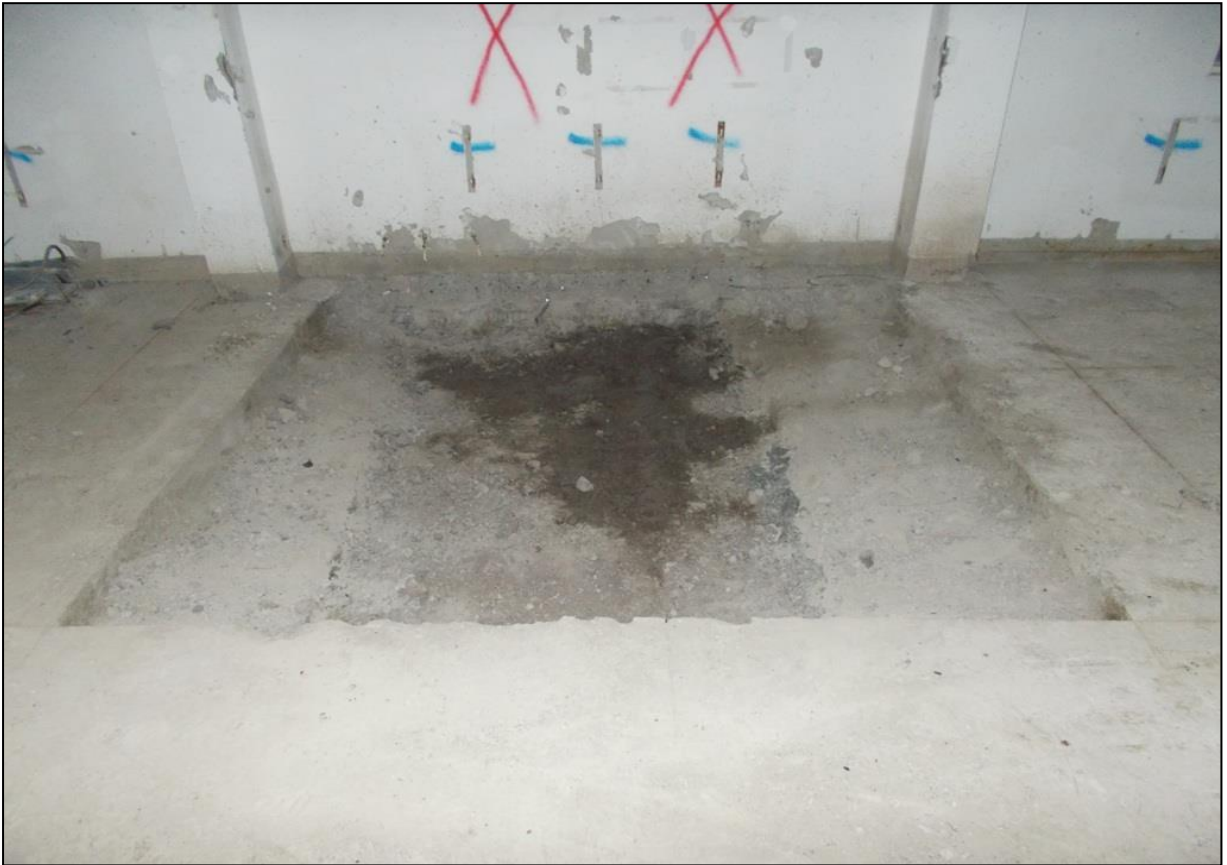
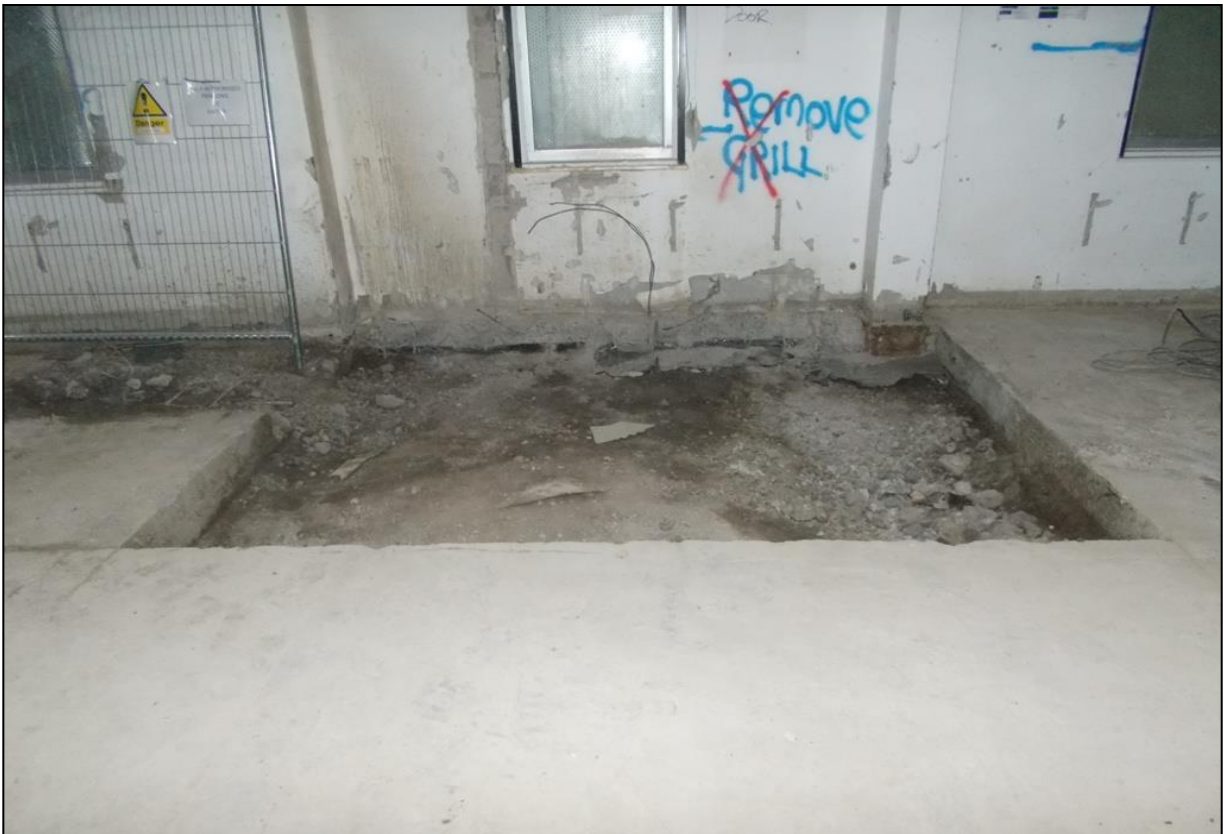
36. The test pits excavated inside the building were to a depth of 300-350mm with dimensions of 2.5m by 2.5m in size and all aligned NNE to SSW, revealing reinforced concrete (008) and Type 1 aggregate (009) (Figures 15a & 15b).

Figure 15a: Internal Test Pit 4.

Figure 15b: Internal Test Pit 6.

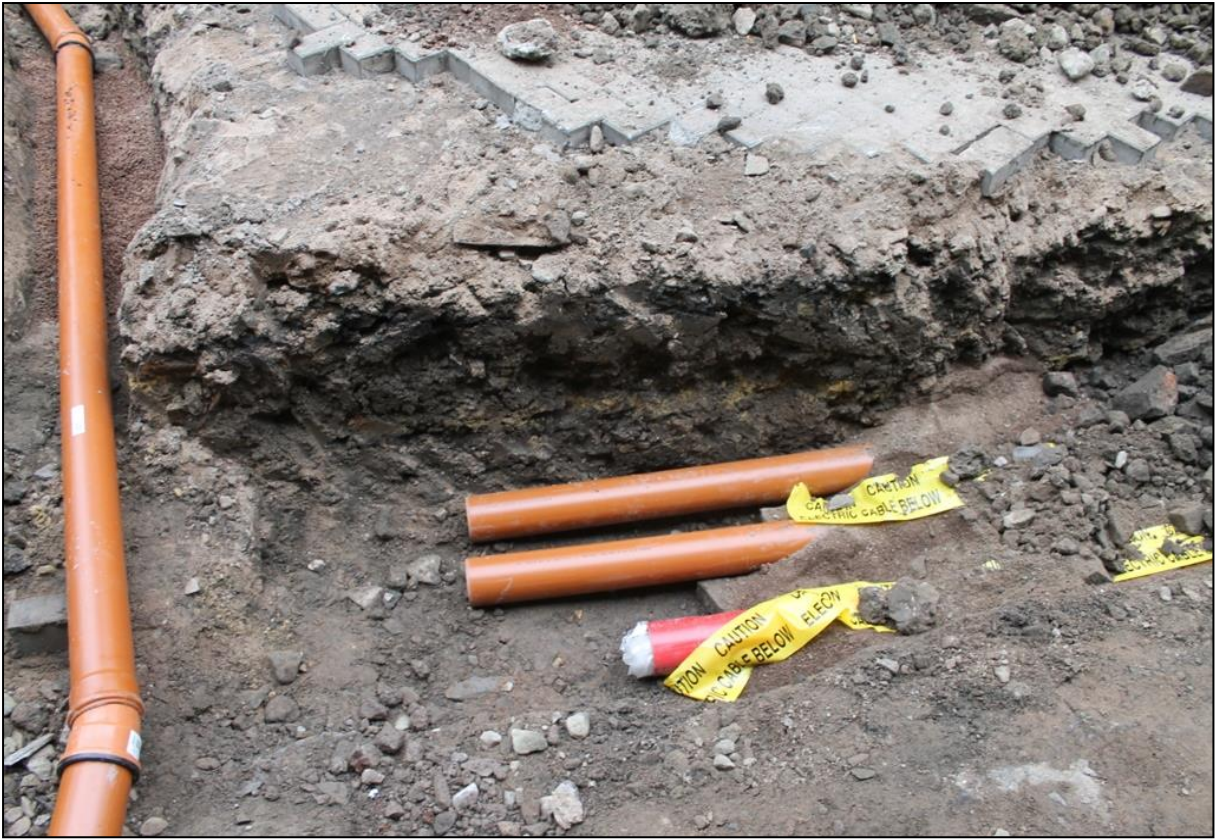
37. The second area monitored was located on the east side of the Garage Block (Figure 3) and consisted of a 'T-Shaped' trench aligned roughly northwest-southeast, 24m in length and halfway along the length an 8m trench excavated and aligned to the southeast (Figure 16a).

Figure 16a: Garage Block Trench context (010)

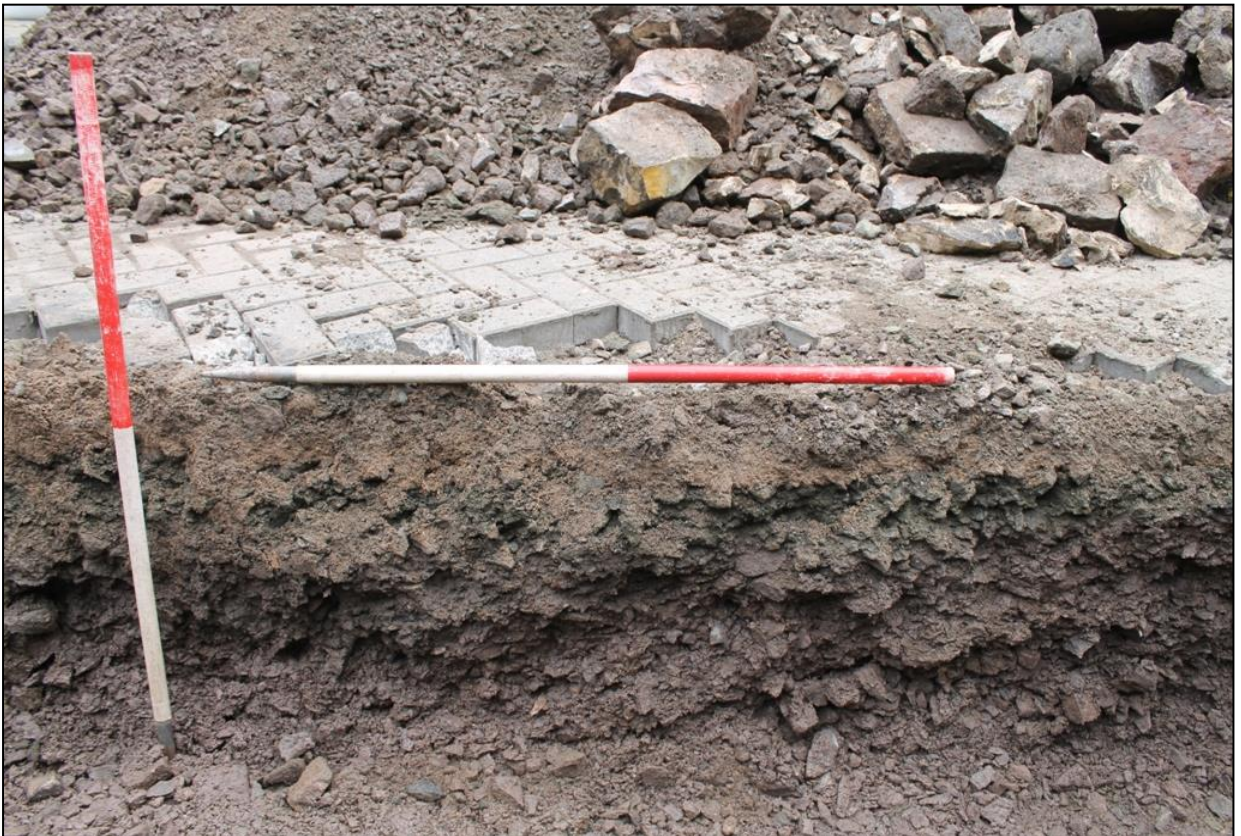
38. Context (010) formed the southeast part of the trench area and was characterised by a loose dark grey silt with small and frequent sub-rounded stones with timber and masonry throughout and approximately 600mm thick (Figure 16b). Forming the deposit for the north area of the trench (011) was a loose greyish red silt with very frequent small to medium sub-rounded & sub-angular stones and approximately 600m thick (Figure 17a).

Figure 16b: Garage Block Trench context (011)

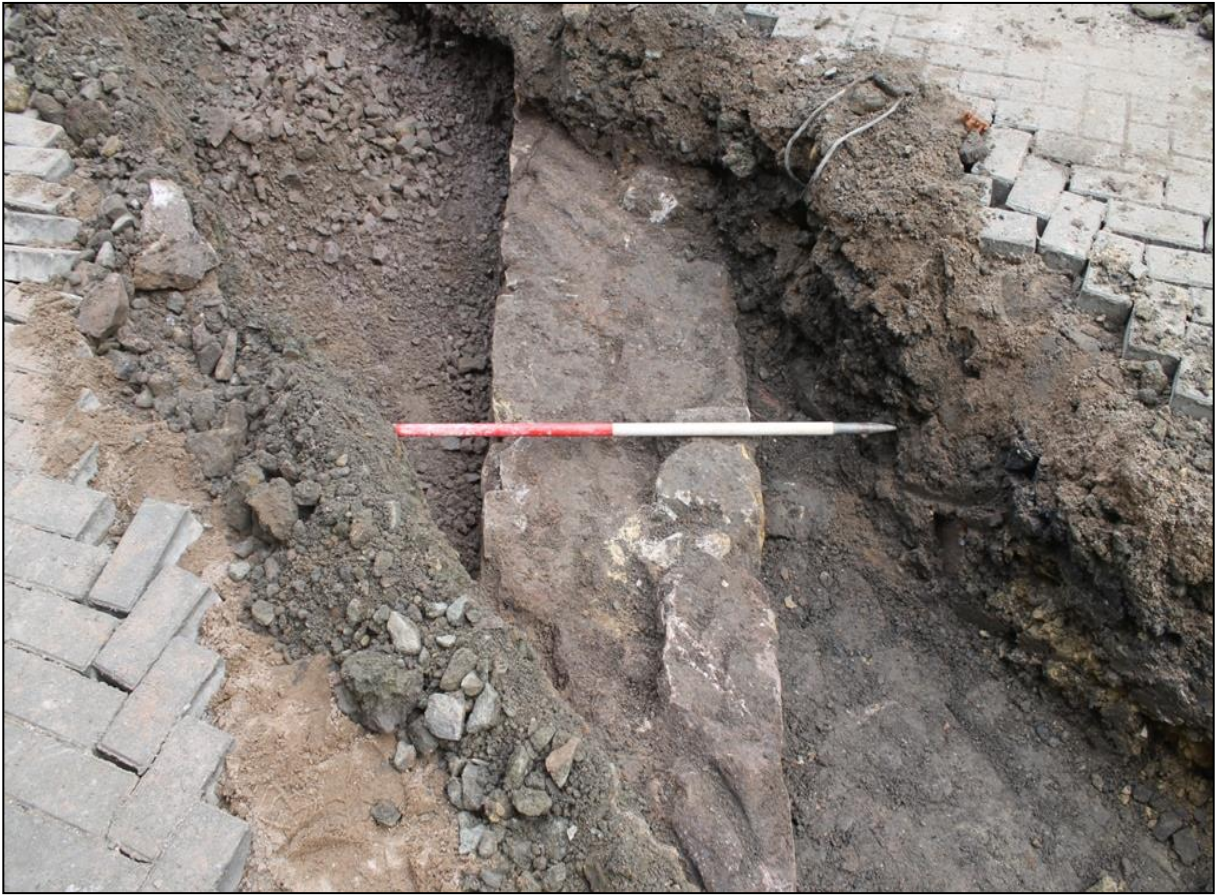
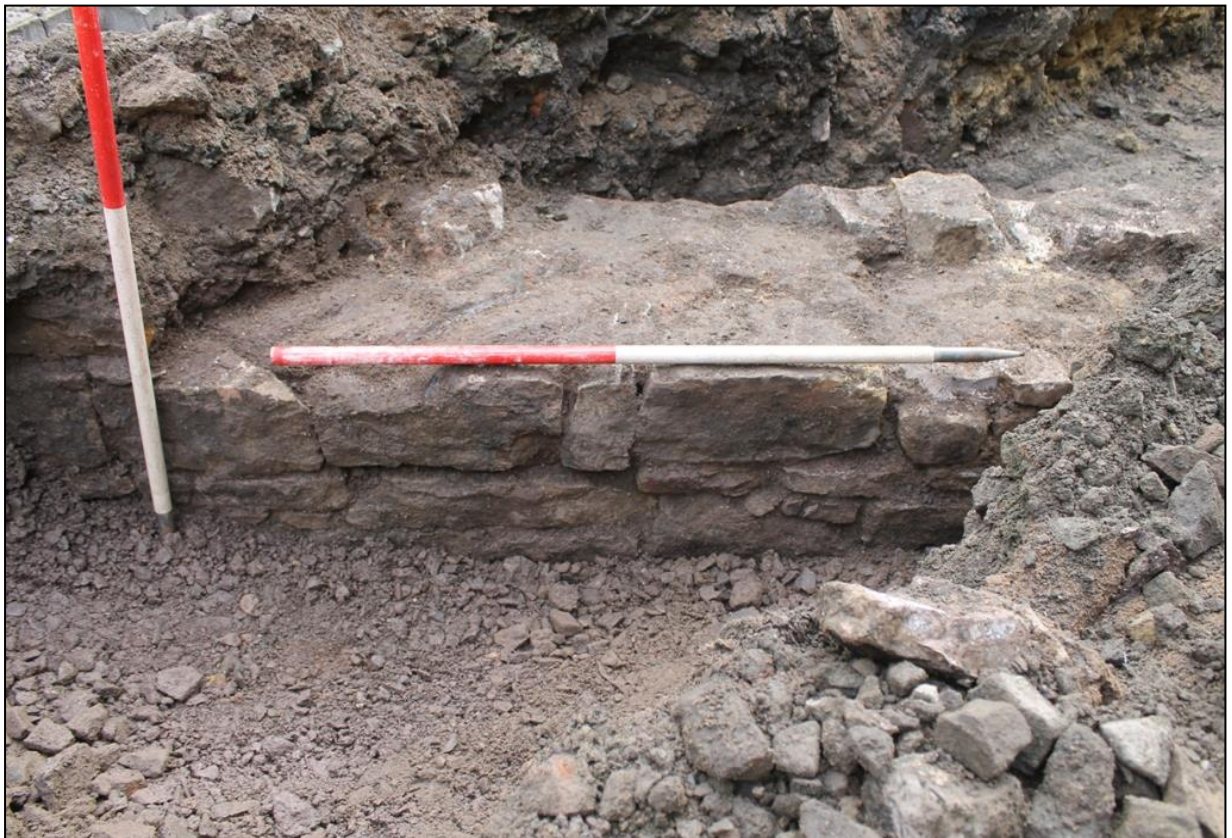
39. A structural feature, located in the northeast end of the trench, was recorded and aligned east-west across the trench. This was characterised by a sandstone wall measuring 300mm in length, 500mm wide and 200mm deep (012) (Figure 17b). In total four courses were exposed with no visible bonding.

Figure 17a: Garage Block Trench: Plan view of Wall (012).

Figure 17b: Garage Block Trench: North facing section of Wall (012)

48. Within the Garage Block Trench the only archaeological feature recorded was the structural feature of (012) that most likely represents part of the remains for a retaining wall that is still present to the east. The above ground elements linked with those recorded in the trench were possibly removed during the 1980s development works. Both the contexts (010) and (011) represent modern disturbance and deposits.

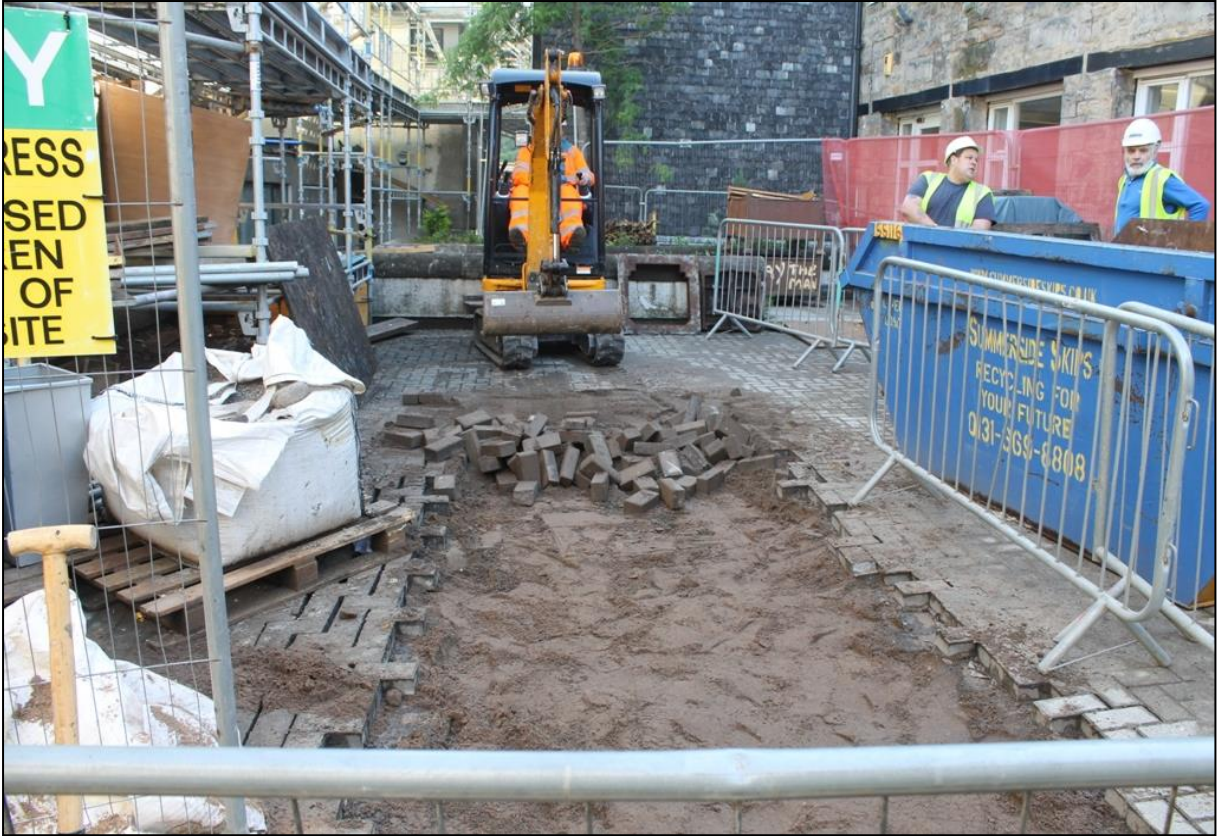
Figure 18a: Courtyard Trench

40. The final area monitored was located in the central courtyard and was formed by a 9m

long and 1.10m wide trench (Figure 18a). The upper 100mm was formed by a grey concrete blocks and an orange brown sand (013) with the underlying deposit of (014) formed by loose Type 1 aggregate of grey sub-angular and sub-rounded stones, 700mm in depth (Figure 18b).

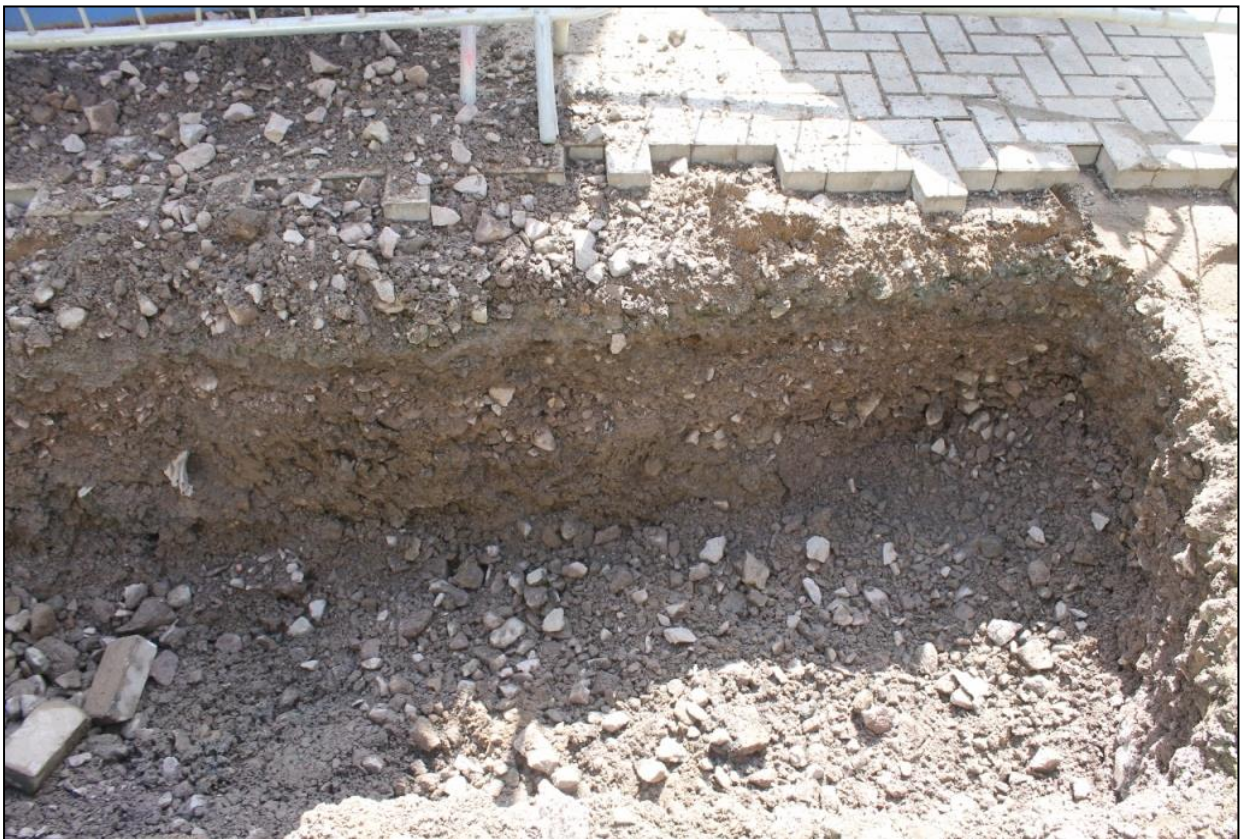
Figure 18b: Courtyard Trench deposits (013) and (014)

49. The contexts (013) and (014) located in the Courtyard area trench were also representative of modern disturbance from the 1980s development. In total a length of 10m was monitored and it was decided after conversation with the City of Edinburgh Archaeologist that the remaining route of the service trench did not have to be monitored. The route of the trench was along areas that had/have been highly disturbed by modern development and thus the nothing would have survived of any earlier subsurface layers or features.
