**Golden Hill Park, Clydebank:
Archaeological Support for
Antonine Wall Enhancement**

by Liam McKinstry and Douglas Gordon
issued 29th September 2016
on behalf of West Dunbartonshire Council

RATHMELL  
ARCHAEOLOGY LTD

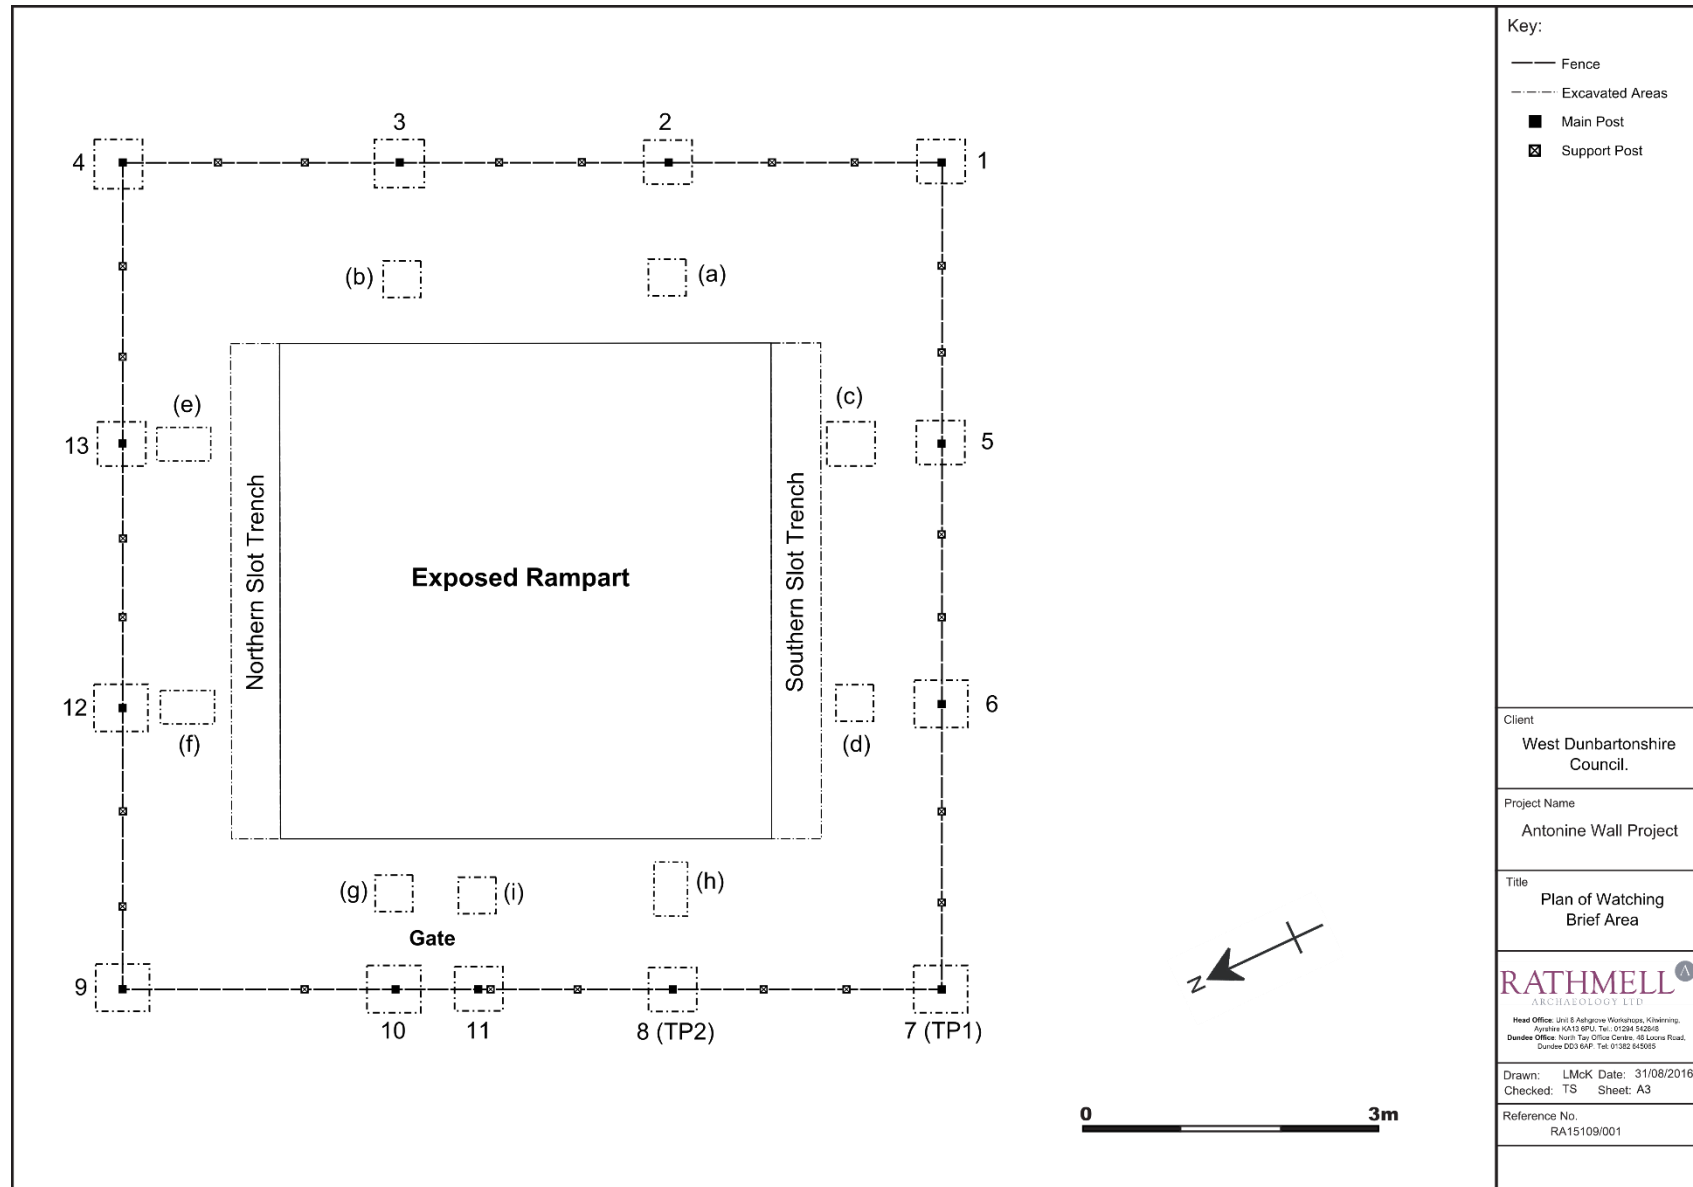
Figure 1: Plan of watching brief area

10. Two test pits were excavated on the WNW side of the original enclosure fence (Figure 1). These test pits were excavated so as to assess the impact, if any, on underlying archaeology from the construction of the original fence. This information was to be used in the design of the new fence - full details of these test pits are shown within Appendix 1.

13. A watching brief (Figure 1) of the dismantling of the original enclosing fence and erection of a new one took place from the 15th to the 16th of August 2016. The fence was square in plan and measured 8.5m by 8.5m. The fenced off area was orientated in a NNE to SSW direction. The original fence was secured to the ground by thirteen main posts (1-13) with the new fence reusing twelve of the original postholes. As well as these main posts there were nine stay supports (a-i), of which eight were reused for the new fence and twelve panel supports which were all reused by the new fence. Two of the main posts, 7 and 8, had already been partially excavated during the initial works (Test Pits 1 and 2). A full list of the original fence post holes is shown within Appendix 1.

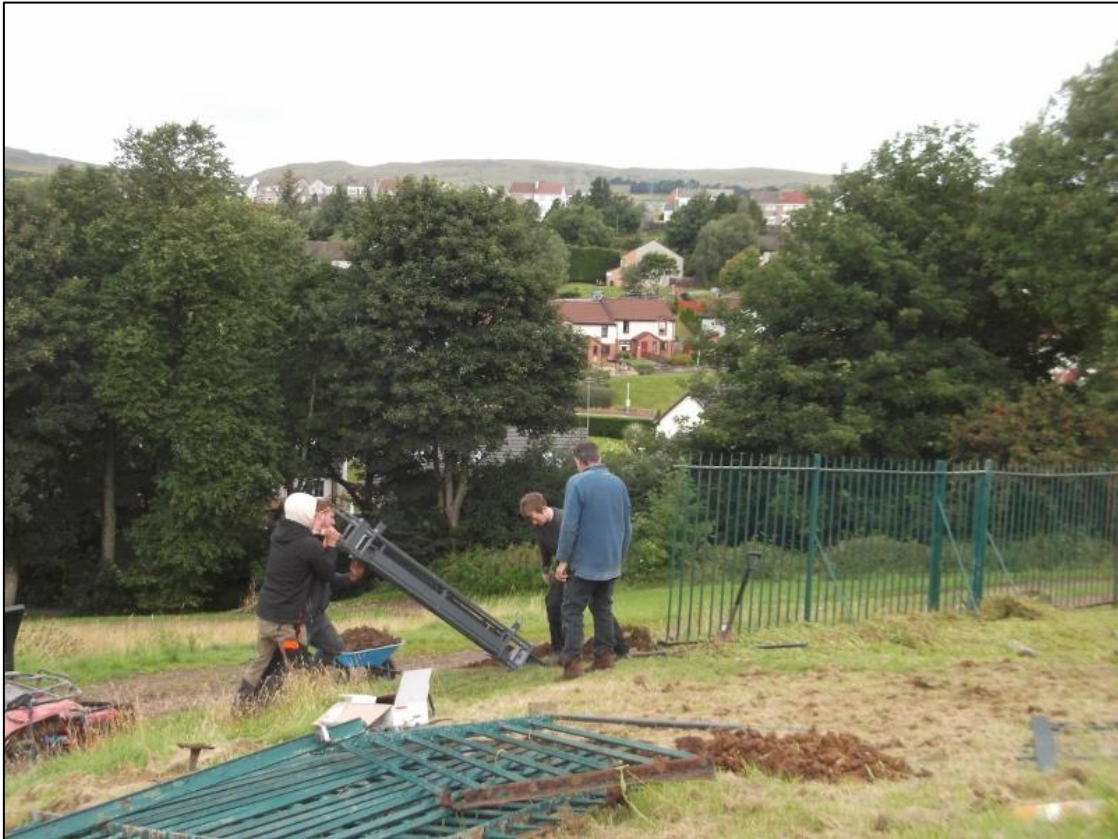
Figure 2a: View of new enclosure fence being erected. From SSE.

14. The upper, topsoil, deposit within all of the fence and stay post holes (001) comprised of moderately compacted mid grey-brown silty clay with occasional small stone and modern detritus (glass, white glaze pottery) inclusions. The deposit had a depth range of between 110 and 310mm. The middle deposit (002) within Fence posts 6-7 and Stay posts (c) and (d) comprised of moderately compacted, mixed mid yellow/mid grey-brown clay with occasional small stone (and pieces of plastic in pit 8) inclusions. The deposit had a depth range within these holes of between 230-390mm. The basal deposit (003) within Fence posts 6-7 and Stay posts (c) and (d) comprised of moderately compacted, mid brown clayey silt with occasional inclusions of small to medium sub-angular stones ≤ 90 mm in size. The deposit has a depth range within these holes of between 120-200mm. The main deposit (004) within Fence posts 2-5, 8-9 and 11-13 and Stay posts (b) and (e)-(i) comprised of moderately compacted, mixed mid orange-yellow/mid grey-brown clay with occasional small stone (and pieces of plastic in Fence post 8) inclusions. The deposit had a depth range within these holes of between 300-550mm. The main deposit (005) within Fence posts (1 and 10) and stay post (a) comprised of moderately compacted, mixed mid yellow/mid grey-brown clay with moderate small to medium sized stone and very occasional plastic inclusions. The layer had a depth range of between 300-550mm.

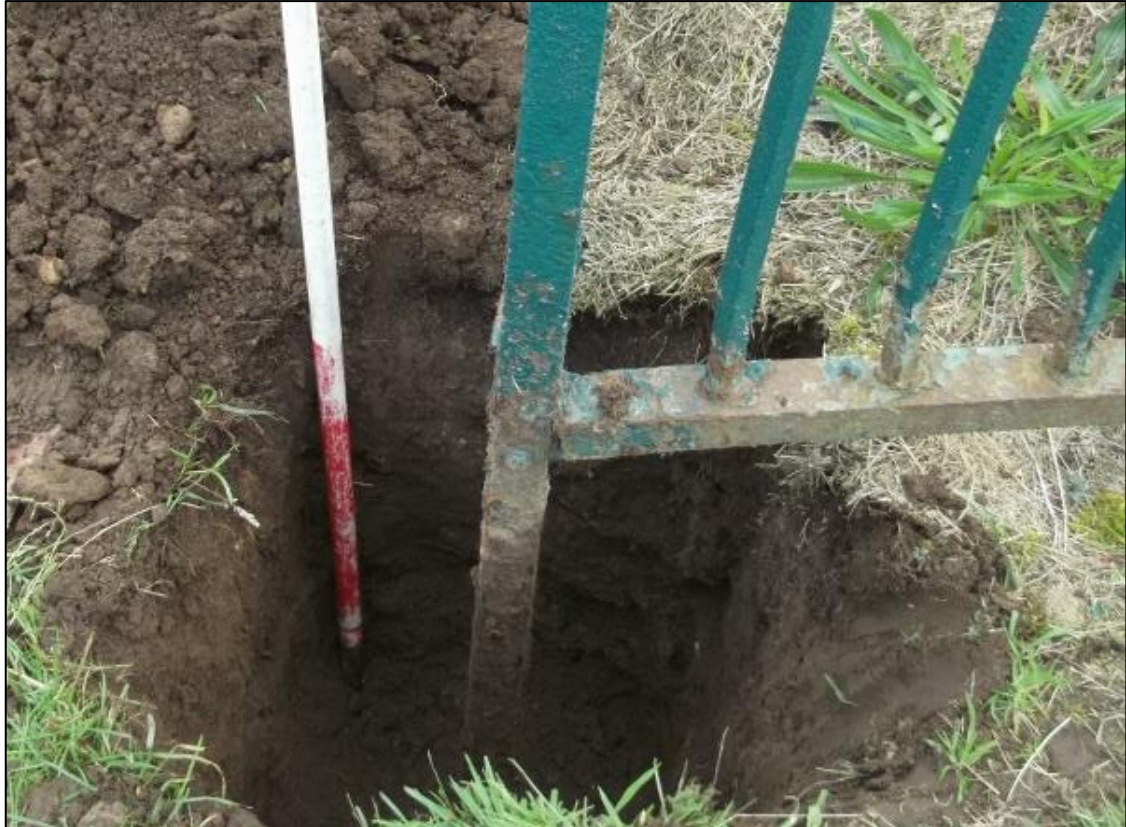
Figure 2b: SSW facing section of corner fence post 7.

22. During the removal of the original enclosure fence only the base of each hole was identified as each fence post and stay had a square shaped metal base plate attached which made this identification easier. The original sides of the holes were not identified as the excavations carried out during each removal was deliberately kept as small as possible to minimise any risk to the Antonine Wall. This would suggest that the area of the holes excavated for the original enclosure fence was much larger. The subsoils ((002)-(005)) identified within the holes were all redeposited natural subsoils from the original enclosure fences post and stay holes. The presence of moderate amounts of stone within some of the holes suggests that they may have been excavated straight through parts of the rampart.

| Fence/ stay holes | Size | Depth | Subsoil Character | Modern/ Agricultural Features | Significant Features | Artefacts |
|---|---|---|---|---|---|---|
| 7 | 0.6m by 0.6m | 800- 850mm | (002) Moderately compacted, mixed mid yellow/mid grey-brown clay with occasional small stone (and pieces of plastic in fence post 8) inclusions. (003) Moderately compacted, mid brown clayey silt with occasional inclusions of small to medium sub-angular stones ≤90mm in size. | None | None | None |

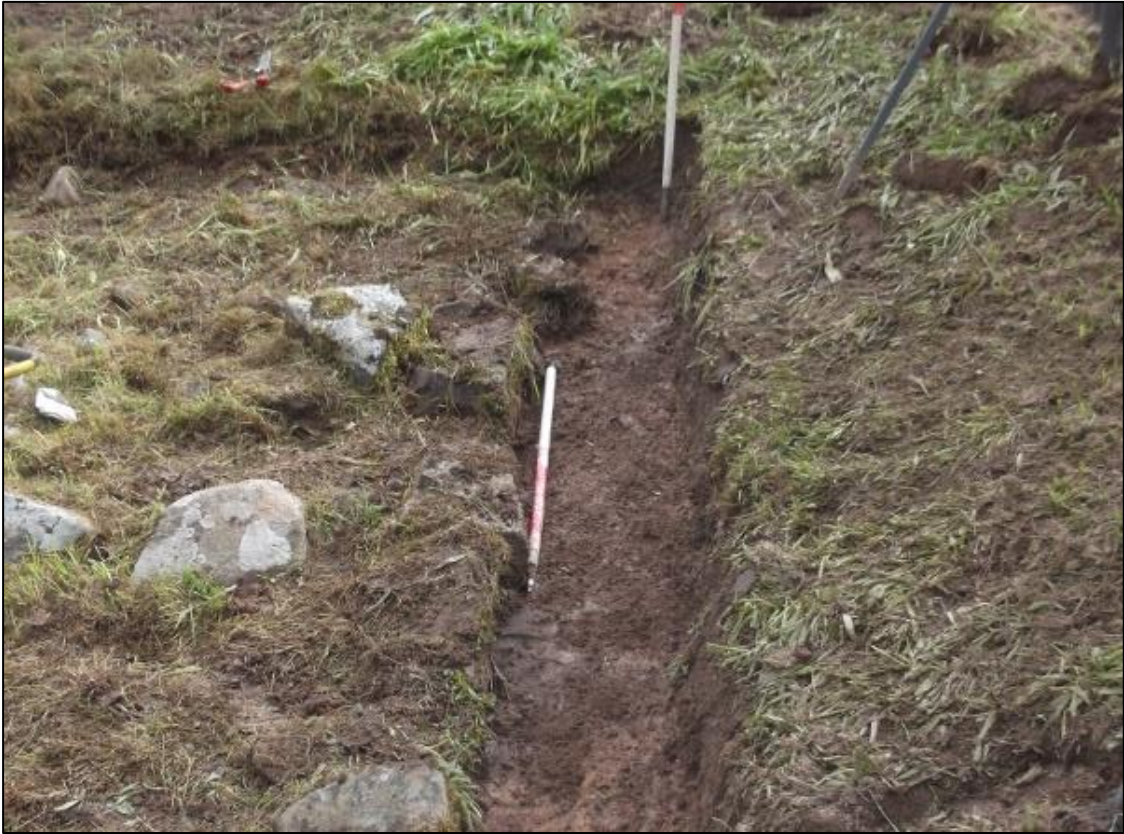
Figure 3a: View of southern slot trench showing rampart base kerb stones. From WNW.

15. Following the erection of the new enclosure fence two shallow trenches 150-200mm in depth were excavated against the front and rear face of the exposed rampart base (Figure 3a). The excavated trenches were lined with a geotextile material (terram) and were filled with a 20mm limestone gravel (Figure 3b). The full details of the two slot trenches are shown within Appendix 1.

16. The upper, topsoil, deposit within both trenches (001) comprised of moderately compacted mid grey-brown silty clay with occasional small stone and modern detritus (glass, white glaze pottery) inclusions, though a single shred of Samian ware (Find No. 4) was also recovered. The deposit had a depth range within the trenches of between 140 and 300mm. The underlying deposit (006) was exposed and cleaned but not excavated as it was possible that it was contemporaneous with the exposed rampart base and as such the scheduled monument consent did not allow it. This deposit comprised of moderately to firmly compacted, mid orange-brown/grey-brown clay with occasional to moderate small stone and occasional medium sized, flattish, stone inclusions.

23. The two shallow trenches excavated against the front and rear face of the exposed rampart base to create gravel strips were only excavated through the topsoil (001) to expose the underlying subsoil (006). The topsoil in both trenches was highly disturbed containing frequent inclusions of modern detritus such as plastic, modern glass, modern ceramic and tin cans (see appendix 2). However one small fragment of Roman period Samian ware (Find No. 4) was recovered within the southern slot trench alongside all of the modern material suggesting that some of this modern disturbance had affected underlying Roman deposits. Some flattish stones were noted within the exposed natural subsoil (006) which may possibly be the result of tumble from the rampart base or could have as easily just been naturally occurring.

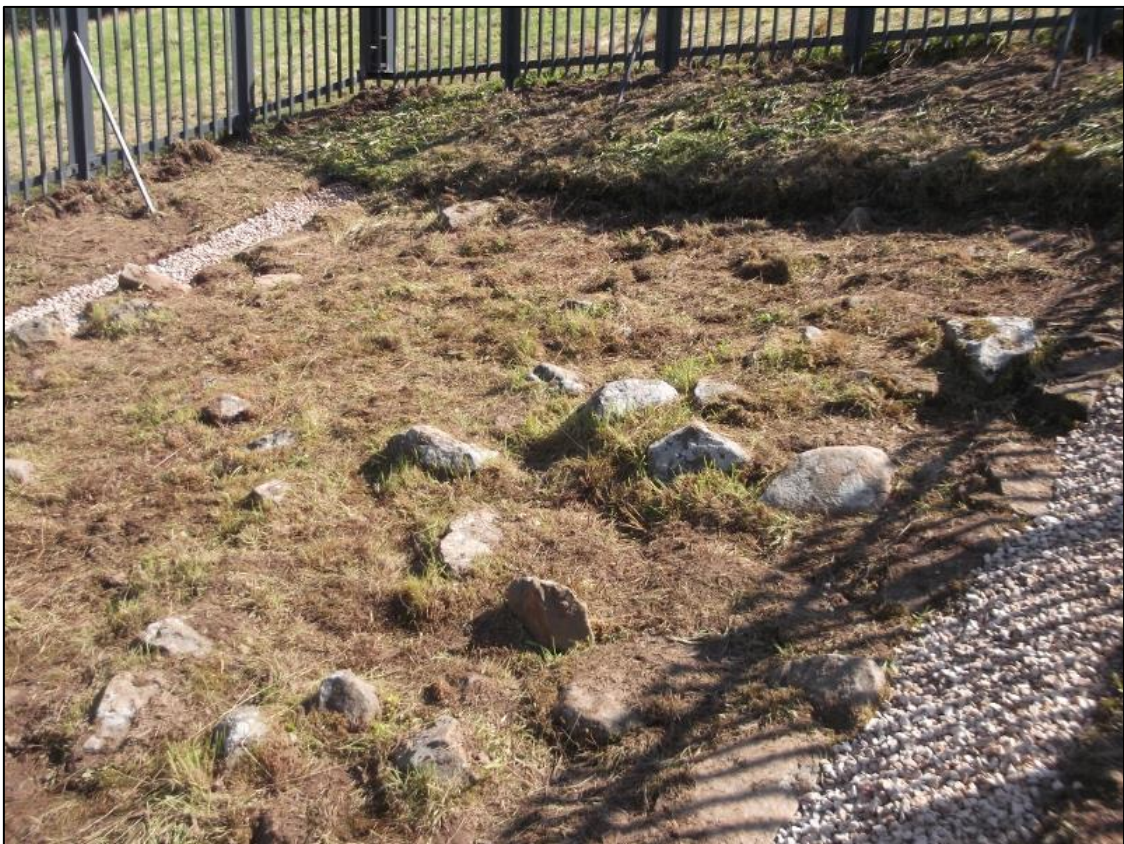
Figure 3b: View of southern and northern slot trenches with gravel laid out. From SW.

17. As well as the insertion of the two gravel strips the exposed rampart base was cleared of excess vegetation and all recent refuse was removed from the site. The vegetation was cut as short as possible using a petrol powered strimmer and hand shears/secateurs but enough was left covering the rampart to retain its structural integrity.

25. The rampart base at Goldenhill Park is NOT a solid bed of stone edged by continuous kerbs. Rather, the wall base has a discontinuous run of kerb stones to either side of a spread of stones bedded into subsoil. To prevent erosion we are managing the stones within a grass surface. The gravel strips have been placed to show the outside edges of these kerb stones.
