58 New Wynd, Montrose: Archaeological Mitigation

Data Structure Report

issued 4th March 2016

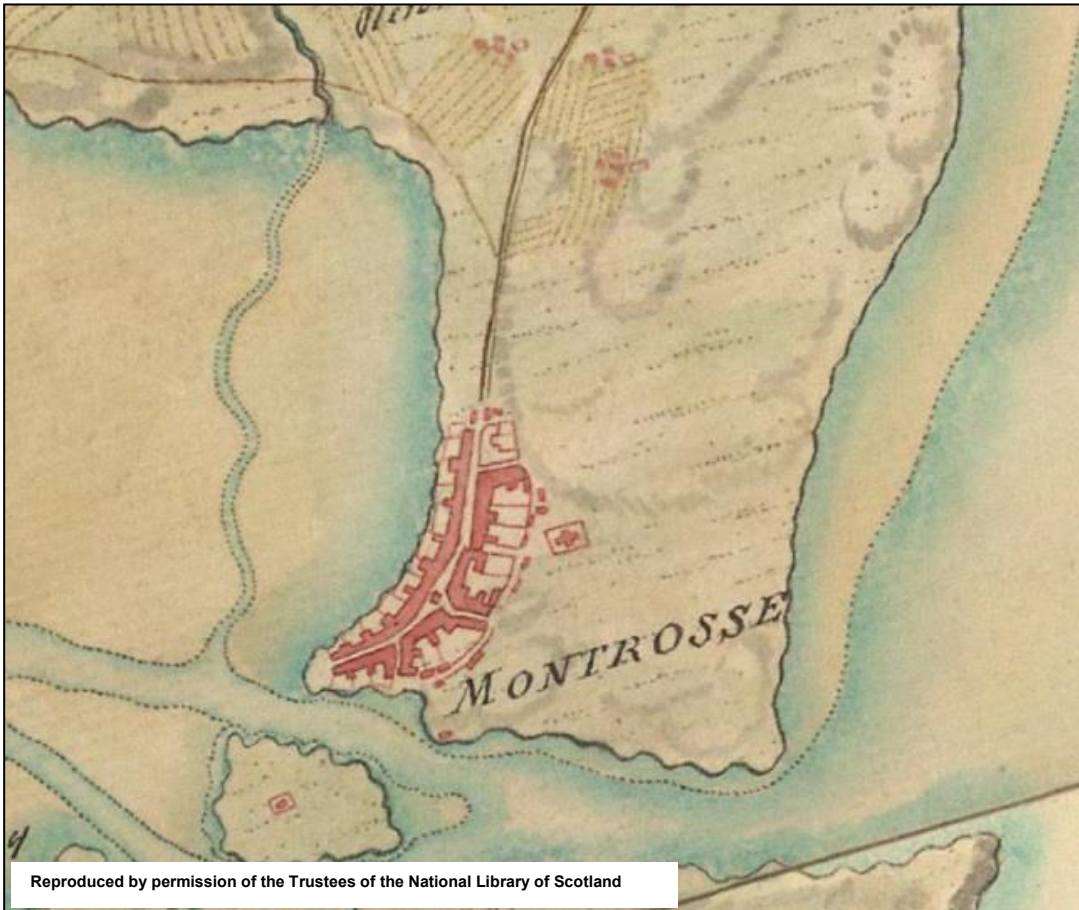
Figure 1a: Extract from Roy's *Military Survey of Scotland (Highlands)* (1747-52)

6. William Roy's *Military Survey of Scotland (Highlands)* (1747-52) (Figure 1a) is the first to provide a detailed depiction of the layout of Montrose formed by a single centrally located high street, with the buildings stretching out both east and west off of it. The town is located on the southwest corner of a peninsula with the North Sea to the east, and fronts onto the Montrose Basin to the west. The immediate area to the north of the town, and where the current proposed development is located, is an open area with three areas of cultivation and associated clachans on either side of the north-south road.

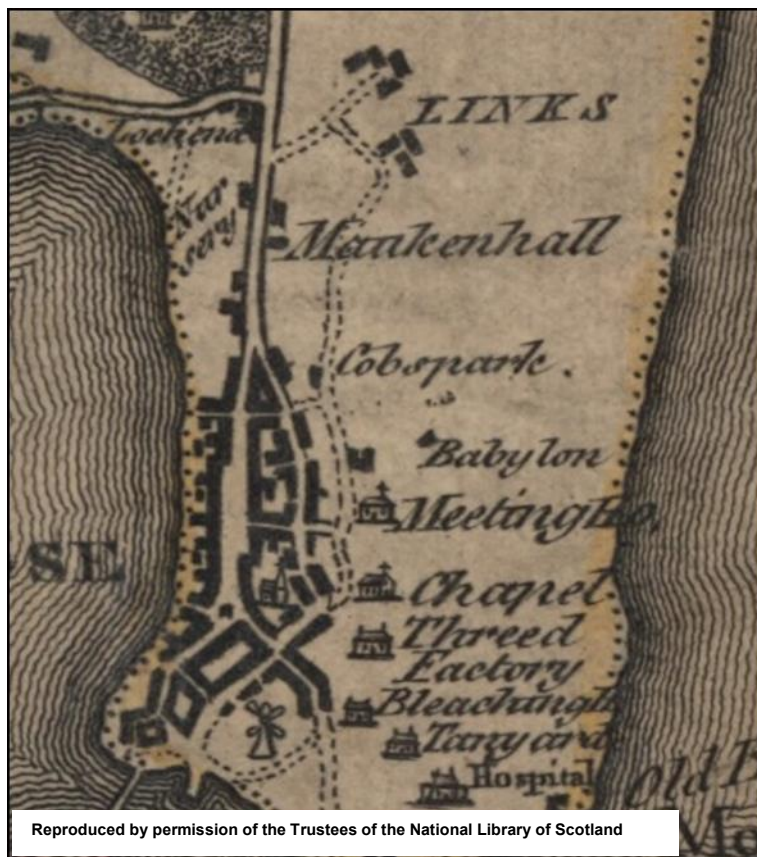
Figure 1b: Extract from Ainslie's *Map of the County of Forfar or Shire of Angus (North East Section)* (1794)

7. John Ainslie's *Map of the County of Forfar or Shire of Angus* (1794) (Figure 1b) depicts the three clachans and accompanying cultivated areas and labels them 'The Links'. There has also been a slight expansion to the north along the main high street road, and also a number of new buildings which are depicted to the east of the main settlement with an accompanying road. Ainslie provides their name/function which includes a thread factory, bleaching hall, tanning yard and a hospital.

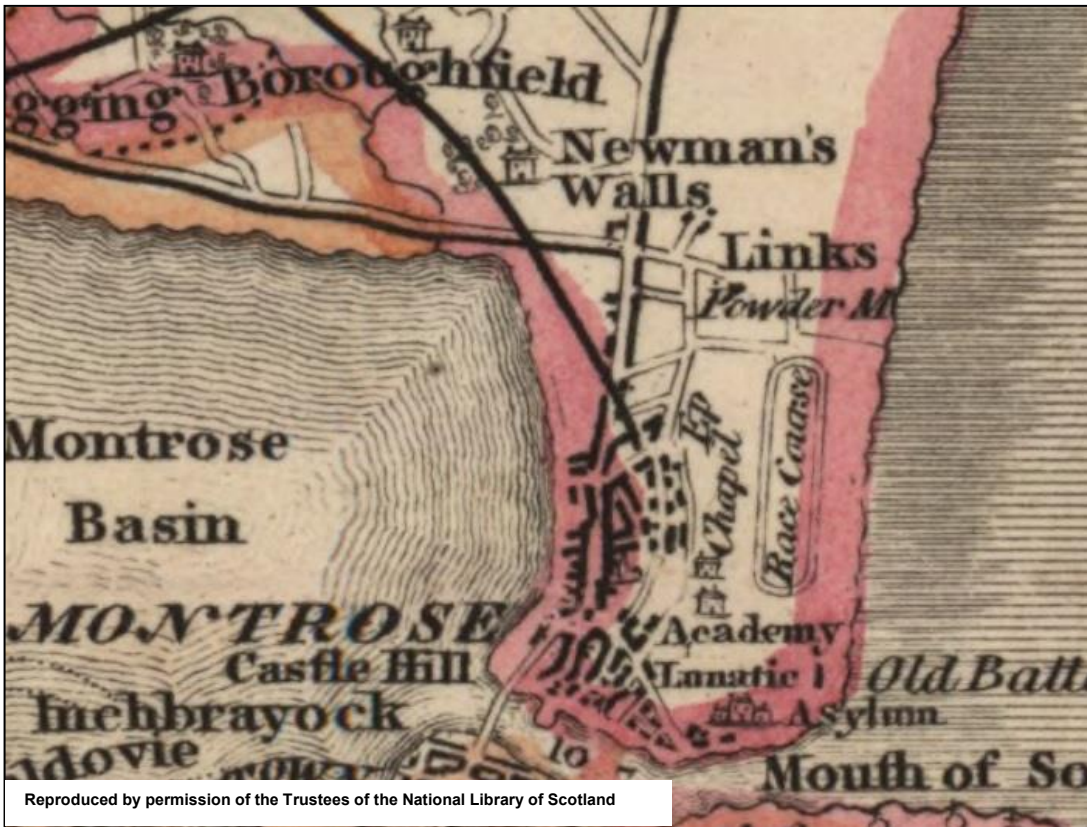
Figure 2a: Extract from Knox's *Map of the Basin of the Tay*, including the greater part of Perth shire, Strathmore and the Breas of Angus or Forfar (1850)

8. There is very little change between Ainslie's (1794) and John Thompson's *Atlas of Scotland: Northern Part of Angus shire* (1825) (not shown) survey. By the time of James Knox's *Map of the Basin of the Tay, including the greater part of Perth shire, Strathmore and the Breas of Angus or Forfar* (1850) (Figure 2a), there has been expansion to the northeast of the original urban area.

9. Knox's survey (1850) (Figure 2a) depicts a period in the growth of Montrose that evolved into the present day layout. Although the roads are not labelled, it is possible to use the current street plan and Knox's to suggest that this is the period that Mill Street and Baltic Street, which joins from the south, were first laid out. There are structures depicted, but it is not possible with any confidence to propose that one of these is the location of the proposed development.

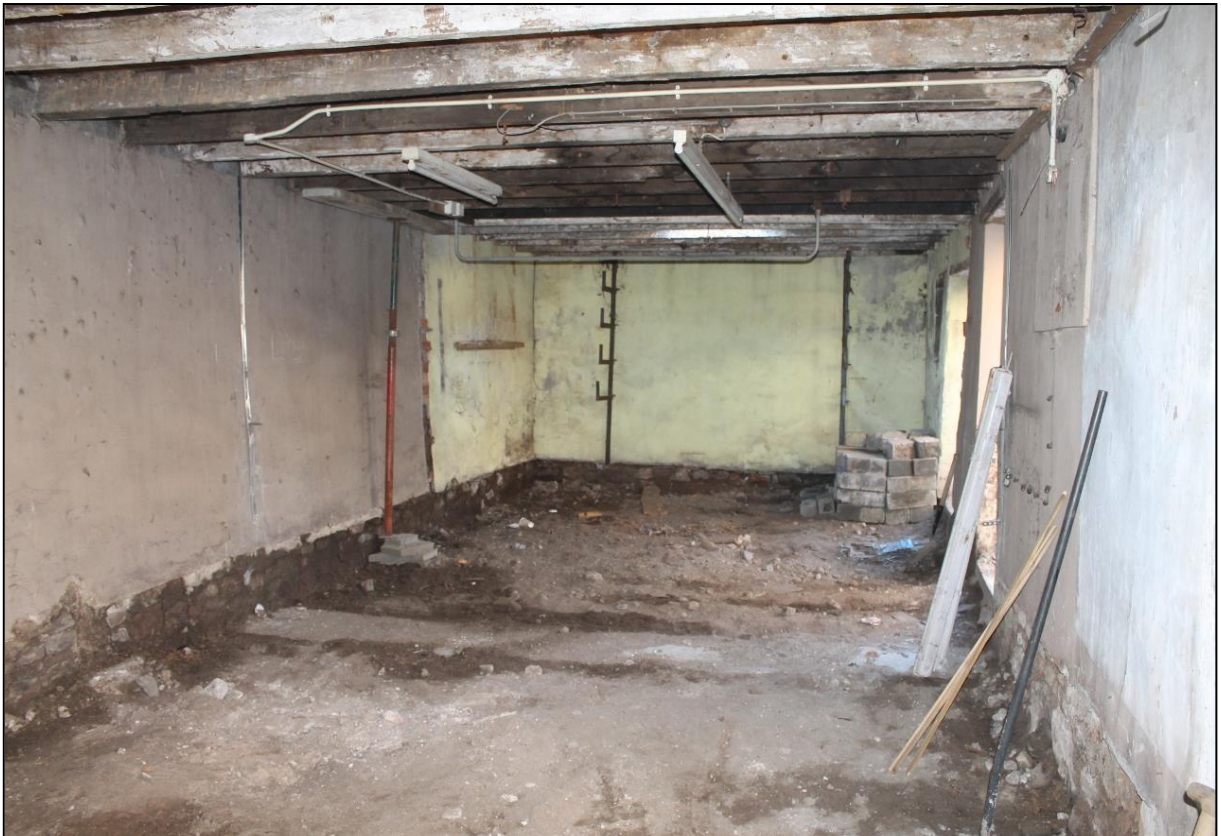
16. The archaeological monitoring works covered the inspection of the interior of the redundant store which had been previously cleared of material (Figure 4a) and the machine digging; by a Kubota KX0164, of a service trench within the courtyard between the redundant store and buildings fronting New Wynd (Figure 4b).

Figure 4a: Interior of the redundant store

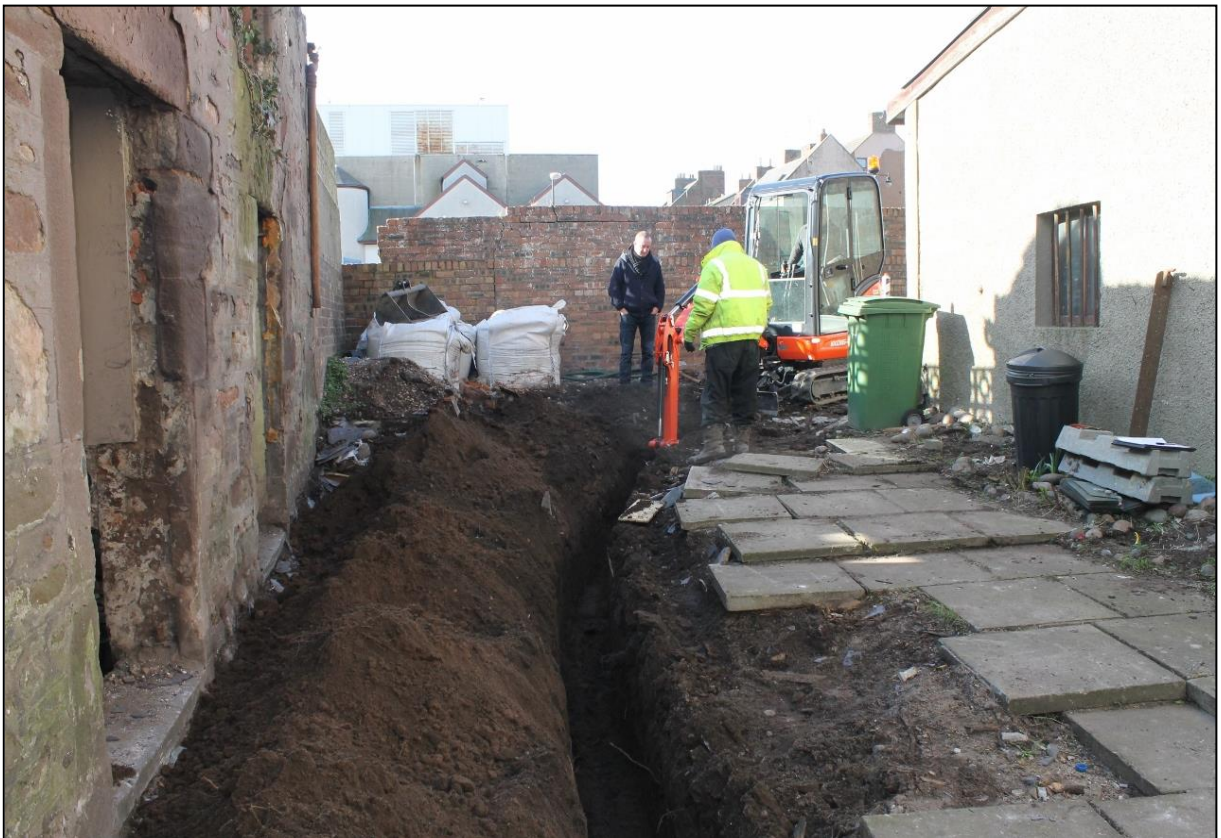
Figure 4b: Excavation for the service trench

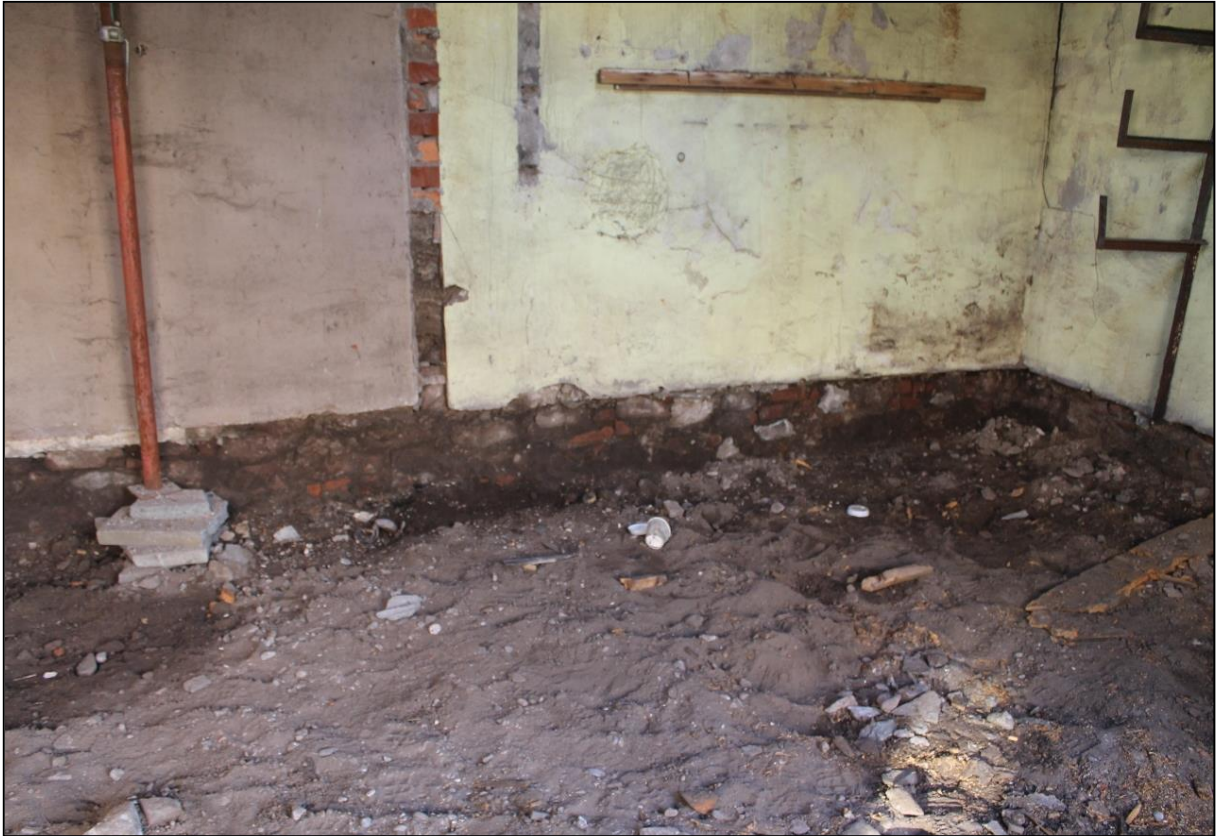
17. The structure that is to be changed into two one bedroom flats is located to the rear of the buildings that front onto New Wynd. Aligned east-west and approximately 11m by 4m, the interior of floor/ground had been reduced by 350mm prior to monitoring taking place (Figure 5a). This material was inspected before removal and consisted of a mid-brown sandy silt with modern inclusions of salt glazed pipe, red brick, concrete, and rounded pebbles that may have been a former floor surface (001).

18. The interior had previously been covered by a concrete floor 120mm thick. A small area was still in-situ and forming the inclusions of the concrete were rounded pebbles that were also observable within the removed material (001).

Figure 5a: Demonstrating the depth of removed material from the interior of the redundant store

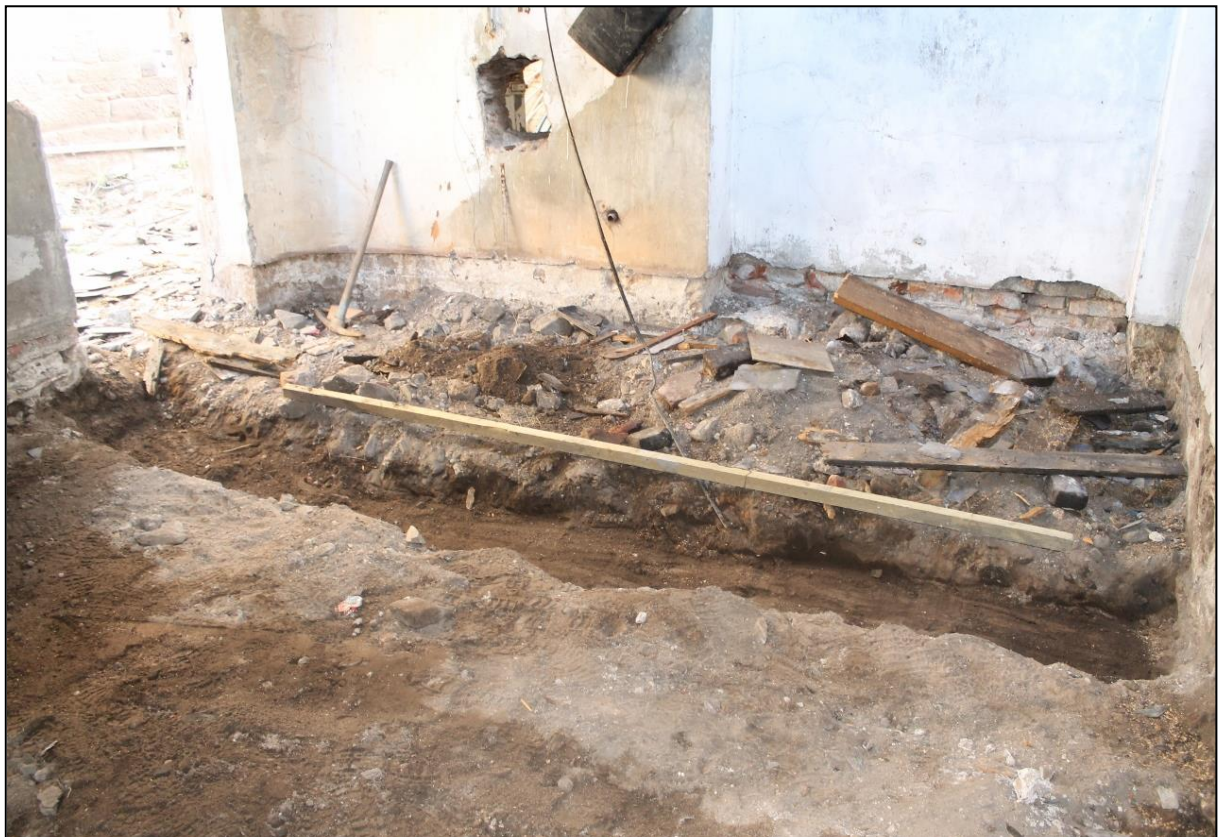
19. At the east end of the structure a service trench had been excavated (Figure 5b). This was located 1.60m from the eastern wall and aligned north-south. It measured 600mm wide by 4m long and 200mm deep and cut through (001), coming down onto a moderately compacted, dark brown sandy silt with no inclusions (002)

Figure 5b: Service trench at the east end of the redundant store

25. The monitoring works did not reveal any significant archaeological material from within the development area. The removal of the paving slabs revealed that (003) formed the levelling surface on to which the paving slabs were laid. The exposed area of (002) from the small service trench within the redundant store may possibly represent an earlier garden soil, but the small area exposed leaves this inconclusive.

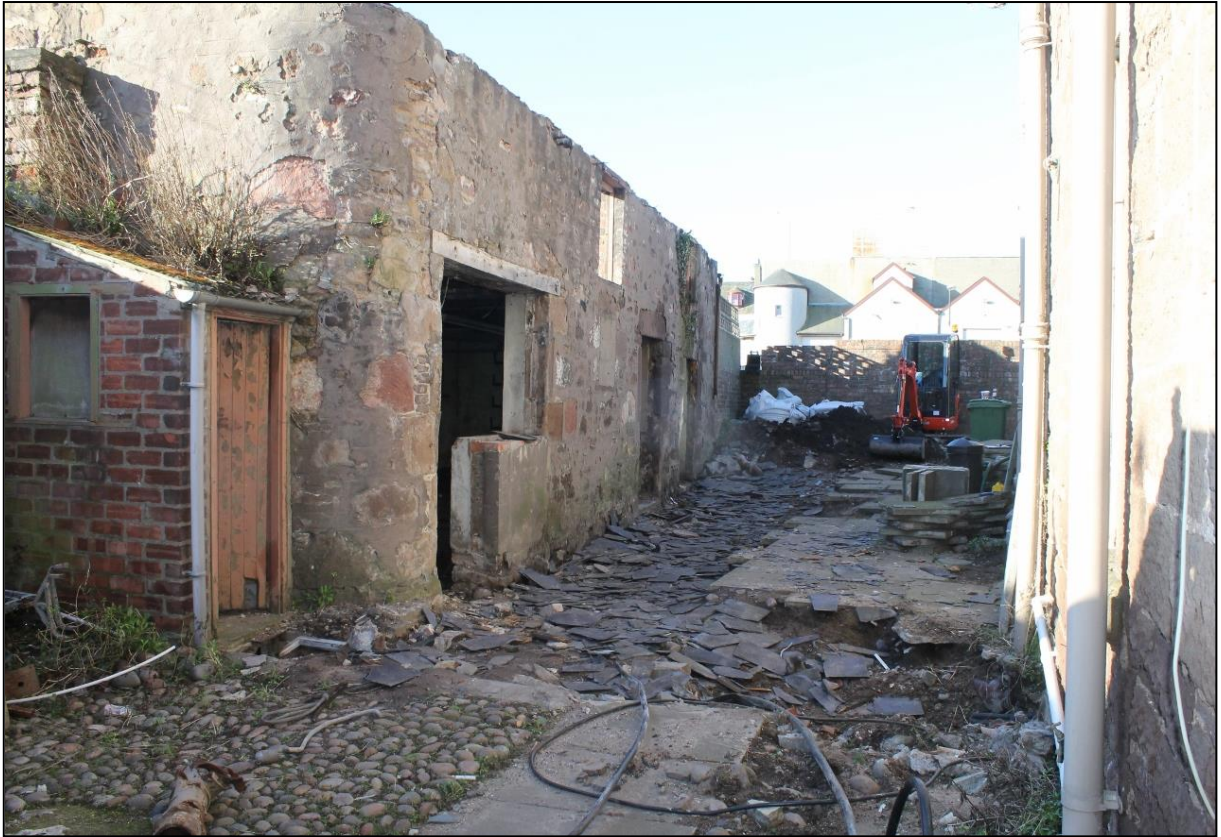
Figure 6a: Demonstrating the area where paving slabs have been removed for the excavation of the service trench

20. Between the redundant store and the shops fronting New Wynd the courtyard had paving slabs forming the ground surface. An area of approximately 12m by 4m of paving slabs had already been removed (Figure 6a) with 140mm of a loose compacted sand with some rootlets (003) from below the paving slabs already removed.

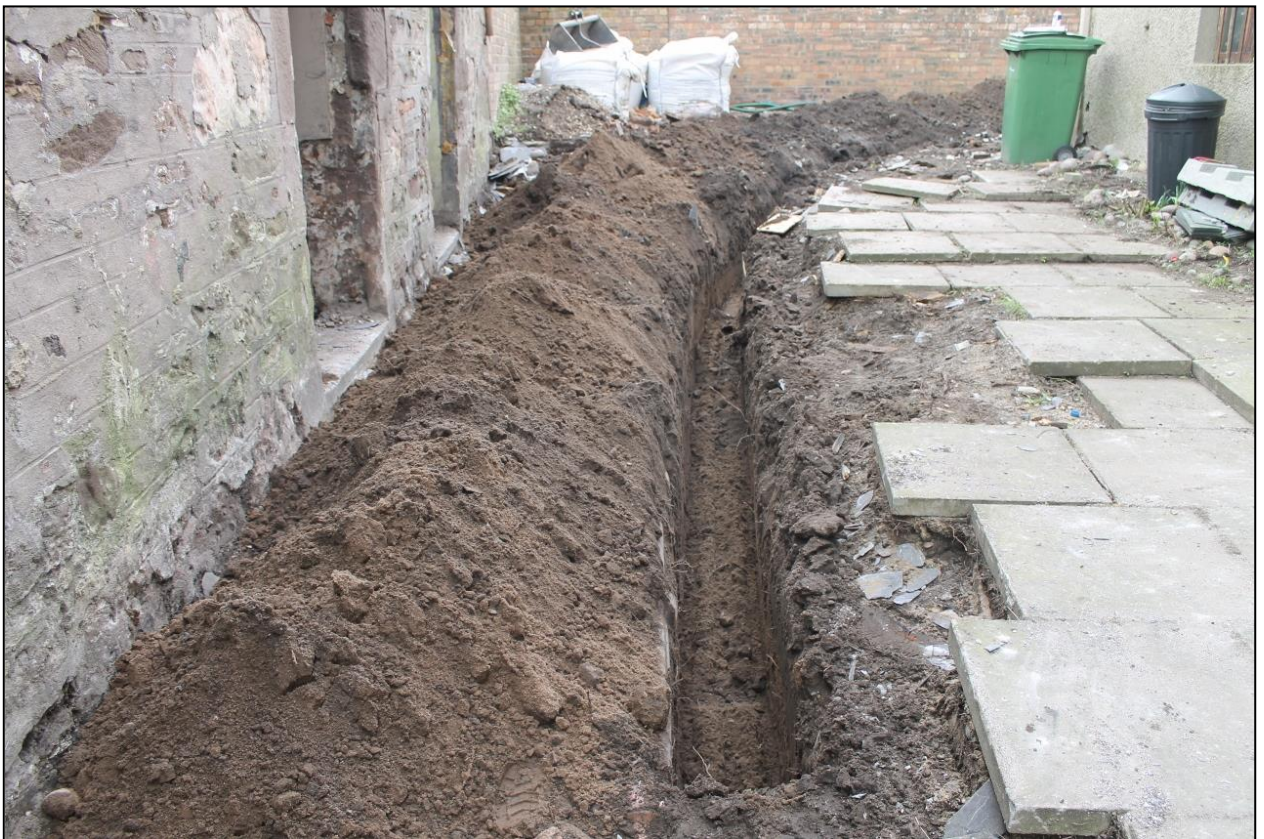
Figure 6b: Service trench excavated

21. The service trench was aligned east-west and located in front of the redundant store (Figure 6b) and measured 16m in length and 400mm wide by 700mm in depth. After 9m the trench turned north to join New Wynd.

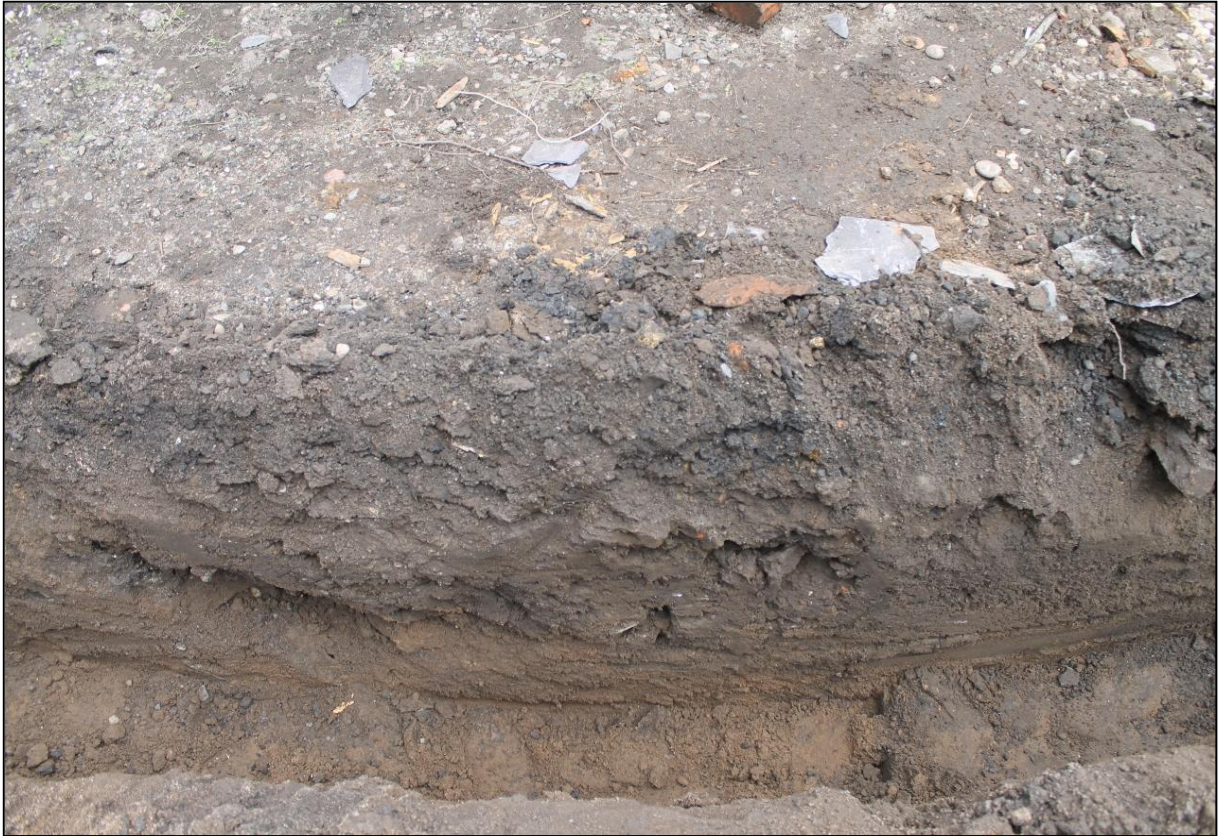
Figure 7a: Demonstrating contexts (002) and (004) within the service trench

22. The upper 300mm of the east end of the service trench for approximately the first 8m had been disturbed by the insertion of previous services with the surrounding deposit formed of (002) (Figure 7a). The base context (004) was formed of a moderately compacted, light brown yellow sand with flecks of charcoal and infrequent roots (Figure 7a).

26. The excavation of the service trench revealed that the courtyard area has been substantially disturbed by the insertion of previous services and affected both deposits (002) and (004). Where (002) represents a possible previous garden deposit, context (004) is most likely the natural subsoil with the flecks of charcoal recorded most likely present due past anthropic activity and bioturbation.

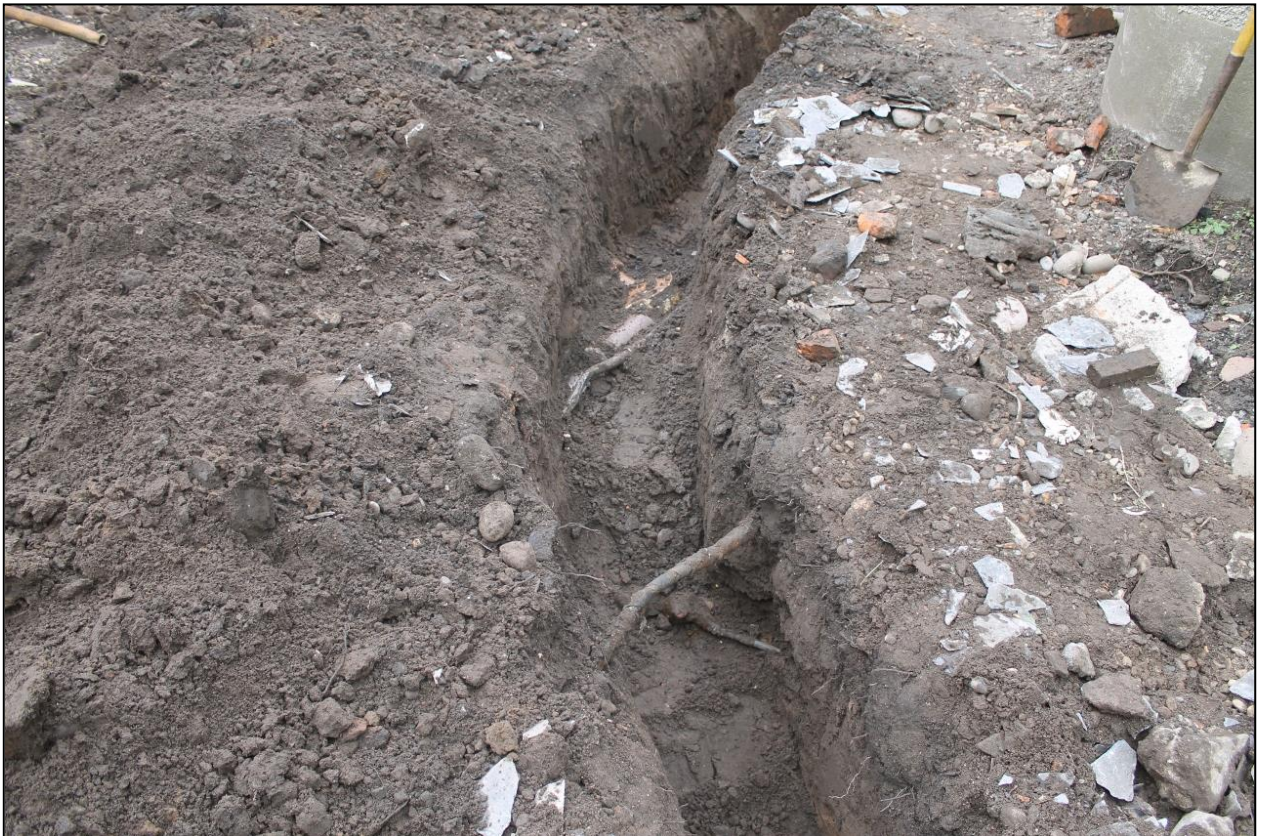
Figure 7b: Demonstrating disturbance from previously laid services

23. At approximately 9m from the start of the service trench to the east there has been substantial disturbance to (002) and (004) from the insertion of more services (Figure 7b). The remainder of the trench has the same underlying deposits as the east end, although (004) has been disturbed and redeposited by the insertion of a service pipe running parallel to the service trench.
