Townhouse, Irvine, North Ayrshire,

Stage 2 Excavation Works:

Data Structure Report Addendum

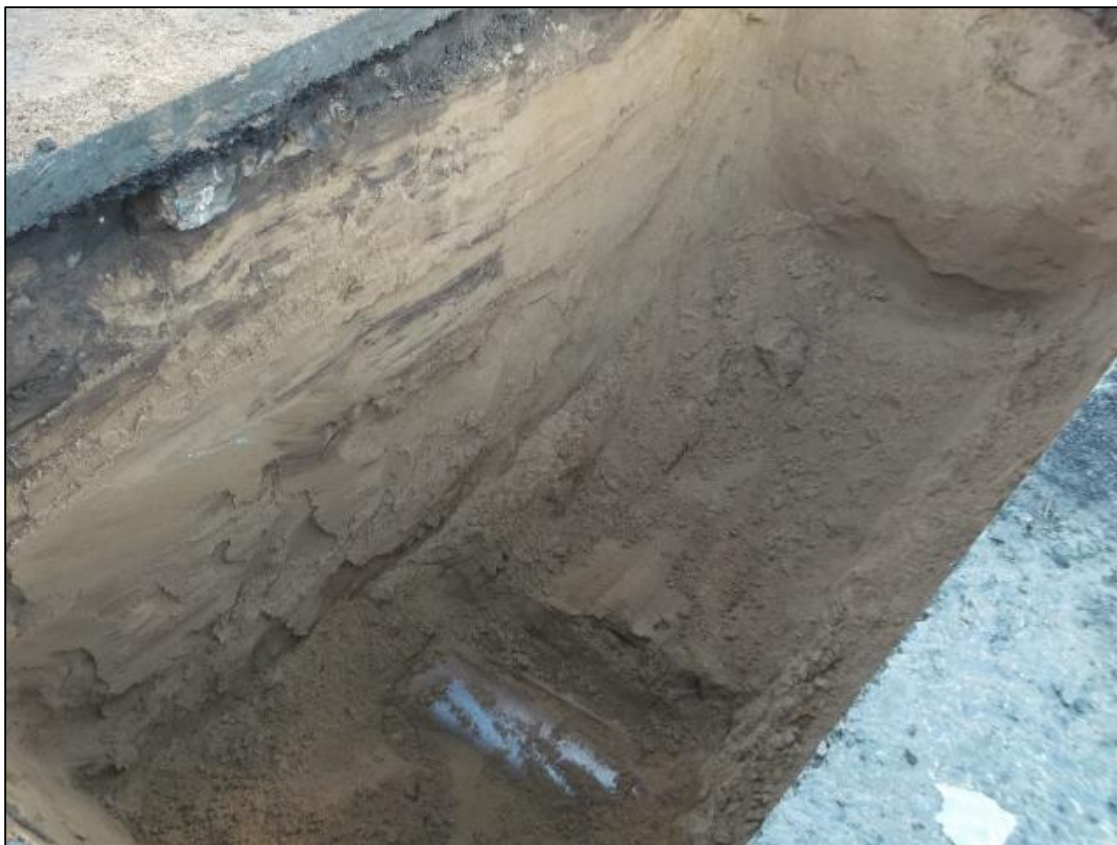
6. Cutting through these sand layers were two service pipes. The SSW pipe was a 19th or 20th century ceramic sewage pipe [5005] / (5006) which was still in use (Figure 1a). The second service pipe [5011] / (5012) was located close to the existing manhole cover in the NNE part of the trench and consisted of a metal water mains pipe (Figure 1b).

Figure 1a: ESE facing section of trench showing sewage pipe [5005] / (5006)

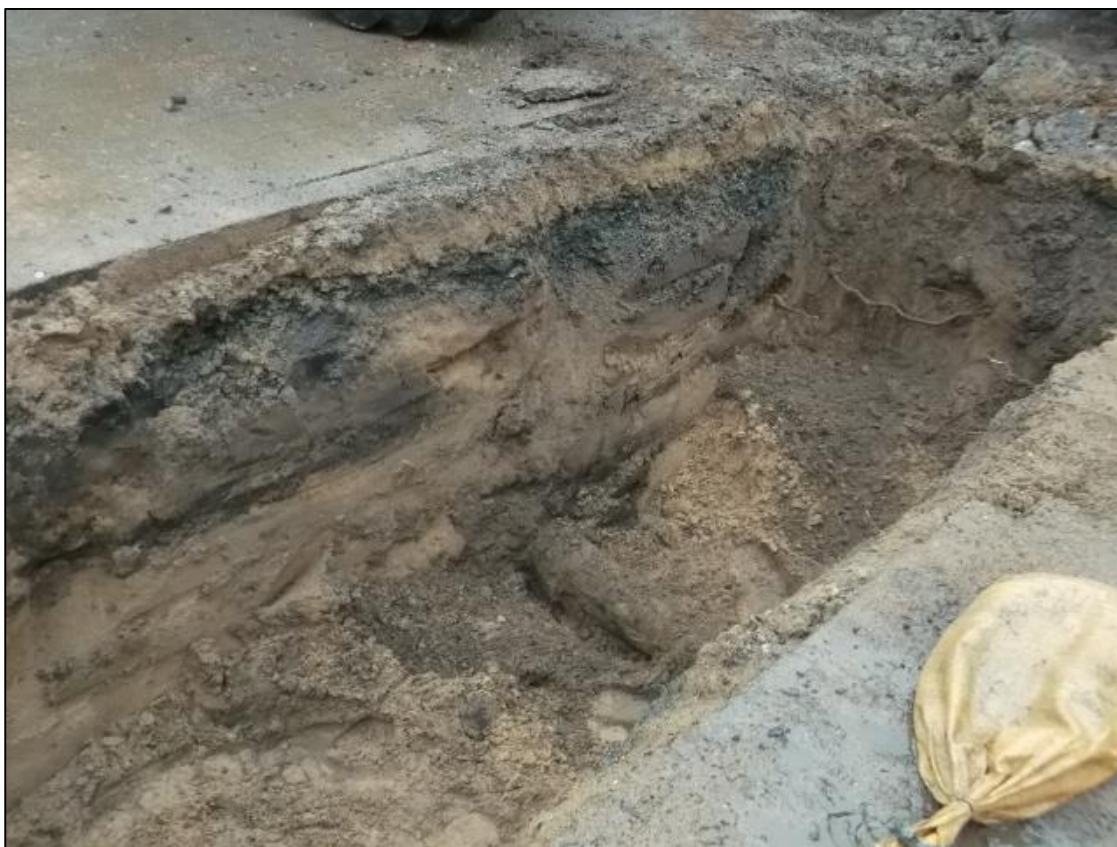
Figure 1b: ESE facing section of trench showing water mains pipe [5011] / (5012)
