Netherhall, Sandilands, South Lanarkshire: Archaeological Watching Brief

Data Structure Report

on behalf of G2 Energy

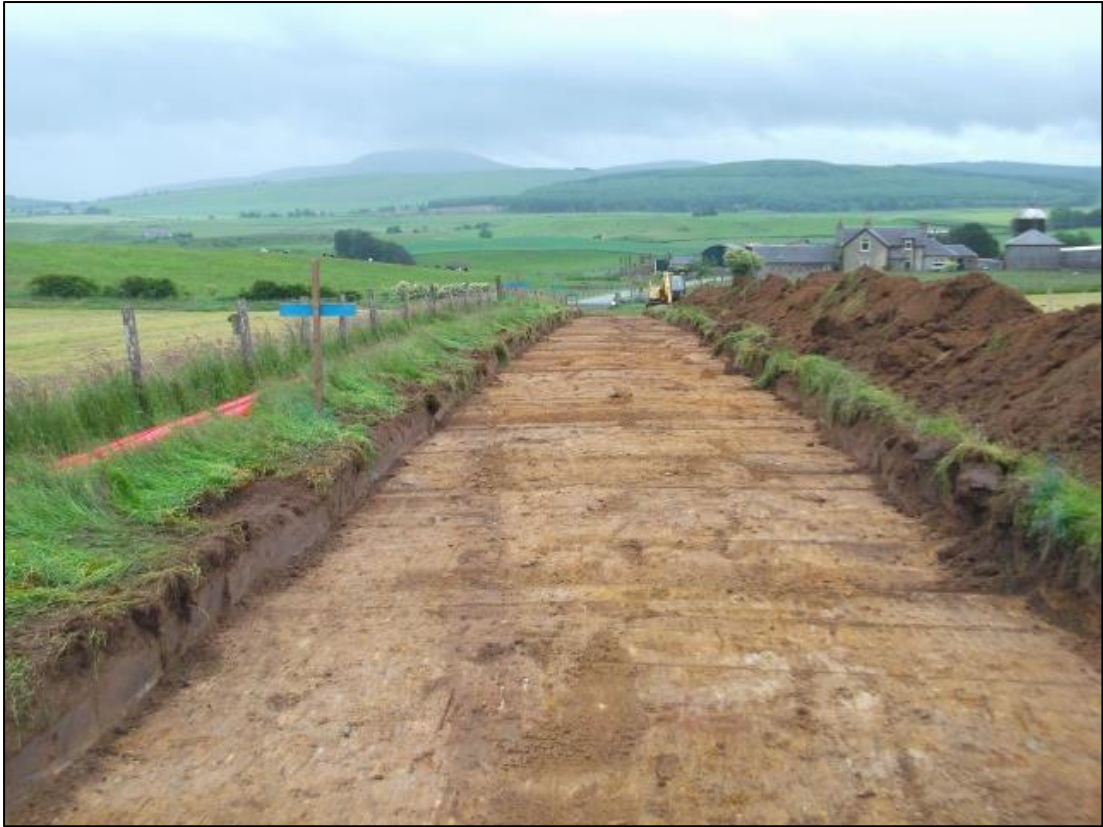
Figure 3a: Post excavation view of access track near main road showing field drains (004). From the NW.

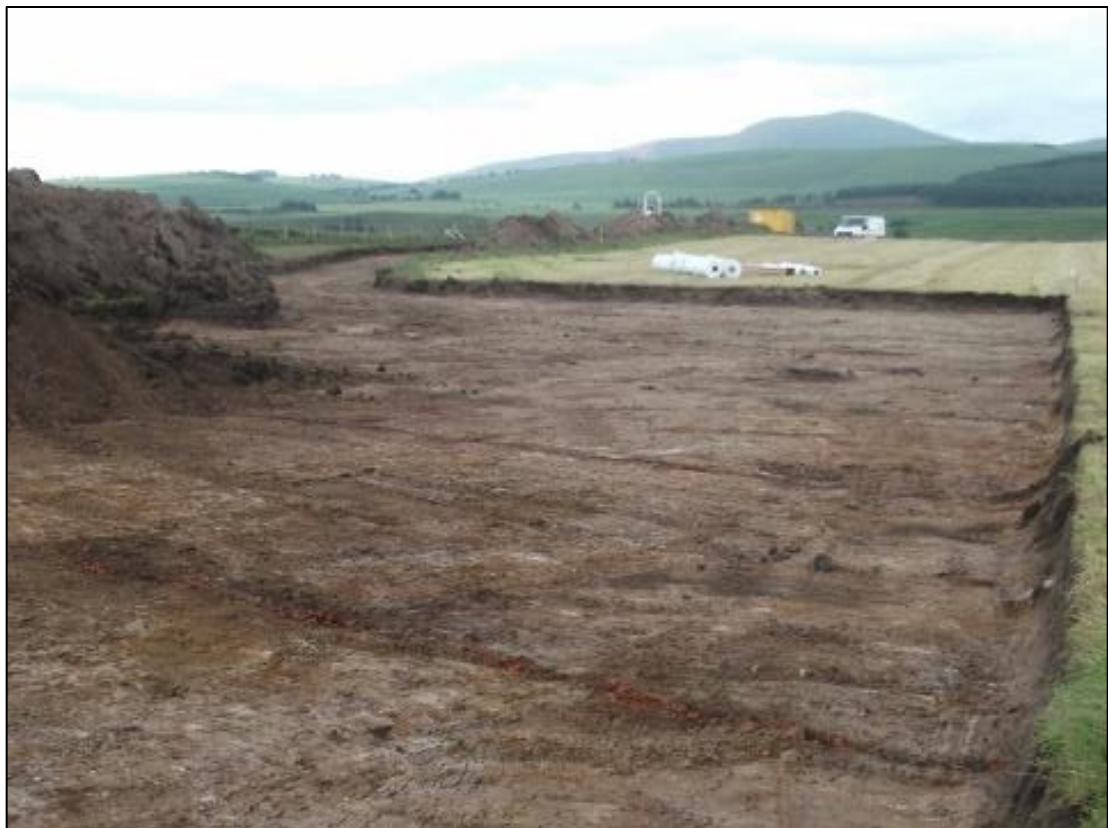
13. The excavation within the main construction area, access track revealed two series of modern drains. The first series of drains, (003), encountered was in the crane pad, north western end of the access track and cable trench. These drains (Figure 3b) comprised of red/buff coloured ceramic pipes running in a NNE-SWW direction across the site. The ceramic pipes had a diameter of 100mm and were within a narrow trenches which had a width of 0.2m. The fill surrounding the pipe consisted of mid to dark grey-brown sandy clay with no inclusions. The drains were located 300-350mm below ground level and each individual drain was spaced at intervals of approximately 5.2m. The second series of drains, (004), were located in the south eastern part of the access track and cable trench. These drains (Figure 3a) comprised of linear features running in a WNW-ESE direction across the site. The linear features had a width of 0.35m and each individual drain was spaced at intervals of approximately 11m. The features fills consisted of a compact, mixed mid orange-brown/red-brown silty sand with occasional small and medium stone and pebble inclusions.

Figure 3b: Post excavation view of the crane pad showing ceramic drains (003). From the WNW

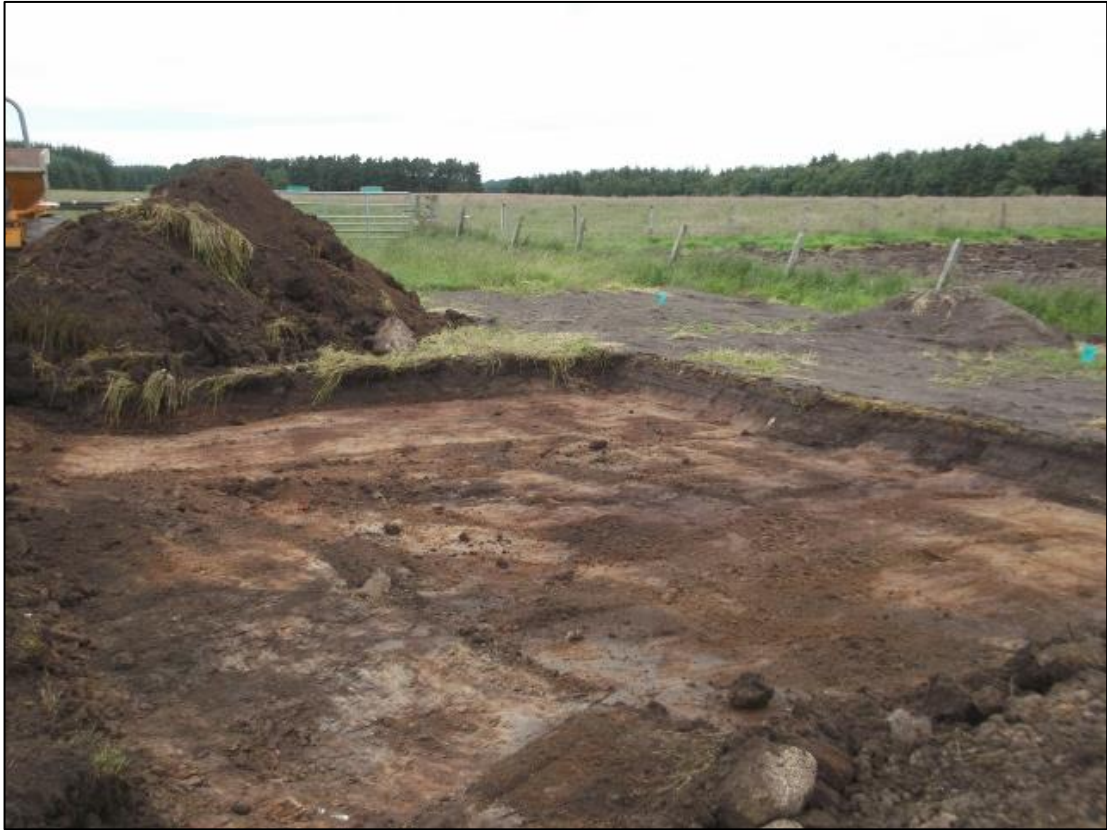
11. The Crane pad (Figure 3b) joined on to the western end of the access track and consisted of a large rectangular area which measured 35m from southwest to northeast and 20m from northwest to southeast. The crane pad excavation had a depth range of 400-450mm. The turbine pad (Figure 4a) and substation (Figure 4b) were located to the immediate northwest and northeast respectively. The turbine pad was sub circular shaped with a diameter of 10m and was excavated to a depth of 350-400mm. The substation was rectangular shaped and measured 7.5m from southwest to northeast and 8.5m from northwest to southeast.

Figure 4a: Post excavation view of substation. From the S.

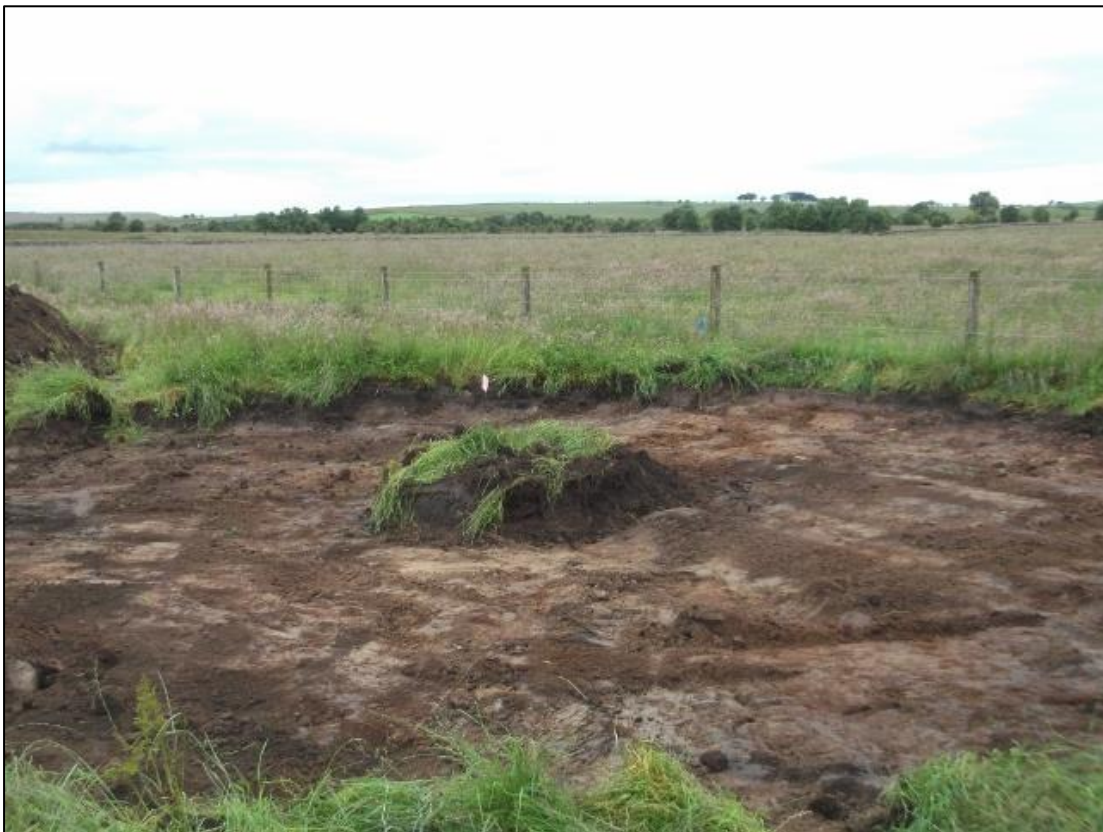
Figure 4b: Post excavation view of turbine pad. From the SE.
