Millbrae Bridge, Glasgow City: Archaeological Watching Brief

Data Structure Report

issued 21st July 2016

on behalf of Scottish Water Specialist Services

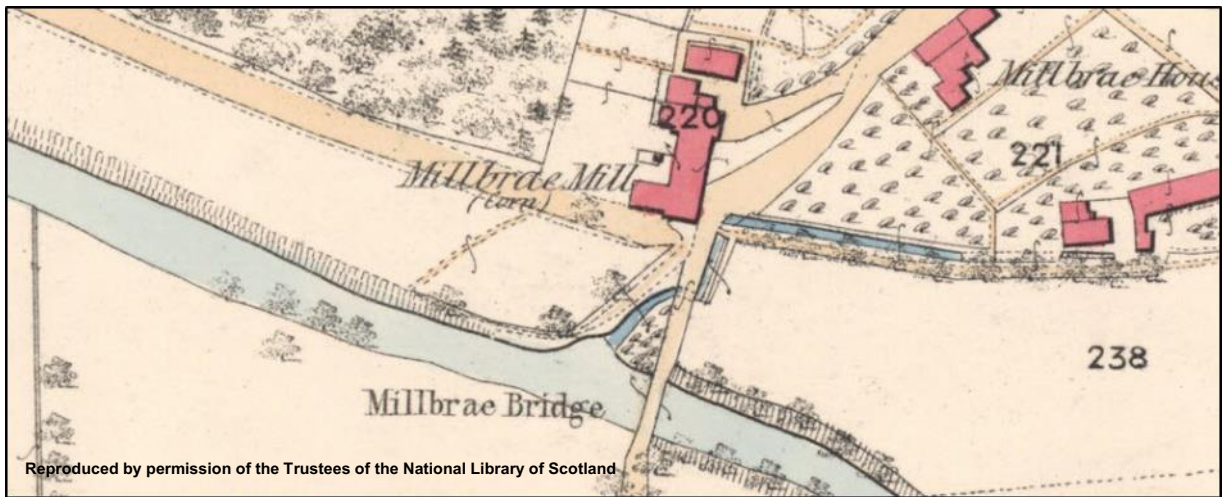
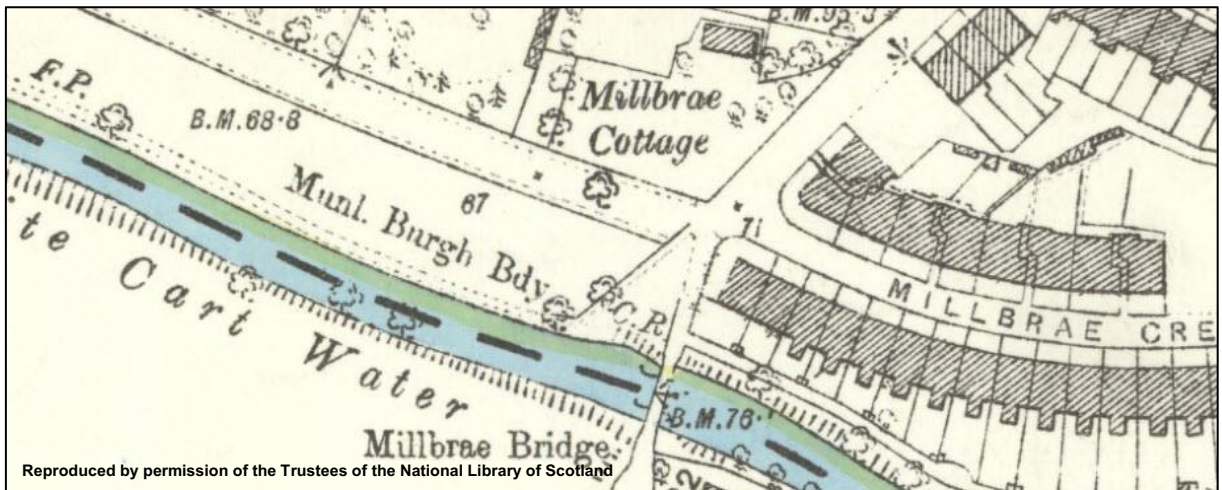
Figure 1: Extract from historic Ordnance Survey maps

A – 1863 1st edition Ordnance Survey

B – 1896 2nd edition Ordnance Survey

C – 1915 3rd edition Ordnance Survey

6. In the mid 19th century the ground to the immediate NE was dominated by Millbrae Mill (see Figure 1a). This industrial complex extended into the development area with the outfall of the lade, that provided water power, discharging into White Cart Water to the immediate west of the Millbrae Bridge. A track also fell down to the waterside adjacent to this lade outfall.

7. Industrial use of the areas appears to end in the mid to late 19th century, with the change to late 19th century residential expansion, shown through the construction of Millbrae Crescent (Figure 1b). It is notable at this time that the open lade had been covered or infilled – through the broader garden to the W of the end terrace on the southern side of Millbrae Crescent clearly respected the line of the lade.

8. By the early 20th century (Figure 1c) the historic, narrow bridge at Millbrae had been replaced by a newer, broader bridge. The alignment and placement of this new structure clearly shows that it was built to the immediate west of the historic bridge. This presumably allowed the historic bridge to be in use until the replacement bridge was completed, that in turn enabled the dountaking of the historic bridge. This migration W of the bridge means that the majority of the alignment of the lade to the W of the historic road (Figure 1a) now lies under the modern carriageway.

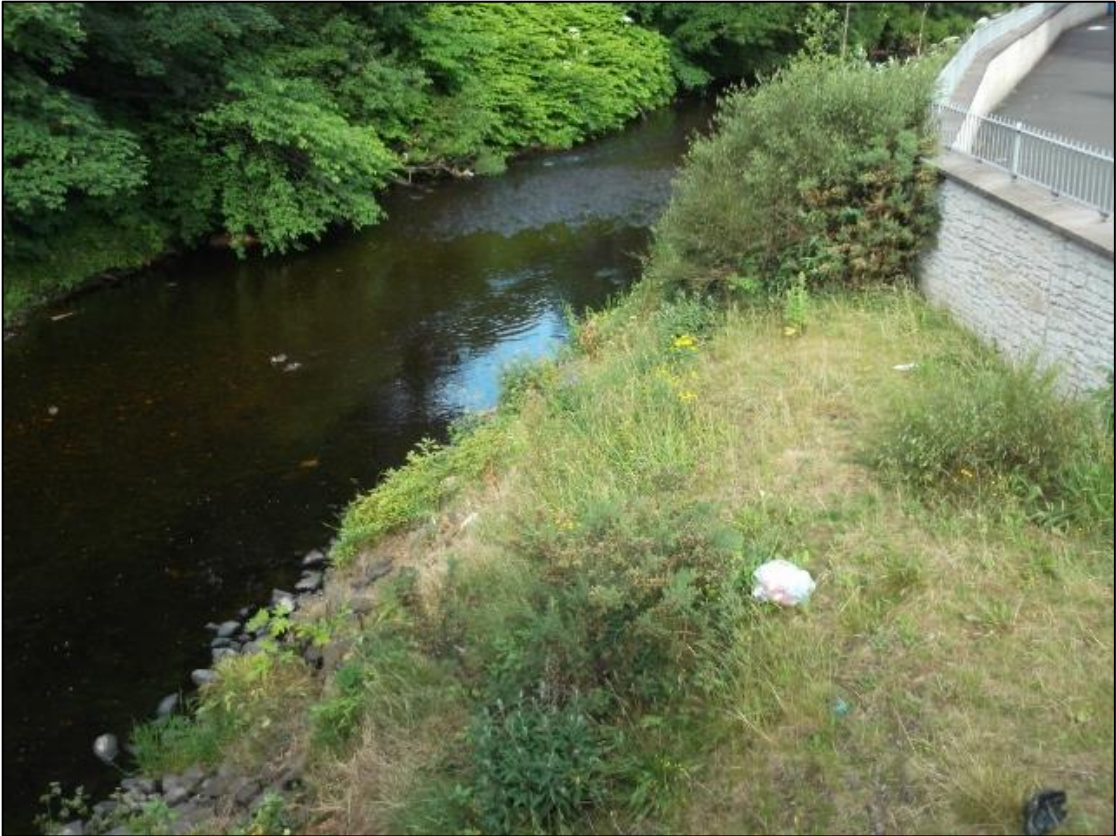
Figure 3a: Pre excavation view of the Outfall Trench area. From W

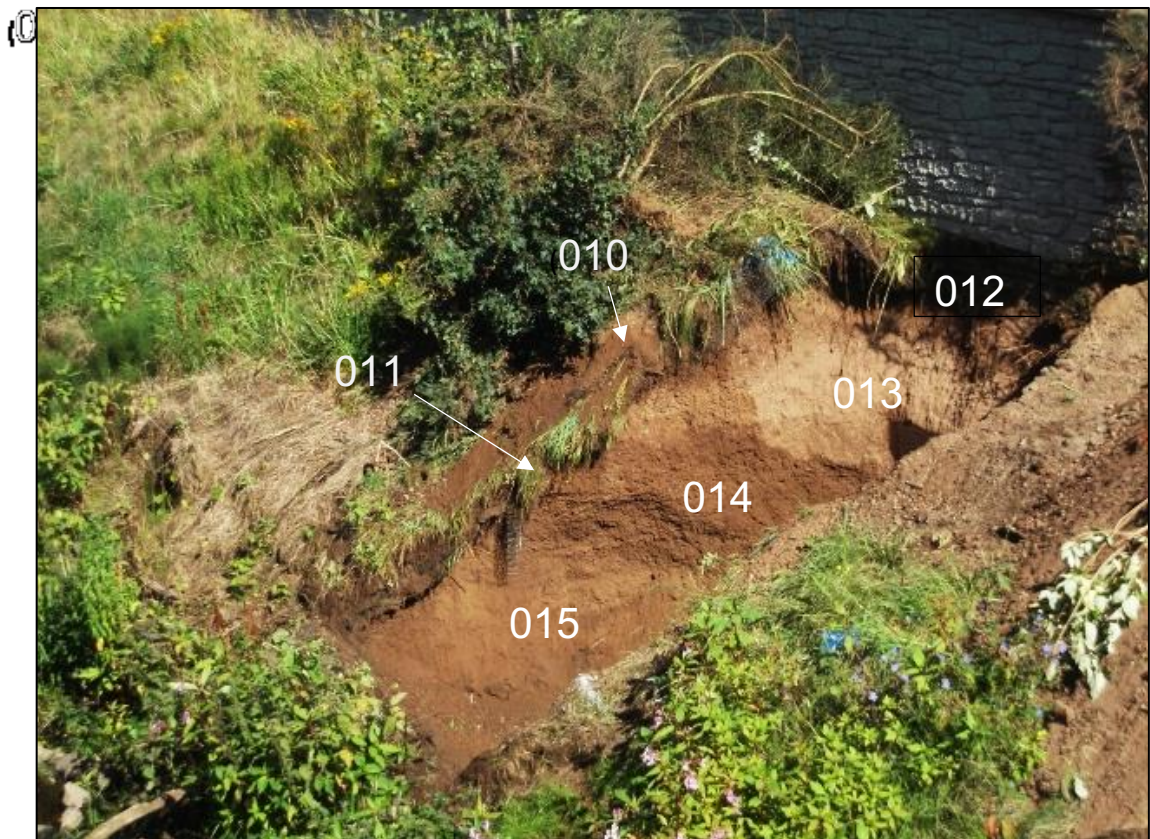
12. Three main areas were monitored during the archaeological watching brief. The first was the outfall trench (Figures 2 and 3b) which was located on the northern bank of White Cart Water and to the immediate WNW of Millbrae Bridge. The trench measured 4m from SSW to NNE (bottom of riverbank to top of riverbank), 2m from WNW to ESE and had a depth range of 0.75m at the bottom of the river bank and 3m at the top of the riverbank. The upper layer within the outfall trench, (010), comprised of moderately compacted, mid to dark grey brown silty sand with occasional small stone and pebble inclusions. The thickness range of the deposit was between 0.1-0.15m. Beneath this deposit was a thin layer of metal and plastic meshing, (011).

13. Beneath the meshing layer the riverbank was made up of a series of four deposits, (012), (013), (014) and (015). The uppermost deposit, (012), comprised of moderately compacted, light to mid grey brown sand with occasional small stone and pebble inclusions. Thickness of the deposit was 0.4m. Deposit (013) comprised of moderately compacted, pale yellow sand with no inclusions. The thickness of the deposit was between 0.5-0.7m. Deposit (014) comprised of moderately compacted, mid yellow-brown sand with occasional gravel and pebble inclusions. The thickness of the deposit was between 0.8-1.2m. The lowest deposit, (015), comprised of moderately compacted, mid grey-brown sand with moderate gravel, pebble and small stone inclusions. The deposit was excavated to a depth of between 0.75-1.2m.

17. All of the deposits identified within the outfall trench were anthropic in nature rather than a naturally occurring riverbank (Figure 3b). Deposits (010), (012) and (013) and the metal

and plastic meshing, (011), all abutted the modern wall, (016), which was associated with the flats located in between the river and Tantallon Road. The meshing, which lay under the topsoil, seems to have been a recent attempt to stop erosion along the river bank. The lowest deposits within the outfall trench, (014) and (015), abutted metal sheeting, (017), which lay, vertically, beneath the modern wall, (016). This sheeting seems to have acted as a retaining support along the northern riverbank which stopped erosion or subsidence to the ground directly behind the riverbank.

Figure 3b: Post excavation view of Outfall Trench, showing context numbers. From WSW

21. The archaeological monitoring works at the outfall trench (covered by the planning consent) cut through the riverbank uncovered anthropic deposits most likely relating to the reconstruction of the riverbank at some point during the twentieth century.

22. No significant archaeological remains were identified within this element of the development area, it is recommended that no further work should be carried out. The appropriateness and acceptability of our recommendations rest with Glasgow City Council and their advisors, the West of Scotland Archaeological Service.

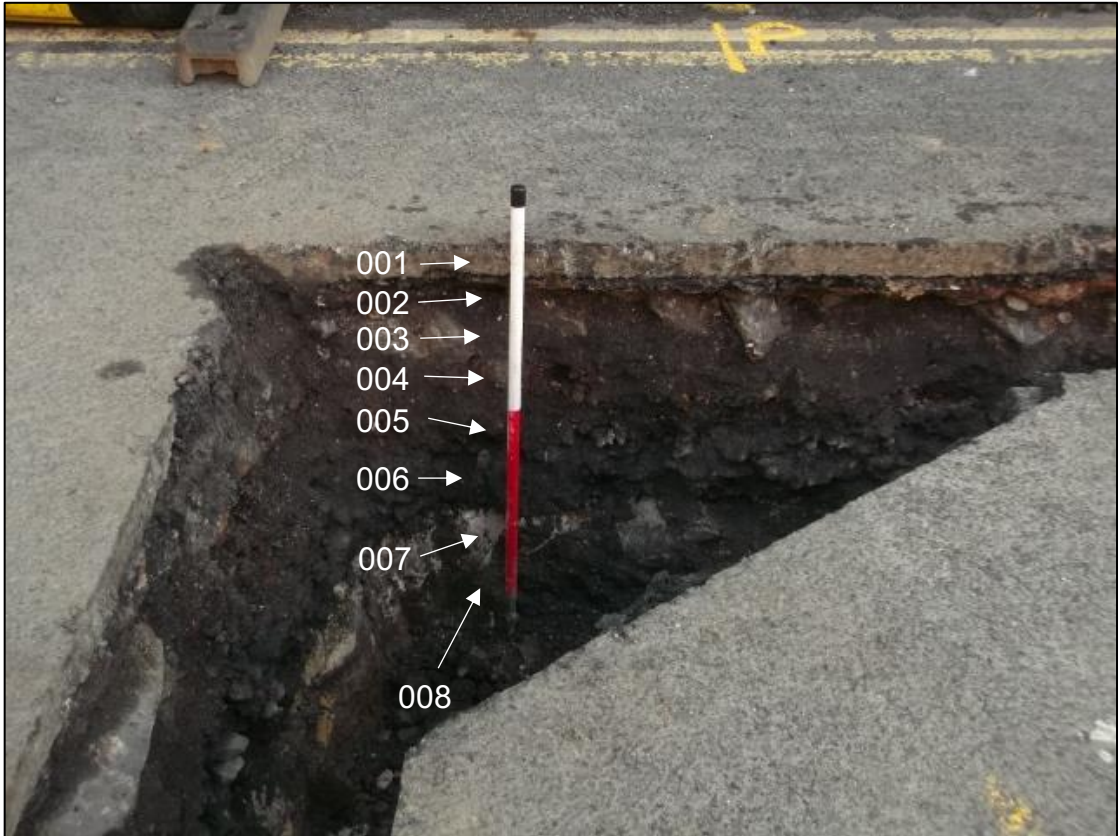
14. The second area monitored was a pipe trench (Figures 2 and 4a) which mainly ran in a WNW to ESE direction (with an off shoot to the SSW at the WNW end of the trench). Within the trench three anthropic surfaces were identified beneath the current road surface, (001) and (002). The first surface, (003), identified beneath the current road comprised of moderately compacted, grey yellow cobble stones (0.45 x 0.23m in size) with mid grey sand in between the stones. The thickness of the road surface was 0.2m. Underneath this road surface was a deposit, (004), which comprised of moderately compacted, mid grey sand and gravel with small pebble inclusions. The thickness of this deposit was 0.1m. The second surface, (005), comprised of moderately compacted, dark grey/black mix of gravel and tar. The thickness of the deposit was 0.04m. Underneath this surface was a deposit, (006), which comprised of moderately compacted, mid grey silty sand with very frequent (80%) inclusions of medium sized, irregular shaped stone (mainly at the bottom of the deposit) and smaller stones and pebbles (nearer the top of the deposit). The thickness of the deposit was 0.2m. The third surface, (007), comprised of moderately compacted, light grey-yellow cobble stones (0.4 x 0.25m in size) with mid grey silty sand in between the stones. The thickness of the deposit was 0.23m. Underneath this surface was another deposit, (008), which comprised of moderately compacted mid grey sand with no inclusions. The thickness of the deposit was 0.07m. The final deposit, (009), identified within the pipe trench comprised of moderately compacted, mid orange-brown clayey silt with occasional small stone and pebble inclusions. The deposit was excavated to a depth of 0.04m.

18. The three anthropic surfaces (Figure 4a) identified within the pipe trench were older nineteenth or twentieth century roads underlying the present day road, (001) and (002). The uppermost road, (003), consisted of a cobbled surface overlying a bedding layer, (004). This road may have been constructed in the late nineteenth or early twentieth century, possibly at the same time as Millbrae Bridge was widened as depicted in the 3rd edition Ordnance Survey (Figure 1c). The middle road, (006), consisted a thick packed and graded stone road surface which was sealed by a layer of tar (005). This road was possibly part of an early tarmac road, named after an early nineteenth century Scottish engineer John Loudon McAdam, which may relate to the road depicted in the 2nd edition Ordnance Survey map (Figure 1b). This roads construction may have occurred at the same time as the demolition of Millbrae Mill, and filling in of its associated lade, and the construction of the terraced housing at Millbrae Crescent at the end of the nineteenth century. The lowest road identified, (007), consisted of another cobbled surface under which lay a bedding layer, (008). The road surface seems to relate to the road depicted within the 1st edition Ordnance Survey map (Figure 1a) which was associated with the earlier narrow bridge crossing White Cart Water and Millbrae Mill. The lowest road and its associated bedding overlay what appeared to be the naturally occurring subsoil, (009).

Figure 4a: Post excavation view of Pipe trench showing context numbers. From SSW

23. Within the pipe trench excavated along Tantallon Road the remains of three nineteenth or twentieth century road surfaces were identified and a possible twentieth century demolition layer was identified underneath a present day yard surface located between Tantallon Road and the outfall trench.

24. No significant archaeological remains were identified within this element of the development area, it is recommended that no further work should be carried out. The appropriateness and acceptability of our recommendations rest with Scottish Water.

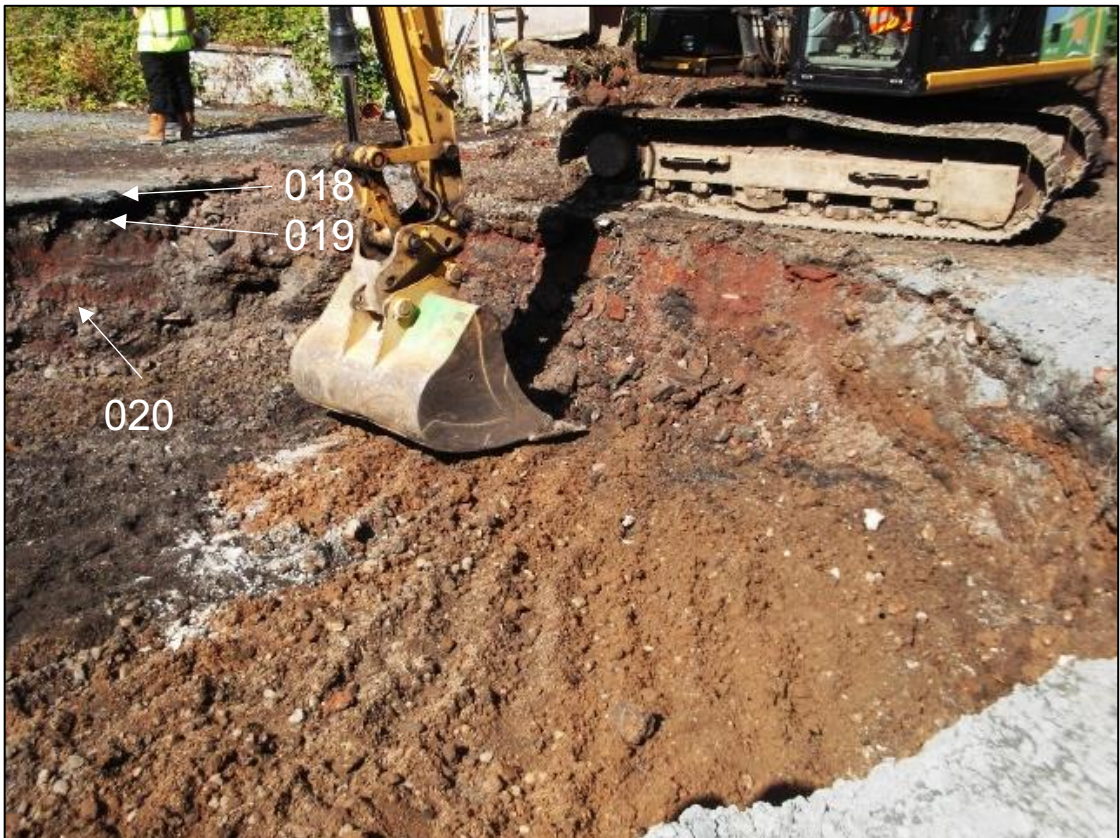
15. The third area to be monitored was the main manhole (Figures 2 and 4b) which was located in between the outfall trench and the pipe trench within a mixed concrete and tarmac yard area (018). The main manhole trench was circular shaped with a diameter of 5m and was excavated to a depth of 1.2m. Underneath the yard surface was deposit (019) which comprised of moderately compacted, mid grey sand with frequent moderate sized stone and CBM inclusions. The thickness of the deposit was 0.2m. The final deposit identified, (020), comprised of loosely compacted, mixed yellow/grey sandstone and mid grey silty sand with very frequent (80%) CBM inclusions. The deposit was excavated to a depth of between 0.8-0.9m.

19. The layers identified under the yard surface within the main manhole trench consisted of a bedding layer, (019), for the mixed concrete and tarmac yard, (018), and underneath that was a large mixed demolition layer, (020), which was not fully excavated. It was unclear from the material within this demolition layer if it represented twentieth century structures demolished along Tantallon Road and then spread out to create a level surface close to the riverbank or material brought in from another location to serve the same purpose.

Figure 4b: Post excavation view of Main Manhole Trench showing context numbers. From NNE
