**Kilwinning Old Parish Church,  
North Ayrshire:  
Archaeological Evaluation**

Data Structure Report

issued 29<sup>th</sup> April 2016

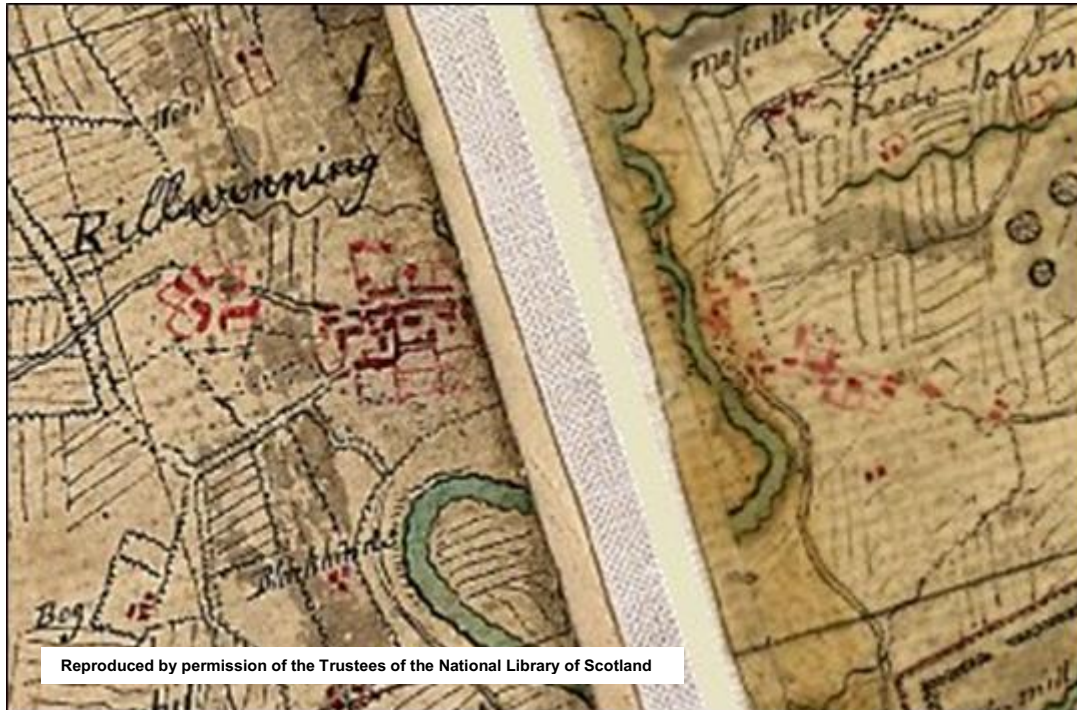
Figure 1a: Roy's Military Survey of Scotland, 1752-1755, Lowlands

6. The first detailed post-reformation plan of Kilwinning is from 1747-55 (General Roy's Military Survey of Scotland; Figure 1a); it forms a cluster settlement forming from three locales along what is now Main Street. The central hub is located around the Abbey buildings, another is located immediately on the east side of the river Garnock near the Corsehill and the third to the west at Byres.

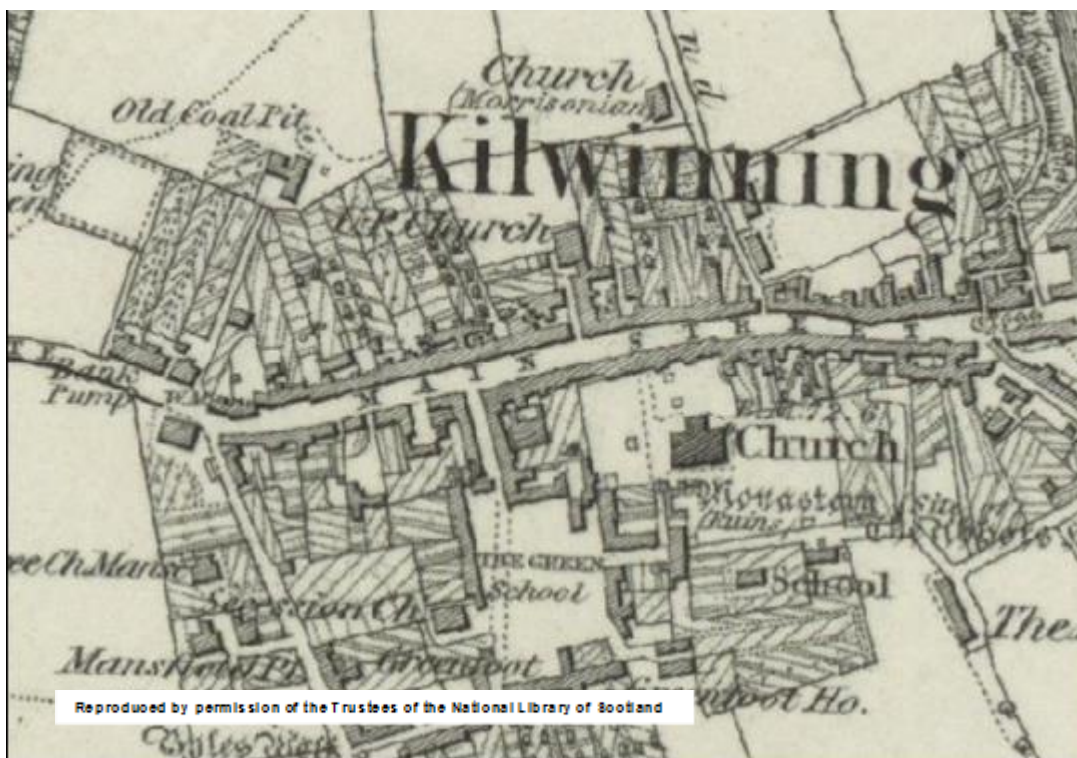
Figure 1b: 1<sup>st</sup> edition Ordnance Survey, 1856, Ayrshire, Sheet XVI.4

7. By the 1st edition Ordnance Survey (1856) Kilwinning had expanded to include a full street frontage on either side of Main Street (Figure 1b). This rigid streetscape has been progressively altered through the 19th and 20th century with the opening out of the 'square' area at the west end of the Main Street and clearance to form the entrance to the Old Parish Church (removing the original property given to the Freemasons for their Mother Lodge).

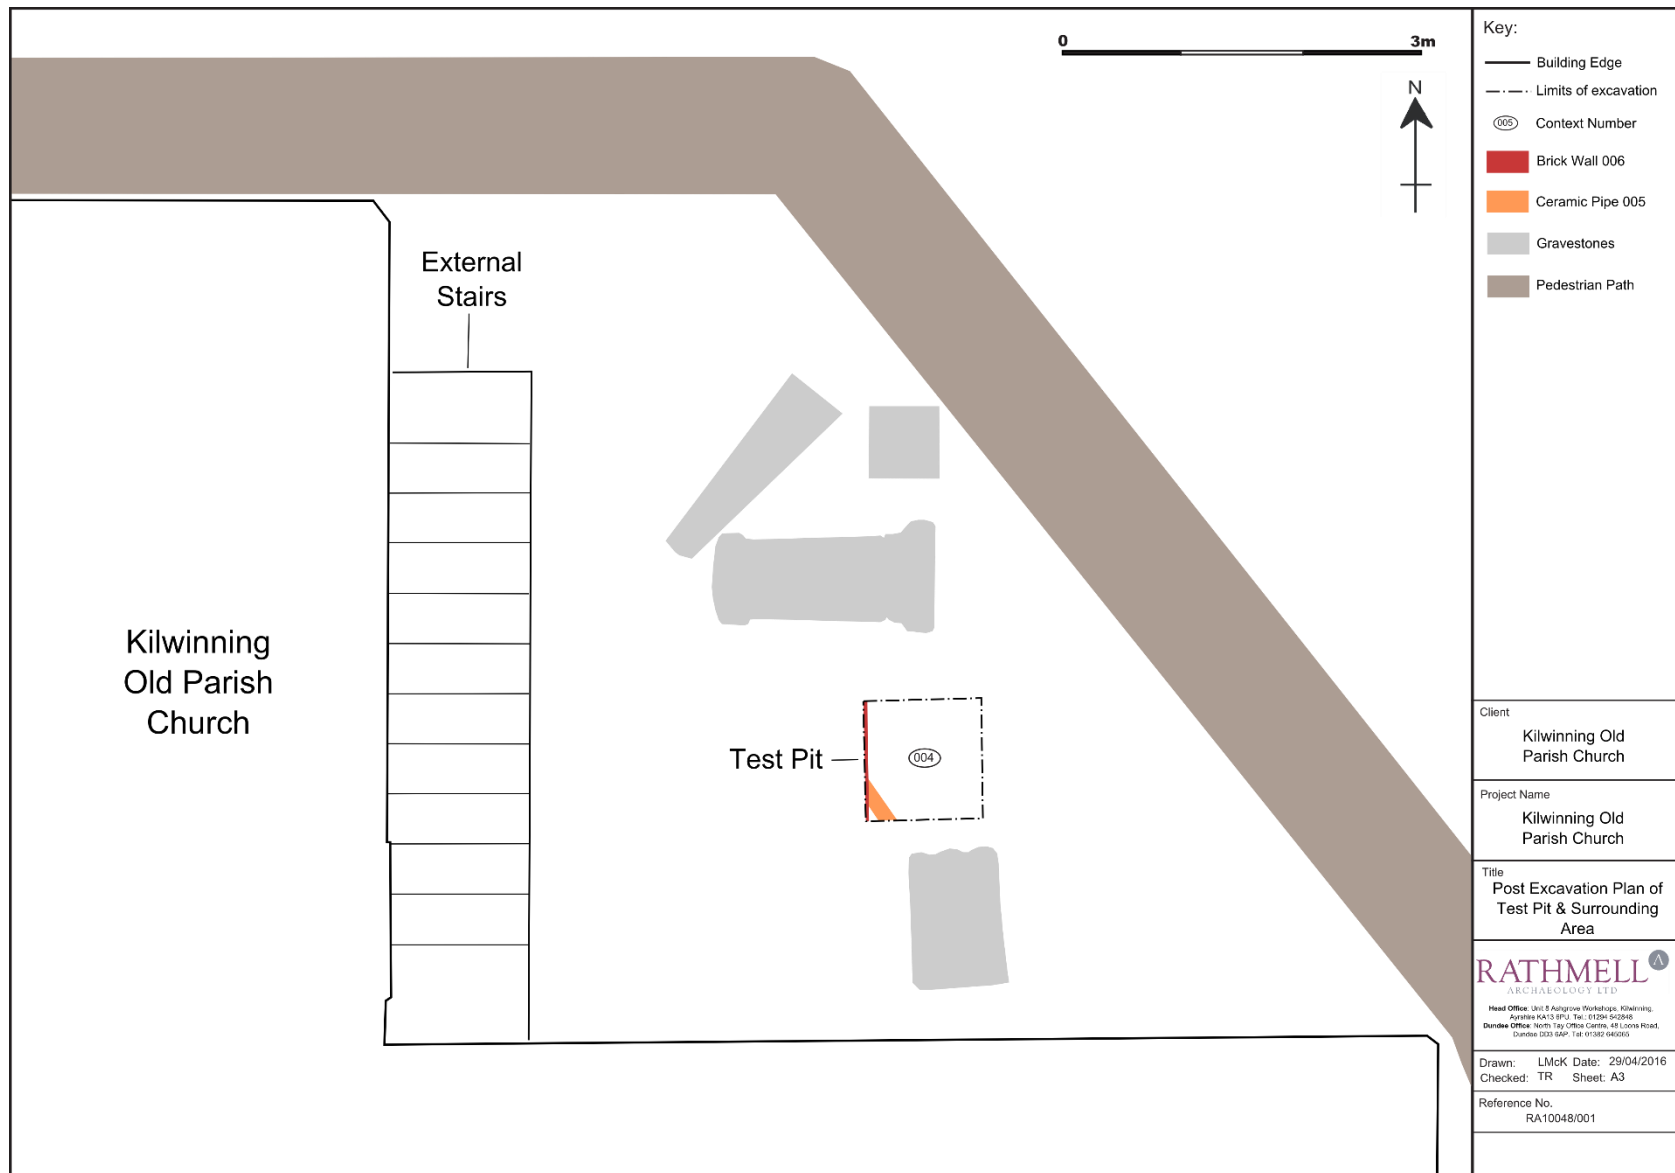
Figure 2: Plan of Test Pit and surrounding area.

12. The test pit was located in a central area to the immediate north of the church and east of the external stair (Figure 2). It was positioned in this manner so as to avoid a number tumbled gravestones and the probable position of the buried remains of a 19<sup>th</sup> or 20<sup>th</sup> century coal cellar. At the test pit location the current ground surface was 0.14 to 0.22m higher than the adjacent paver path (the range reflects a slight fall in the path from NW to SE). The highest point of the area was 0.24 to 0.32m above the paver path.

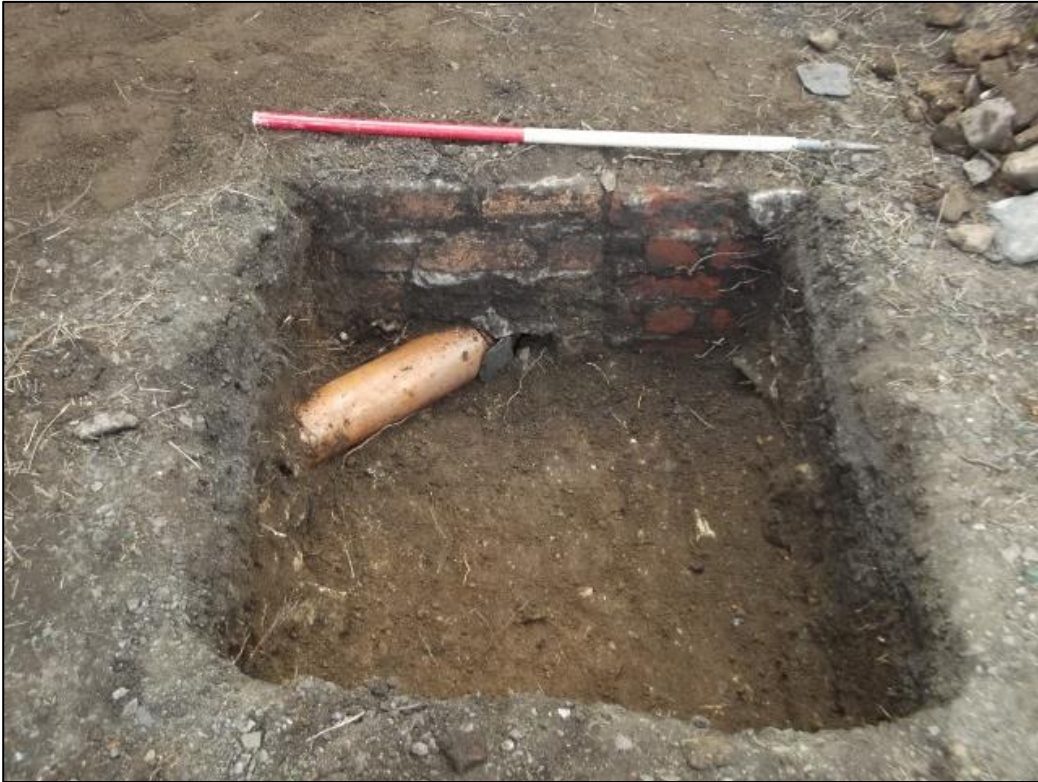
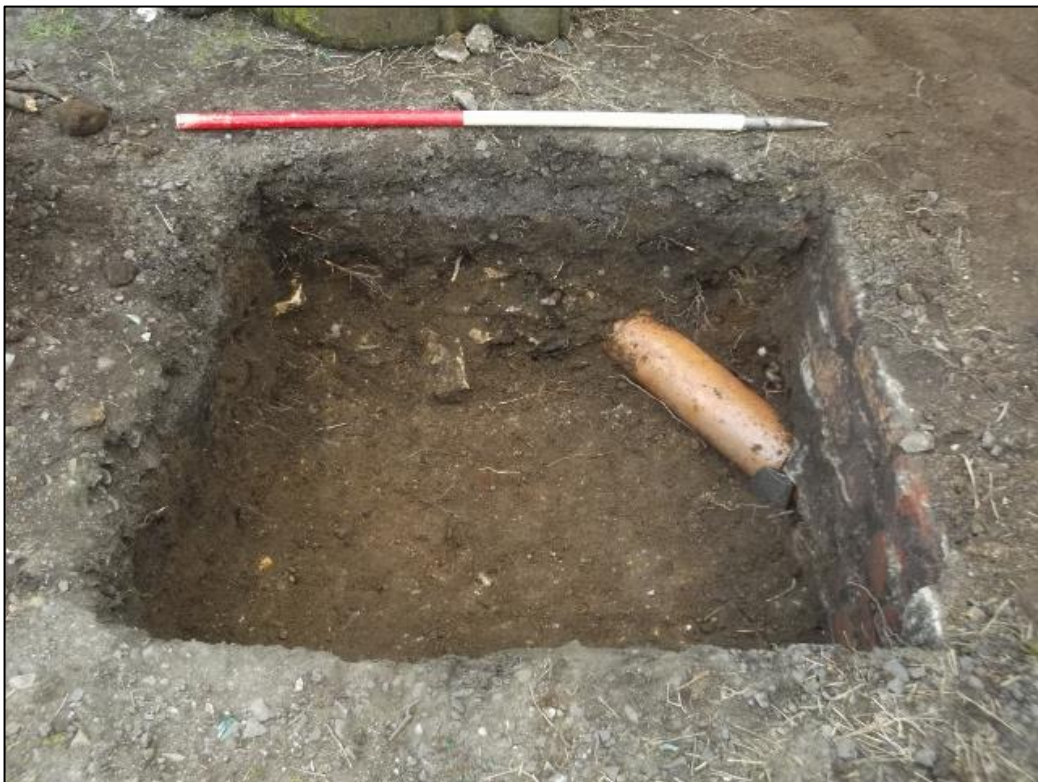
15. Layers (002) and (004) both abutted a brick wall (006) which was identified in the east facing section of the test pit (Figure 4a and 4b). The walls structure was made up bricks which were 0.2m long and 0.08m thick. The width of the individual bricks was unclear as only the front of the wall was exposed during the excavation. Two types of bricks were identified in the construction of the wall with the majority being light orange or buff in colour with the rest being orange-red in colour, suggesting an opening in the wall which had been sealed up. The wall was orientated in an N-S direction.

16. A modern 19<sup>th</sup> or 20<sup>th</sup> century ceramic pipe was located within layer (002). It was orientated in a SE to NW direction and had a diameter of 0.15m and was located at depth of 0.39m from the surface. The Pipe also passed through a hole cut into the brick wall (006).

19. It does seem probable that the north to south orientated brick wall, (006), was part of a cellar possibly for coal storage for the church. The use of different brick in part of the wall suggests that there had been an opening into the structure, possibly an entrance or more likely a chute for the unloading of the coal, that was later sealed up. It is also unclear if the hole in the wall used to accommodate the ceramic drainage pipe was part of the original wall or a later addition.

22. Rathmell Archaeology recommends that the ground breaking works within the angle of the church should be monitored by a professional archaeologist. This will primarily be to recover disarticulated human skeletal material and any pre-19<sup>th</sup> century artefacts. The acceptability of these recommendations must be confirmed with Historic Environment Scotland prior to any ground breaking works on-site.
