**Dunlop Parish Church Vestry Extension
East Ayrshire:
Archaeological Mitigation**

Data Structure Report

Event Name Dunlop Parish Church Vestry Extension

Event Type Watching Brief

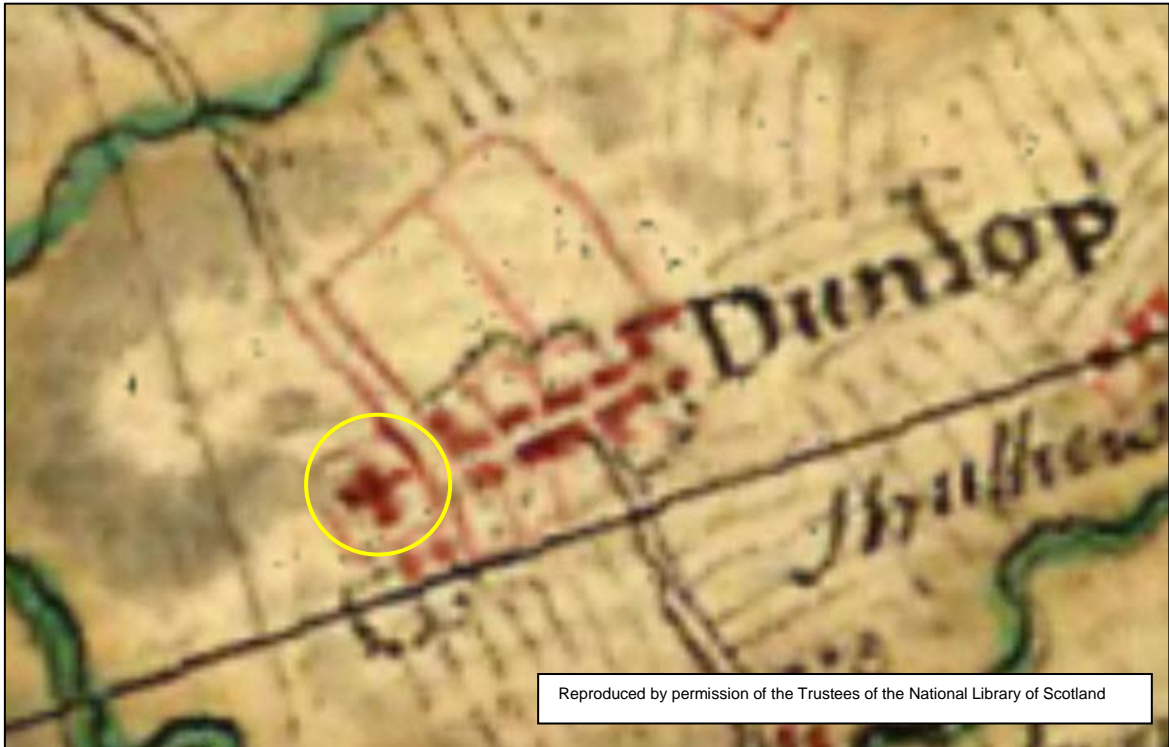
4. Dunlop Kirk is depicted at the western end of the small, linear village of Dunlop in the mid 18th century (see Figure 1a). The category B listed church (Canmore Id 42915) is known to have been built in 1641 as part of a building project funded by Viscount Clandeboye. This building project, which is a category A listed building group, includes the Clandeboye School (Canmore Id 42916) and the adjacent Mausoleum (Canmore Id 42911) that lie to the southeast of the Kirk on the boundary of the surrounding graveyard (see Figure 1b). Viscount Clandeboye's father, Hans Hamilton, is buried within the mausoleum and was the first protestant minister within the parish.

Figure 1: Roy's Military Survey of Scotland, Lowlands 1752-55.

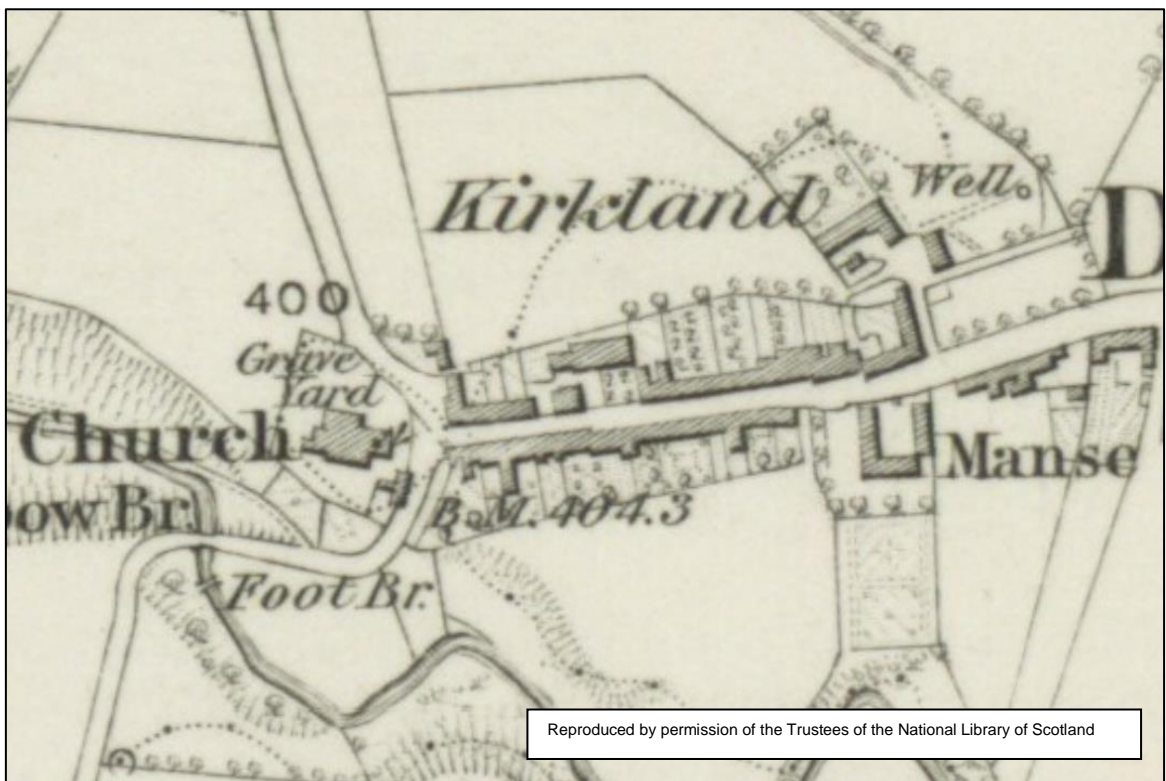
Figure 1b: 1st edition Ordnance Survey (1858).

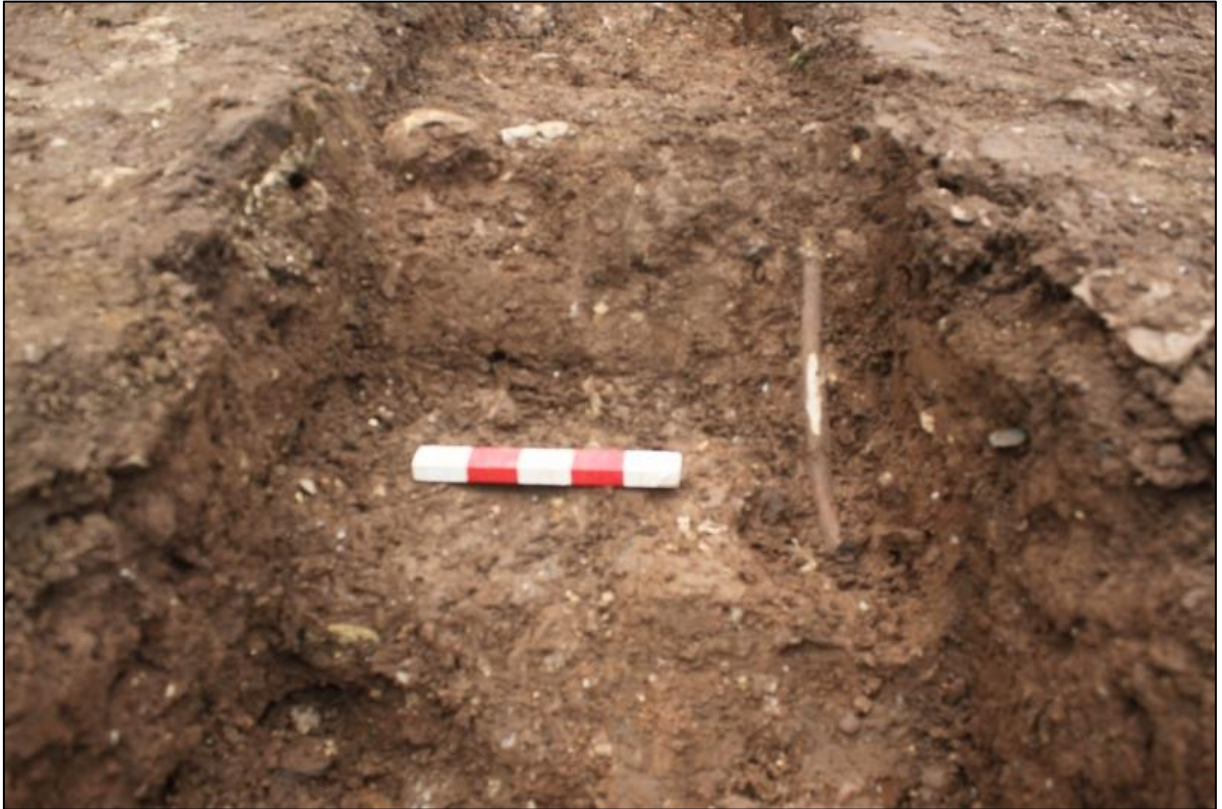
16. Disarticulated human bone was found within layer (003) across all of the foundation trenches. However, the vast majority of it was found in the southern end of Trenches 1 and 3 and the western portion of Trench 2. The bones were found at a depth of between 0.1m and 0.6m. The majority of bone recovered was well preserved and found in relatively large sections. Some of the bones appeared to have been previously broken, probably when disinterred and redeposited within layer (003).

Figure 3a: Large cluster of bones in Trench 3. Photo taken from the North.

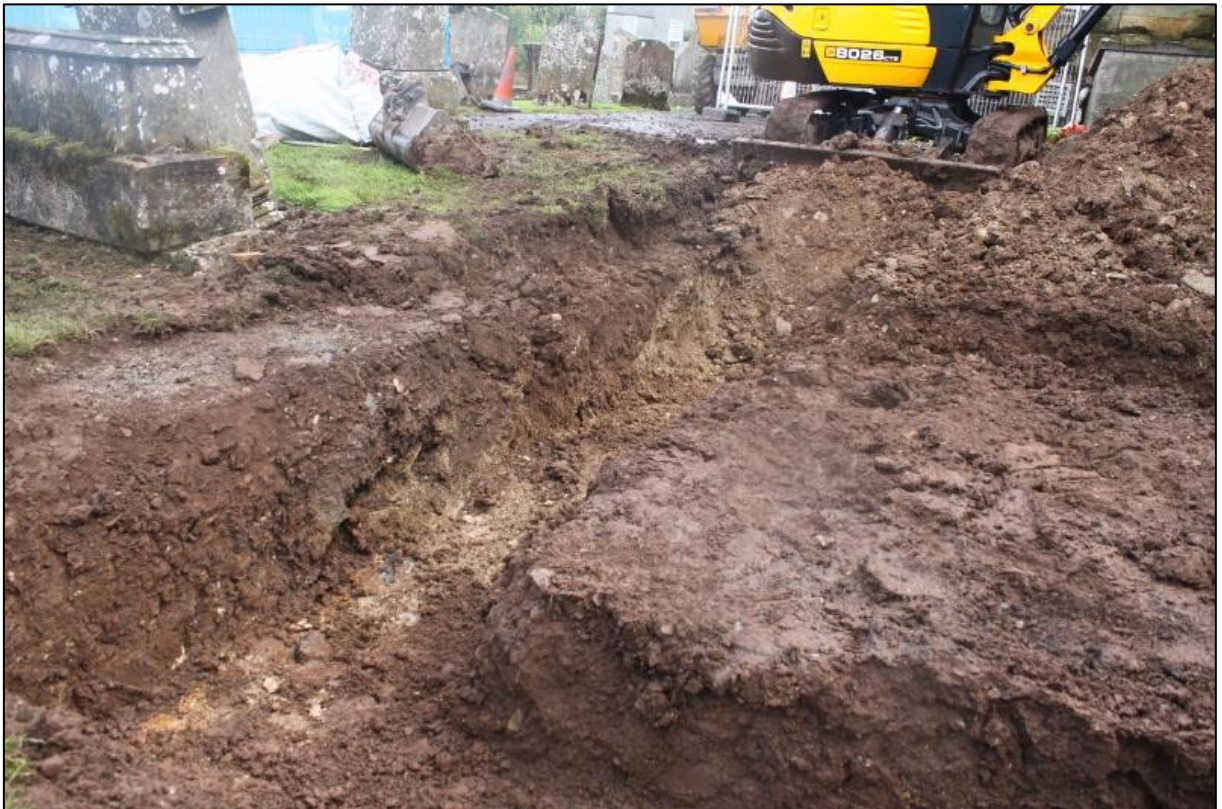
Figure 3b: Mid-excitation shot of Trench 4 showing sandstone remains (006). From the southwest.

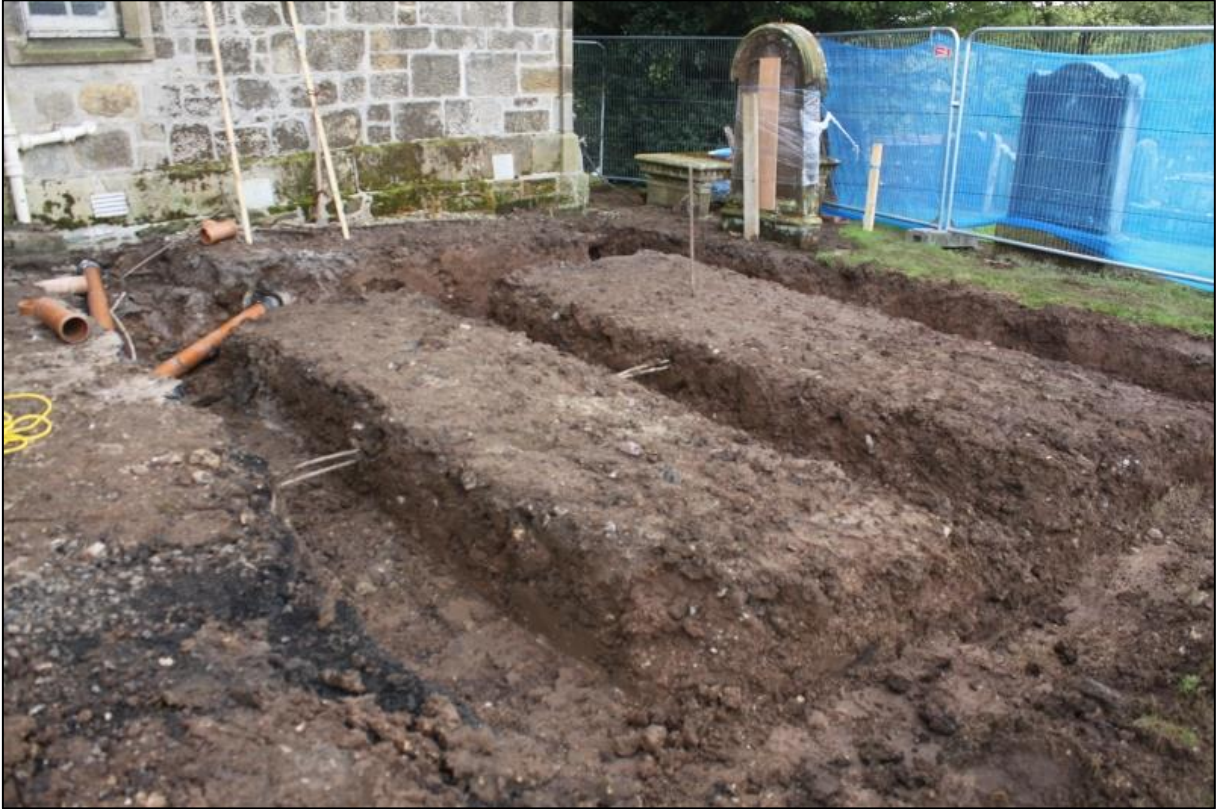
17. A number of 19th to 20th century services were identified within the development area. These comprised four salt-glazed ceramic pipes and three metal pipes, possibly made from lead. All of the ceramic pipes had a diameter of 0.2m and the lead pipes had a diameter of 0.05m. Ceramic pipe [007] ran from east-west in Trench 1 immediately adjacent to the church wall at the southern end of the trench at a depth of 0.25m. Ceramic pipe [009] ran from northeast-southwest through Trenches 2 and 5 for 1.6m. Ceramic pipe [010] ran south-northwest from the Kik Vestry through Trench 5. It was 0.4m deep and 1.3m long. Lead pipe [011] followed the line of [010] (Figure 2, 4a). Both pipes were 0.24m deep. All three pipes were overlain by a loose mottled small black, brown and white gravel 0.05m thick (005). Pipes [010] and [011] were also seen in trench 6 at a depth of 0.4m.

Figure 4a: Post-excitation shot of Trenches 1-5, showing services [008], [009], [010] and [011]. From the northeast.

18. The two other lead pipes [008] ran east-west through Trenches 1,3 and 5 at a depth of 0.15m. In addition, 1.4m from the southern end of Trench 1 was a small linear deposit of loosely compacted, black gravel (004) which ran in an east to west direction. The deposit had a width of 0.3m, a thickness of 0.09m but the full length was unknown as it extended outwith Trench 1.

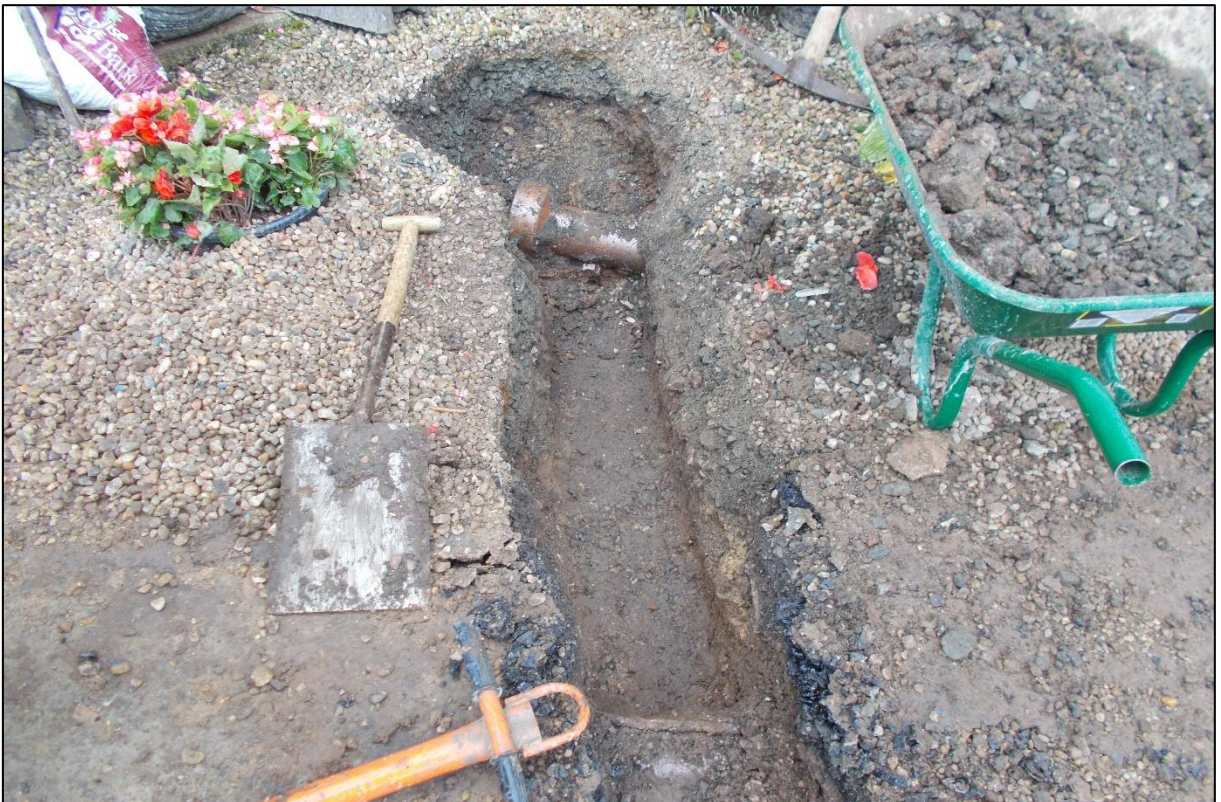
Figure 4a: Working shot of Trench 6, showing pipes [010], [011] and [012]. From the west-northwest.

012	T6	Structure	Brown salt glazed pipe 0.2m in diameter running northeast-southwest at the southwestern end of Trench 6. Pipe was located at a depth of 0.3m.	Salt glazed water pipe running northeast-southwest in Trench 6.
