# **Huntly Flood Alleviation Scheme, Aberdeenshire: Archaeological Mitigation**

## **Data Structure Report**

issued 21<sup>st</sup> March 2017

on behalf of Aberdeenshire Council

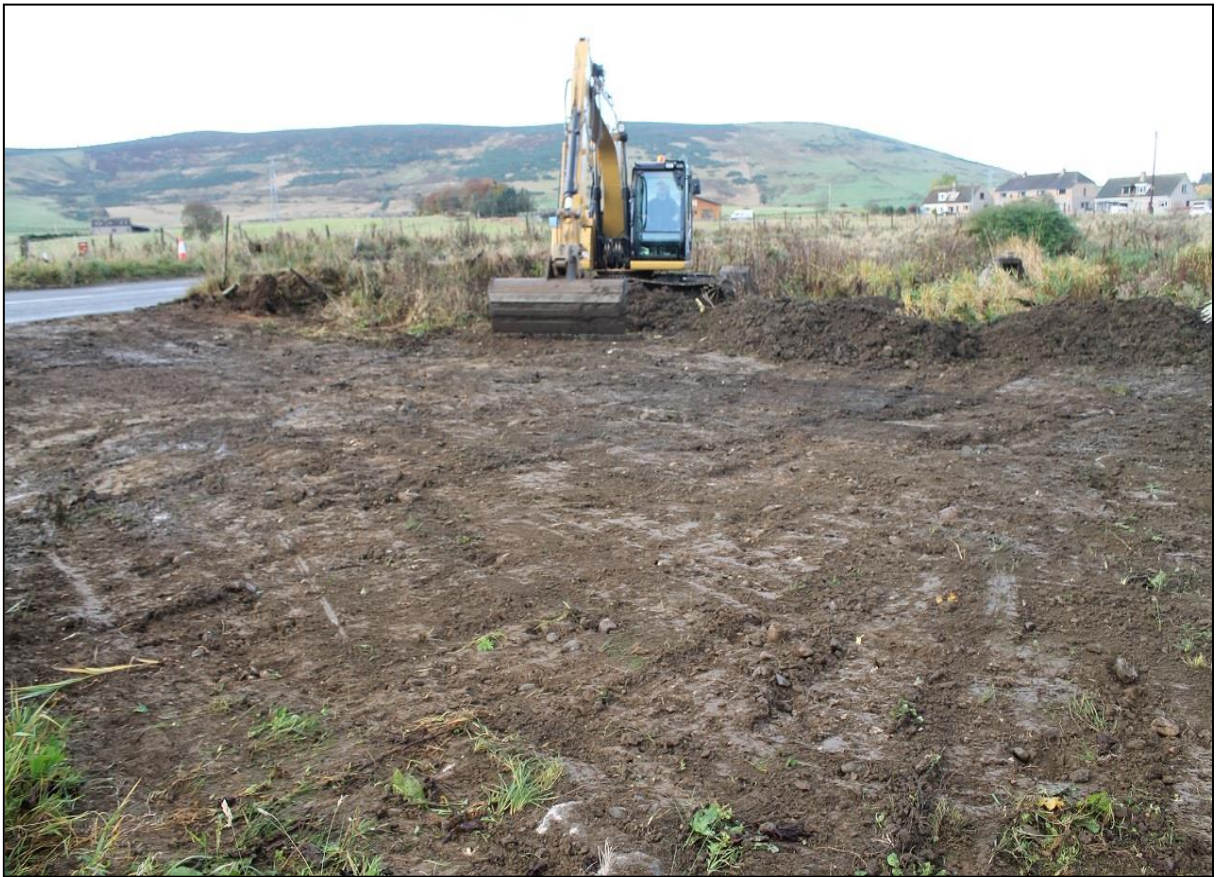
14. Stripping for a small site compound in Area 1 at the eastern extent of Bund 1 comprised of stripping a 48m<sup>2</sup> area (Figure 3a). Stripping here was to a depth of 200mm and a single deposit was uncovered comprising loose, mid-brown loam with infrequent small sub-rounded and sub-angular stones, rooting, and modern white ceramics and glass (001).

Figure 3a: AREA 1: Bund 1 Compound, working shot of area stripping

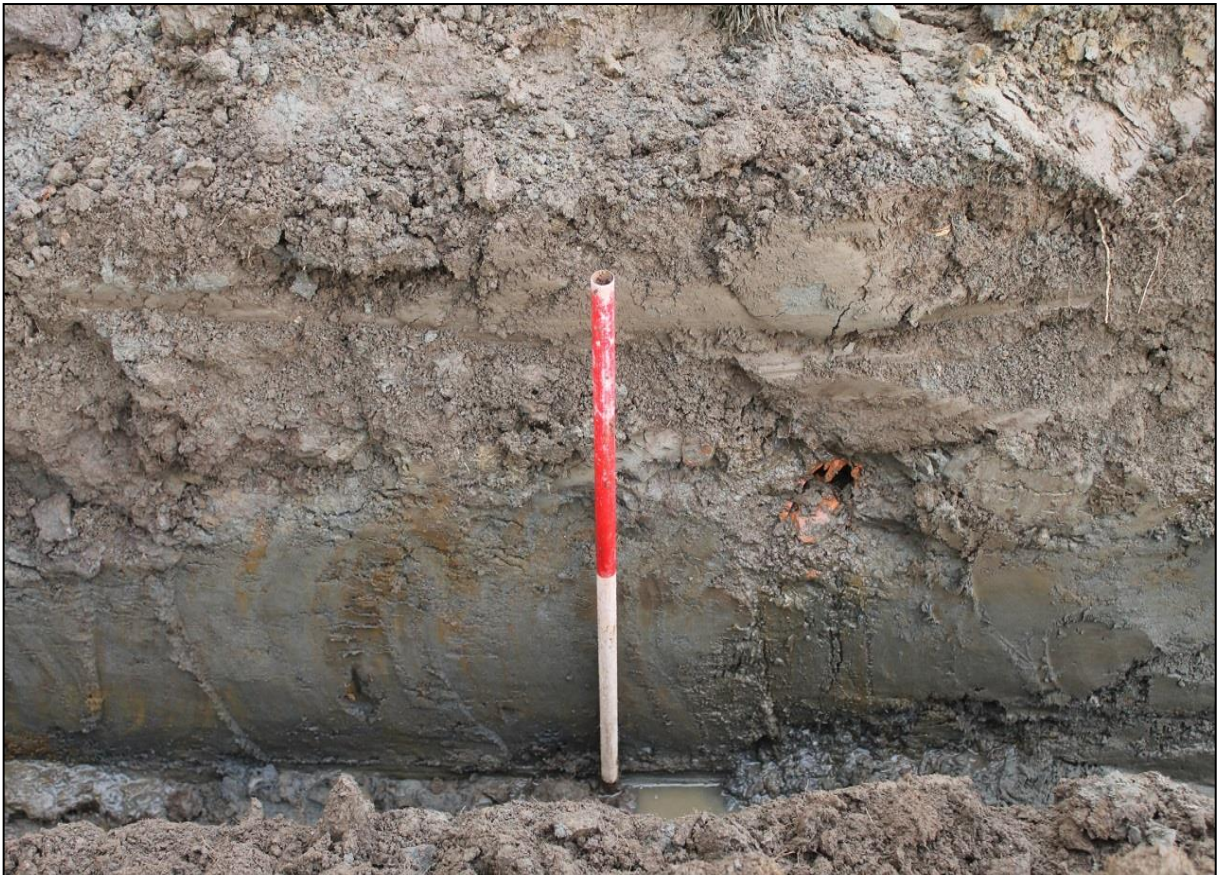
16. This width of trench was monitored along the majority of the route and deposits (002); a firm, mid-brown silty clay with very infrequent medium sub-rounded stones, and (003); a very firm, grey clay with iron panning and very infrequent large sub-rounded boulders, were uncovered at depths of 350-400mm and 600-650mm respectively (Figure 3b). A further deposit comprising wet, dark bluish grey clay with frequent very small stones and gravels was also encountered at the base of the trench (004) (Figure 4a).

Figure 3b: AREA1: Surface Water Sewer, north facing section at east end

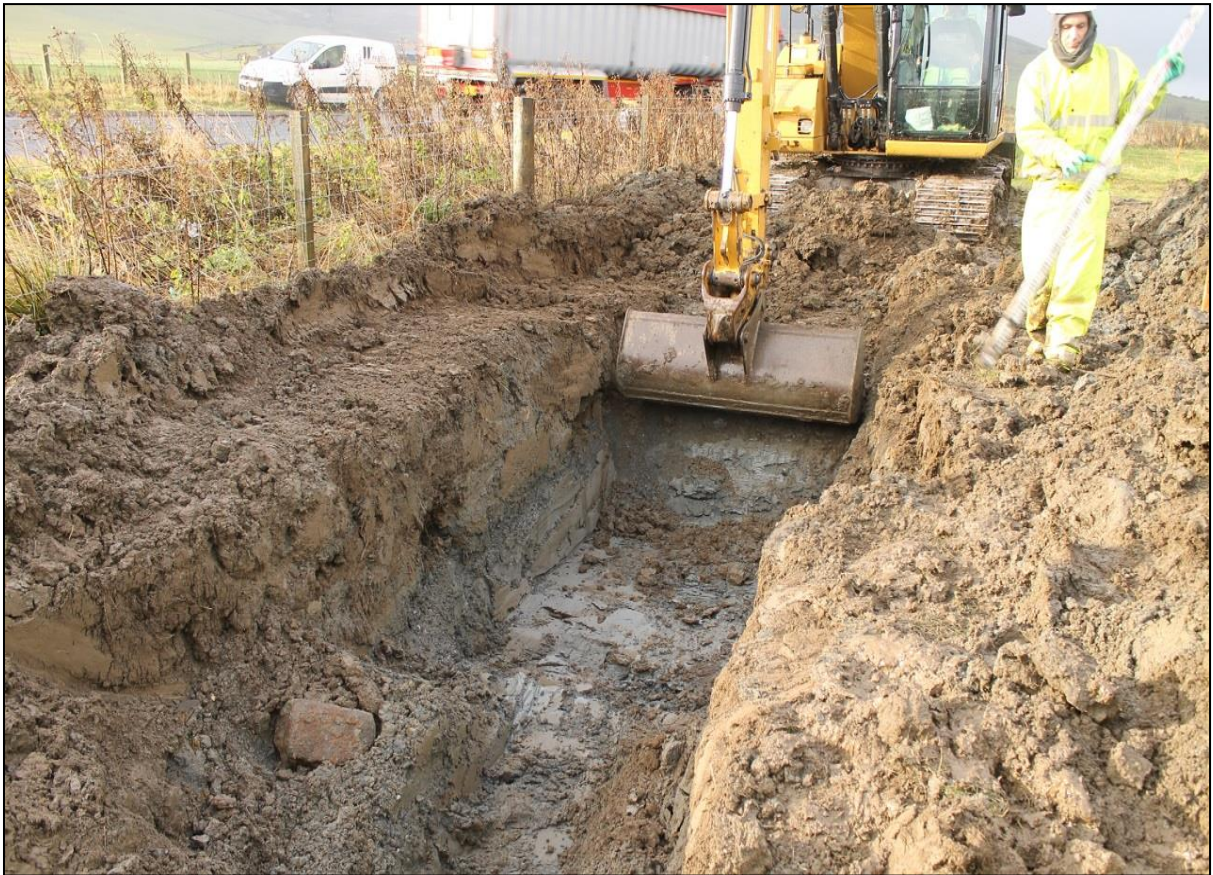
Figure 4a: AREA 1: Surface Water Sewer, working shot at east end

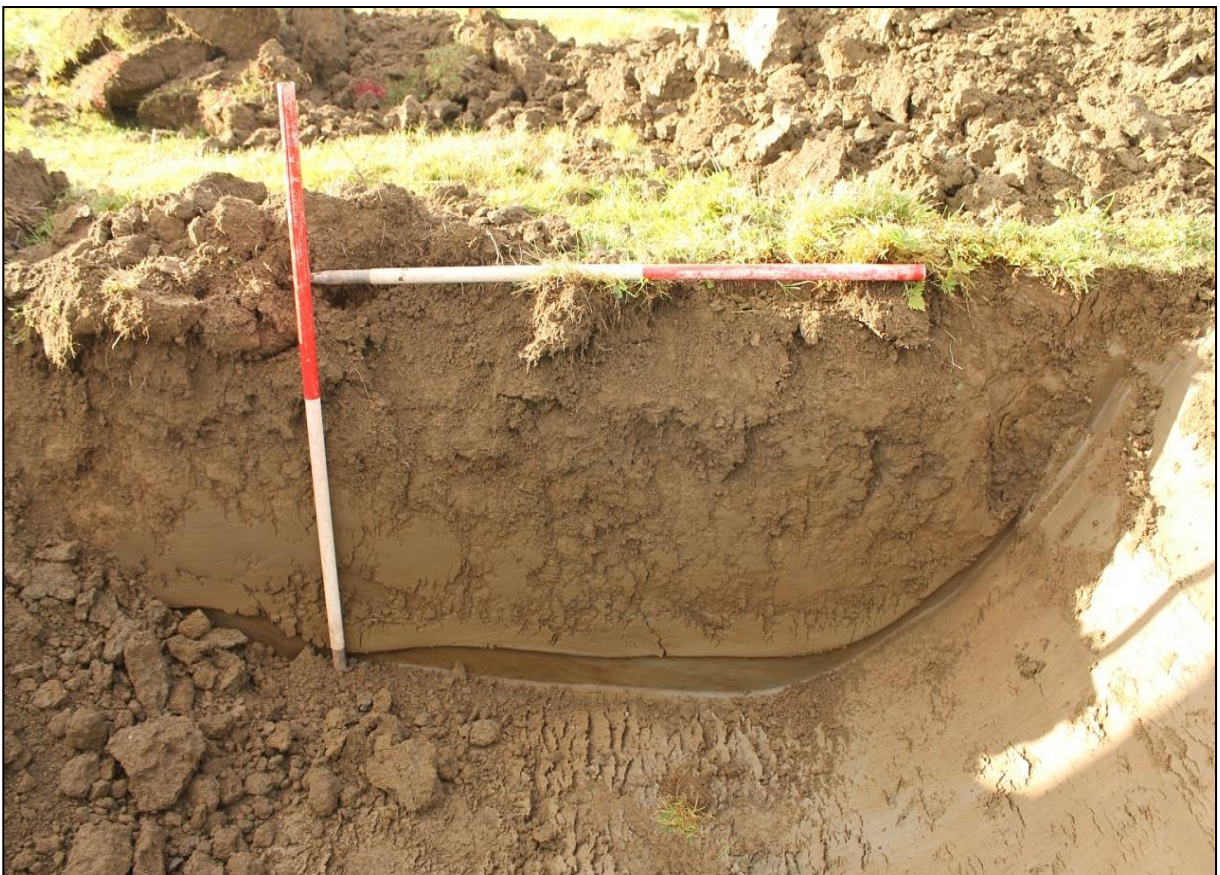
17. Along the course of the Filter Drain, four test pits were excavated to evaluate ground conditions prior to excavation. These test pits were excavated to a depth of 600-750mm deep and two deposits were encountered; (002) at a depth of 500-600mm and (003) (Figure 4b). Excavation for the filter drain did not uncover any different deposits than those encountered within the test pits.

Figure 4b: AREA 1: Filter Drain, Test Pit 1 west facing section

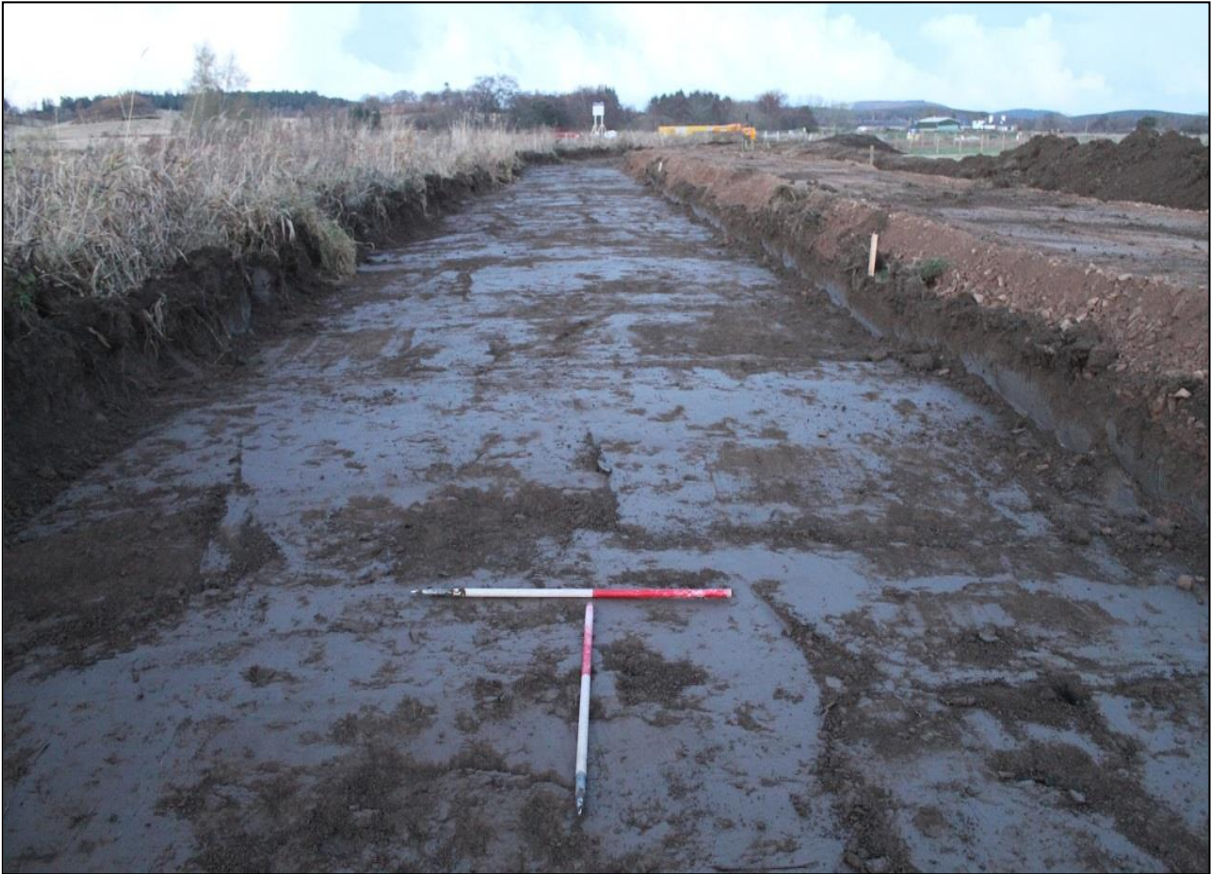
18. Bunds 1 and 2 comprised the construction of a new bund over the course of the Filter Drain and either side of the Ittingstone Burn respectively, and comprised a topsoil strip 4-5m wide to a depth of 300mm. Only (002) was recorded during the monitoring of these works (Figure 5a).

Figure 5a: AREA 1: Bund 2, post-excavation of central section of east area

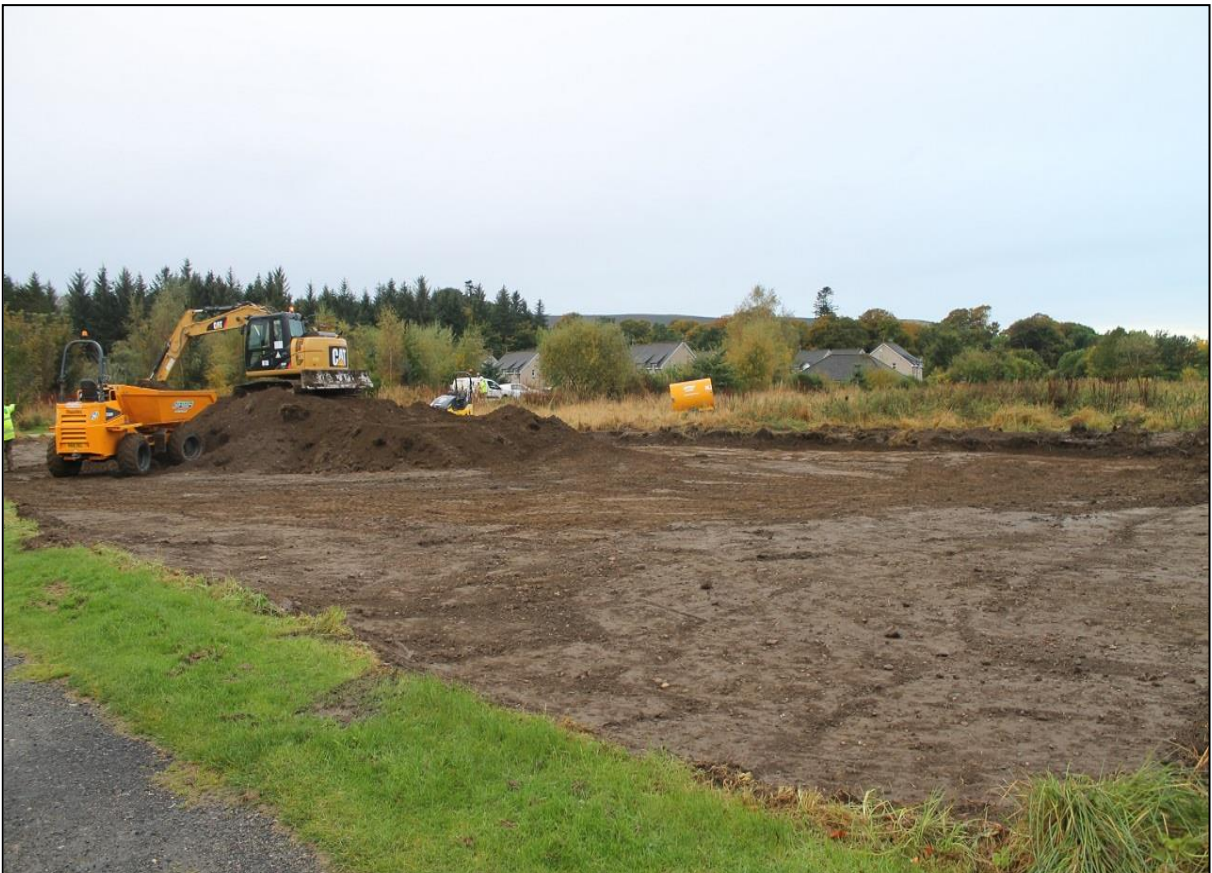
19. Monitoring of the Site Compound within Area 2 consisted of stripping a 60m<sup>2</sup> area on marshland with reeds and weeds over 1m in height. Stripping here was to a depth of 200mm and a single deposit was encountered comprising loose, mid-brown loam with infrequent small sub-rounded and sub-angular stones, rooting, and modern white ceramics and glass (001) (Figure 5b). A test pit was excavated within this area to determine the depth of this deposit which was found at 400mm.

Figure 5b: AREA 2: Site Compound, working shot

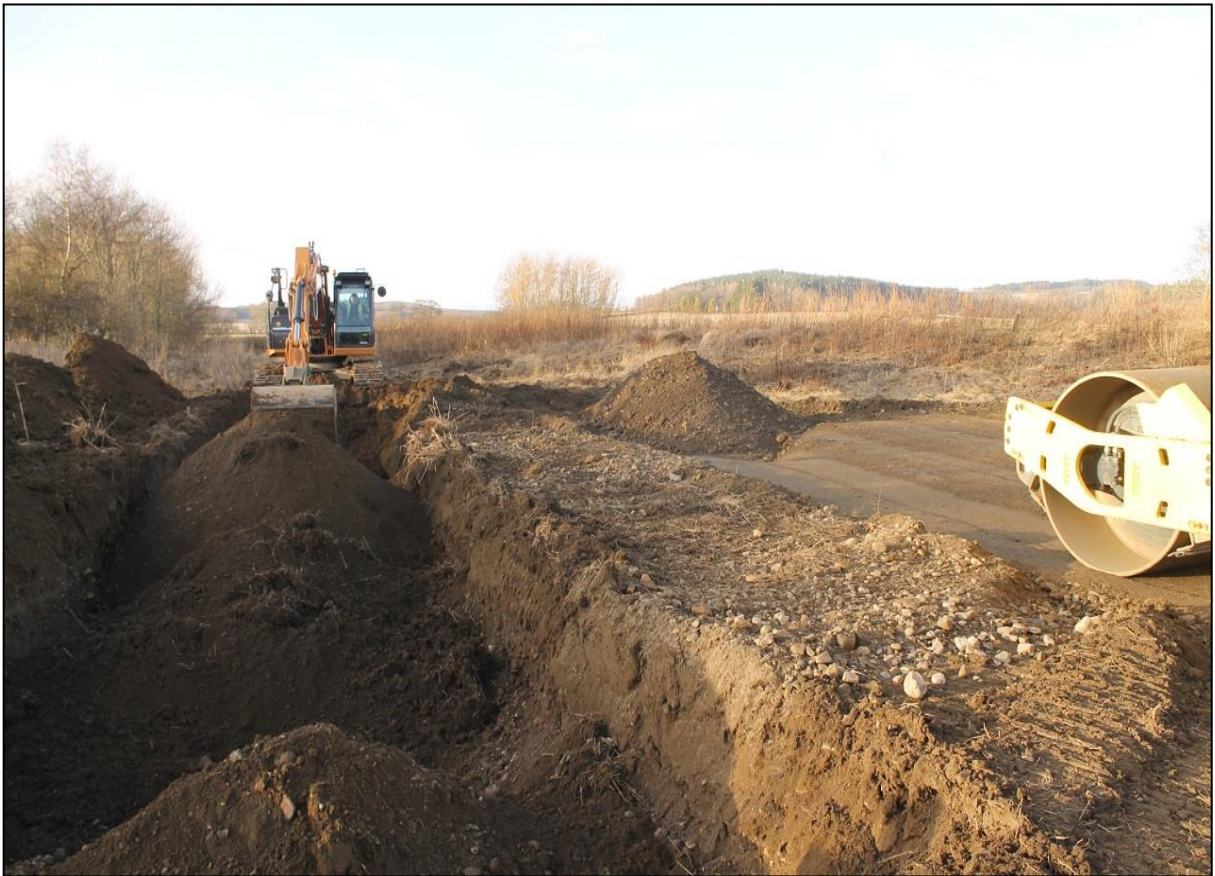
20. A 10m wide area running from the west of the Site Compound northwards to Bund 4 was stripped to form an access track. Works comprised stripping topsoil to a depth of 300mm and extraction of underlying gravels to use in the construction of the road (Figure 6a). Three deposits were encountered during monitoring that comprised (001) at a depth of 300mm, a firm, mid-brown silty clay with infrequent small to medium sub-rounded stones and rooting (005) 500mm deep and loose, grey sandy gravels with very frequent small to medium rounded stones (006) (Figure 6b).

Figure 6a: AREA 2: Access Road, working shot of gravel extraction

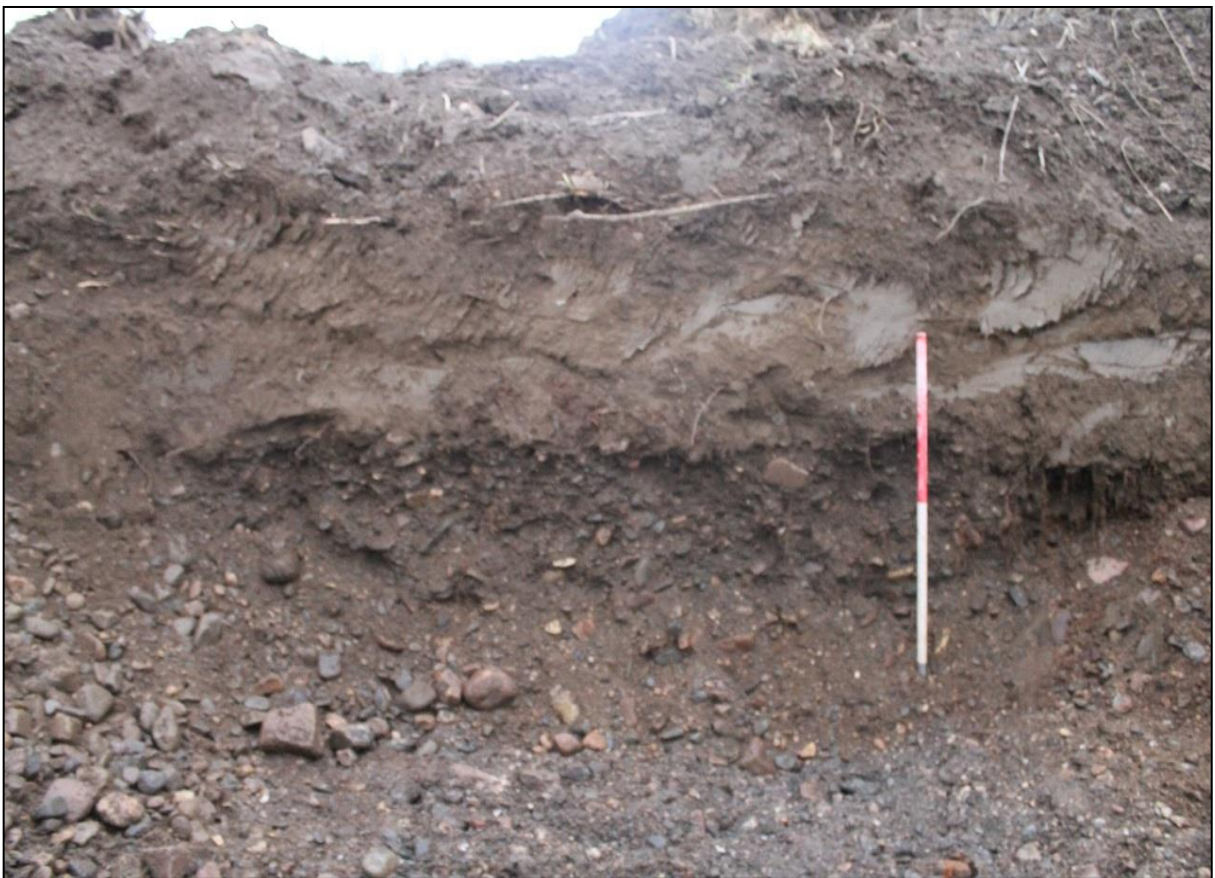
Figure 6b: AREA 2: Access Road, west facing section of gravel extraction

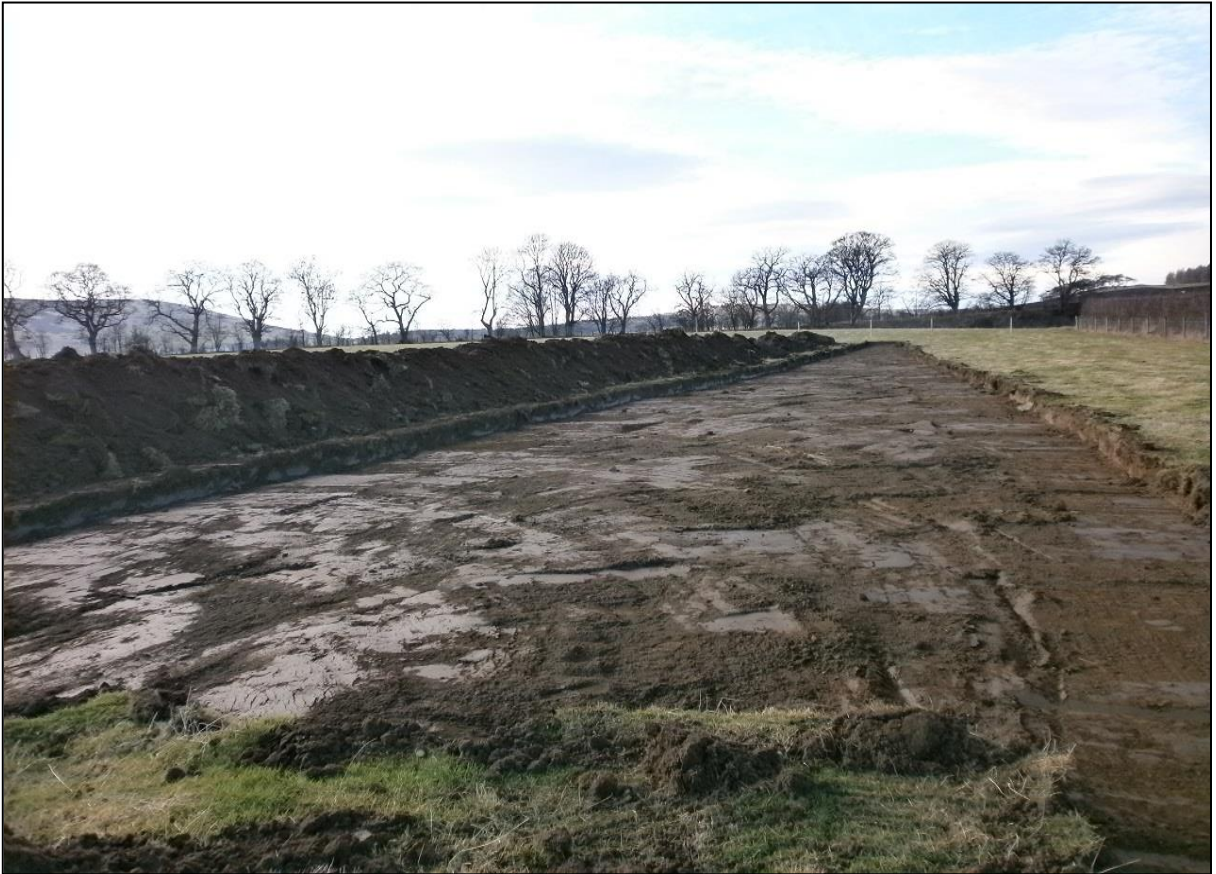
21. An approximate area measuring 150m long by 8m wide was stripped to a depth of 300mm for the construction of a new bund at Bund 3 (Figure 7a). A single deposit was encountered during the strip; a loose, mid-brown loam with infrequent small sub-rounded and sub-angular stones, rooting, and modern white ceramics and glass 400mm deep (001). Some late 19<sup>th</sup> to early 20<sup>th</sup> century ceramics were identified within this deposit but were not retained.

Figure 7a: AREA 2: Bund 3, post-excavation of strip

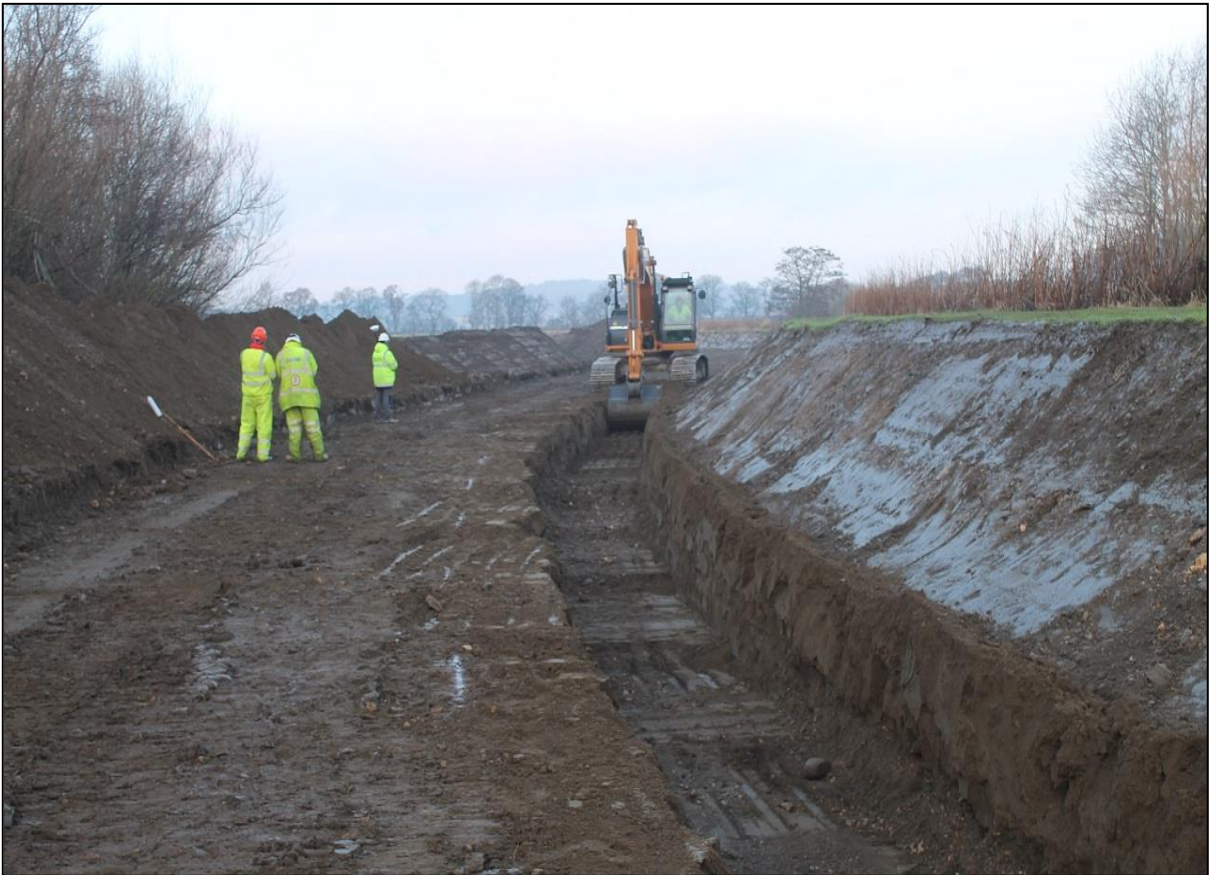
22. Works for Bund 4 consisted of a 300mm strip alongside and on the existing bund, and a trench 1m deep and 1.5m wide running along the base of the bund (Figure 7b). Throughout the works the main stratigraphic sequence comprised loose, mid-brown loam with infrequent small sub-rounded and sub-angular stones, rooting, and modern white ceramics and glass 400mm deep (001) overlying a firm, mid-brown silty clay with infrequent small to medium sub-rounded stones and rooting 500mm thick (005) with an underlying deposit (006) of loose, grey sandy gravels with very frequent small to medium rounded stones (Figure 8a).

Figure 7b: AREA 2: Bund 4, working shot of western trench excavation

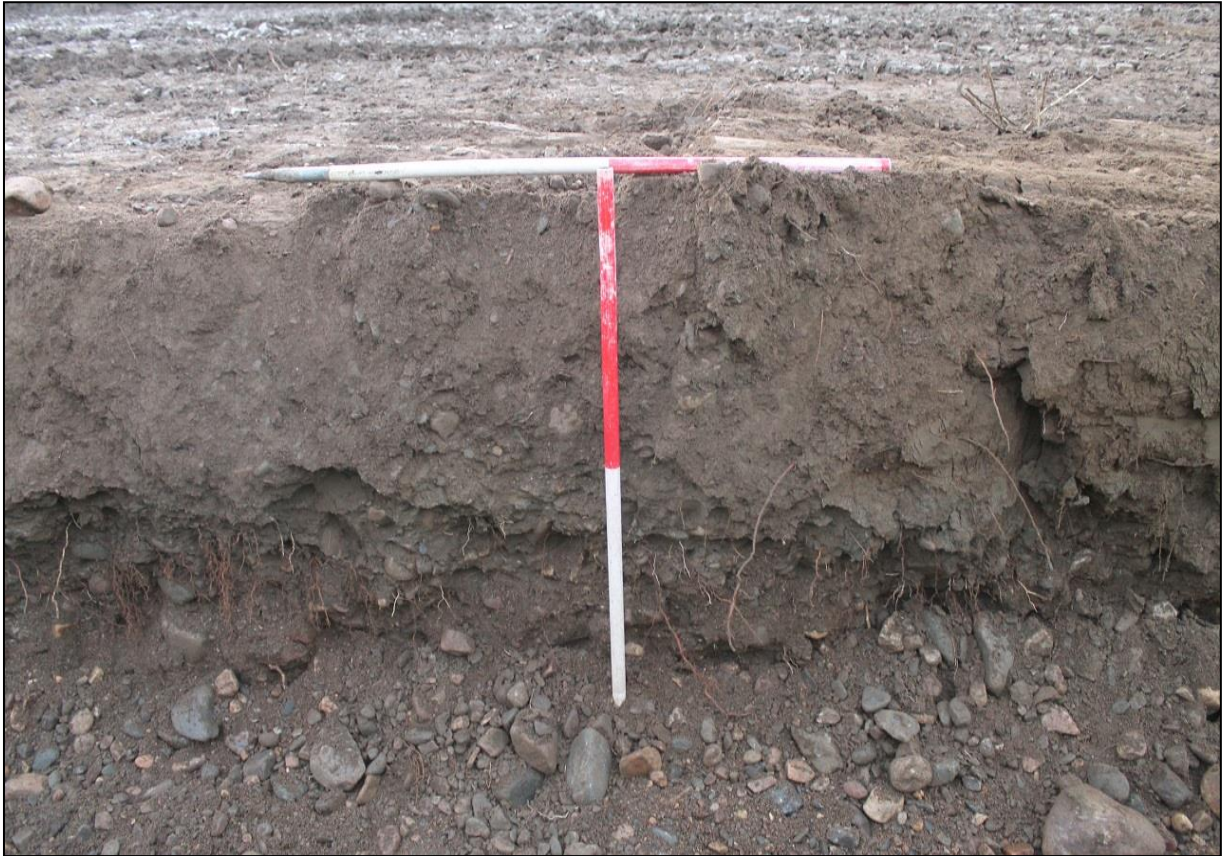
Figure 8a: AREA 2: Bund 4, east facing section of western trench excavation

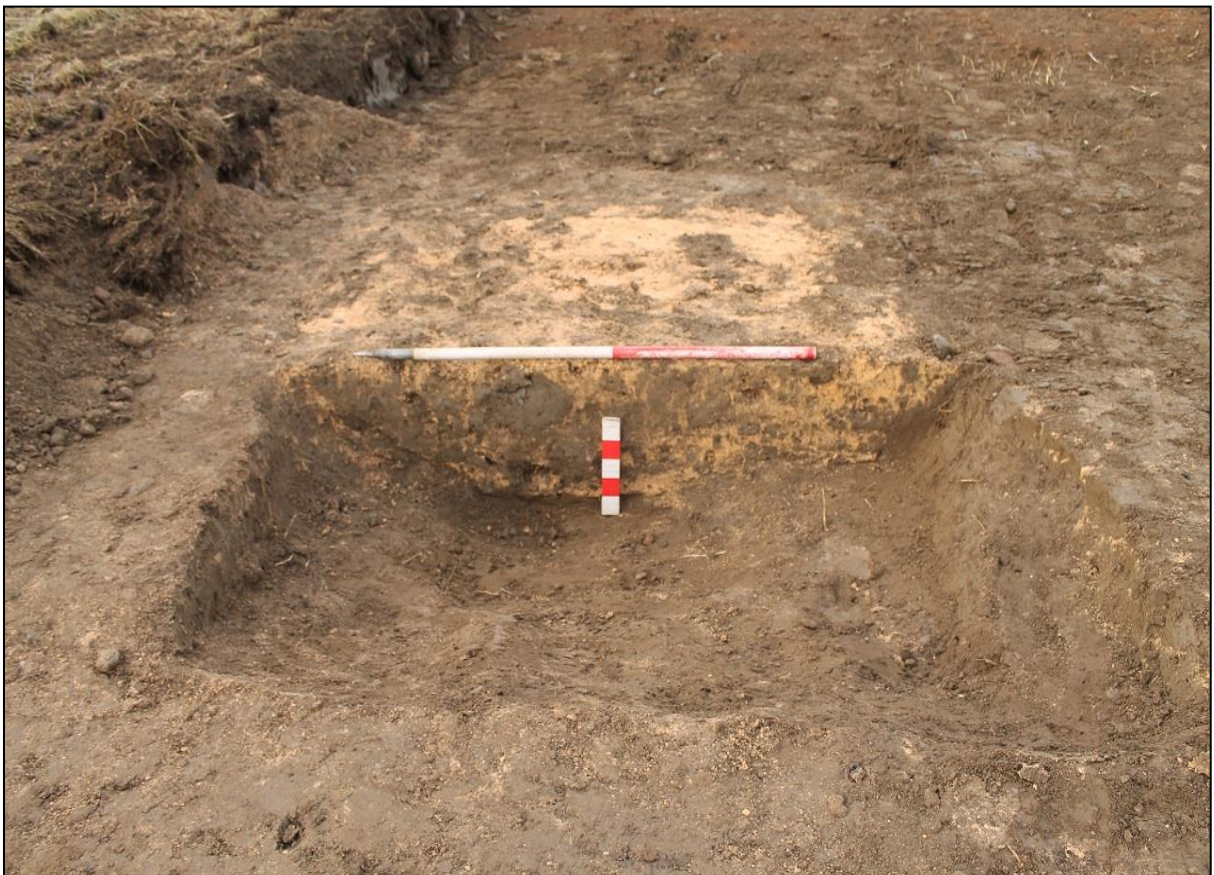
23. During the strip in the western part of Bund 4 two features were identified cutting in to the topsoil (001); [007] was a sub-square cut with gentle to steeply sloping sides and an uneven base measuring 2.2m long, 1.8m wide and 0.4m deep. This was filled with loose, mottled yellow sand and topsoil (001) with very infrequent small to medium sub-rounded stones and rooting (008) 400mm thick (Figure 8b).

Figure 8b: AREA 2: Bund 4, east facing section of feature [007]

29. All the deposits recorded; (001), (002), (003), (004), (005), (006) and (009) were of natural origin with the two features, [007] and [010] and their associated fills (008) and (011) also being natural in origin.
30. The only anthropic evidence recorded across the monitored areas was ceramics representing late 19<sup>th</sup> to early 20<sup>th</sup> century wares, these were not retained. There were also general 20<sup>th</sup> and 21<sup>st</sup> century detritus in the form of plastic bottles and food wrapping waste. A British Telecom cable recorded in Bund 7 demonstrated that part of the route had been previously disturbed.

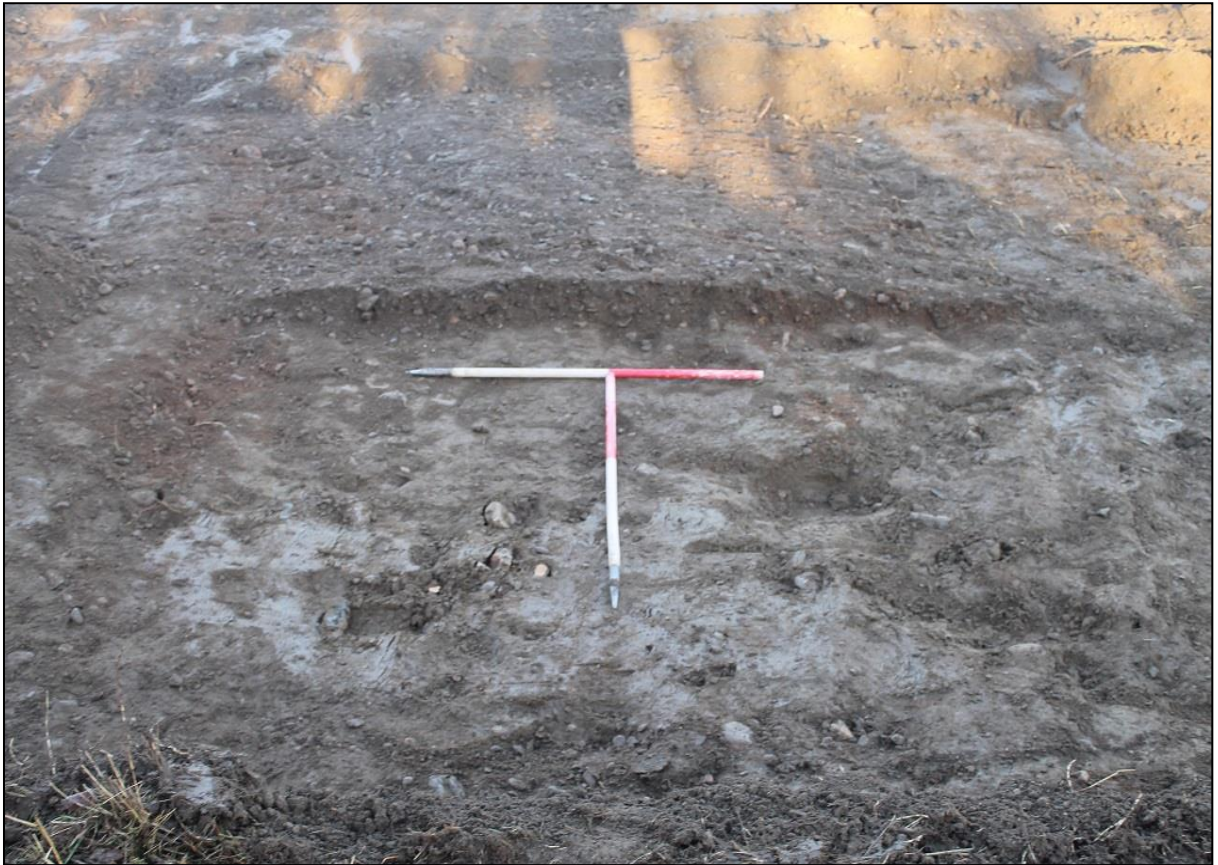
24. The other feature (009) was a linear deposit running north to south comprising loose, light brown/orange gravel (Figure 9a). Stripping for the access to the southern area of Bund 4 revealed another feature cutting in to the topsoil (001); [010] was a sub-square cut with straight edges, rounded corners, shallow sloping sides, and slightly concave base that was filled with loose, black humic loam with frequent charcoal and small to medium sub-angular and sub-rounded stones (011) (Figure 9b).

Figure 9a: AREA 2: Bund 4, post-excitation of feature (009)

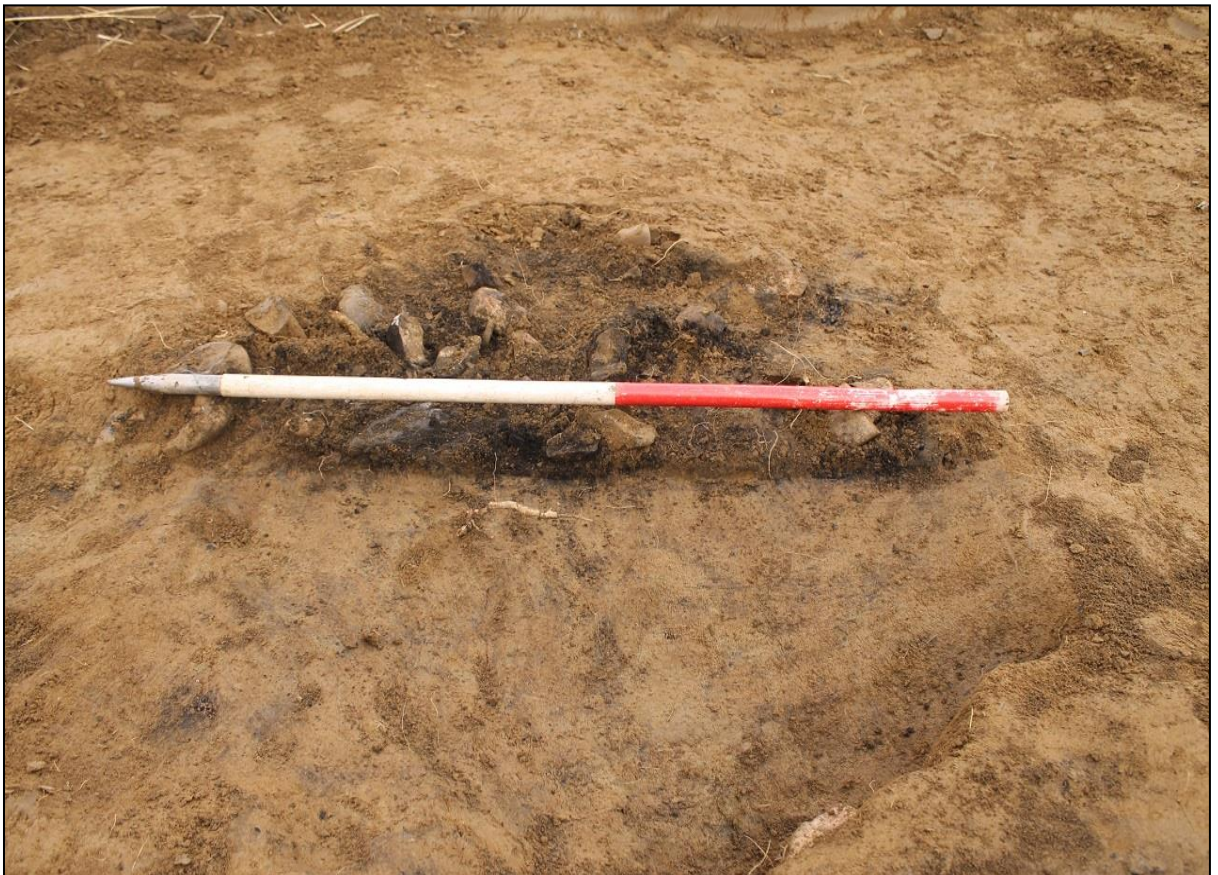
Figure 9b: AREA 2: Bund 4 Access, south facing section of [010]

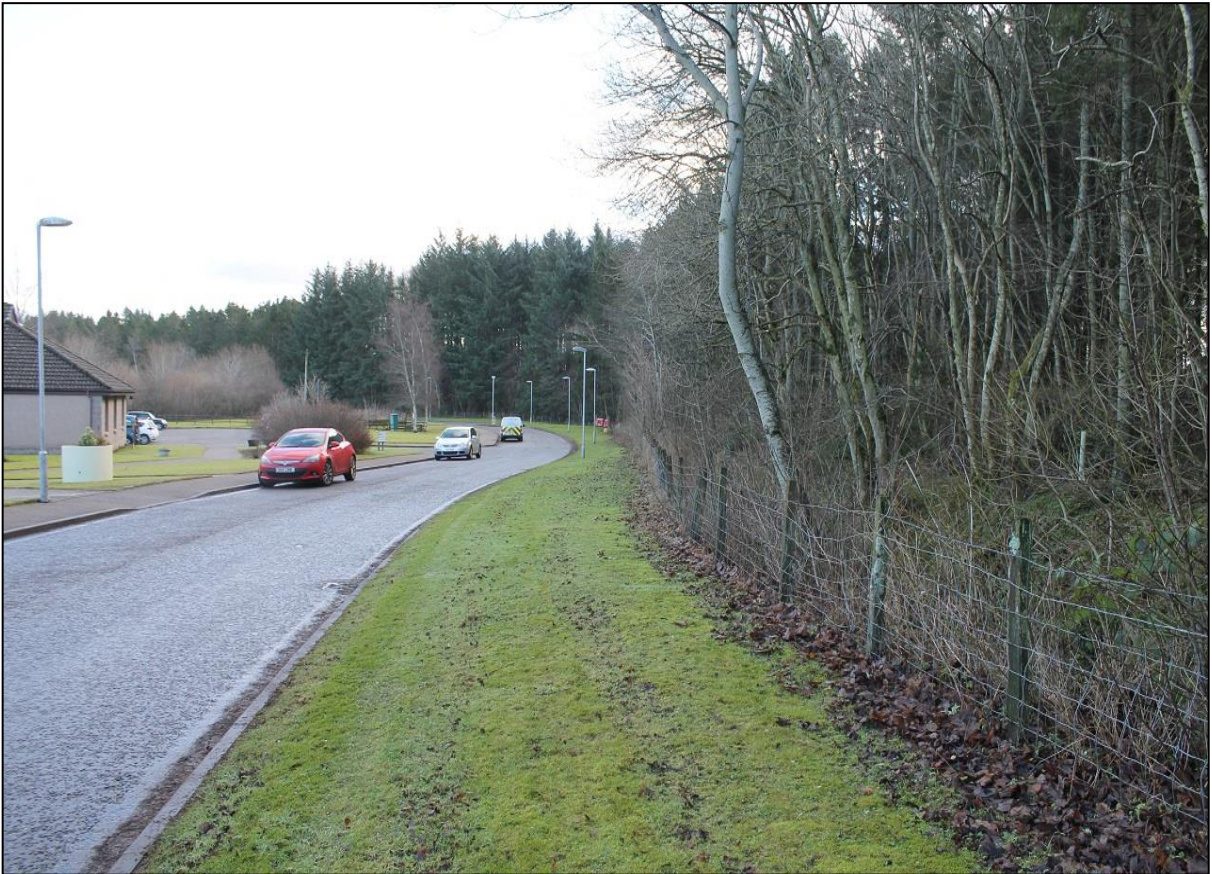
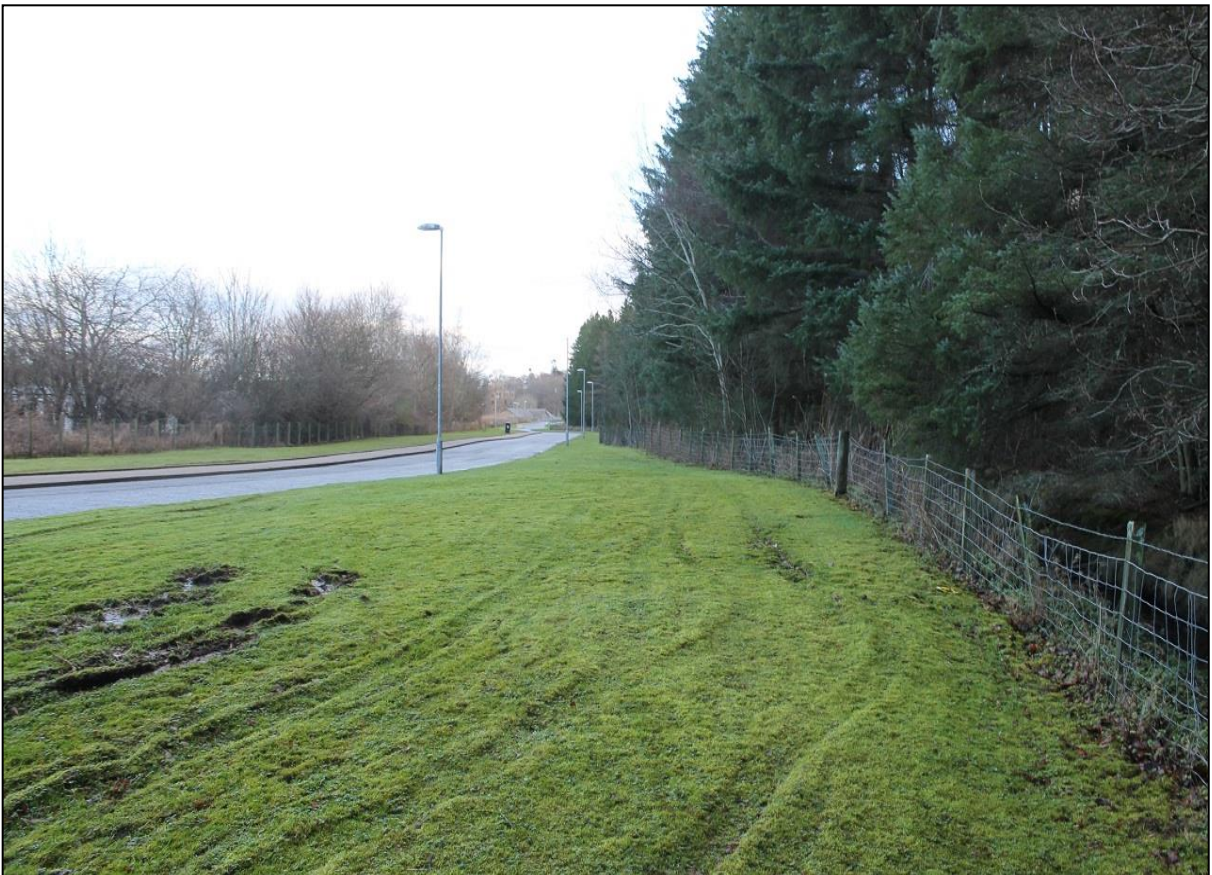
25. After agreement with Aberdeenshire Council Archaeological Service, Bunds 5 & 6 were not monitored due to their proximity with the modern road and the likelihood that any possible archaeological resource had been disturbed by this (Figures 10a and 10b).

Figure 10a: AREA 2: Bund 5, location shot

Figure 10b: AREA 2: Bund 6, location shot

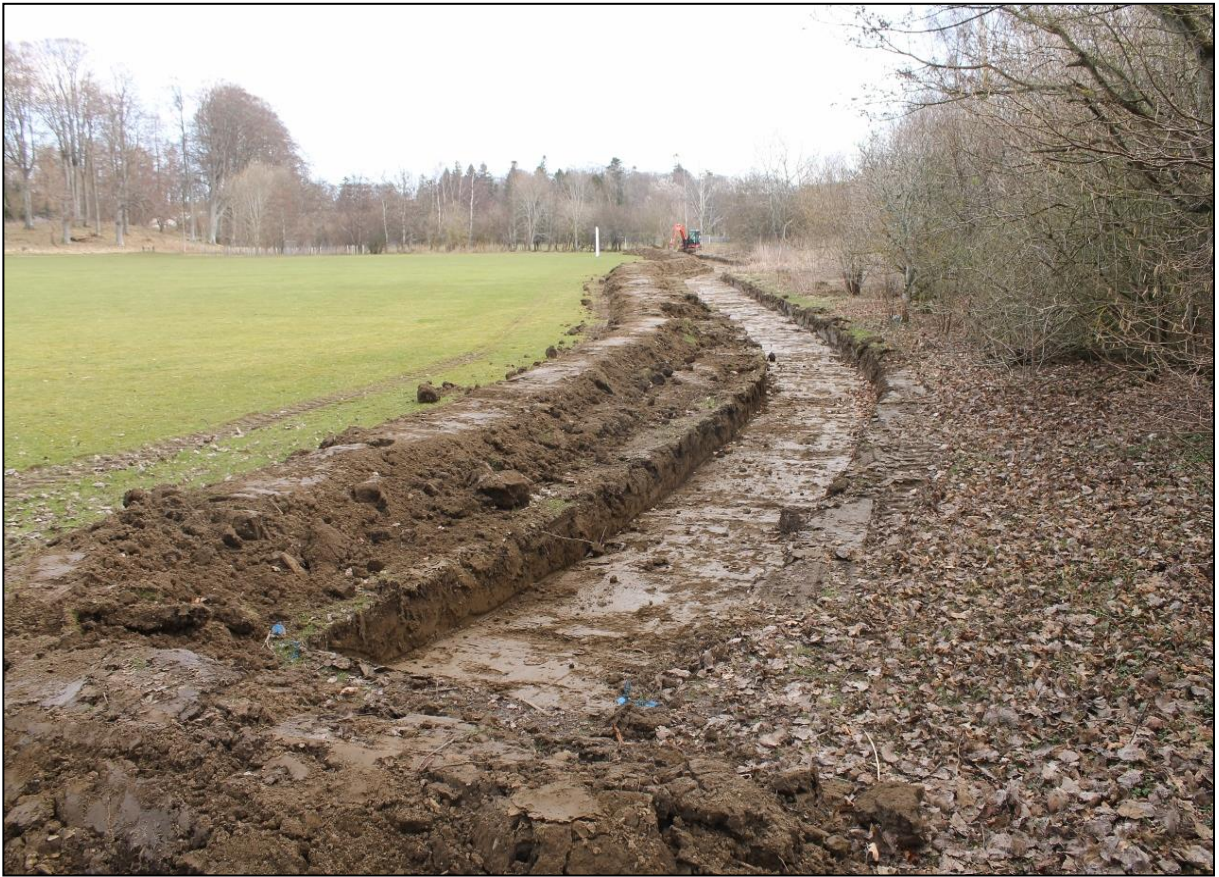
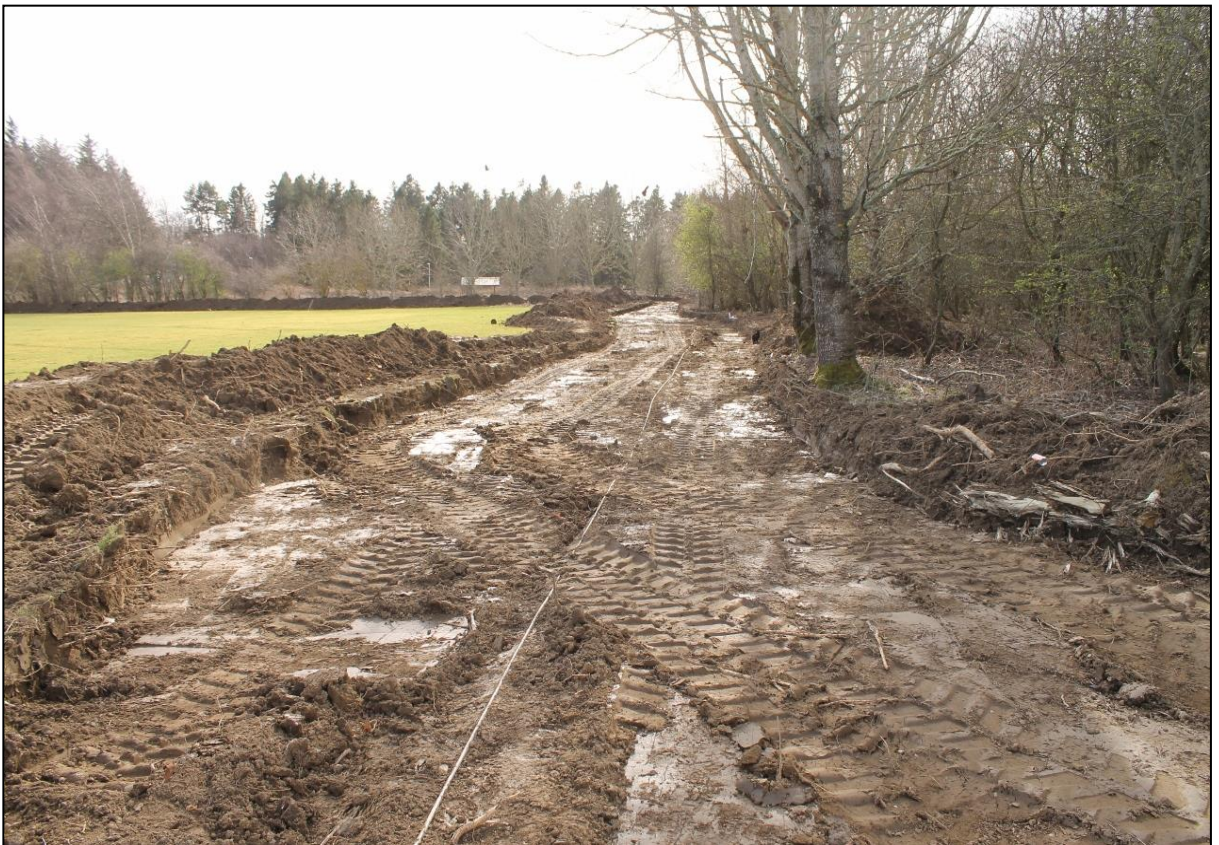
26. Bund 7 was aligned west-east for the first approximately 110m where it then changed course and ran south for approximately 70m and then changed alignment to run in an easterly direction for the rest of its length. An approximate area measuring 260m long by ranging in width from 1.5m to 5m was stripped to a depth of 300mm for the construction of a new bund at Bund 7 (Figures 11a & 11b).

27. A single deposit was encountered during the strip which consisted of a moderately compacted, mid-brown clayey silt with infrequent small sub-rounded and sub-angular stones, and grass roots in the upper 100mm (001). Some late 19<sup>th</sup> to early 20<sup>th</sup> century ceramics were identified within this deposit but were not retained. An unknown modern British Telecom cable was found running north-south (Figure 11b) through the middle area of the bund route. No other features were recorded.

Figure 11a: AREA 2: Bund 7, west end

Figure 11b: AREA 2: Bund 7, central area with BT cable running north-south
