**Kinneil Woods, Falkirk:
Archaeological Support for Antonine Wall Access
Improvements**

Data Structure Report

issued 2nd December 2016

on behalf of Central Scotland Green Network Trust

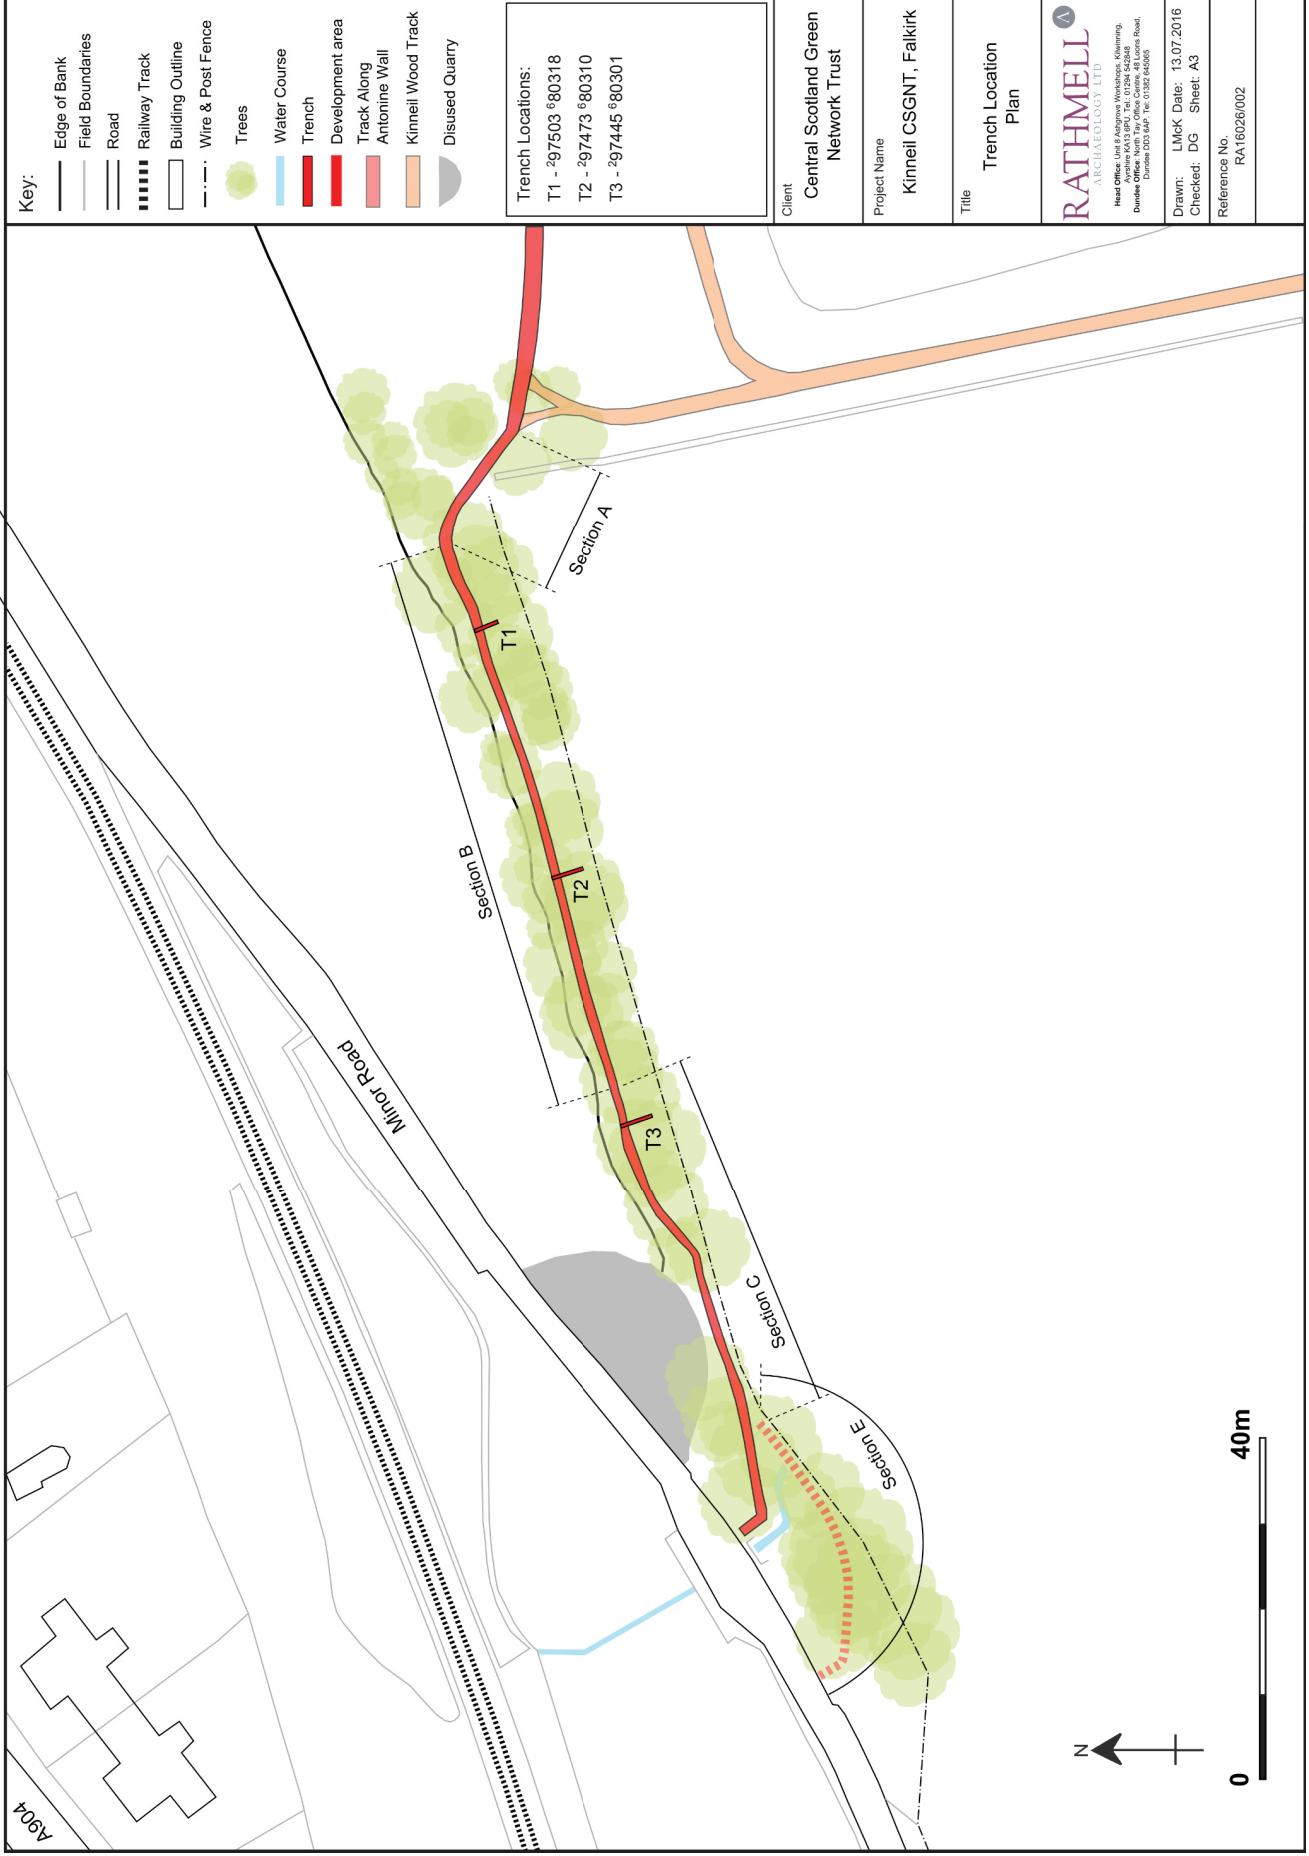
Figure 2: Trench Location Plan.

7. The three trenches (1-3) were each set out across the modern footpath and part of the adjacent, upslope, bank (Figures 2-5). The sections (2 and 3) of the modern path which were the focus of the study ran in a WSW-ENE direction. The existing bank ran to the immediate SSE of the path with a steep slope to the NNW. On both sides of the path there was extensive tree and other vegetation. The full details and dimensions for each of the trenches can be found within Appendix 1.

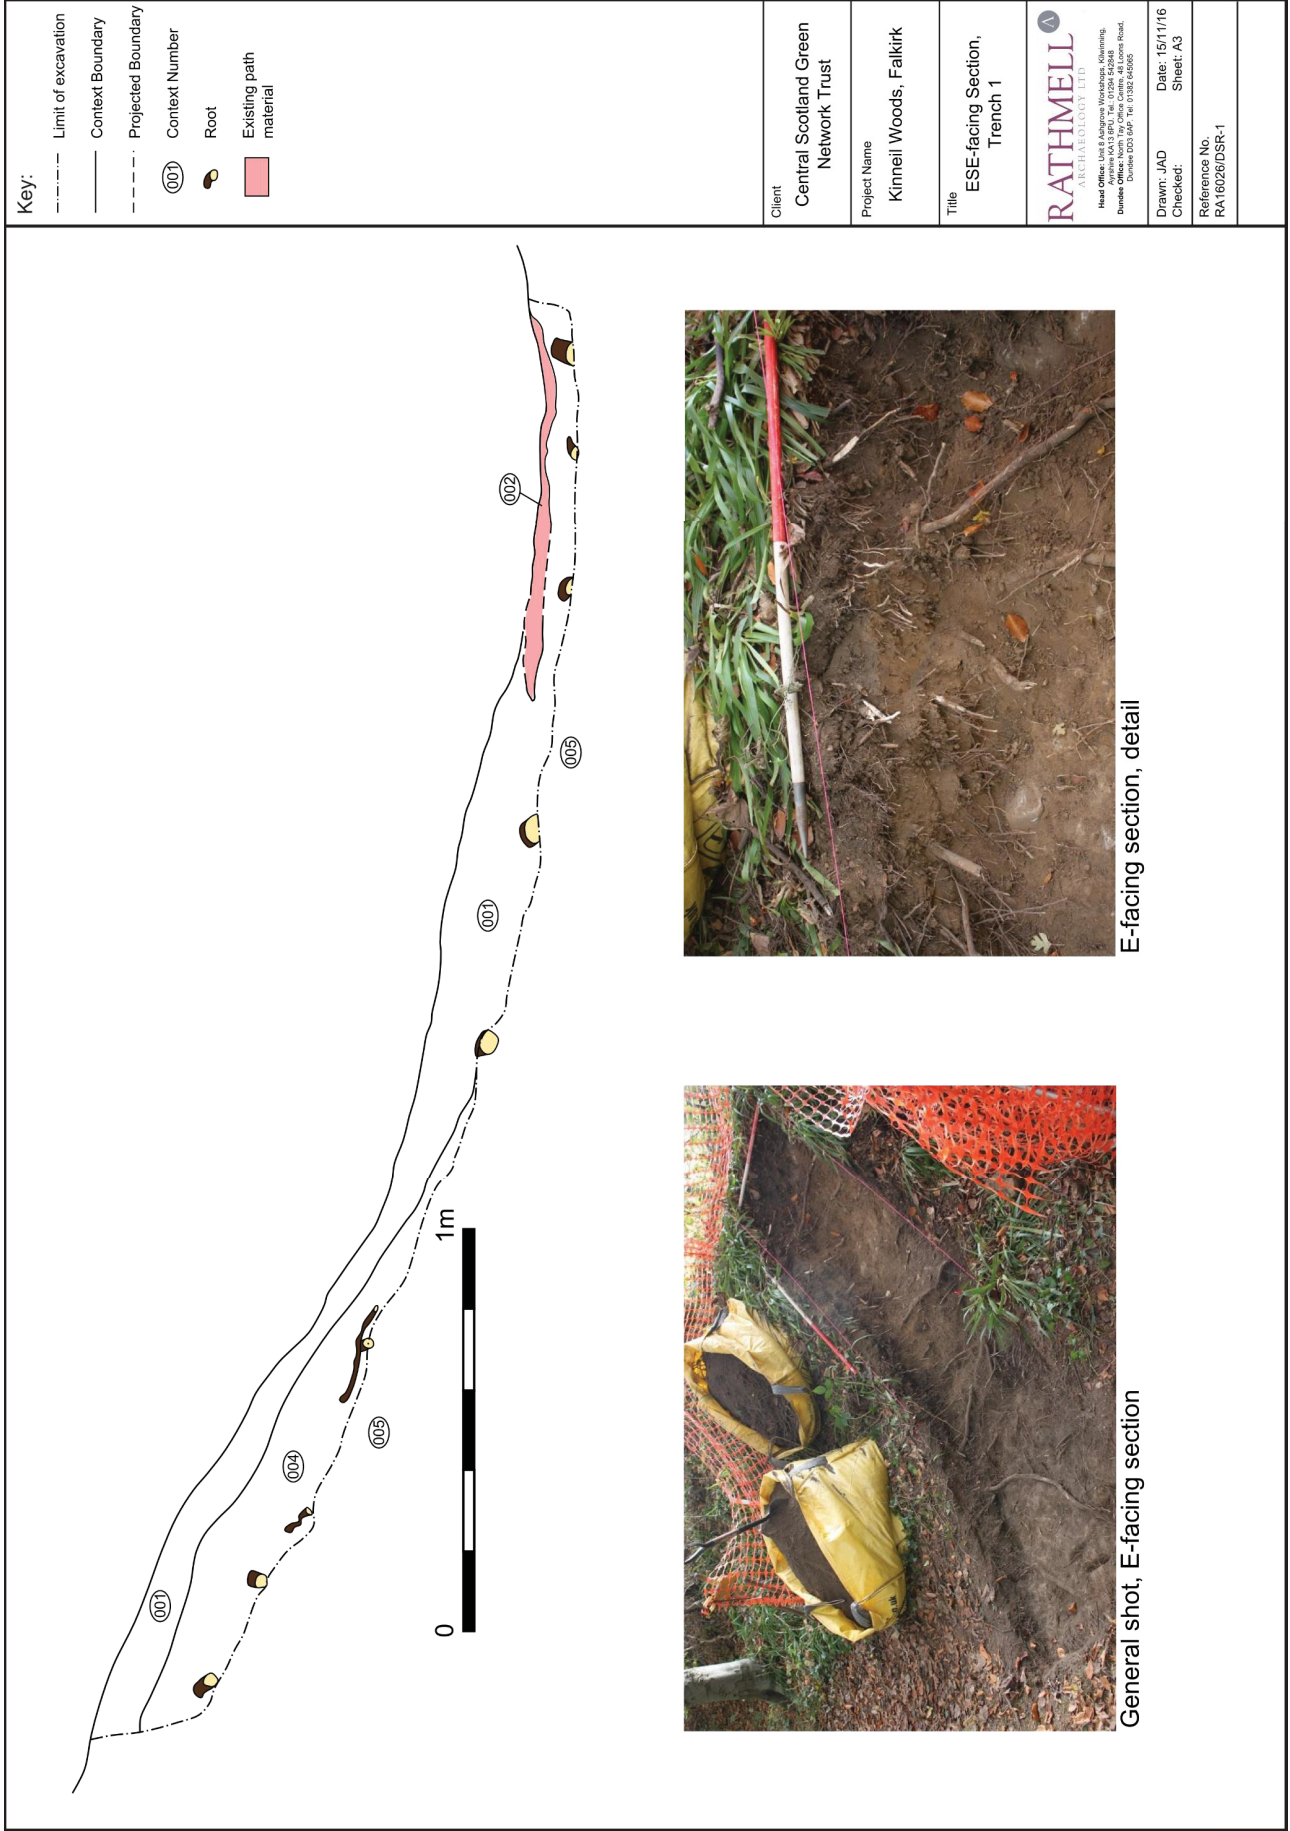
Figure 3: ESE facing section of Trench 1.

9. Material provisionally interpreted as bank or slumped bank material (004) was located beneath both the topsoil (001) and the path (002) (Figures 3-5 and 6b-7b). The sediment consisted of very firmly compacted, light-mid yellow-brown sandy/silty clay with occasional small to medium sub-angular stone inclusions (especially at the higher SSE end of the trenches) and moderate root inclusions. The bank material had a depth range of between 100-450mm - with the deposit being thickest at the higher, SSE, ends of the trenches where it was encountered. The layer also sloped from SSE to NNW where it was encountered with a change in height of 1m in Trench 3 and 1.3m in Trench 2.

11. In all three trenches thick and dense root masses, (005), were identified (Figures 3-5 and 6b-7b). This material consisted of large tree, bush and shrub roots, the largest of which were 30-80mm in diameter, and a mass/concentration of smaller roots located within and between deposits (004) and (003). Trench 2 in particular was subject to areas of destructive vegetative growth where areas of bioturbation, (006), was noted in section.
