Knoxville Road, Kilbirnie: Archaeological Evaluation and Survey

Data Structure Report

by Douglas Gordon

issued 5th June 2007

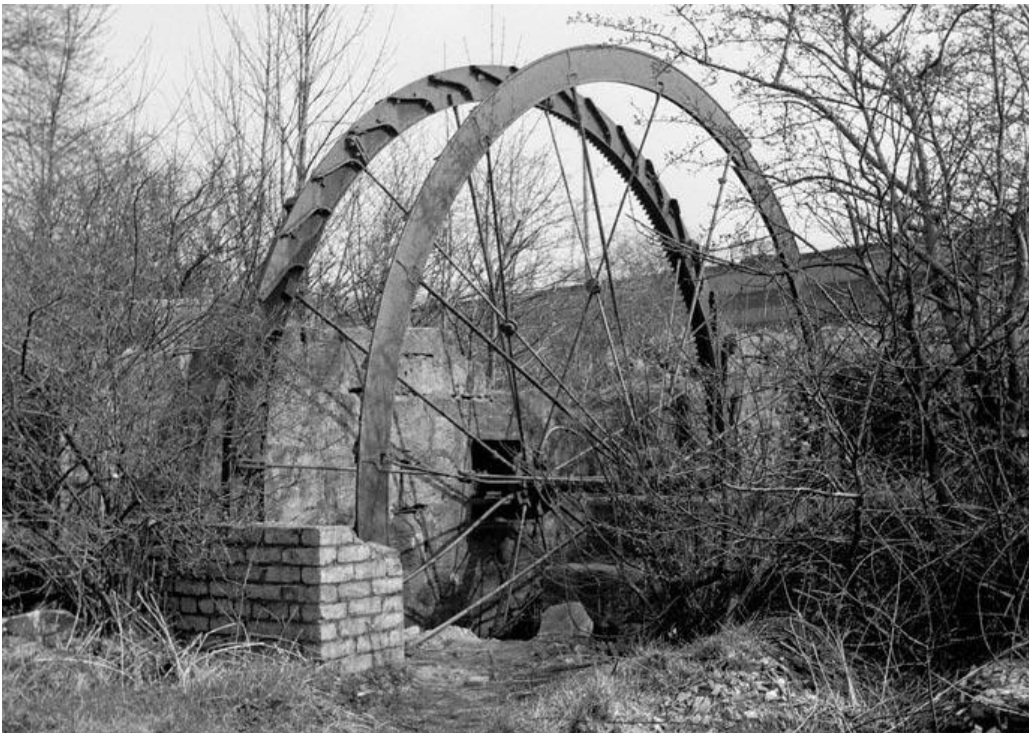
Figure 2: General view of mill (RCAHMS 1967)

- 3.3 The Royal Commission on Ancient and Historical Monuments of Scotland concur that the mill (see Fig 1c) dates mainly from the mid-19th century, although they consider this *“to have been a remodelling of an older corn mill. All that was left in 1967 was the skeleton of a*

suspended high-breast waterwheel, and the lower courses of the sandstone mill building. This shows the remains of the wheel, with the remains of the ashlar wheel gable beyond. The iron spokes and cross-braces of the wheel are clearly visible, as is the profile of the buckets on the rim. This was an unusual type of wheel for a corn mill. The wheel was 0.91m by 5.59m, and drove the mill from a gear ring bolted to the left-hand wheel rim. This type of wheel was developed in the 1820s, and was used mainly in textile mills. This one may have been second-hand from such a mill."

- 6.9 At an even later date all internal mill machinery was removed, the Mill Lade isolated from the Garnock and the Mill Pond breached. The mill in 1967 seems to have been as now except both hubs of the skeleton Wheel survived, the outer hub having now been removed.

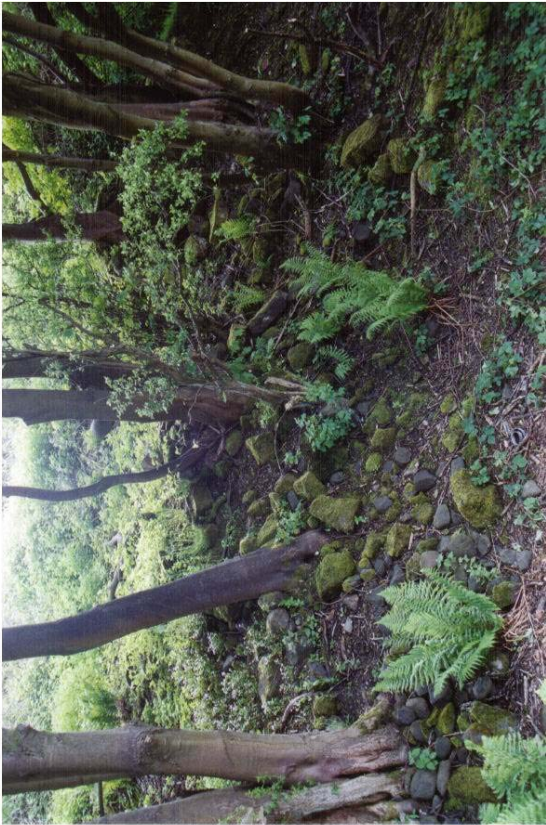
Figure 4a: North-east Mill wall; internal

- 4.3.4 The south-western chamber (Figs. 4a-d) is internally 11.3m by 8.9m with the long axis aligned north-west to south-east. Slightly north of the midpoint in the north-west wall is a filled 2.5m broad opening, presumably a door. The north-western and north-eastern walls are some 0.7m broad of sandstone quarried stone which have been badly denuded and now stand at most some 0.7m high. In contrast the south-eastern and south-western walls are only 0.4m thick of ashlar blocks, some with masons drag visible. The south-western wall is also capped with sandstone flags at 2.2m.

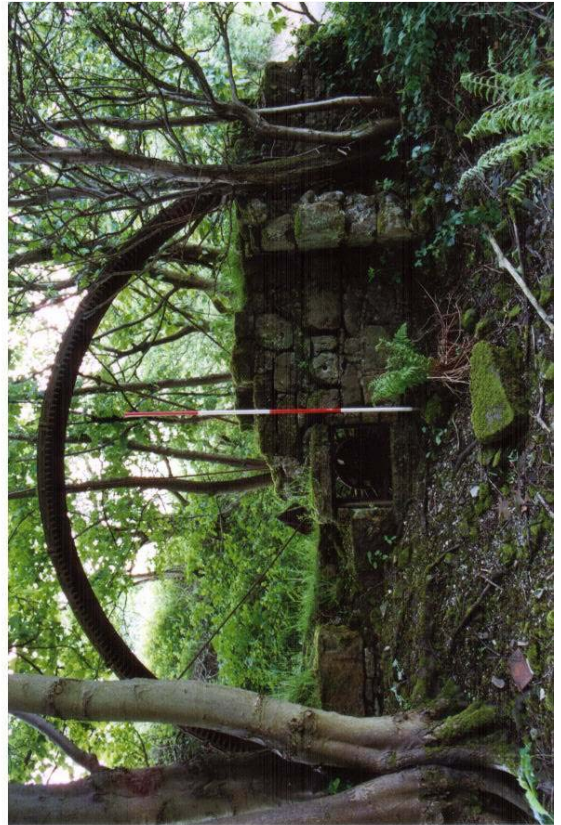
Figure 4b: South-east Mill wall; internal

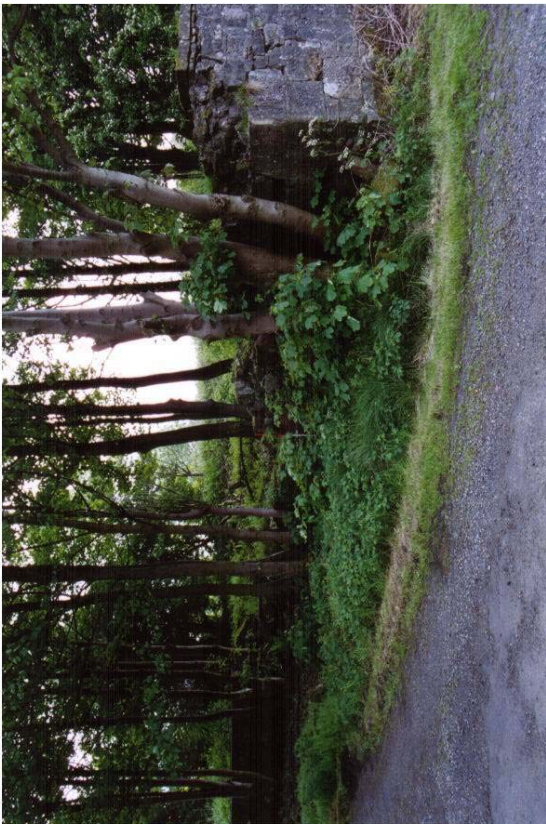
Figure 4c: North-west Mill wall; external

- 4.3.2 The two chambers of the structure are set perpendicular to one another forming an L form. The north-eastern chamber (Figs. 4c & 5d) is internally 10.4m by 5m with the long axis aligned north-east to southwest. Slightly south of the midpoint in the north-west wall is a filled 0.9m broad opening, presumably a door. The walls are some 0.6m broad of sandstone quarried stone which have been badly denuded and now stand at most some 0.7m high.

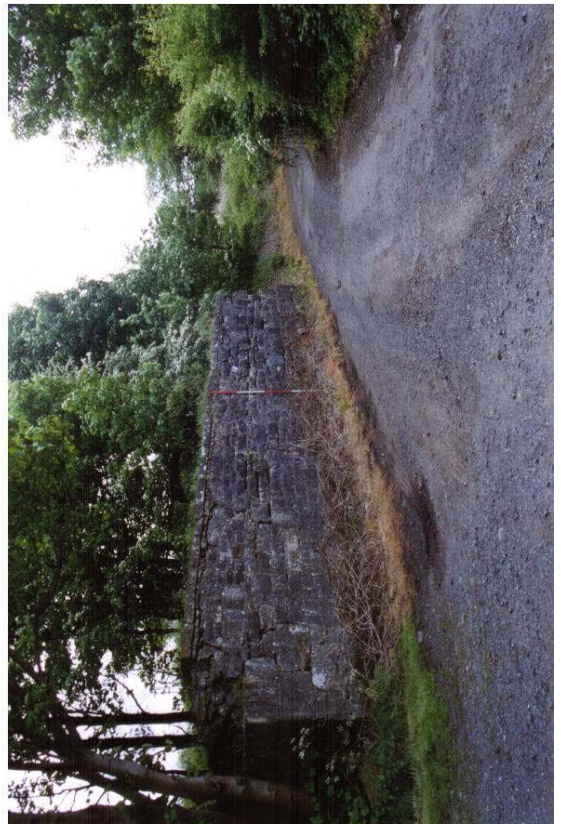
Figure 4d: South-west Mill wall; external

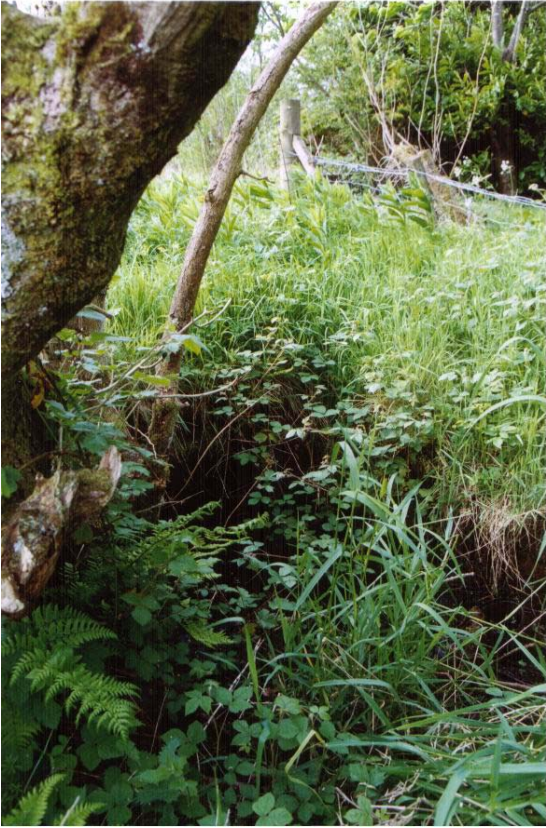
Figure 5a: Bridge over Lade

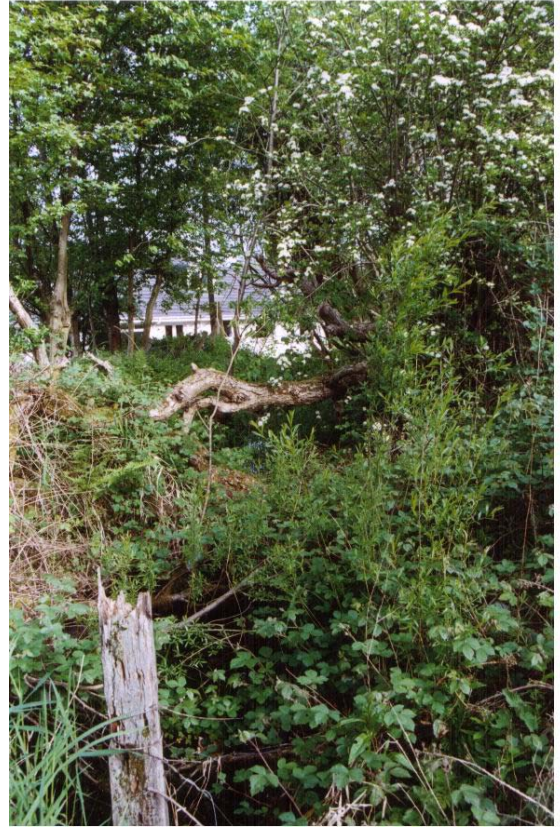
Figure 5b: Lade, looking north

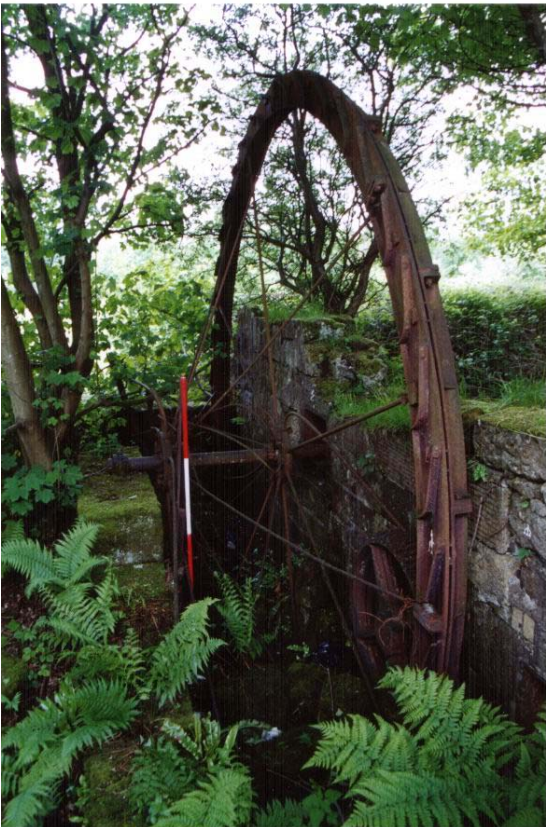
Figure 5c: Wheel, looking west

- 4.3.7 The high breast Wheel survived as a single iron rim, spokes, central axle and both hubs mounted in the correct location. The character of the buckets was visible in the form of the surviving rim. The wheel, based on axle measurement, was 1m broad and 5.6m in diameter with a gear ring around the inner edge of the rim which meshes with a smaller gear wheel whose axle runs through the wall into the Mill.

- 6.6 By its form and design the Wheel is post-1820 so cannot have been the original Wheel, indeed it has been suggested that this is a re-used wheel from textile mill. It is of note that such a textile mill was burnt down in 1834 in Kilbirnie (Urquhart 1834-45, 715) before being rebuilt. One highly speculative possibility was that the Wheel was from the rebuild of this destroyed textile mill, although a much later sourcing of such a wheel is possible. Certainly the layout of the chambers and the location of the Wheel Pit are unlikely to have been altered even with the introduction of the new form of Wheel. That this wheel is inserted within a pre-existing structure is evidenced partly by the use of brick to form the cavity for the spindle of the drive/gear wheel in the gable wall of the mill.

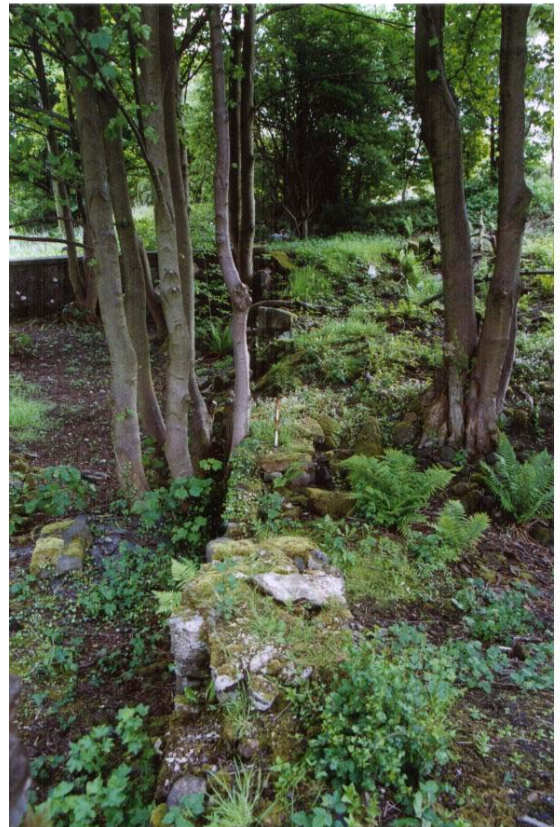
Figure 5d: Mill, north-western wall

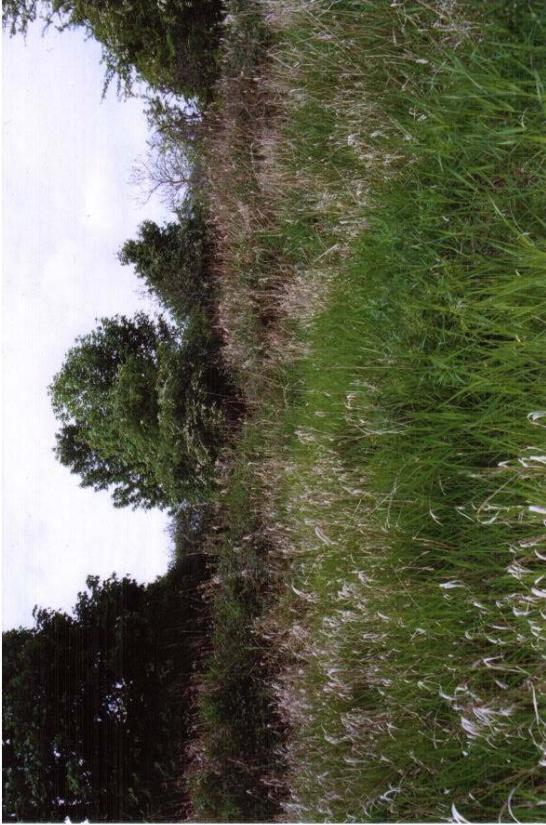
Figure 6a: Mill Dam, looking south-east

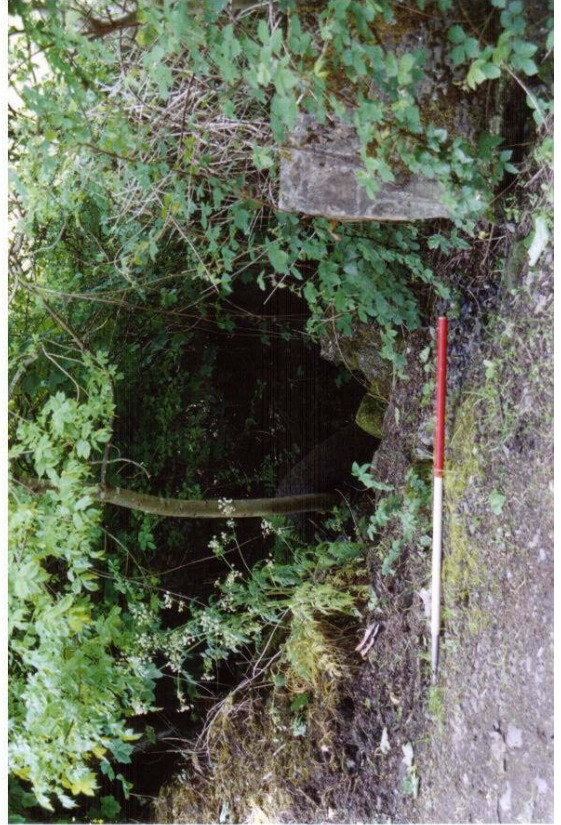
Figure 6b: Outfall from mill, south of road

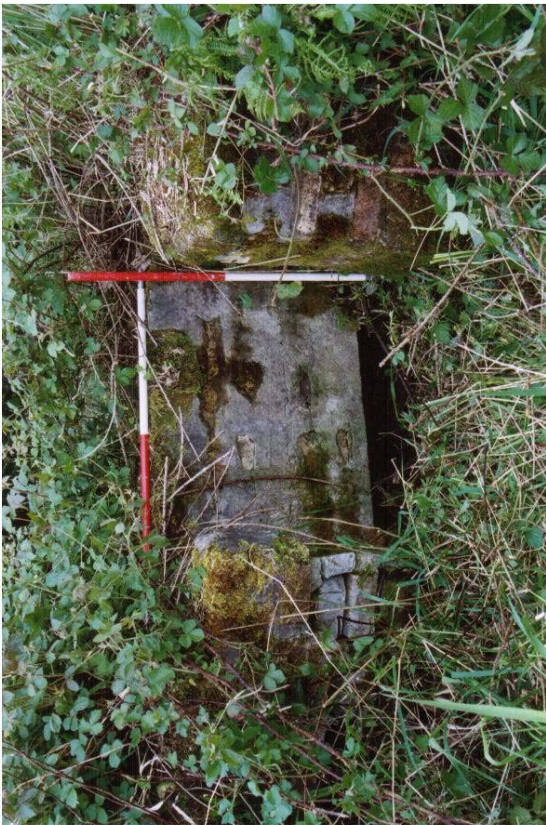
Figure 6c: Outfall from Mill Pond

- 4.2.3 A Sluice (Fig 6c) is evident at the south-western end of the Mill Pond from where a short Mill Race is discernible running to the Wheel Pit (see Mill Structure below). To the southwest of the mill structure the Tail Race is culverted beneath the modern track before falling south to the Garnock (Fig. 6b). The Tail Race and subsequent ditch does appear to still carry some water, although this is probably runoff from surrounding surfaces.

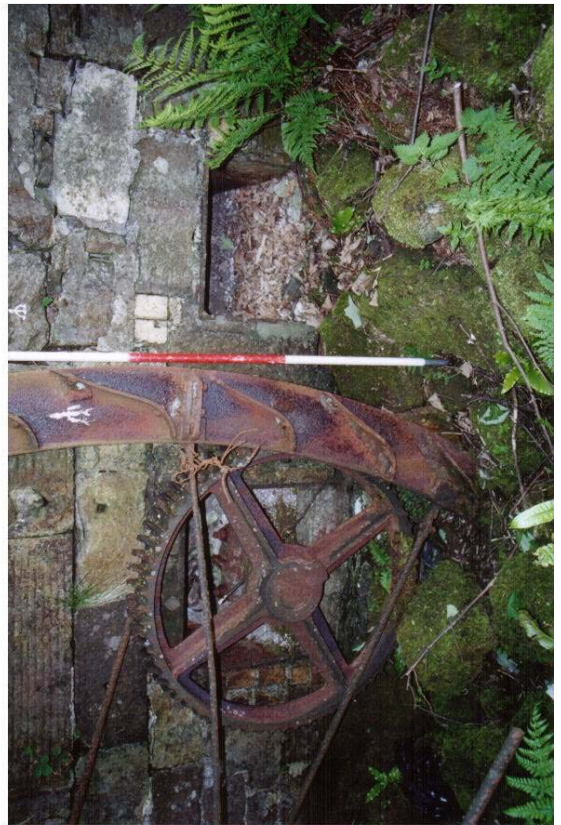
Figure 6d: Internal gear on Wheel

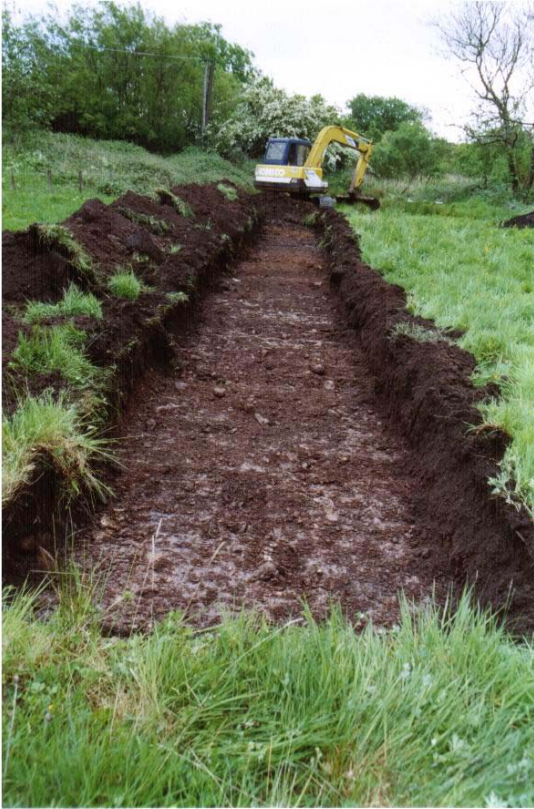
Figure 7a: Trench 9

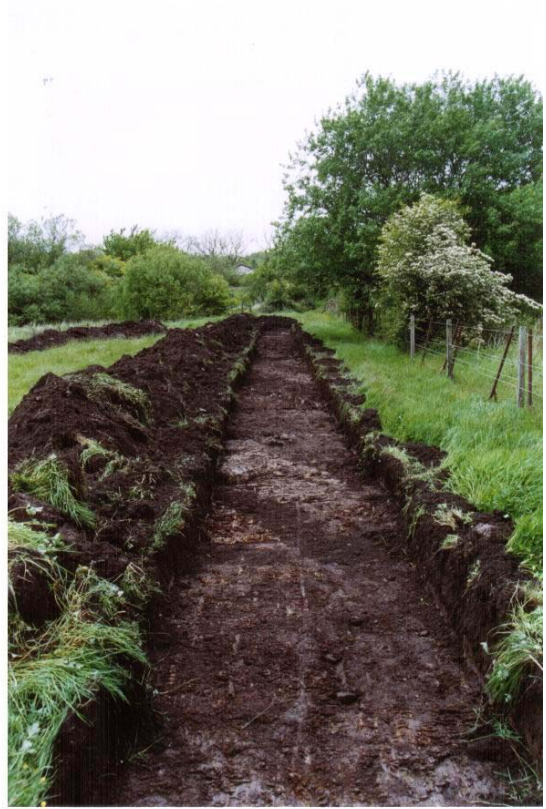
Figure 7b: Trench 6

| Modern features: | Rd tile field drain (206) runs SE-NW across trench at 4.7m until 6.7m. Measures 0.1m wide. Stone rubble field drain (204) runs SE-NW across trench at 13.5m, 23.5m and 26.5m and runs SW-NE across trench at 31.2m. Measures 0.3m wide with sub-rounded stones $\leq 200\text{mm}$. |
| Rig & Furrow: | Some 2 linear features (203) interpreted as furrows commonly aligned northwest to southeast. The furrows are 2.5m to 3.2m wide. The furrows are spaced at 6m apart (centre furrow to centre) and appear in the trench between 8m and 20m. |

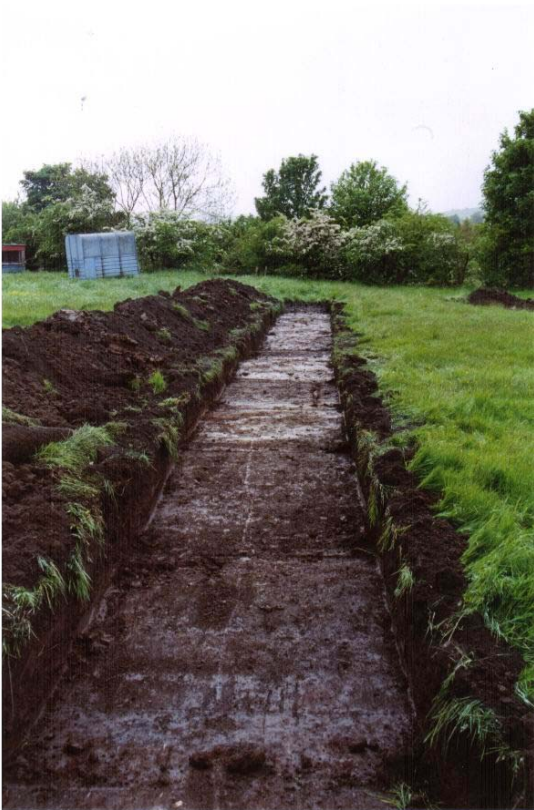
Figure 7c: Trench 4

Subsoil character: Subsoil (207), a mottled grey/brown silty sandy gravel, is present in trench until 5.5m before being replaced by subsoil (202), a quite compact pale orange/brown silty clay with frequent small to medium sized stone inclusions.

Modern features: Stone rubble field drain (204) runs SE-NW across trench at 5.7m and at 17.5m. Measures 0.3m wide with sub-rounded stones ≤ 200mm.

Rig & Furrow: Some 3 linear features (203) interpreted as furrows commonly aligned northwest to southeast. The furrows are 1.1m to 2.8m wide. The furrows are generally commonly spaced at 4.5m apart (centre furrow to centre) and appear in the trench between 5.5m and 17m.

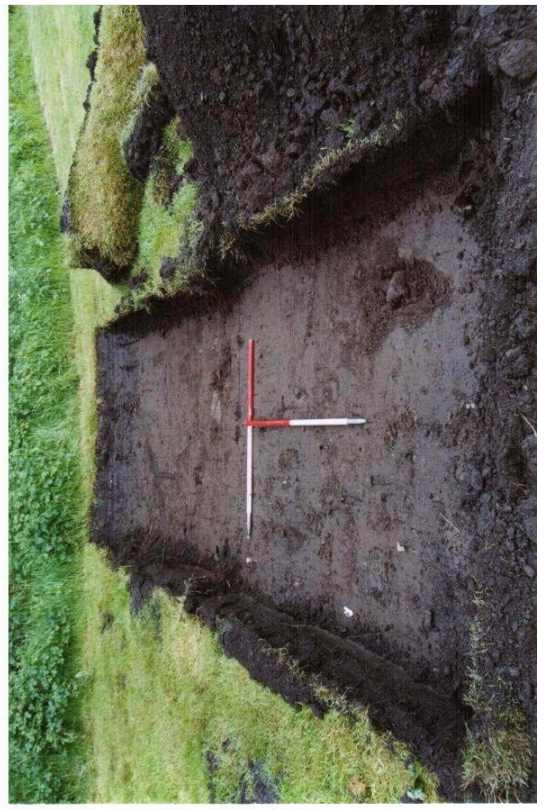
Figure 7d: Trench 1

- 6.2 Trench 1, in the vicinity of the long cist exposed in 1798, failed to identify additional funerary features. However, the location of the original cist is not well mapped and there must remain the potential for additional funerary features. The trench does offer some guidance that this potential, if realised, is unlikely to be extensive or highly significant within this portion of the development area.

| Subsoil character | Subsoil (102), a very dark brown, moderately compact slightly clayey silt with frequent small stone inclusions, is present along whole of trench. |
