Arinagour Water Pipeline Realignment, Coll: Historic Environment Assessment

by Callum Allsop
for Scottish Water Shared Solutions
issued 16th January 2017

RATHMELL  
ARCHAEOLOGY LTD

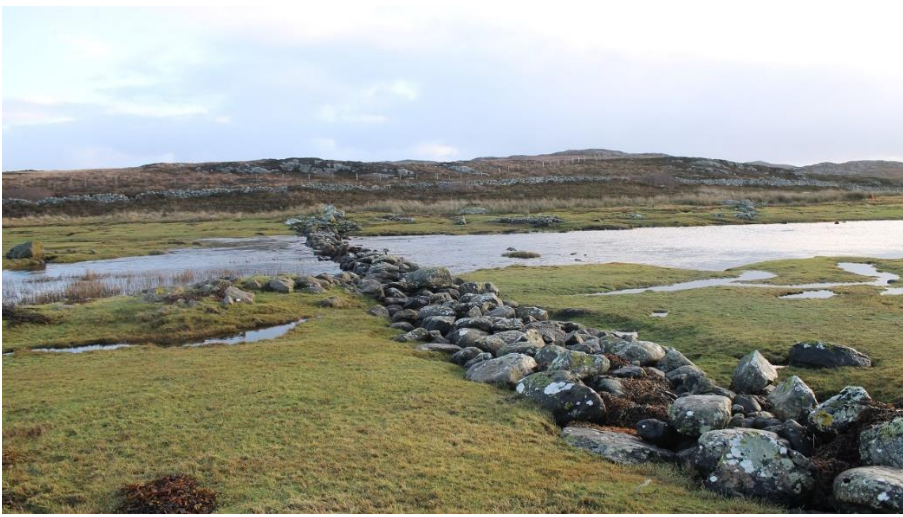
Site	Name	NGR Ref:	UID, Designation & Description	Period	Image from Site Inspection
S01	ARINAGOUR	NM 22394 58241	<p>WoSAS ID: 59957 – FISH TRAP</p> <p>A wall constructed from large boulders extends across the tidal end of the river at the mouth of Loch Eatharna, to the north of Arinagour. It measures some 2-2.5m in width and stands some 1.5m high; in overall length it exceeds 50m. It is locally thought to serve as a salmon trap. The wall head is broad enough to walk over and it is probable that it also served as a crossing place. From this point inland, the river appears to have been embanked, one of the effects of which has been to contain the water and create deeper pools within the river.</p> <p><i>Site inspection confirmed presence of the recorded feature. While the site does have credible views to the development area at its western extremity, it will not be compromised by the proposed pipeline.</i></p>	Post-Medieval (AD 1560 – 1900)

19. Arinagour Fish Traps **S01** and **S02** were inspected and the form and nature of these features are readily identified. The structure of **S01** appears in good condition with very little displacement of the stones used in its construction. In contrast, the condition of **S02** is rather poor with many stones being robbed out or washed downstream.

27. The development as currently understood does not constitute a significant impact on Arinagour Fish Traps **S01** and **S02**, Arinagour Enclosure/House Platform **S03**, Arinagour Slipway **S06**, and Loch Eatharna Mound **S07**.

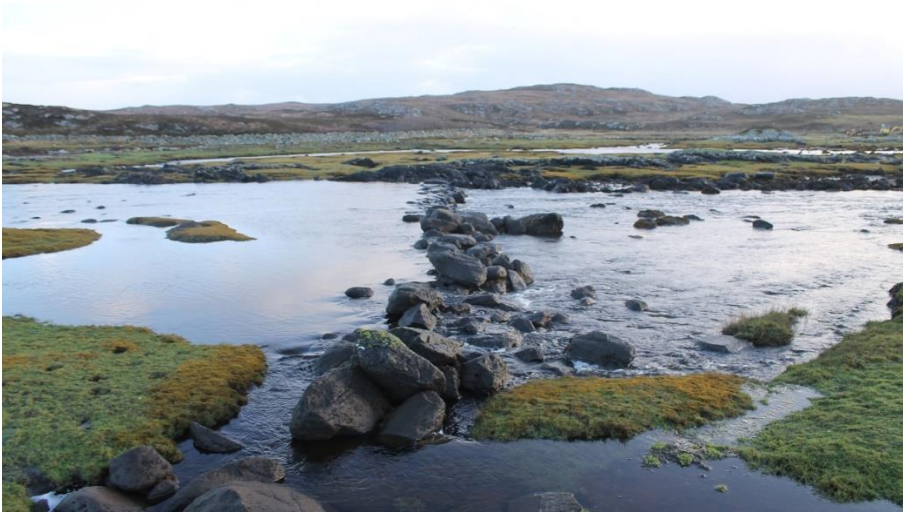
S02	ARINAGOUR	NM 22433 58133	<p>WoSAS ID: 59967 – FISH TRAP</p> <p>A wall constructed of large boulders extends across the river at the head of Loch Eatharna. Measuring some 35m in length, this wall is 2-2.5m in width and up to 1.5m high. It is locally thought to be a salmon trap but may also have served as a crossing place on the river.</p> <p><i>Site inspection confirmed presence of the recorded feature. While the site does have credible views to the development area at its western extremity, it will not be compromised by the proposed pipeline.</i></p>	Post-Medieval (AD 1560 – 1900)

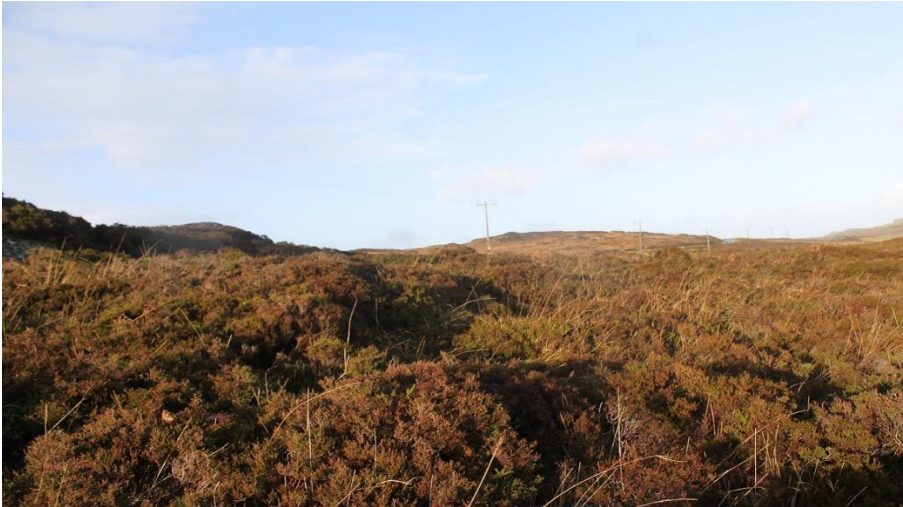
S03	ARINAGOUR	NM 22444 57874	<p>WoSAS ID: 60015 – ENCLOSURE/HOUSE PLATFORM</p> <p>The footings of a possible enclosure occupy an area of greener vegetation on sloping ground some 25m from the coast edge. Some stonework remains but more has been robbed out. The enclosure measures 8m by 4m and is aligned E-W. The W end is best preserved. The enclosure has been on a platform of apparently artificial origin and more likely to have been constructed to accommodate a house.</p> <p><i>Site inspection confirmed presence of the recorded feature, although it was significantly overgrown with heather vegetation. While the site does have credible views to the development area towards the northwest of the feature, it will not be compromised by the proposed pipeline.</i></p>	Post-Medieval (AD 1560 – 1900)

20. The assessment identified the locations of the Arinagour Enclosure/House Platform **S03**, Arinagour Ford **S04**, Arinagour Enclosure **S05**, and Arinagour Slipway **S06**. The condition of Enclosure/House Platform **S03** could not be determined due to heavy heather vegetation covering the feature. Heavy vegetation also obscured the Enclosure **S05**, however the condition of this site was noted as poor with the majority of the stonework robbed out. Comparatively, the Ford **S04** and Slipway **S06** were both of good condition; with evidence of the ford still being in use today.

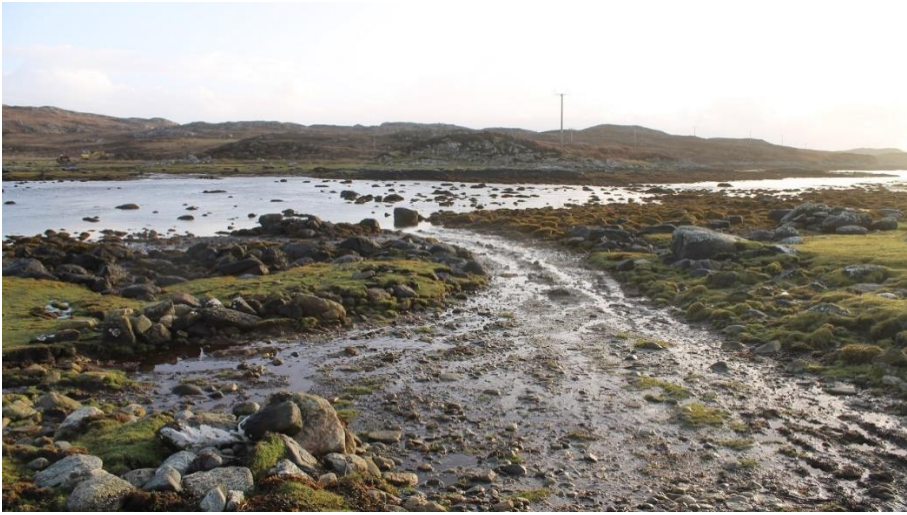
Site	Name	NGR Ref:	UID, Designation & Description	Period	Image from Site Inspection
S04	ARINAGOUR	NM 22412 58073	<p>WoSAS ID: 60016 – FORD</p> <p>A ford across the river reuses an old slipway for boats. The channel has been cleared of large stone with the displaced material piled up to either side. There are several trough-like features set into the ground surface in this area. All are filled with washed in stone. They may represent old kelp kilns but could equally be associated with the fishing industry.</p> <p><i>Site inspection confirmed presence of the recorded features. There is a likelihood that the western extremity of the site will be compromised by the proposed pipeline.</i></p>	Post-Medieval (AD 1560 – 1900)

28. Arinagour Ford **S04** and Arinagour Enclosure **S05** will be affected by the pipeline development, but are considered to be of Other significance and do not warrant mitigation by themselves. However, due to the relatively high level of anthropic activity dating to the Post-Medieval Period along the western bank of Loch Eatharna, it is recommended that ground-breaking works should be subject to archaeological monitoring on a precautionary basis in case additional sites that are not identifiable from surface remains are present.

29. Specifically, we recommend that mitigation should cover:
- a. works along the pipeline on the west bank of the estuary between the track at NM 22370 57905 and the field boundary at NM 22362 58245;

30. An archaeologist should be present during ground breaking work to monitor activity, identify potentially significant archaeological features and safeguard such features until they have been subject to archaeological excavation. The locations of these areas are depicted on Figures 1 and 2.

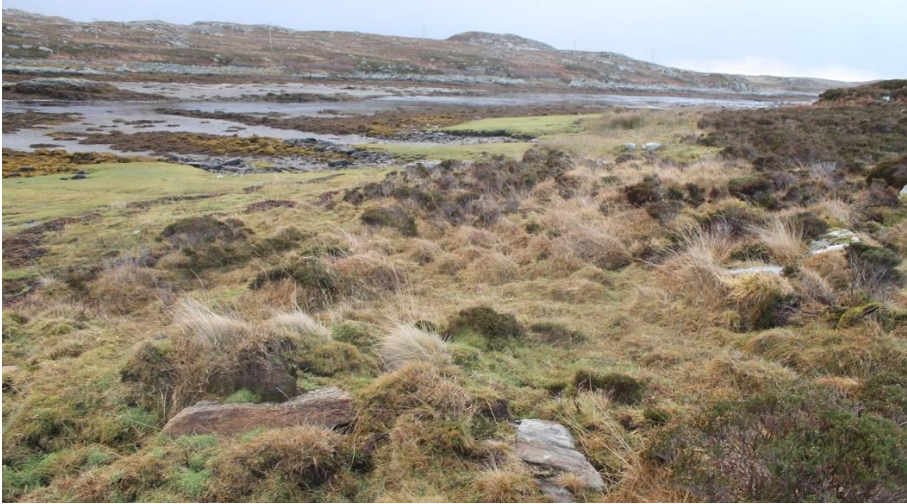
S05	ARINAGOUR	NM 22397 58046	<p>WoSAS ID: 60017 – ENCLOSURE</p> <p>A small curvilinear enclosure backs onto a bedrock outcrop. It measures 3m in diameter and is constructed from a double row of stones. The function of this structure is unclear.</p> <p><i>Site inspection confirmed presence of the recorded feature. There is a likelihood that the majority of this site will be compromised by the proposed pipeline.</i></p>	Post-Medieval (AD 1560 – 1900)

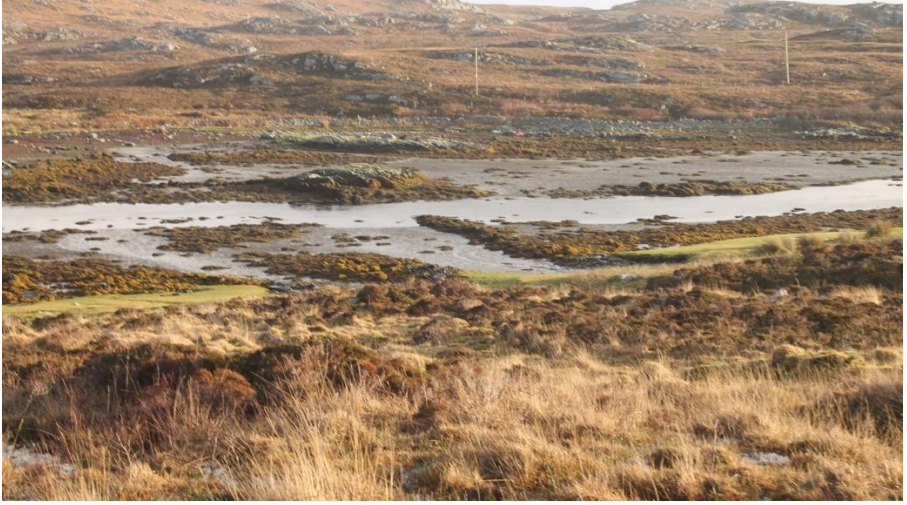
S06	ARINAGOUR	NM 22453 57930	<p>WoSAS ID: 60018 – SLIPWAY</p> <p>Two slipways are cleared at the side of the river. The displaced stone is heaped into three rows forming rough rubble walls. The slipway extends for some 40m into the deep water channel.</p> <p><i>Site inspection confirmed presence of the recorded feature. While the site does have credible views to the development area, it will not be compromised by the proposed pipeline.</i></p>	Post-Medieval (AD 1560 – 1900)

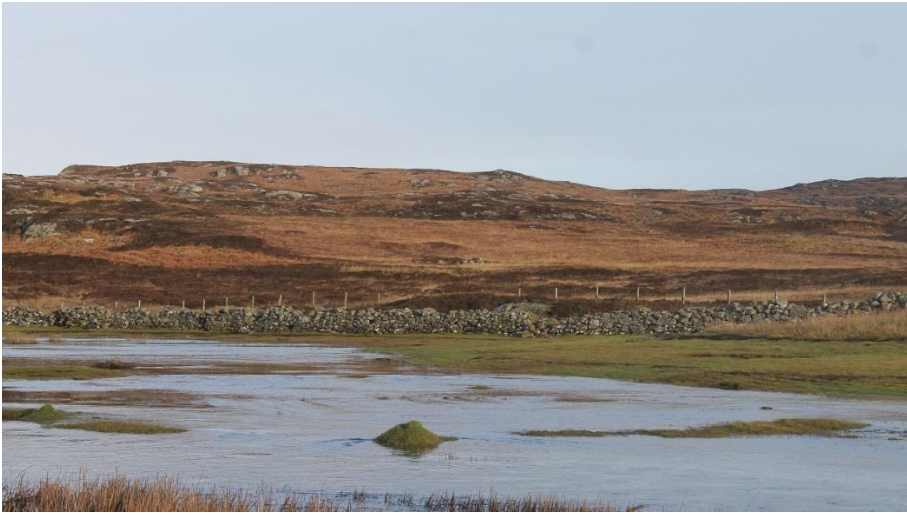
Site	Name	NGR Ref:	UID, Designation & Description	Period	Image from Site Inspection
S07	LOCH EATHARNA	NM 2240 5849	<p>CANMORE ID: 21687, WoSAS ID: 279 – 'MOUND'</p> <p>On the east side of Loch Eatharna, just where the stream enters the sea-loch, is a bracken-covered mound, which seems to be an ancient site of some description, although its precise character has not been satisfactorily determined. This is probably a green mound, c. 5.0m in diameter. There are indications of a rectangular structure, c. 4.0m by c. 3.0m, within it. To the immediate vicinity are two or three smaller bracken-covered humps, classification uncertain.</p> <p><i>Site inspection could not confirm presence of recorded features due to high water levels in the estuary obstructing access.</i></p>	Unclassified

21. It was not possible to confirm the location of Loch Eatharna Mound **S07**; although the open moorland on the eastern bank of the estuary appears to have several bracken-covered mounds with one showing visible stonework. The on-site assessment was that the mound/s stand on a southwest facing slope where a burn enters the sea-loch.

24. The Mound **S07** could not be satisfactorily inspected due to ground conditions. What can be inferred of this feature is that the mounds are possibly elements of a larger site, traces of which may yet survive and embody sufficient information that would allow us to better understand the character of that site. Therefore, the potential for the residual elements of

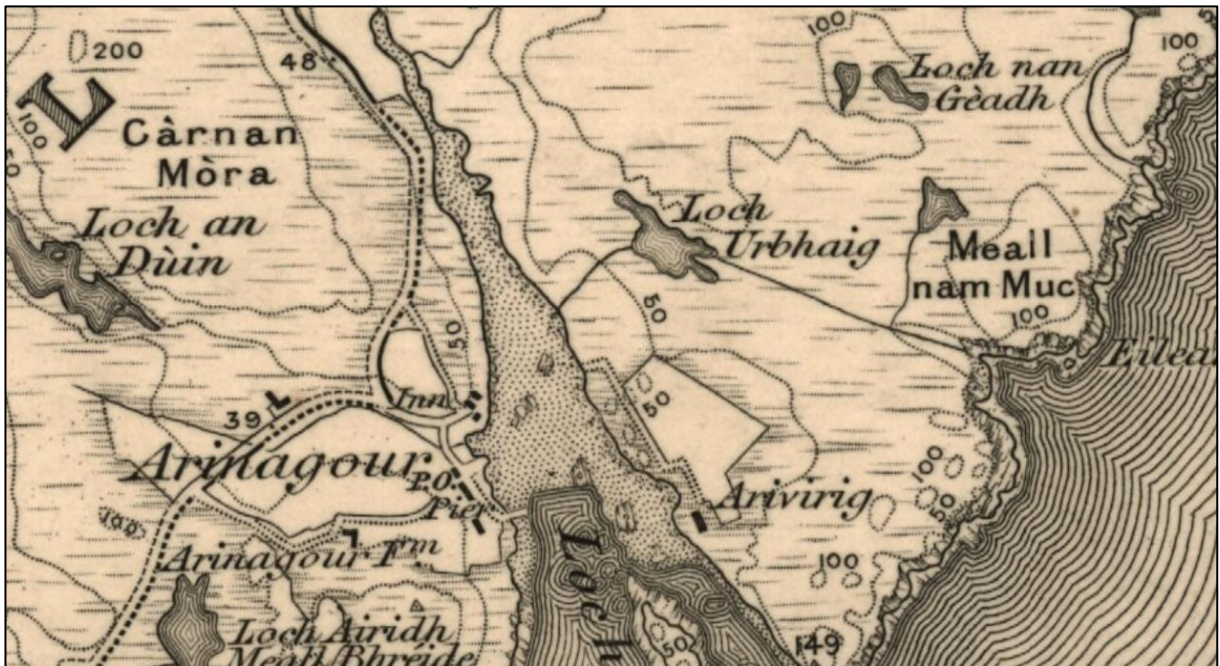
Figure 3a: 1st Edition Ordnance Survey (1885)

13. The earliest available mapping which shows the assessment area in an appropriate level of detail is the 1st edition Ordnance Survey 1885 (See Figure 3a). It shows the route of the pipeline to be passing through open moorland. This land use does not change over time and is largely unchanged on both the 2nd edition Ordnance Survey 1896 and 3rd edition Ordnance Survey 1907 (See Figures 3b and 4). By the time of the 2nd edition Ordnance Survey the settlement of Arinagour has established a church and school to the north of the village.
14. No archaeological features within the study area are depicted on any cartographic evidence.
