**Goldenhill Park, Clydebank:
Archaeological Investigation for
Access Improvement**

Data Structure Report

on behalf of West Dunbartonshire Council

RATHMELL  
ARCHAEOLOGY LTD

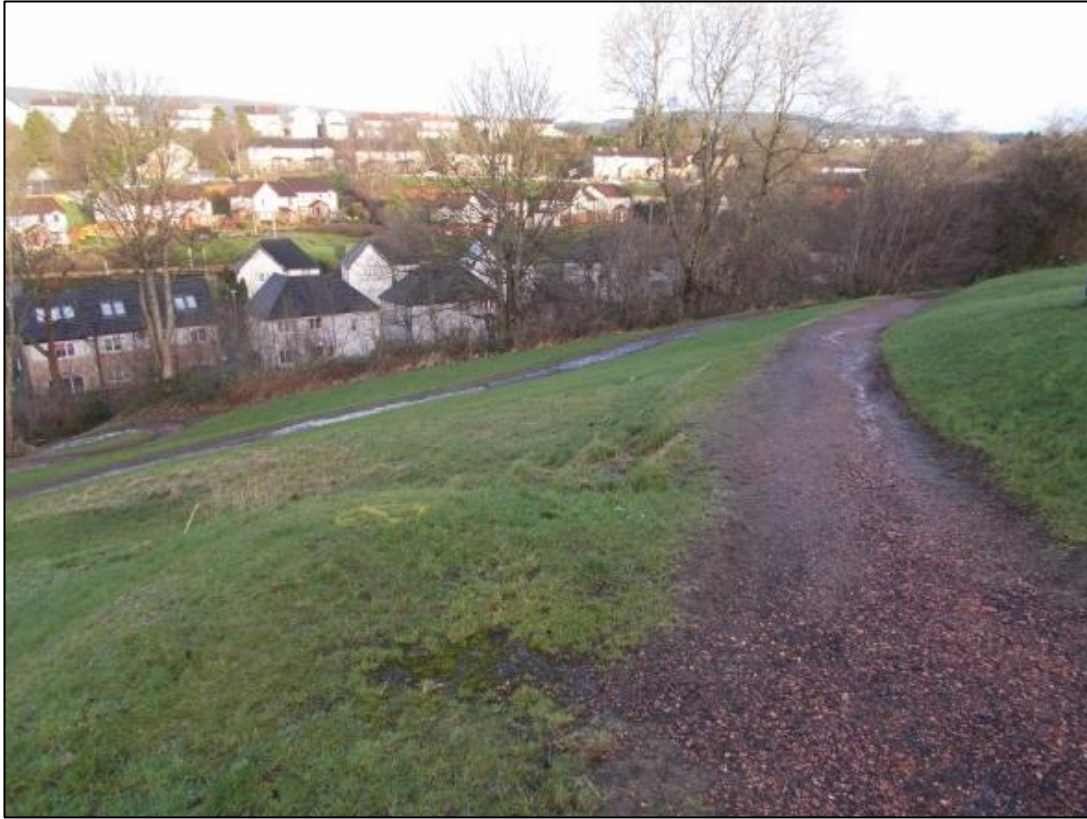
18. Test Pit **2** examined the mound adjacent to the path network and the steps at the top of the 'slide'. This showed that under a skim of topsoil (002) was buried path fabric (001) of some 200mm thickness. Beneath this was very compact clay (007) that was sufficiently robust as to prevent deeper hand excavation than 550mm depth.

Figure 2a: Path falling past upper platform of 'slide' to be tested by TP 2, steps to rear

27. Test Pit **2** is at another location that is depicted on the scheduling document map as a path, at the top of the 'slide'. This was confirmed by the path fabric exposed under another skim of topsoil. The very compact clay (007) that underlay this is dissimilar to the subsoil located anywhere else in the test pits; suggesting it is redeposited material – potentially cast material from excavation immediately downslope – that would have formed the topography to mirror and support the slide. This strongly suggests that the landform at this location is artificial and generated by landscaping within the park.

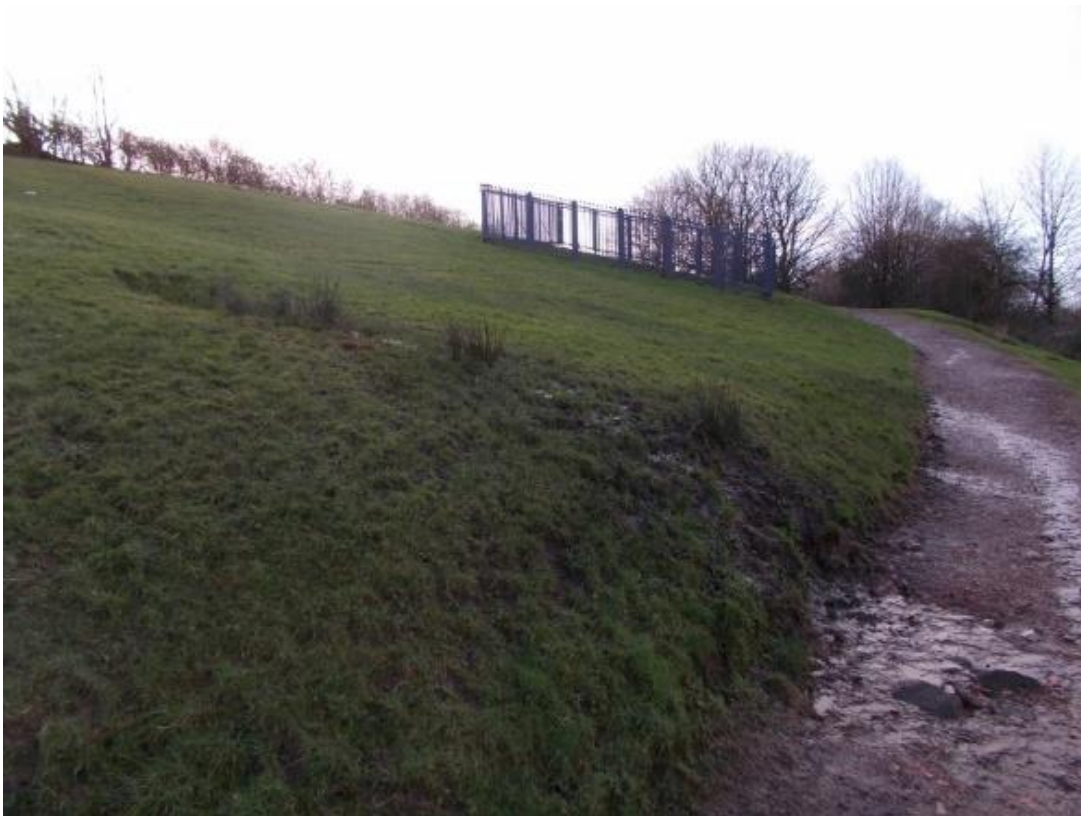
16. Five test pits (Test Pits **1** to **5**) were excavated off the path network to address other specific improvement issues.
17. Test Pit **1** sought to clarify the origin of the water that appeared as a 'spring' upslope of the path network. Excavation immediately upslope of the spring exposed a ceramic tile drain (006) within a cut (005) aligned roughly SE to NW. Subsoil (003) at this location was 300mm below the surface.

Figure 2b: Spring emerging onto pathway to be tested by TP 1

28. Similar landscaping and park management is evident from the shallow field drain exposed in Test Pit **1**, the source of the water emerging as a 'spring' adjacent to the path network. This field drain, a modern extruded ceramic drain, is most likely twentieth century in origin and presumably drains part of the ditch complex to the fore of the fort and fortlet. Its shallow run strongly suggests that this is a park rather than agricultural drain.

29. The drain presumably extended further W and the 'spring' is the result of a failure of that downhill section of the drain. The renewal of the drain downslope, under the path network, before discharging should have a low potential for archaeological impact. Consideration should be given to ensuring any overland flow of discharged water not having the potential to initiate erosion. This drain is already presumably dewatering the ditch complex, as such the impact on the characteristics of these ditch fill sediments should not alter through the renewal of the downslope element of the drain (as the field drain is discharging now, but in an unmanaged way).

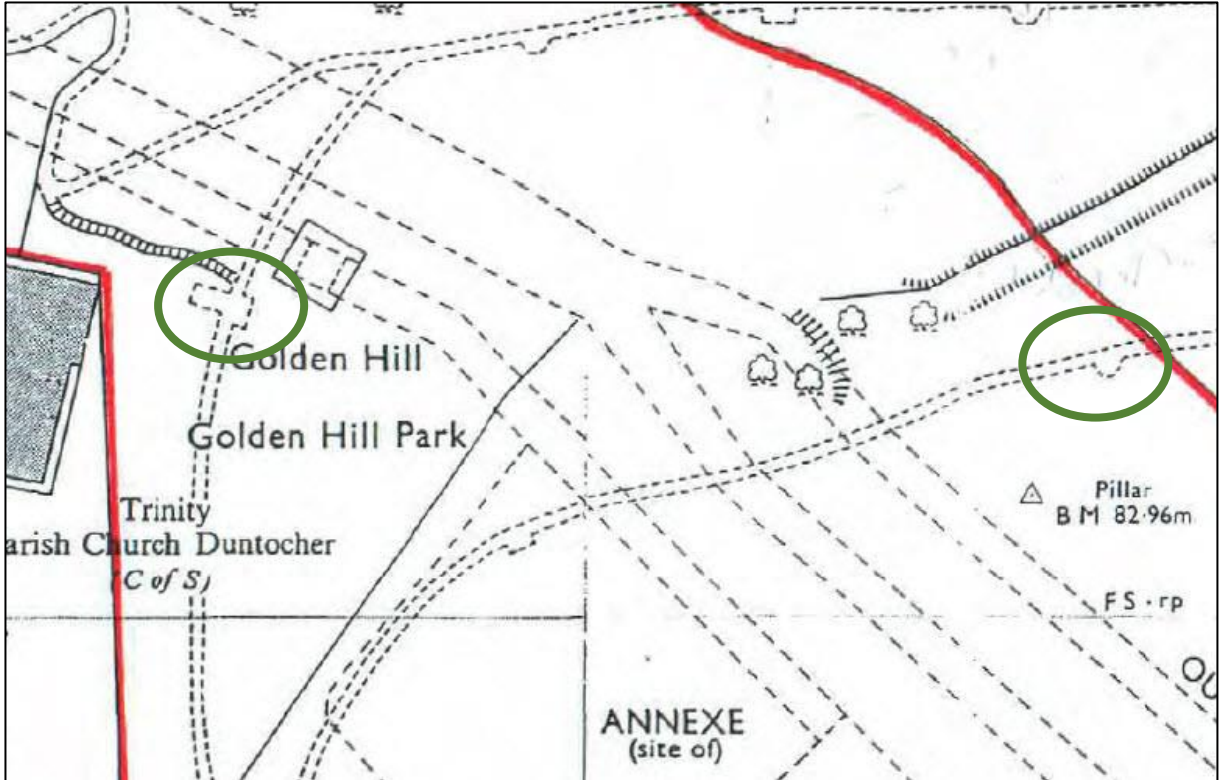
Figure 4a: Extract from scheduling document with circles (green) for former path areas

26. The examination of the upslope lip (see TP **I**) at a location where a bench is proposed showed the presence of path fabric overlain by a topsoil skim. The scheduling document (Figure 4a) shows that the area around TP **I** has consistently been depicted as part of the path network – presumably a small terrace cut for a bench. The re-exposure of the path fabric and the installation of a bench along with any necessary resurfacing should have no archaeological impact.

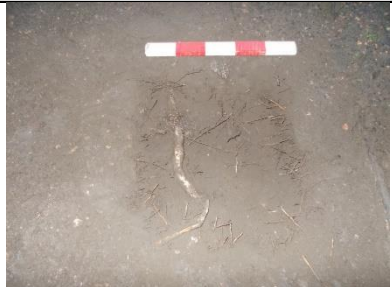
Test Pit	Heritage Sensitivity	NGR	Location Detail	Target Depth	Description	Image
a	Wall crossing	NS 49414 72768	In path fabric, avoiding tree roots	100mm	Excavated to 100mm wholly within path fabric (001). Dense roots and rootlets.

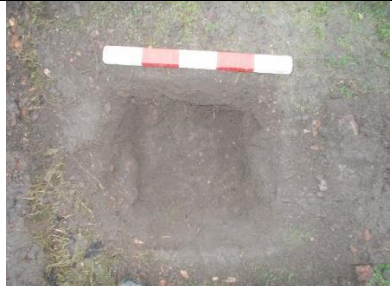
b	Ditch crossing	NS 49439 72772	Downslope lip adjacent to path fabric	300mm	Topsoil (002) upto 300mm deep (E side) overlay (W side) path fabric (001) at 100mm and subsoil (003) in centre of TP at 200mm depth. Subsoil dipped out of TP to E.

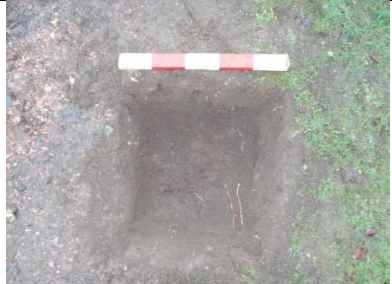
c	Wall crossing	NS 49431 72760	Downslope lip adjacent to path fabric	300mm	After removal of shallow spread of path fabric (001) from SE edge TP, balance of TP removed only topsoil (002) to 300mm depth.

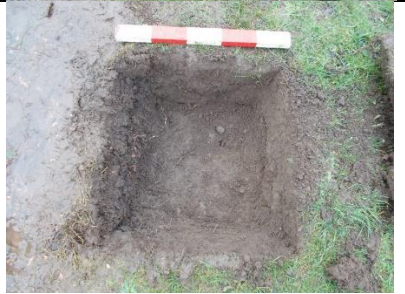
e	Ditch crossing	NS 49457 72764	Downslope lip adjacent to path fabric	300mm	Topsoil (002) upto 296mm deep with subsoil (003) under.

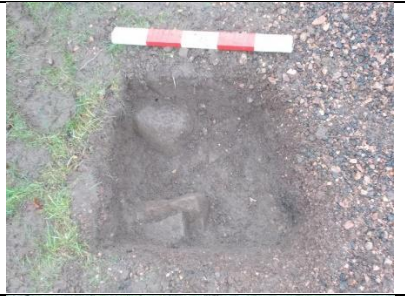
f	Ditch crossing	NS 49466 72760	Downslope lip adjacent to path fabric	300mm	Topsoil (002) some 290 to 300mm deep in majority of TP, with upper surface of subsoil (003) exposed across most of bed of TP. At W edge exposed series of sub-angular stones (004) within (002).

25. The examination of the downslope lips (slight grass covered ridges adjacent to the edge of the path network) is clearly within the Scheduled Monument. The test pits examining this (Test Pits **c** to **i**) showed this lip to be wholly formed of topsoil (002). As such removal of this lip to enable water runoff from the path network should not impact on significant archaeological strata. However, the shallow depth of subsoil (typically 300mm) and the presence of possible *ex situ* wall base fabric (see TP **f**) suggests that lip removal works should be kept as shallow as possible.

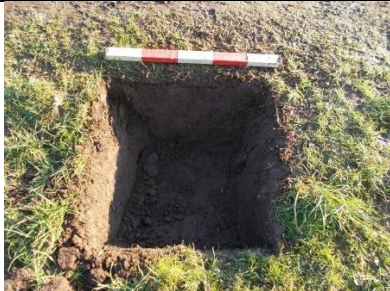
h	Ditch crossing (Annexe)	NS 49462 72675	Downslope lip adjacent to path fabric	300mm	Excavated to 300mm wholly within topsoil (002).

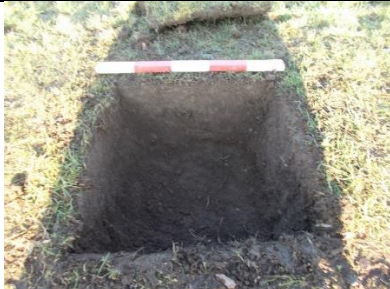
i	Wall crossing	NS 49503 72715	Downslope lip adjacent to path fabric	300mm	Topsoil (002) upto 295mm deep with subsoil (003) under.

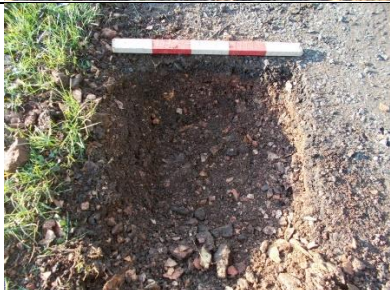
j	Ditch crossing	NS 49518 72717	In path fabric	100mm	Excavated to 100mm within path fabric (001).

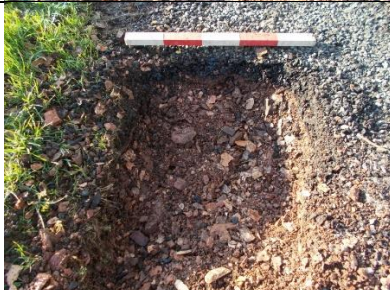
k	Ditch crossing	NS 49536 72722	In path fabric	100mm	Excavated to 100mm within path fabric (001).

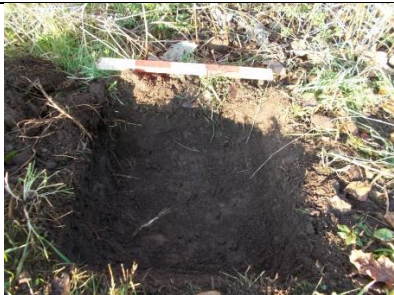
3	Hedge Removal	NS 49499 72733	To immediate rear of hedge in accumulated/retained material that should overlie the NW berm of the Annexe to characterise this material.	Topsoil (002) upto 280mm deep with subsoil (003) under.

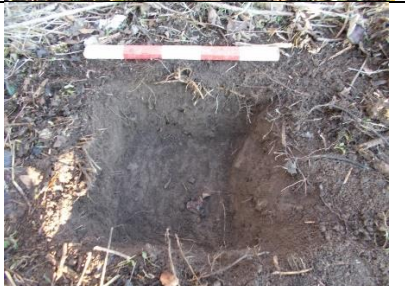
4	Hedge Removal	NS 49482 72713	To immediate rear of hedge in accumulated/retained material that should overlie the NW berm of the Annexe to characterise this material.	Topsoil (002) upto 280mm deep with subsoil (003) under.

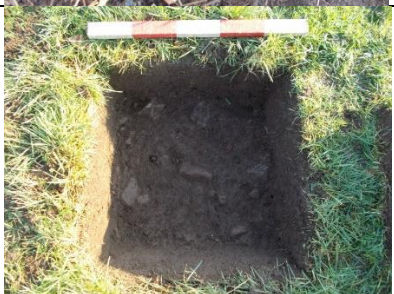
5	Signage Location	NS 49531 72668	Location within fortlet/forts to assess potential to introduce signage within core of (reinstated) site.	Topsoil (002) some 220mm deep overlay probable metalling material (008) that covered base of TP. Four sherds of pottery <001> recovered from Topsoil (002)
