Glithno Farm, Stonehaven: Archaeological Mitigation

Data Structure Report

Author(s)	Peter Klemen		
Date of Issue	23 rd February 2017	Version	1.0
Commissioning Body	Fotheringham Property Developments		
Event Name	Glithno Farm, Stonehaven		
Event Type	Historic Building Recording; Appraisal Level		
Event Date(s)	February 2017		
Rathmell Archaeology Code	RA17015	OASIS Ref:	Rathmell1-277250
Location	United Kingdom: Scotland: Aberdeenshire		
NGR	NO 8606 8932	Parish	Fetteresso
Designation(s)	None

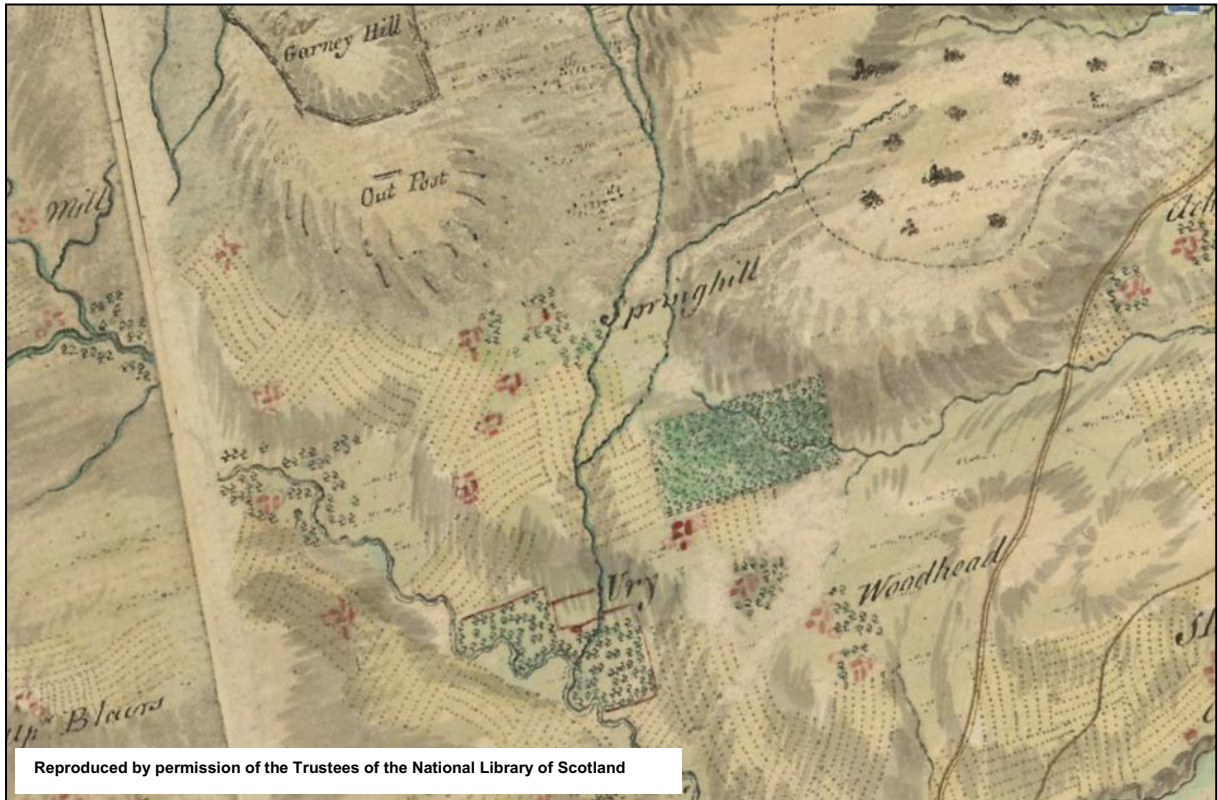
Figure 1a: William Roy's (1747-52) *Military Survey of Scotland*

3. On Roy's *Military Survey of Scotland* (1747-52) (Figure 1a) there are a number of farmsteads located within the approximate area where the present Glithno Farm is sited. However, it is not possible to be conclusive as to whether any of the farmsteads depicted by Roy represent those of Glithno Farm.

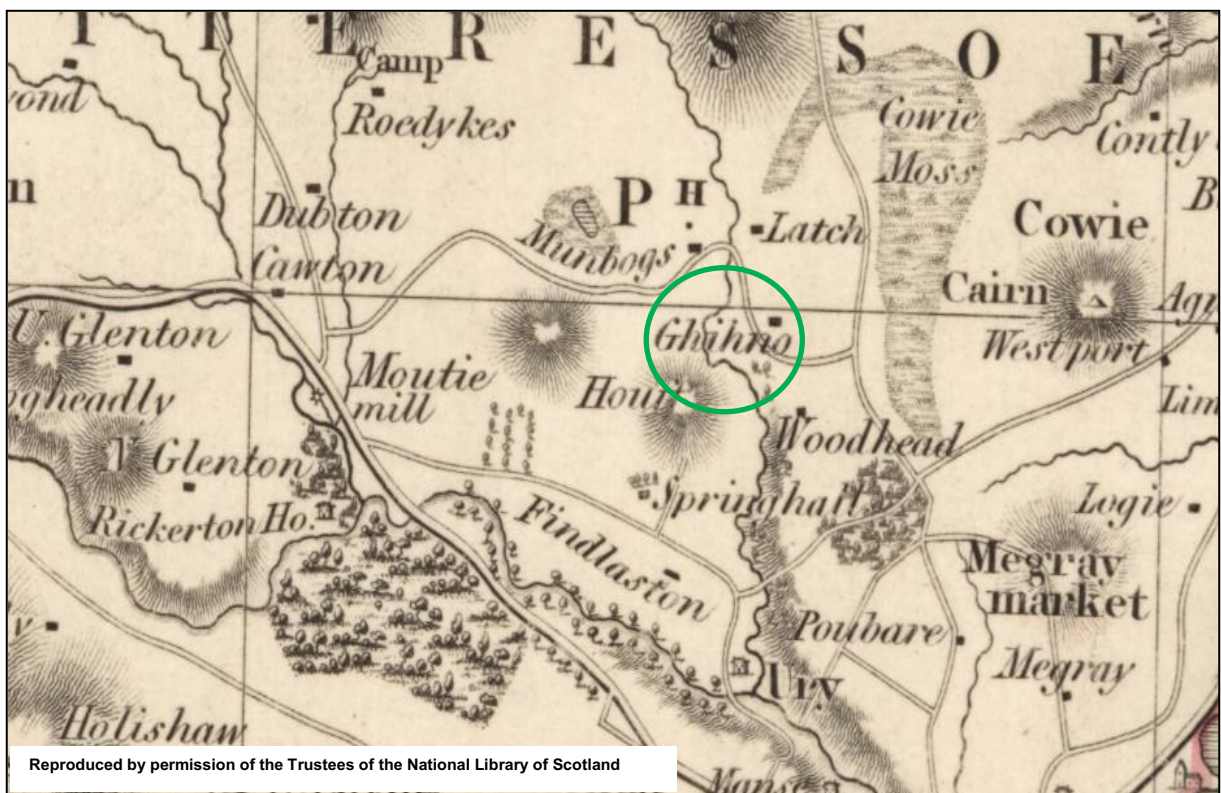
Figure 1b: Extract from Thomson's (1822) *Atlas of Scotland: Kincardine Shire*

4. With John Thomson's survey *Kincardine Shire* (1822) (Figure 1b) the location and name of Glithno is depicted although spelt 'Ghithno'. There is very little detail with the farmstead depicted only as a single black rectangular feature. The current course of the B979 is also depicted.

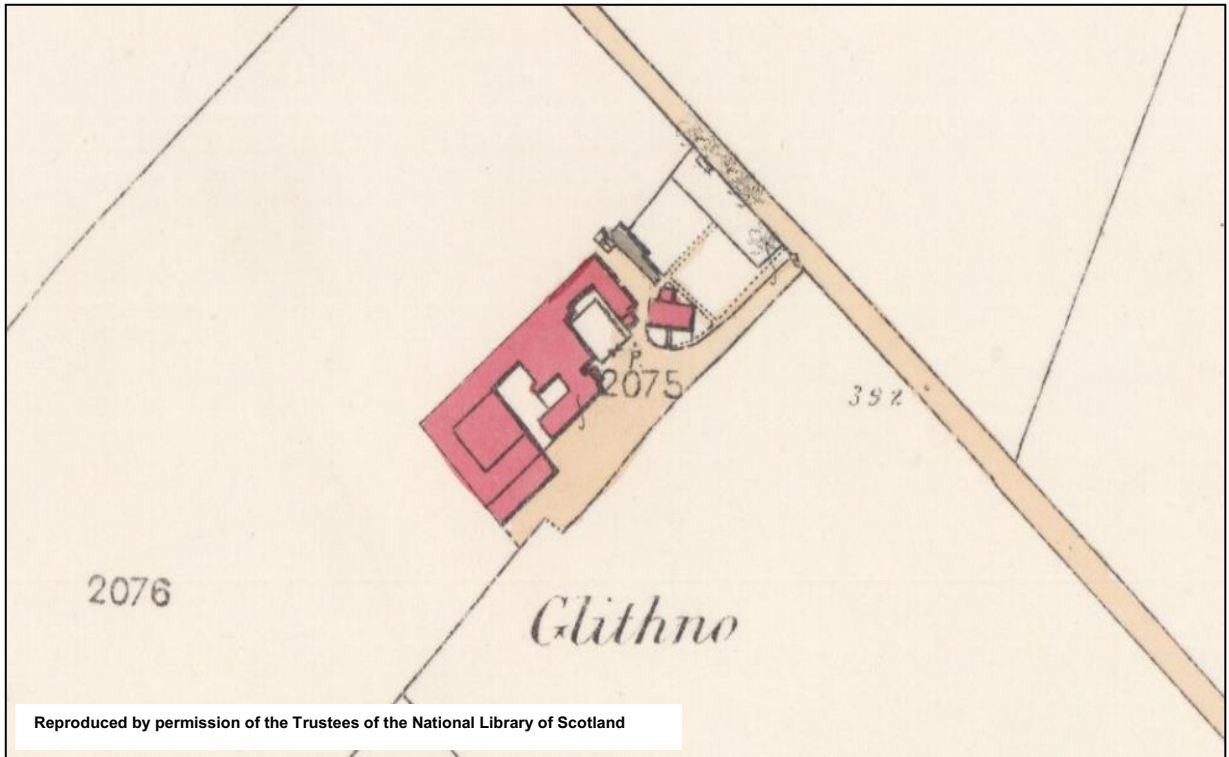
Figure 2a: Extract from 1st edition (1868) *Ordnance Survey 25-inch, Kincardine Sheet XII.11 (Fetteresso)*

5. The *1st edition Ordnance Survey 25-inch map* (1868) (Figure 2a) provides a detailed depiction of Glithno Farm and its associated structures. The outline of the buildings takes the form of a roughly 'E shaped' range with many of the current buildings already in existence by this time. There are two small open courtyards at the northeast and southwest ends.

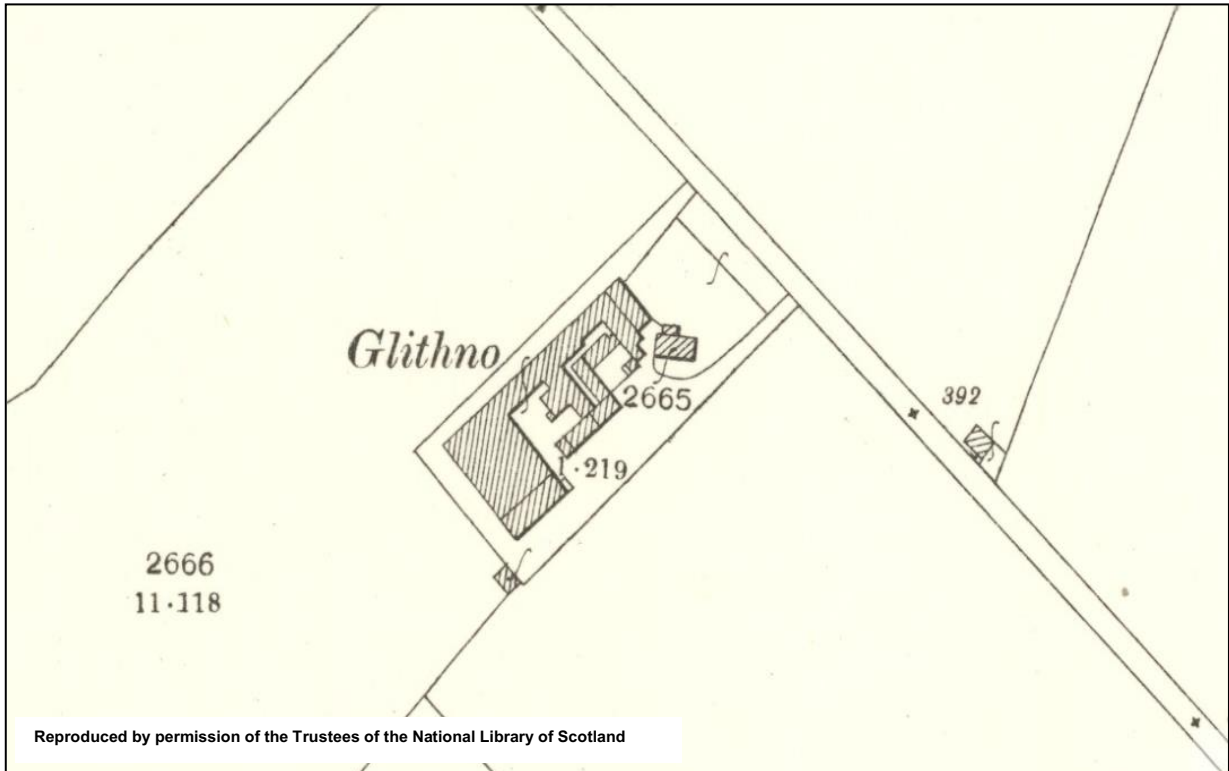
Figure 2b: Extract from 2nd edition (1903) *Ordnance Survey 25-inch, Kincardineshire 015.08 (includes: Fetteresso)*

6. By the *2nd edition Ordnance Survey 25-inch map* (1903) (Figure 2b), there is very little change apart from the addition of a small building located on the northeast side of the range and two structures constructed in the northeast courtyard forming an 'L'-shape.

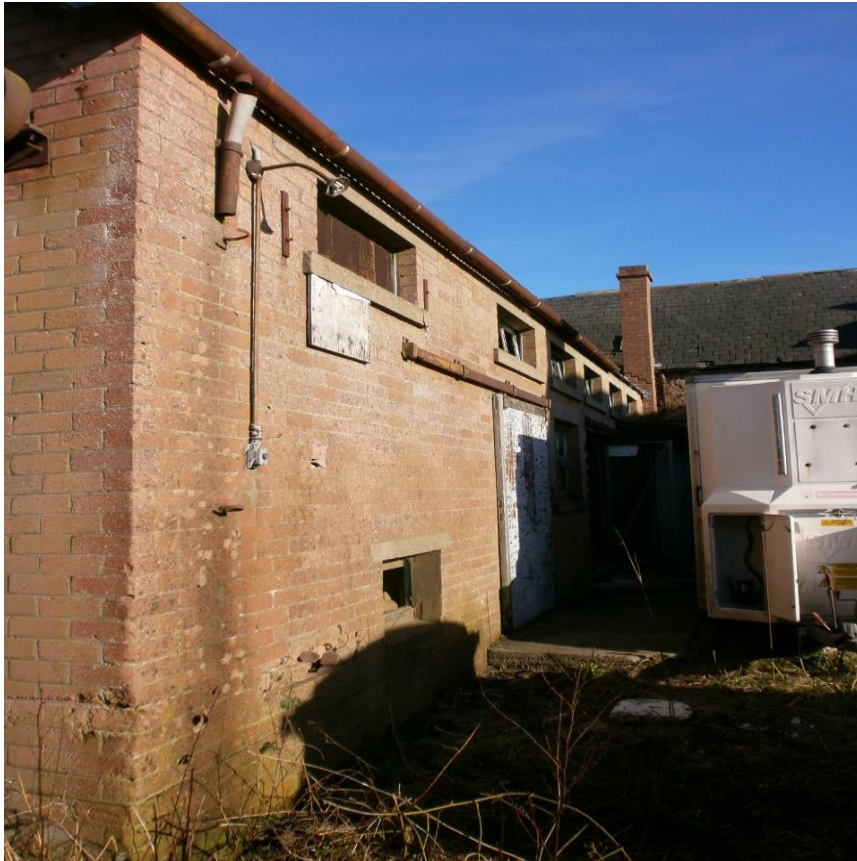
12. Glithno Farm steading is a traditional farm steading comprising a rectangular arrangement of barns and byres of snecked granite rubble construction built around two courtyards. There are two modern buildings sited within the original layout of the steading. Building K is a modern red brick single storey 1 x 1 bay structure (Figure 4a), rectangular in plan with a small red brick extension on the northeast side. Accessed from the outside on southwest side of Building K is a small engine room (Figure 4b: left): there is evidence on the exterior southwest elevation for a belt driven mechanism (Figure 4b: right).

Figure 4a: Building K: southwest elevation modern 20th century red brick.

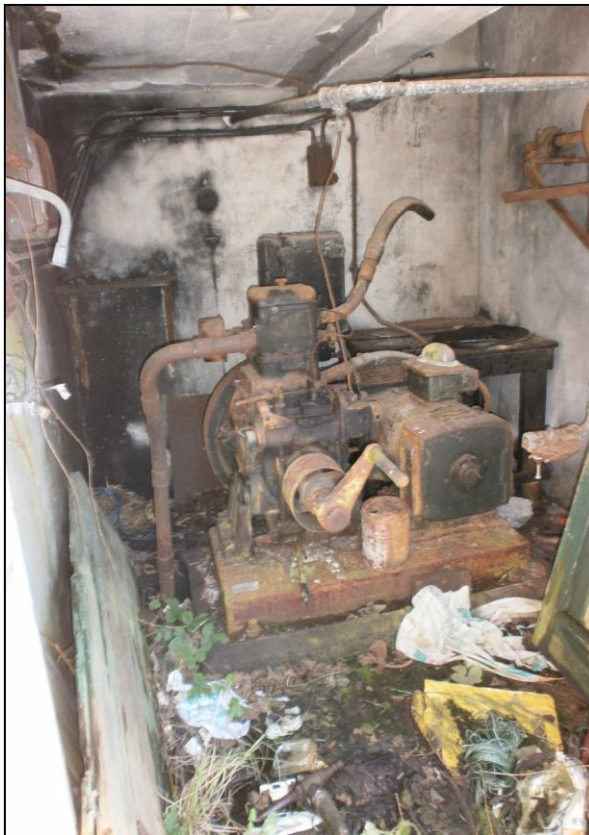
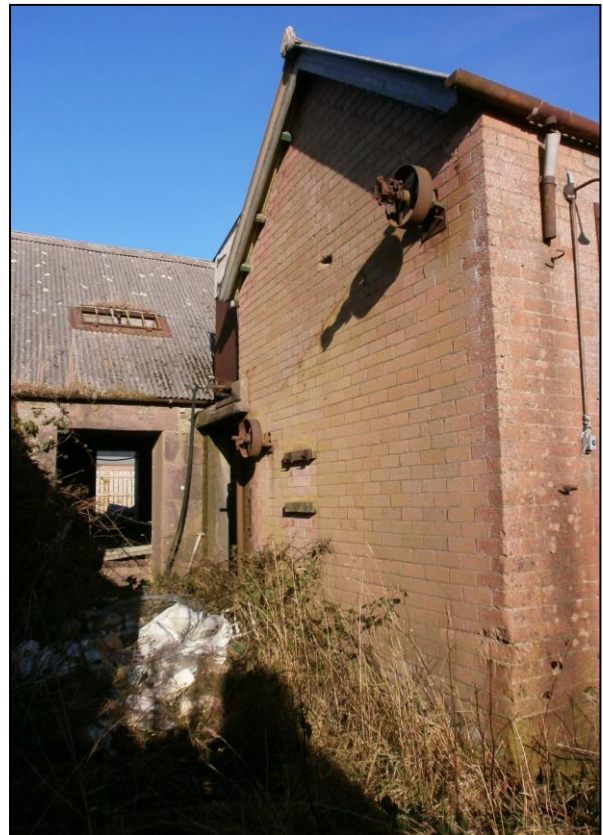
Figure 4b: Building K: Engine (left) and evidence for a former belt driven mechanism (right), suggesting building K was possibly used as a granary or threshing room.

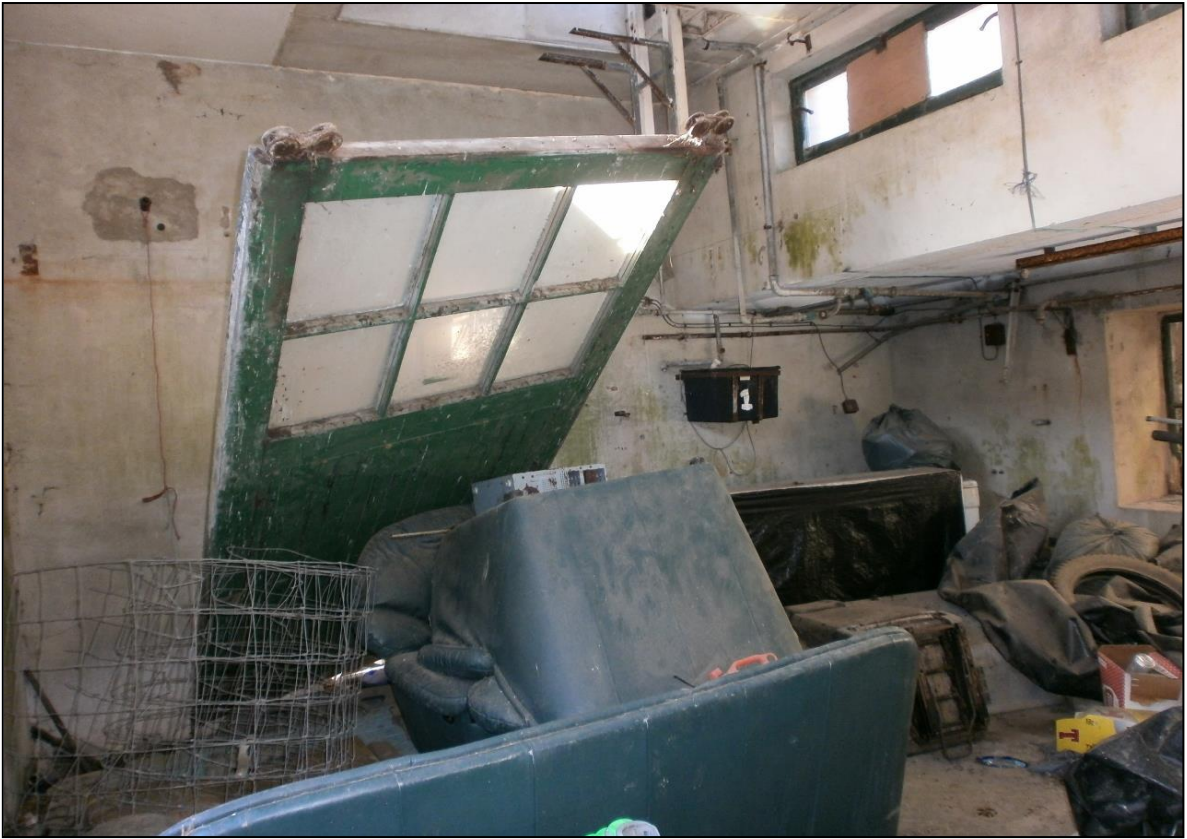
13. Measuring 13m northeast-southwest and 5m northwest-southeast, internally it has been divided in modern times into three separate rooms. All three interior rooms are lined internally with plasterboard and painted white (Figure 5a & 5b). The presence of modern rubbish suggests it was recently used for storage. The floor was of concrete with a corrugated sheet glass-fibre roof with the southwest end gable ended. There is a doorway on the southeast side and another in the northwest corner that leads into Building C.

Figure 5a: Building K: Room b.

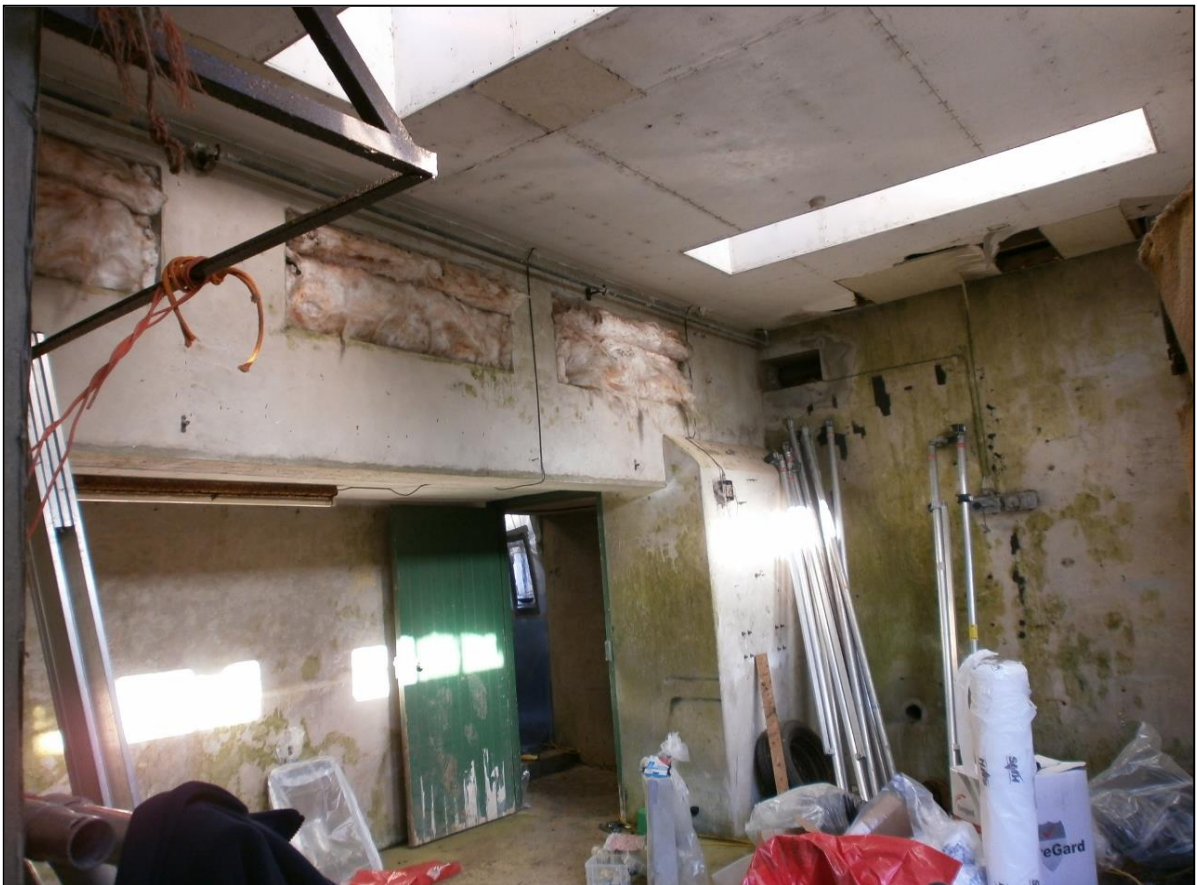
Figure 5b: Building K: Room c.

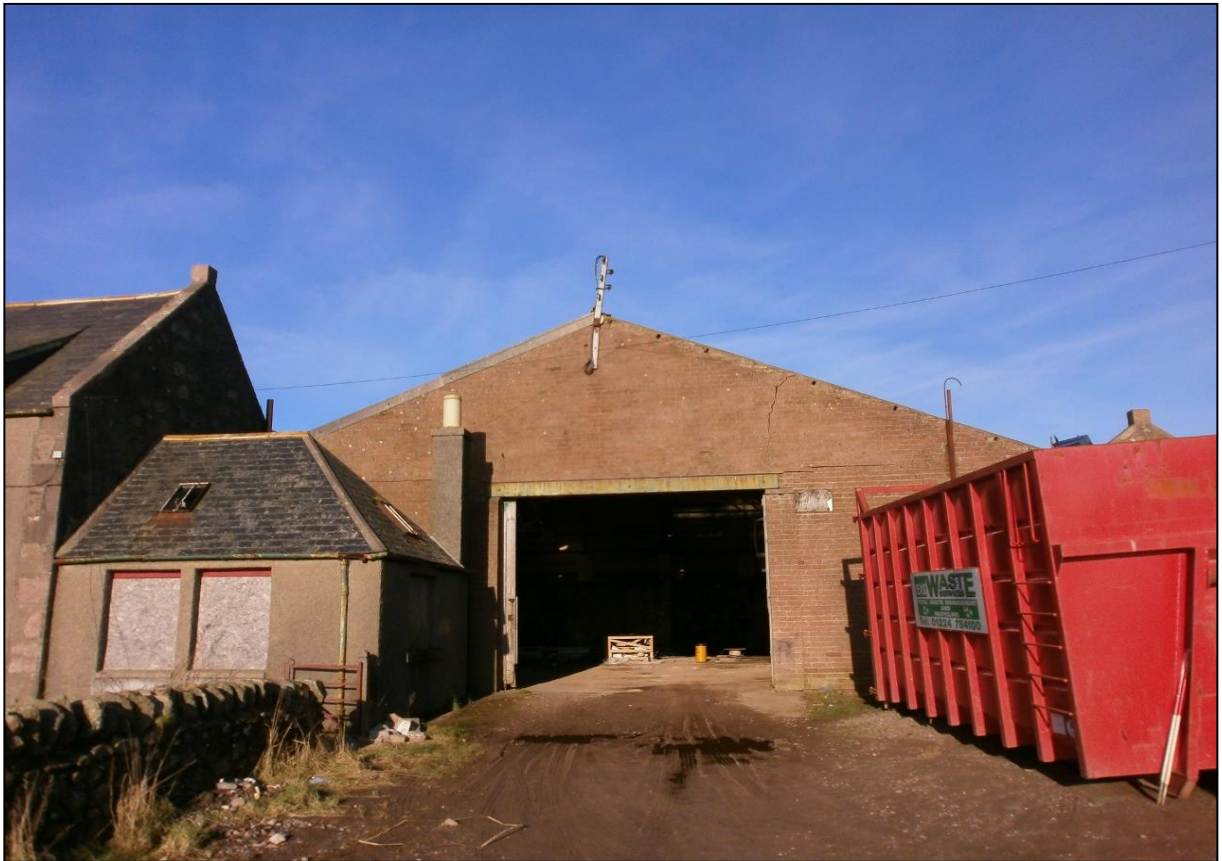
14. Building M is a modern construction that infills the area between buildings B, C, L and N (Figure 3), giving a space that is square in plan with dimensions of 13.7m northeast-southwest and 14.3m northwest-southeast. The main entrance on the southeast side is via a modern red brick pitched gable (Figure 6a). Snecked granite rubble is visible in the interior of Building M although a modern breeze block wall blocks most of the southwest elevation. The roof is modern steel truss and corrugated sheet glass fibre (Figure 6b).

Figure 6a: Building M: exterior southeast elevation showing the modern 20th century red brick extension.

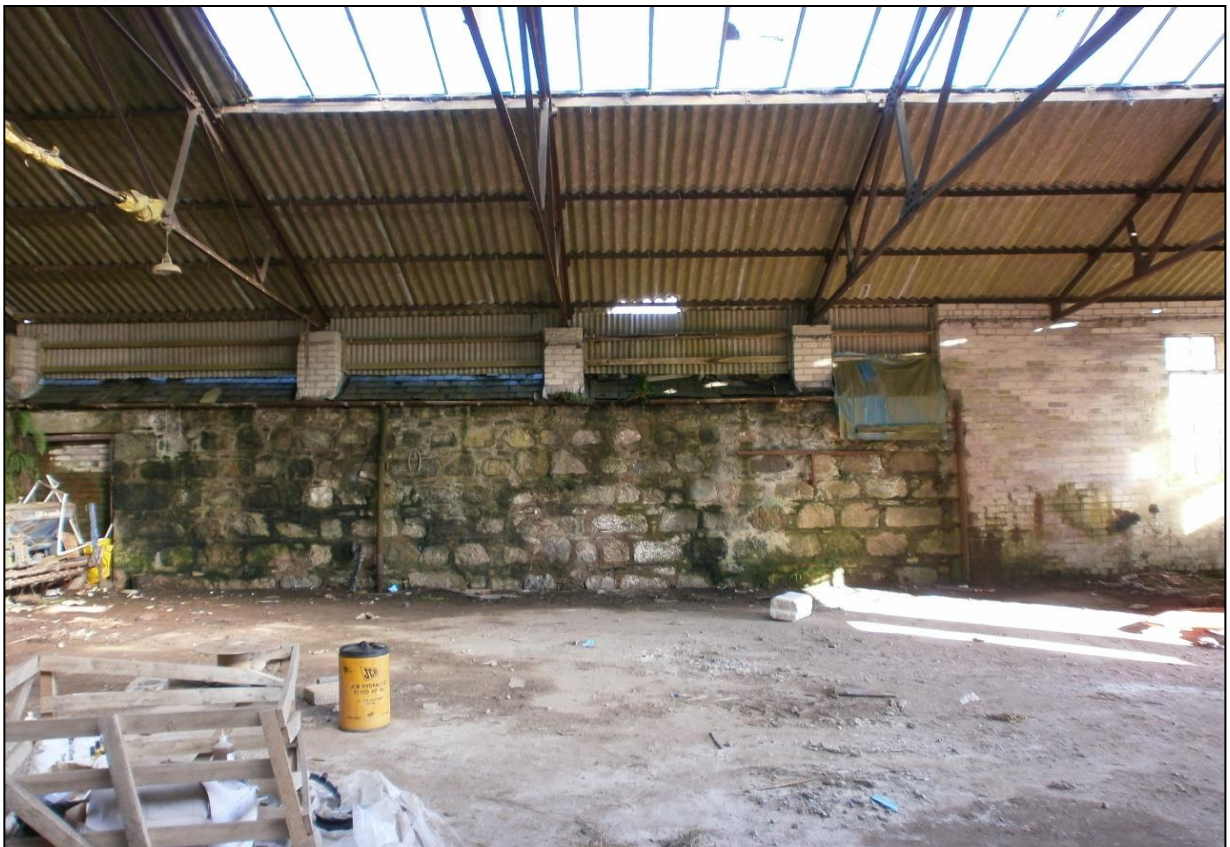
Figure 6b: Building M: northeast elevation showing the sneaked granite rubble and modern roofing.

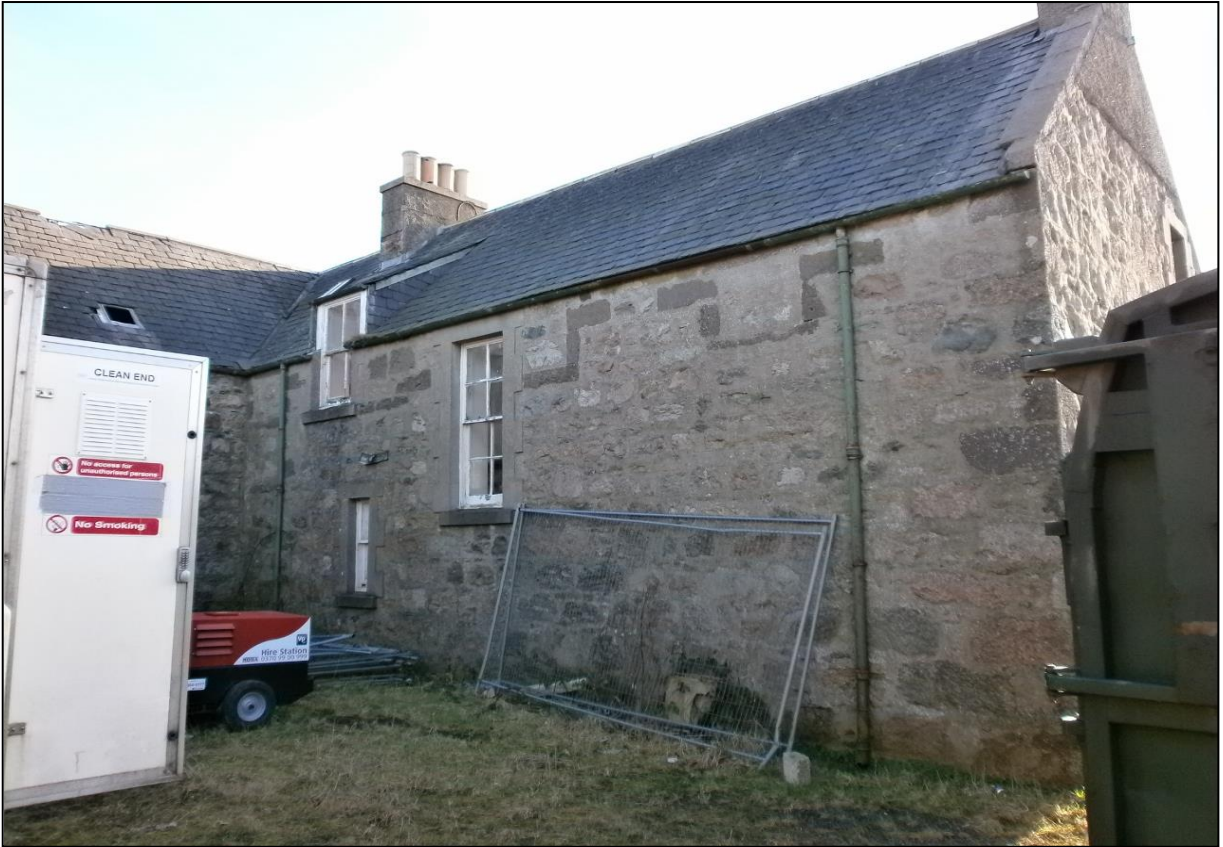
15. The majority of the guttering and downpipes were of cast iron and where still in good condition were painted green (Figure 7a). The quoins and margins on the early elements are worked granite.

Figure 7a: Northwest elevation of Building J demonstrating the cast iron guttering and downpipe.

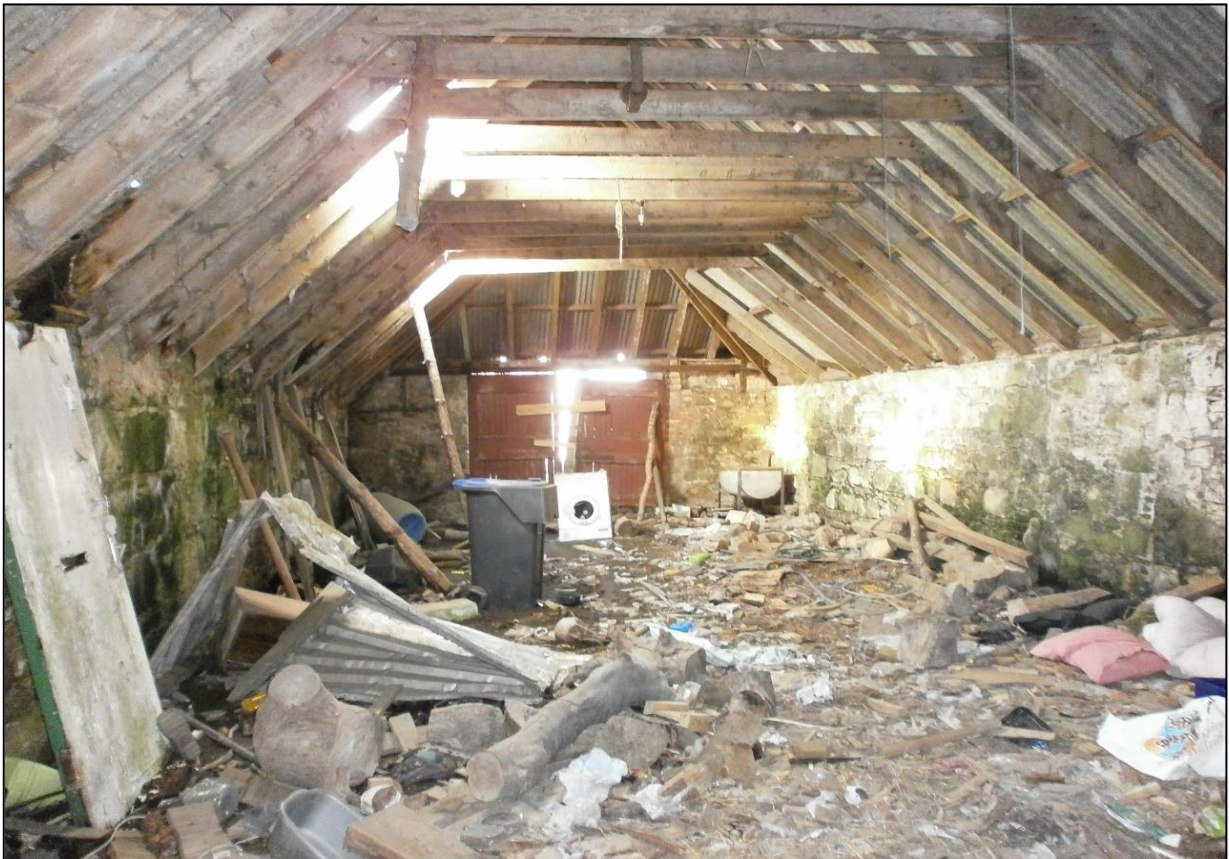
16. Building A is rectangular and a single storey 1 x 1 bay structure measuring 13.4m by 5.6m (Figure 7b). The northwest, northeast and southwest elevations are of snecked granite rubble. The northeast elevation is a gable wall, composed of modern corrugated sheet glass fibre. The roofing is corrugated sheet glass fibre with modern timber trusses and a hip ended northwest end with two skylights. There is evidence that the interior had been painted white (Figure 7b). There is a blocked doorway on the southwest wall to the southeast end of the building and a doorway into Building B at the northwest end. Its original function is unclear.

Figure 7b: Building A: showing the interior to the northwest

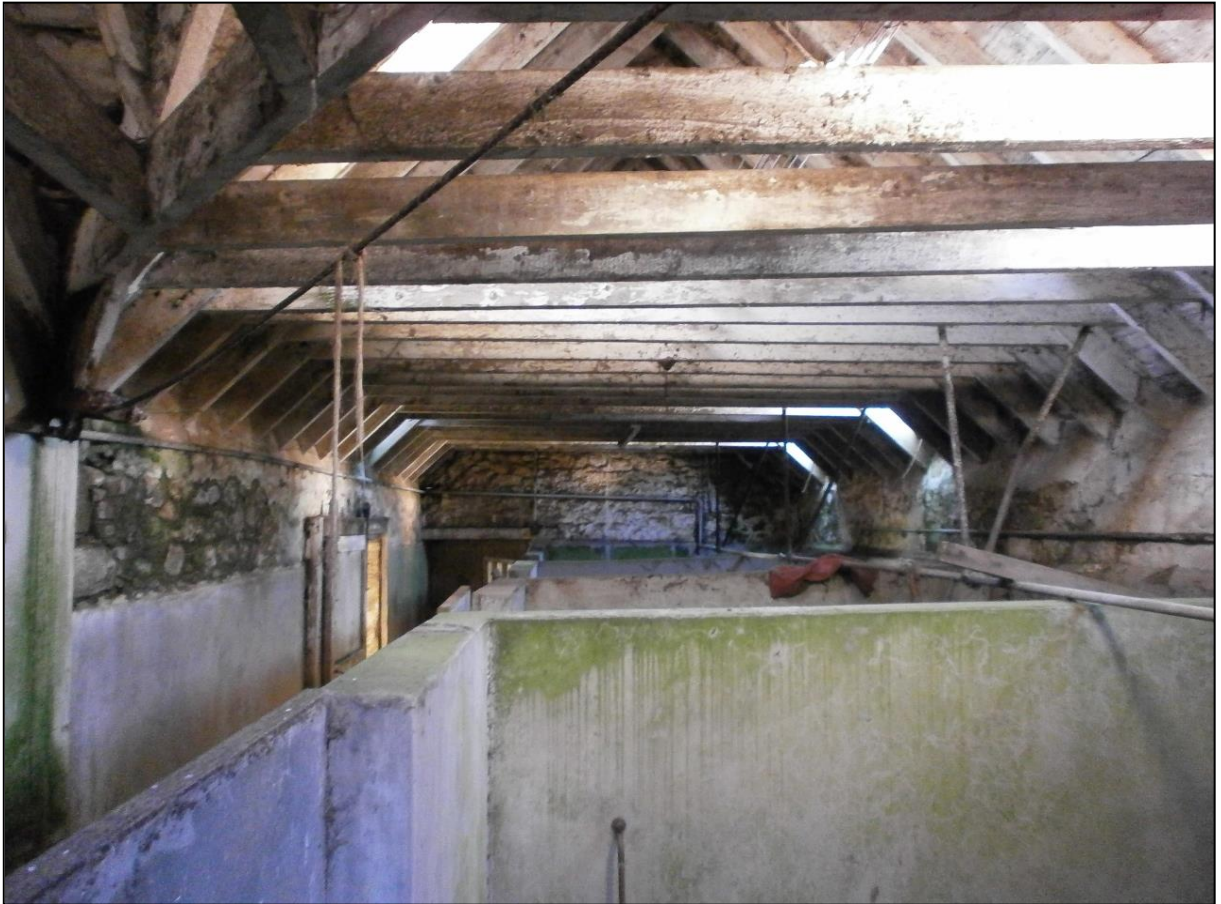
17. Building B is rectangular and a single storey 1 x 1 bay structure measuring 14.1m by 4.2m with timber roof trusses and timber sarking with seven skylights (Figure 8a). There is very little of the original snecked granite structural elements visible as they have been obscured by modern concrete livestock pens. There are five livestock pens all measuring 2.8m by 2.6m and 1.8m in height. The exterior elevations demonstrate the coursed snecked granite rubble with a pitched and slated roof (Figure 8b).

Figure 8a: Building B: view to the southwest showing the concrete livestock pens and timber trusses

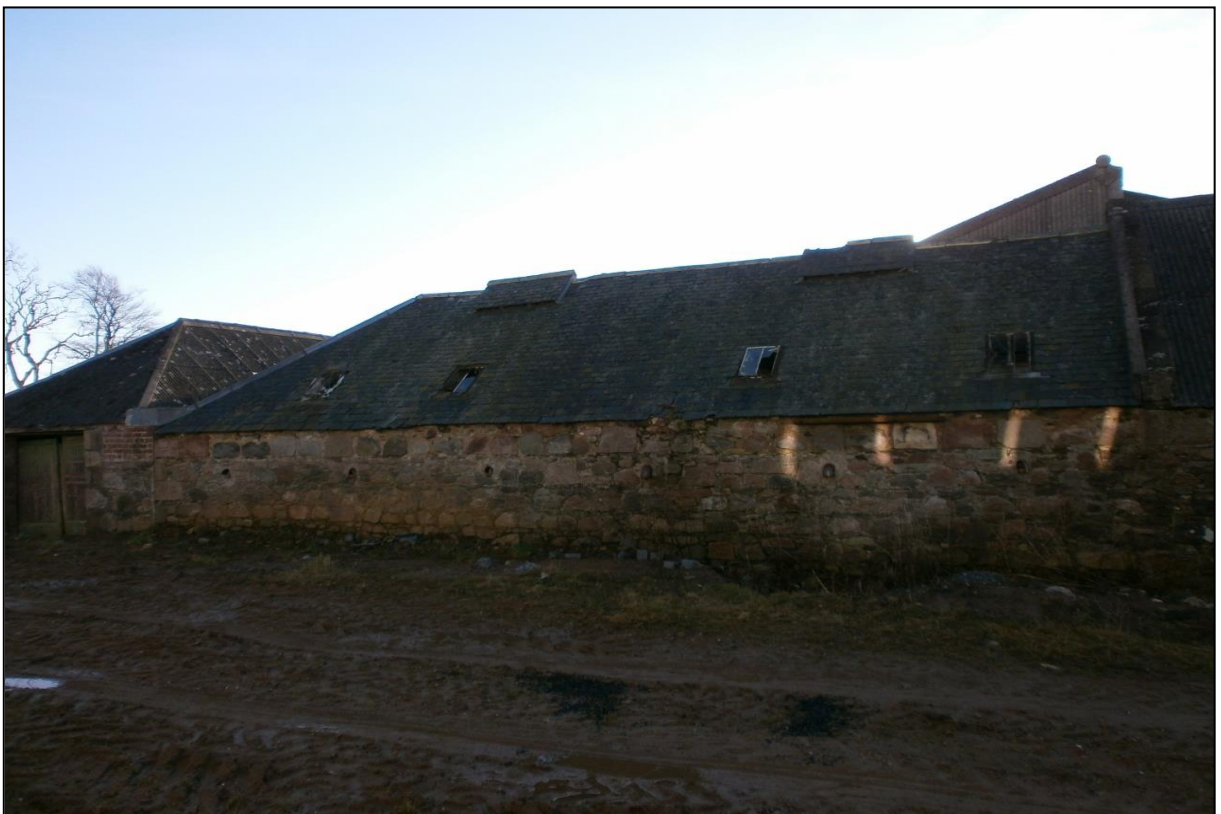
Figure 8b: Building B: exterior northwest elevation

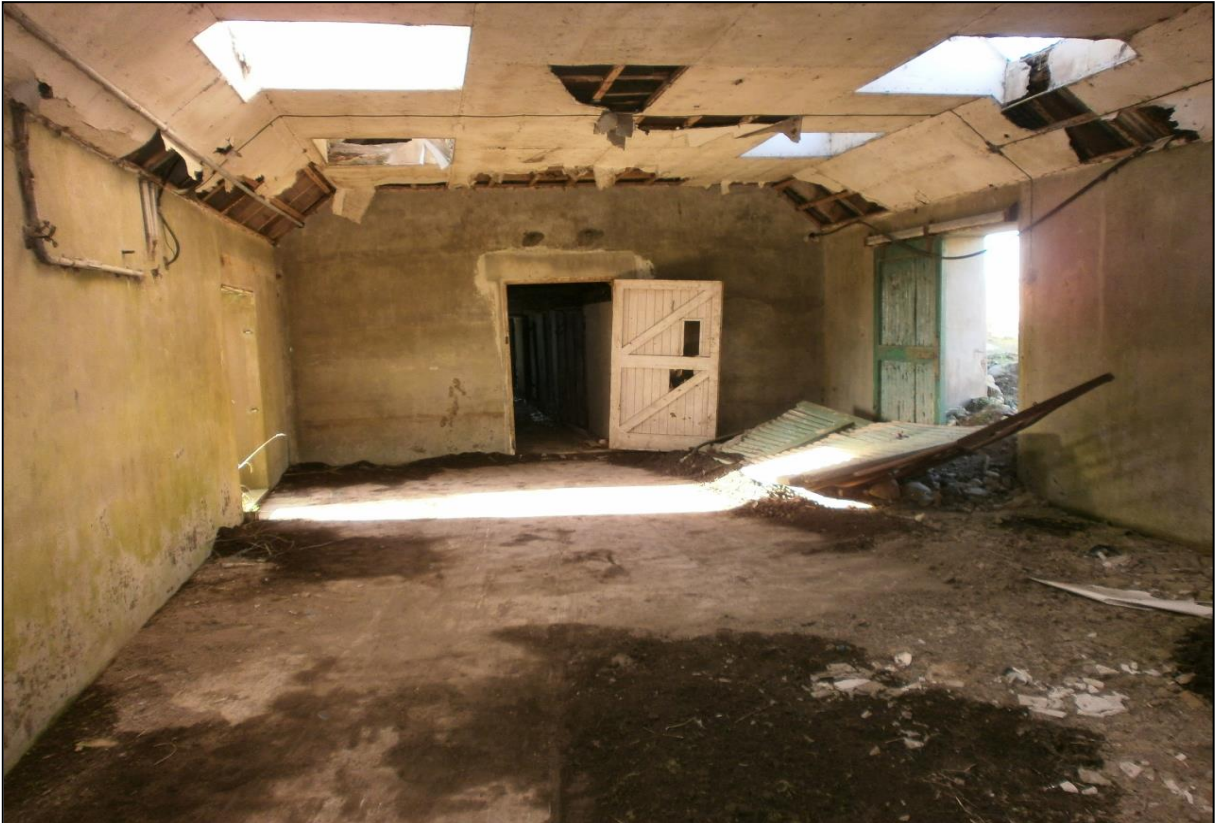
18. Only the southwest end of Building C (Figure 9a) was able to be recorded due to the removal of asbestos in the northeast end. Building C is rectangular in plan and divided into 2 separate rooms. Together Buildings B, C and G are all adjoined and form the northwest side of the steading.

19. The southwest end of Building C measured 15m by 5m with no original fabric visible. The floor and walls were of concrete with the ceiling formed of plasterboard and painted white with eleven skylights (Figure 9a). Behind the plasterboard it was possible to see that the roof was formed of modern timber trusses and corrugated glass fibre sheets. There are two sliding doors on the northwest side of the building. It is unclear what the function of the Building C was.

Figure 9a: Building C: showing the southwest end and doorway into Building G.

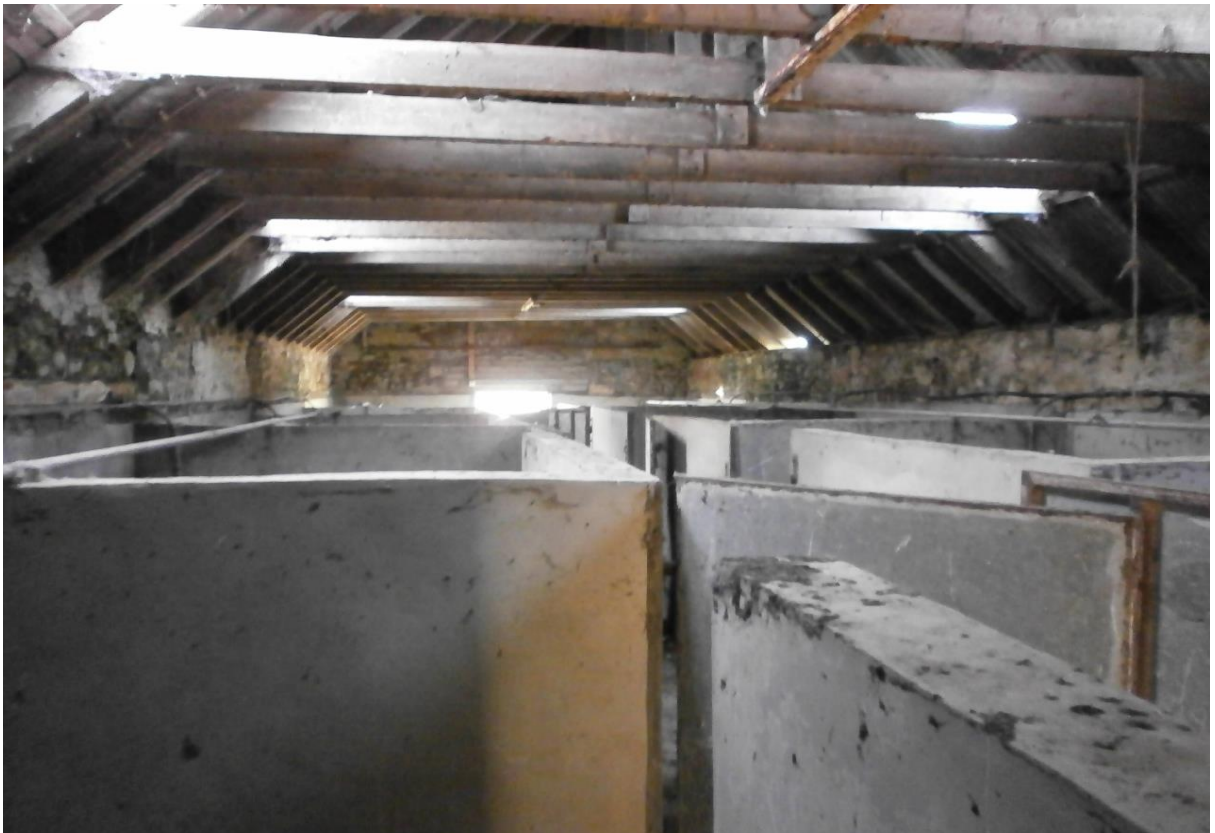
20. Building G is rectangular on plan and comprises a one-storey 1 x 1 bay measuring 16.7m by 5.8m and constructed of snecked granite rubble. As with Building C the roof is constructed of modern timber trusses and corrugated glass fibre sheets (Figure 9b with a southwest gable wall. As with Building B the interior comprises concrete livestock pens that obscure much of the original structural elements. The ten pens measure 3.2m by 2.1m and 1.8m in height. There is a central doorway in the southwest elevation that has been infilled with modern brick and cement with an arched brick lintel (Figure 10a). The original doorway would have measured 2.4m by 2.4m. The quoins and margins are broached granite. The size of the original entrance would suggest access for carts or livestock.

Figure 9b: Building G: view to the southwest showing the modern roof and livestock pens.

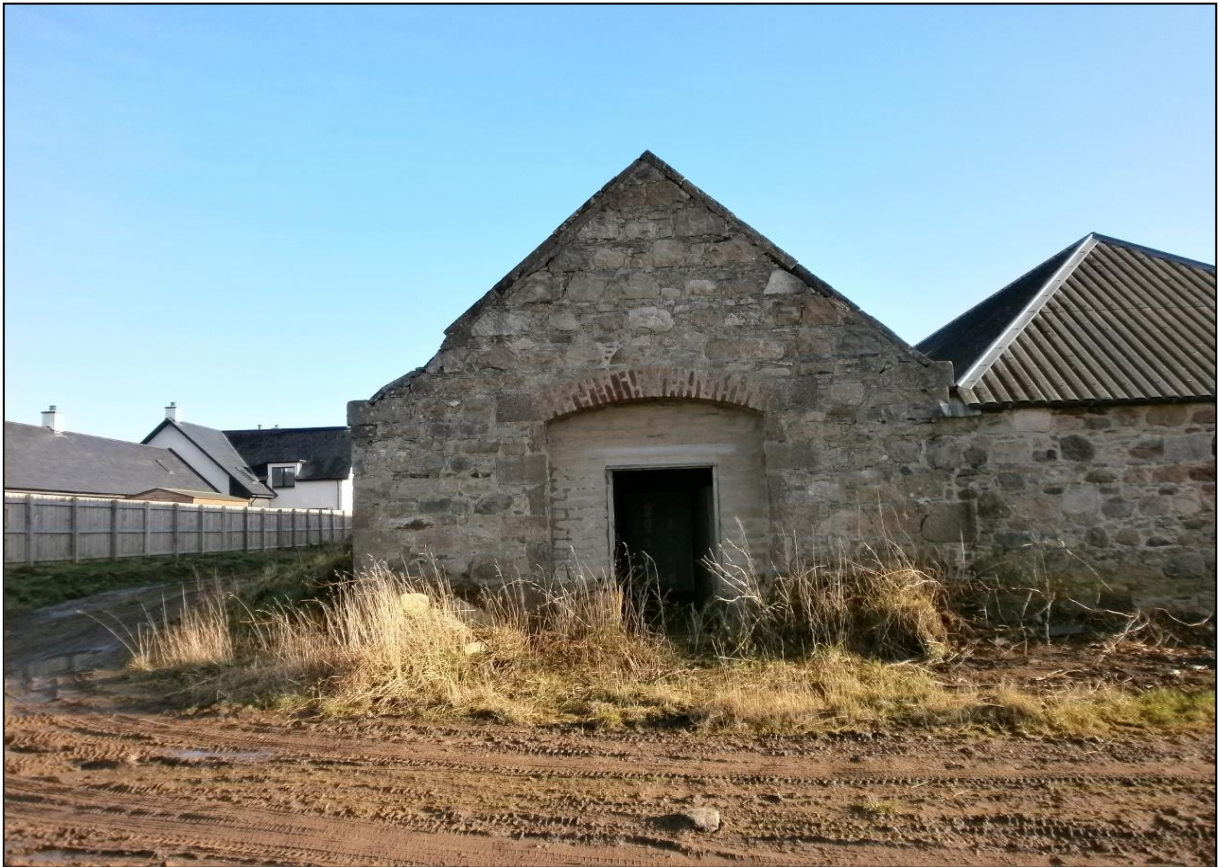
Figure 10a: Building G: southwest elevation showing the original entrance and modern infilling.

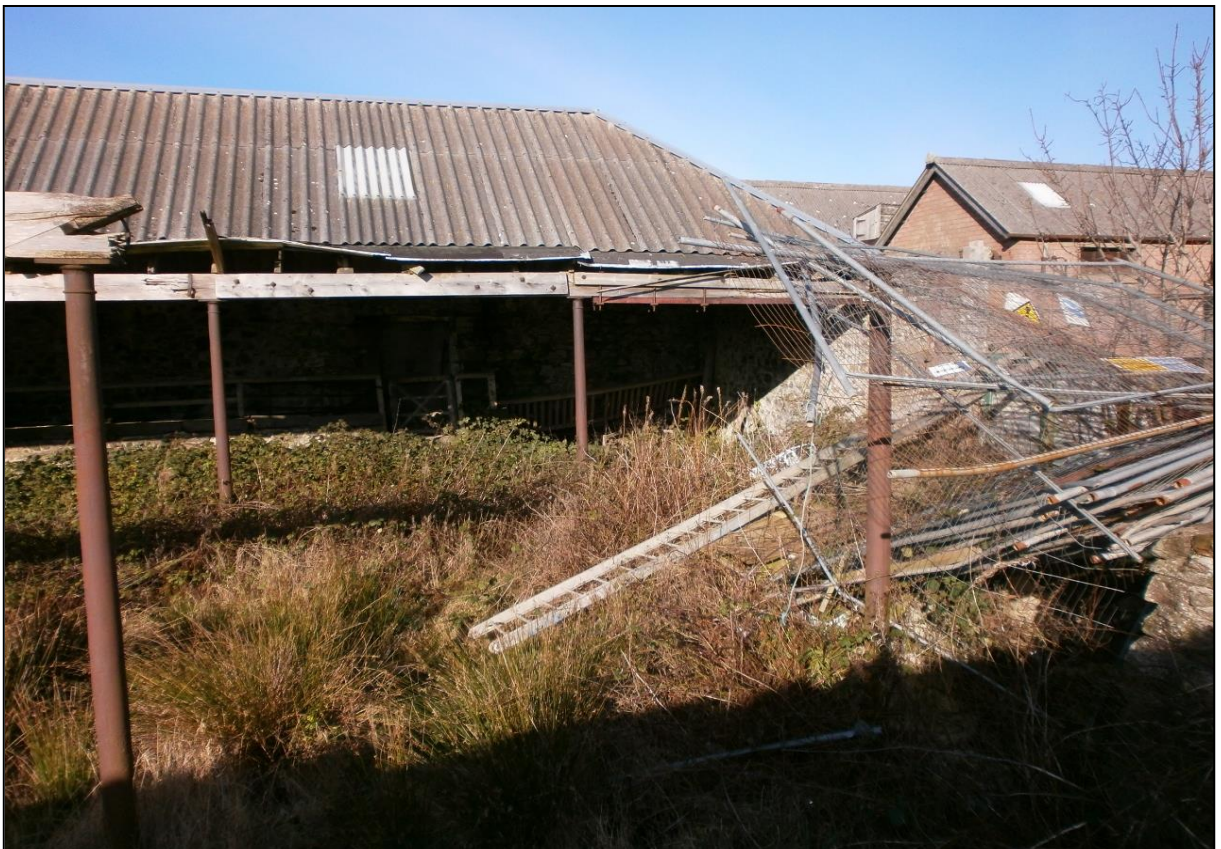
21. Building H is square in plan, comprising a single storey 1 x 1 bay structure and measuring 16m by 16m. Originally the building would have been roofed around the northwest, southwest and southeast sides with an open central courtyard. The original cast iron columns are still present. However, only the northwest side is still roofed; this comprises modern timber trusses and corrugated glass fibre sheet roofing (Figure 10b & 11a) with a hipped roof arrangement. The roof would originally have covered a raised stone walkway that is 1.10m above the interior courtyard and 1.40 wide (Figure 11b & 12a).

Figure 10b: Building H: northwest side

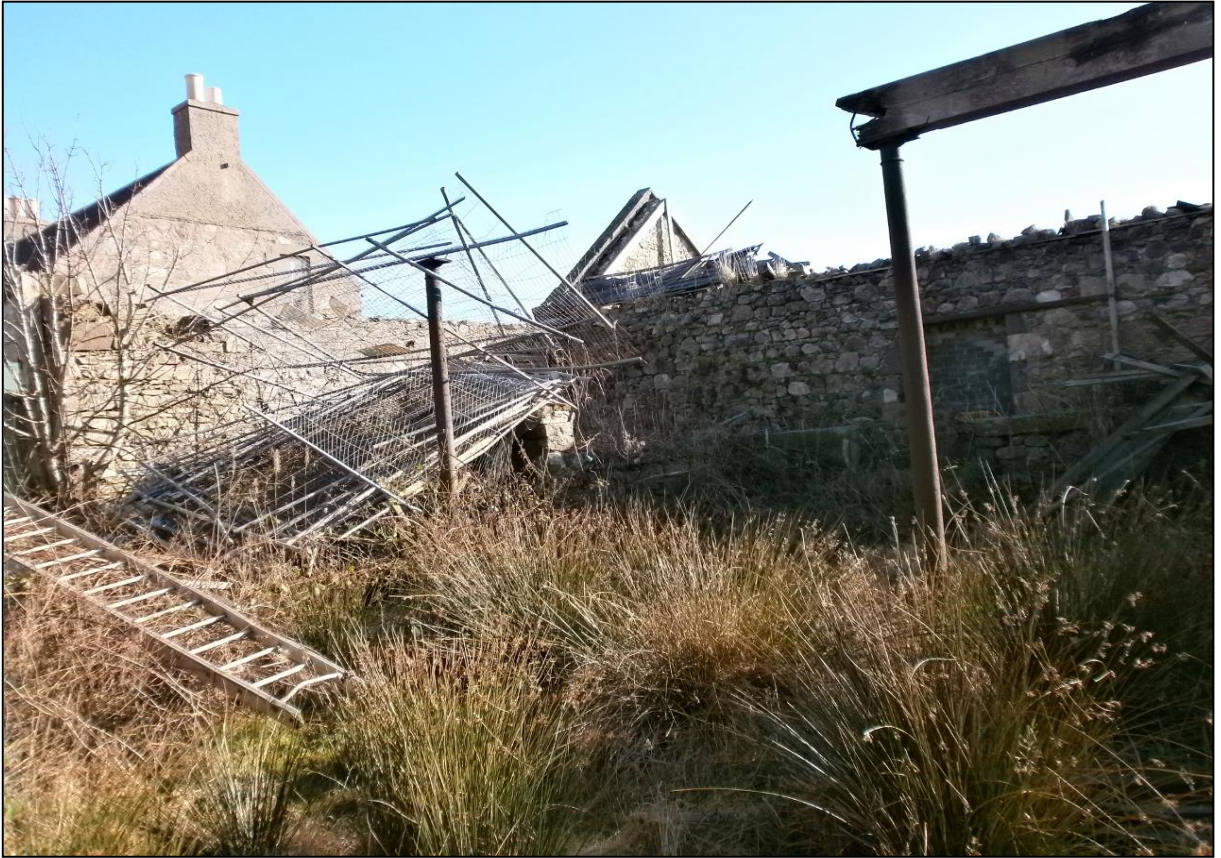
Figure 11a: Building H: southeast side

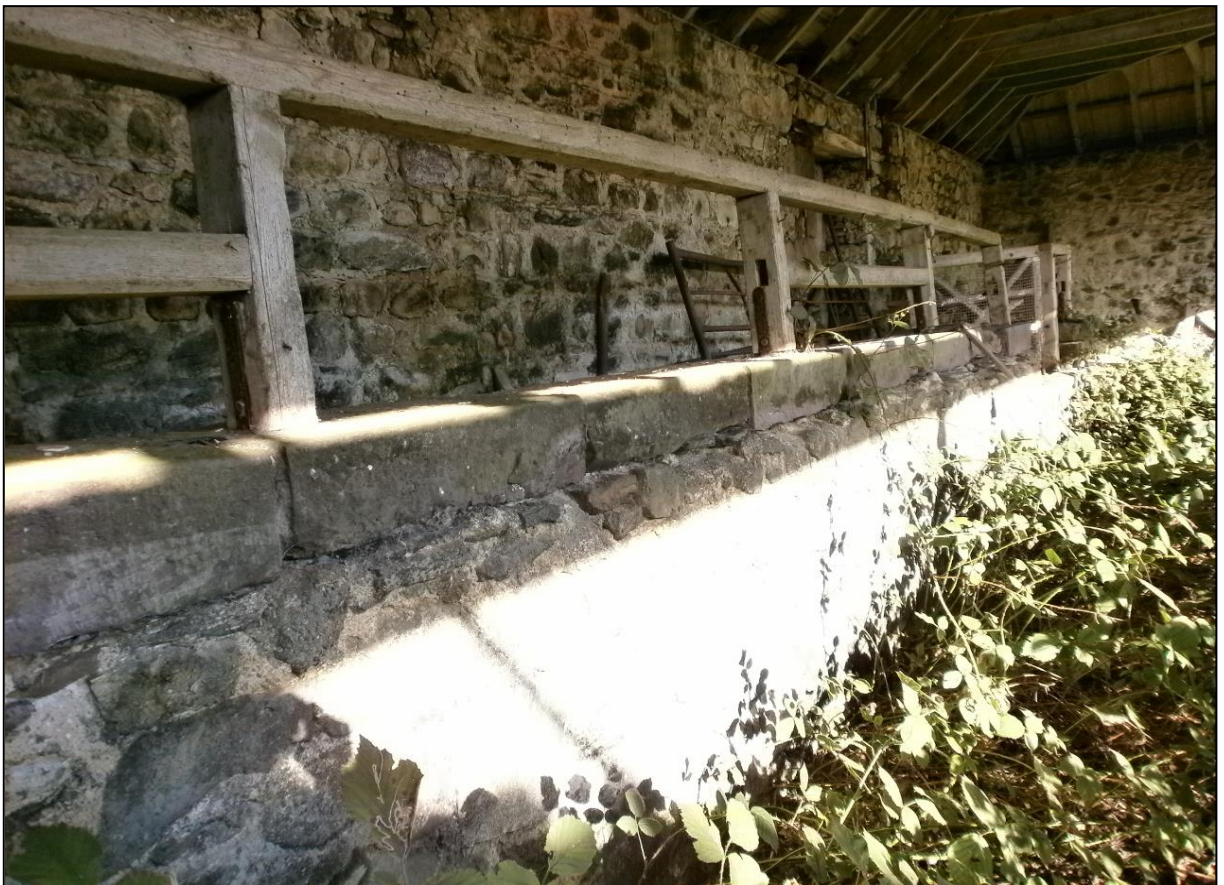
Figure 11b: Raised walkway in along the northwest side of Building H
