Glithno Farm, Stonehaven: Archaeological Mitigation

Data Structure Report

Author(s)	Peter Klemen		
Date of Issue	23 rd February 2017	Version	1.0
Commissioning Body	Fotheringham Property Developments		
Event Name	Glithno Farm, Stonehaven		
Event Type	Historic Building Recording; Appraisal Level		
Event Date(s)	February 2017		
Rathmell Archaeology Code	RA17015	OASIS Ref:	Rathmell1-277250
Location	United Kingdom: Scotland: Aberdeenshire		
NGR	NO 8606 8932	Parish	Fetteresso
Designation(s)	None

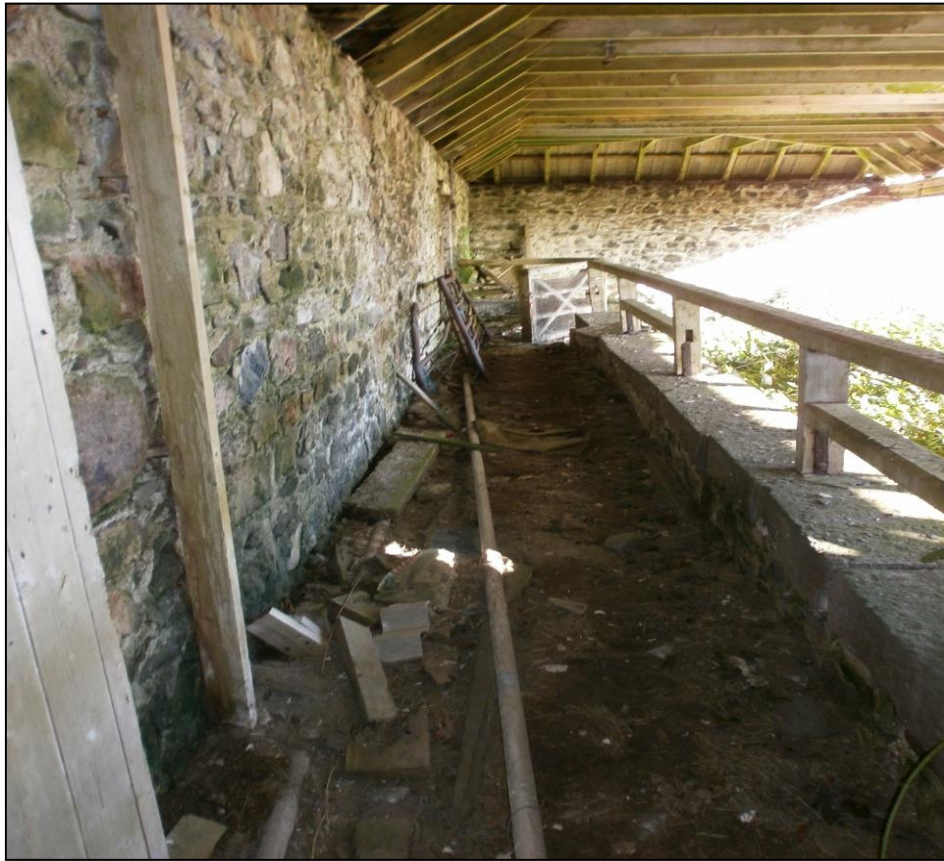
21. Building H is square in plan, comprising a single storey 1 x 1 bay structure and measuring 16m by 16m. Originally the building would have been roofed around the northwest, southwest and southeast sides with an open central courtyard. The original cast iron columns are still present. However, only the northwest side is still roofed; this comprises modern timber trusses and corrugated glass fibre sheet roofing (Figure 10b & 11a) with a hipped roof arrangement. The roof would originally have covered a raised stone walkway that is 1.10m above the interior courtyard and 1.40 wide (Figure 11b & 12a).

Figure 12a: Raised walkway in along the northwest side of Building H

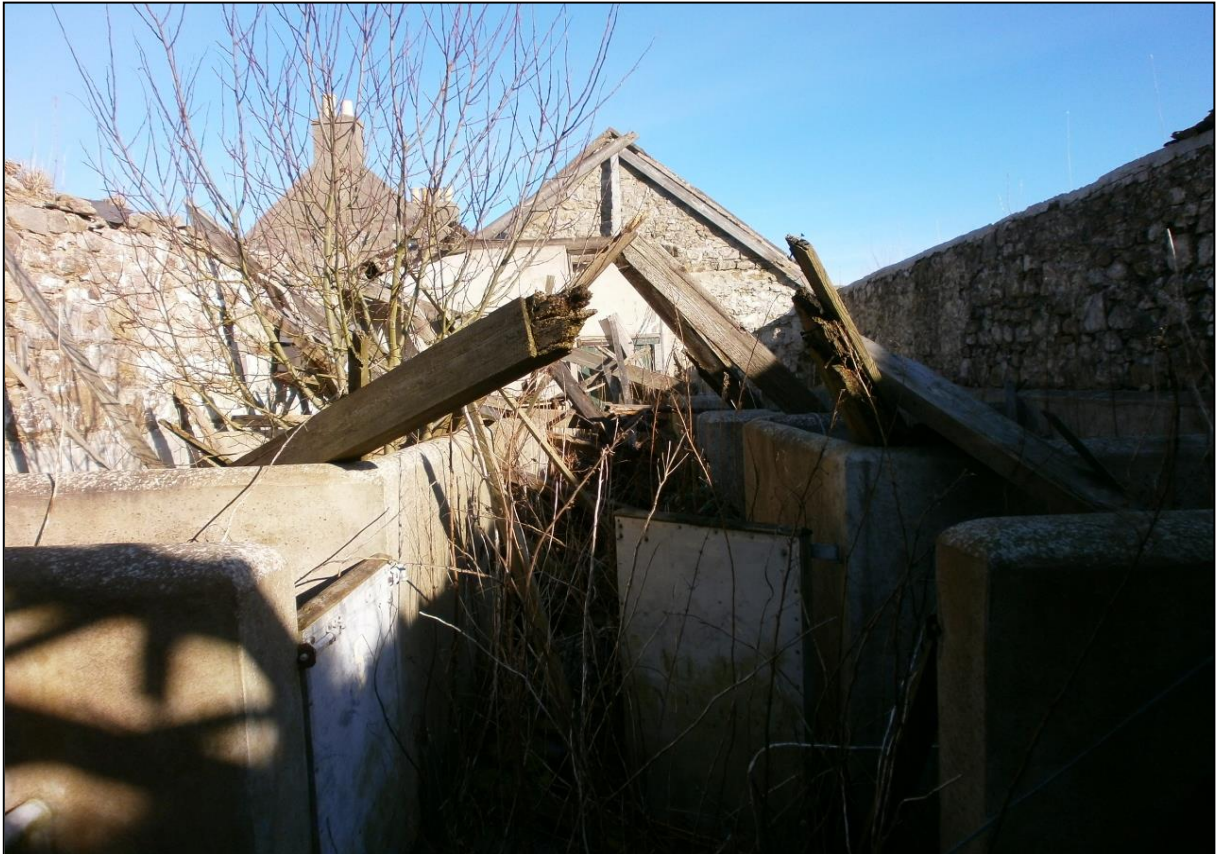
23. Building I is rectangular in plan, one storey in height and measuring 1 x 1 bay (16.7m by 5.8m), and constructed of snecked granite rubble. As with Building G, there is a central doorway in the southwest elevation that has been infilled with modern brick and cement with the original brick arch *in situ*. The original doorway would have measured 2.4m by 2.4m. The roof had collapsed into the interior and as a result the structure could not be fully accessed. The quoins and margins are broached granite. There are seven concrete livestock pens measuring 4.3m by 2.4m by 1.3m in height.

Figure 13a: Building I: showing the structures poor condition and livestock pens

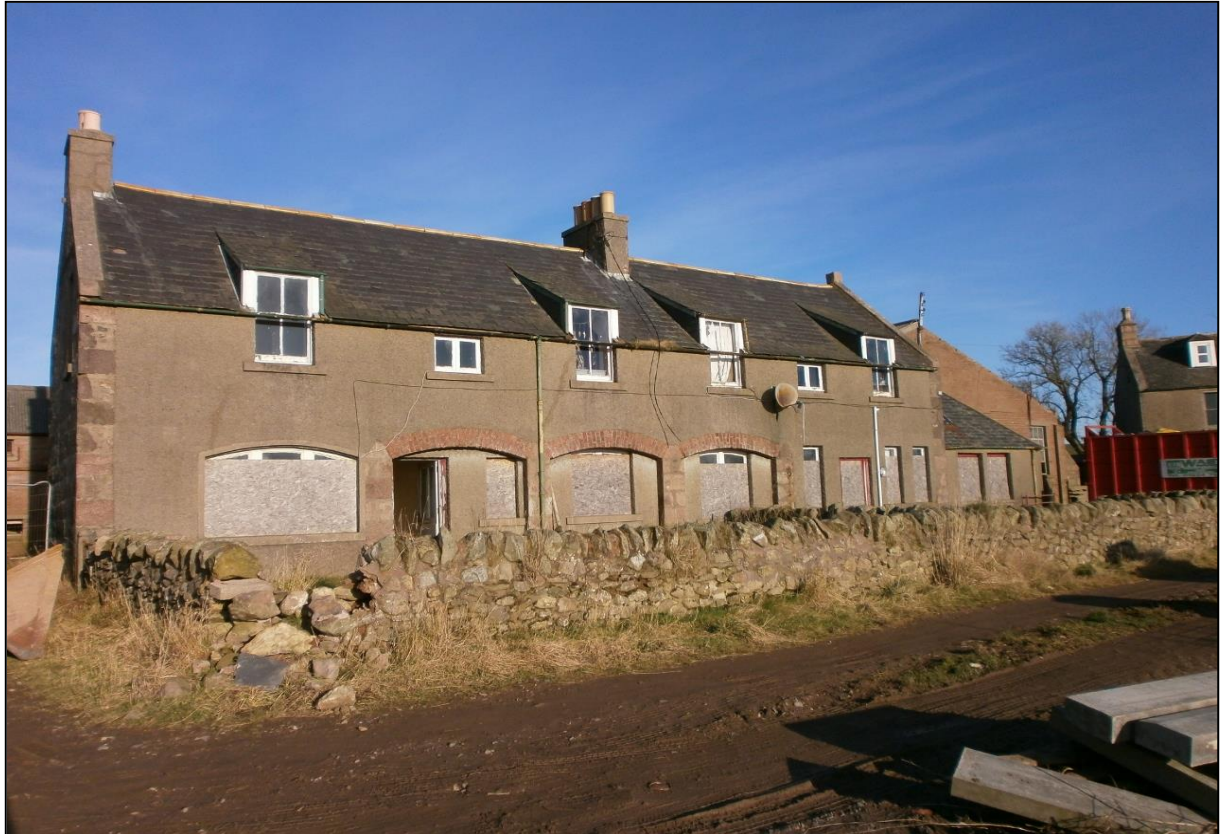
24. Building J is a rectangular in plan, 6 x 1 bay, two storey structure. The original snecked granite rubble is visible on the northwest, southwest and northeast elevations with a cement render, coloured brown, covering the southeast elevation. The render does not cover the worked granite quoins, visible on the southeast elevation. The roof is pitched and slated, with four catslide dormers projecting from the wallhead on the southeast side and one on the northwest side. On the southeast elevation the window margins/rybats are of cast concrete, with the three windows on the northwest elevation and the one on the southwest having worked granite margins.

Figure 13b: Building J: southeast elevation

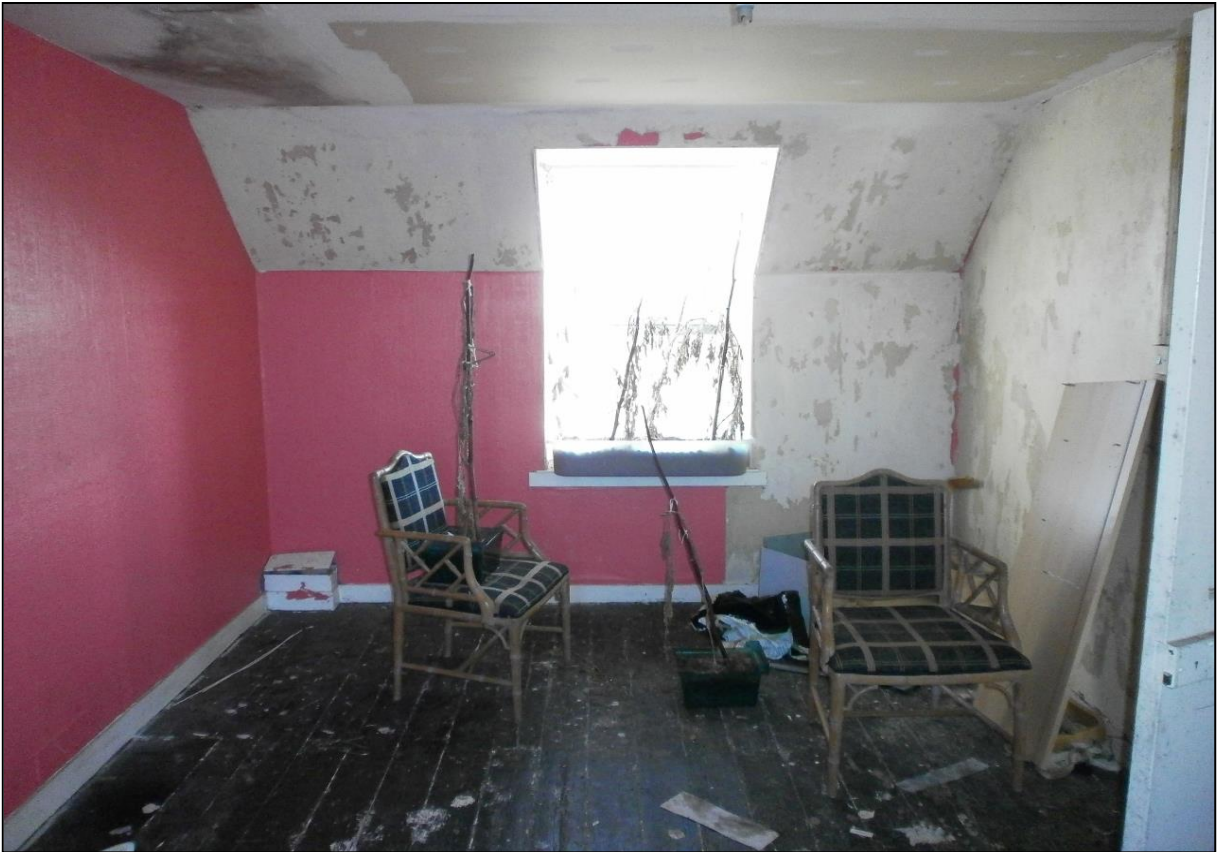
25. Building J is two individual dwellings with a small extension on the northeast end which has a hipped roof and slated. Only the southwest dwelling could be accessed. On the first floor there are four rooms including the hallway and a small cupboard. Room 1 (Figure 14a) is located on the northeast side of the first floor and rectangular in plan and measures 3.1m northeast-southwest and 4.8m northwest-southeast. There are two sash & case windows; on the southeast and northwest walls. All fixtures and fittings are modern.

Figure 14a: Building J: Room 1, southeast and northeast walls

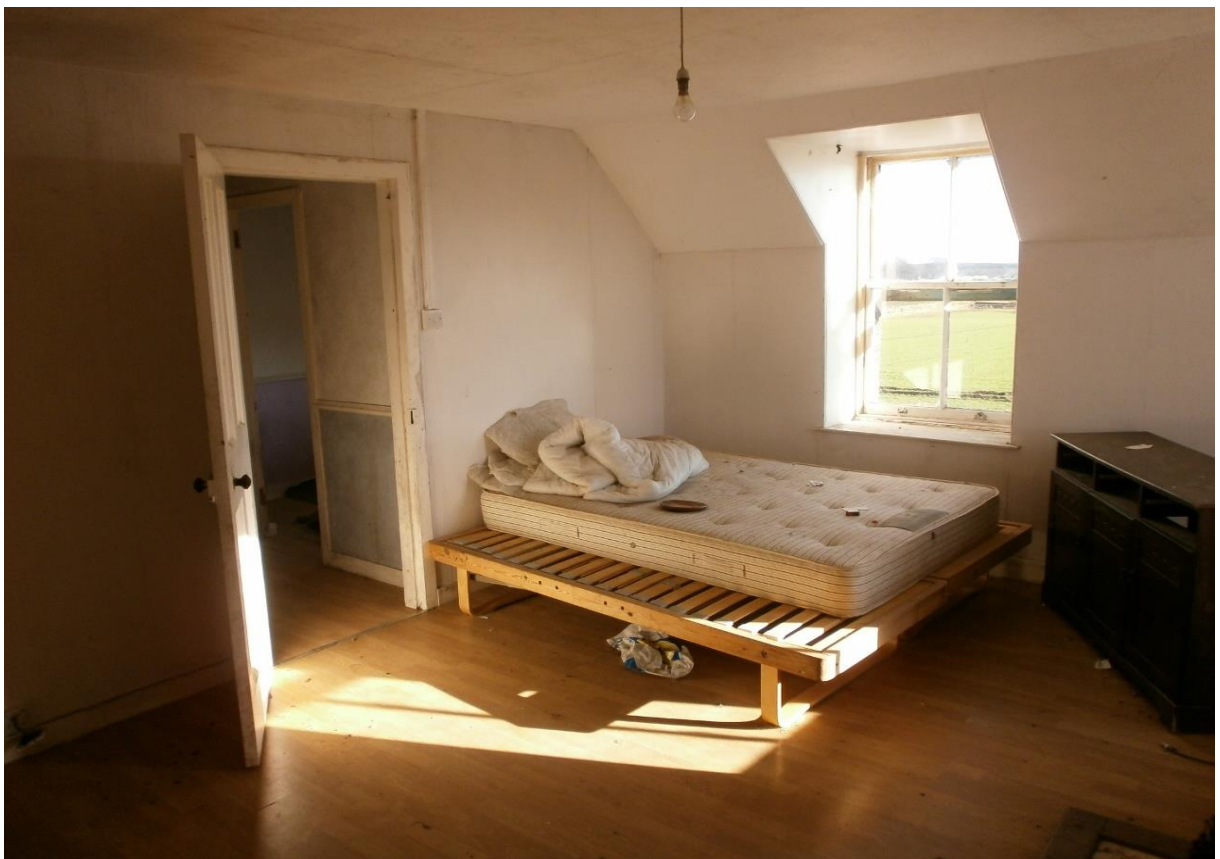
Figure 14b: Building J: Room 2, southeast and northeast walls

27. The hallway is rectangular and measures 2.5m by 1.16m with the small cupboard on the northwest side and measures 1.4m by 0.4m and houses the fuse box. Room 2, located on the southwest side is rectangular in plan and measures 3.6m northeast-southwest and 4.8m northwest-southeast. There are two sash & case windows, one on the southeast side and one on the southwest side. There is a fire place on the southwest side and all fixtures and fittings are modern.

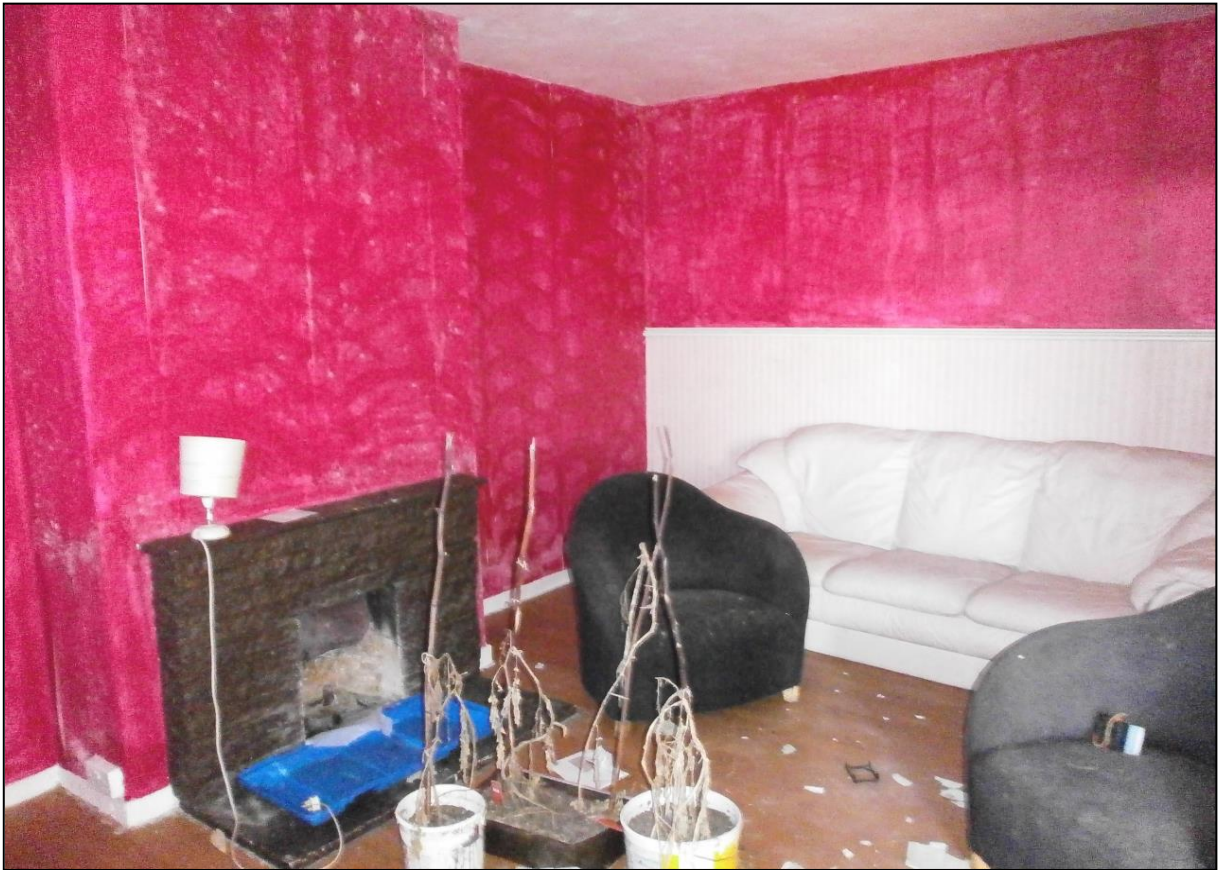
Figure 15a: Building J: Lounge room southwest and northwest walls and fire place

28. On the ground floor there is a lounge (Figure 15a), bathroom and kitchen (Figure 15b) with a small cupboard under the stair. All the rooms have modern fixtures and fittings with the modern windows in the kitchen and bathroom and sash & case windows in the lounge. All the windows are blocked. The lounge measures 3.0m northeast-southwest and 4.8m northwest-southeast, the kitchen measures 3.4m northeast-southwest and 4.8m northwest-southeast with the bathroom measuring 1.9m northwest-southeast by 2.1m northeast-southwest.

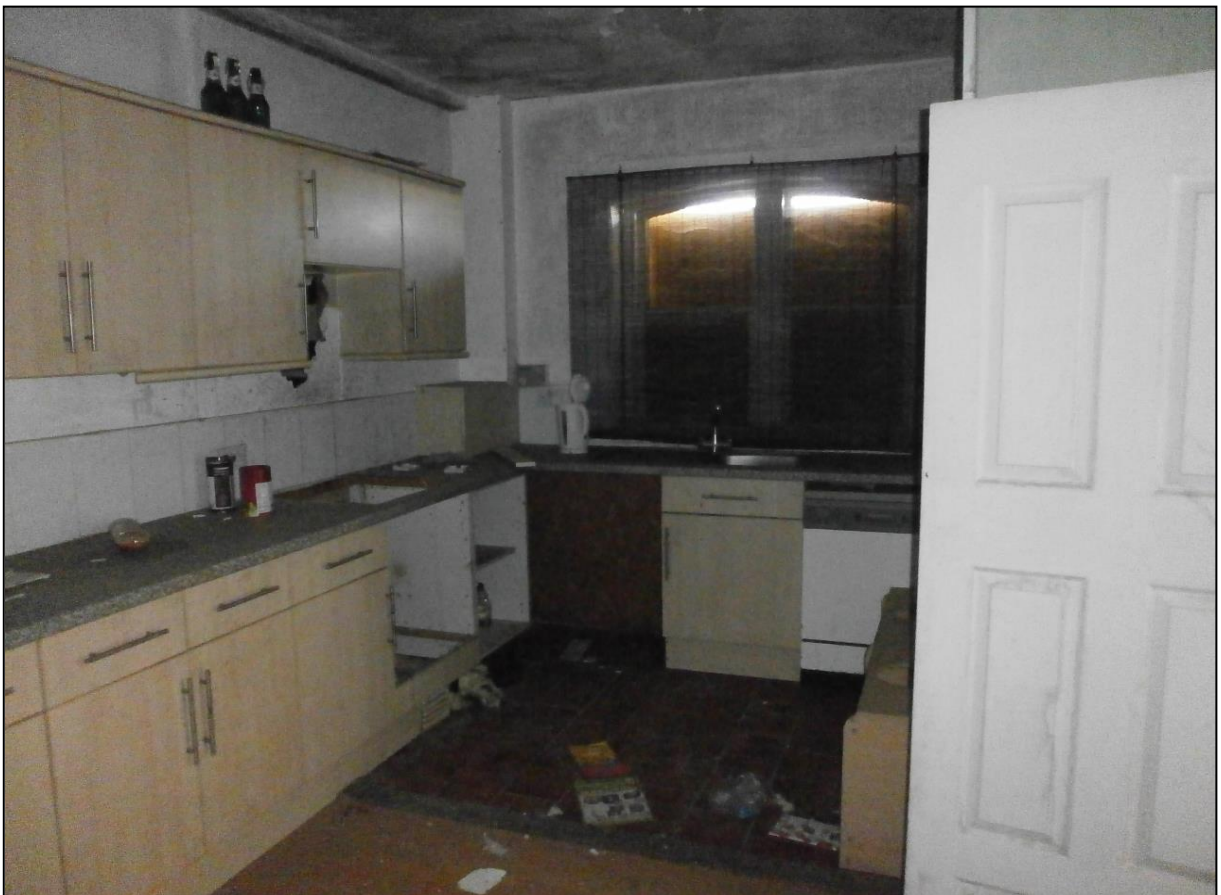
Figure 15b: Building J: Kitchen, southeast and northeast walls

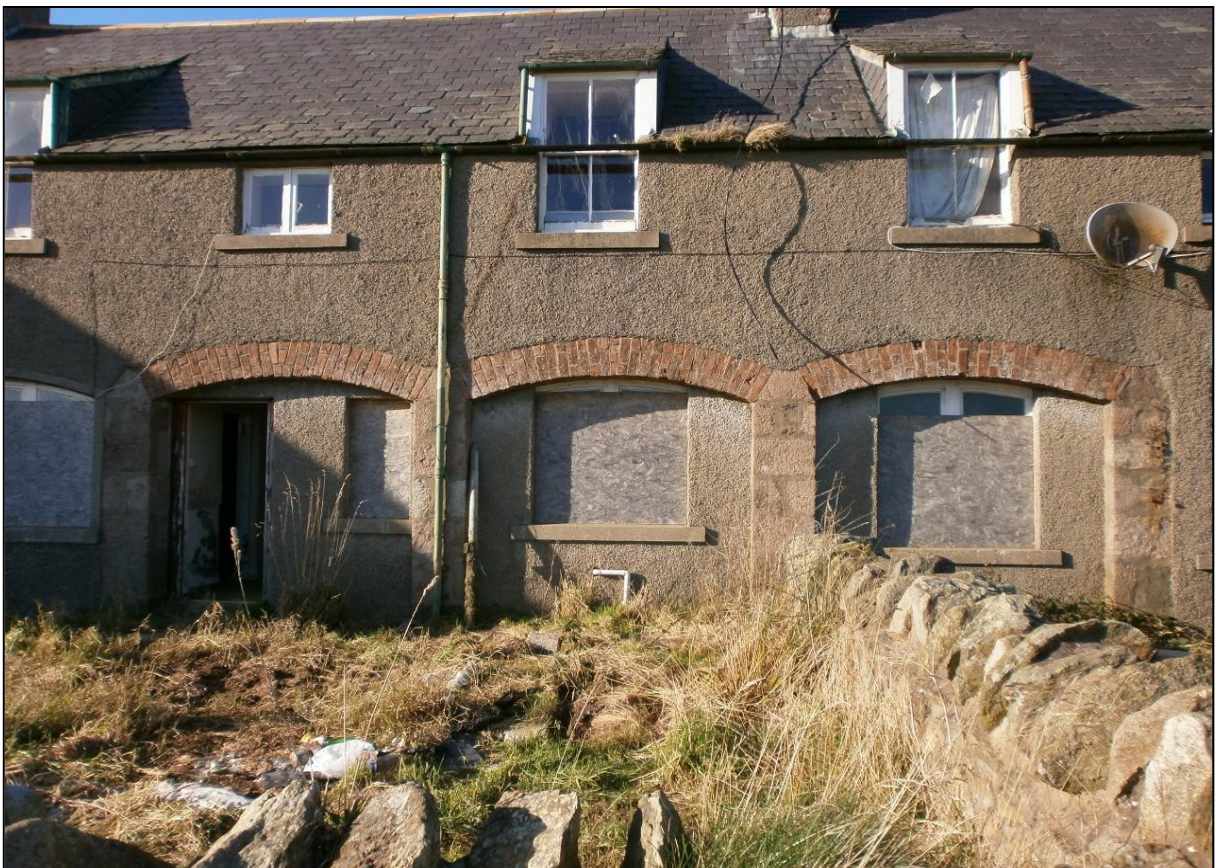
Figure 16b: Building J: southeast elevation with the brick arches and granite columns visible

29. There are two features of interest on the southeast and northeast elevations. On the northeast elevation there is a date stone where the first three numbers can be made out but the last number cannot, it reads '182?' (Figure 16a). Although the exact date cannot be concluded, the date of the 1820s fits with Thomson's (1822) survey that records the farm (Figure 1b). A further feature are the three brick arches with granite columns that are visible on the southeast elevation (Figure 16b). The presence of the brick arches that suggests that Building J may have been built for use as a cart shed, with the upper floor providing workers' accommodation.

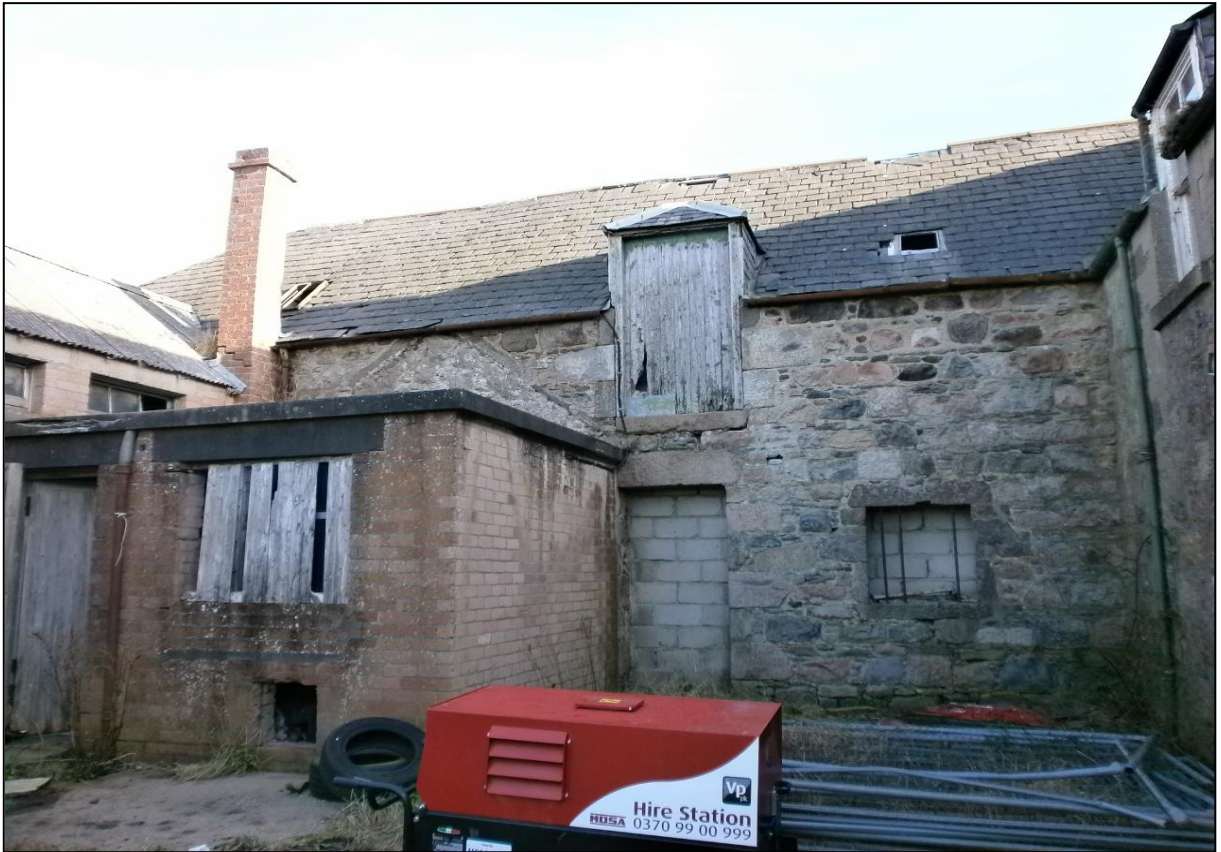
Figure 17a: Building L: exterior, southwest elevation

30. Building L could not be accessed due to the removal of asbestos. However, it was possible to photograph the southwest exterior elevation (Figure 17a). This is a two storey snecked granite rubble building with a hipped, slated roof. The presence of a door on the upper storey would suggest that this was used for storage and most likely functioned as a hay loft. The central doorway and window on the ground floor have been blocked up using breeze blocks. The door lintel and margins around the door and window are worked granite blocks. This may have functioned originally as a stable.

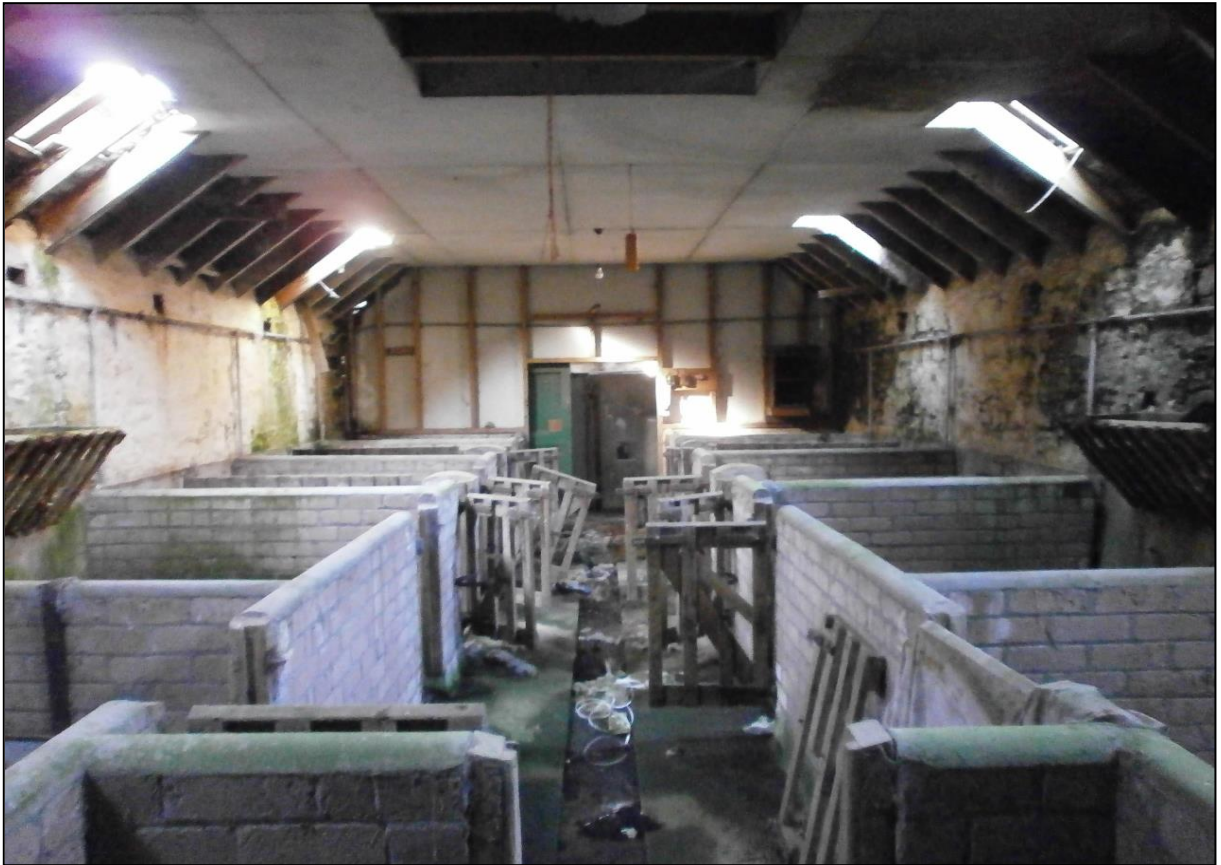
Figure 17b: Building N: view along the room to the southeast

Figure 18a: Building N: view along the room to the northwest.

31. Building N is rectangular in plan, single storey single storey and a 1 x 1 bay structure constructed of coursed snecked granite and measuring 11.7m by 5.6m (Figure 17b & 18a). There is a modern partition between Buildings B & N so they would have originally been an 'L'-shaped structure. There are eleven small livestock pens, four of which have wooden dividers so they can be made larger. The average size is 1.3m by 1.9 by 1.3m in height and they are constructed from brick and concrete. The floor is of concrete, and the ceiling is lined with plasterboard. Six skylights located within the roof, which has revealed timber trusses and timber sarking in places where the plasterboard has been removed. The walls have been plastered and painted white. The large quantities of wool/fleece detritus on the floor would suggest that the building had recently been used for housing sheep.

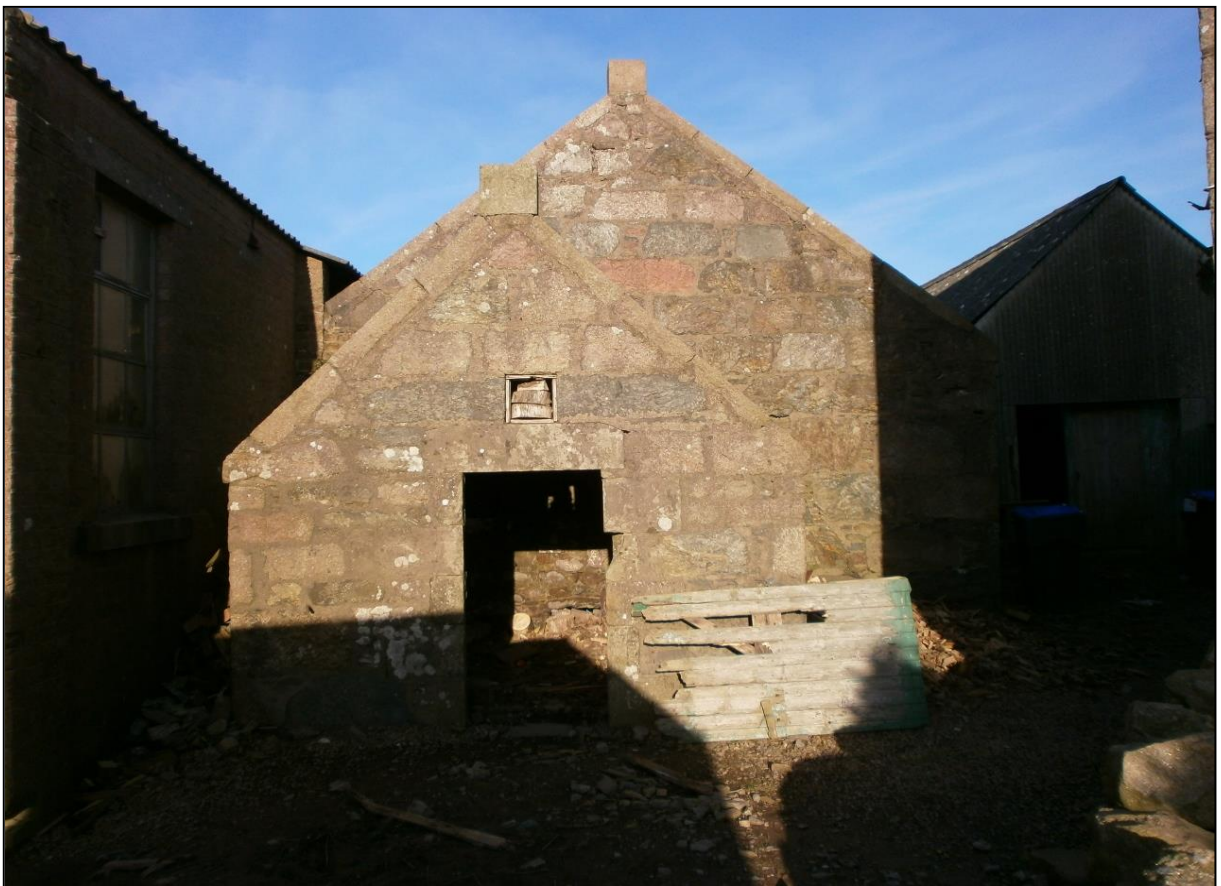
Figure 18b: Annexe on southeast side of Building N.

32. There is a small square structure joined to the southwest end but without an access to the main building (Figure 18b). This is also constructed of coursed snecked granite with a gable style roof with corrugated glass fibre sheets and measures 2.5m by 2.5m. The original use is unknown, but its recent use has been for storage.
