Coylton Water Treatment Works Upgrade Pipeline, South Ayrshire: Archaeological Mitigation

Data Structure Report

by Claire Williamson
issued 31st March 2017
on behalf of Scottish Water

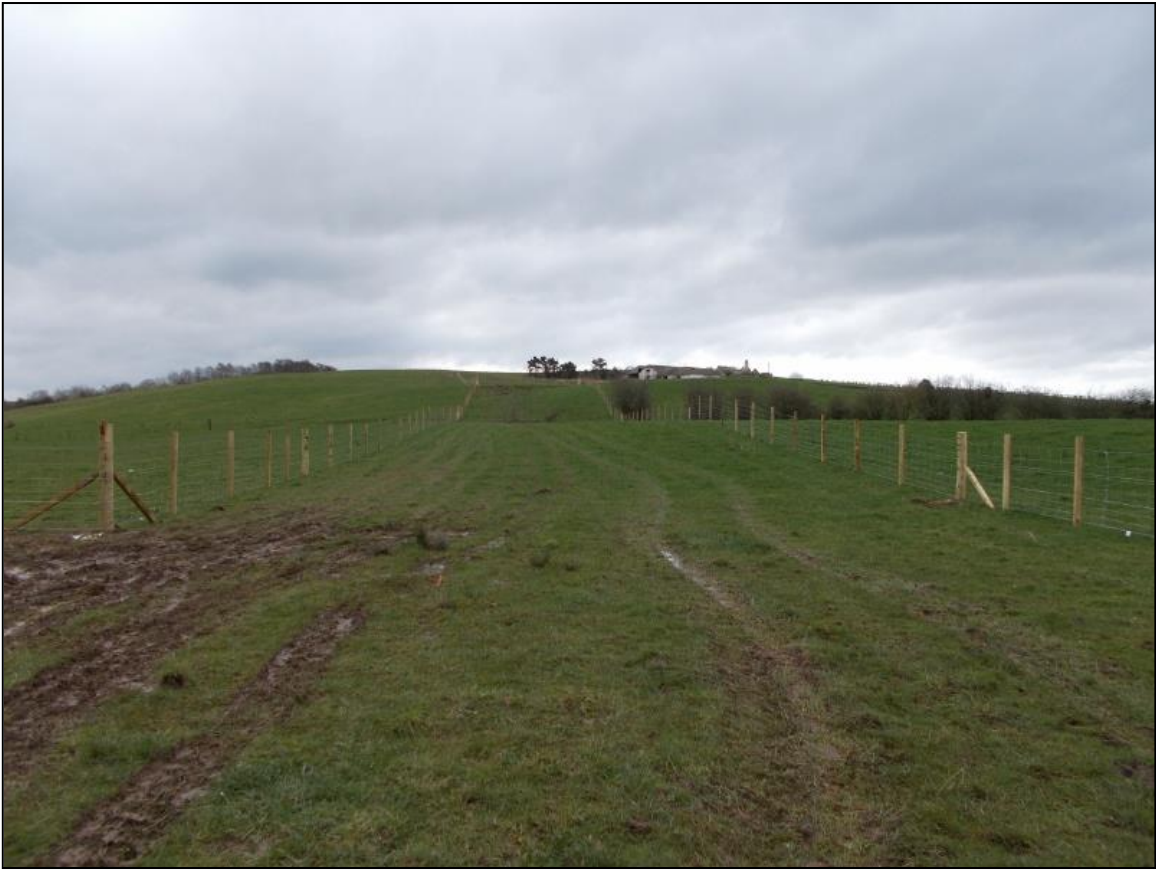
Figure 2a: Pre-excitation shot along route of pipeline from the north, with Barclaugh Farm visible at the top of the hill

11. The section of the pipeline route which required monitoring sat at its northern end where it crossed enclosed fields to the north and east of Barclaugh Farm (Figure 2a). The fields were enclosed by post-and-wire fencing which often accompanied fragmented hedgerows, and had been used for pasture in recent times.

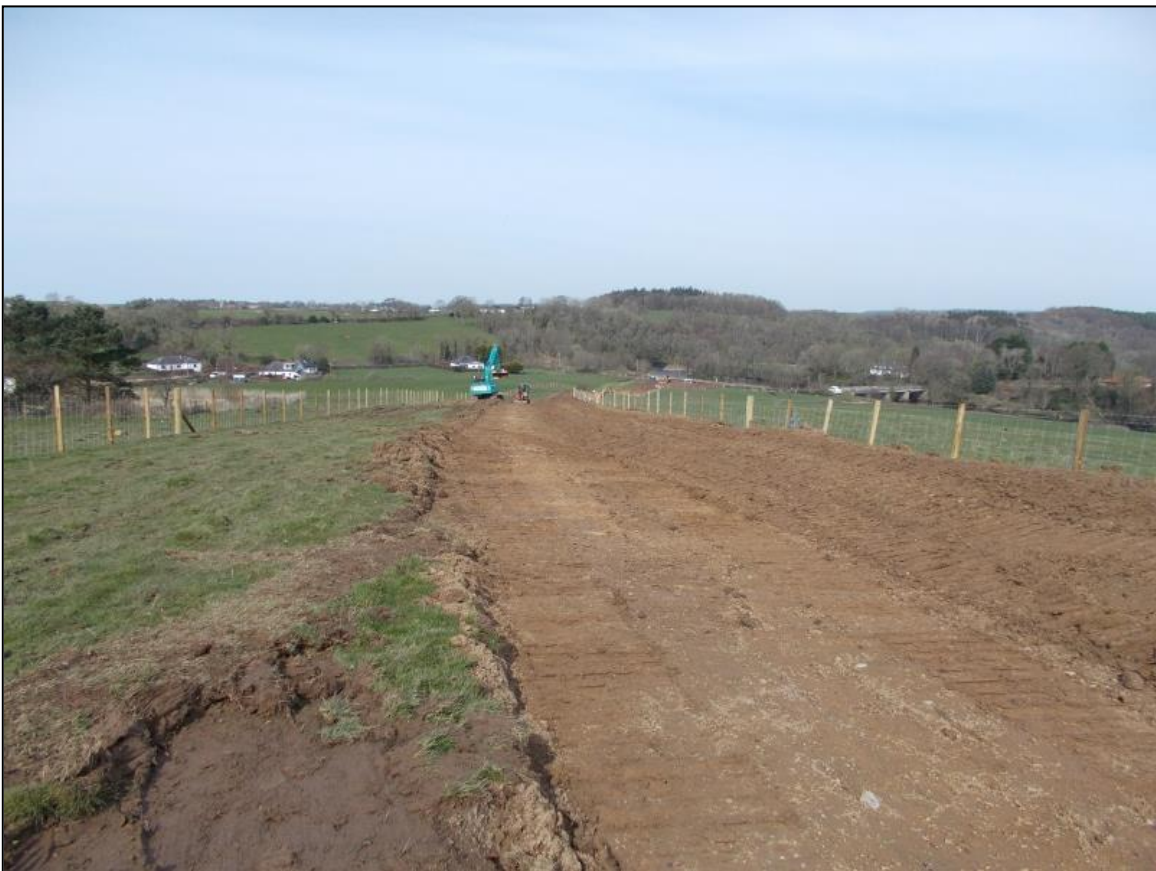
Figure 2b: General view of the pipeline route to the east of Barclaugh Farm from the south

12. The monitored section of the route started on the southern edge of the B744 and ran south for approximately 530m, stopping at a field boundary to the south of Barclaugh Farm (see Figure 1). The stripped area measured 4.2m wide (Figure 2b).

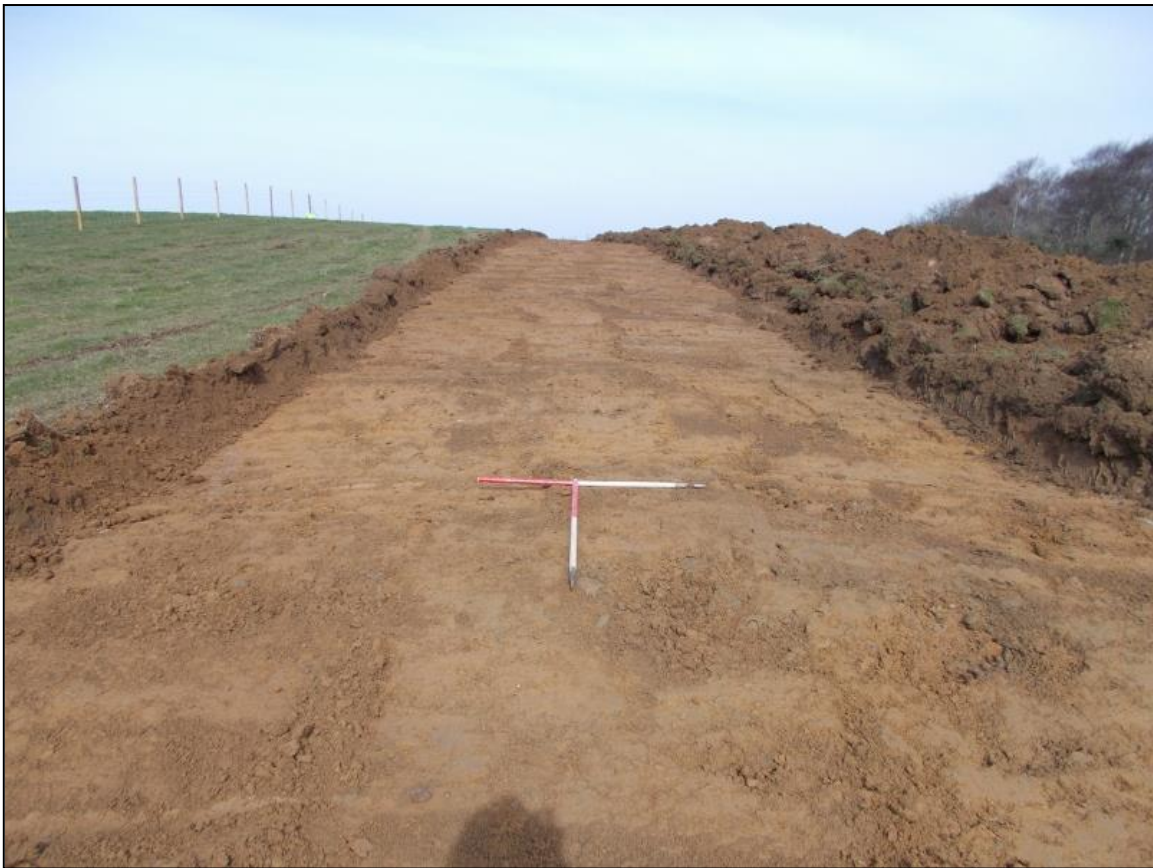
Figure 3a: Shot of pipeline route showing subsoil (002)

14. The works removed topsoil (001) to reveal the underlying natural subsoil. This was predominantly (002), a very compact light to mid-orange sand clay with occasional small stone inclusions (Figure 3a) which was present across the majority of the pipeline route. Along a small section of the route as it ran up-slope towards Barclaugh Farm, the subsoil changed to a quite compact mid-orange brown clayey sand and gravel (003) (Figure 3b), for a length of approximately 30m before changing back to (002).

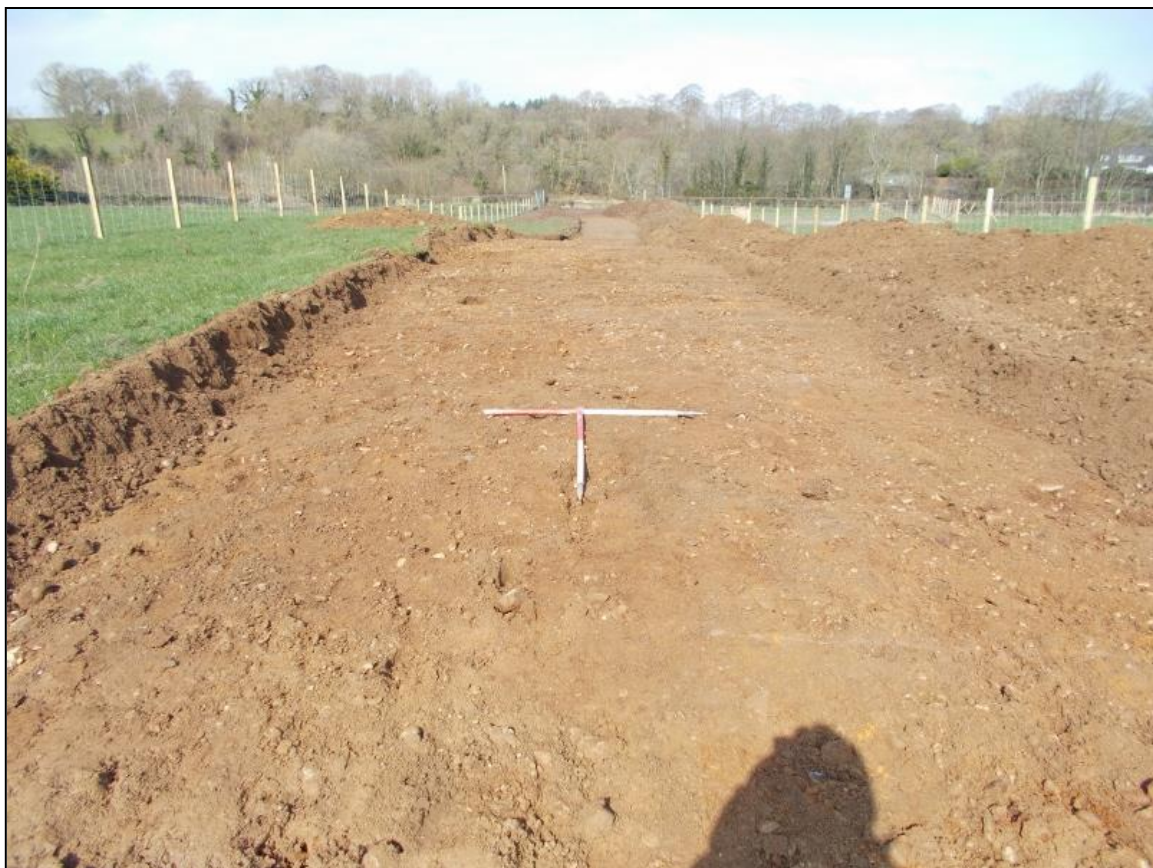
Figure 3b: Shot of pipeline route showing subsoil (003)

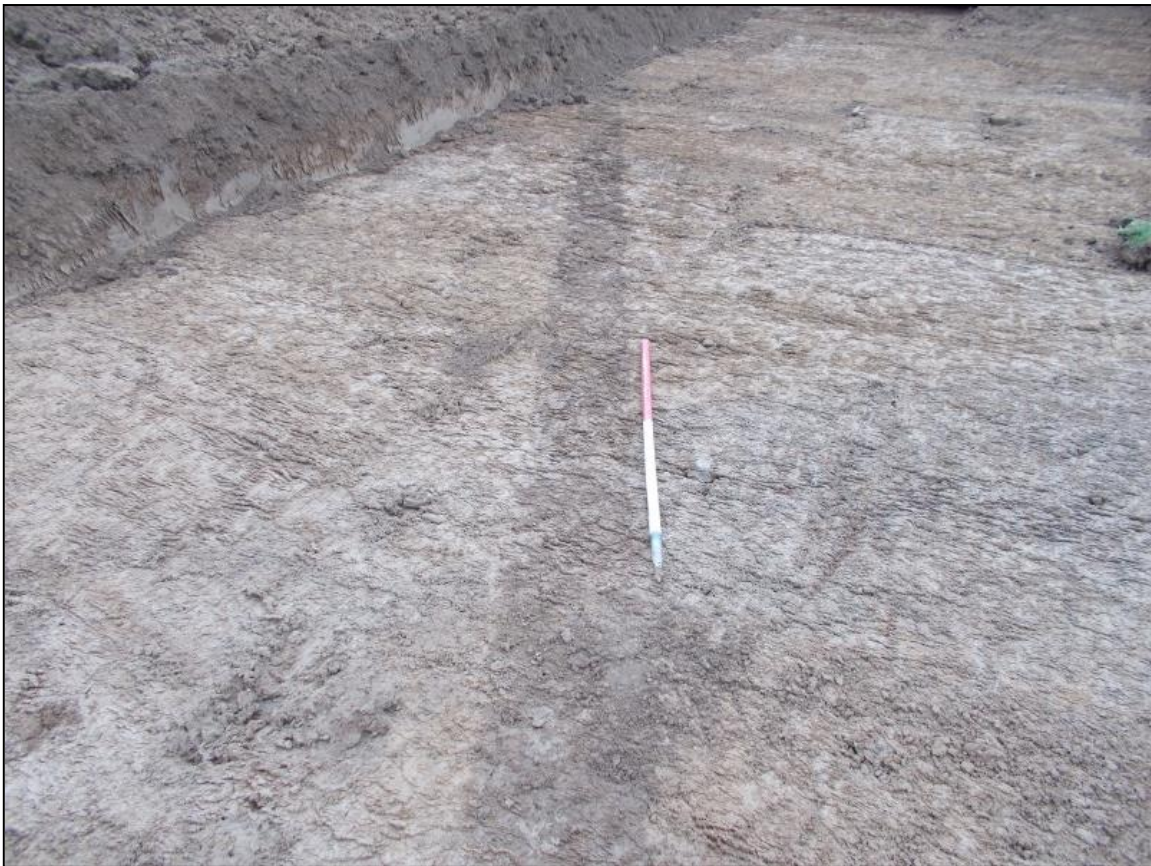
Figure 4a: Shot of field drain [004] from the southeast

15. The only archaeological features present along the monitored section of the pipeline route were field drains [004]. These linear shaped features ran northwest to southeast and measured 0.3m wide (Figure 4a). They had vertical sides and contained a topsoil fill overlying circular red tile drains. These were present in the section of the route as it passed close to Barclaugh Farm, starting on the slope just to the north and continuing across the upper terrace.

20. The only archaeological features to be revealed during the monitoring works were field drains [004] which mainly appeared in the area around Barclaugh Farm. Field drains are commonly associated with the Improvement Era, a period which saw vast changes to the layout of farms mainly throughout the 18th to 19th centuries to better their production and efficiency. This places the insertion of the drains to some point either throughout this period or after, with an aim to improve the drainage of the ground where the underlying

22. The earliest style of field drains adopted were either open or infilled with stone (i.e. rubble or French drains), although occasionally other materials such as bracken or straw could be used where stone was less readily available (Davis & Davis 2013, 5-6). Red tile drains were not introduced until the very end of the 18th century, becoming more common during the 19th century (*ibid.*, 9-18). As such, rather than forming a part of the initial changes introduced in the Improvement Era, the field drains [004] represent a later phase in the process of ongoing improvements made to the farm throughout its lifetime.

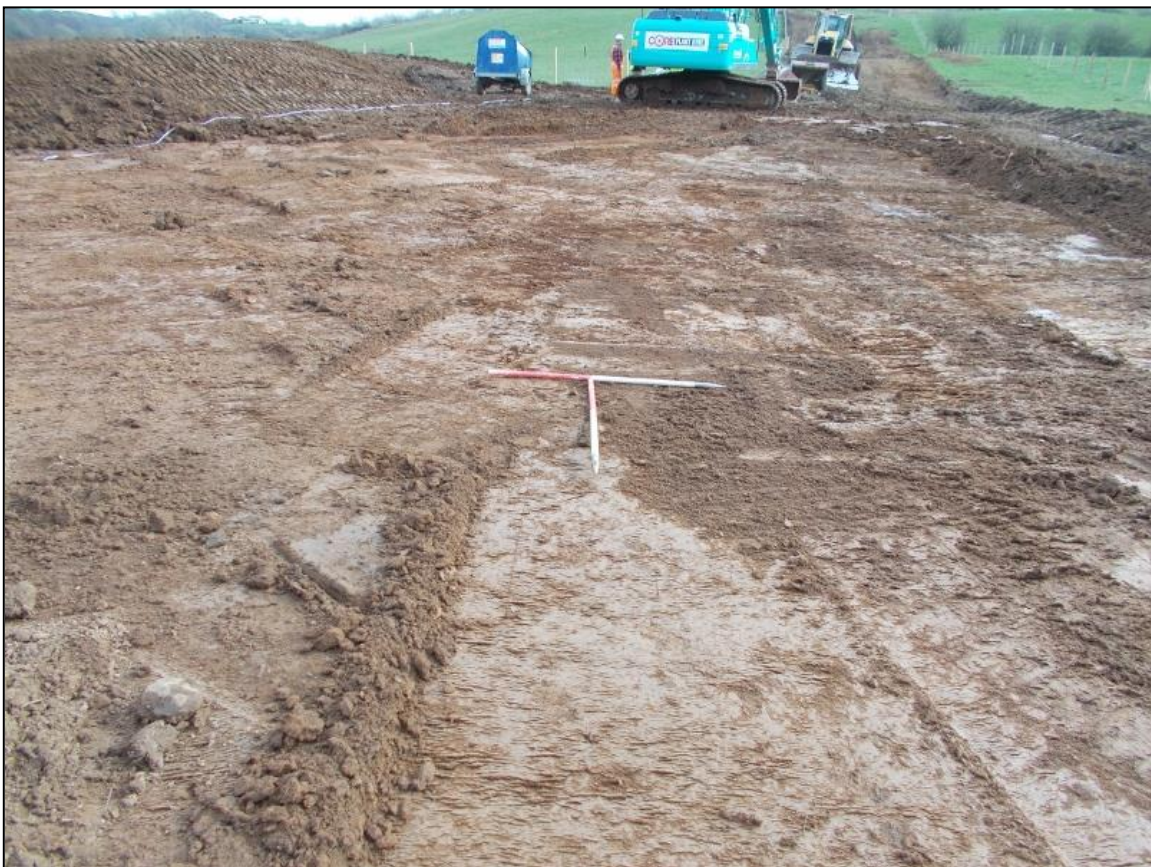
Figure 4b: Shot of compound area from the northwest

17. The compound area sat at the northern end of the monitored area, to the east of the pipeline route and just to the south of the B744 (see Figure 1). It measured roughly 29m north-south by 18.5m east-west, although narrowed to 10.5m at its southern end (beyond the section of pipeline which sat adjacent).
18. As with the pipeline route, the entire area of the compound was covered by topsoil (001) which measured 300mm deep in this area. The topsoil was removed to reveal natural subsoil (002) present across the entirety of the compound (Figure 4b).
19. No archaeological features were present within the compound area, and the only artefacts recorded were the occasional 19th and 20th century finds seen within topsoil (001).
