Auld Kirk Graveyard, Beith: Archaeological Watching Brief

Data Structure Report

issued 14th June 2017

on behalf of North Ayrshire Council

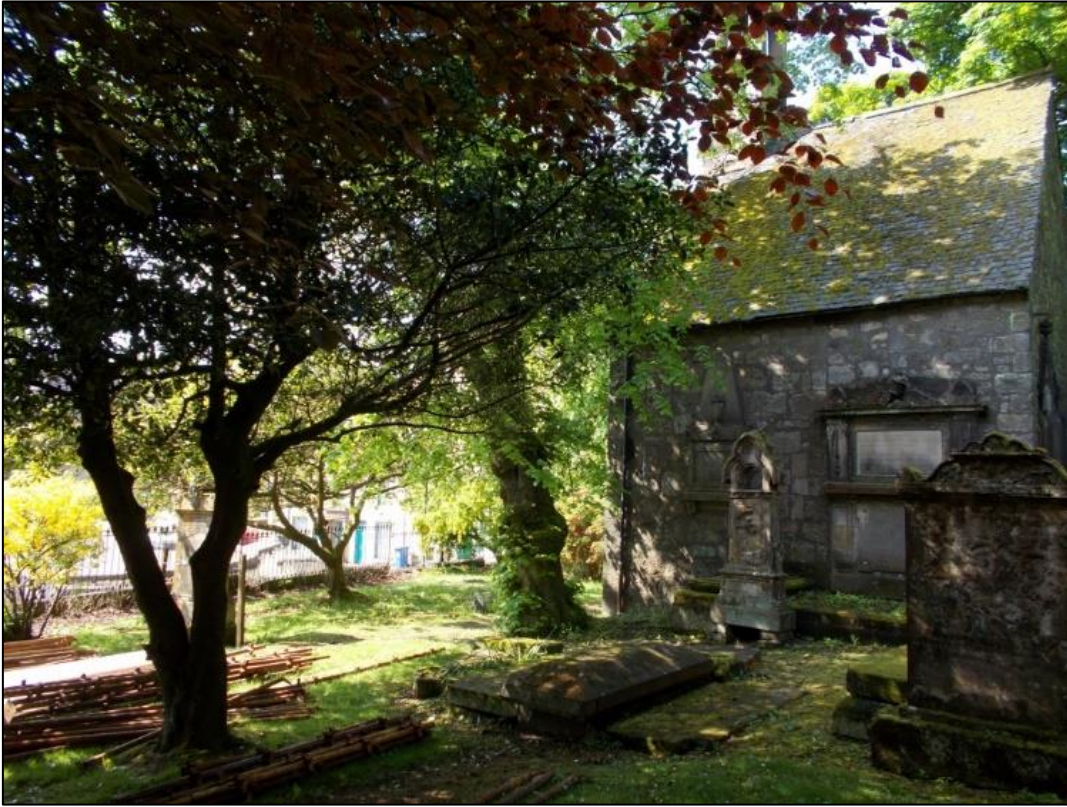
Figure 4a: View of the graveyard and church buildings. From the WSW.

10. The programme of works comprised the archaeological monitoring of excavations at the Auld Kirk Graveyard at Beith (Figures 3 and 4a). These works were for the repair and reconstruction of stone boundary wall [001] surrounding the graveyard. The works were to include the erection of wall props and buttresses in the north western and western parts of the wall (Figure 3).

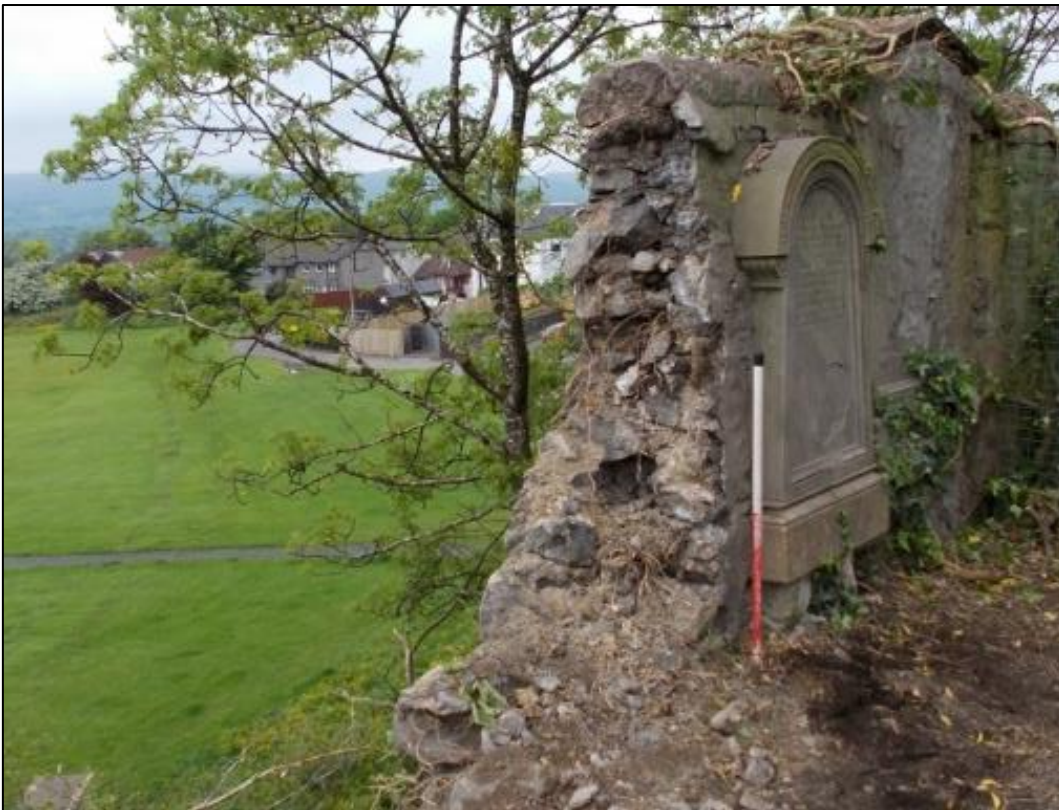
14. The boundary wall surrounding the graveyard, [001] (Figure 4b), was constructed with sub rounded/angular stone (mid grey basalt). The larger sub rounded stones, which formed the inner and outer faces of the wall, measured 0.4m x 0.37m x 0.28m and the smaller angular stones, which made up the core of the wall, measured 0.13m x 0.12m x 0.09m. The stones appeared to be unworked, though later stones inserted as repairs within the structure were faced. The elements of the wall were bonded with a white/light grey mortar. The wall had a maximum height of 2m (though it had collapsed in places), its width at the base was 0.6m and at the top was 0.4m. The wall enclosed an oval area which stretched 64m from north to south and 51m from east to west (approx. 2000m²).

Figure 4b: View of a section through the boundary wall [001]. From the S.

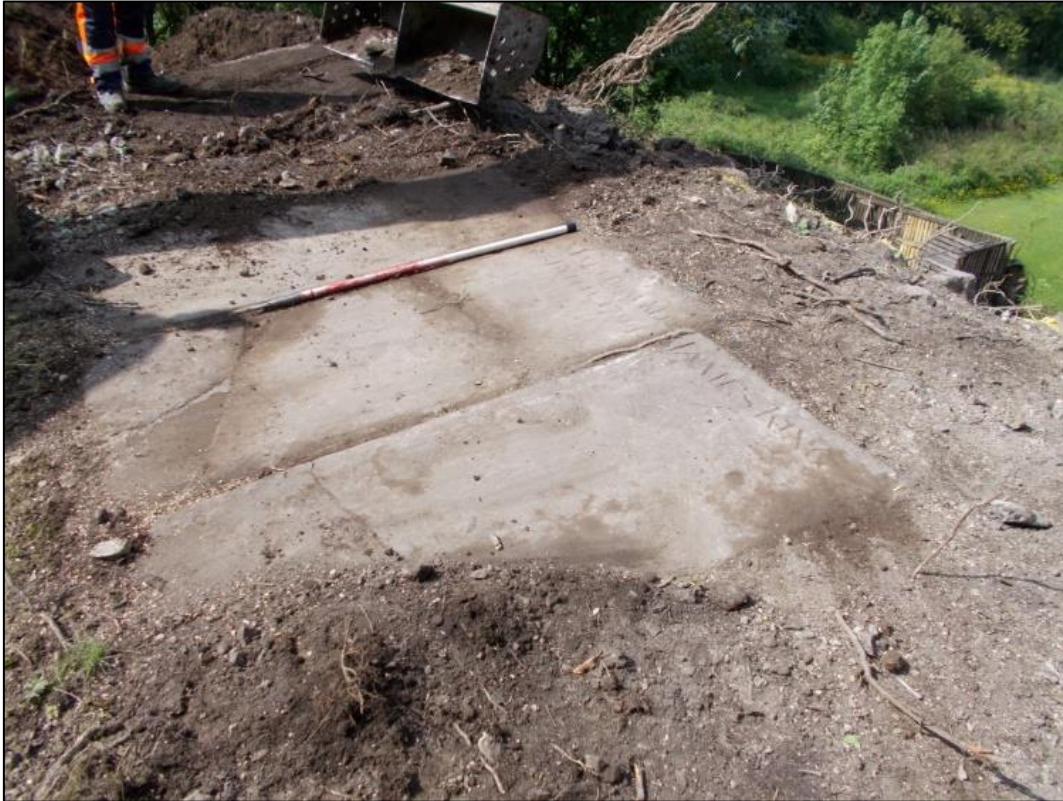
Figure 5a: View of the inscribed 18th century gravestones (009). From the N.

17. No *in situ* graves were identified during the excavation of Trench 1. The group of four gravestones (009), from the inscriptions on three of them, were from the late 18th century but appear to have been moved from their original location within the graveyard as there was only the disturbed subsoil, (004), beneath and no evidence of grave cuts.

22. The archaeological monitoring works identified disarticulated human bone and a group of four 18th century gravestones within one of the three trenches that were subject to an archaeological watching brief. Neither the bone nor the gravestones appeared to be *in situ* and seemed to have been redeposited and moved from another part of the graveyard. No other significant artefacts or features were identified within the other two trenches and as such it is recommended that no further work should be carried out.

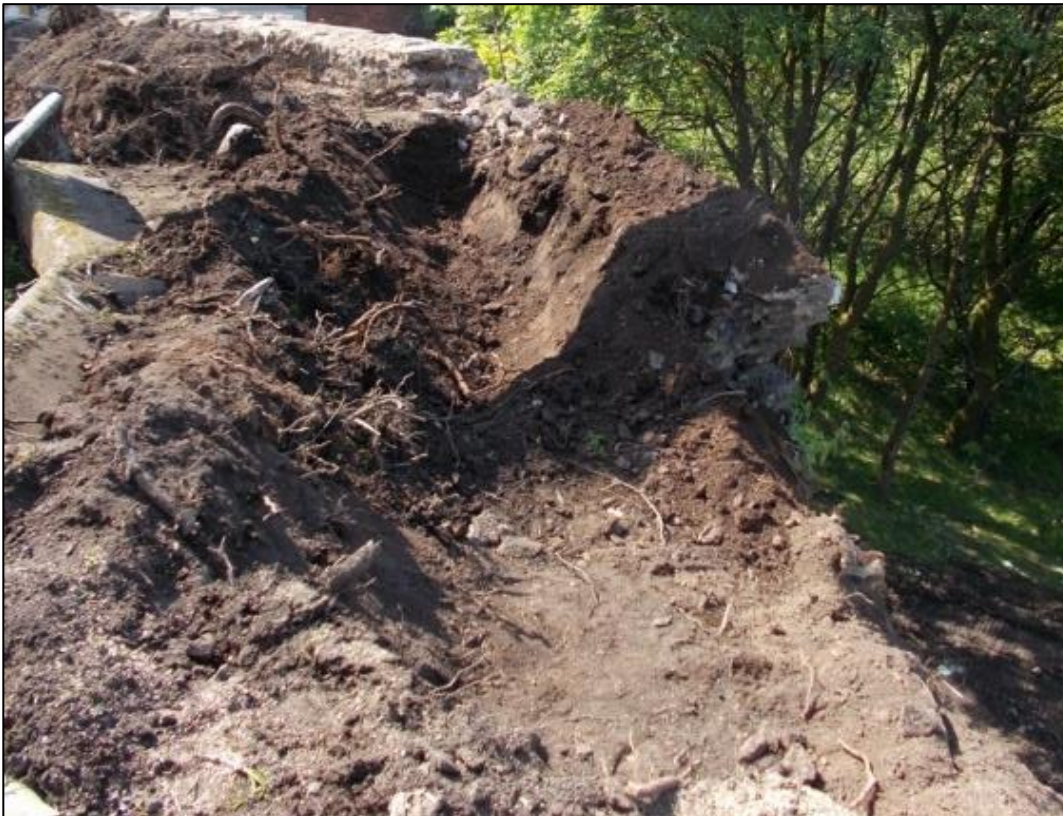
13. The topsoil within Trench 1 (Figure 5b) and the graveyard, (002), consisted of moderately compacted, mid grey brown silty sand with frequent root and moderate to frequent irregular shaped stone inclusions. The topsoil layer had a thickness range of between 0.25m-0.38m. Beneath this was a layer of disturbed subsoil, (004) (Figure 5b), consisted of moderately compacted, mid orange brown silty sand with occasional to moderate stone and disarticulated human bone and frequent root inclusions. The layer had an excavated thickness range of 0.12m-0.25m. Beneath the subsoil layer lay mid grey (basalt) bedrock which formed a sheer cliff edge on the graveyards northern and western sides.

15. A rectangular area formed by a series of kerbstones, [008] (Figure 5b) and the graveyard boundary wall [001] was located at the southern end of Trench 1. The area enclosed measured 8m by 1.5m and the individual kerbstones, [008], measured 1m by 0.2m and 0.25m high. The stones were faced on all sides though the upper, display, part of the stone was rounded. The foundation trench in which the kerbstones were set cut through the topsoil (002) and the underlying subsoil (004). At the northern end of Trench 1 there lay a group of four rectangular shaped gravestones, (009) (Figure 5a), which were orientated in an east to west direction. The slabs measured 1.5m by 0.5m and had a thickness range of between 0.1m-0.14m. The three northernmost gravestones (Figure 5a) were inscribed with 'John Kerr Born 1794', 'Matthew Kerr Born 1791' and 'James King'. Two artefacts (see Appendix 1) were recovered from the disturbed subsoil layer, (004), a corroded iron 'coffin' handle and a glazed floor tile with adhered mortar on its underside.

Figure 5b: Post excavation view of Trench 1 with Kerbstones in background. From the NNE.

19. The series of stone kerbs, [008], which along with the boundary wall [001] at the southern end of Trench 1 and enclosed a small rectangular area was most likely part of later landscaping within the graveyard. The subsoil within the enclosed area contained no human bone but did contain frequent root activity suggesting the stone demarcated a garden feature.

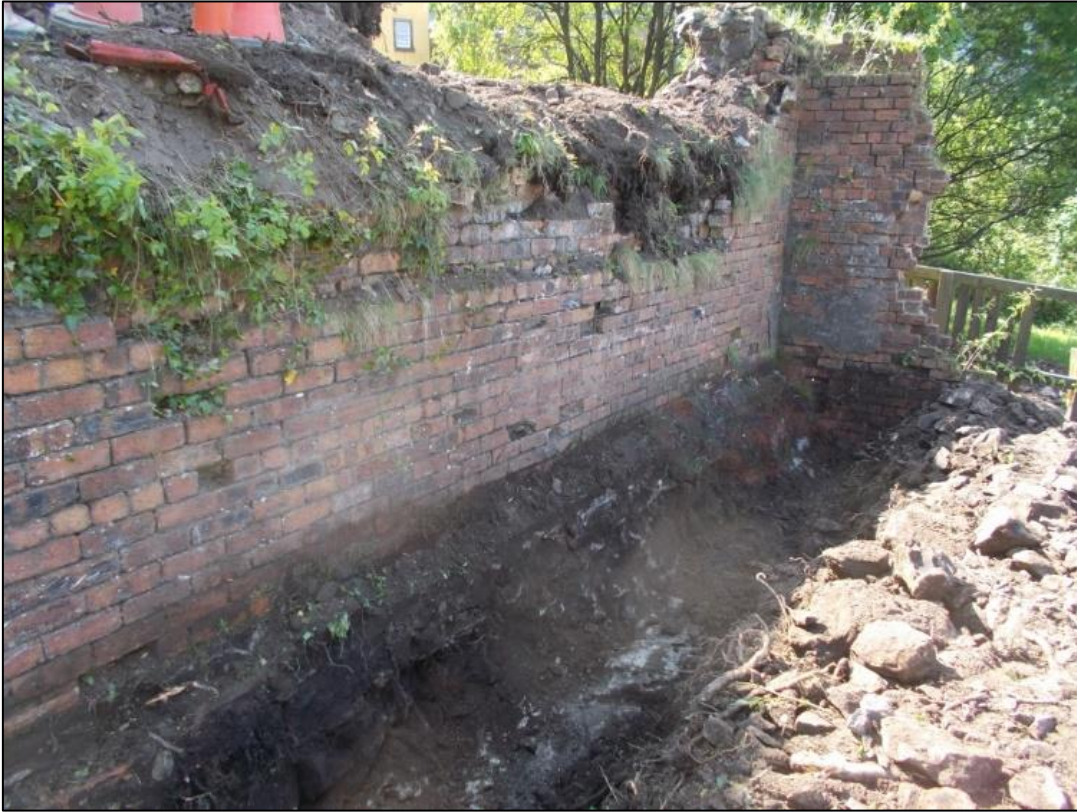
16. The topsoil, (003), within Trenches 2 and 3 (Figures 6a and 6b) which lay at the base of the north western and western parts of the boundary wall [001] and the sheer bedrock layer, (006), beneath, consisted of moderately compacted, mid grey brown/black silty sand

Figure 6a: Post excavation view of Trench 2. From the N.

with moderate to frequent stone and root inclusions. Layer had a thickness range of between 0.28m-0.33m. The underlying subsoil, (005), consisted of moderately compacted, mid to dark grey brown/black silty sand with occasional CBM and root and moderate to frequent stone inclusions. The layer had an excavated thickness range of between 0.58m to 0.68m. No significant artefacts or features were identified within Trenches 2 and 3.

20. No significant artefacts or features were identified within either Trenches 2 or 3. Both the subsoil, (003), and the subsoil, (005), appeared to be either disturbed or redeposited as modern CBM was identified within the subsoil.

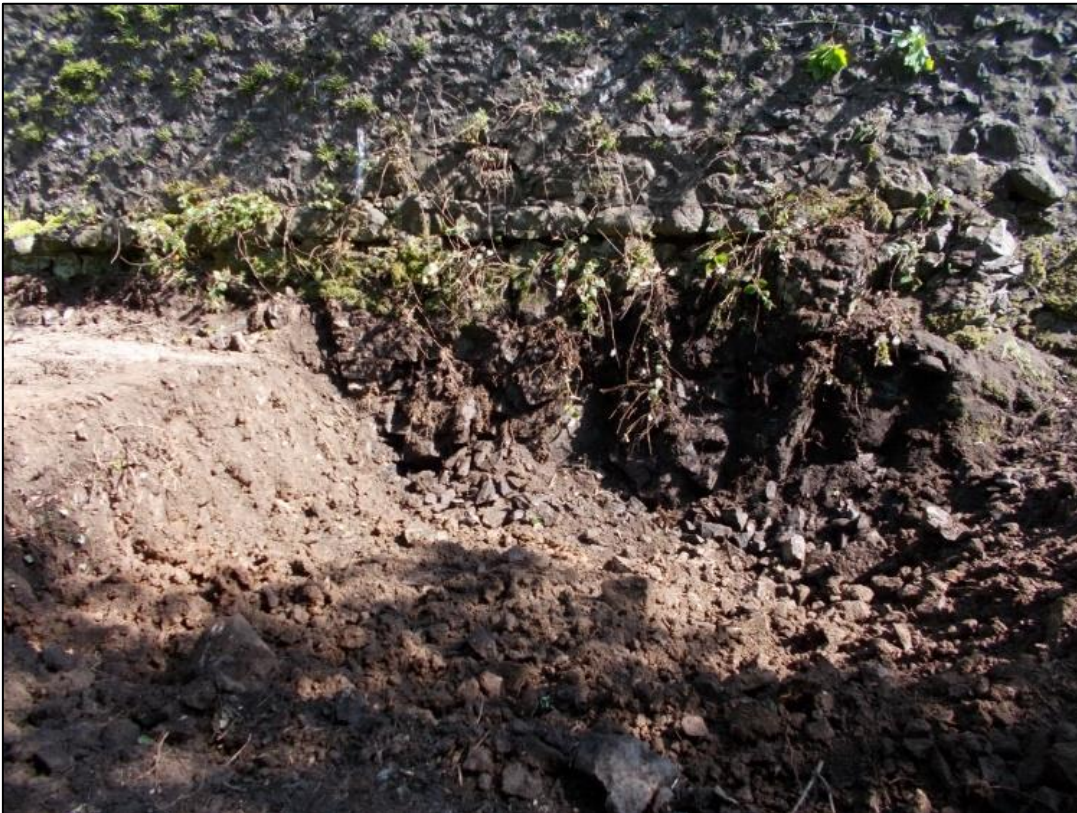
Figure 6b: Post excavation view of Trench 3. From the W.
