Monifeith Parish Church, Angus: Archaeological Mitigation

Data Structure Report

issued 8th June 2017

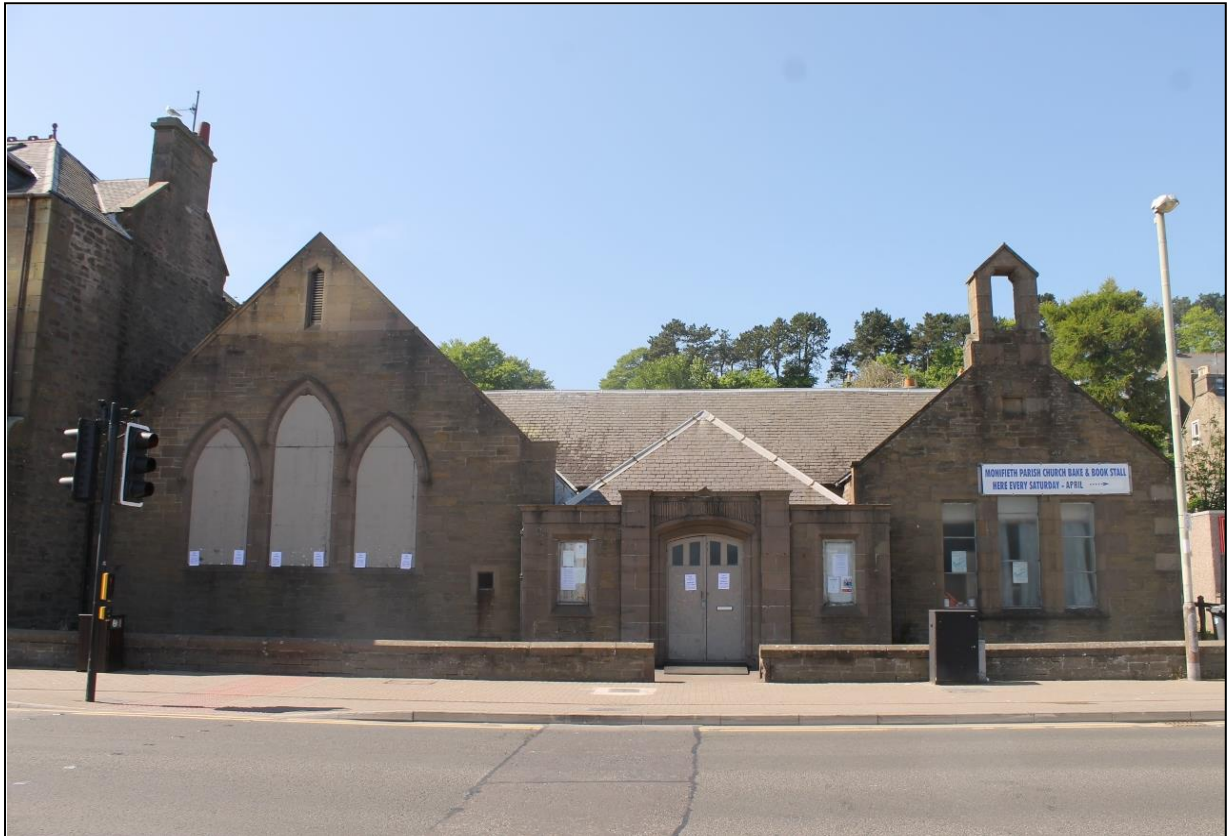
Figure 2a: Front southeast elevation

16. The structure is rectilinear on plan with the southeast elevation measuring three bays; 23m length by 8m high (Figures 2a & 3). There was thick vegetation along the side and rear of the building (Figure 2b) which prevented the ability to get clear images and measurements of the northeast and northwest elevations but this is also 3 bays wide.

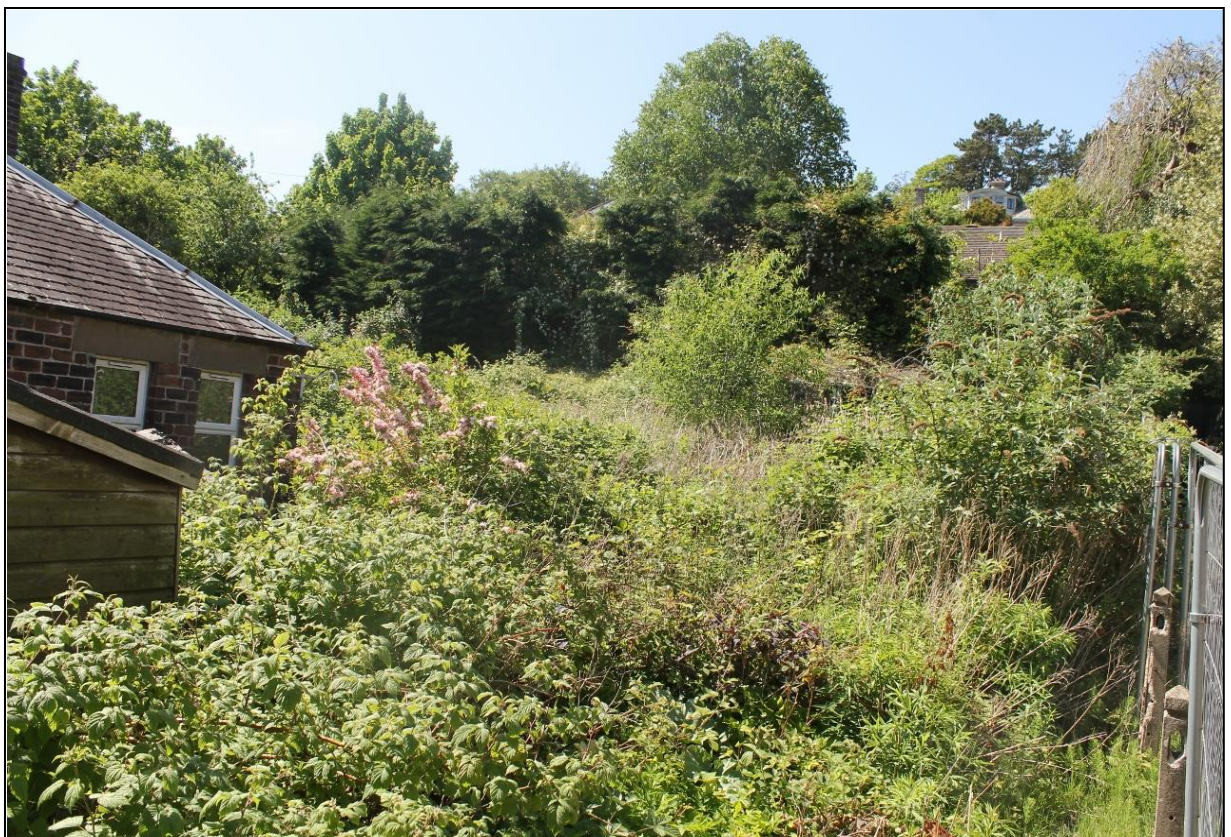
Figure 2b: Thick vegetation at the side and rear of the building made it difficult to gain a clear view of the northwest and northeast elevations

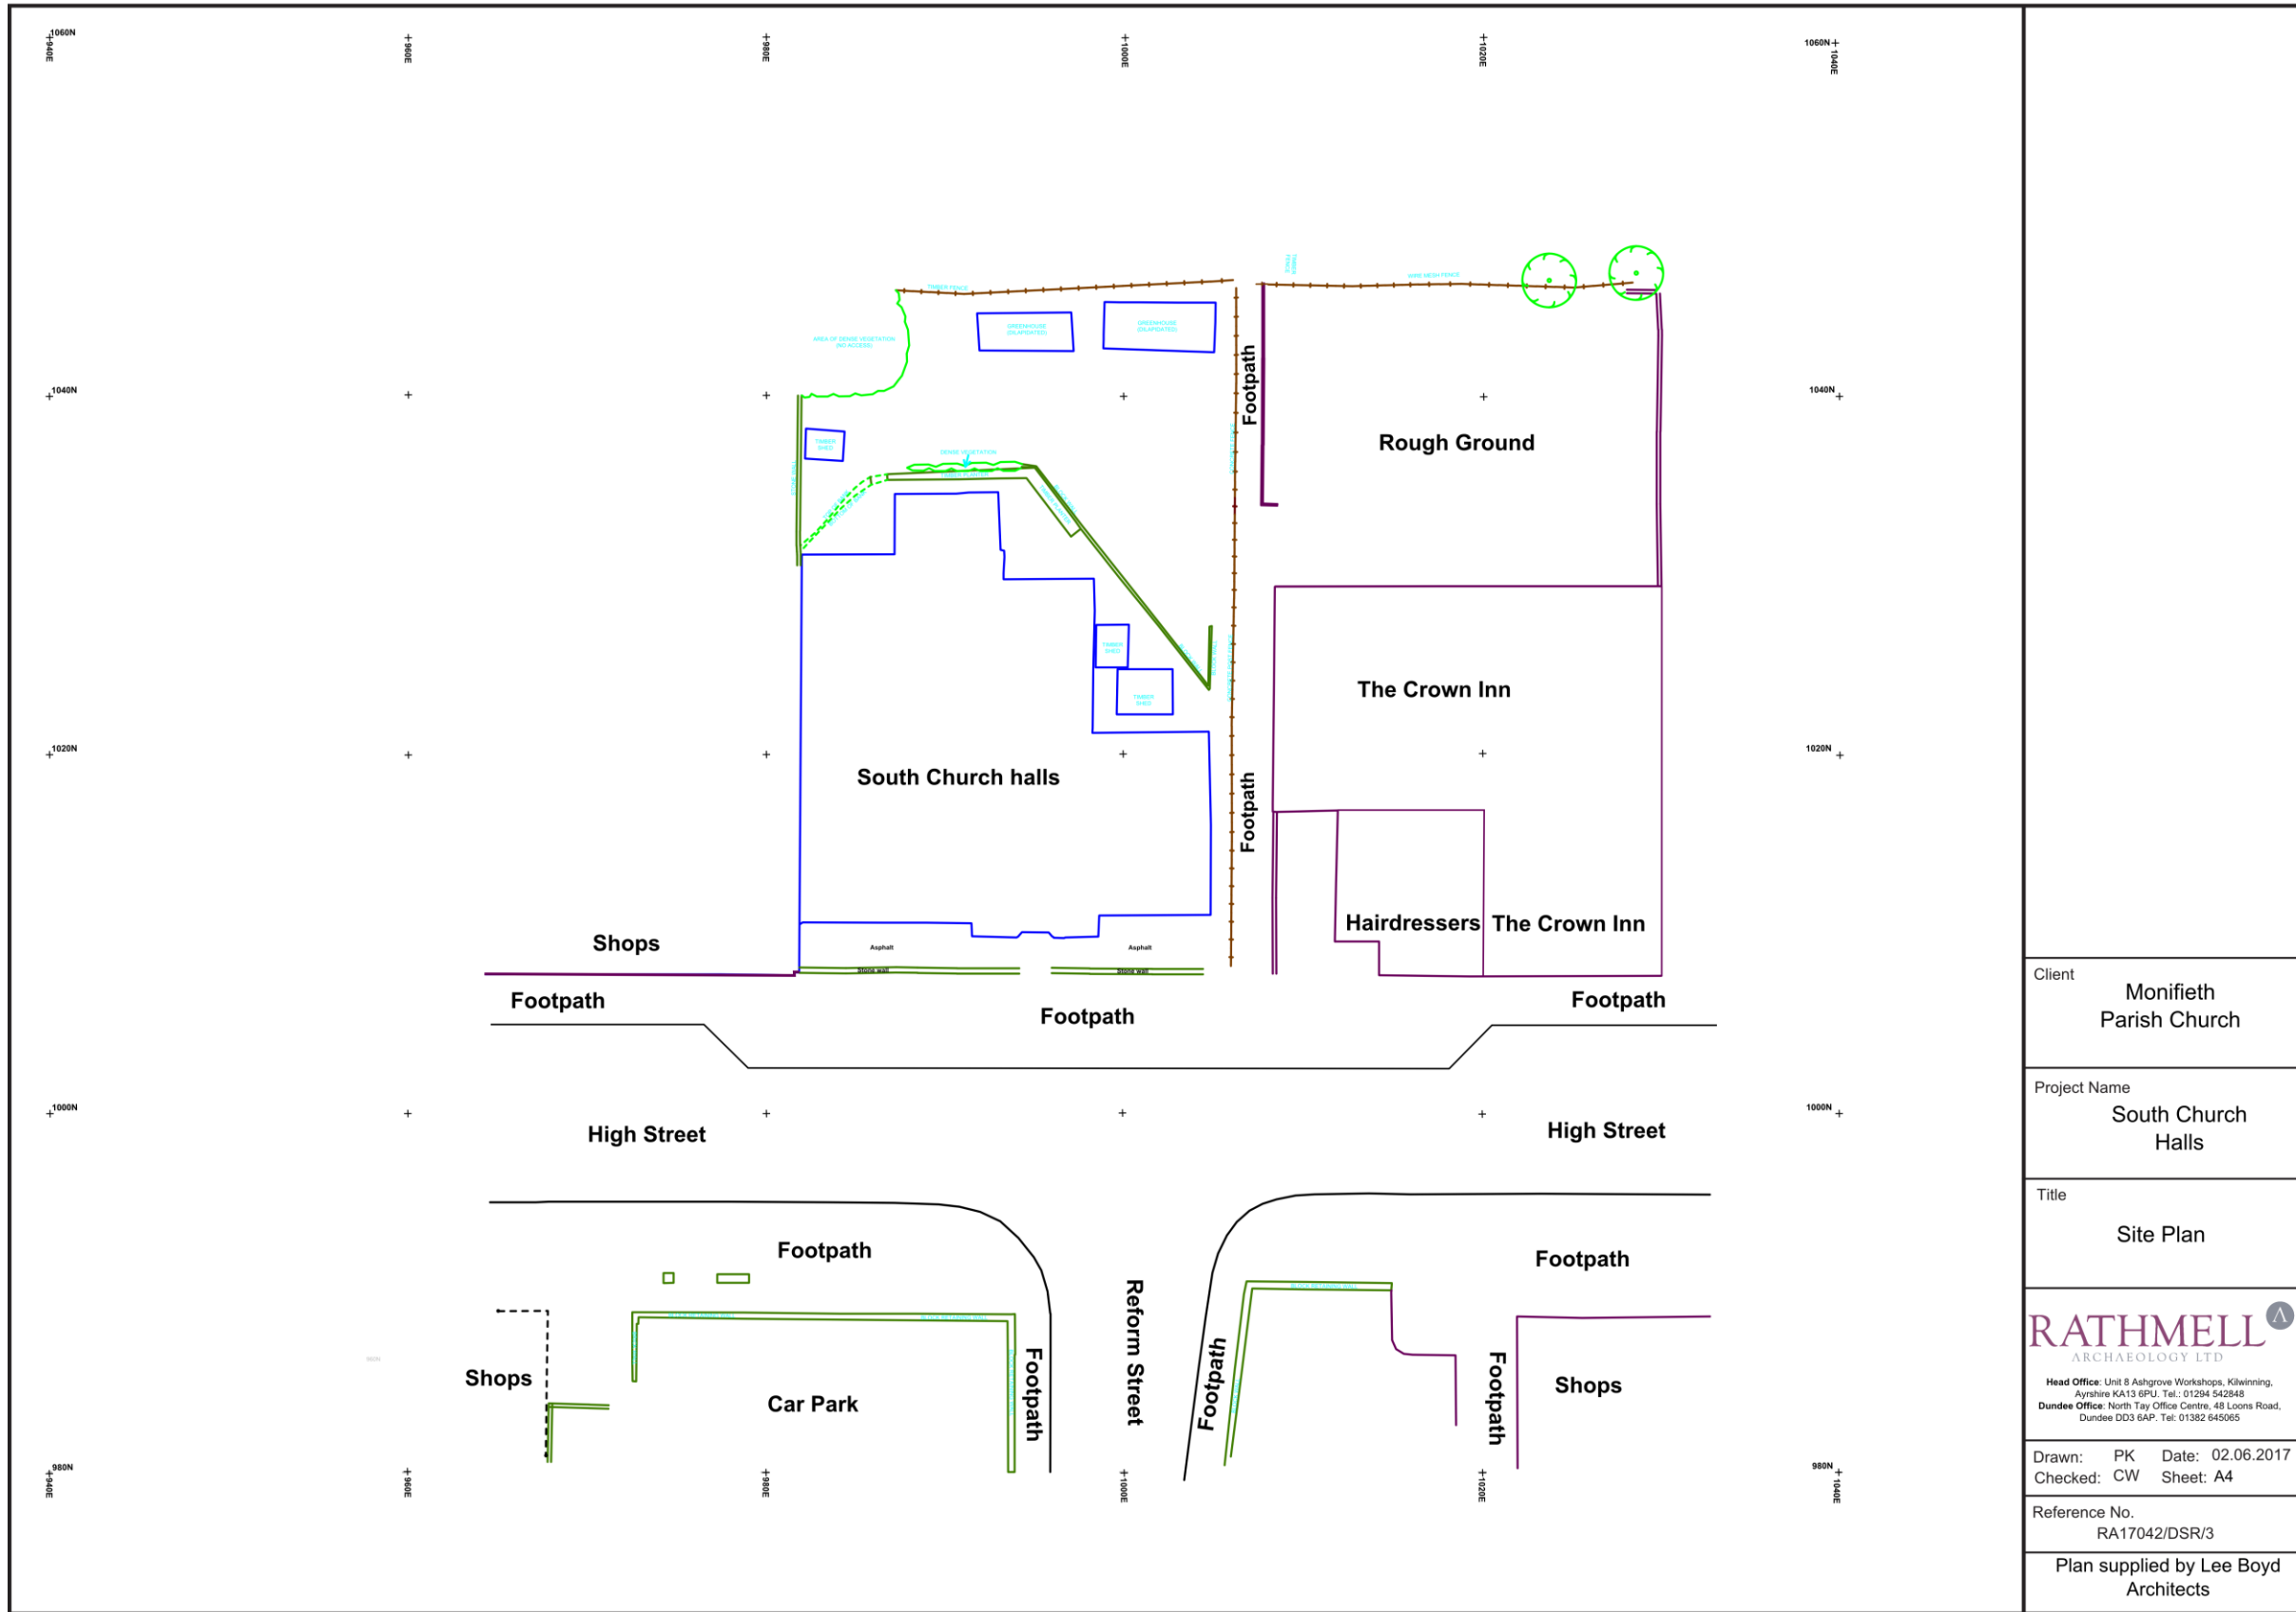
Figure 3: Existing Site Plan

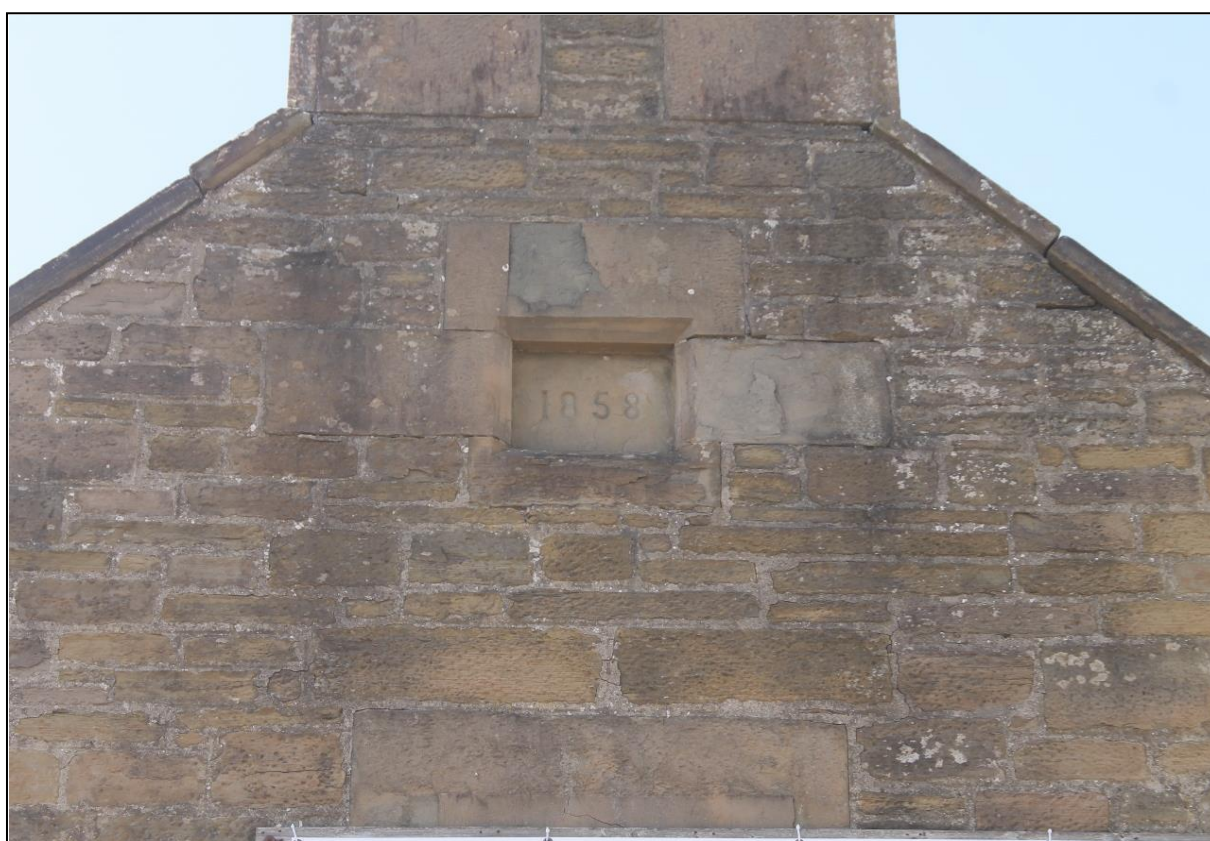
Figure 6a: Date Stone with 1858 inscribed

18. On the southeast elevation and on the original Preaching Hall the date stone with 1858 inscribed on it (Figure 6a) and the belfry (Figure 6b) that would have once held a bell, are clearly visible and distinct architectural features. There are three rectangular windows with a further two blocked windows on the northwest elevation (Figure 7a). The cills, lintels and rybats defining the windows, are all of the same light brown squared sandstone blocks. There are three rectangular vents sited along the northeast elevation.

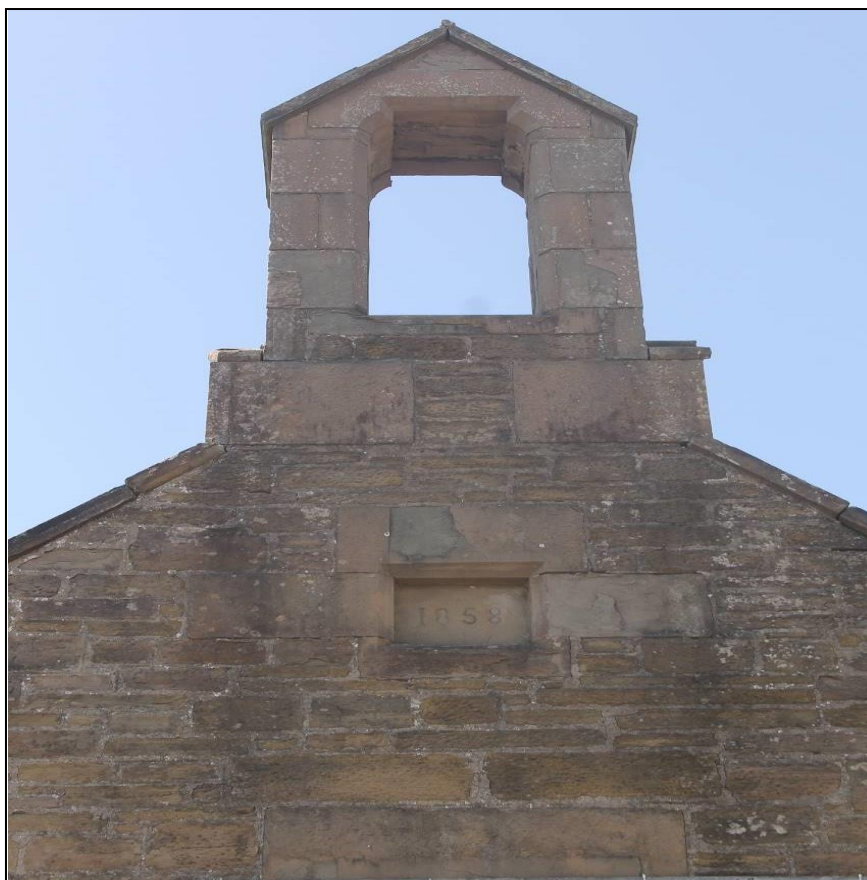
Figure 6b: Belfry which would once have held a bell

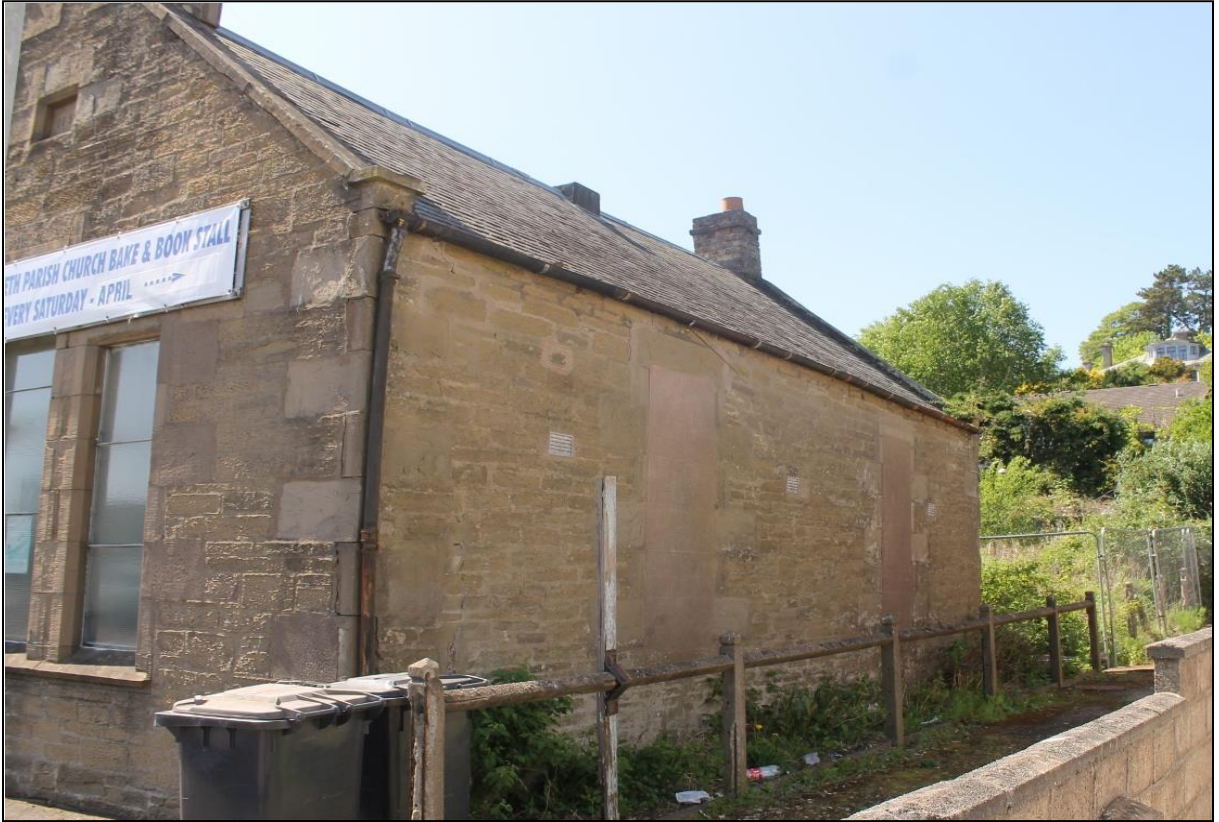
Figure 7a: Northeast elevation showing the two blocked windows

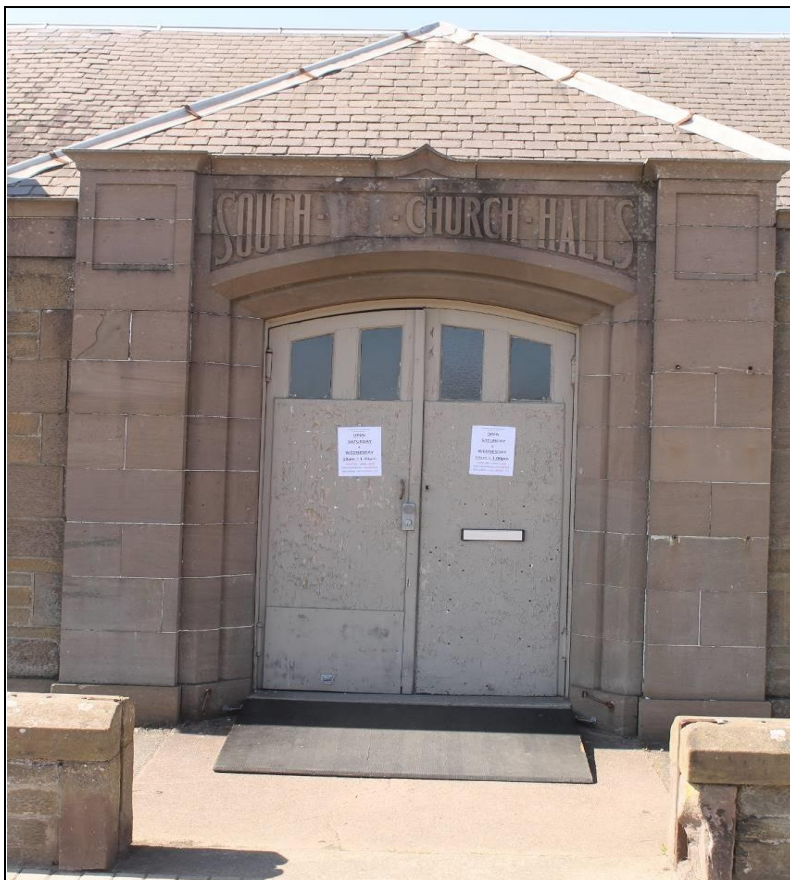
Figure 7b: Main entrance

19. The main entrance is of worked light brown sandstone blocks with 'South Church Halls' carved over the top of the lintel. It is possible to see that a 'U' and 'F' have been removed. These would have originally stood for 'United Free' (Figure 7b).

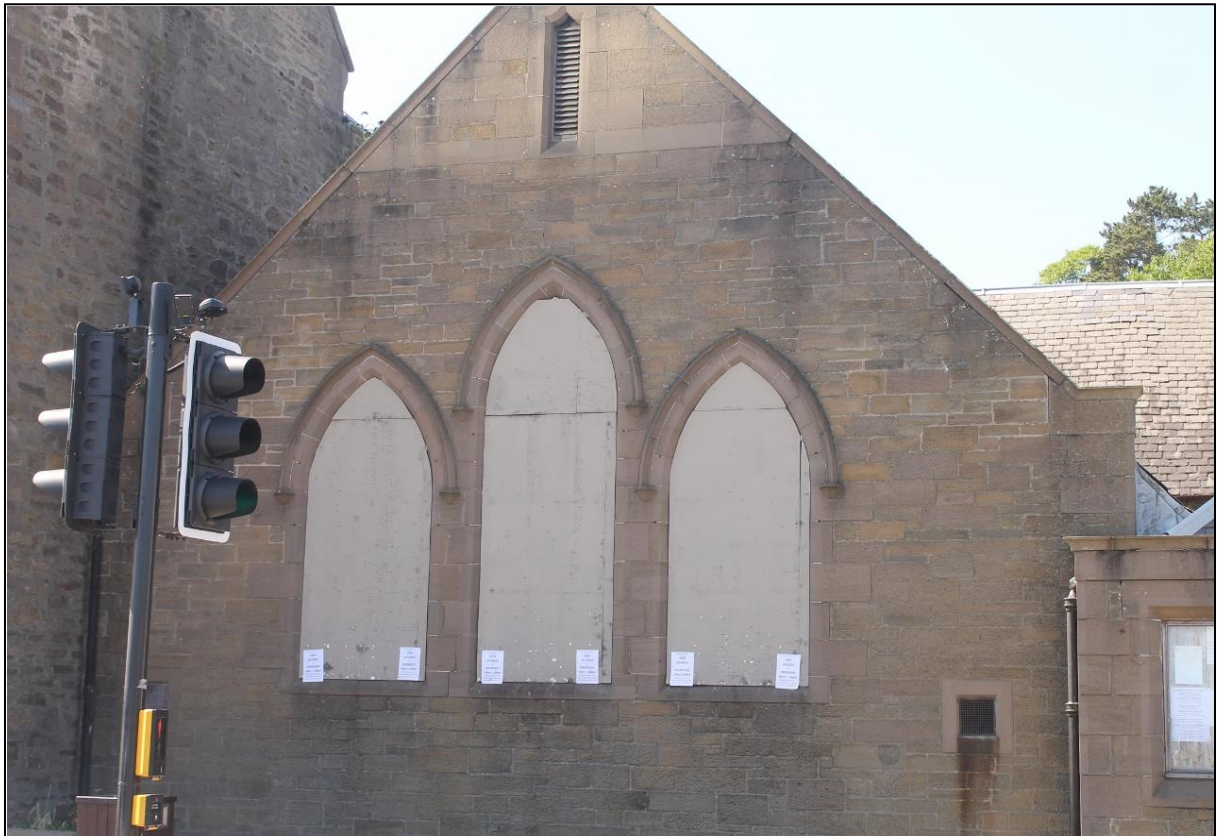
Figure 8a: Southeast elevation exterior; Main Hall

20. There are a further three arched windows; which have been blocked, on the southwestern bay (Figure 8a) with an arched air vent located at the top of the bay. The cills, lintels and rybats defining the windows, are all of the same light brown squared sandstone blocks.

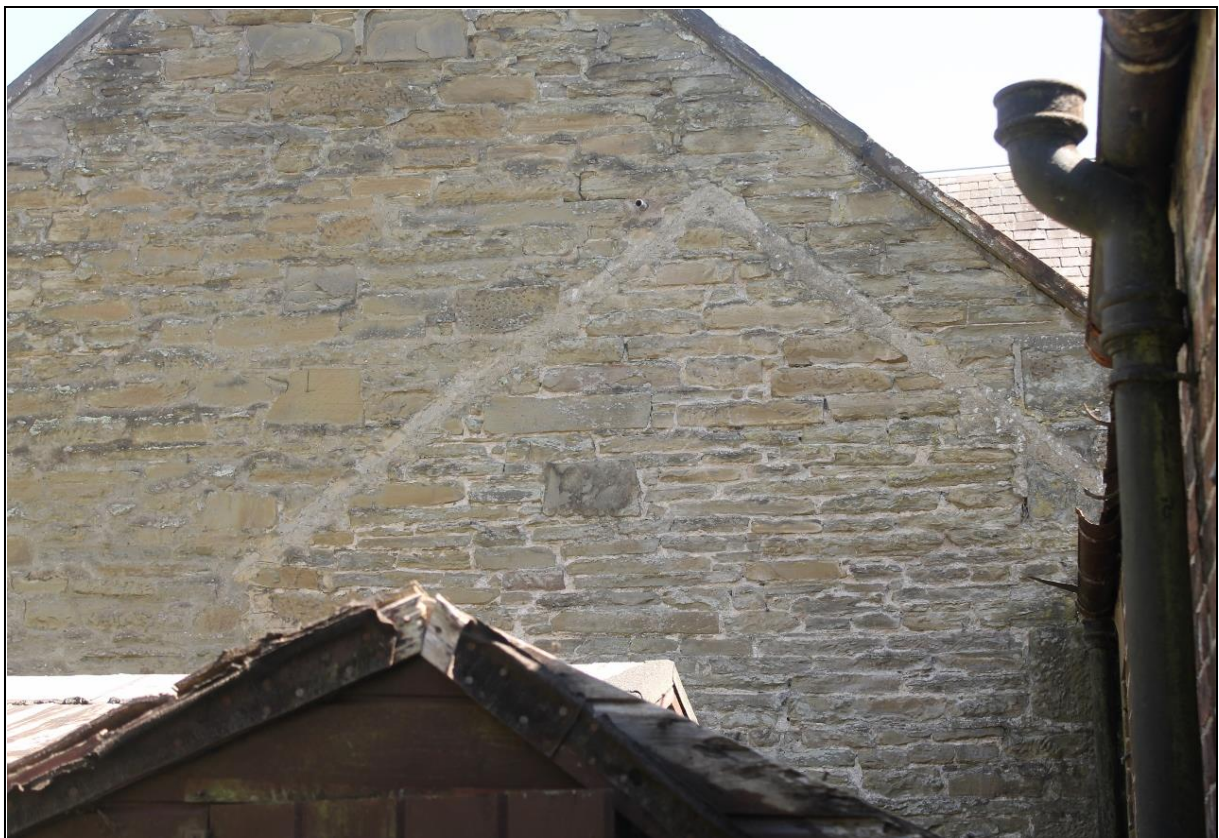
Figure 8b: Rear northeast elevation of the Preaching Hall showing evidence for a previous roof line

21. The whole of the original Preaching Hall is constructed of coursed sandstone with different sized sandstone blocks used across the building (Figure 8b). On the rear northwest elevation there is evidence for a previous building to have existed due to the remains of a roof line clearly visible (Figure 8b).
22. The exterior of the Main Hall has a brick rear northwest elevation with red brick also being used in the construction of the later nineteenth-century extension that houses the toilets area (Figure 4 and 9a). The roofing over the whole building is slated with the Preaching Hall and Main Hall both Gabled and the roofing over the main entrance formed of a Hip and Valley roof and the roof over the area that houses the toilets formed by a Hip roof.

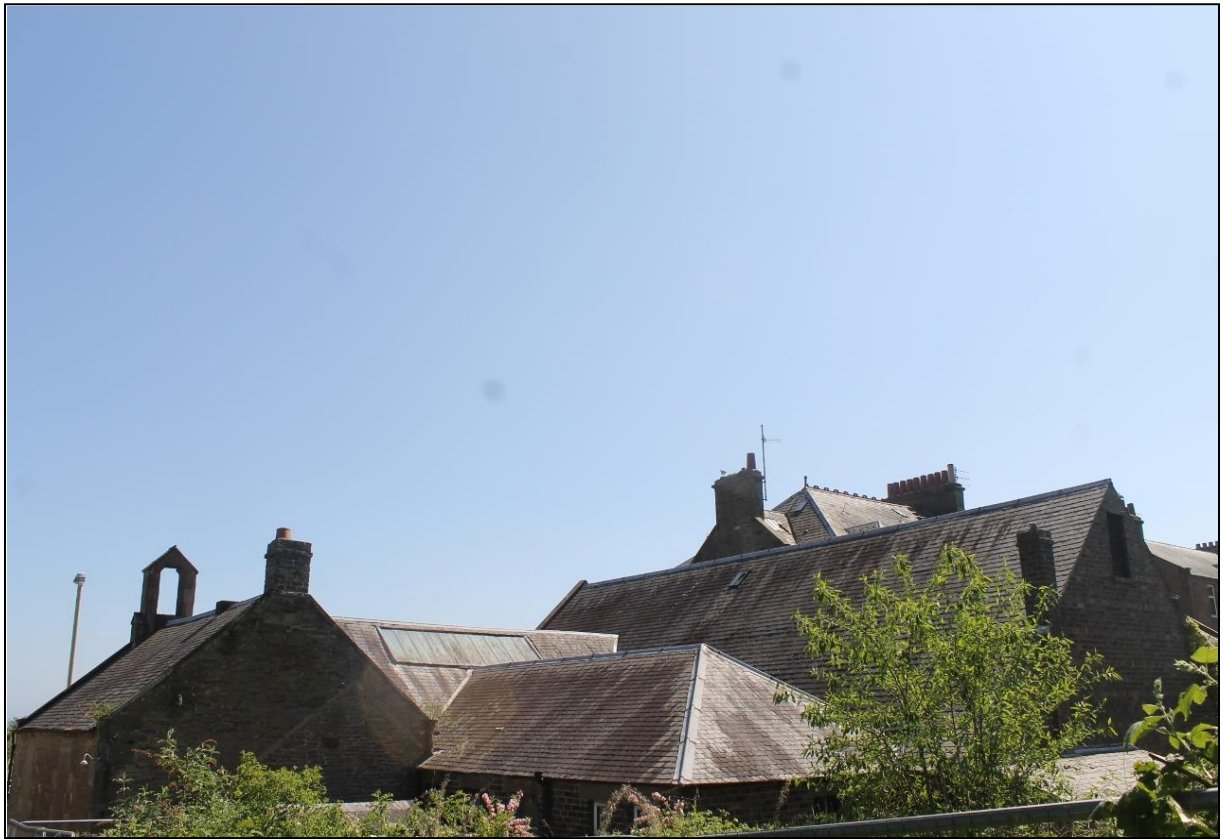
Figure 9a: Showing the red brick of the late-nineteenth century extension and the roofline

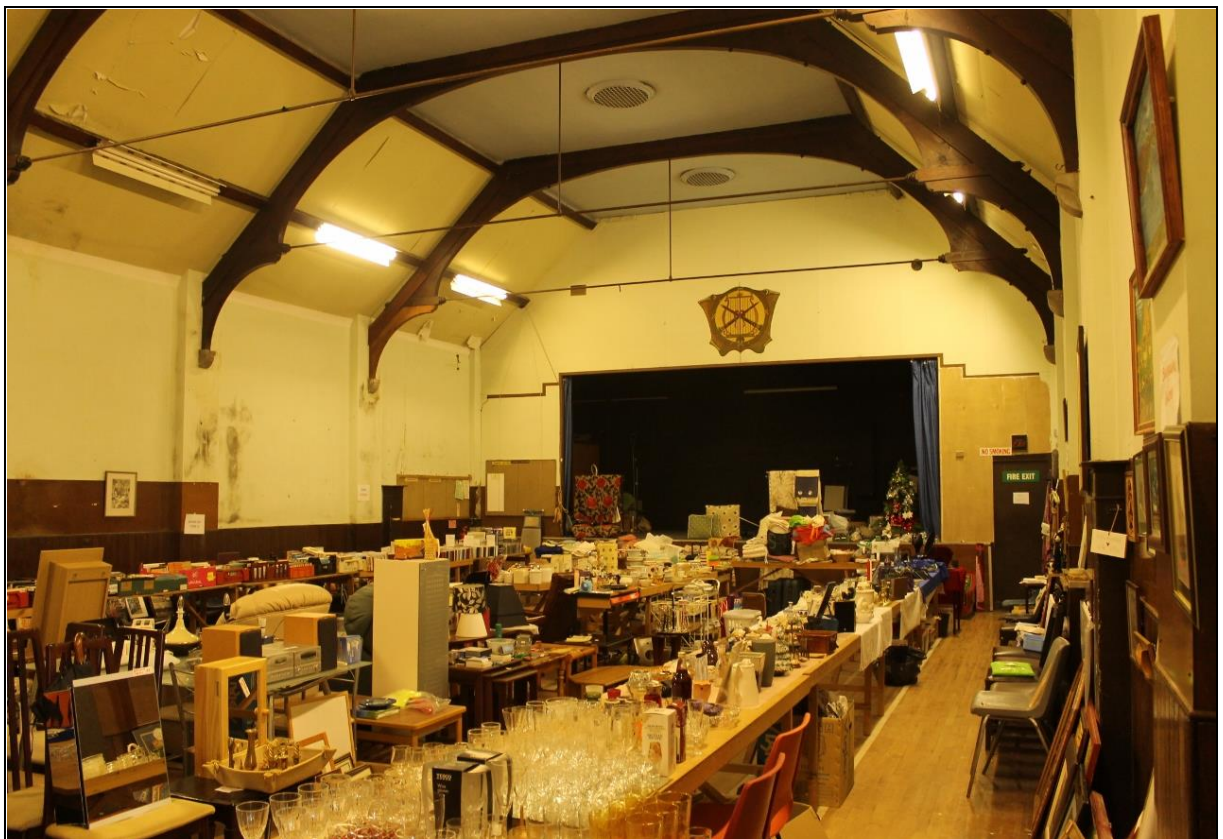
Figure 9b: Interior: Main hall

23. The Main Hall is rectangular with a modern stage area at the northwest end and measures 20m by 9.30m and 6m in height (Figure 9b). There are three windows in the southeast elevation and three doors; two at the northwest end and the main access located at the southeast end. Wood-panelling covers the lower 1.2 m of the walls and is present all the way around the room. The floor is modern and of wood with plastered and painted walls. The ceiling has three metal circular air vents and located on the walls are four metal funnel features (Figure 10a). These are most likely used to heat the hall as there are no radiators. Structurally the ceiling is formed of four large and exposed timber joists spanning the width of the room and forming a ribbed effect (Figure 9b).

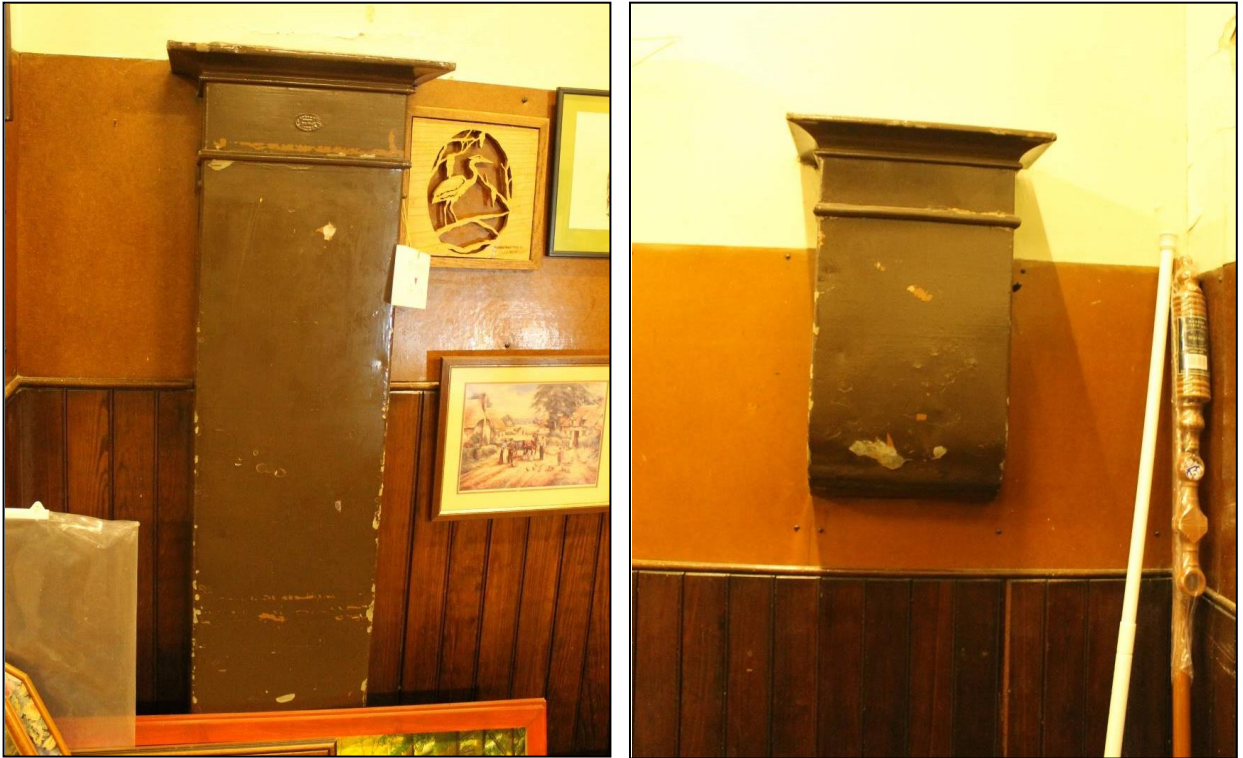
Figure 10a: Heating ducts/vents in the Main Room

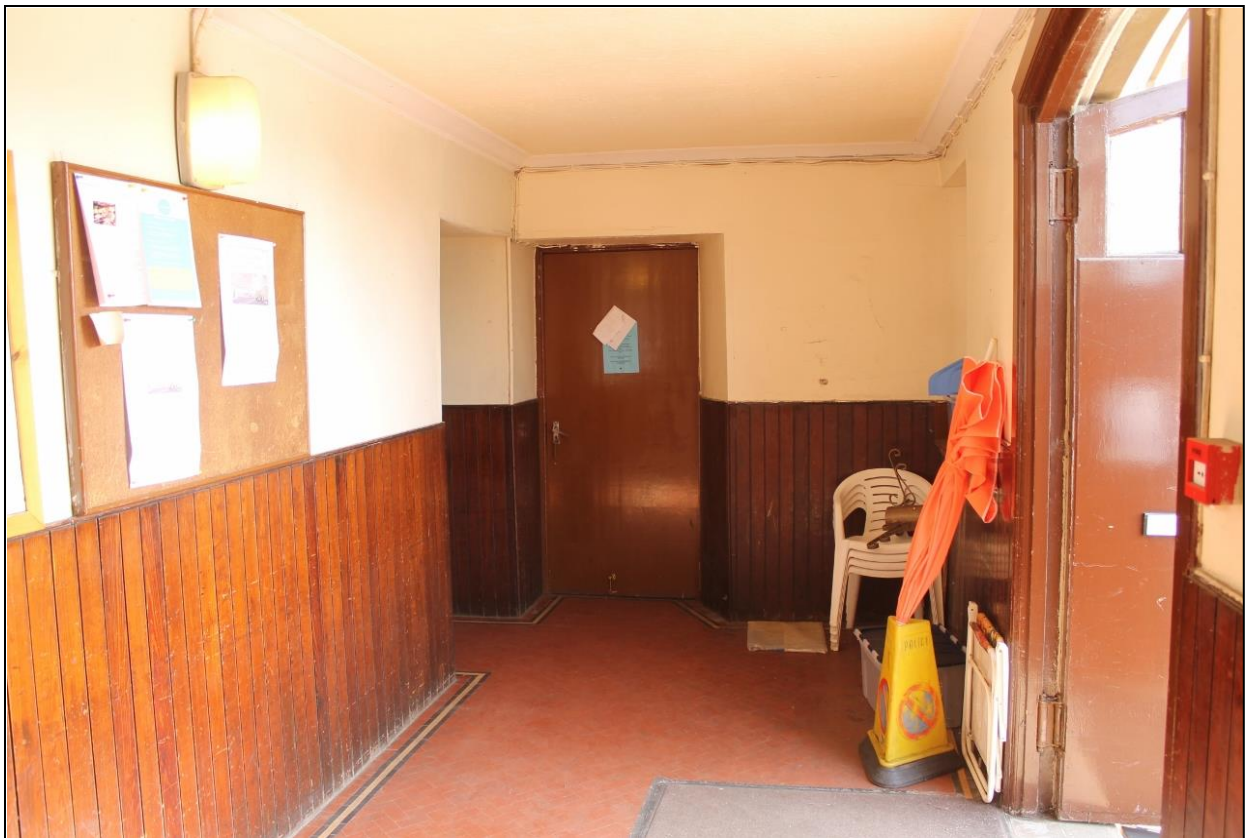
Figure 10b: Interior: Reception room

24. The reception area/room is rectangular in shape and measures 5.9m by 2.27m and 2.5m in height with five doors; two on the northwest, one on the northeast, one on the southeast (main access) and one on the southwest elevation(s), and two blocked windows on the southeast elevation. There is wood-panelling around the lower 1.2m of the walling with a red tiled herring bone design floor that has a white and black border (Figure 10b).

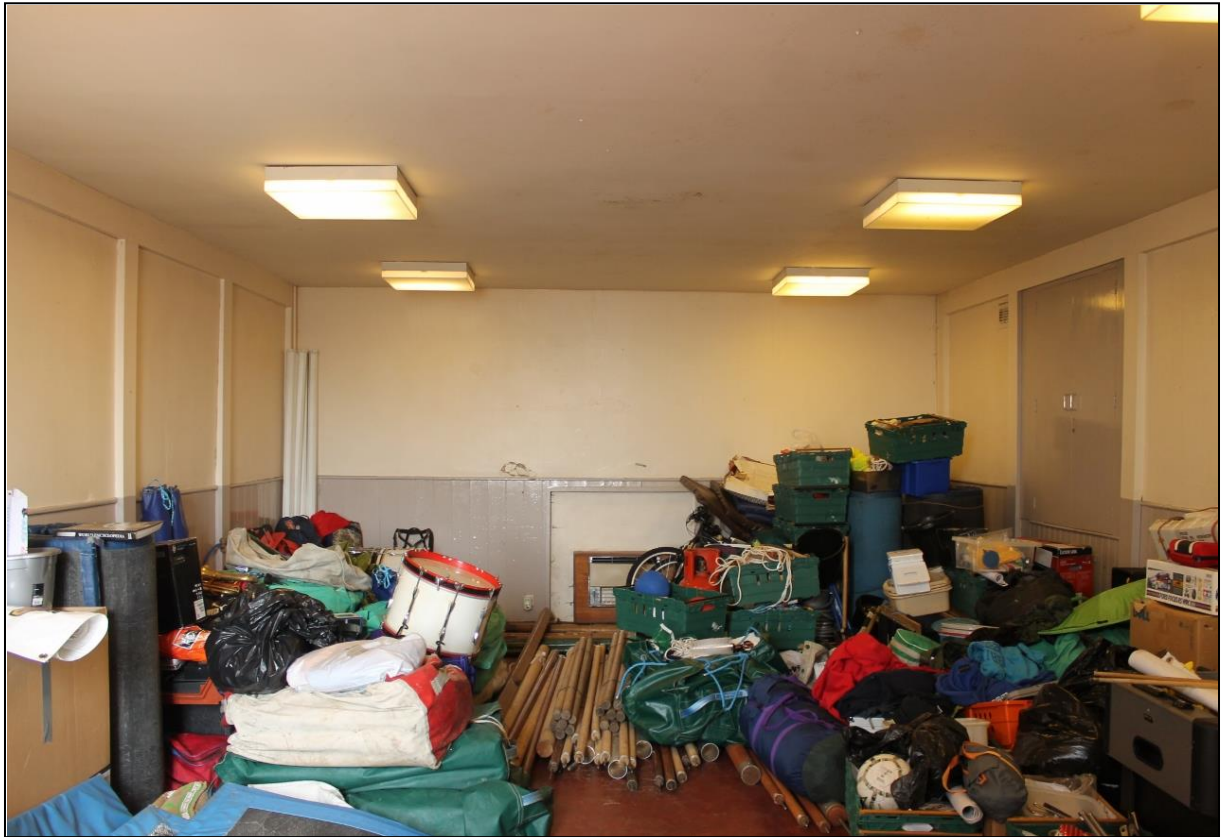
Figure 11a: Interior: Original Preaching Hall (1858)

25. The Preaching Room is rectangular with dimensions of 8.8m by 5.6m and 2.7m in height with three rectangular windows in the southeast elevation and two blocked windows on the northeast elevation that have been converted into cupboards. There is a blocked fire place at the northwest end and three modern air vents (visible on the exterior) on the northeast elevation. There are no original features with a modern linoleum floor and modern fixtures (Figure 11a). There is one door on the southwest side of the room.

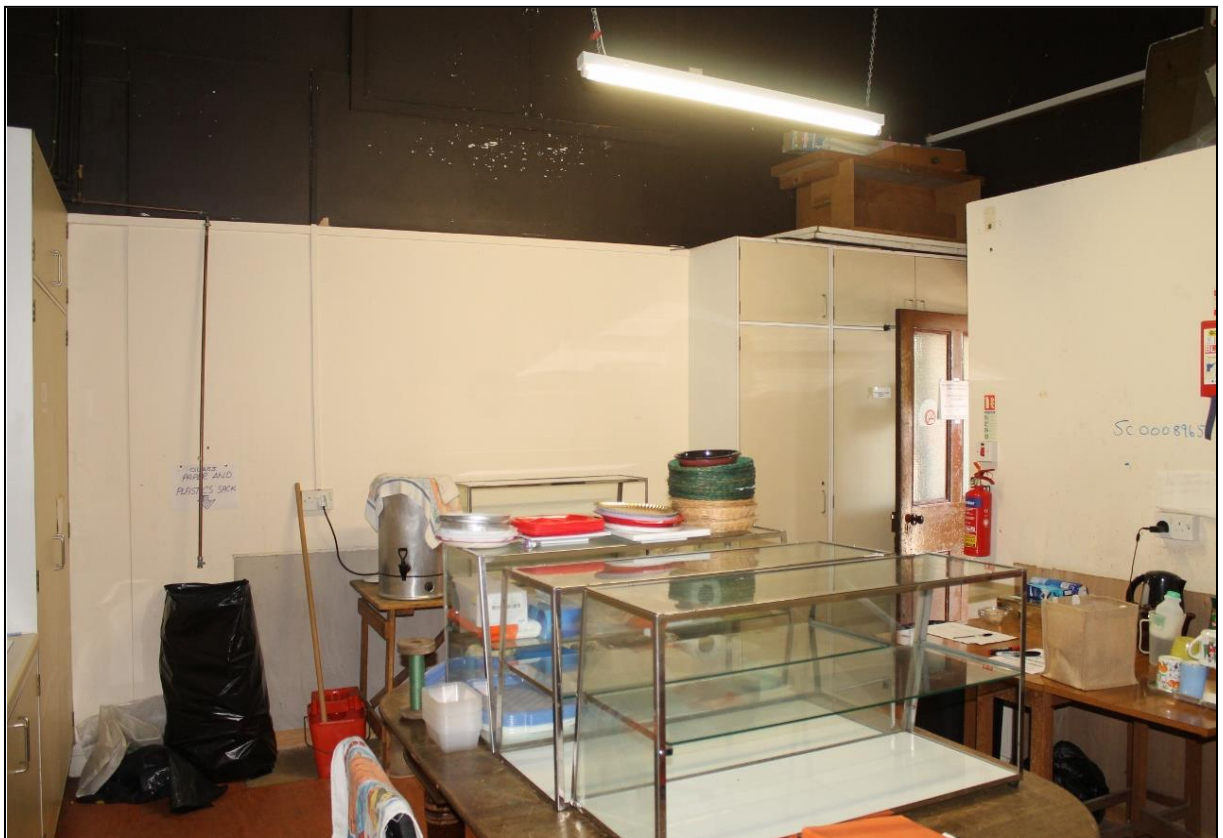
Figure 11b: Interior: Kitchen

26. The kitchen has all modern fixtures with a modern walk-in cupboard on the southeast side of the room. Rectangular in shape and dimensions of 5.5m by 5.1, and 4.3m in height (Figure 11b). There is natural light provided by a centrally located skylight, this may well be a twentieth-century addition. The top half of the southwest side of the room has been partitioned off to be used as a cupboard and also extends into the hallway. The upper northeast side has also been partitioned off to create storage and extends into the adjoining room which is the original Preaching Hall/Room. There are two doors; one on the southeast side and one on the northwest side.

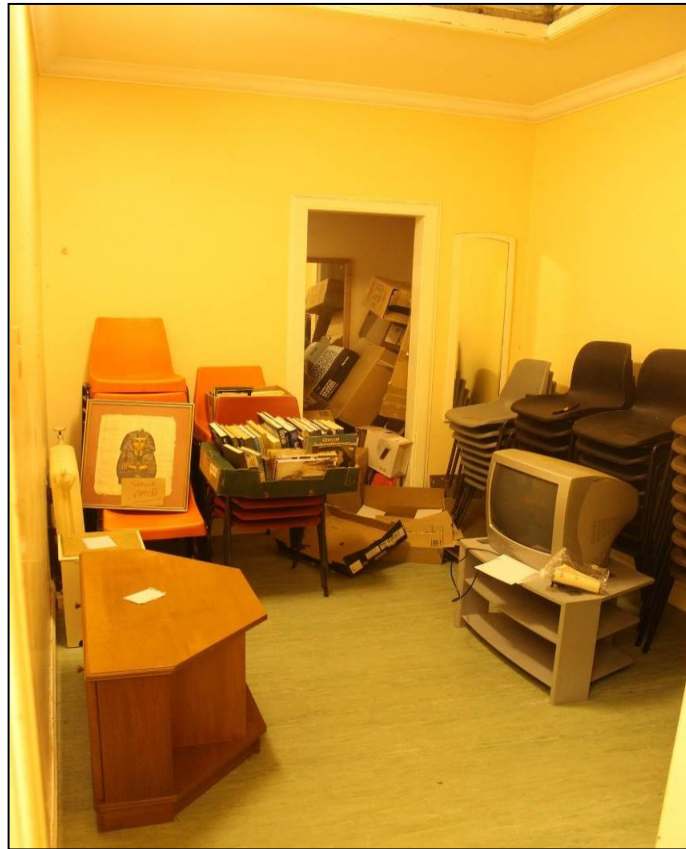
Figure 12a: Interior: Toilet Room 1

28. Along with the kitchen there are a further four rooms that are located off the northeast side of the hallway (Figure 4). These consist of three toilet rooms and one small storage room (Figure 4). Toilet Room 1 measures 4.8m by 2.6m by 2.8m high and forming a rectangular shaped room. There is one toilet and window on the northeast side of the room (Figure 12a). Centrally located there is access to the roof. This may be an original feature and through it you can see timber sarking. No other original features are visible.

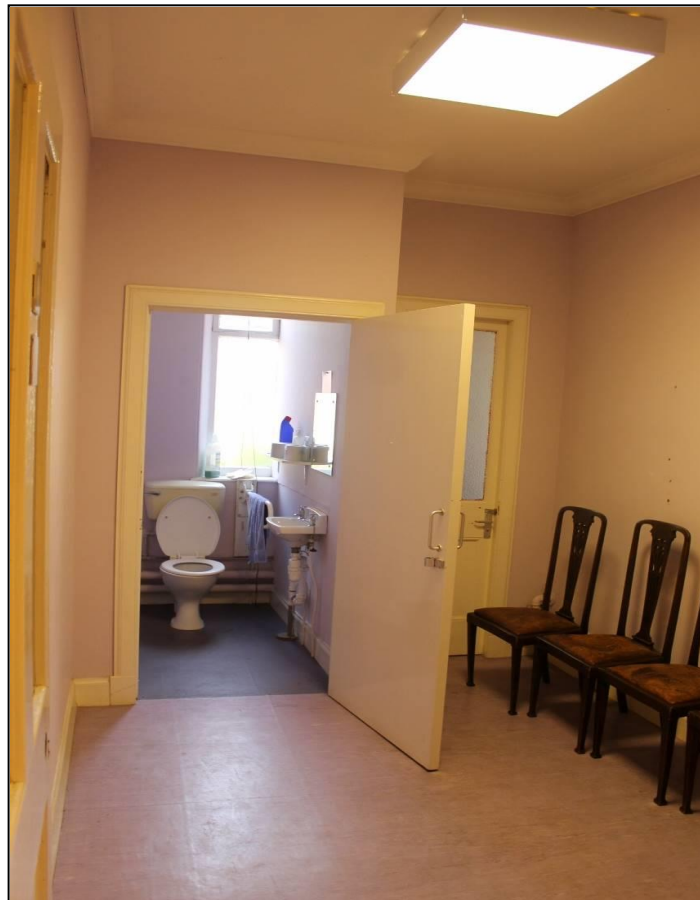
Figure 12b: Interior: Toilet Room 2

29. Toilet room 2 measure 4.8m by 2.5m again forming a rectangular shape and a height of 2.8m, with two toilets and two windows located on the northeast side of the room. Only one of the toilets is currently in use (Figure 12b). The Small Room has been extended into from the northwest and Toilet Room 3 (Figure 4). The room is rectilinear in shape with maximum dimensions being 4.8m by 1.60m and one window a height of 2.8m.

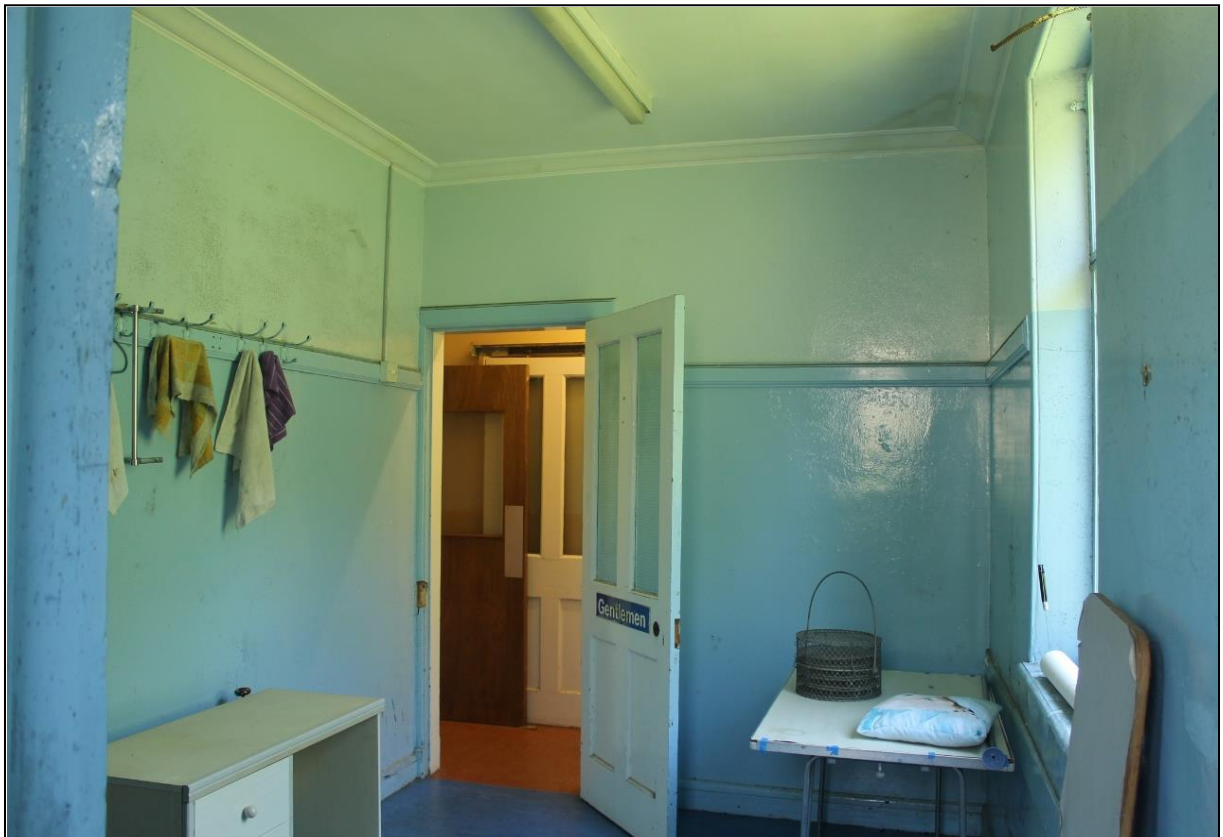
Figure 13a: Interior: Toilet Room 3

30. Toilet Room 3 has maximum dimensions of 4.85m by 3.74m with a height of 2.8m and has extended on the southeast side of the room into the Small Room. There is a urinal and a toilet on the northeast side of the room and in total four windows (Figure13a).

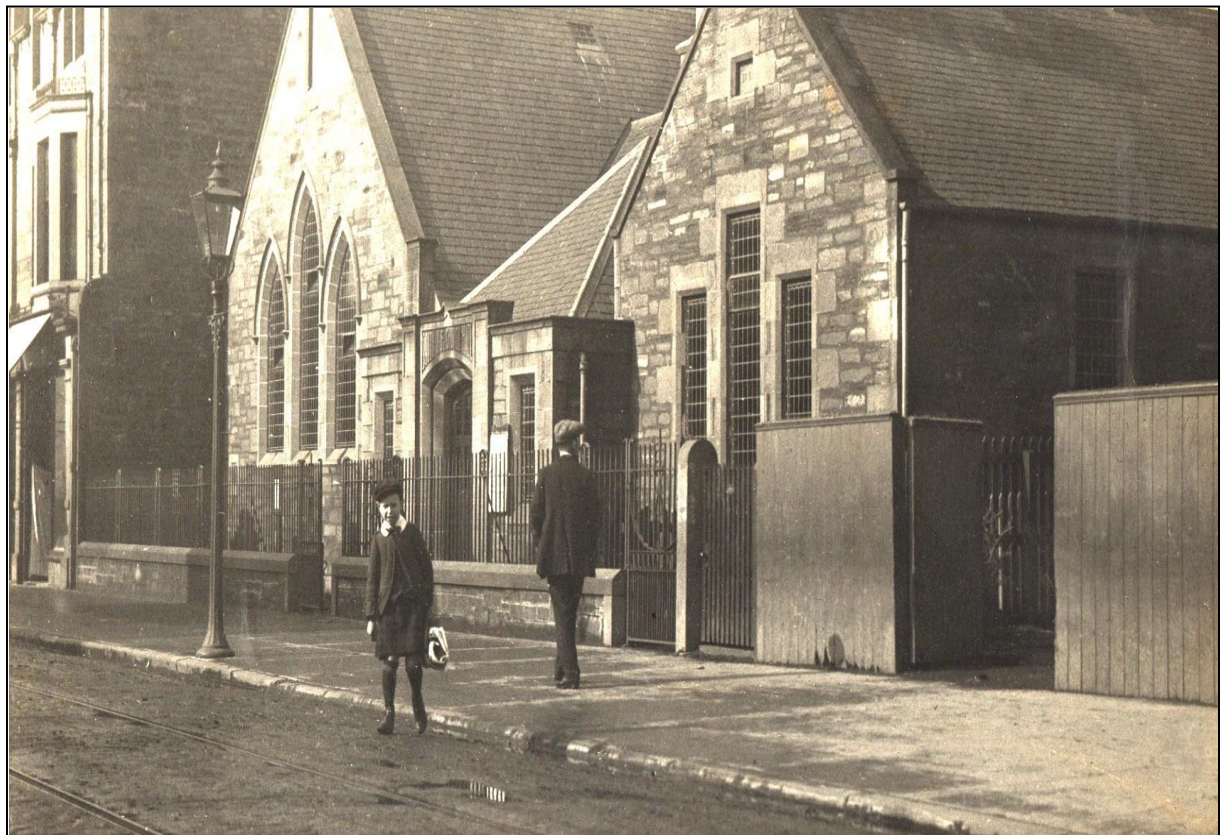
Figure 13b: South Church Halls 1905

35. The second phase is the extension that included the Main Hall, Reception Area, and what are now the Kitchen, Toilet Rooms and the Small Storage Room. The date of the extension is not known, but a photo from 1905 demonstrates the extension present and also the windows are all unblocked on the southeast and northeast elevations (Figure 13b).
