# **Laggan Dairy, Ballantrae: Archaeological Watching Brief**

Data Structure Report

issued 19<sup>th</sup> June 2017

on behalf of J & A McKinley Ltd

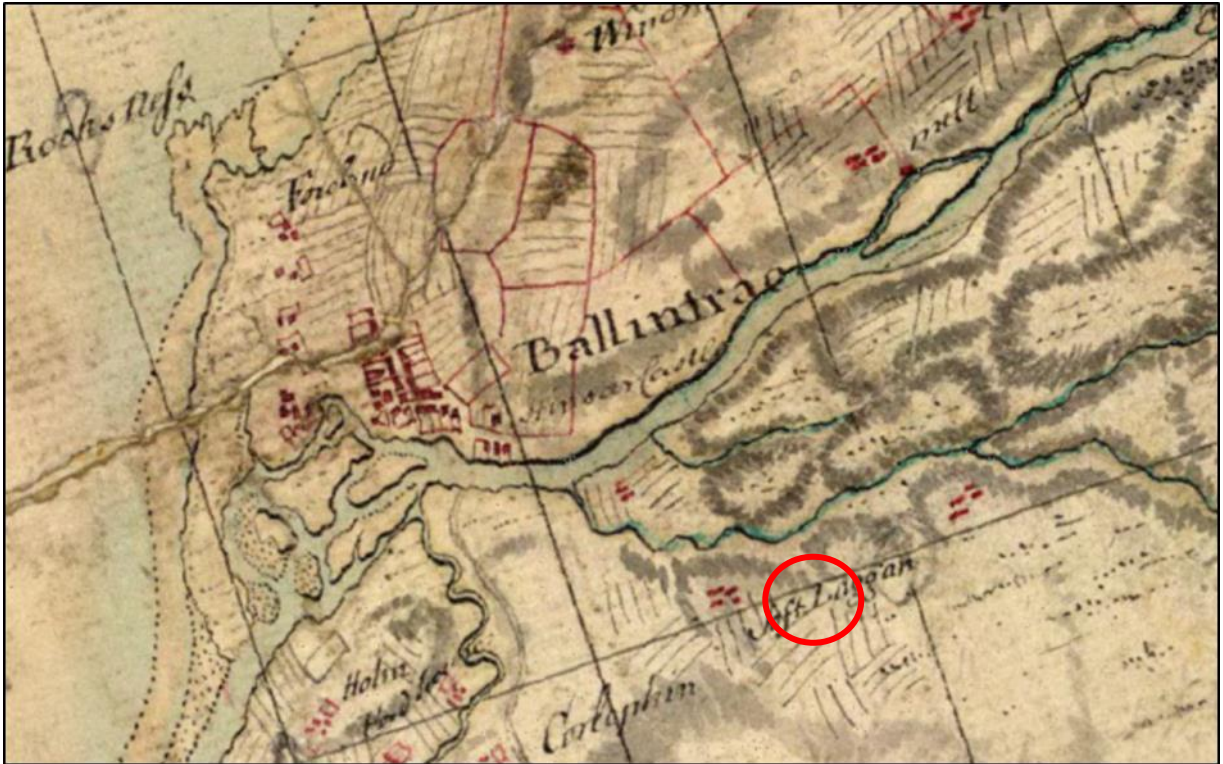
Figure 1a: Roy's Military Survey of Scotland (1752-55)

11. The first definite evidence of activity within the development area comes from Roy's Military Survey of Scotland (1752-55) (Figure 1a). It provides the earliest mapping of the area that is sufficiently accurate to allow clear and direct comparison with the modern landscape. The map shows a largely unimproved landscape with significant proportions of the ground under cultivation in the form of rigs, but much of the land is unenclosed.
12. The 1st edition Ordnance Survey (Figure 1b) of 1857 depicts the area as open land on the downslope of Moat Knowe hill to the east framed by Crailoch Burn to the west and south, and the route of the modern classified road to the north. The same is shown on the 2nd edition Ordnance Survey of 1909 (Figure 2) and it is of note that the existing access track between the Old Steading and New Steading has not yet been established.

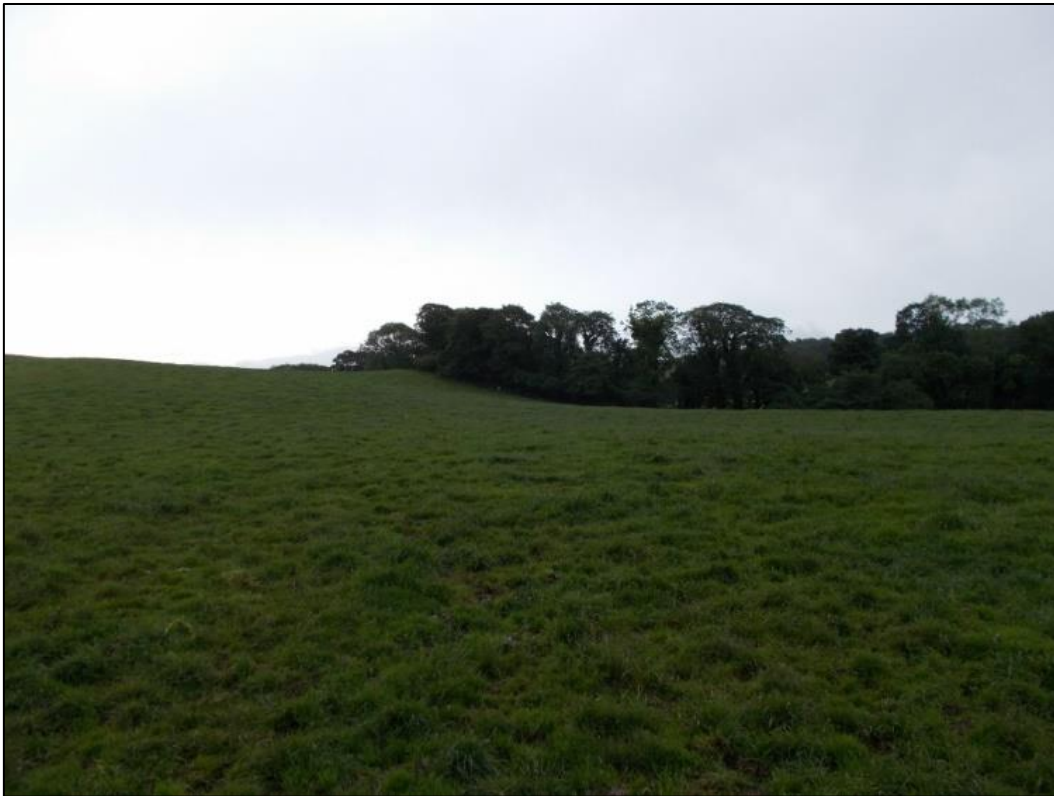
Figure 4a: Pre excavation view of the development area. From the NW.

13. The programme of works comprised the archaeological monitoring of excavations at Laggan Dairy, Ballantrae (Figures 3 and 4a). These works involved the monitoring of the construction works for a new slurry lagoon at Laggan Dairy, Ballantrae. The footprint of the development consisted of a large trapezoidal shaped area linked by a new access track which ran off an existing farm track (Figure 3) which covered an area of 4279m<sup>2</sup>. Only part of the development footprint was to be machine stripped down to the underlying subsoil with the outer limits retaining its topsoil and having soil deposited as banks on it and the access track only having the upper layer of sod removed over which a terram layer was to be added followed by a layer of type 2 hard-core. The area monitored was rectangular shaped and measured 37m (from east to west) by 38m (from north to south), 1443m<sup>2</sup> in total. The works were carried out in compliance with the terms agreed in the Written Scheme of Investigation (Allsop 2017).

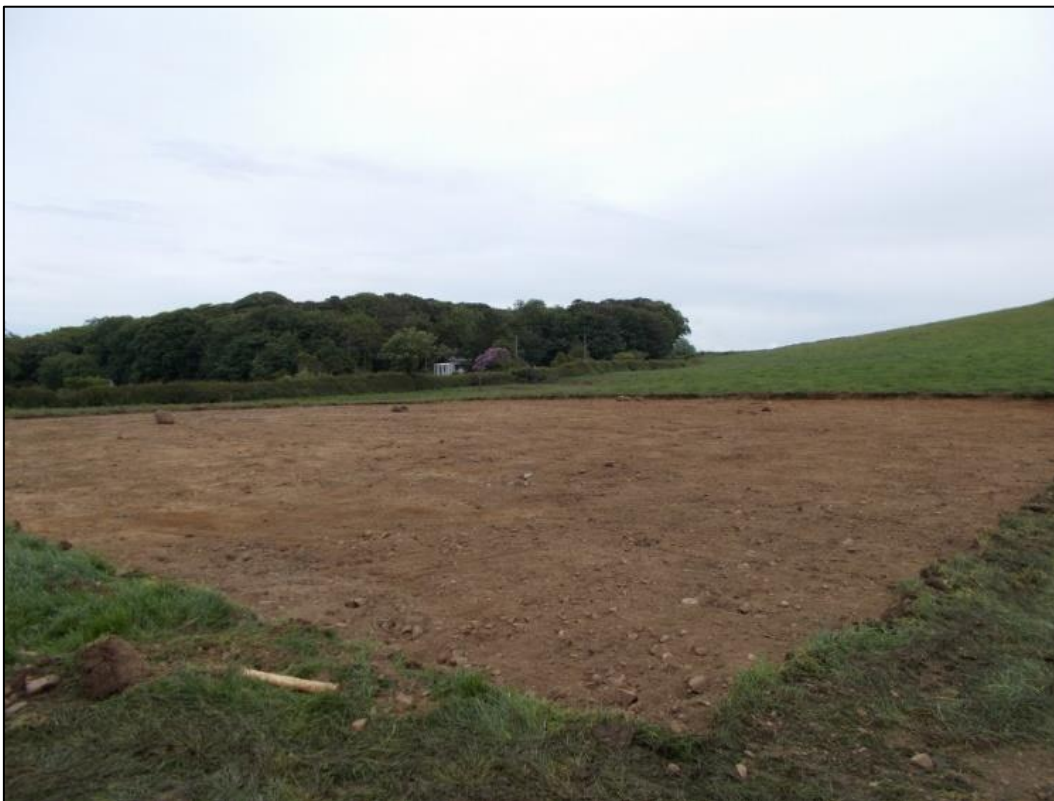
Figure 4b: Post excavation view of the development area. From the SW.

15. The Topsoil, (001), within the excavated part of the development area (Figure 4b) consisted of moderately compacted, mid grey brown sandy silt with occasional small stone and pebble inclusions. The topsoil layer had a depth range of between 0.16m-0.27m (Figure 5a). The main underlying subsoil, (002), consisted of moderately compacted, mid orange brown (with mid yellow patches) sandy silt with moderate grey coloured angular and small rounded stone inclusions. In the easternmost part of the excavated area the subsoil, (004), though similar to the main subsoil, contained more frequent inclusions of stone.

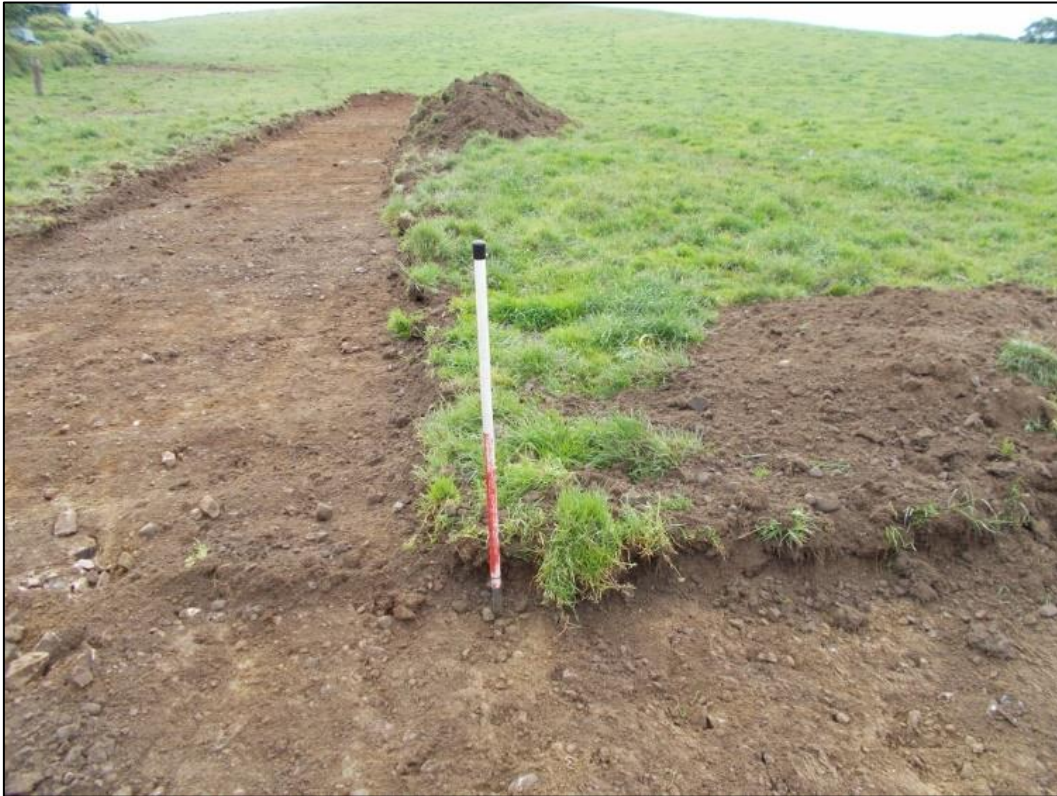
Figure 5a: View showing the topsoil thickness within the development area. From the NW.

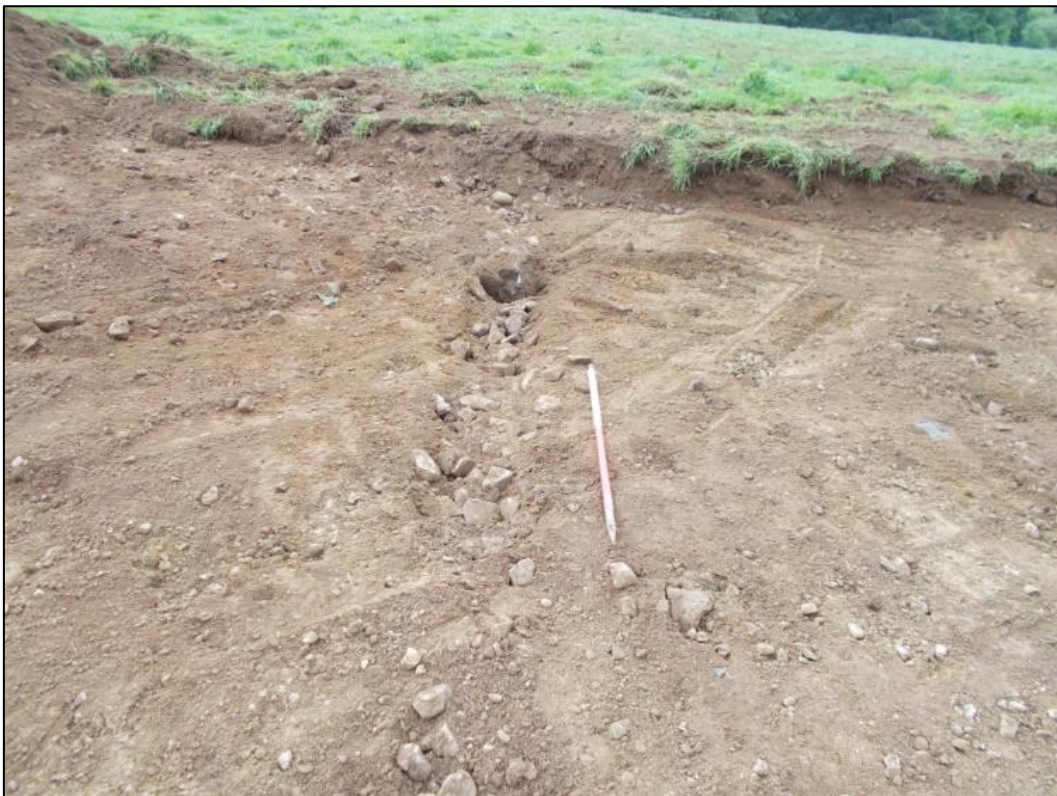
16. A group of two parallel linear trenches, (003), were identified crossing the easternmost part of the site (Figure 5b). These features were spaced 6m apart and measured 0.3m wide by 0.37m deep. The trenches cuts were filled by a mix of 80% sub angular and sub rounded stone and 20% redeposited subsoil material similar to the main subsoil type on site (002). No other significant features or artefacts were identified on the site.

17. The only anthropic features within the development area were a group of 19th century (or later) stone filled field drains, (003), which were located in the north eastern part of the development area. The sparsity of other agricultural drains and features may be due to the subsoil within the excavated part of the development area which upon inspection appeared to be well drained and also the fact that development area and the surrounding fields seems to be used almost exclusively as pastureland rather than for arable farming which would explain the lack of agricultural features like furrows or drains.

Figure 5b: View stone filled drains (003). From the NNW.
