31/33 Bishop Street, Rothesay: Archaeological Evaluation

Data Structure Report

by Alan Matthews

issued 19th October 2007

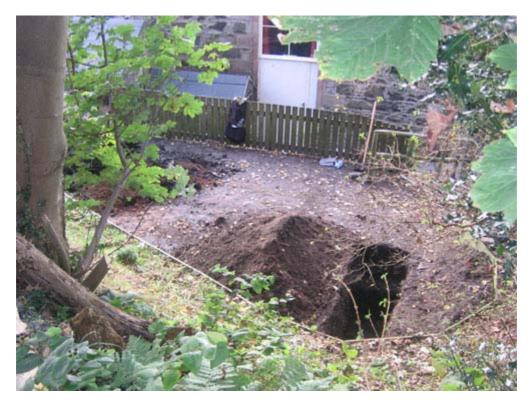
Figure 3a: Site showing Trench 1

- 4.1 The three trenches were excavated in sequence. Trench 1 was located so as to give the highest possibility of reaching bedrock or geological soils and therefore get a complete profile of the sediment on site (Figure 3a). Trench 2 was located at the furthest point from Trench 1 to test the information already gained and Trench 3 was placed between them to complete the picture and support the general conclusions.
- 4.2 The sediment sequence in Trench 1 was very clear and although not exactly mirrored in the other trenches it did give a complete sequence of the surviving sediments on site. There was very little mixing of the surface sediments due to the presence of a weed suppressant geo-

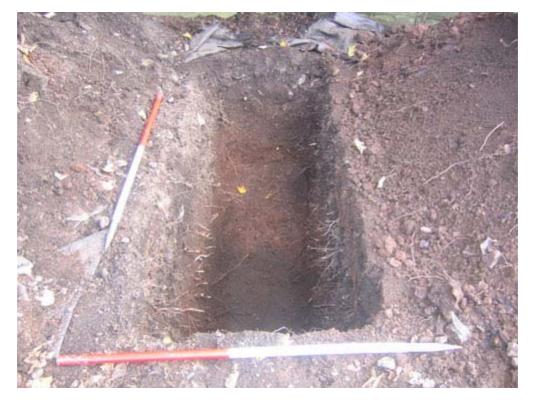
Figure 3b: Trench 1 showing bedrock

- 4.3 The lower sediments of Trench 1 showed a layer of orangey brown clayey silt (104) which was of a very uniform consistency and contained nothing in the way of artefacts or inclusions. This sat immediately below Context (103). Beneath this orangey brown layer (104) another layer of dark material containing pieces of modern ceramic, glass and brick (105). Beneath (105) was another layer of orangey brown sediment with no anthropic material. The Trench ended when we hit bedrock at approximately 1m depth in the east end (Figure 3b).

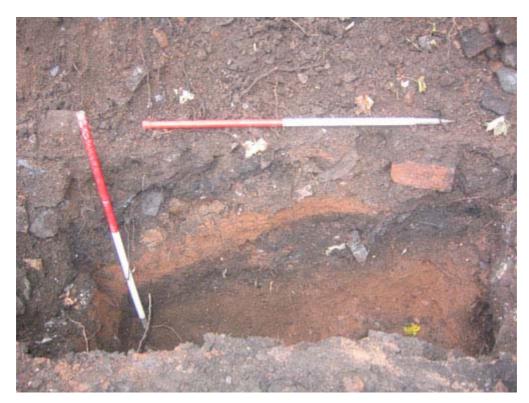
Figure 5a: Trench 3 section

- 4.4 We were not able to uncover so complete a cross section of sediments in Trenches 2 and 3 as we were in Trench 1. However, the sediments observed in Trenches 2 and 3 did support the findings for Trench 1 and suggest that there was a broadly similar sediment sequence across the entire site (Figure 4). Both trenches had dark brown sediment in their upper portion which contained quantities of modern ceramic and glass. The majority of the fill of both trenches was composed of dark brown sediment containing large quantities of modern ceramic, glass, construction debris and brick. At their base both trenches contained compact, orangey brown sediment with no inclusions or artefacts recovered. We did not reach bedrock in either trench due to the danger of collapse from unstable sediments.

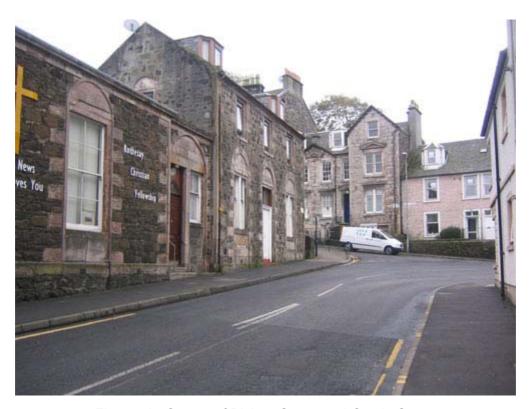
Figure 5b: Corner of Bishop Street and Castle Street

- 1.3 The area concerned is in the urban centre of Rothesay. At the corner of Bishop Street and Castle Street (Figure 5b) the ground to the east slopes sharply upward along what is referred to as Serpentine Road (Appendix 3). The development area is at the end of Bishop Street to the rear of the existing buildings where the ground slopes upward. The close proximity of the development area to Rothesay Castle and the medieval centre of Rothesay suggested potential for the preservation of archaeological remains within the development area.
