Brodick Castle Adventure Play, Arran:
Archaeological Watching Brief
Data Structure Report

by Joss Durnan & Liam McKinstry
issued 16th August 2017
on behalf of National Trust for Scotland

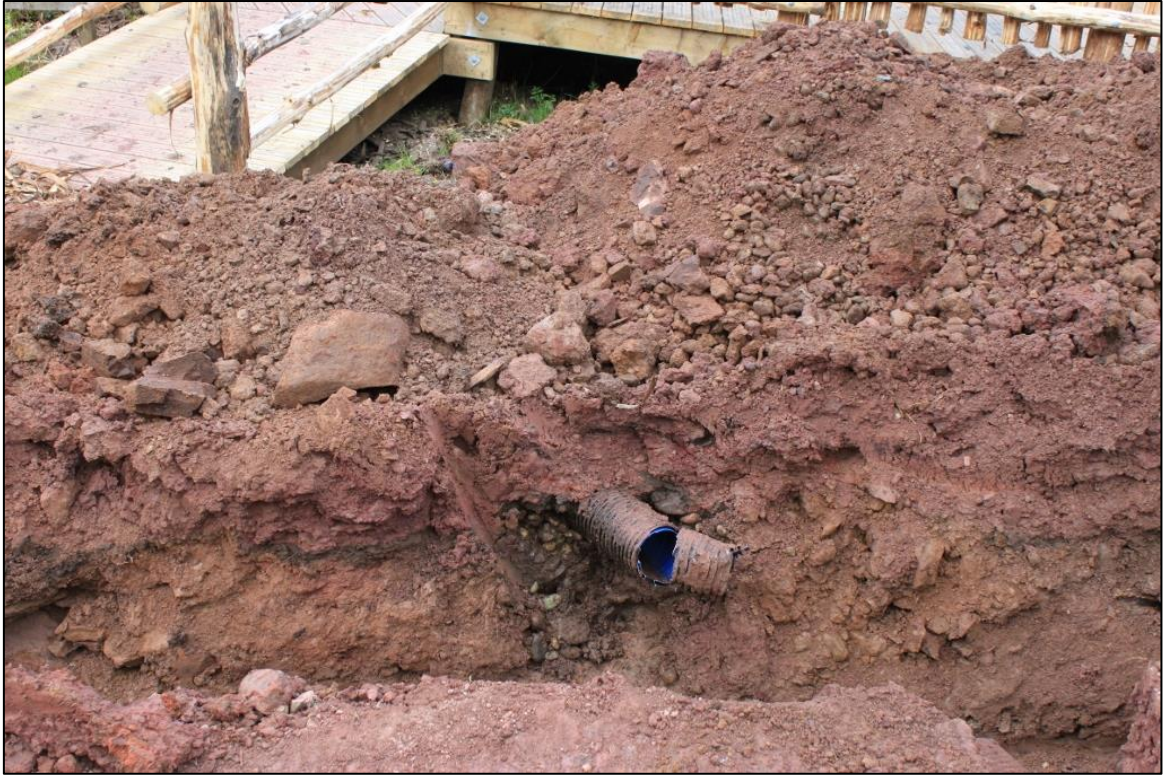
Figure 2a: Plastic drainage pipe (006) within Area 1. From E.

drain (006) was identified 14m from the southern end of Area 1 (Figure 2a). The cut into which this drain had been placed was within subsoil layer (004). It had cut through the overlying, buried, topsoil layer (003) but not the layers above.

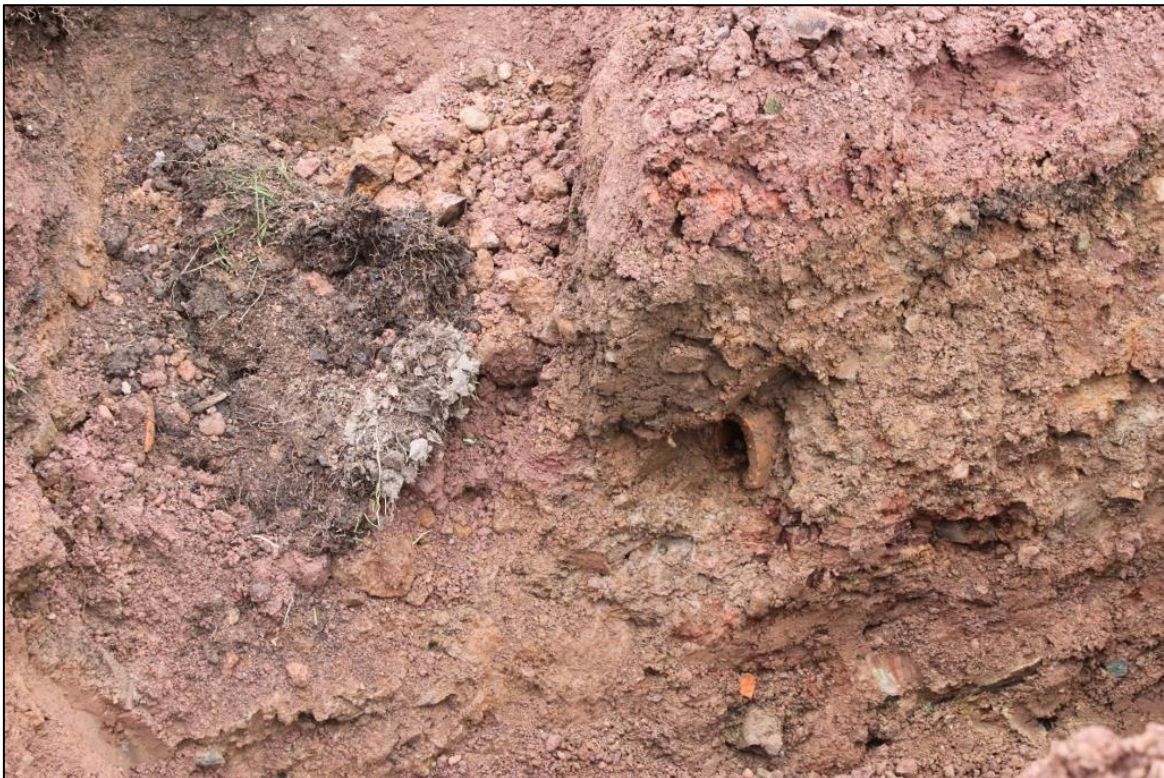
Figure 2b: Ceramic horseshoe pipe at junction of Areas 1 and 2. From NW.

11. Four features were identified in Area 2. The first of these was a horseshoe shaped ceramic field drain (006) located at the junction between Areas 1 and 2 (Figure 2b). This drain had a diameter of 180mm and was located at a depth of 600mm, within (004). The second feature was the continuation of the plastic drain (006) which was identified crossing Area 2, 8.5m from the western end of the area. The third feature identified was a northeast to southwest orientated rubble drain (008) located 11.2m from the western end of Area 2 (Figure 3a). The drain was filled with rough cobbles and was 500mm wide by 1.3m deep. The final feature identified was a, north to south orientated, narrow metal pipe (010) which was located 13.5m from the western end of the area. The metal pipe was located at a depth of 100mm within (003).

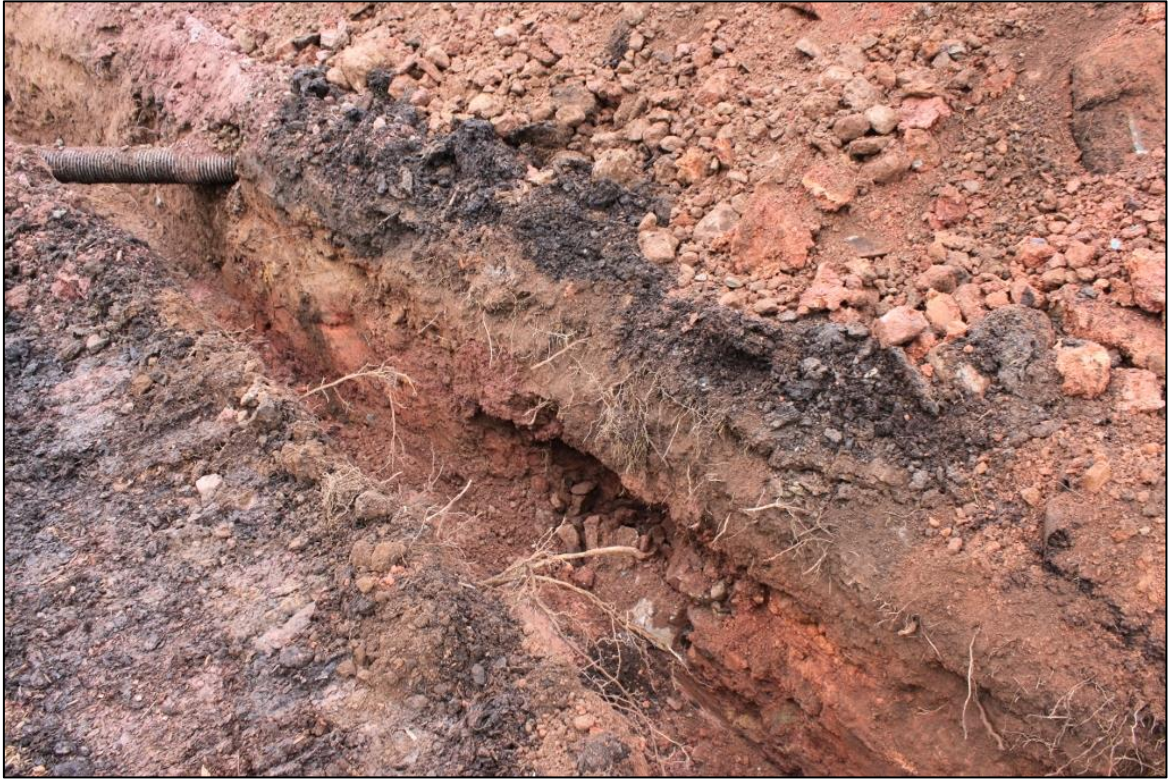
Figure 3a: Plastic drainage pipe (006) and rubble drain (008) within Are 2. From ESE.

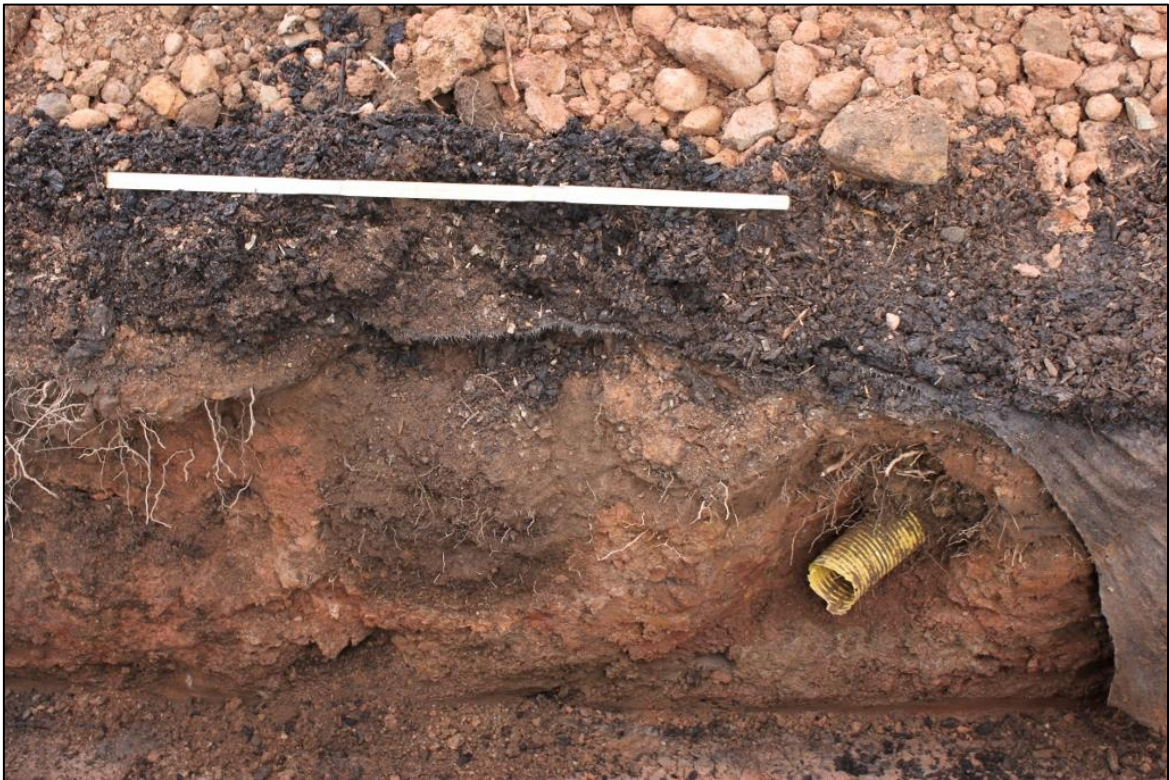
Figure 3b: Pit (013) and plastic service pipe (012) within Area 3. From SSE.

12. The third stretch of trench (Area 3) was orientated in an approximate west southwest to east northeast direction and measured 19m from the eastern end of Area 2 to its junction with Area 4. The trench was 800mm wide and had a maximum depth of 1.1m.
13. Two features were identified in Area 3 located 5-6m from the junction with Area 2 (Figure 3b). The first of these was a pit feature (013) which underlay the bark/terram layer (011). The pit had a width of 500mm and a depth of 440mm. Its fill was comparable to the buried topsoil layer (003) except it contained more organic material in the form of rootlets. The second feature identified was a yellow plastic field drain located within a narrow trench filled with small stones and gravel. The trench it was located in had a width of 90mm and was located at a depth of 700mm cut into the naturally occurring subsoil (009).

17. One feature whose function and date are not as clear is pit (013) though its shape in section looks to be machine cut so it may be the result of 20th century activity before the creation of the original play area.
