**Land North of Woodlea Cottage, Whiting Bay,  
Arran:  
Archaeological Evaluation**

Data Structure Report

by Liam McKinstry  
issued 25<sup>th</sup> September 2017  
on behalf of Mr Angus McLeod

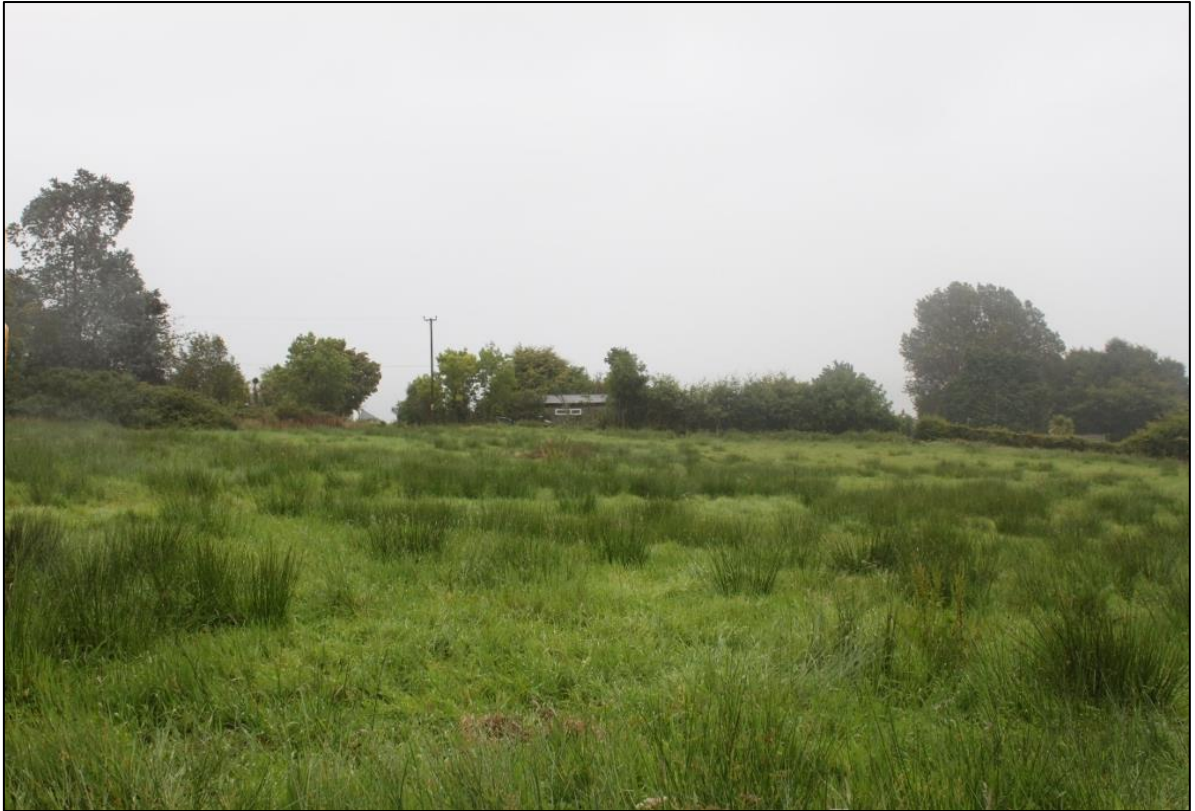
Figure 3a: Pre excavation view of the site. From the SW.

9. In total, eleven evaluation trenches were excavated across the available portion of the development area (Figures 2 and 3a), using a tracked 360° mechanical excavator with a toothless 2m ditching bucket.
10. The topsoil within the site, (001), consisted of moderately compacted, mid to dark grey-brown clayey silt with occasional small to medium sized stone inclusions. The topsoil had

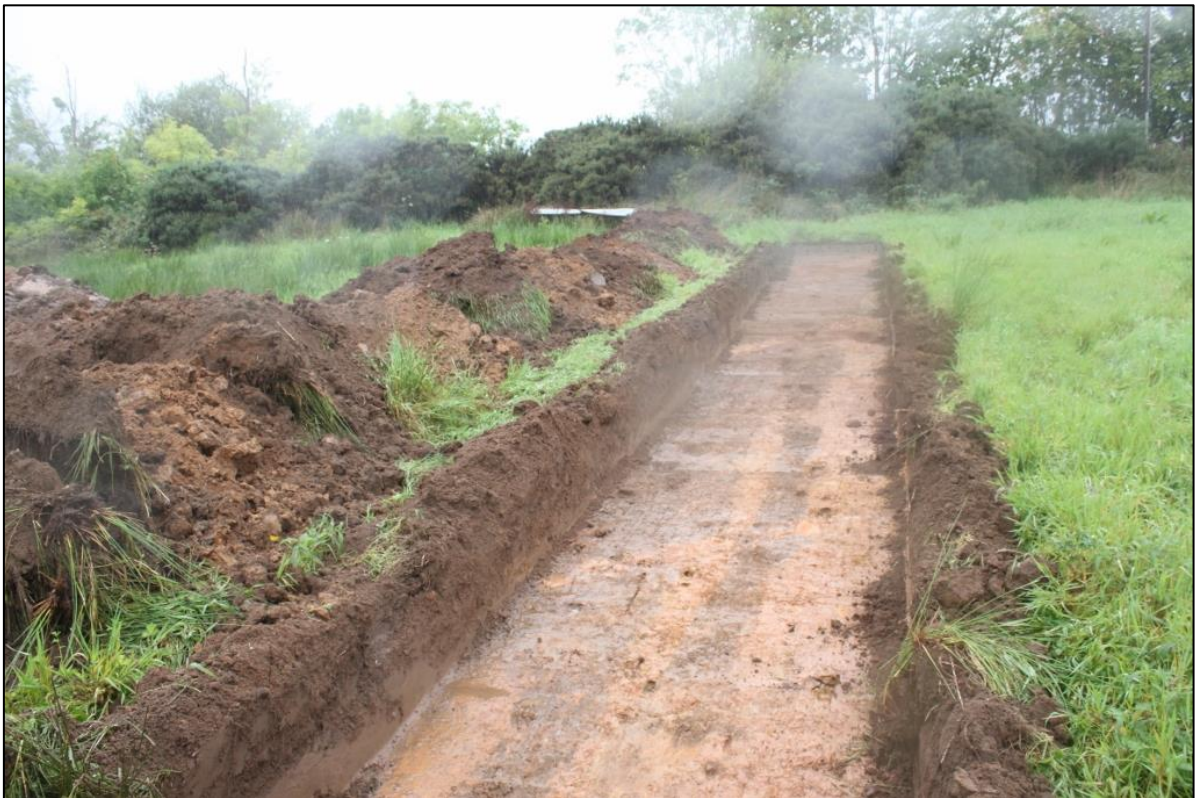
Figure 3b: Post excavation view of Trench 5. From the E.

a thickness range of between 0.28m and 0.5m. Two main subsoil layers were identified across the evaluation area, (002) and (003) (shown here in Figures 3b and 4a). The first of these subsoil layers, (002), consisted of moderately compacted, light orange-brown/red-brown sandy-silt/clay with occasional small stone and pebble inclusions and very occasional larger, rounded, stone inclusions. The second subsoil layer (found in the westernmost part of the development area), (003), consisted of moderately compacted, mid orange brown sandy silt with occasional pebble inclusions.

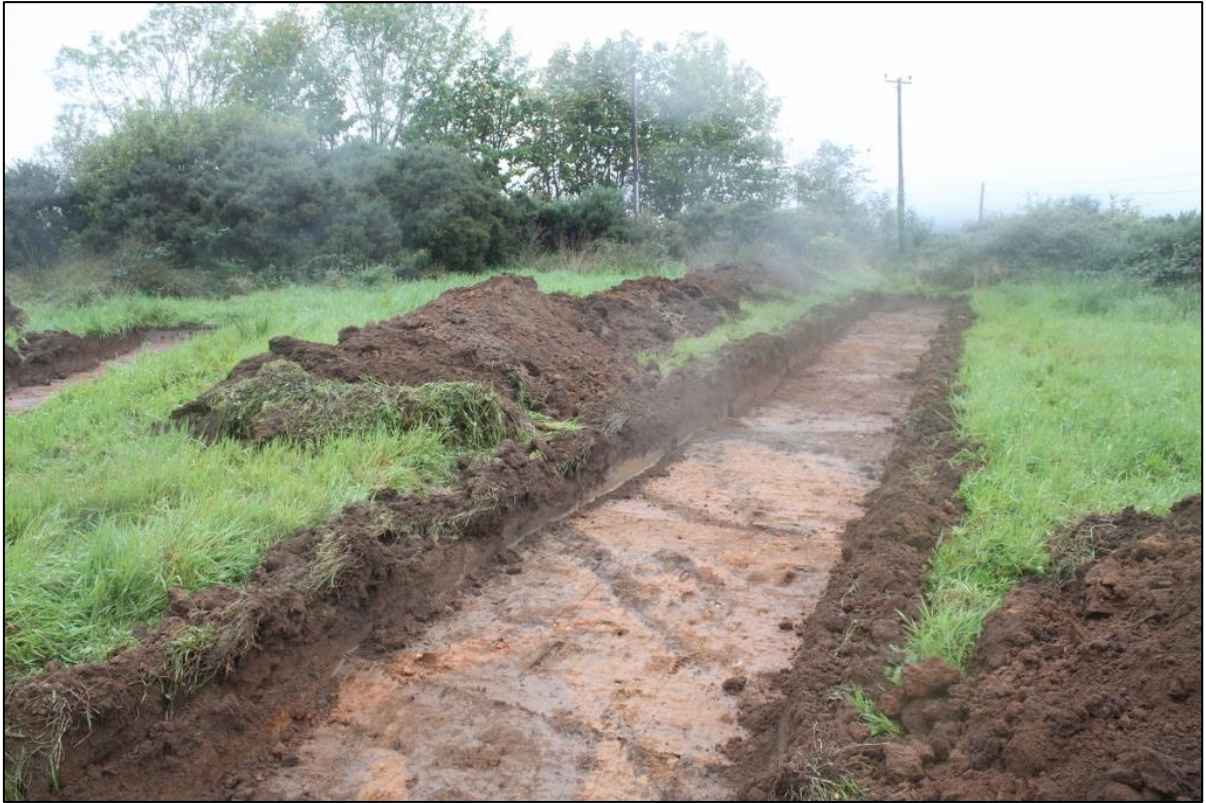
Figure 4a: Post excavation view of Trench 1. From the SE.

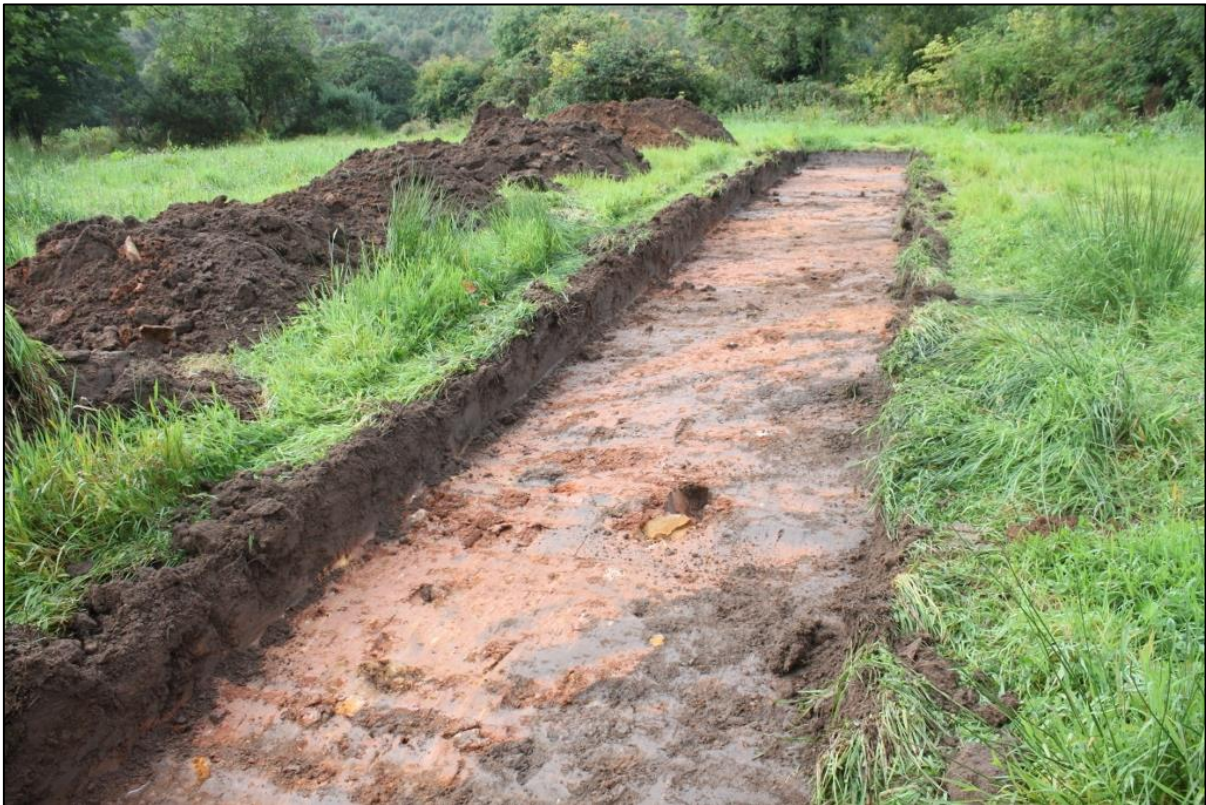
Figure 4b: Post excavation view of Trench 11 showing drains (004). From the S.

12. Four groups of linear, silted up, agricultural drains were identified during the excavation of the evaluation trenches. All of these drains were similar in nature with their fills consisting of 10-20% mid to light grey brown clay and 80-90% small to moderate sized rounded stones. The orientation and widths of the drains however, differed between each group. The first group (Figures 4b and 5), (004), was orientated in an east to west direction and had a width of 0.2-0.3m. The second group, (005), was orientated in a northwest to southeast direction and had a width of 0.2-0.8m. The third group, (006), was orientated in a north to south direction and had a width of 0.3-0.8m. The final group, (007), was orientated in a north to south direction and had a width of 0.8m (see Appendix 1 for detailed location information).

11	SW-NE	2m x 18m  36m <sup>2</sup>	0.28m- 0.33m	(002) Moderately compacted, light orange-brown/red-brown sandy-silt/clay with occasional small stone and pebble inclusions and very occasional larger, rounded, stone inclusions.	At +4m, +5m, +8m, +11m, +13.5m and +16m (004) Stone filled drain.	None	None

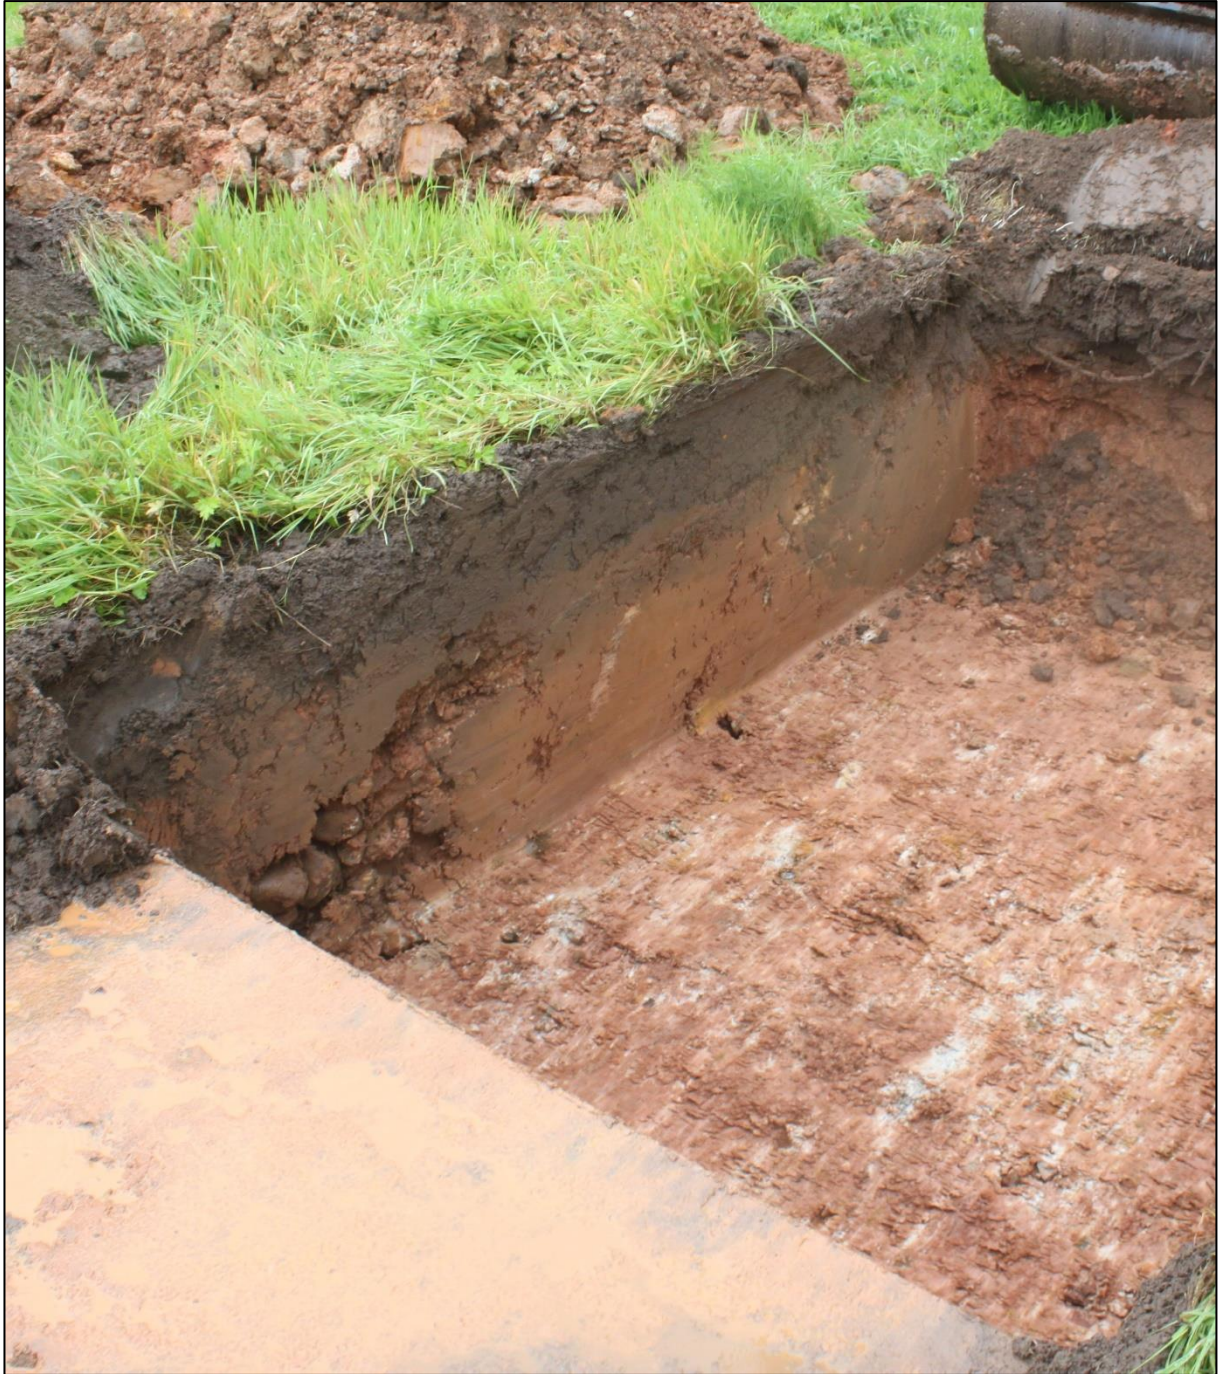
Figure 5: Post excavation view of SW end of Trench 11 showing rubble drain (004) in section. From the NW
