Mill of Kincardine Farm, Aberdeenshire: Archaeological Mitigation

Data Structure Report

issued 4th September 2017

RATHMELL  
ARCHAEOLOGY LTD

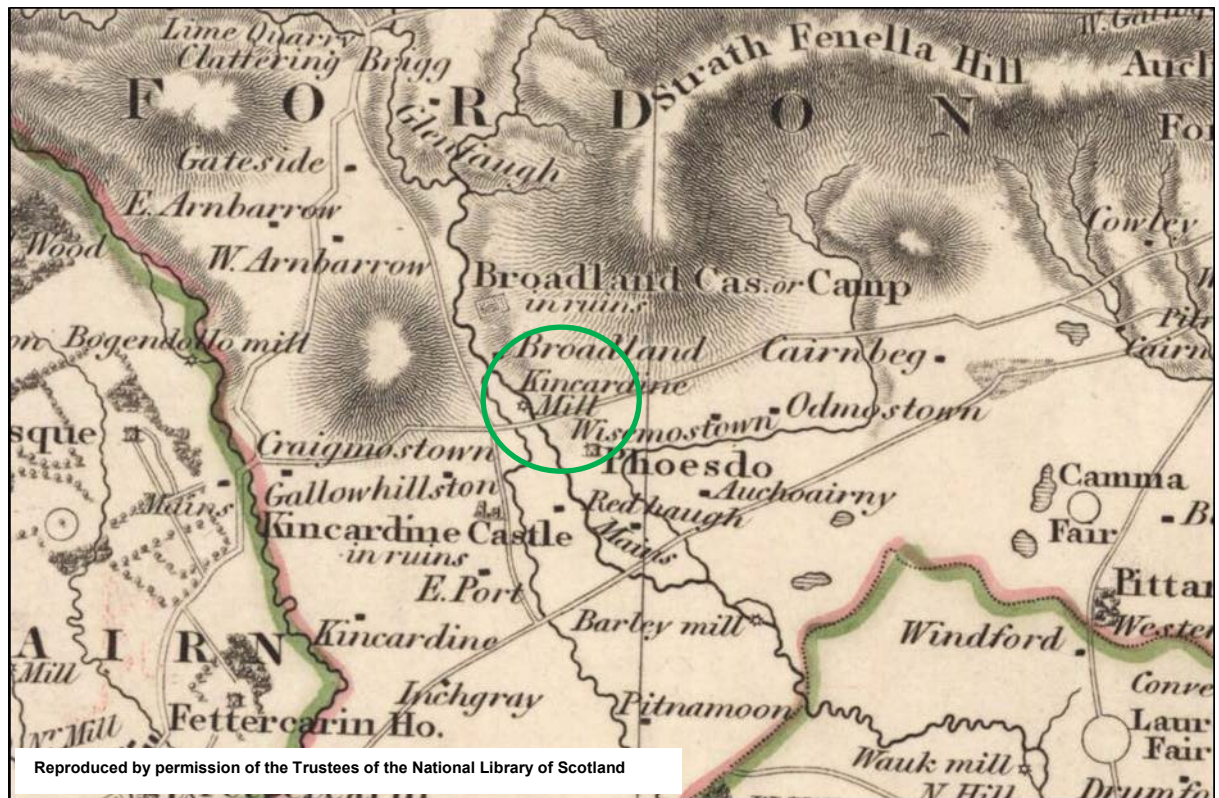
Figure 1b: Extract from John Thomson's Kincardine Shire (1832). Green circle denotes location of the Mill.

5. Moving into the 19th Century John Thomson's (1832) *Kincardine Shire* (Figure 1b) further depicts and labels the area of the Mill of Kincardine. It is not until the *1st edition Ordnance Survey* (1868) (Figure 2b) that a detailed survey of the Farm is provided. Between the 1st (1868) and 2nd (1901) edition surveys (Figure 2a & 2b) there has been very little change.

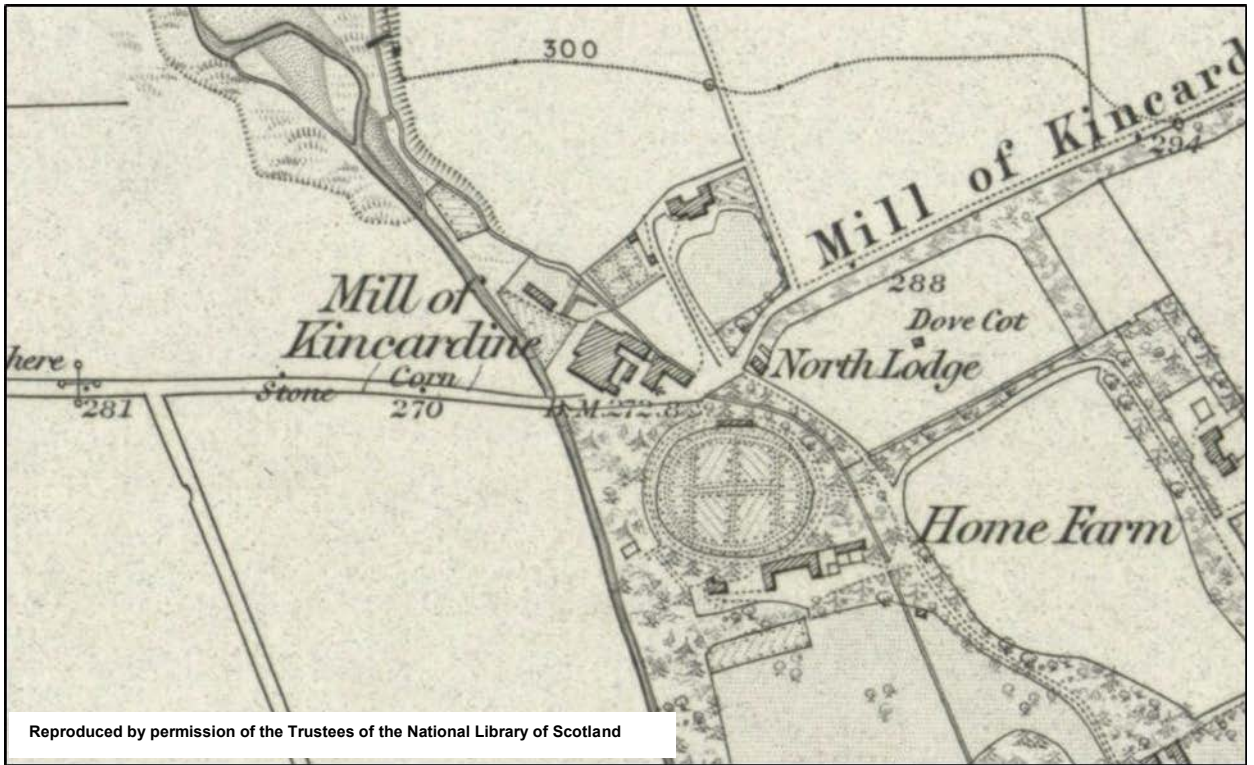
Figure 2a: Extract from the 6-inch 1st edition Ordnance Survey Kincardenshire Sheet XIX (includes Fettercairn, Fordoun) (1868).

6. The 1st edition Survey (1868) depicts the area for development (figure 3) as having an 'L-Shaped' range; currently the South Barn (figure 3) and a rectangular building; currently the North Barn which are still present. The rectangular North Barn is adjoined to a larger rectilinear building.

24. The 1st edition Survey (1868) (Figure 2a) depicts the area for development (Figure 3) as having an 'L-Shaped' range; currently the South Barn and a rectangular building; currently the North Barn which are still present (Figure 3). The 1st edition Ordnance Survey depicts a building to the northwest and where the now demolished Building A once stood on a roughly similar alignment but smaller footprint.

31. Through the survey it was possible to record the original stone buildings depicted in the 1st edition Ordnance Survey (1868) (Figure 2a) and later additions. It is suggested that the structural alterations that have occurred are representative of 20th century changes.

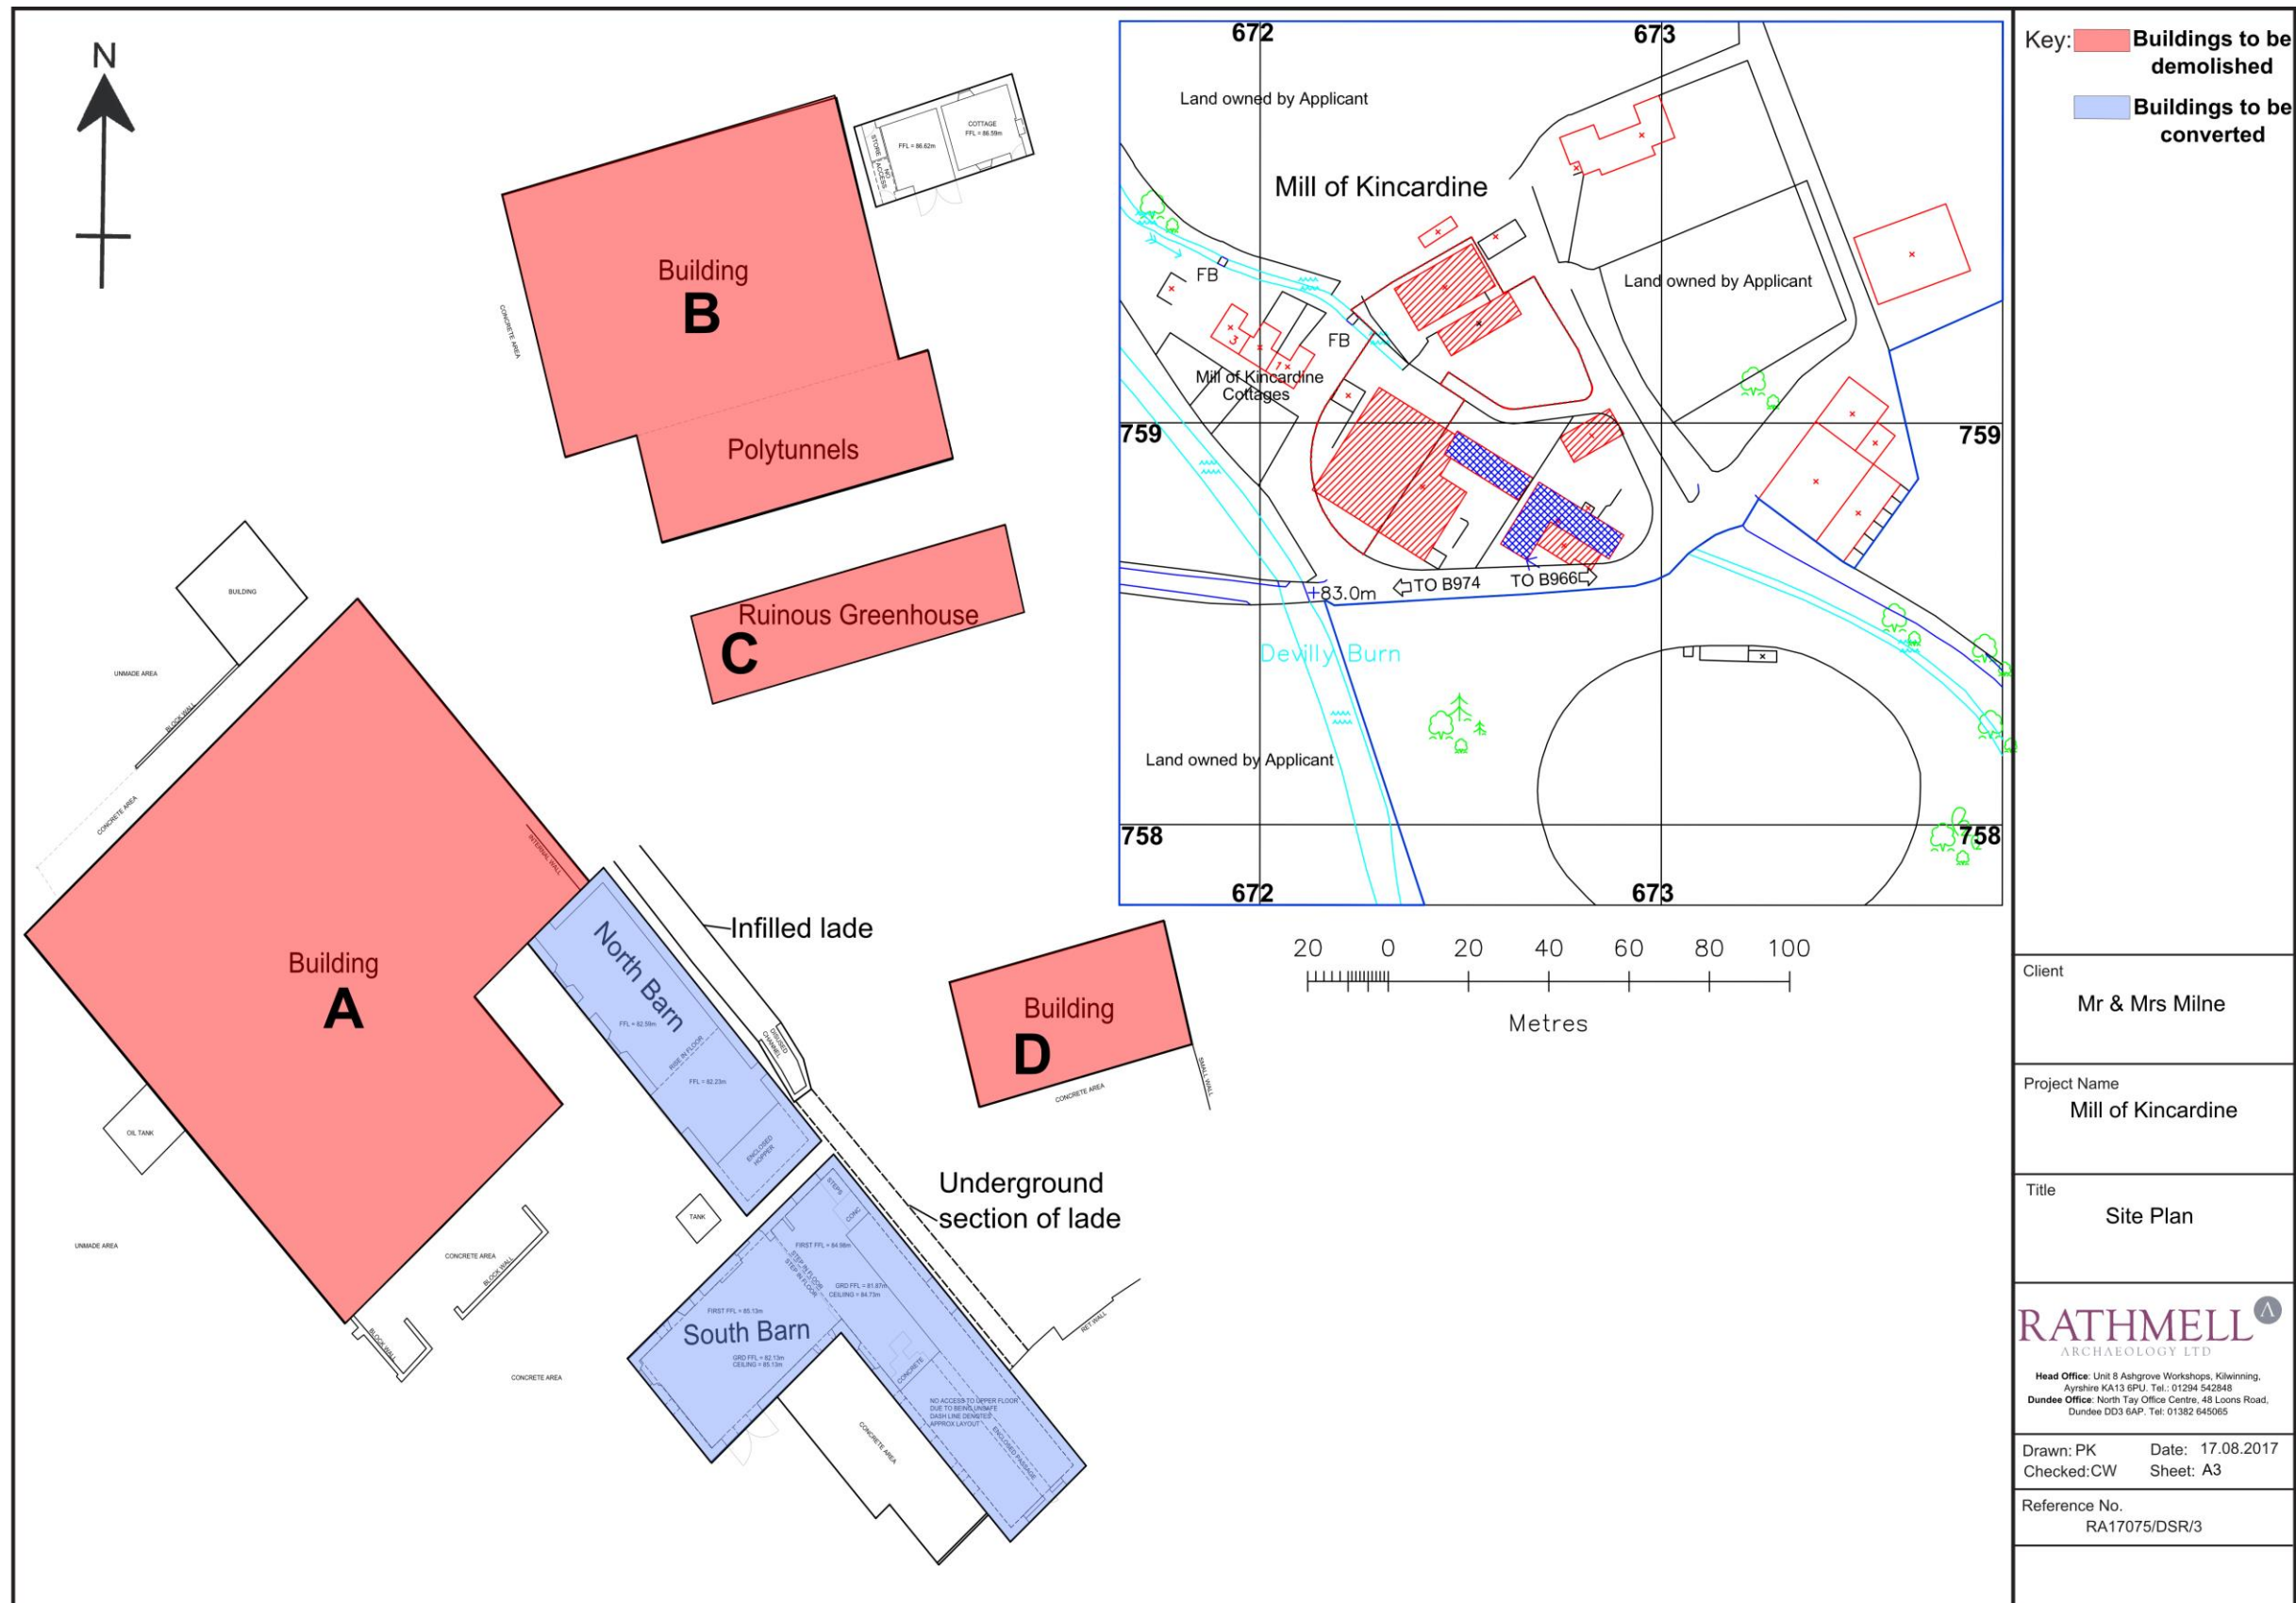
Figure 3: Site plan of Mill of Kincardine Farm.

7. The current 'Building' (Figure 3) adjoined to the current North Barn has been substantially reduced since the 1st and 2nd edition Ordnance Surveys and is proposed for demolition. The current three buildings in the northeast of the development site and also proposed for demolition are not depicted on the previous Ordnance Surveys and are most likely later additions.

12. An annotated plan of the current site layout (Figure 3) provides the location of the structures associated with the development. The buildings are labelled 'A' through to 'D,' with the 19th century structures labelled 'North Barn and 'South Barn'.

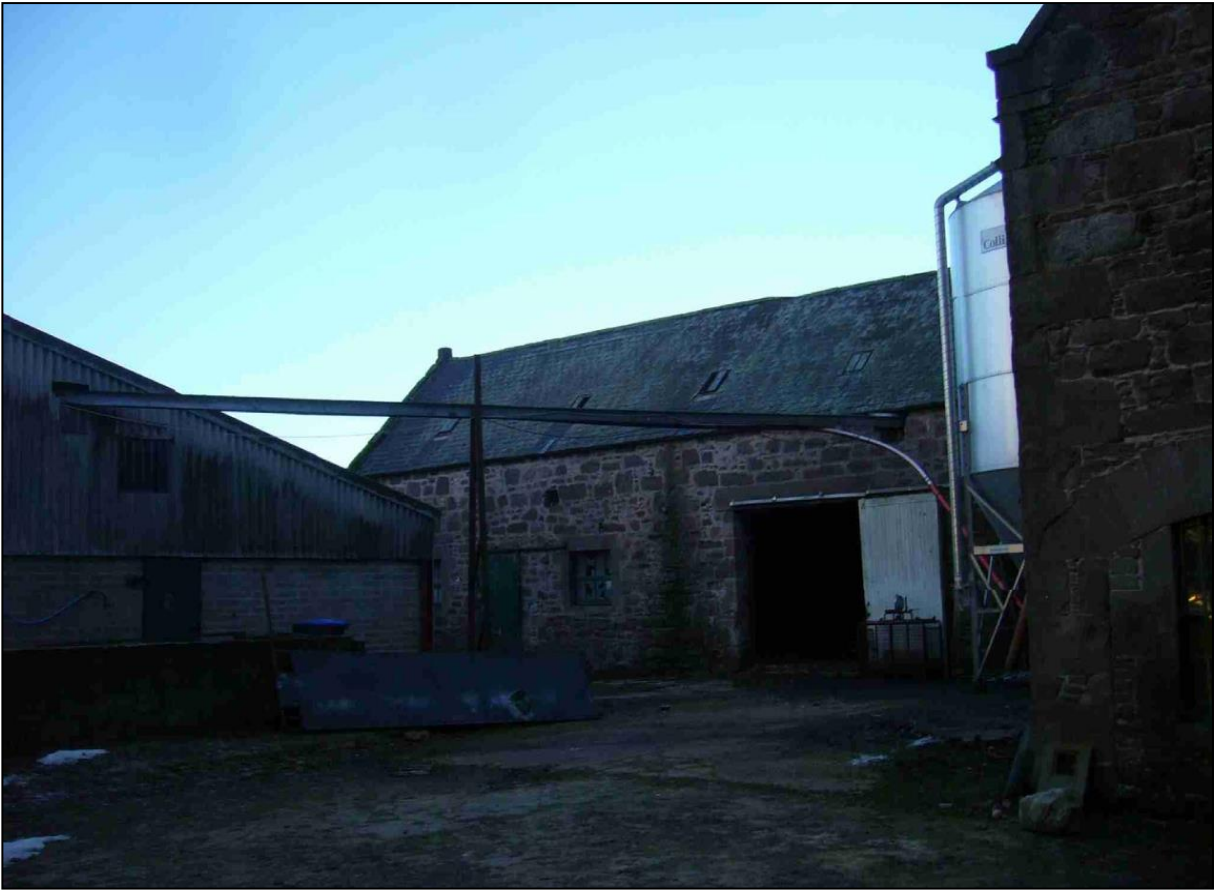
Figure 4a: Building A, adjoining to the North Barn.

13. Structures A-D had already been demolished as part of a previous phase of development. However, a previous engineering survey had taken images of the buildings before any demolition had taken place (Figures 4a to 7a). Inspection of these images suggest that all four structures were of modern construction and probably comprised steel framed buildings with corrugated sheet glass fibre roofing. During the on-site works it was possible to observe the changes that had taken place (Figures 7b to 9b).

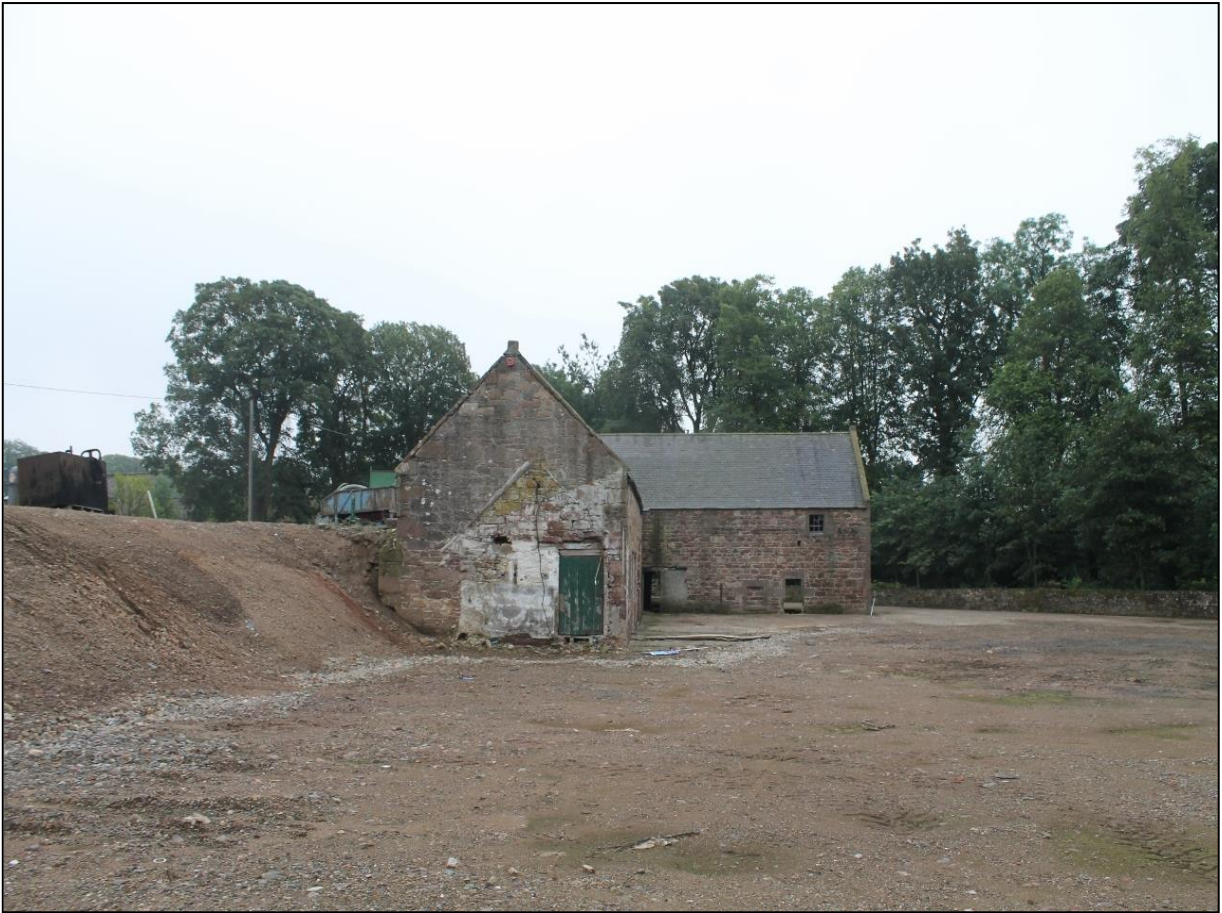
14. The North Barn is rectangular in plan measuring 20m by 5.50m (Figure 21), single storey and a 1 x 3 bay structure (Figures 8a, 10a & 18). Accessed from the southwest, Building A originally adjoined the North Barn on the northeast side and there is evidence on this side of the previous roofline (Figure 8a). The barn is snecked constructed and uses roughly worked red sandstone which in areas is in poor condition with roughly worked sandstone quoins. The roof is gabled and slated with five original skylights on the southwest facing side and one on the northeast side and sandstone ridge capping.

Figure 8a: Area where Building A would have stood. Evidence on the northwest elevation of the North Barn demonstrates where the two buildings adjoined.

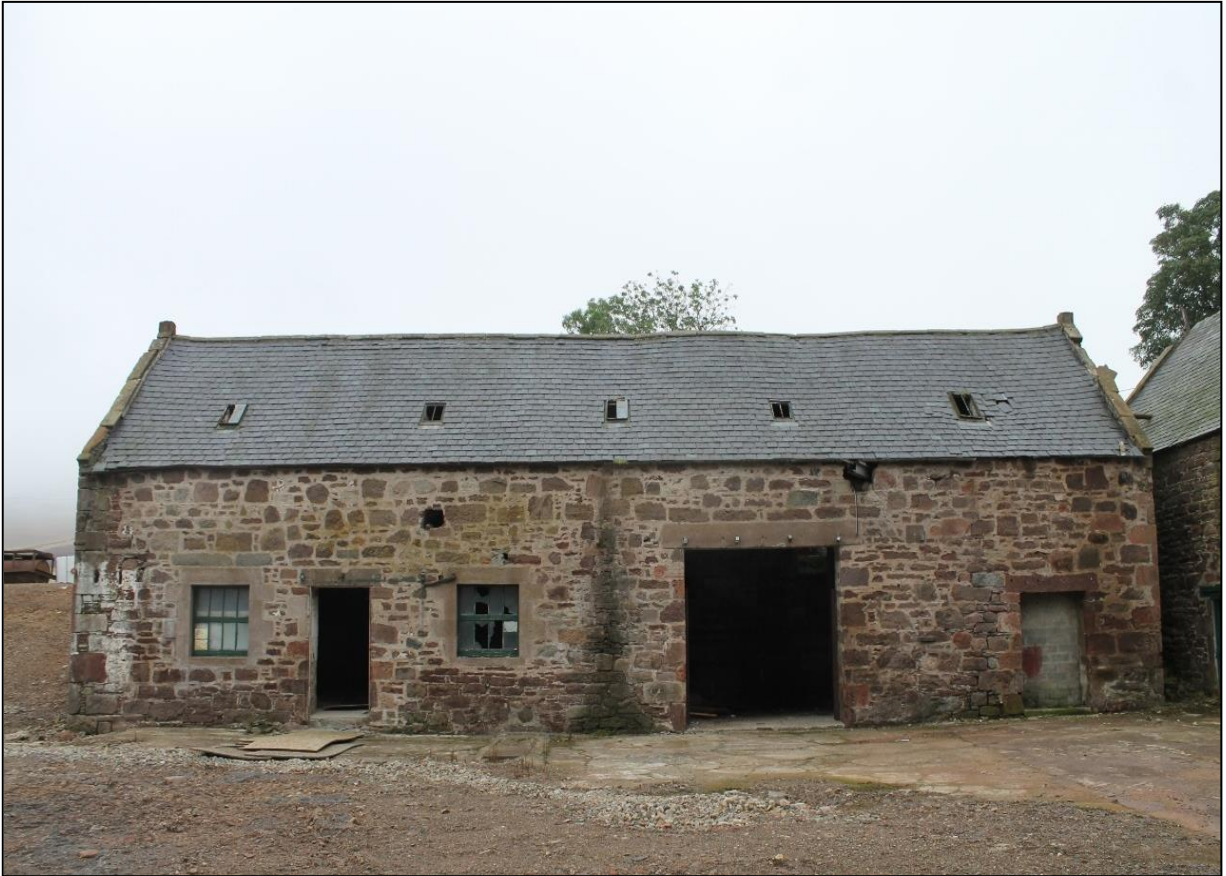
15. There are two windows with modern cement cills and rybats and three doorways. The largest centrally located doorway has a concrete lintel with one of the doorways blocked using modern breezeblocks (Figure 10a). Internally, the building is in poor condition with damp clearly visible in the interior and on the northeast wall with evidence of previous white washed plaster (Figure 10b). The floor is concrete with wooden sarking visible and timber roof trusses (Figure 11a). The southeast end of the building has been divided to form what would appear to be storage, potentially for arable crops (grains) (Figure 11a).

Figure 10a: Southwest elevation of the North Barn

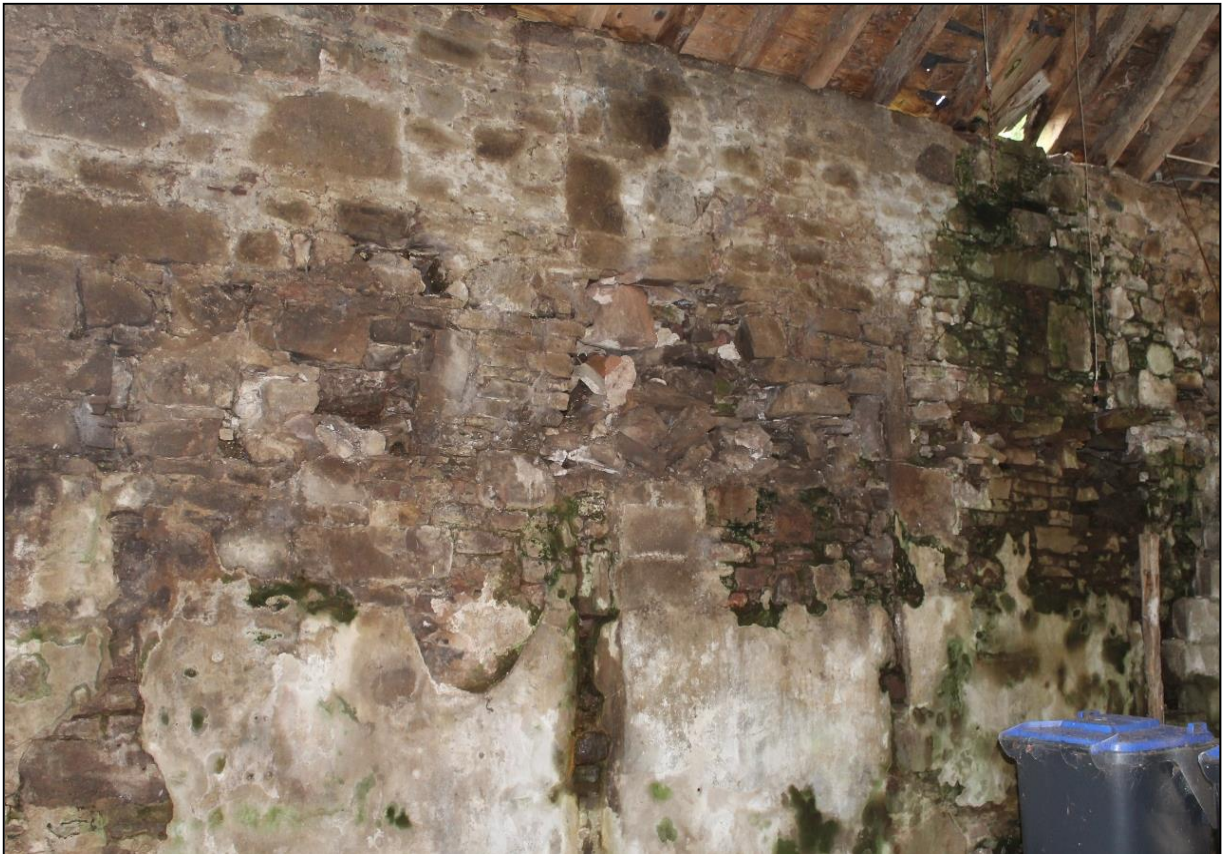
Figure 10b: Northeast wall in North Barn showing damp and evidence of white wash wall.

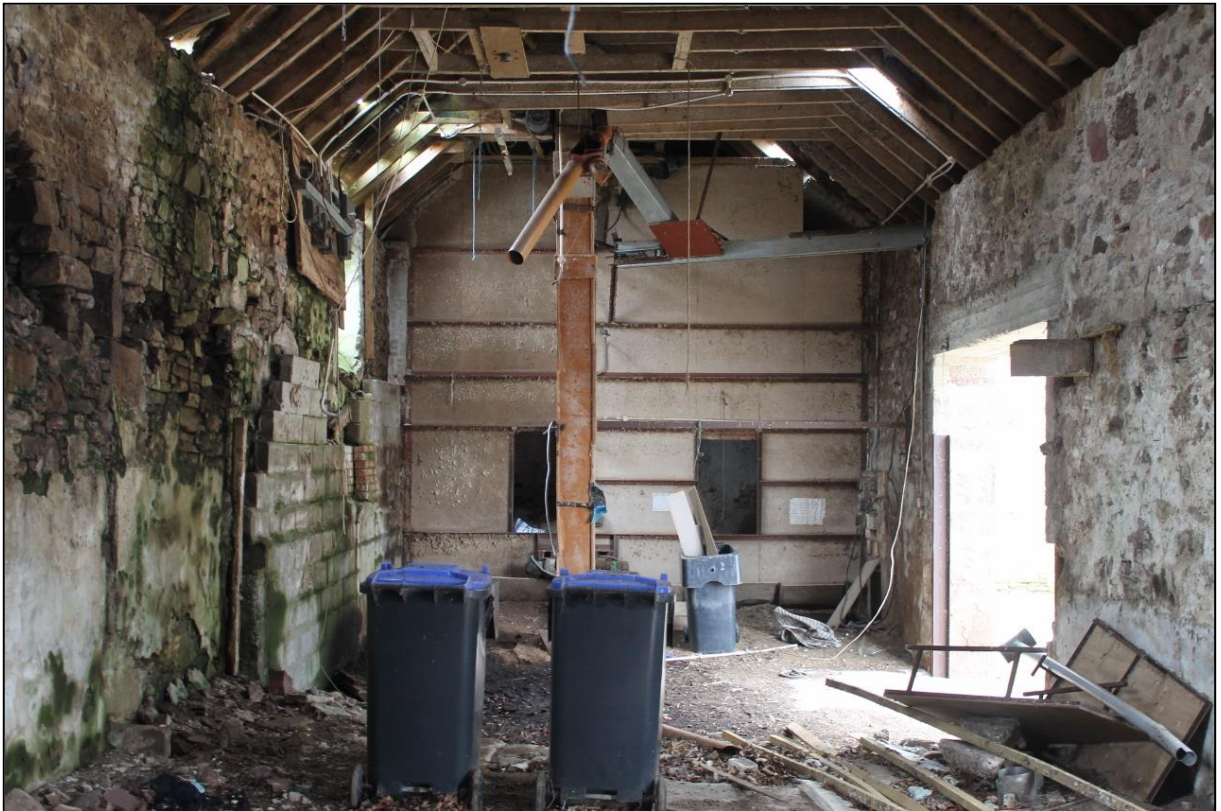
Figure 11a: The North Barn showing the timber roof trusses and grain storage at the southeast end.

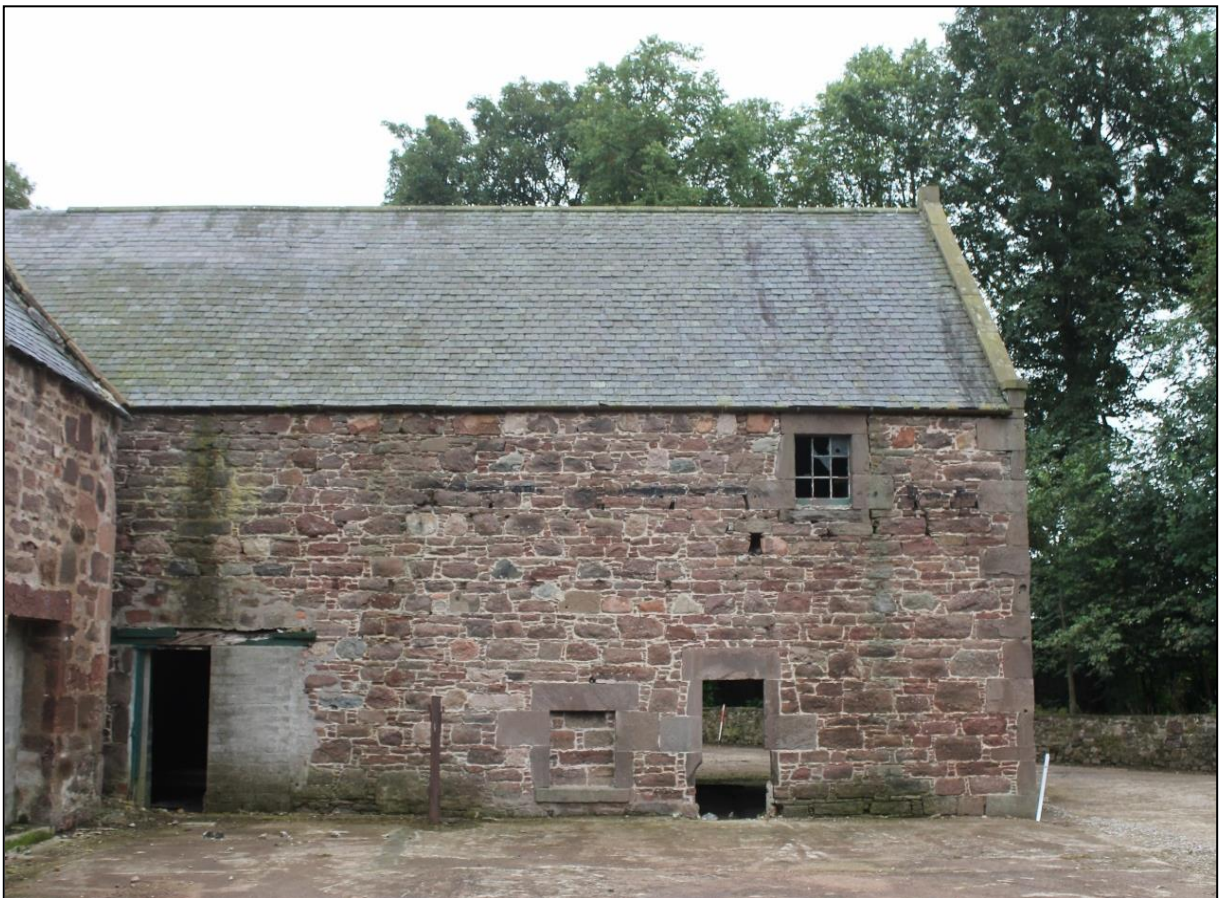
Figure 11b: Northwest elevation of the South Barn.

20. There are two doorways and one window on the northwest elevation (Figure 11b) with another possible doorway in the upper floor that has been blocked and is blocked from view by the North Barn. On the single bay of the southwest elevation (Figure 12a) there is one window and one wooden slatted vent that may have originally functioned as a window. The lower window most likely is a later alteration and originally functioned as a doorway as there is clear evidence that it has been infilled using sandstone blocks and it also has a sandstone segmental arch with sandstone rybats (Figure 12a).

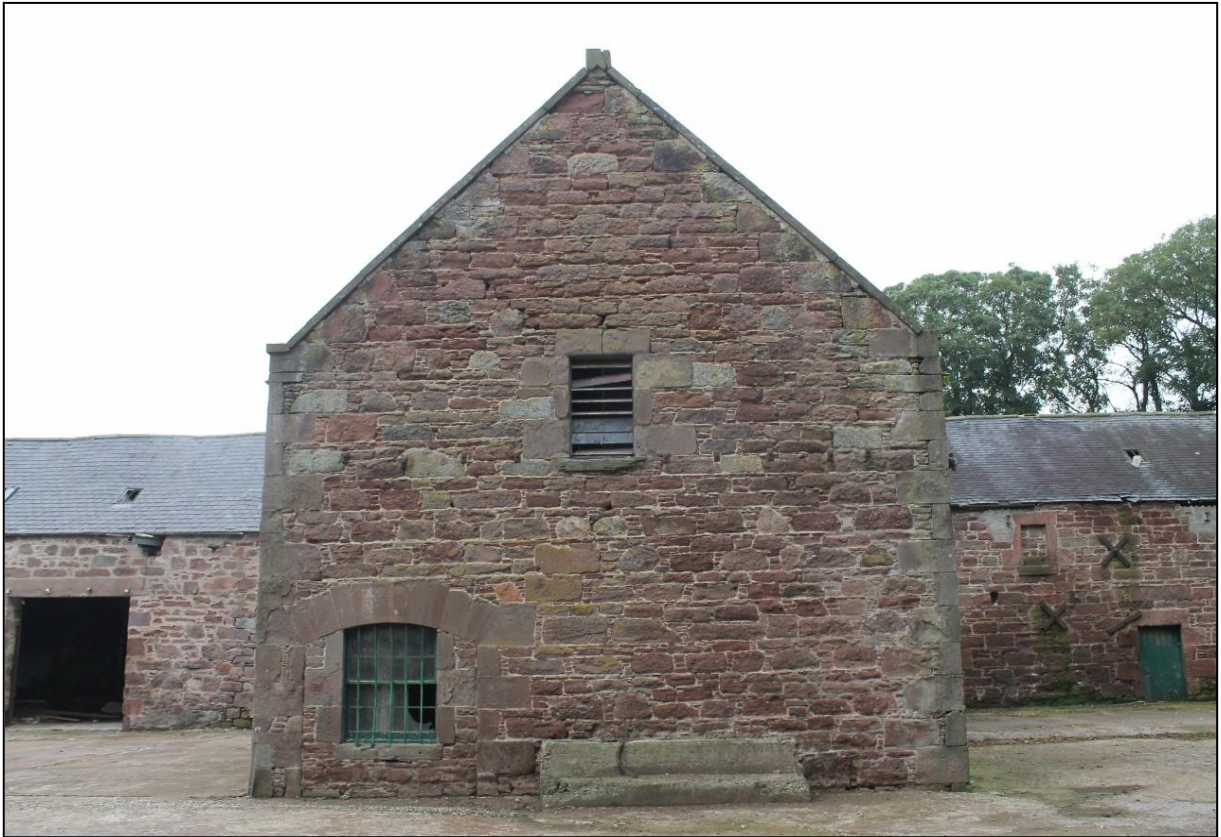
17. The roof is Cross-gabled and slated with three original skylights on the northwest facing side and sandstone ridge capping. The red sandstone used in the construction has been roughly worked into rectangular blocks with the use of Cherry-cocking to produce a more coursed and refined appearance (Figure 12a) the quoins are also of roughly worked sandstone. All the window cills and rybats are of sandstone with the lintels and rybats for the doorways also all formed of sandstone. Overall the South Barn is in good condition and of better construction than the North Barn.

Figure 12a: Southwest elevation of the South Barn.

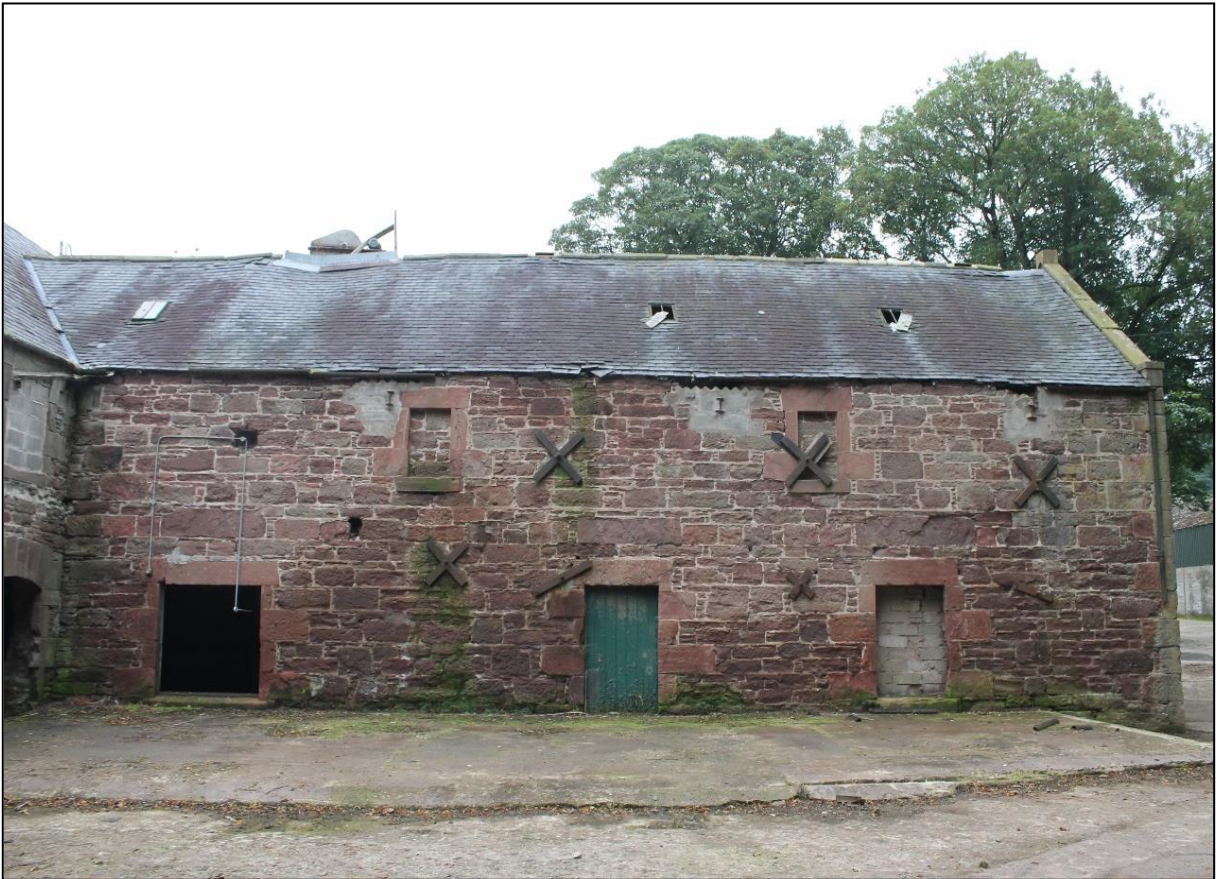
Figure 13a: Southwest elevation of the South Barn.

21. The 3 bay southwest elevation has four windows, of which three have been blocked and one doorway. The windows on the upper floor have been blocked using sandstone blocks and would suggest that they were blocked at a substantially earlier date than the lower the window which has blocked using breezeblocks (Figure 13a). The 1 bay southeast elevation originally had a large doorway which has been blocked using cement with the presence of a small modern access hatch and a small window on the upper floor which has also been blocked using cement (Figure 13b).

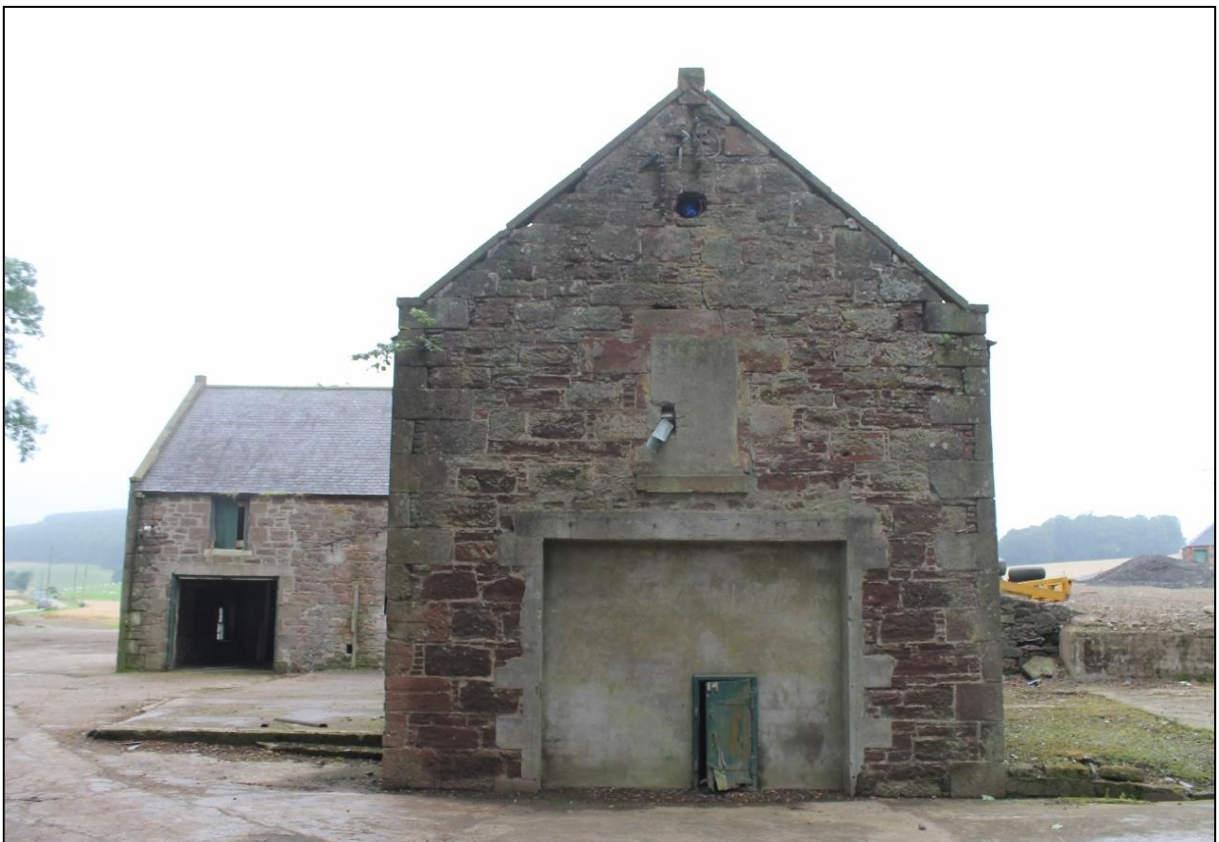
Figure 13b: Southeast elevation of the South Barn.

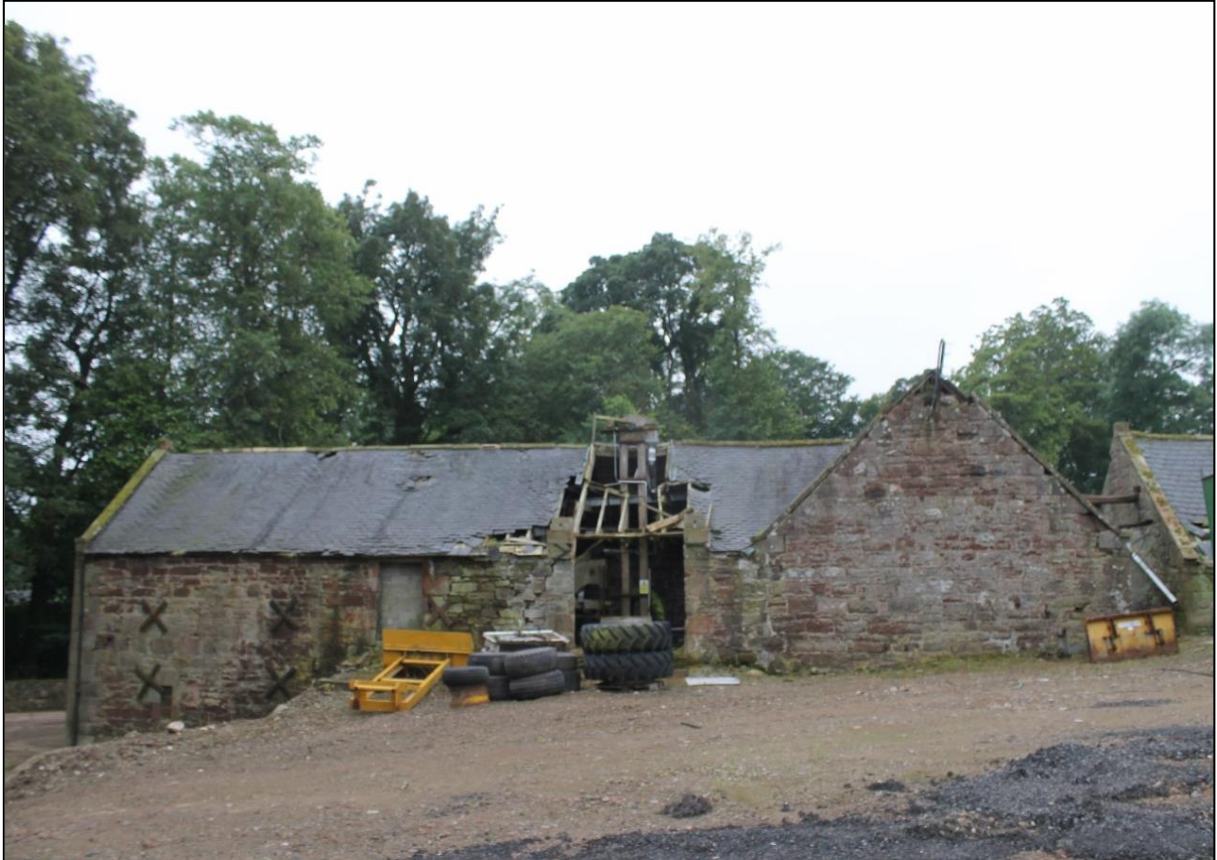
Figure 14a: Northeast elevation of the South Barn.

22. The northeast elevation has one small doorway which has been blocked using sandstone and two doorways; one which has been blocked using breezeblocks. Both provide access to the upper floor (Figure 14a). It is along the northeast side of both the North and South Barn that the infilled lade (Figure 16a) and the underground course of the lade (Figures 16b, 17a & 17b) that would have originally provided power to the mill is located.

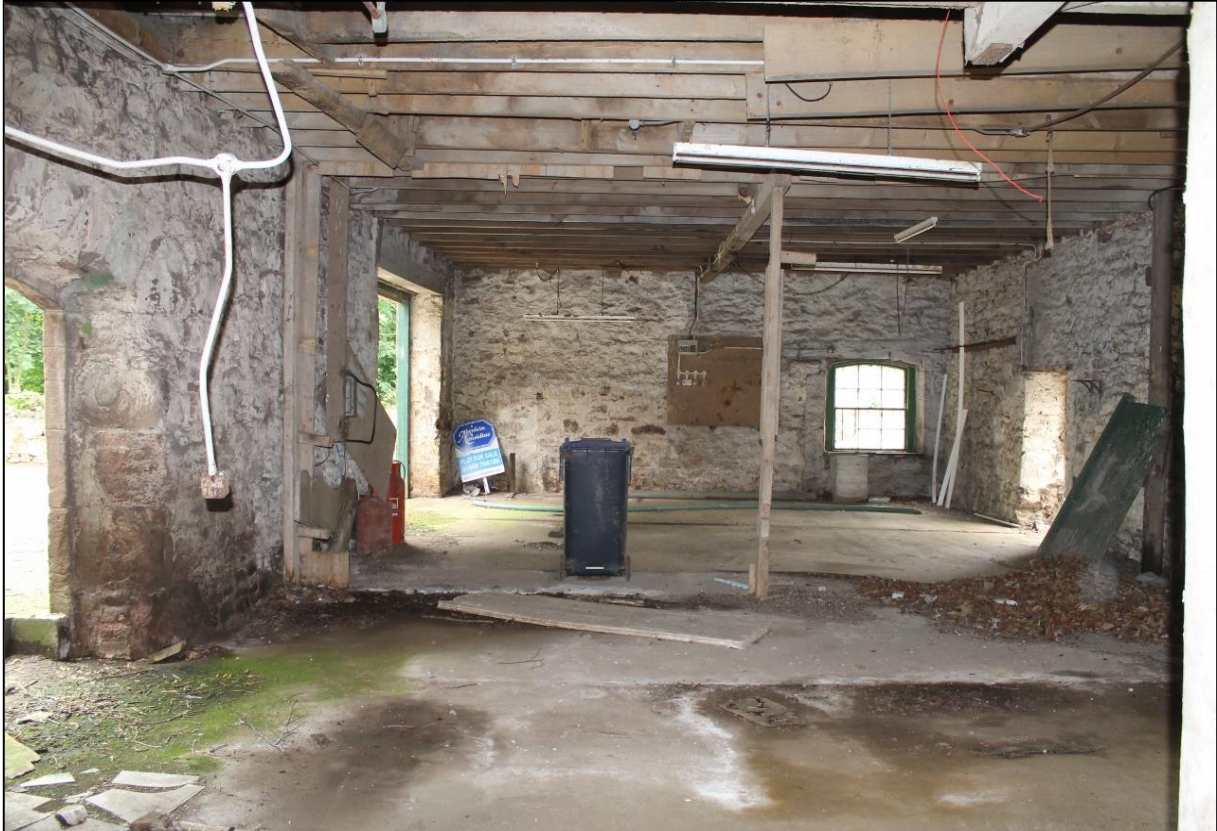
18. The upper storey was not fully accessed, although it was possible to observe that the sarking was of wood and the roof trusses were of timber construction. The floor is of concrete and there is evidence of the walls having been white washed (Figure 14b).

Figure 14b: The southwest-northeast aligned element of the South Barn, showing the white washed walls.

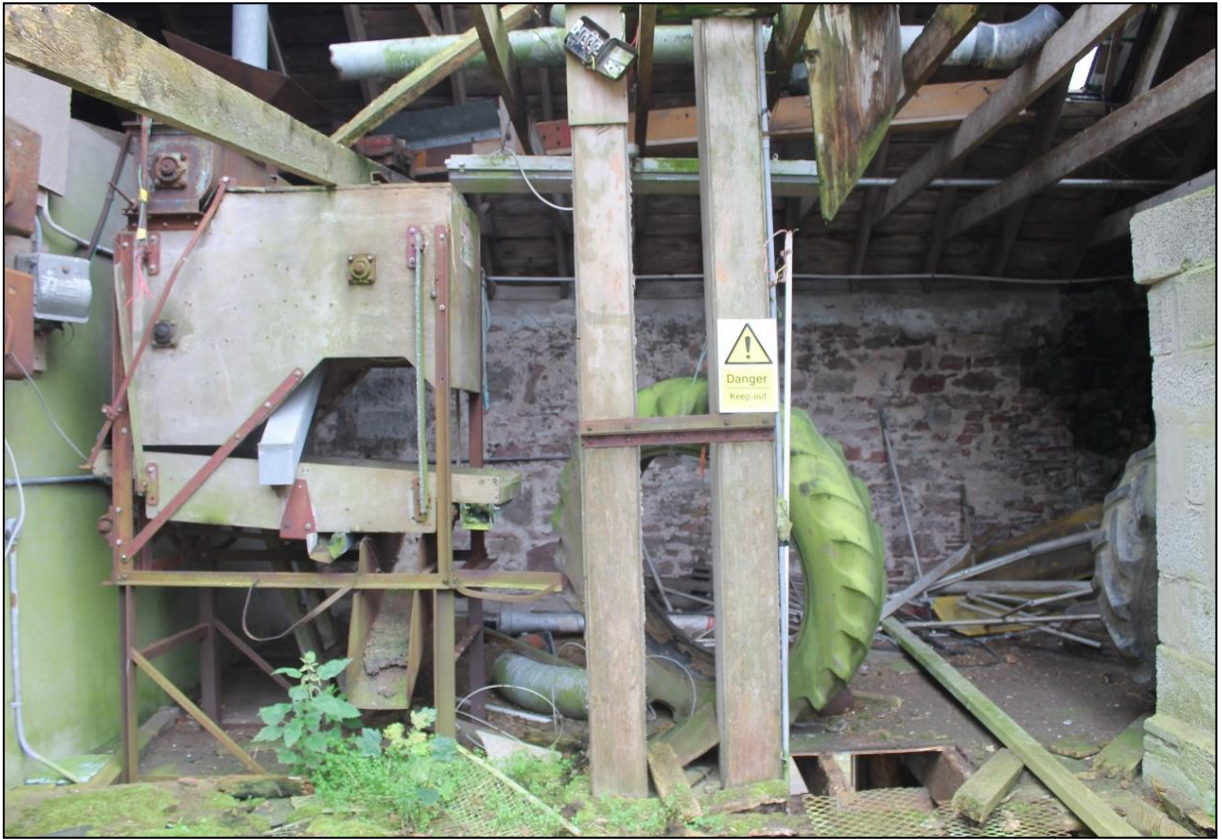
Figure 15a: Farm machinery (threshing) in the upper floor of the South Barn.

19. The presence of what would appear to be threshing machinery (Figure 15a) and the large quantity of grain chaff would suggest that the South Barn functioned to process grains (Figures 15b).

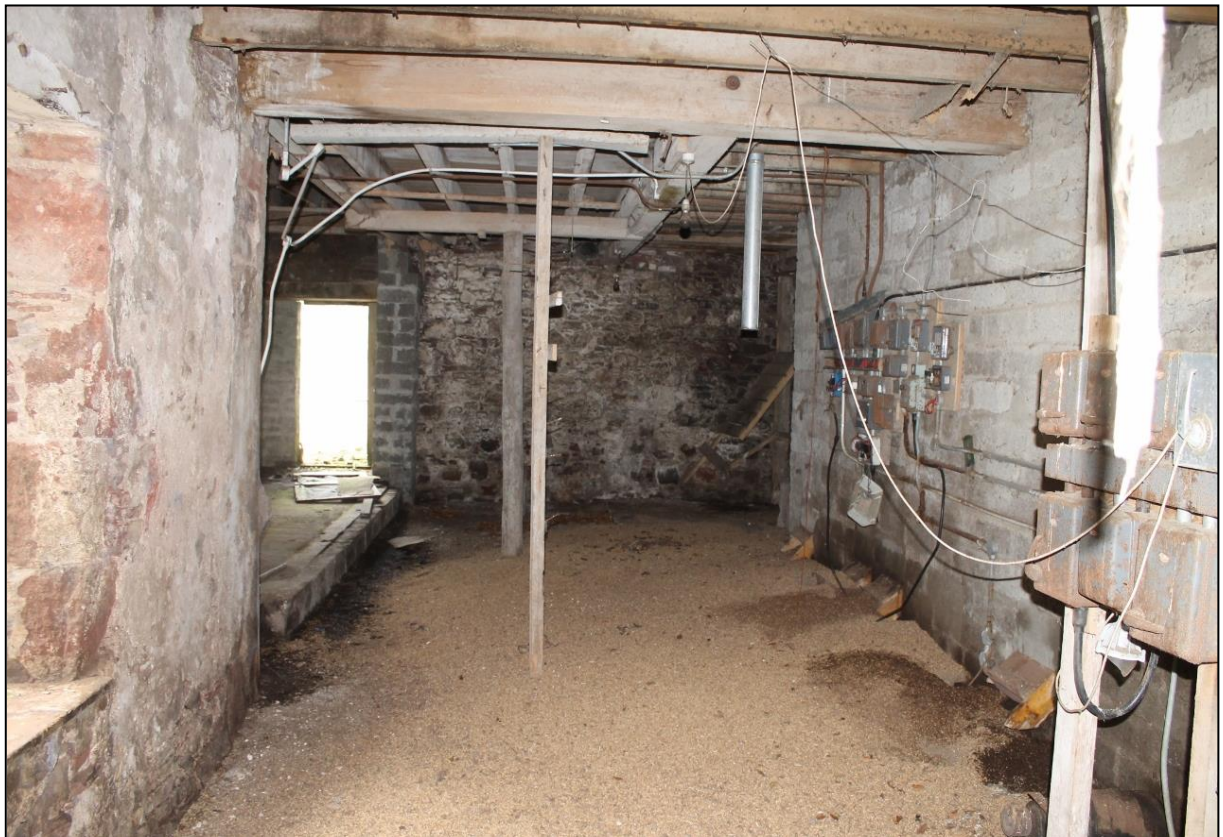
Figure 15b: The northwest-southeast aligned element of the South Barn showing the grain chaff.

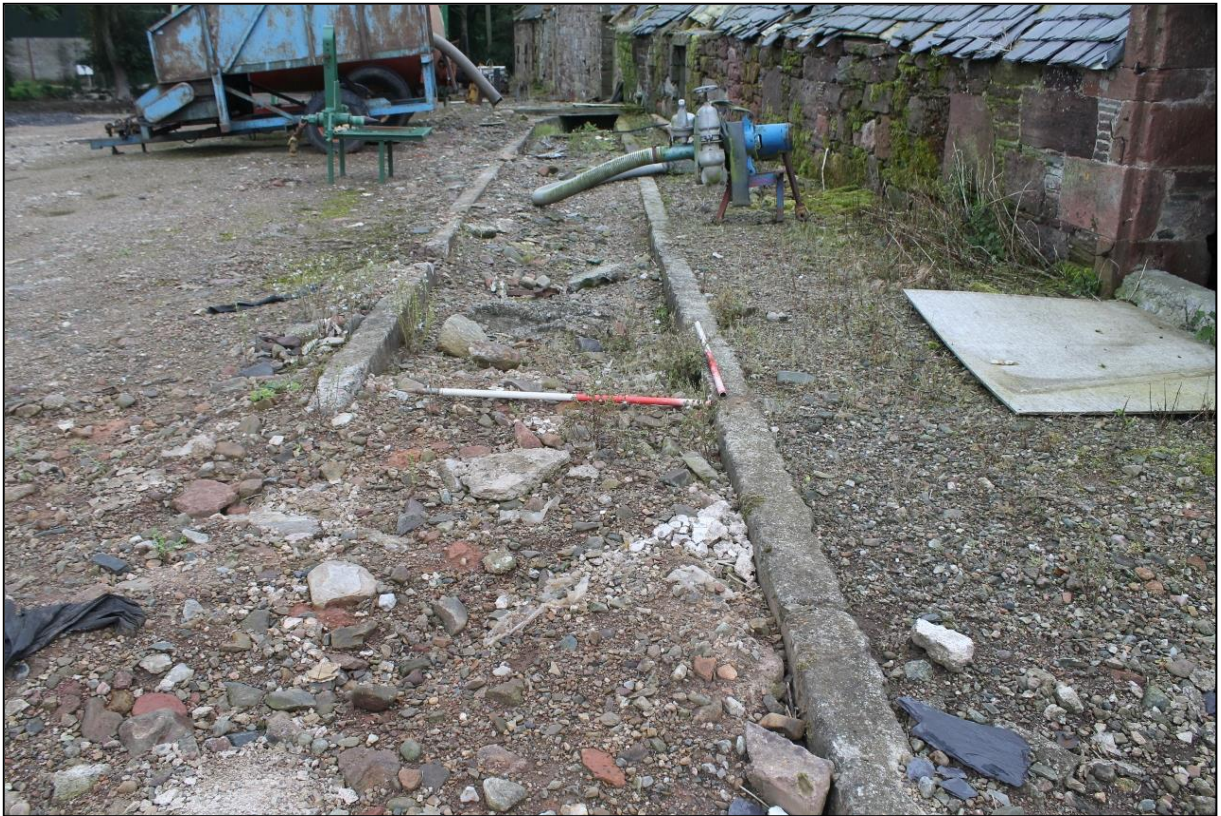
Figure 16a: The infilled lade to the northeast running along the side of the North Barn
