Mill of Kincardine Farm, Aberdeenshire: Archaeological Mitigation

Data Structure Report

issued 4th September 2017

RATHMELL  
ARCHAEOLOGY LTD

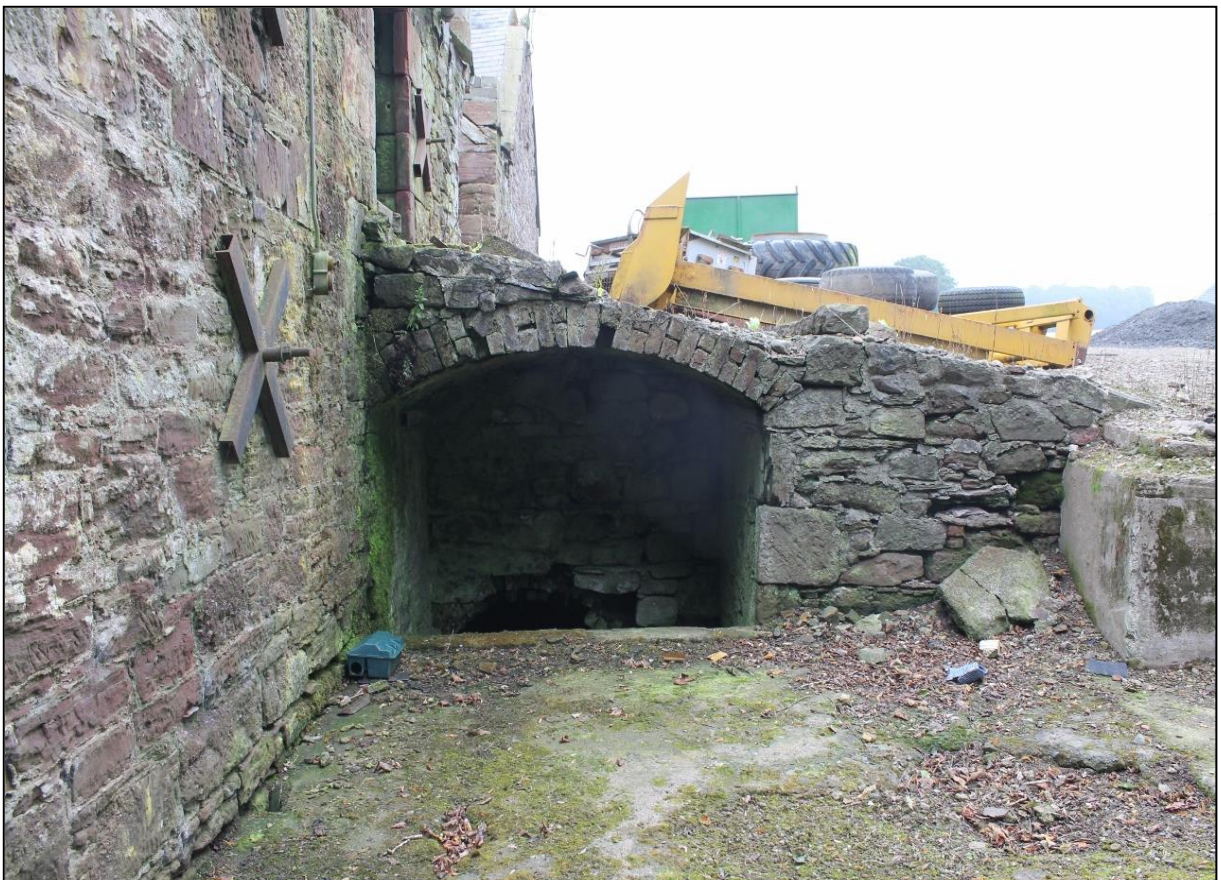
Figure 16b: Access into the underground part of the lade that runs along the side of the South Barn.

22. The northeast elevation has one small doorway which has been blocked using sandstone and two doorways; one which has been blocked using breezeblocks. Both provide access to the upper floor (Figure 14a). It is along the northeast side of both the North and South Barn that the infilled lade (Figure 16a) and the underground course of the lade (Figures 16b, 17a & 17b) that would have originally provided power to the mill is located.

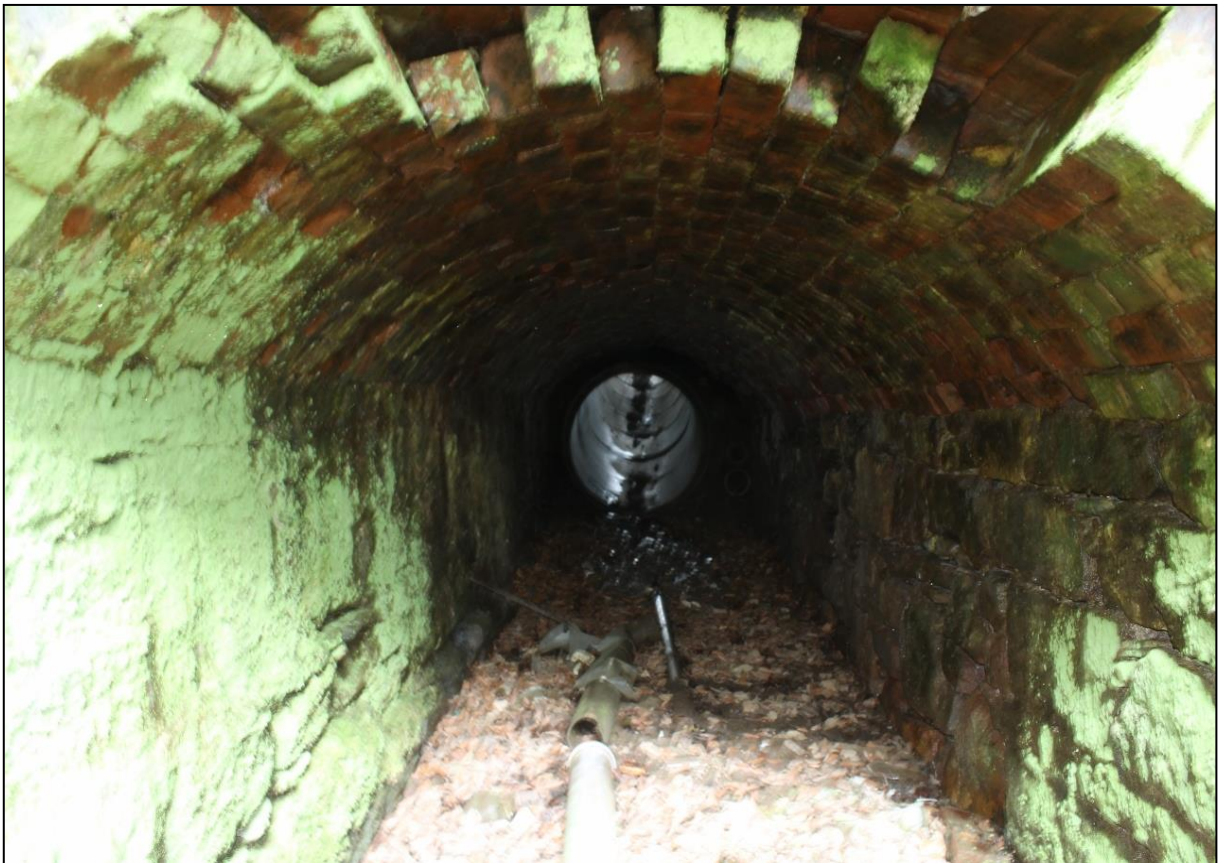
Figure 17a: The earlier, possibly 19th century tunnel for the lade.

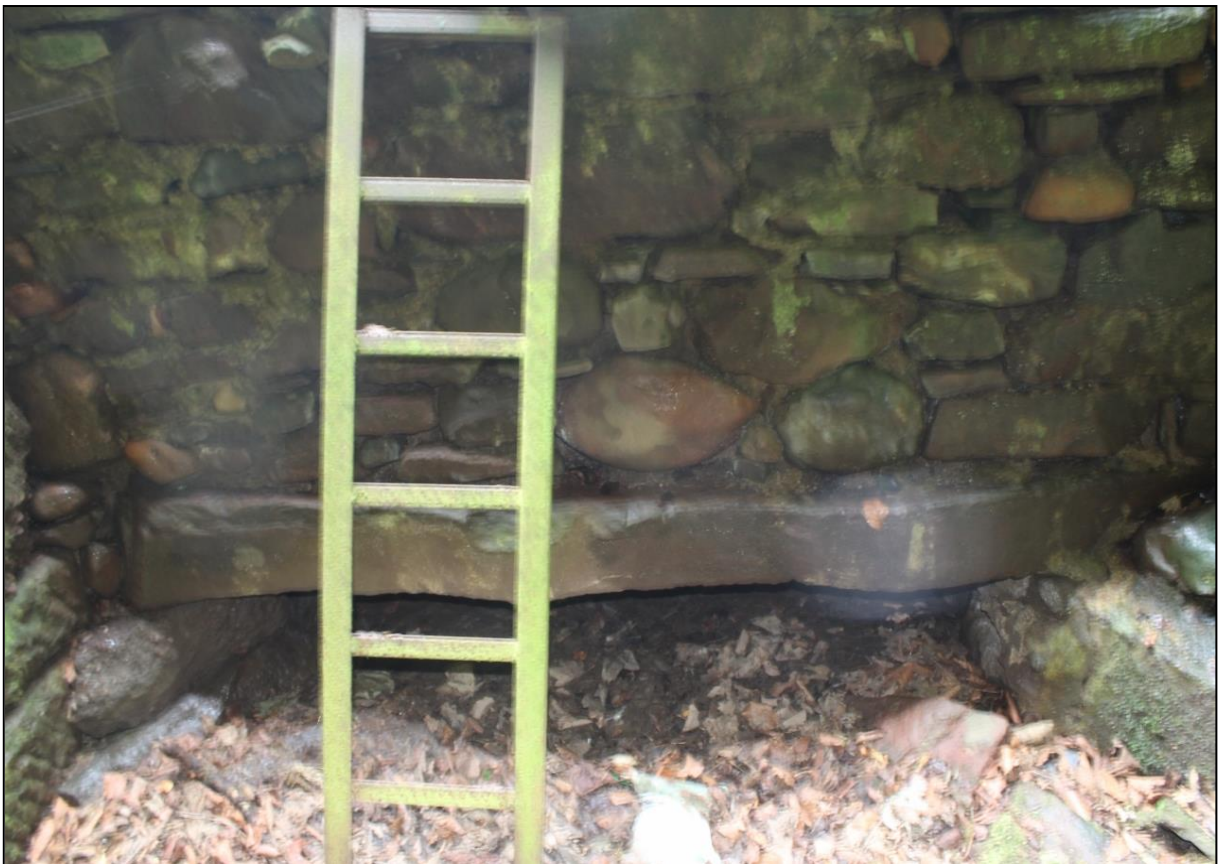
Figure 17b: The southeast exit for the lade.
