March Cottage, Toward: Archaeological Evaluation

Data Structure Report

by Douglas Gordon

issued 30th May 2007

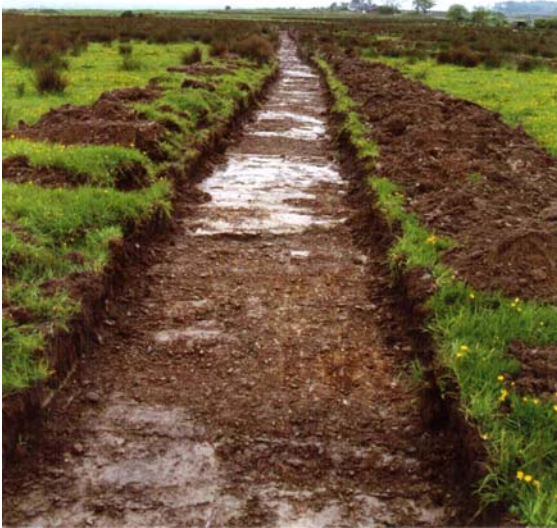
Figure 2a: Trench 1

Orientation:	East to West
Size:	2m by 107.7m (215.4m ²)
Topsoil depth:	120mm to 240mm
Subsoil character	Subsoil (102), a light grey brown clay with gravel, is present for the first 74m of the trench before being replaced by subsoil (104), a mottled orange grey sandy gravel.
Modern features:	Stone rubble field drain (103) runs NE-SW across the trench at 30.2m till 34.5m. Measures 0.5m wide with sub-angular and sub-rounded stones \leq 180mm. Stone rubble drain (103) also runs NNE-SSW across trench at 71m and at 103m. Stone rubble drain (105) runs ESE-WNW along trench from 73.5m till 97m. Measures 0.13m wide.
Significant features:	None
Artefacts:	None

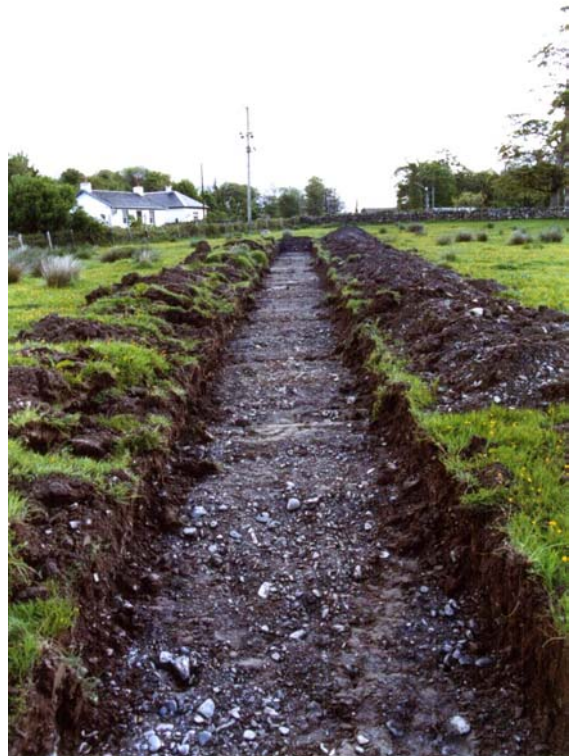
Figure 2b: Trench 6

Subsoil character: Subsoil (110), a moderately compact medium sized grey gravel, is present in trench until 19m where it is replaced by subsoil (102), a light grey brown clay with gravel.

Modern features: Stone rubble field drain (105) runs WSW-ENE across trench from start of trench until 4.5m and NW-SE across trench at 7m. Measures 0.13m wide.

Significant features: None.

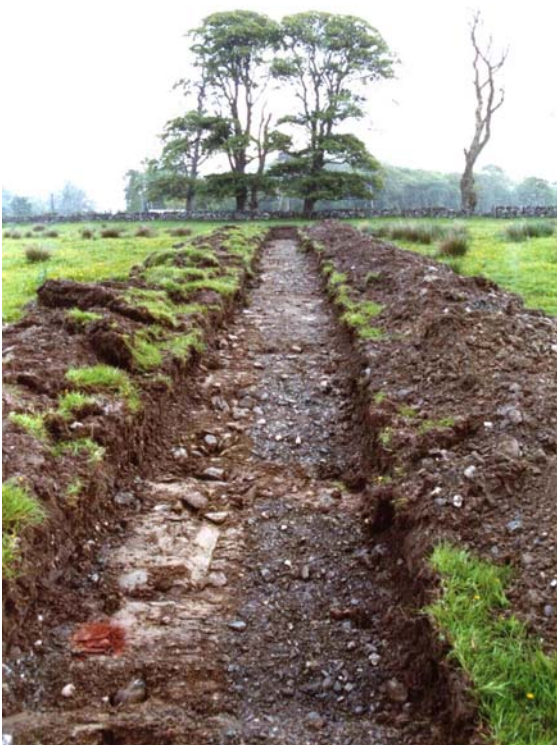
Figure 2c: Trench 7

Subsoil character: Subsoil (110), a moderately compact medium sized grey gravel, is present along whole of trench.

Modern features: Stone rubble field drain (103) runs WSW-ENE across trench from the start until the end of the trench, and runs N-S across trench at 5m and at 40m. Measures 0.5m wide with sub-angular and sub-rounded stones ≤ 180mm.

Significant features: None.
