Bowerwalls Place, Barrhead: Archaeological Watching Brief

Data Structure Report

on behalf of Scottish Water

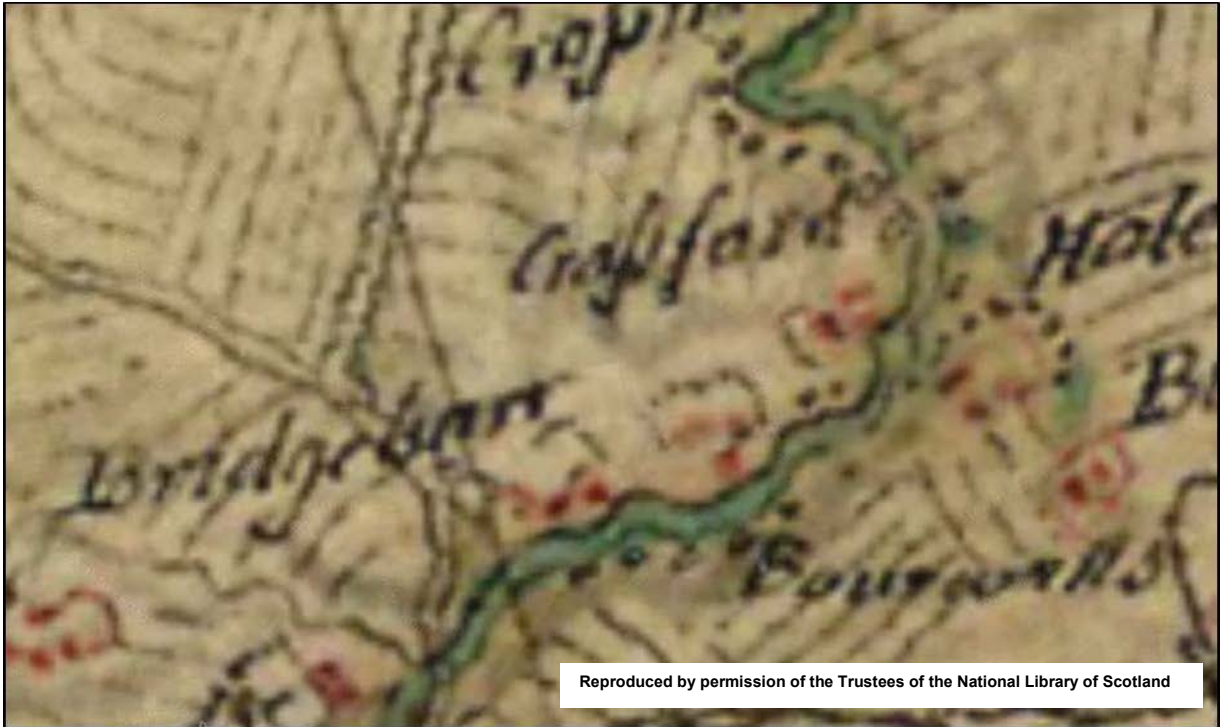
8. Roy's Military Survey of Scotland of 1752-55 (Figure 1a) provides the earliest sound mapping of the development area. This shows the curving path of the Lavern Water as she flows N with a series of small settlements of fermtouns on her W bank. From the S they run Bridgebarr, Bourwalls and Crossford – the last opposite Hole on the E bank. There is then a significant gap in the settlement pattern of the W bank before Crossmill (lying to the N of the development area). The ground within the meander of the river is depicted as open arable fields bounded to the W by the road running N to Glasgow.

Figure 1a: 1752-55 Roy's Military Survey of Scotland

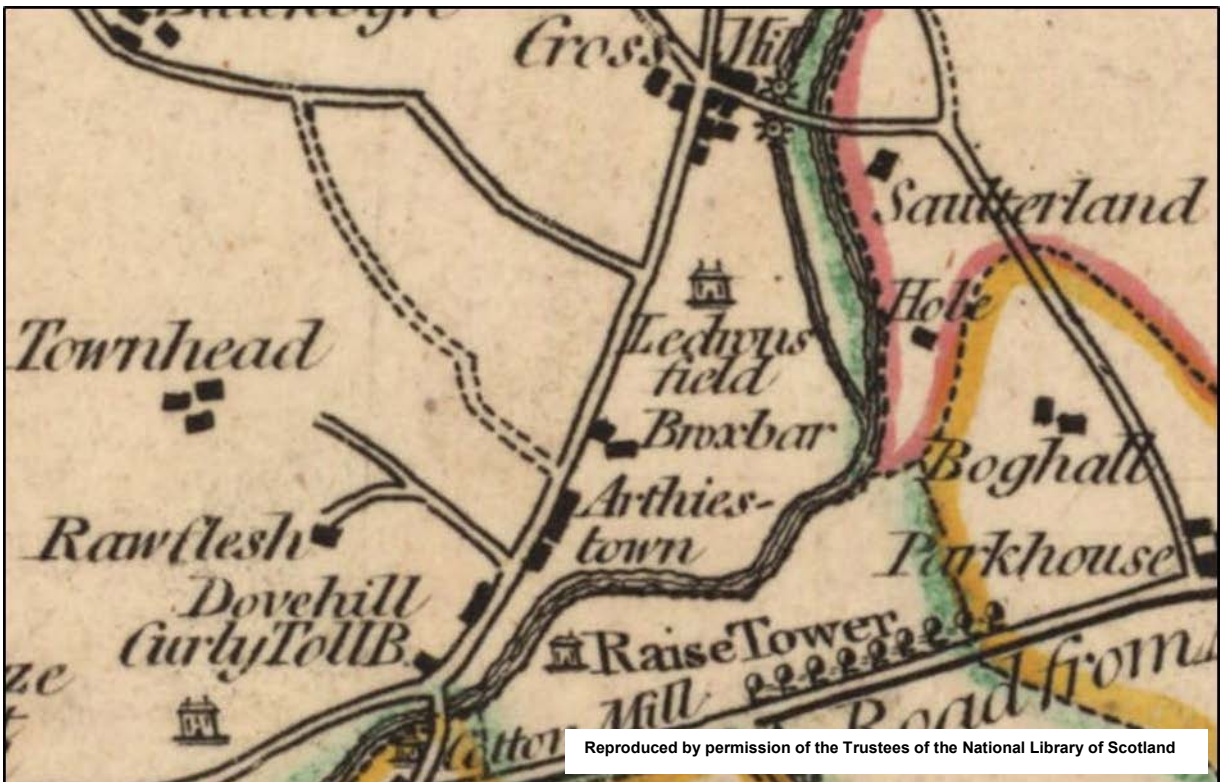
9. By the late 18th century, Ainslie's map (Figure 1b) shows a transformed landscape. The road N to Glasgow has been realigned, sitting now further E running the shortest path to Crossmill. The two of the settlement sites on the W bank, Bourwalls and Crossford, appear to have been cleared with a mansion house established set back from the bank (presumably with grounds) named Ledronsfield. The third bank-side settlement appears to have spread into a linear form along the realigned round, its southern element named Arthiestown and slightly to the N, Broxbar.

10. Ainslie's map also shows the industrialisation of the Renfrewshire landscape, with a mill lead shown taking water off the Lavern Water to carry it to Crossmill to the N. This mill lead is consistently depicted in the subsequent historic Ordnance Survey maps (Figures

Figure 1b: 1796 Ainslie's Map of the County of Renfrew

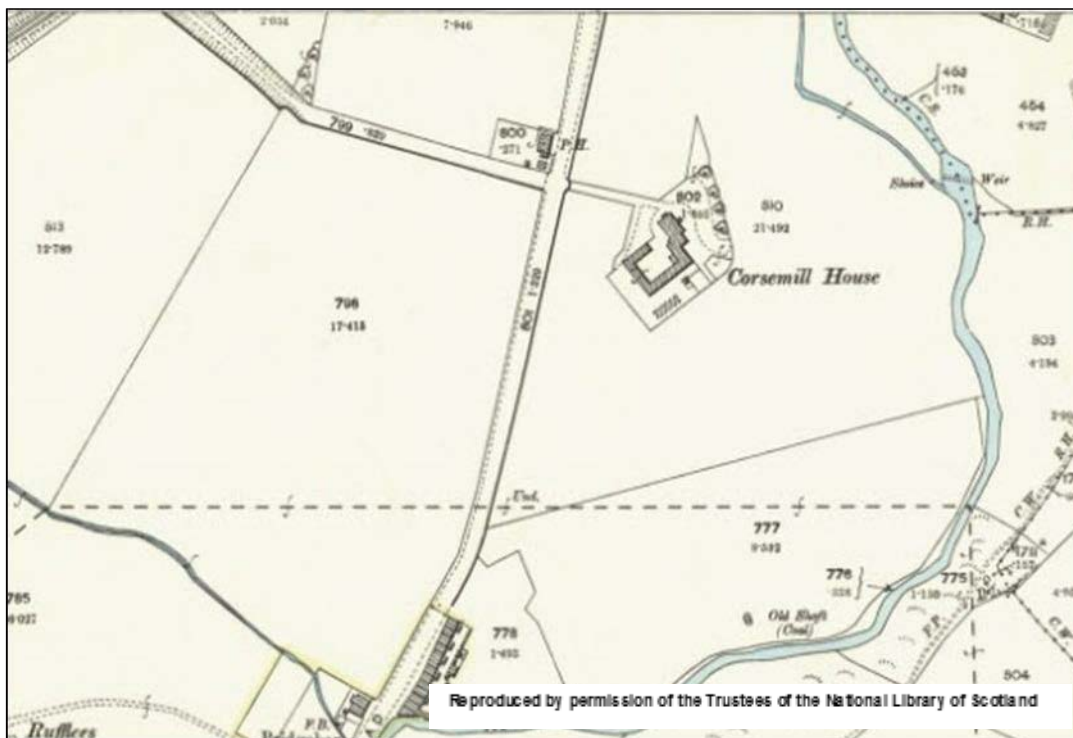
Figure 2b: 1897 2nd edition Ordnance Survey

13. Some riverbank development is shown, the mid 19th century an 'old shaft (coal)' (see Figure 2b) while a Sewage Works is established by the early 20th century (Figure 2c), expanded by the mid 20th century when housing is built to the S of Crossmill Farm (see Figure 2d). All these developments are within the area that would become Crossmill Business Park.

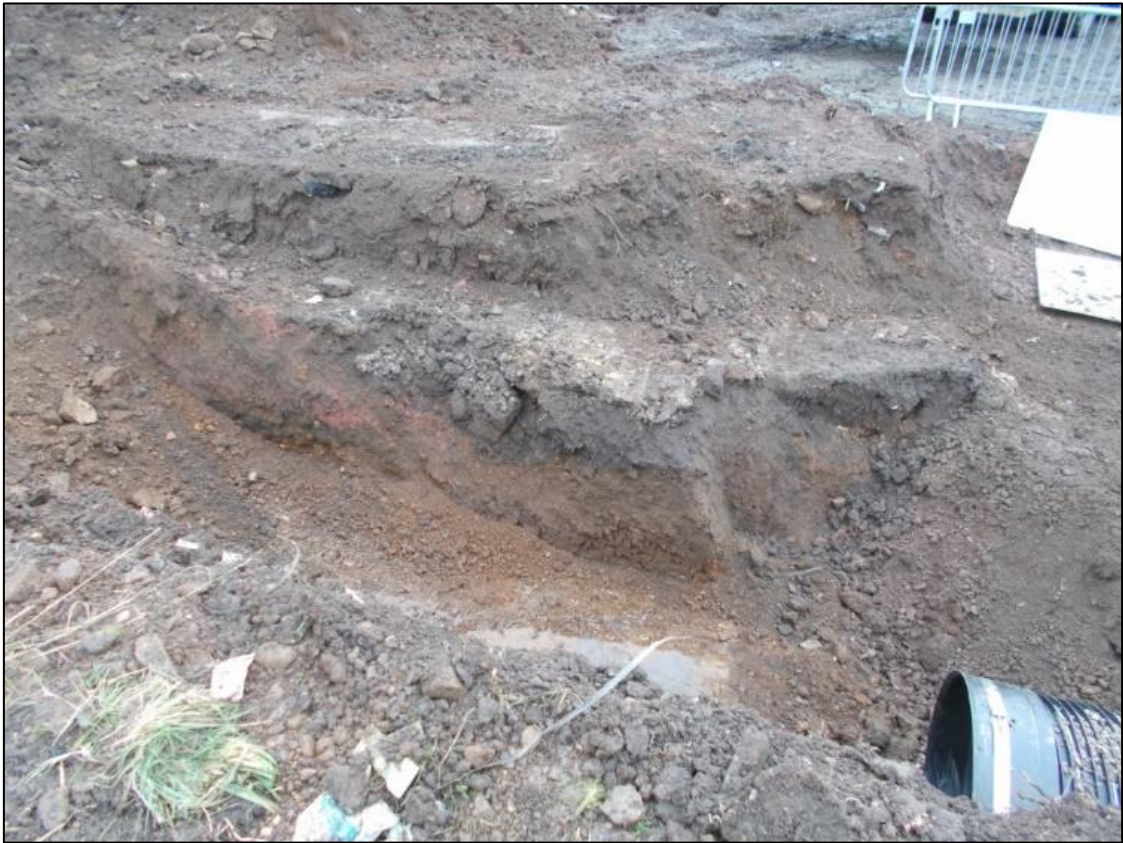
19. Underlying both the topsoil (001) and the tarmac surface (005 and 006) in Areas A and B was layer (002) a firmly compacted layer, mid to dark orange brown sandy silt/clay with very frequent stone and gravel and occasional to moderate plastic and CBM inclusions. This layer had a depth range of between 0.1-0.15m. A number of complete and fragmentary glass bottles (Find <001>) were recovered from this layer throughout Area A. Beneath this layer (002) were a number of similar type layers, (003), (007) and (011) (Figure 5a):

- ❖ Layer (003) consisted of moderate to firmly compacted, dark orange brown silty clay with occasional gravel, CBM, stone and occasional to moderate root inclusions;

- ❖ Layer (007) consisted of moderate to firmly compacted, dark brown grey/grey clay with occasional to moderate CBM, moderate stone inclusions and very occasional plastic fragments; and

- ❖ The final layer (011) beneath (002) consisted of moderate to firmly compacted, dark brown grey/grey clay with occasional to moderate CBM and large sandstone blocks, moderate stone inclusions and very occasional plastic fragments.

Figure 5a: View of layers (001-003) with in pipeline trench in Area A. From the SW.

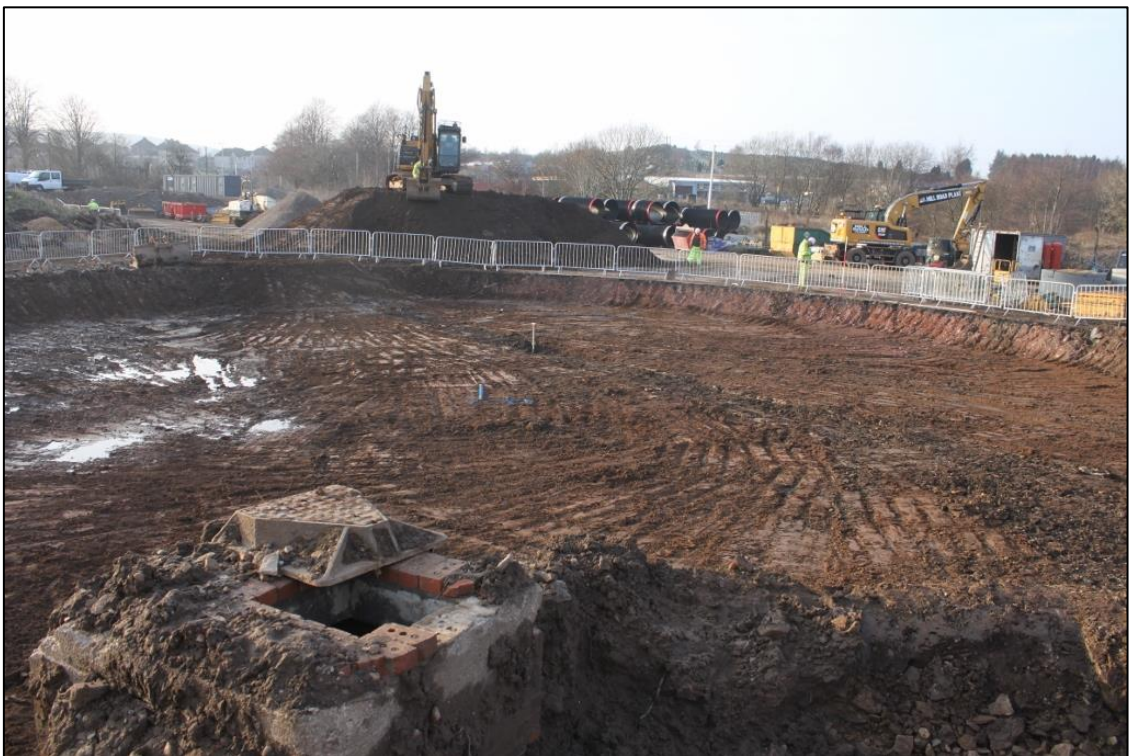
21. One linear feature (013) was identified within the footprint of the storm tank which cut into layers (003) and (010) (Figure 5b). This feature ran in a west southwest to east northeast direction for 30m then in a southeast to northwest direction for 16m within the excavated part of the storm tank. The feature consisted of a 1.4m wide trench whose sides were lined with roughly shaped sandstone blocks (0.4m x 0.2m x 0.15m in size). The linear was filled with moderately compacted, dark brown grey clayey silt with frequent modern 20th century CBM inclusions. Located at a depth of 0.3m within this fill, and running between the sandstone block linings, was a ceramic red pipe which had a diameter of 0.3m (Figures 4 and 6a).

Figure 5b: View of 20th century drainage and pipe (013) within storm tank excavation. From the ESE

26. The only feature identified during the monitoring of the site was the substantial stone lined trench and its associated ceramic pipe (013). The fill within this features trench and surrounding the pipe contained 20th century CBM material and may represent a later reuse of the stone lined feature. It seems likely that both phases of this feature were in some way associated with either the former Nestle works or the earlier farm possibly as a drainage culvert or pipe for the deposition of waste water into Levern Water though other uses cannot be ruled out.

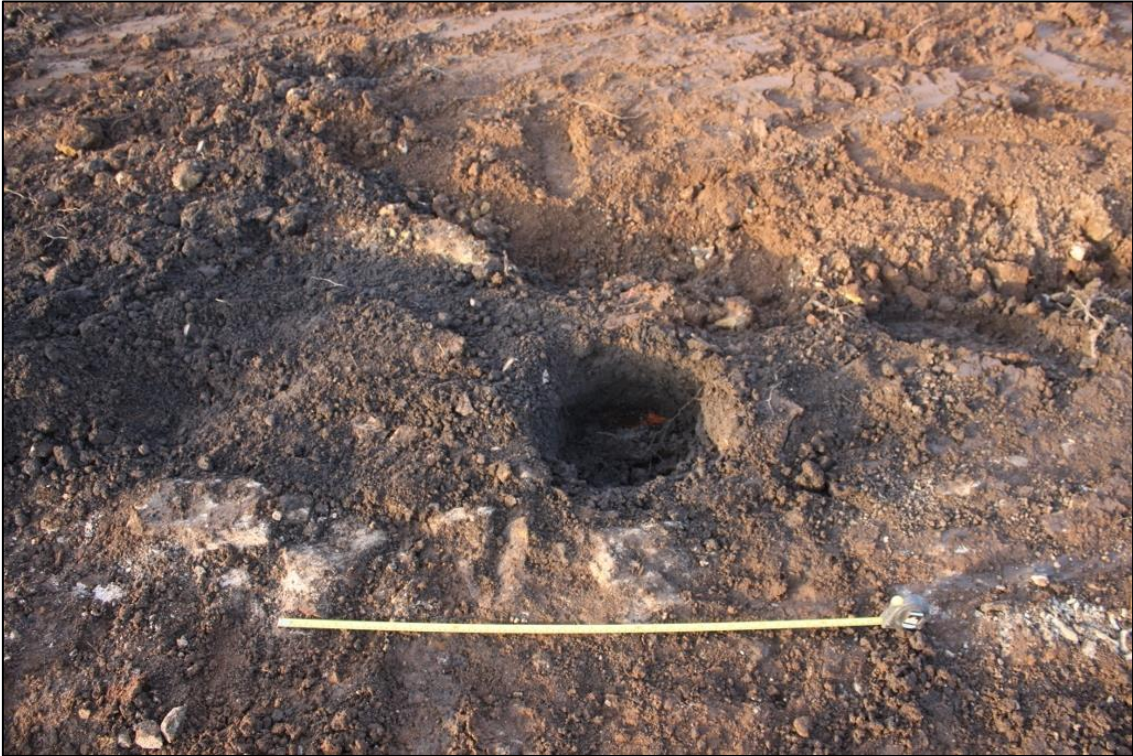
Figure 6a: Close up view of the drainage culvert and pipe (013). From the SSW

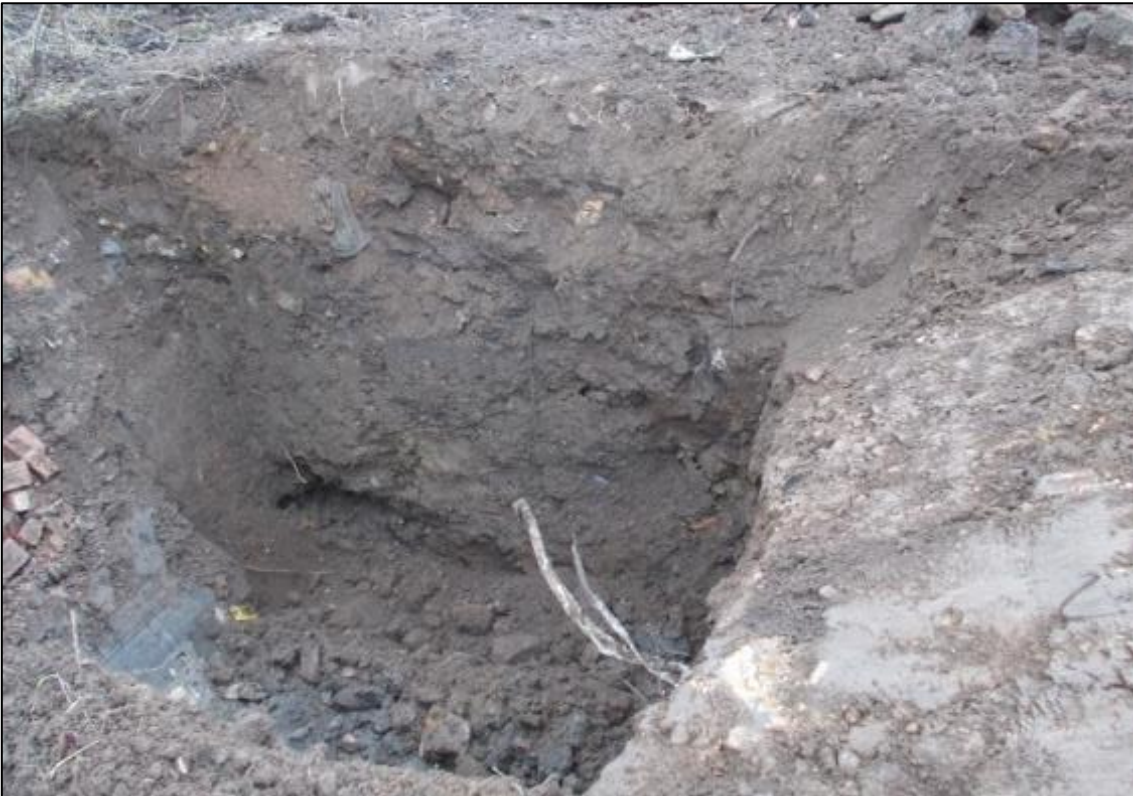
22. There was one main layer (015) (Figure 6b) underlying the topsoil (014) within the southern part of Area B and Areas C-E. This layer consisted of moderate to firmly compacted, mid to dark orange brown sandy silt/clay with frequent stone and gravel and occasional to moderate plastic and CBM inclusions. The layer had a depth range of 0.14-0.18m throughout that part of the site.

23. Beneath this layer lay another (016) which consisted of moderate to firmly compacted, dark brown grey/grey clay with occasional CBM, moderate stone inclusions and very occasional plastic fragments. The naturally occurring subsoil was not identified within this part of the site as the pipeline trench became gradually shallower from the southern part of Area B to the terminus of the pipeline at Area E with a depth range of 2m to 0.9m.

Figure 6b: View of layers (014-016) within the pipe trench in the southern part of Area B. From the WSW.
