**Stronmilchan Mains Rehabilitation,
Argyll & Bute:
Archaeological Watching Brief**

Data Structure Report

on behalf of Scottish Water Specialist Services

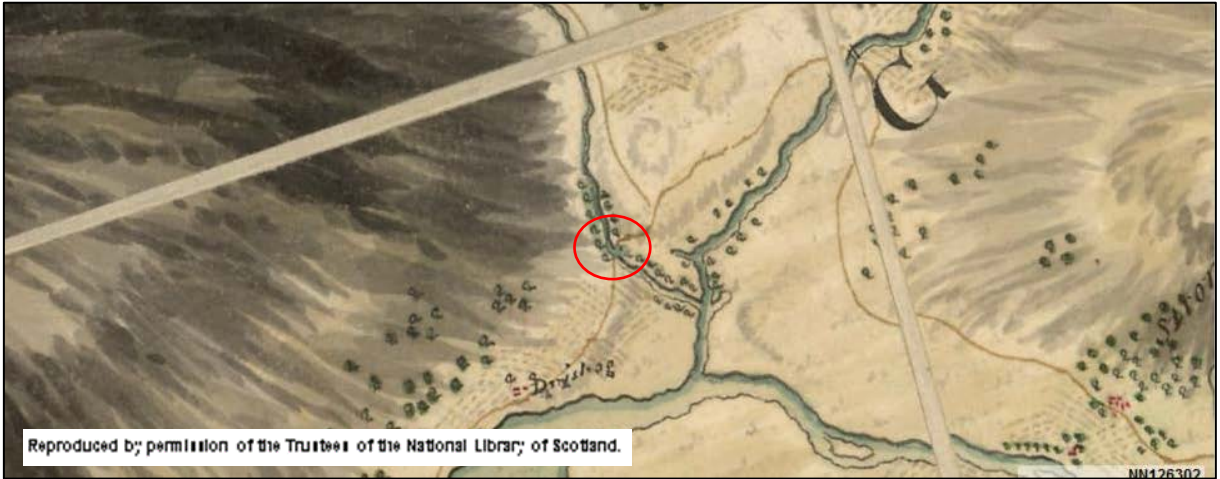
5. A review of the historical mapping reveals that the development area has been dominated by agriculture and has remained largely unchanged. Roy's Military Survey (Figure 1a) shows the road surrounded by open country. The field boundaries seen on both the 1st and 2nd edition of the ordinance survey, surveyed in 1870 and 1897 respectively (Figures 1b and c) are consistent with the present day implying that there has been no change away from agricultural use during this time. The 1st Edition Ordinance Survey map appears to show the road crossing the Allt Mhoille at a bridge, suggesting that the line of the road had moved slightly north to its current location between the 1750s and 1870. By the 2nd edition of Ordinance Survey the bridge can be clearly identified, so the road has definitely moved by this point.

Figure 1a: Extract from Roy's Military Survey 1752-55

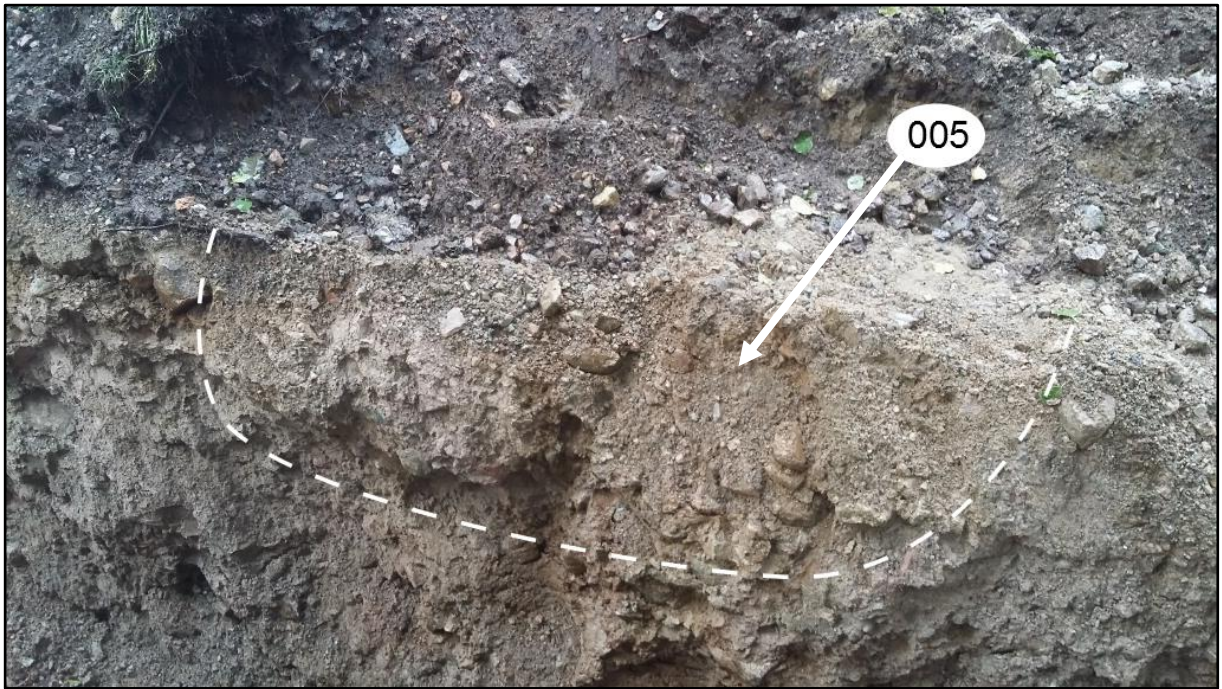
12. One feature of anthropic origins was identified in the northeast stretch of pipe trench. This feature was a gravel deposit, (005), which consisted of moderately compacted, light orange gravel with large rounded cobble inclusions (with an average size of 0.3m x 0.4m x 0.3m). It was located 16m to the northwest of the river (Figures 2a and 2b). The deposit had a thickness of 0.3m and a width within the trench of 2.6m. It underlies topsoil (001) and overlies subsoil (003).

Figure 2a: North facing section showing road (005) to the northeast side of Allt Mhoille. Taken from the north.

16. Only gravel deposits (005) and (007) are likely to be anthropic in origin. The gravel comprising (005) was significantly more compact than the surrounding natural gravel deposits. It contained large sub-rounded stones arranged to form a flat surface. It is likely that this surface was part of the military road from Dalmally and Bonawe built between 1750 and 1754 (Taylor, 1996).

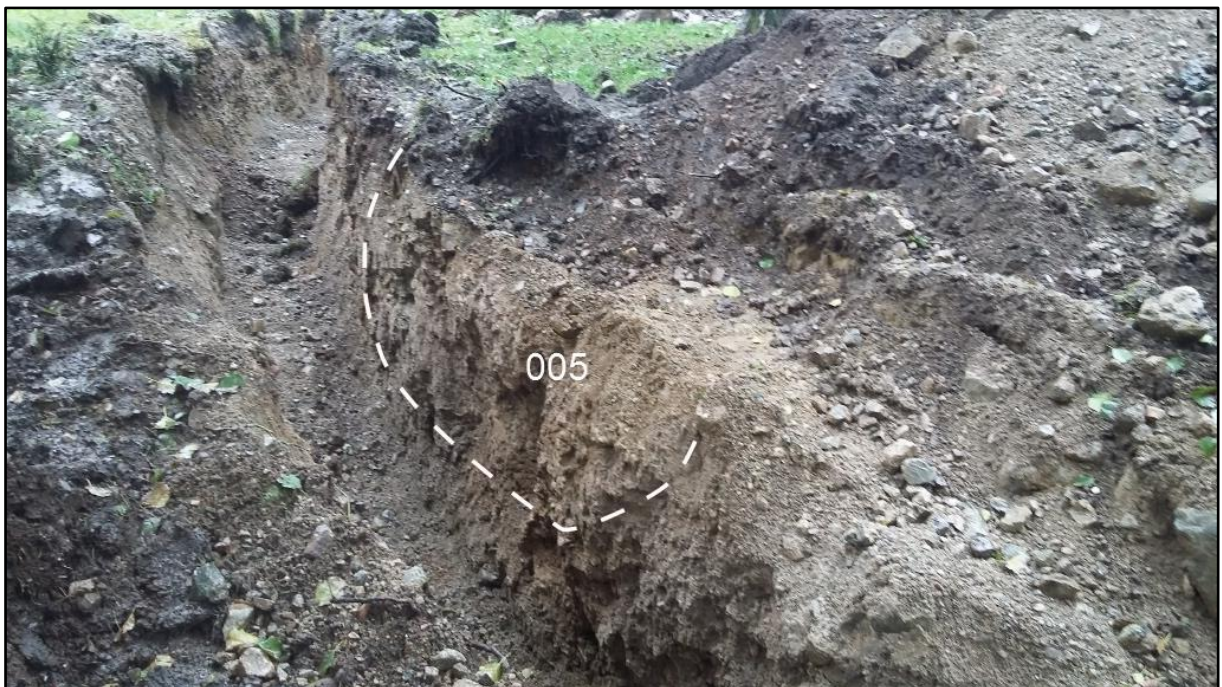
Figure 2b: Post excavation shot of military road (005) to the northeast of Allt Mhoille. Taken from the northwest.

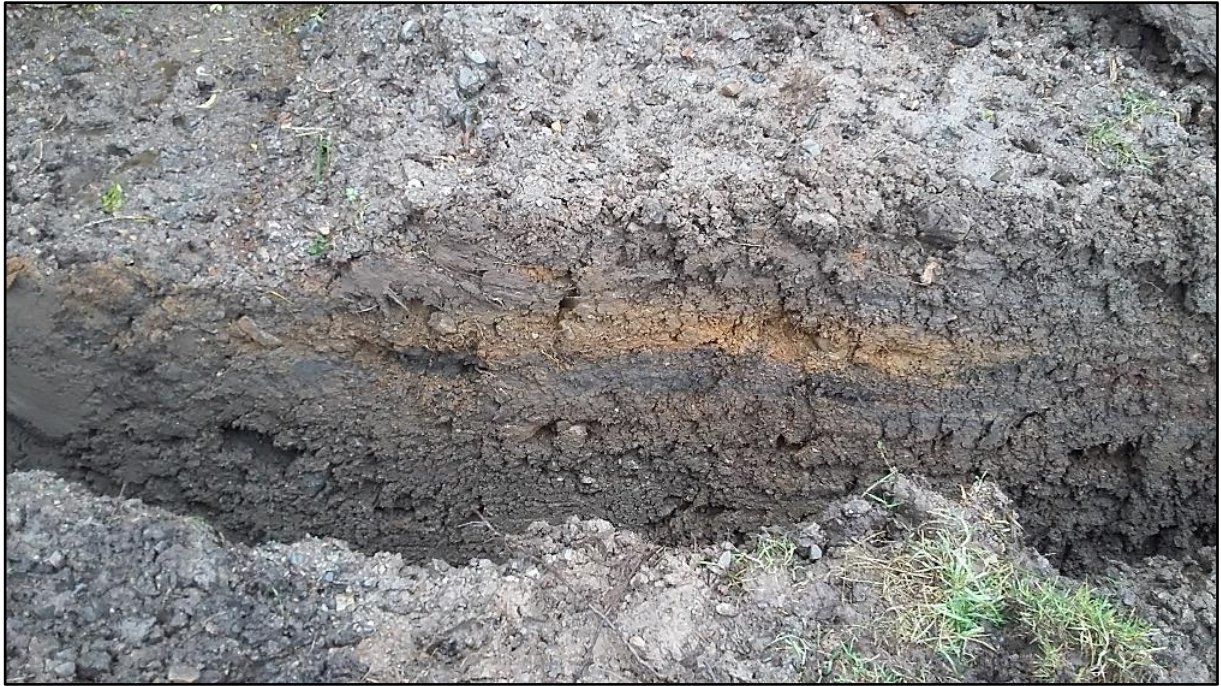
15. Another gravel deposit, (007), similar that identified within the north eastern stretch of pipe trench was identified in the south western stretch close to the modern road. The deposit consisted of moderately compacted, mid orange brown gravel (Figure 3a). It had a thickness of 0.2m and width within the trench of 2.5m. The deposit lay between a peat layer (009) and peat layer (006). Peat layer (009) represents the regrowth of the peat over the anthropic gravel deposit after it fell out of use.

Figure 3a: Post excavation shot of possible military road (007) to the southwest side of Allt Mhoille taken from the southwest.

17. There is a possibility that the thin layer of orange gravel (007) found to the southwest of the stream also represents the surface of the military road. It forms a clear layer in the relatively homogenous peat, showing that it was intentionally laid down. Work carried out on the military road outside the Kings House Hotel in Glencoe found that the road surface had been laid directly onto the peat (Lewis, 2009). Therefore, despite the lack of bedding layer it is still a distinct possibility that gravel deposit (007) represents an 18th century road surface.

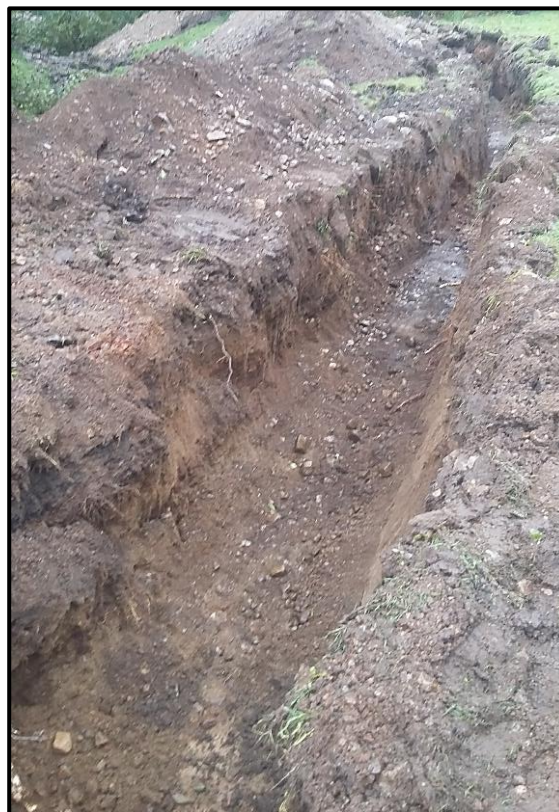
Figure 3b: Post-excavation shot of pipe trench to the northeast side of Allt Mhoille. Taken from the northeast.

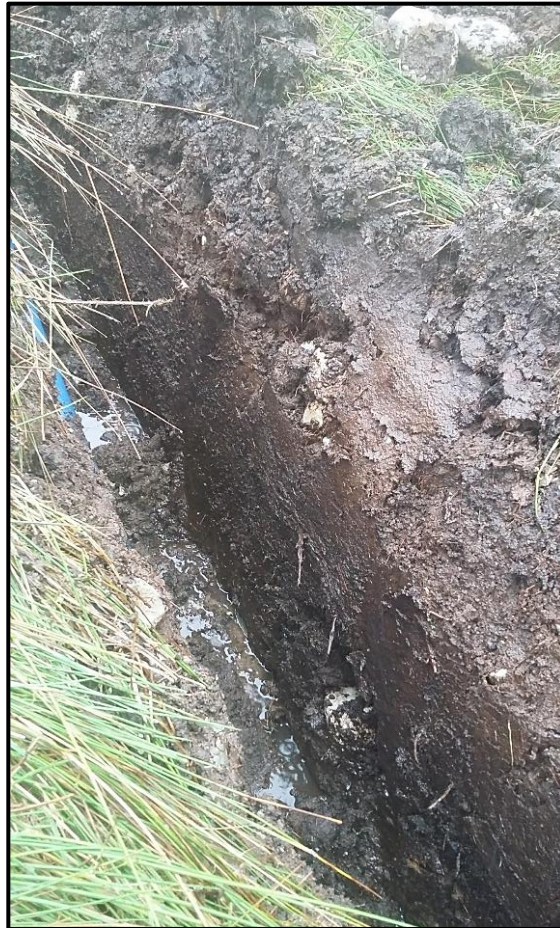
14. The topsoil overlay two naturally occurring subsoil layers, (006) and (008). Peat layer (006) was a loosely compacted and was mid to dark brown in colour. It had occasional sub-angular stone and was excavated to a depth of 1.4m. The deposit was heavily waterlogged. A deposit of loosely compacted light orange gravel (008) underlay (006) in sections.

Figure 4a: Section of trench to the southwest side of Allt Mhoille showing peat (006) throughout section. Taken from the south.

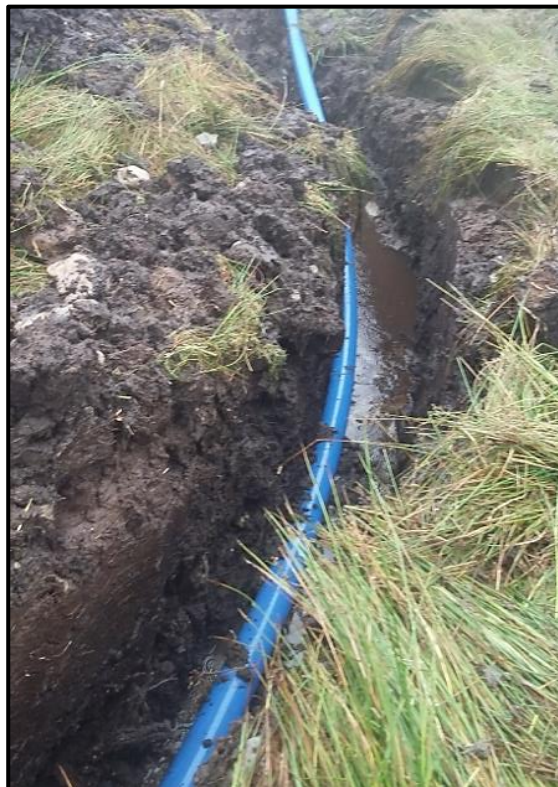
Figure 4b: Post-excitation shot of trench the southwest side of Allt Mhoille. Taken from the west.
