# **Knock Fell Water Main Replacement (SI Works) Galloway: Archaeological Mitigation**

Data Structure Report

issued 8<sup>th</sup> April 2019

on behalf of Scottish Water Shared Solutions

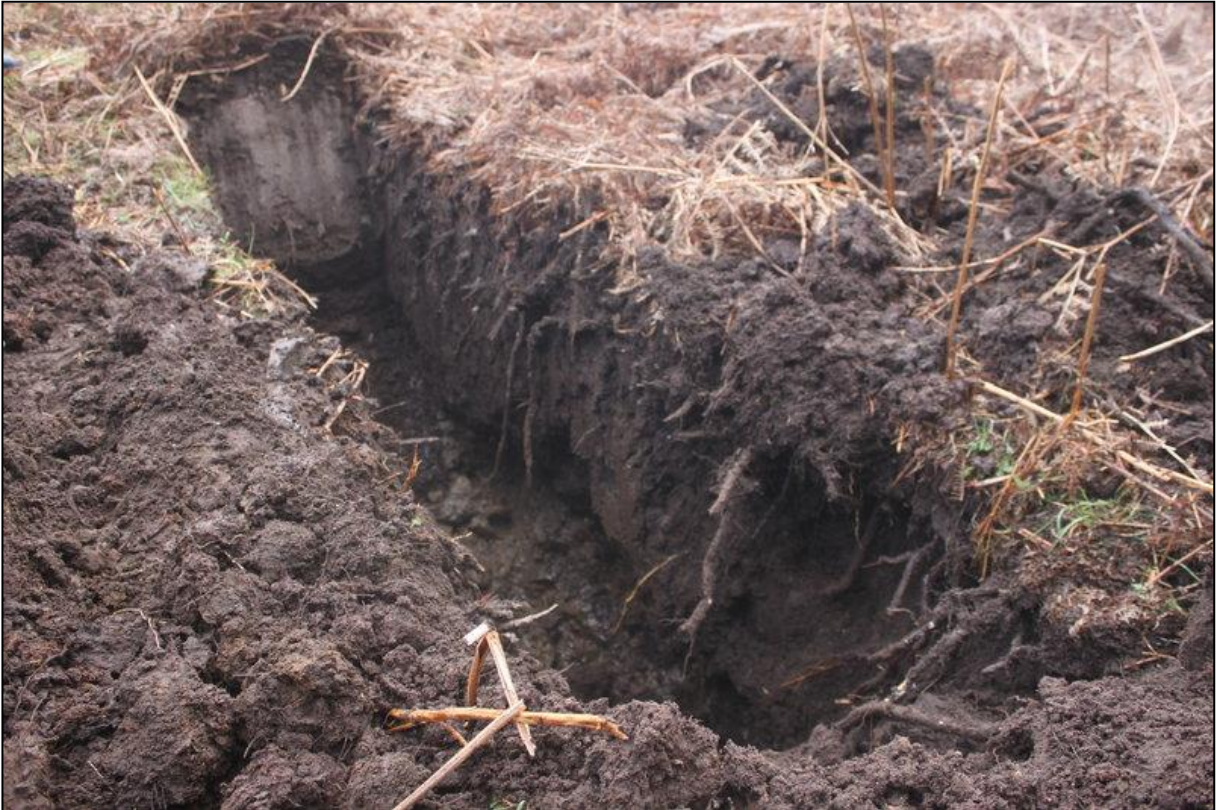
10. Trial Pit 10 was located to the southeast of the track, in an area of rough pasture separated from the track by a post and wire fence (Figure 3). It was oriented northwest-southeast and measured 2.4m by 0.5m. The trial pit was 1m deep. It was excavated through dark brown peaty topsoil (005) with frequent root inclusions. This was underlain by greyish orange clay with medium to large stone inclusions (006) at a depth of 0.5m. This was in turn underlain by grey bedrock (004) at 1m (Figure 1a).
11. Trial Pit 11 was located to the immediate north of the track (Figure 3). It measured 2.8m by 0.7m and was 1.05m deep. The trial pit was oriented northeast-southwest. It was excavated through dark brown clay sand topsoil (007). This was underlain by a yellow brown clay subsoil with frequent stone inclusions (008) at a depth of 0.3m. This was in

turn underlain at 0.72m by a grey orange clay with medium to large stone inclusions (006). The full extent of this deposit is not known as the trench was terminated at 1.05m.

Figure 1A: Post-excavation shot of Trial Pit 10 from the south.

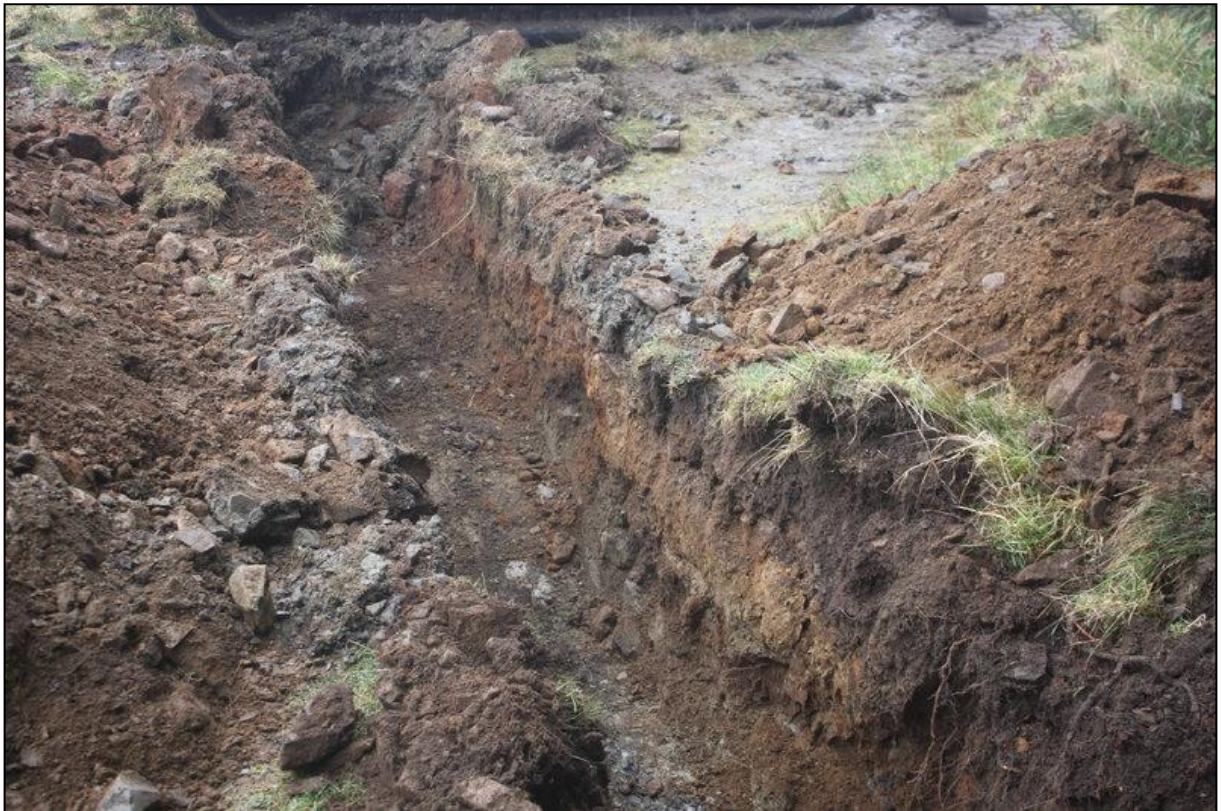
14. Slit Trench 1 ran northeast-southwest across the line of the modern forestry track between NX 27019 54627 and NX 27104 54599 (Figure 3). It was 5.2m long by 0.7m wide and 0.75m deep. The trench was excavated through road surface (001), a loose grey subangular aggregate gravel with occasional root inclusions. It was 0.15m deep and found in the southwestern 1.6m of the trench. The north-eastern 3.6m of the trench was cut through moderately loose dark brown clay topsoil with frequent root and stone inclusions (002) to a depth of between 0.2 and 0.55m (Figure 1b).

15. Both road surface (001) and topsoil (002) were underlain by disturbed subsoil (003), a moderately compact grey orange clay with small stone inclusions. This continued to a depth of 0.5m and was underlain by moderately compact greyish orange clay with frequent medium to large stones (006) to a depth of 0.75m. This was underlain at 0.75m by grey bedrock of the Gala Unit 4 – Wacke type (004).

Figure 1B: Post-excavation shot of Slit Trench 1 from the east.

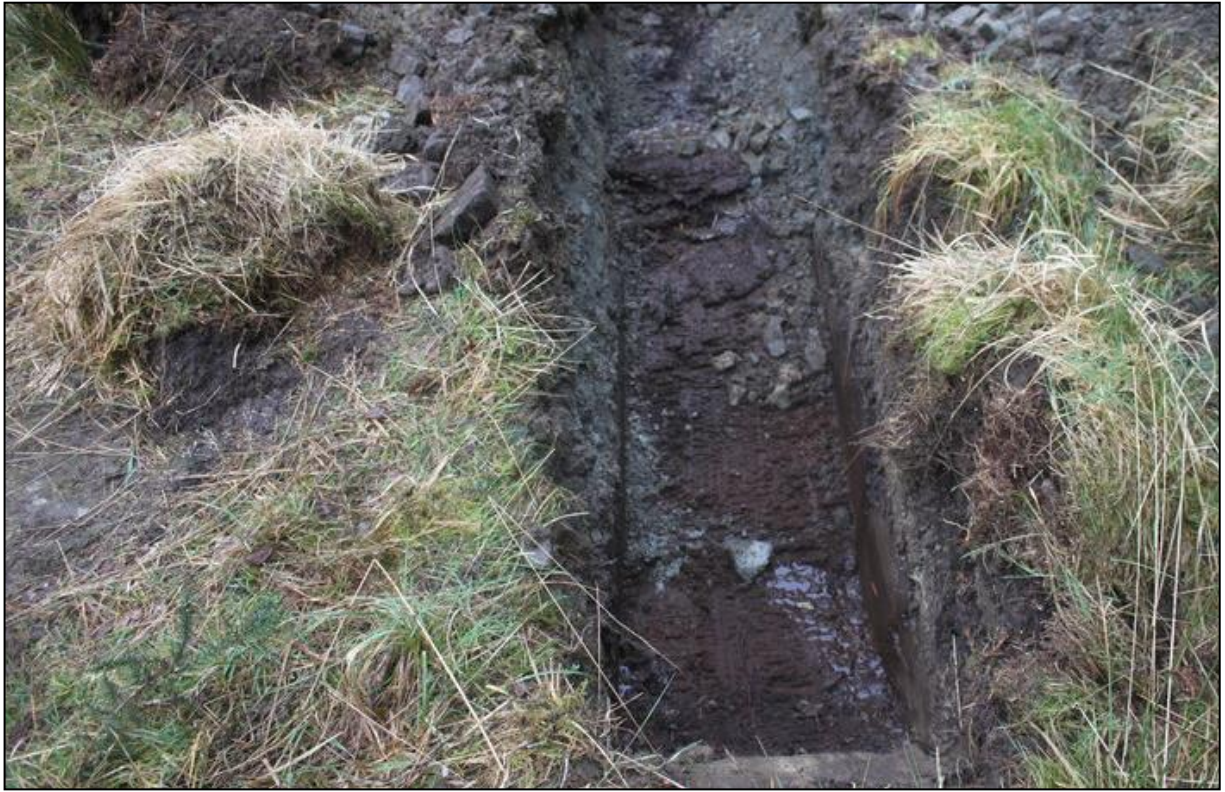
16. Slit Trench 2 ran north-south across the track between NX 27426 54732 and NX 27425 54729 (Figure 4). It measured 3.2m long by 0.7m wide. It was 0.6m deep. The trench was excavated through road surface (001) and dark brown clay topsoil (009) with small stone and root inclusions. (001) was 0.4m thick and (009) 0.3m thick. (001) and (009) were underlain by (010), a pale yellow clay with no inclusions. It was 0.1m thick. (010) was underlain at a depth of between 0.36 and 0.46m by (011), a firm dark brown peat deposit. The full extent of this deposit was not known but it was excavated to a depth of 0.6m (Figure 2a).

Figure 2A: Post-excavation shot of Slit Trench 2 from the north.

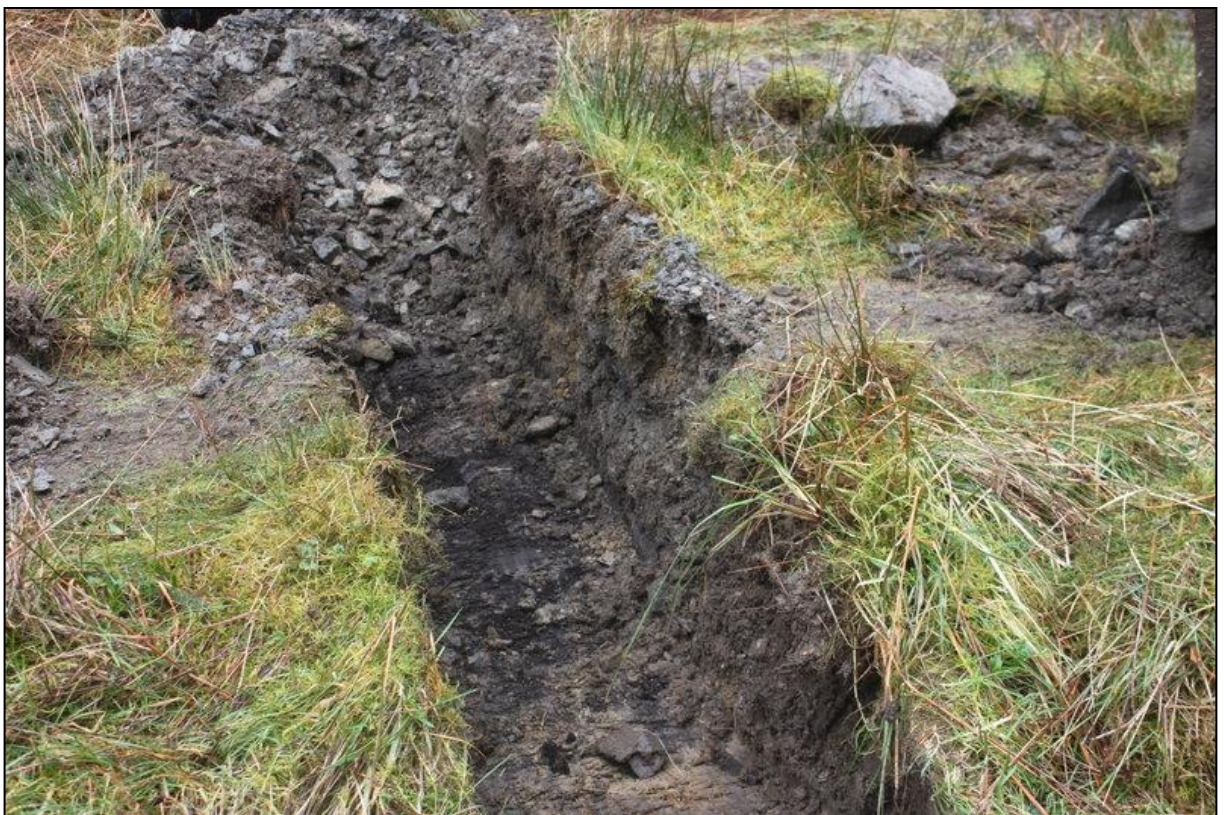
17. Slit Trench 3 ran north-south across the track between NX 27899 54785 and NX 27899 54811 (Figure 4). It was 3.2m long by 0.7m wide. The trench was 0.43m deep. It was excavated through overgrown modern road surface (001) in the southern section of the trench and mid- pink brown clay topsoil (013) with small stone inclusions in the northern 0.85m. The road surface (001) was 0.3m deep while (013) measured 0.4m deep. Both deposits were underlain by clay (008), which was underlain by peat deposit (011) at 0.43m. The trench terminated when (011) was encountered (Figure 2b).

Figure 2B: Post-excavation shot of Slit Trench 3 from the north.
