Laggan Burn Farm, Dumfries, Dumfries & Galloway

Data Structure Report

issued 20th November 2017

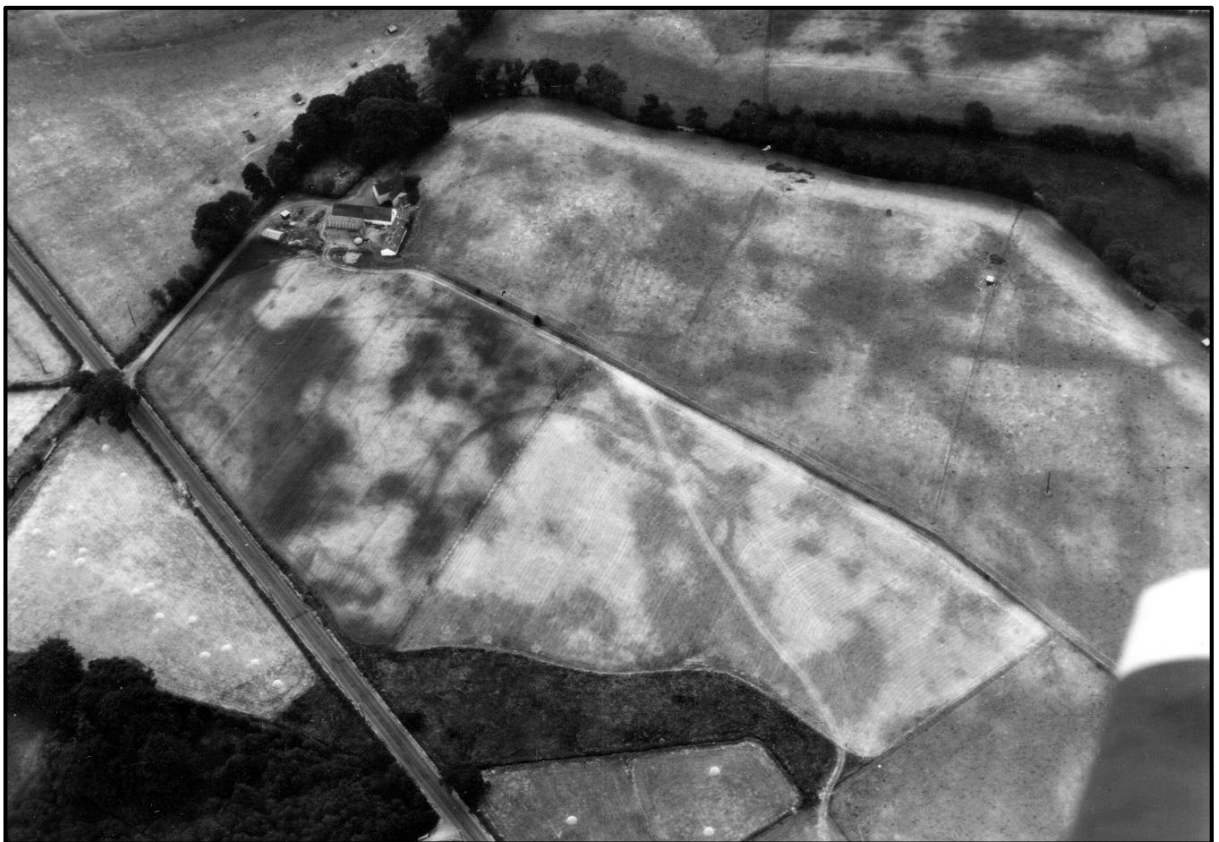
Figure 2: Oblique aerial photograph of cropmark features MDG6412

5. Oblique aerial photography in 1949 (see Figure 2) identified cropmarks depicting an oval enclosure on the ridge to the NW of the farm (see Figure 1). Ground inspection failed to identify any surface features related to this oval enclosure, with the inference made that this is a prehistoric enclosure. Two sides of a further rectilinear enclosure were also identified on the same images, encompassing the modern farm and the ground where the new agricultural building will be sited. This enclosure contained cropmarks indicating rig and furrow agriculture that respected and were aligned with the enclosure, suggesting they were contemporary. While the enclosure remains undated, its form suggests it is post-medieval in origin.

11. Linear features [005], [007], [009] and [011] were all anthropic in nature. The features, [007], [009], and [011] were all furrows which were all part of the rig and furrow system observed in the aerial photography for the area (Figure 2) The found furrows are to the northwest of the boundary indicating that the ploughing seen in figure 2 within the rectilinear enclosure continued outside of it. Feature, [005], was the rectangular drainage ditch observed in the aerial photographic evidence (Figure 3). No material suitable for dating was recovered from any of the features excavated on site. The ephemeral remains of other, similarly orientated, furrows were observed within the excavated area, but were too insubstantial for further investigation.

12. The entire development area seems to have been subjected to modern mechanised ploughing which had substantially reduced the area, meaning that only the features which had cut into the subsoil (003) had survived. The drainage ditch seen in figure 2 was likely to be for demarcating land boundaries as oppose to keeping stock out. It is likely that the ditch was originally accompanied by a low bank but no trace of this has survived in the development area.

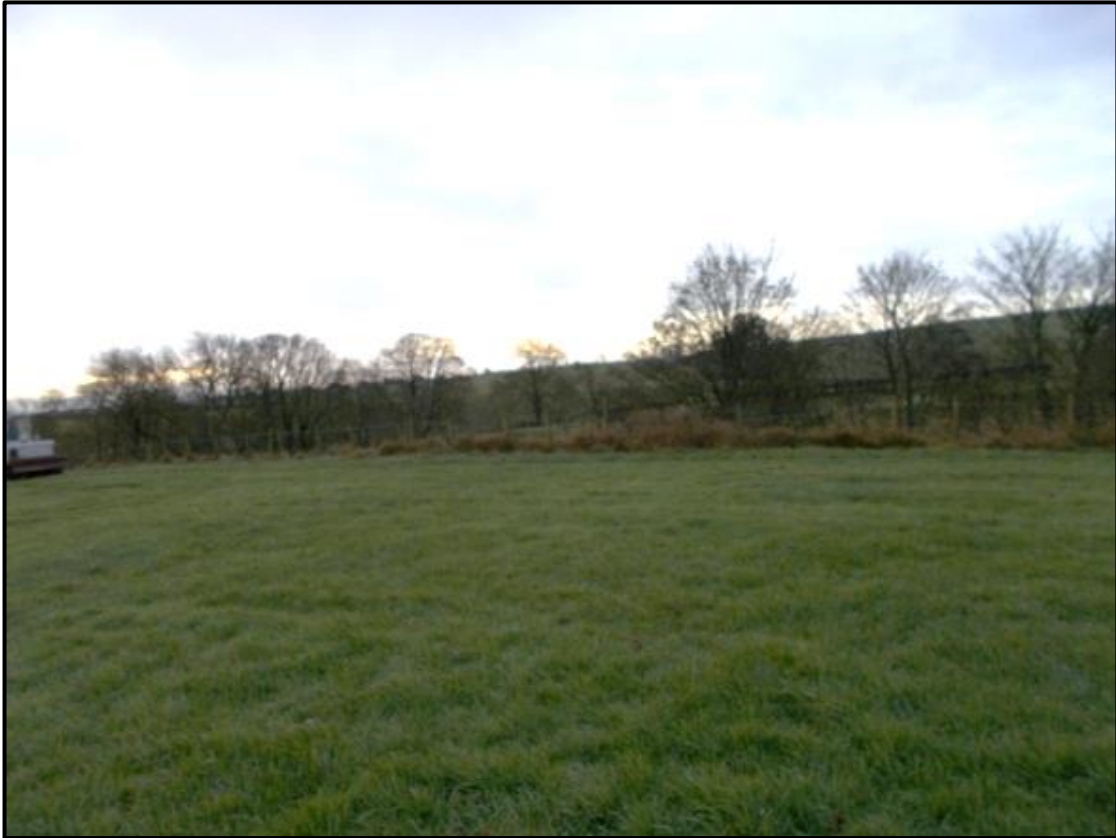
Figure 5: Pre excavation view of development area. From the W.

9. The excavation area lay at the southwest edge of a field above a bank slopping down to the Laggan Burn. The excavation area sloped slightly downhill to the southwest side (Figure 5). Topsoil layer (001) was found throughout the excavation area to a depth of 0.1m. This comprised a loosely compacted, mid-yellowish brown silty sand with frequent roots. Plough soil layer (002) underlay (001) and had a depth of 0.2m throughout the excavation area. (002) was a loosely compacted mid-yellowish brown silty sand with frequent sub-rounded stone inclusions and occasional roots (Figure 6). The natural subsoil (003) underlay (002) throughout the excavation area (Figure 7). (003) was moderately compacted orange gravel with small to medium sub-rounded stones.

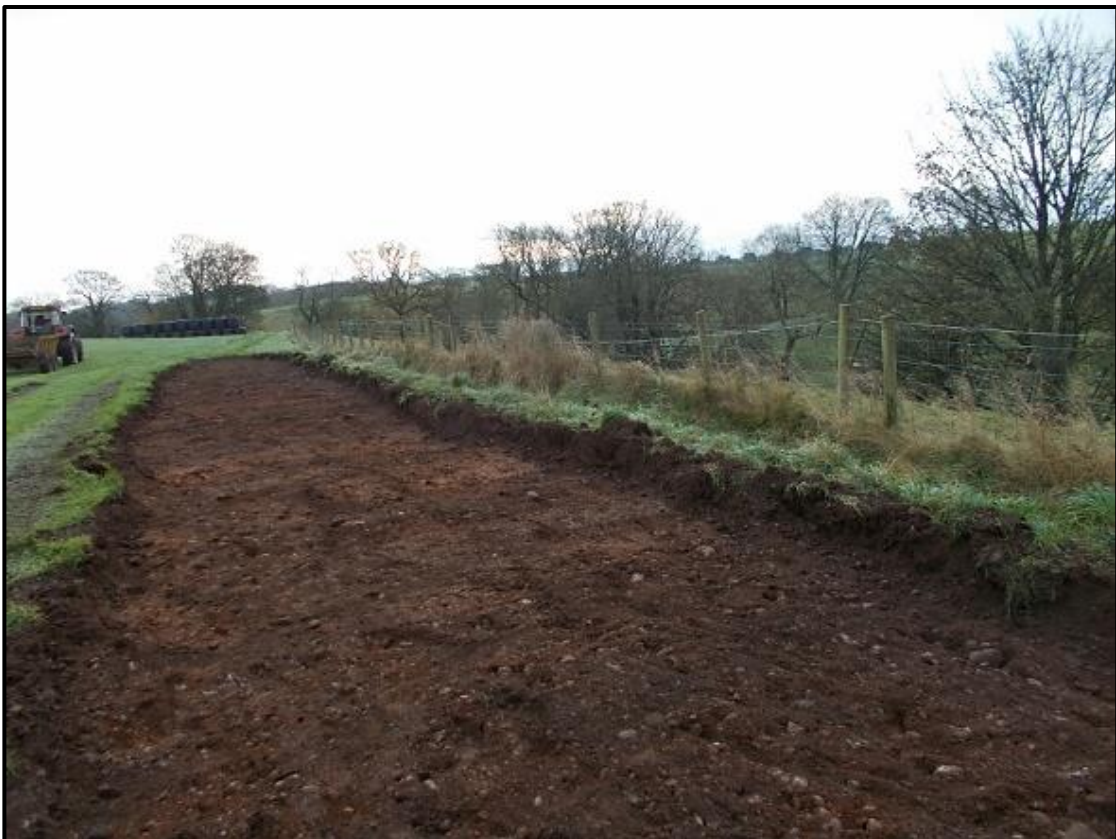
Figure 6: Mid ex-photo of development area showing section. Taken from the N.

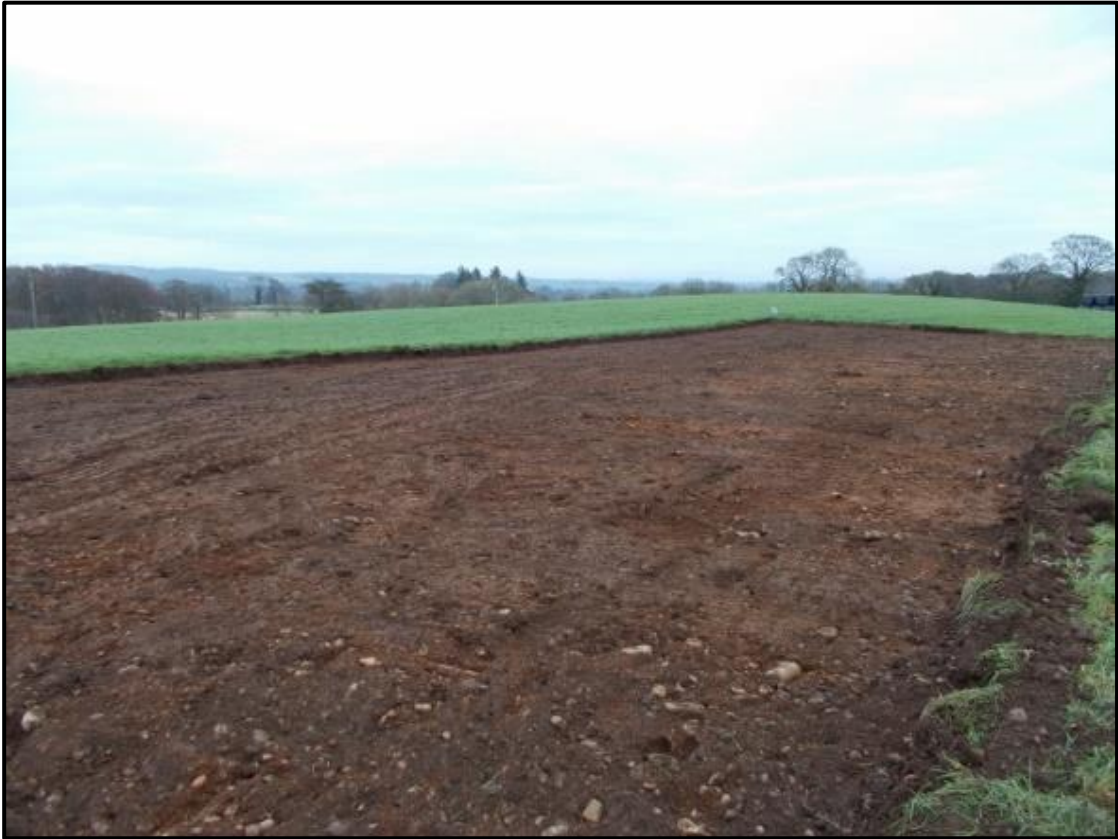
Figure 7: Post excavation view of development area. Taken from the W.

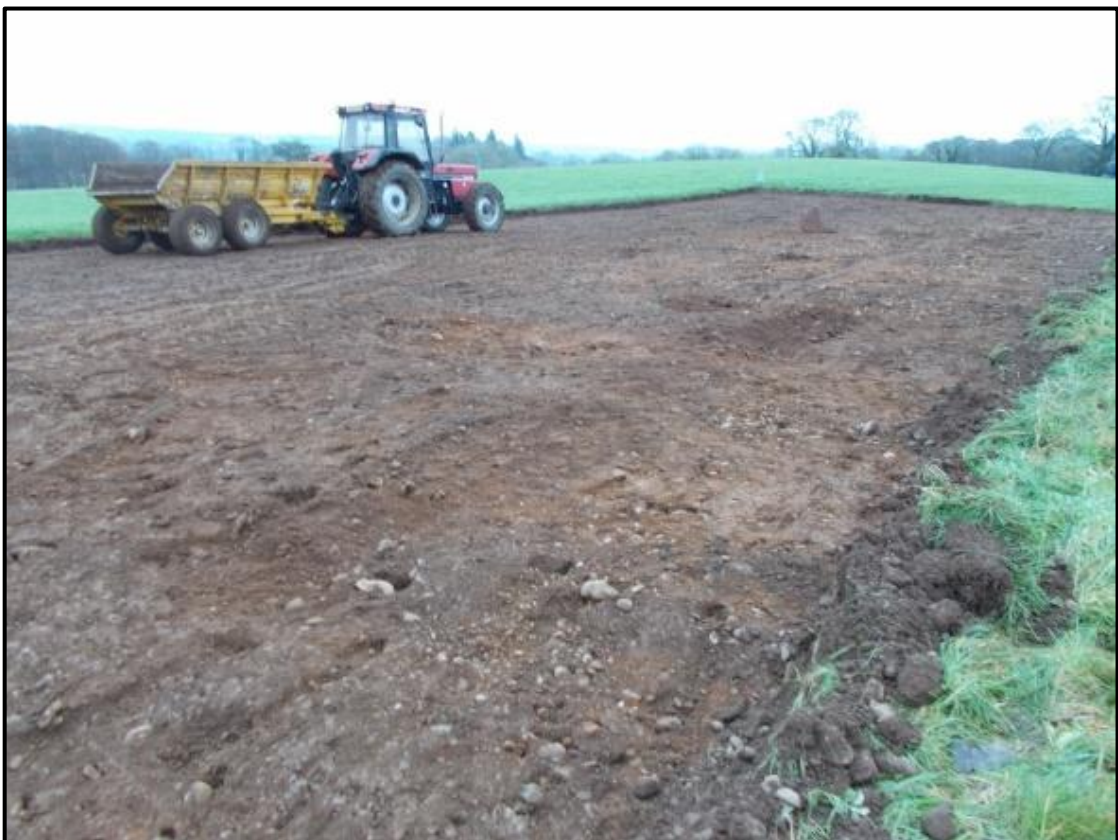
Figure 8: View of rig and furrow and boundary ditch. Taken from the W.

10. Linear anthropic features were found throughout the excavation area with preservation ranging from good to very poor (Figure 8). Four features ([005], [007], [009] and [011]) at the northeast end of the area were investigated by digging slots into them (Figure 4 and Figure 3 for the location of the slot). All features were oriented northeast-southwest. The fills of these features (004), (006), (008) and (010) were moderate to loosely compacted mid-yellowish brown silty sand with frequent sub-rounded stone inclusions and occasional roots. [005] was 1.3m wide and 0.24m deep. [007], [008] and [009] ranged in depth from 0.06m to 0.07m and in width from 0.7m to 0.92m. All features continued across the entire 15m area northeast-southwest.
