Fisher Court, Knockentiber, East Ayrshire: Archaeological Evaluation

Data Structure Report

by Sarah Krischer issued 5th January 2018 on behalf of Ms MacAllister

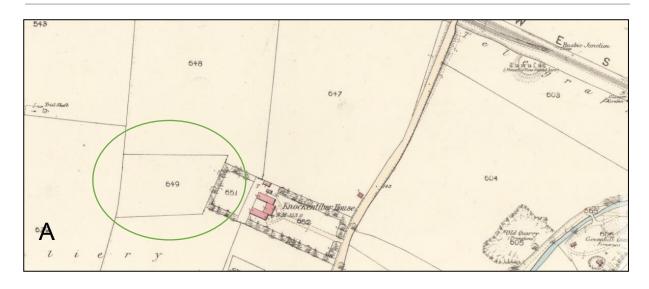
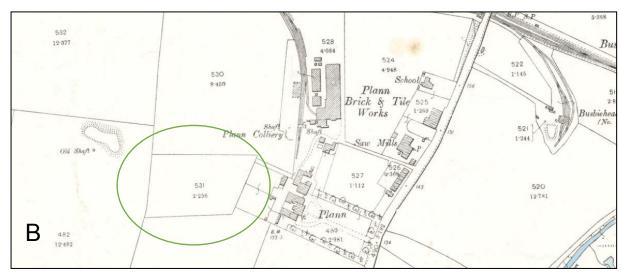
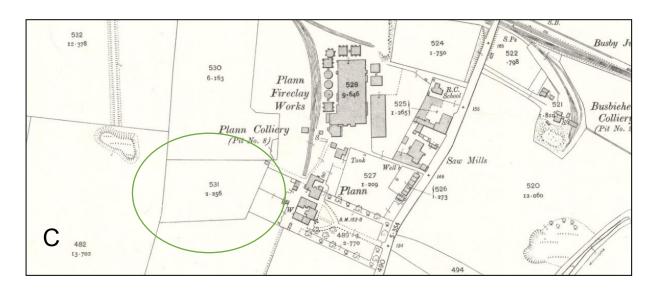
Figure 1: Historic Ordnance Survey maps from (a) 1860 (b) 1896 and (c) 1910

- 3. Historical mapping (see Figure 1) shows that broadly the field within which the development area lies has consistently been a single field since at least 1860. Site inspection reveals an improved field bounded by substantial hedgerows to the immediate west of Knockentiber. Colliery activity is depicted on the historic map sequence in the surrounding area though there are no surface workings within the field.

- 4. Access in the NE corner of the field is onto an area of modern hardstanding. The 3rd edition Ordnance Survey (Figure 1c) shows a structure in the NE corner of the historic field, however this corner has been cut off the field and is now part of the neighbouring residential property.

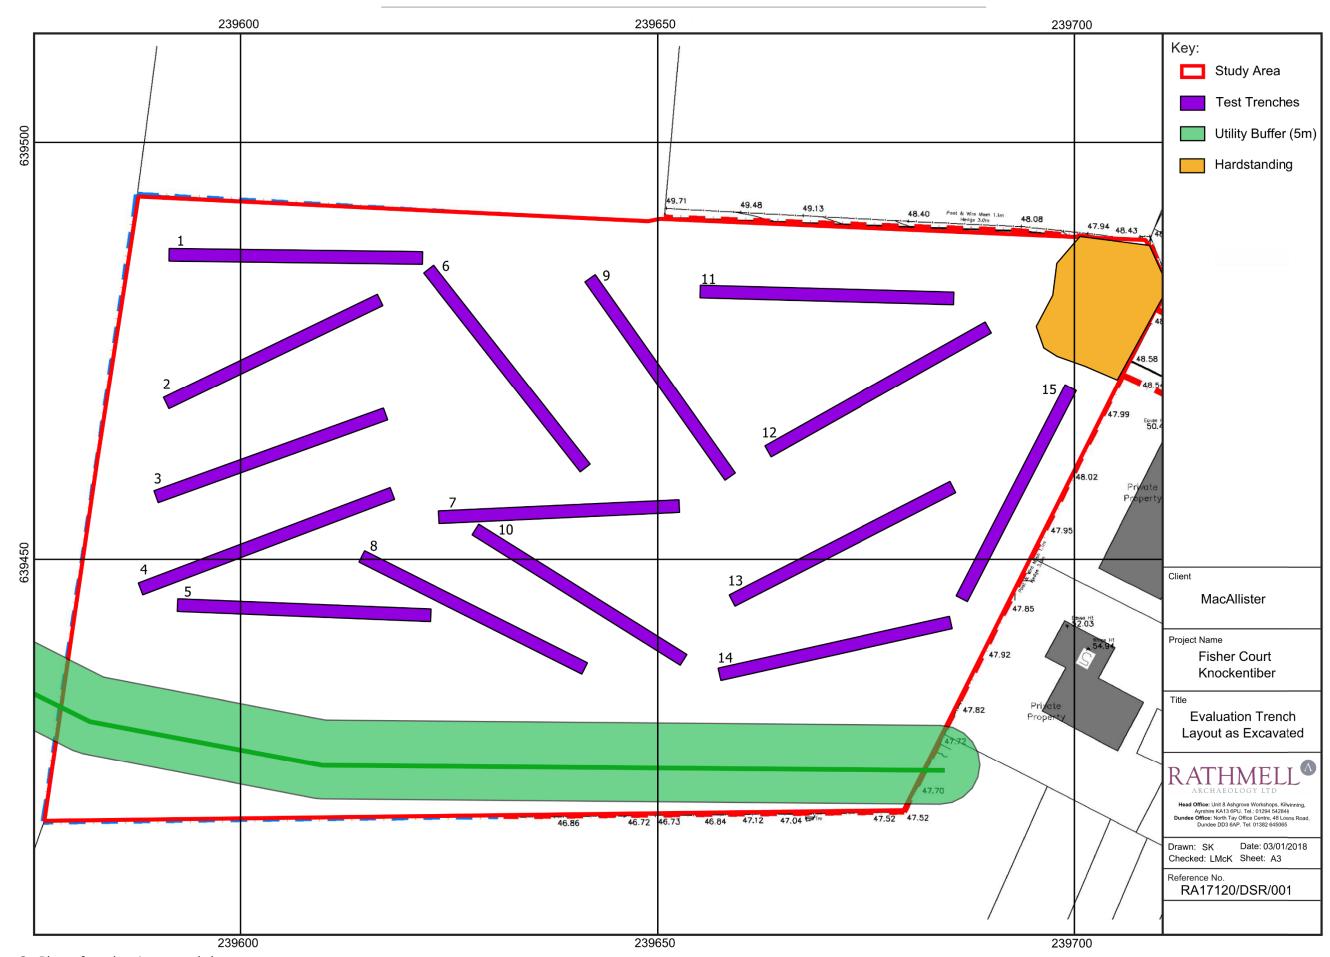
Figure 2: Plan of evaluation trench layout.

- 8. The objective was to determine the presence or absence of archaeological deposits that might be affected by the later construction work. The available portion of the development area that was subject to evaluation was 0.91ha. The West of Scotland Archaeology Service required an 8% trial trenching sample of the area, hence a target of 730m² of trenching. The Written Scheme of Investigation agreed fifteen, 1.6m x 30m, trenches within a proposed layout (Rees 2017). A total of 752.32m² was excavated, slightly more than the required 8% of trenching. Due to the presence of the electricity service farther north than anticipated it was necessary to adjust some of the trenches in order to maintain a sufficient buffer zone (Figure 2).

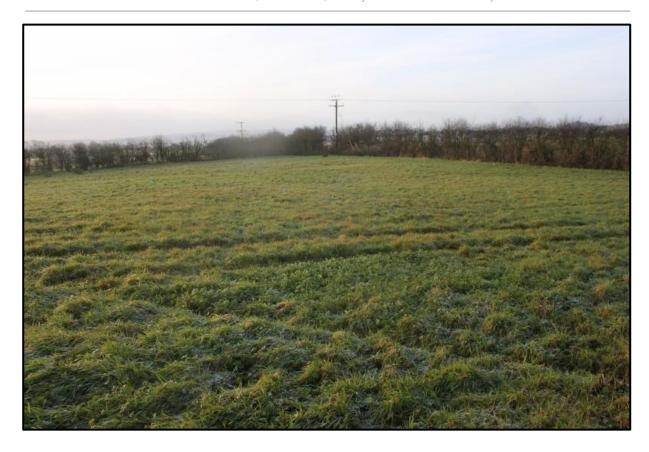
- 10. In total, fifteen evaluation trenches were excavated across the available portion of the development area, using a tracked 360° mechanical excavator with a toothless 1.6m ditching bucket. The development area was a grassy field which sloped down to the east, west and south from a small rise in the north (Figure 3a).

Figure 3a: Pre excavation view of the evaluation area. From the NE.

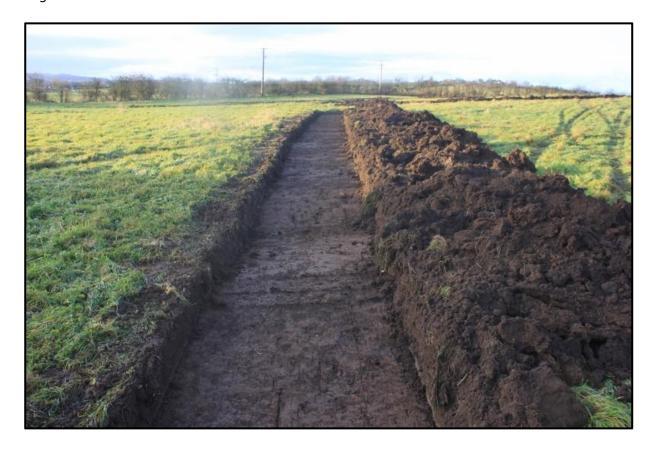
- ❖ (003) was a mid-orangish grey brown clay with small to medium size stones and frequent manganese inclusions (Figure 3b). It was found throughout the development area and dug into between 0.10 to 0.20m; and

Figure 3b: Post excavation view of Trench 12. From the NE.

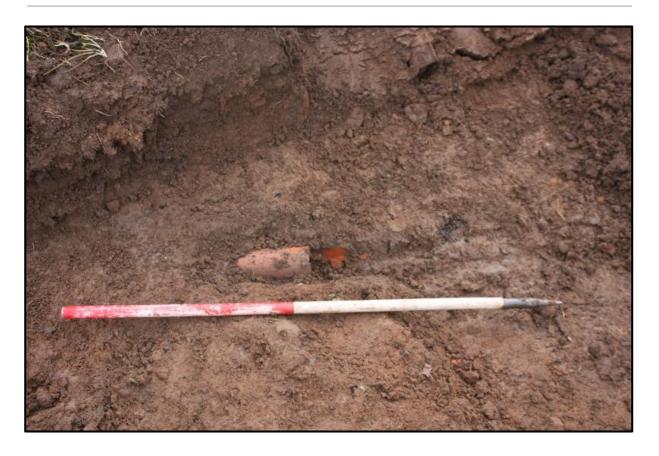
- 14. The slots for the two white tile drains were 0.28 to 0.30m wide and 0.37 to 0.40m deep. The segments of ceramic pipe set at the base of each slot are 0.25m long and range in width from 0.15m to 0.21m. Drain (005) runs north-south and (010) runs northwest-southeast (Figure 4b). The slots for the three red tile drains were between 0.25m and 0.31m wide and had a depth of 0.35m to 0.42m. The segments of ceramic pipe set at the base of each slot were between 0.23m and 0.25m long and 0.14 to 0.16m wide (Figure 4a). (007) and (009) ran north-south and (008) ran northeast-southwest.

Figure 4a: View of red tile drain (009) within Trench 13. From the NW.

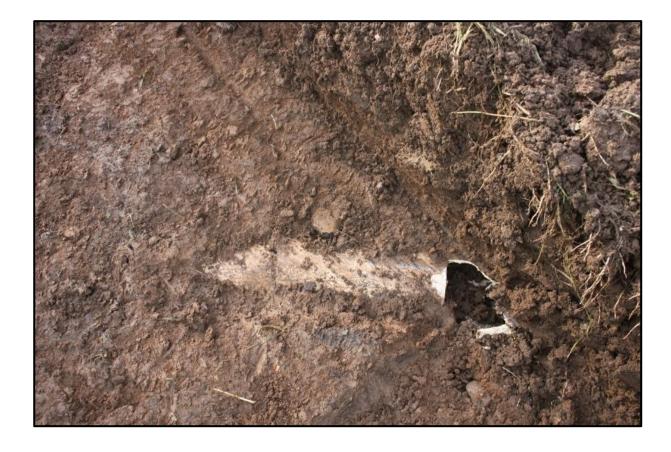
Figure 4b: View of ceramic drain (010) within Trench 15. From the N.
