**Land to the North of 116 Main Street
Newton upon Ayr:
Archaeological Evaluation**

Data Structure Report

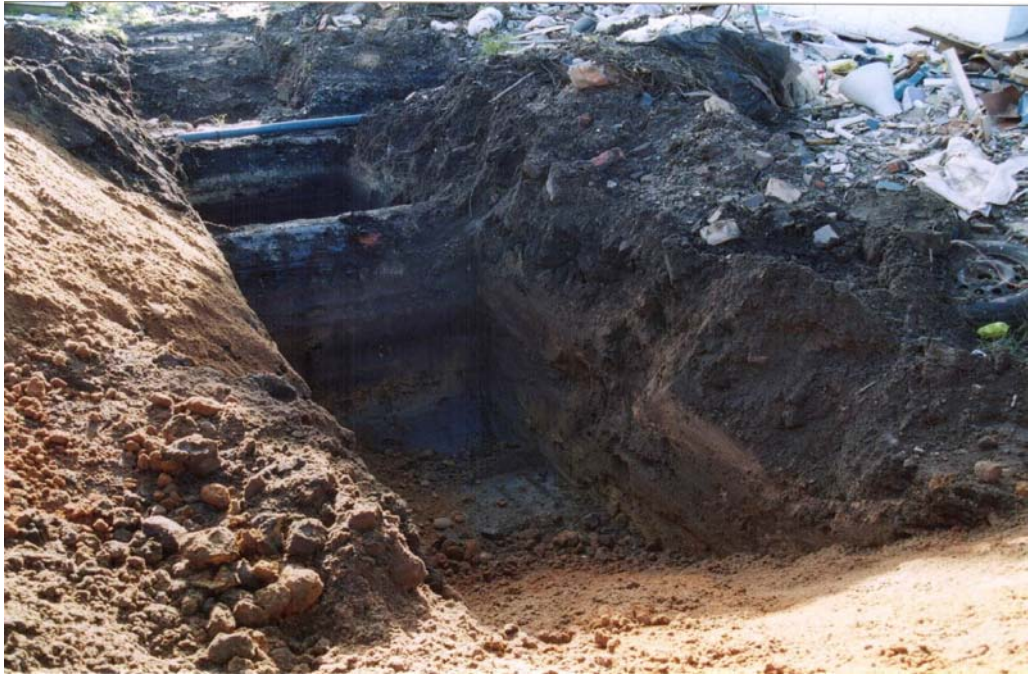
Fig. 3a: General Shot of Trench 2

- 4.3 The top deposit revealed only modern materials: plastic, degraded metal, modern ceramics and window glass. None of these were retained. Trench 1 uncovered one of many iron water pipes within the development area (Fig. 3a). None of these were known to exist and Scottish Water has no record of them. They may have been constructed privately whilst the ground was disused. These pipes are found at a relatively shallow depth of 200-300mm. Three of them run N-S while three run E-W meeting at (at least) one junction found in Trench 2.

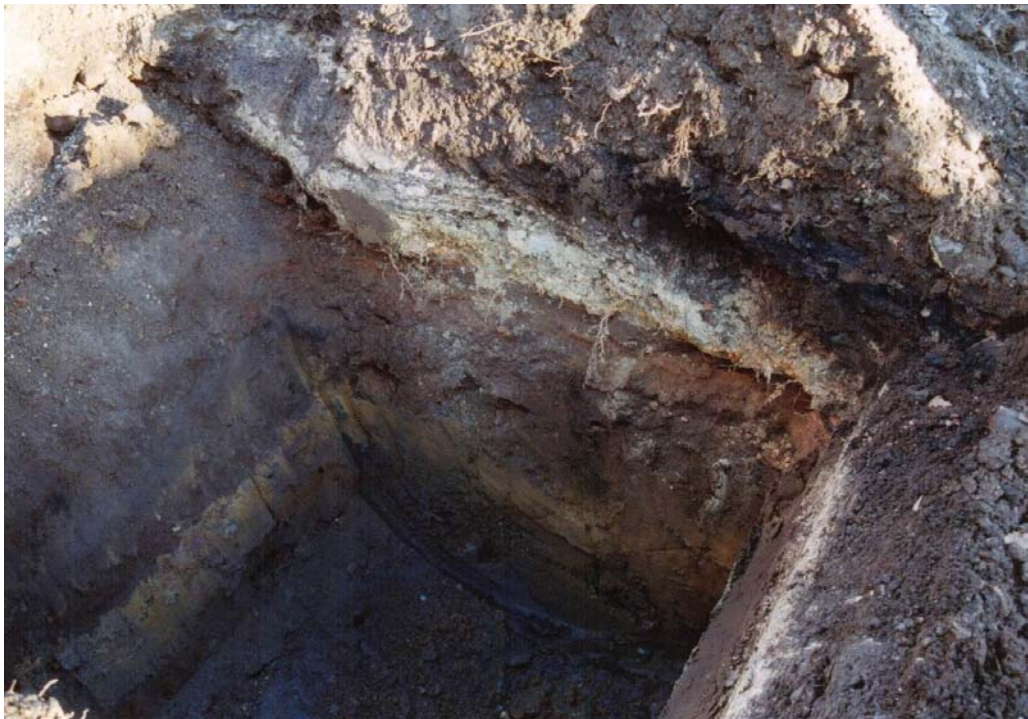
Fig. 3b: Sample Section Shot of Trench 2

- 4.2 The stripping was undertaken using a 1.6m wide toothless ditching bucket. Here, mixed waste materials were removed to reveal mixed demolition debris that comprised of a white lime mortar and brick waste. The underlying sediments were fairly uniform in depth and texture sitting on natural subsoil at a maximum depth of 1.45m. These consisted of brown sand and dark yellow clay, possibly levelling material for the site, and probably a modern deposit. Sample sections (Fig. 3b and Fig. 3d) show the depth and nature of the sediments. The natural subsoil onsite consisted of dark blue-grey stony sand: no charcoal or any other cultural material was recovered from these lower deposits. It is likely that these deposits are an indication of modern (early to mid-twentieth century) landscaping which may have removed any underlying archaeological structures.

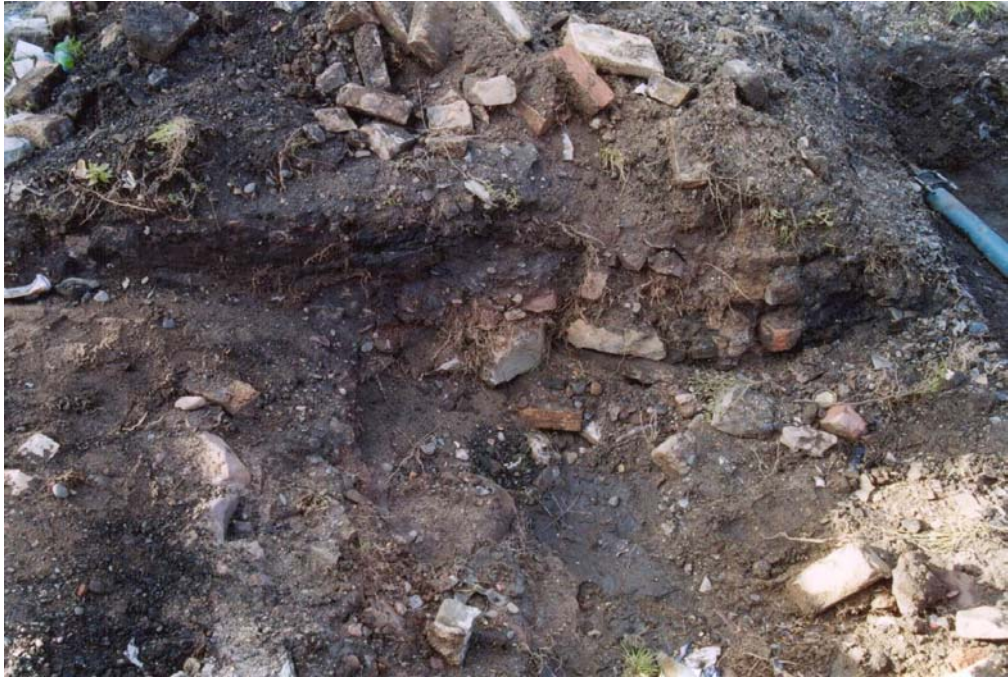
Fig. 3c: General Shot of Trench 2: Shallow Cobbled Surfaces

- 4.4 Several modern surfaces were encountered at fairly shallow depths in Trench 1; two cobbled surfaces in particular (Fig. 3c). These probably relate to a nearby twentieth century Lemonade factory or are earlier versions of Damside to the north. Indeed the site is known to have been fully occupied by buildings in the late nineteenth century (see Fig. 2d) but was open ground by the early twentieth century (see Fig. 2e). It is probable that the cobble surfaces and levelling deposits relate to forming this open ground after the demolition of the structures.
